August 14, 2020									
Miller Searight House									
5400 Fredrich La									
Austin TX 78744									
Window Survey									
Compiled September 20   Vincent P. Hauser Architect									
Abbreviations									
sll Hot rolled Steel / industrial type									
csll Cold rolled steel / Hollow metal fire windows									
wd cmt Wood casement									
wd dh Wood double hung									
wd fx Wood fixed									
Condition notes									
1 Good - Complete and repairable for rehabilitation									
2 Fair - Damaged or missing elements but repairable for conventional rehabilitation *									
3 Poor - Significant missing and / or rotted elements and not repairable for rehabilitation									
4 Missing sash and / or frame or both									
*Note Excluding Texas Windstorm Requirements									
Building Façade / Level									
Window # Window Type Hist Non Hist Condition Notes, Min work Preferred Option Window Chronology

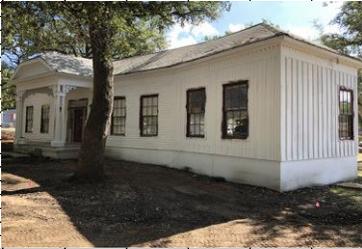
West façade view to north

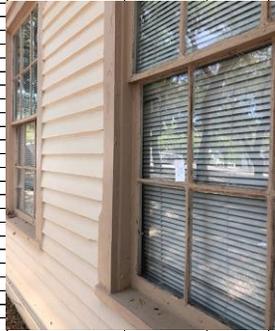
20. Detail of muntins

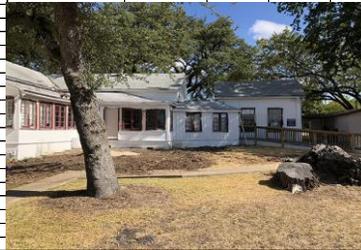
South façade at porch and addition  
Note: Porch windows are non-historic  
Porch to be rebuilt in similar configuration with all new windows  
Variances from current configuration provided to allow suitable porch roof flashing to historic east wall

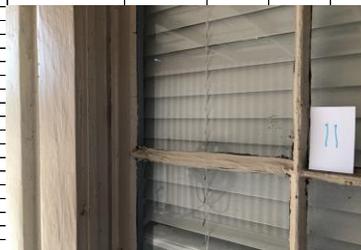
11. Detail at muntin

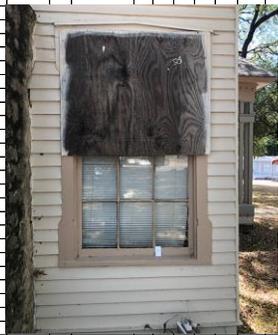
18. North façade. Upper sash missing
