Third Coast Home Inspection

PROPERTY INSPECTION REPORT

Concerning: 1205 Taylor St, Austin, TX 78702
(Address or Other Identification of Inspected Property)

By: Craig A Boarini, Lic #10498 10/23/2020
(Name and License Number of Inspector) (Date)

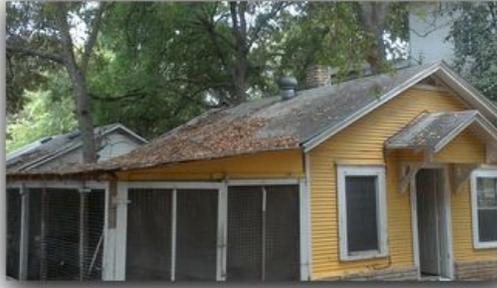
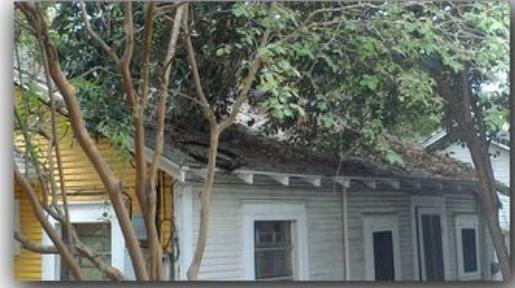
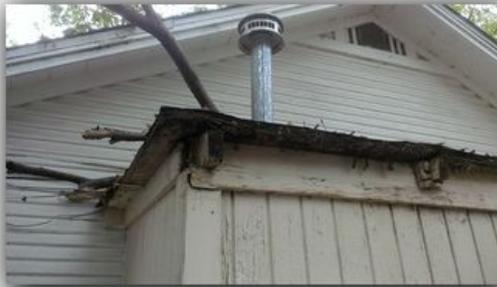
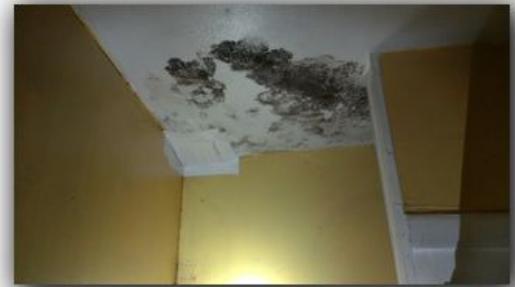
- For total condition and longevity, have roof checked by a certified Roofer.
- Roof shows signs of age, fibers showing on the shingle edges, thinning sand, hail and or tree damage. - Have checked by a certified roofer for total condition and longevity.

Roof shows signs of age, fibers showing on the shingle edges, thinning sand, hail and or tree damage. - Have checked by a certified roofer for total condition and longevity.

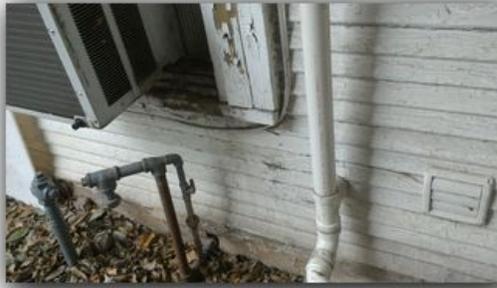
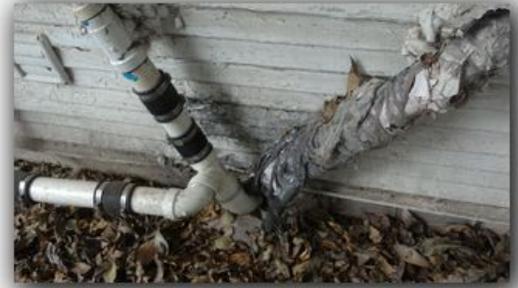
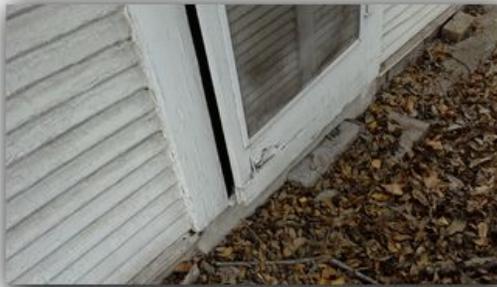
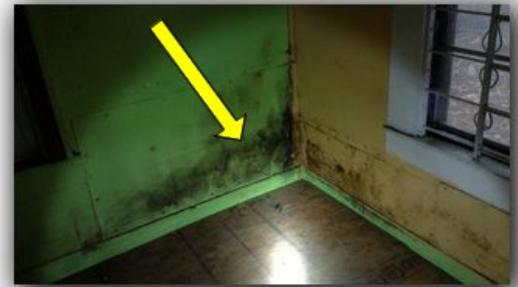
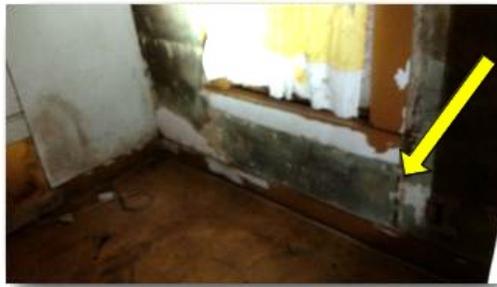
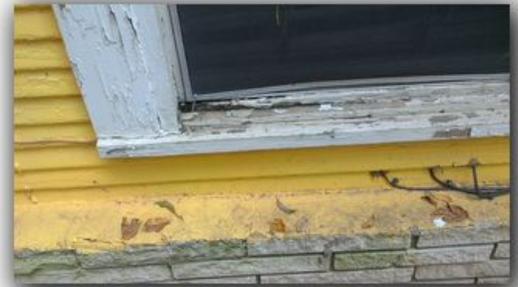
- Mold on interior walls in various locations, evidence of water intrusion in various locations.

- Exterior siding and trim is in very poor shape

Mold on interior walls in various locations, evidence of water intrusion in various locations.

Exterior siding and trim is in very poor shape

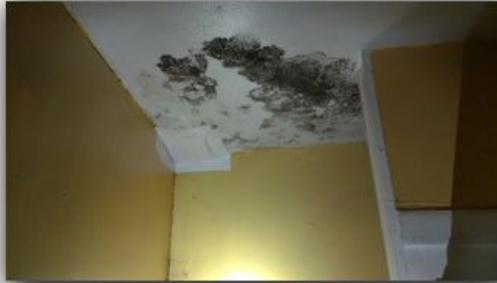
- Mold on the ceiling in the southwest corner,,evidence of roof leak and water intrusion.

Mold on the ceiling in the southwest corner, evidence of roof leak and water intrusion.

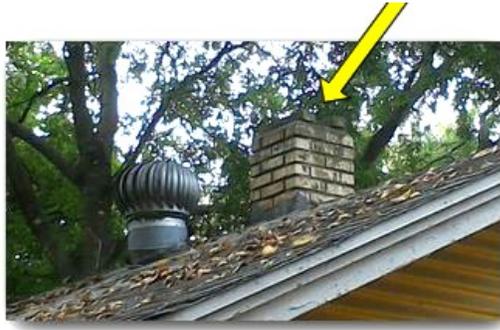
Old chimney on roof that doesn't connect to anything in the house is open, needs to be capped to keep rain and animals out of the attic.

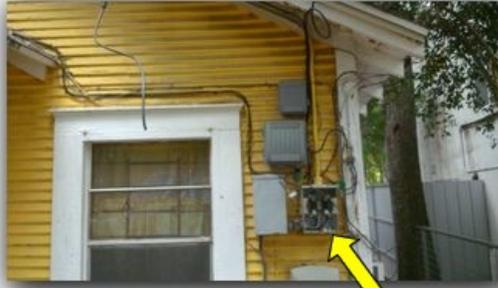
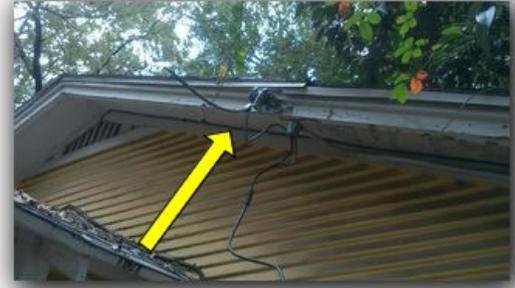
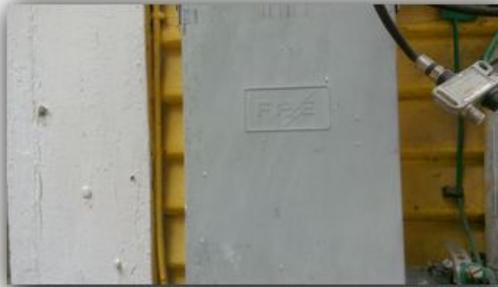
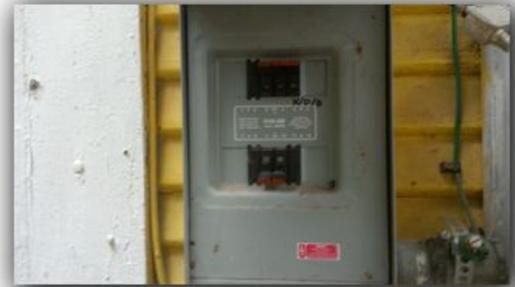
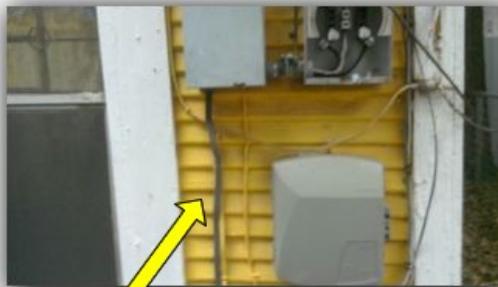
Main power supply wire to the electric meter is unprotected. - Safety hazard (Suggest the installation of a proper mast), power has been cut off from the pole to the building.

Main or sub electric panel is a Federal Pacific, or Zinsco Brand panel and are a known fire hazard. (No scorching was present at the time of inspection)

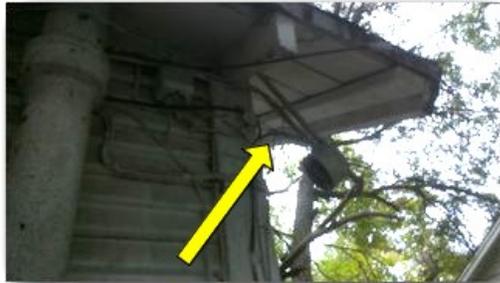
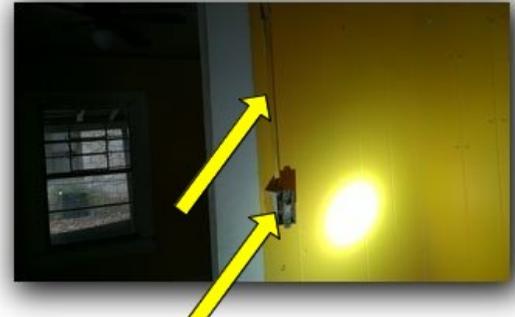
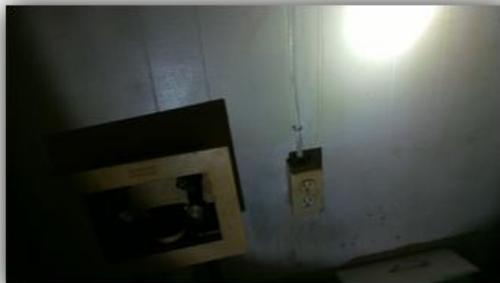
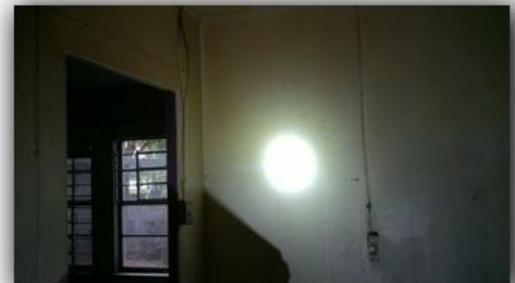
- All electrical outlet and switch wires come from the attic and run down the wall, connections in attic not seen due to access,. But there is a concern about the junctions made up in the attic..
- Loose, damaged, missing outlets / switches / covers - Safety hazard

- Smoke alarms are not present in each sleeping area
- No smoke alarm in hallway
- Missing Carbon Monoxide detectors when gas supply is present on the property - Safety Hazard

Unprotected wires interior/exterior of the structure in various locations - Safety hazard

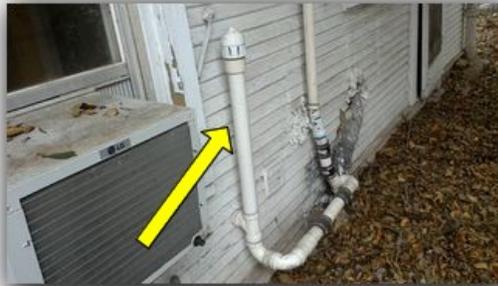
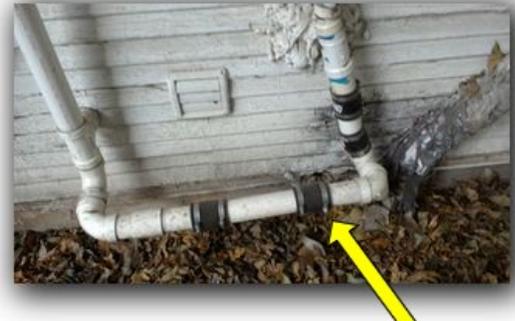
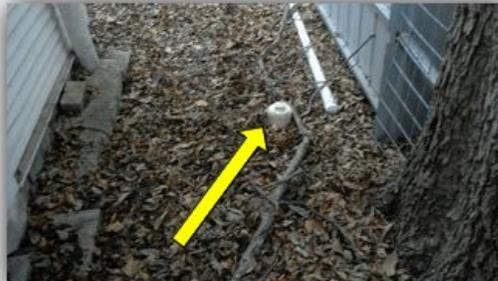
- Plumbing vent on the west side doesn't go above the roof, line is spliced and pieced together.
- Sewer Clean Out is located on the: west side

- Water heater is not working. - Hasn't been on in 15 years

Plumbing vent on the west side doesn't go above the roof, line is spliced and pieced together.

Water heater is not working. - Hasn't been on in 15 years
