**Austin 10/26/2020**

**Re: Existing Residential Foundation and Superstructure Assessment**

808 Avondale Rd, Austin, TX 78704

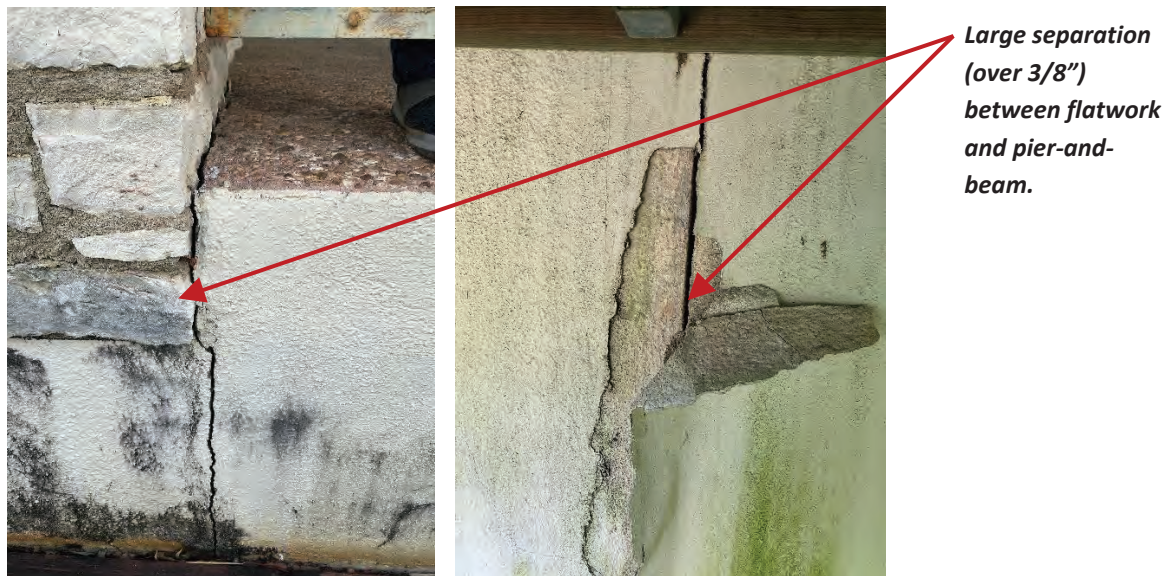
Figure 4. Dissimilar foundation types

- Dissimilar foundation types: “slab on grade” and “pier-and-beam” and concrete flatwork. The original structure was built on a “pier-and-beam” foundation. The multiple foundation types, when not properly engineered, *are not a good construction practice and most likely contributed to the extensive signs of distress observed*. Flatwork construction is not an engineered slab and has no structural value to support residential structures. Large separations were noticed between slab on grade/pier-and-beam and flatwork areas, Figure 4.

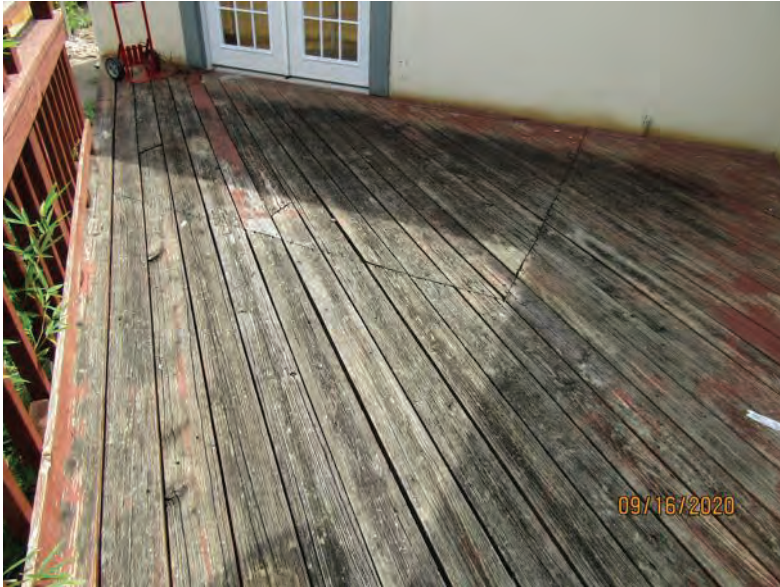
**extensive deck wood rot damage**

*Deficiencies:* The wood decking, guardrail, built-in seating and deck stair step components are substantially rot damaged. Major deck support structure defect conditions were also noted, e.g., the 4x4 posts are undersized and spliced together at several locations, the posts are missing critical diagonal bracing support, the deck beams are improperly secured to the sides of the undersized posts (beams are required to rest on top of beam members), joist hangers support missing under some joist ends, etc., etc. Noted conditions create the potential for catastrophic deck failure under certain conditions, i.e., large groups of people congregating on deck, major storm winds, casual sumo wrestler convention deck get together party, etc. The damaged and open deck edge guardrail structure also creates major fall hazard conditions for children and less-than-mature adults. Noted conditions indicate the need for a qualified engineer to inspect the deck structure and design and oversee all needed repairs prior to deck use.

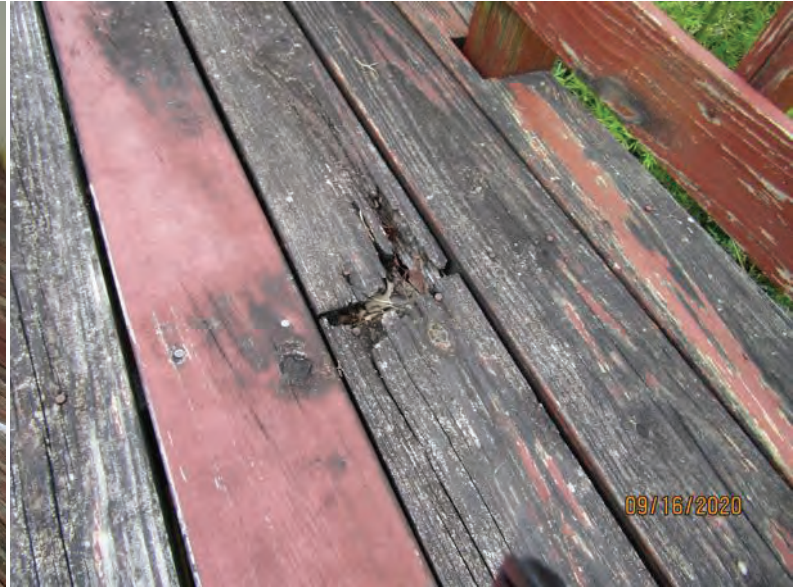
**extensive deck wood rot damage**

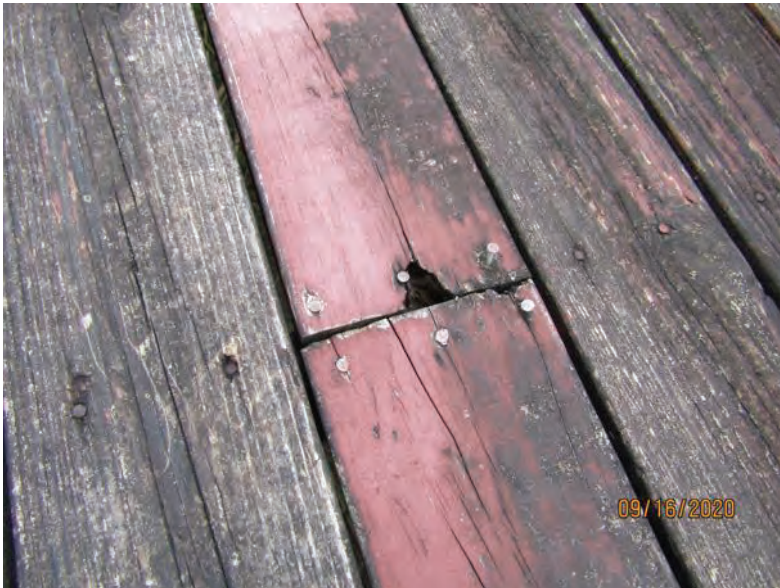
**extensive deck wood rot damage**

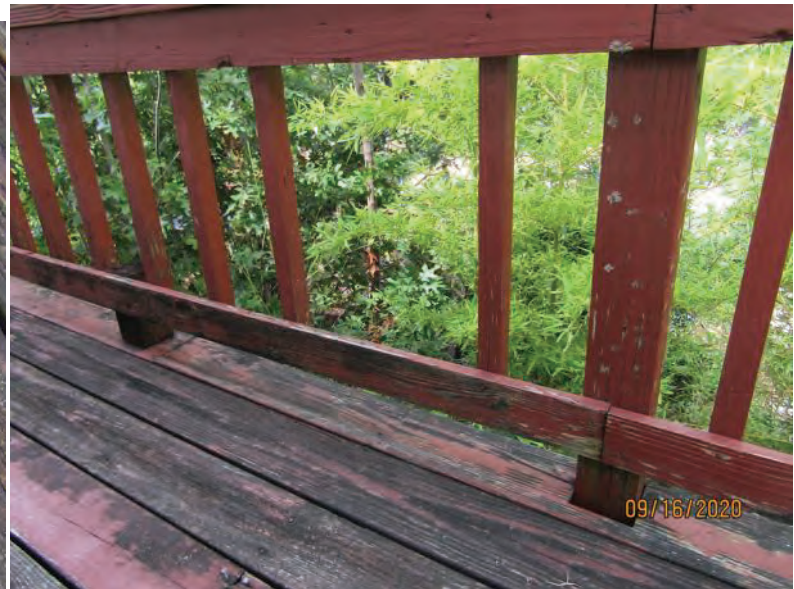
**extensive deck guardrail damage noted and wide baluster spacing creates unsafe conditions**

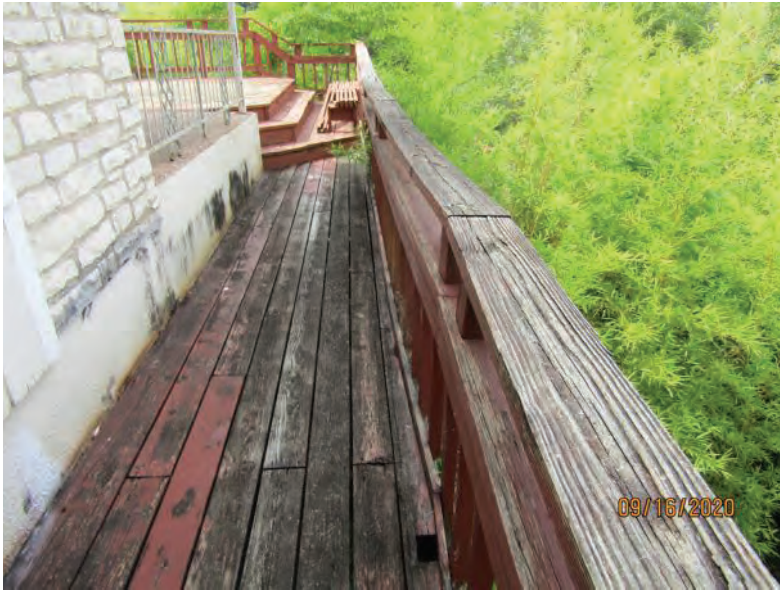
**extensive decking and guardrail structure damage noted**

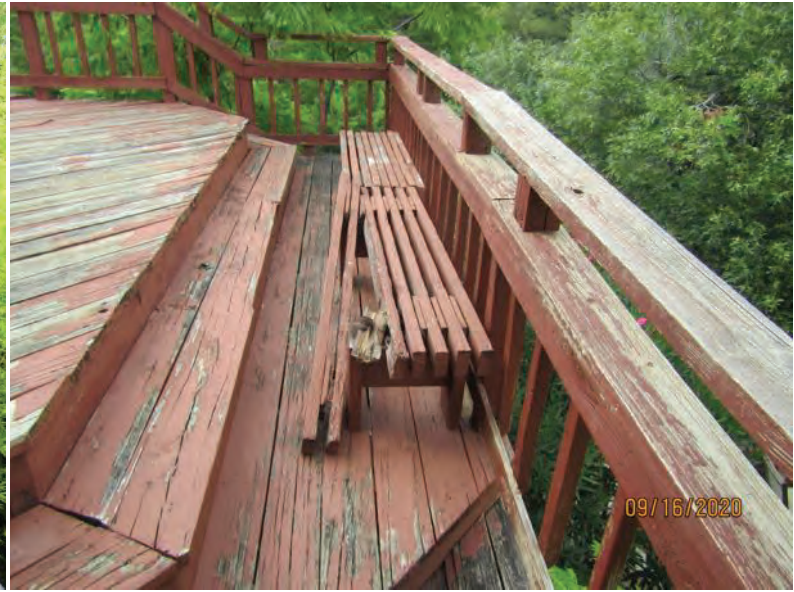
**extensive decking, deck stair, deck bench and guardrail structure damage noted**

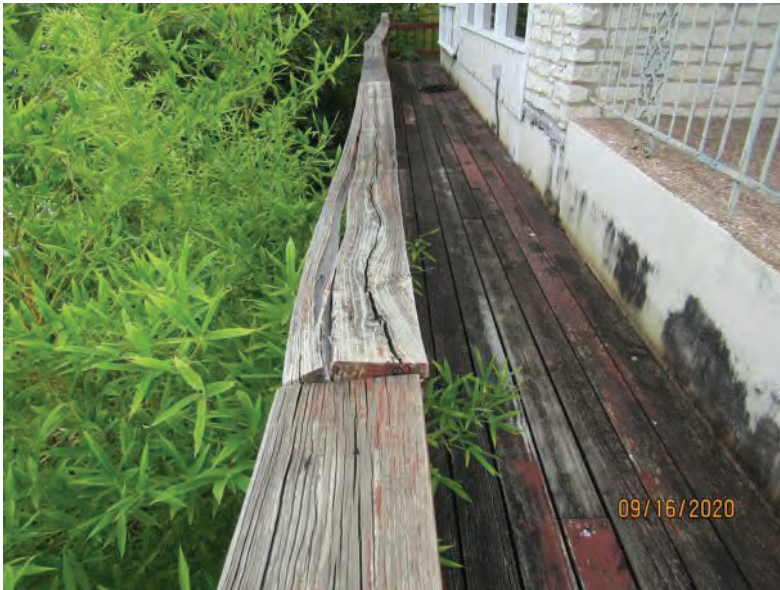
**extensive deck guardrail damage noted**

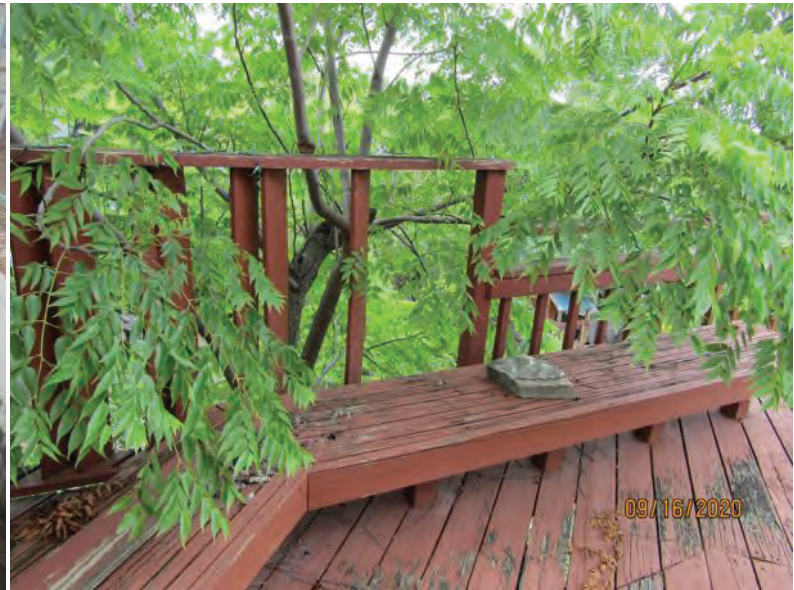
**extensive deck guardrail damage noted**

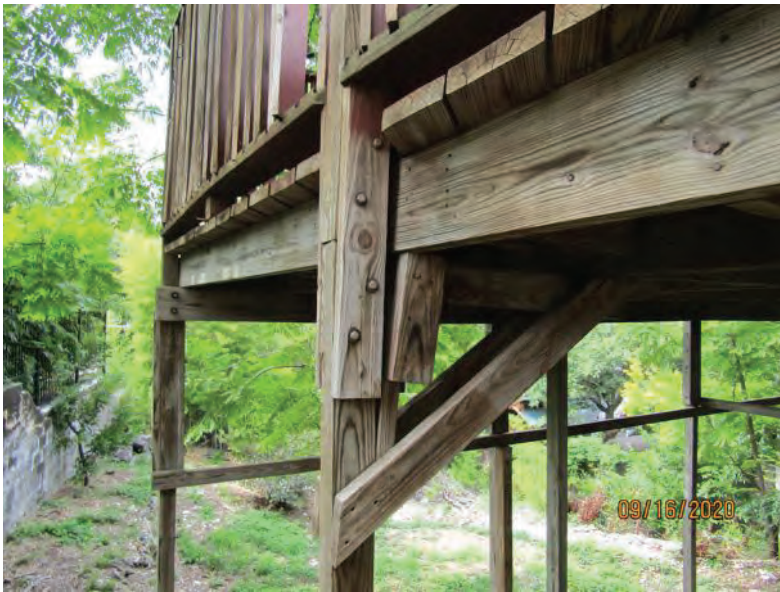
substandard and defective deck support structure conditions create the potential for catastrophic deck failure

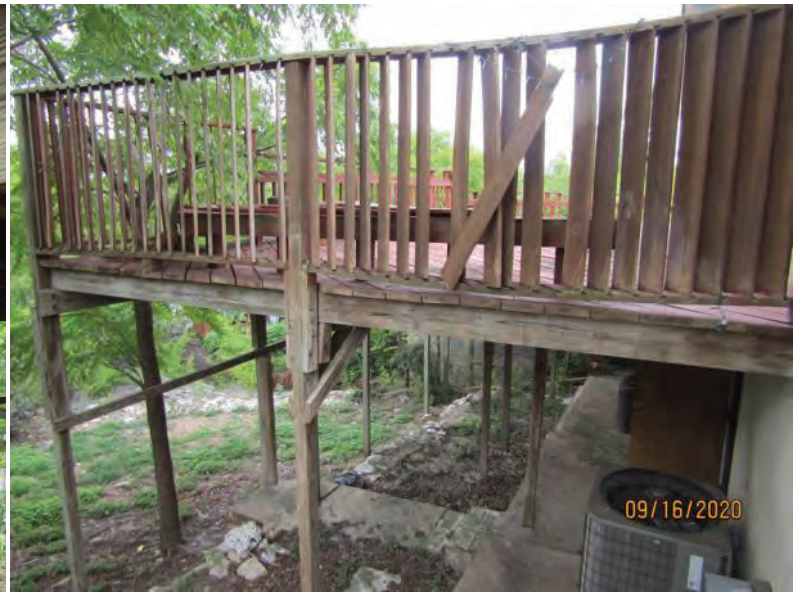
substandard and defective deck support structure conditions create the potential for catastrophic deck failure

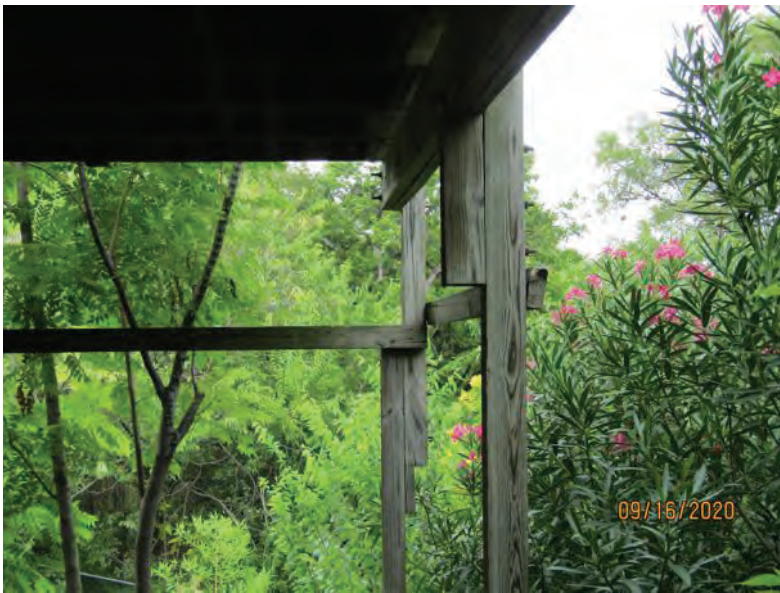
substandard and defective deck support structure conditions create the potential for catastrophic deck failure

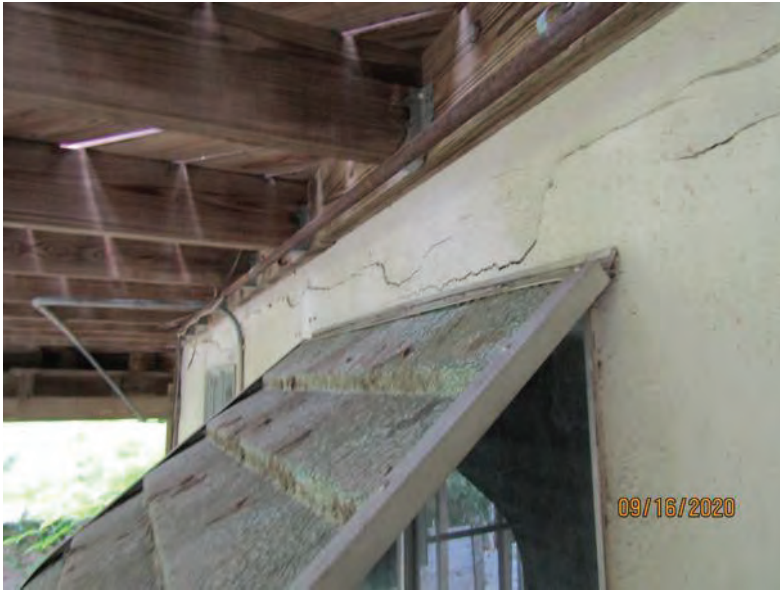
1.2 There are large horizontal cracks running through the lower left side Portland cement plaster coating where the foundation skirt wall ties into the cast-in-place concrete beam structure.

distress crack in stucco coating at left side skirt wall/  
concrete beam joint

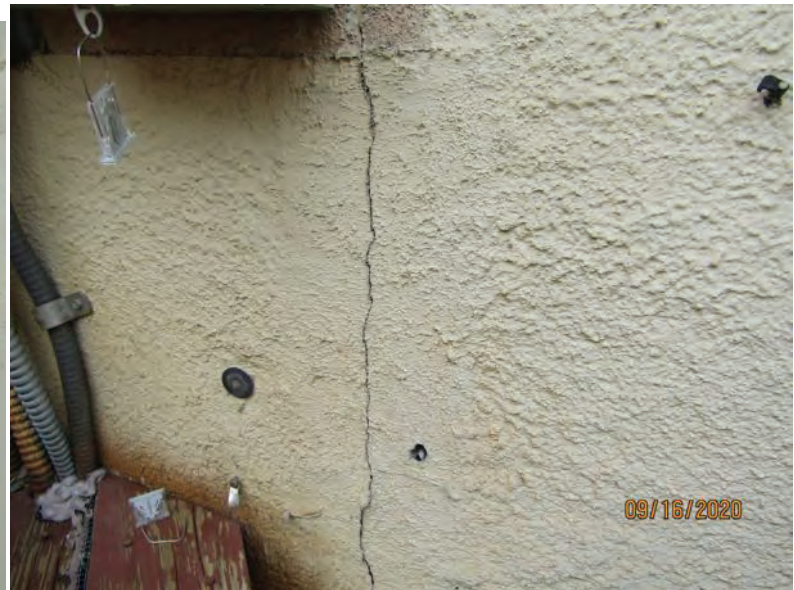
1.1 Stucco and rock veneer siding distress cracks were noted at several locations around the house.

house and foundation skirt wall Portland cement  
plaster/ stucco distress cracks noted at several  
locations around house

1. Stucco and rock siding cracks addressed in the Foundation section of this report should be repaired to prevent water intrusion through the exterior envelope of the building.

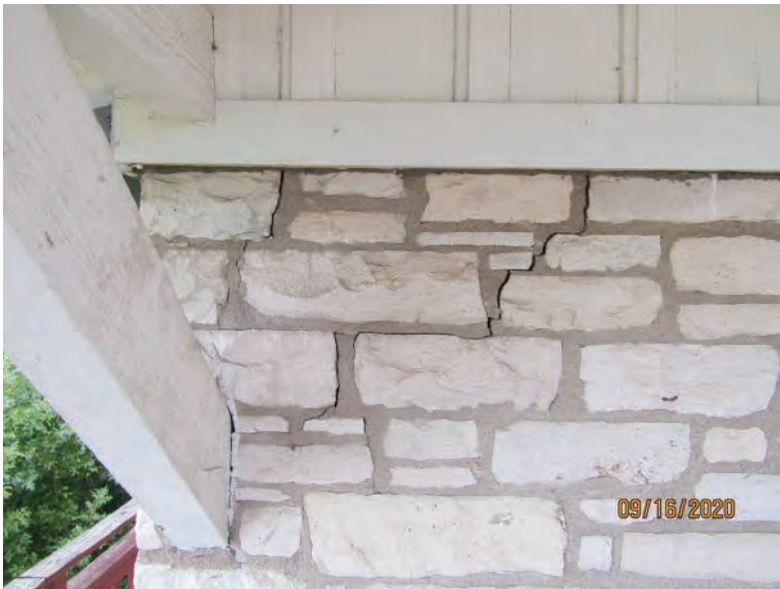
distress crack in rock siding at back left covered  
patio area

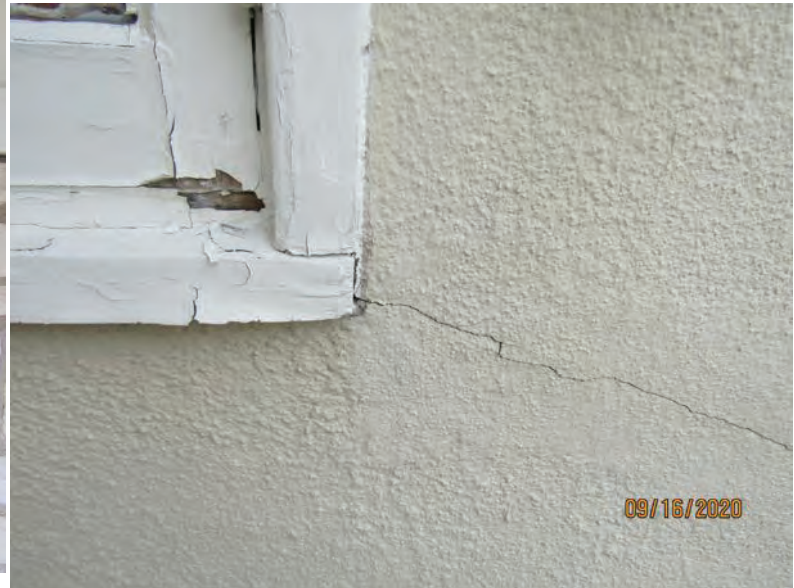
stucco siding distress crack

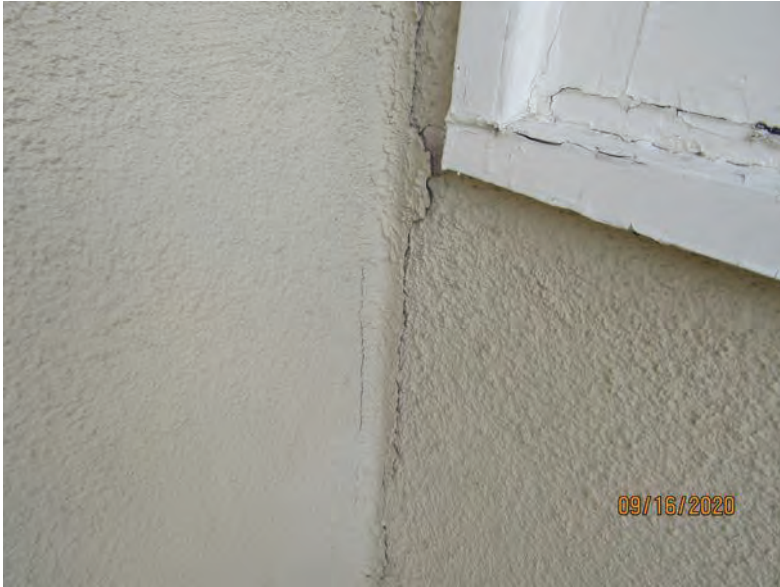
**stucco siding distress crack**

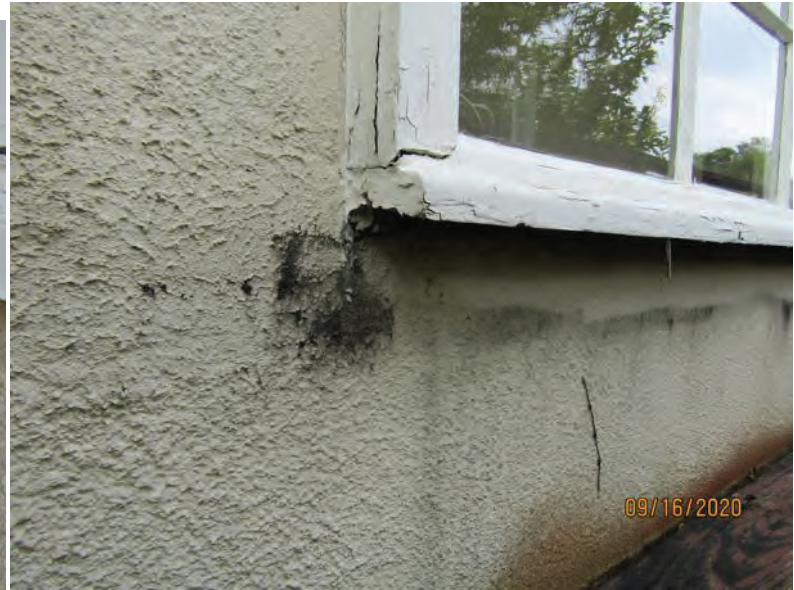
**rot damage to back left window frame wood and mold buildup on siding adjacent to window**

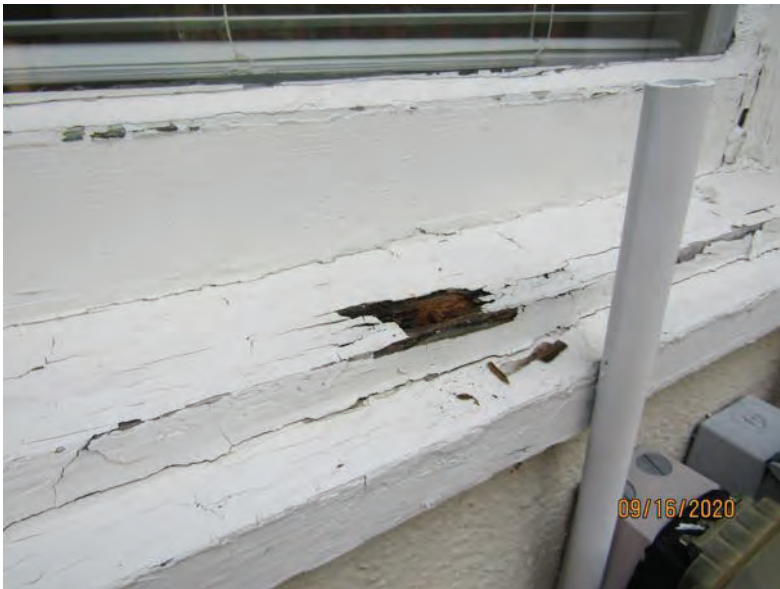
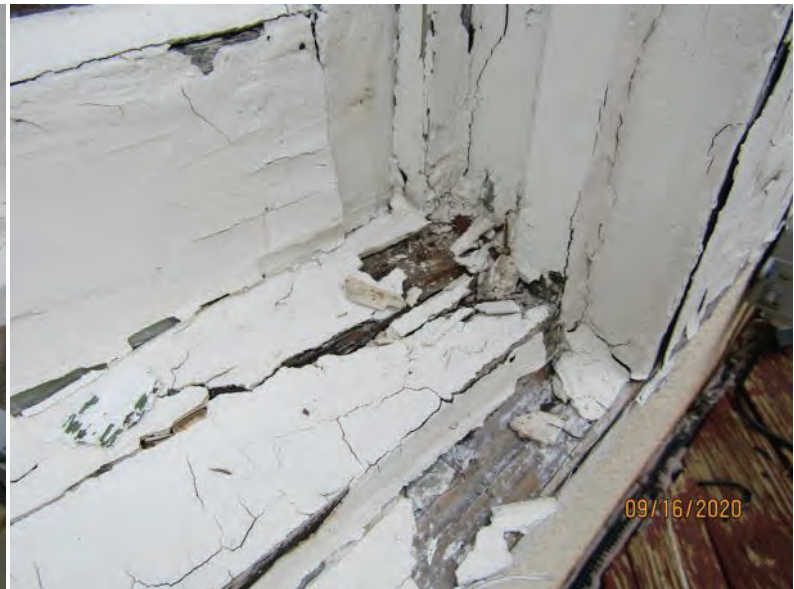
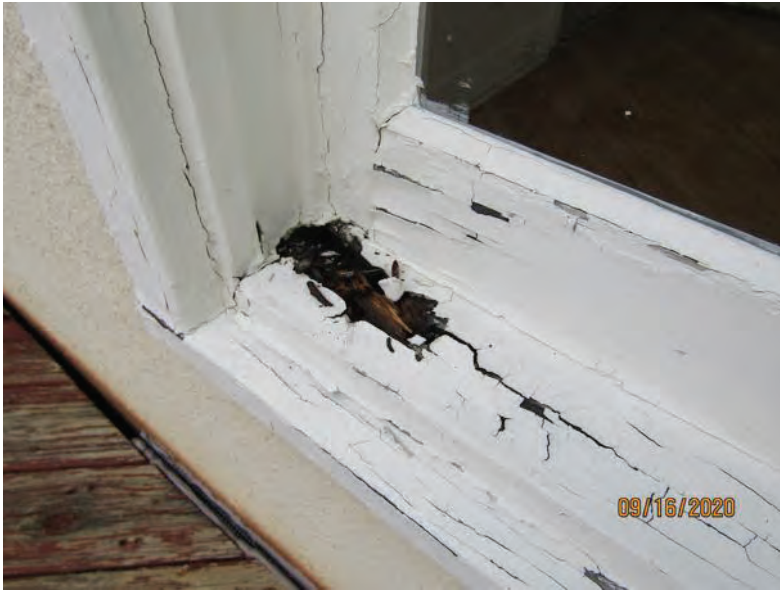
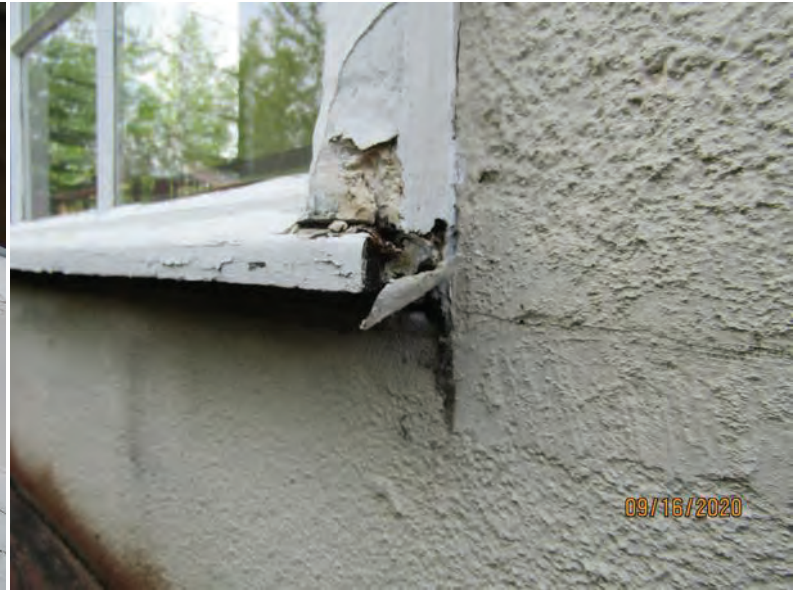
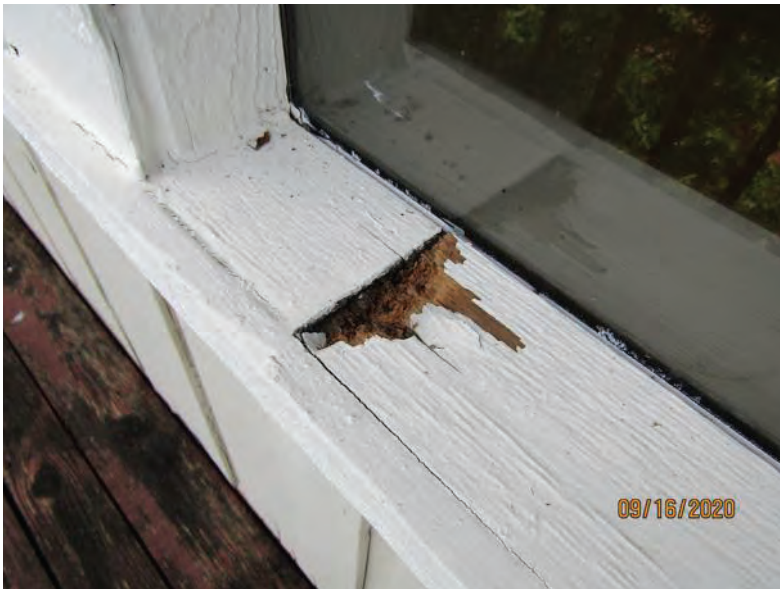
**widespread and major window frame and trim wood rot damage noted**

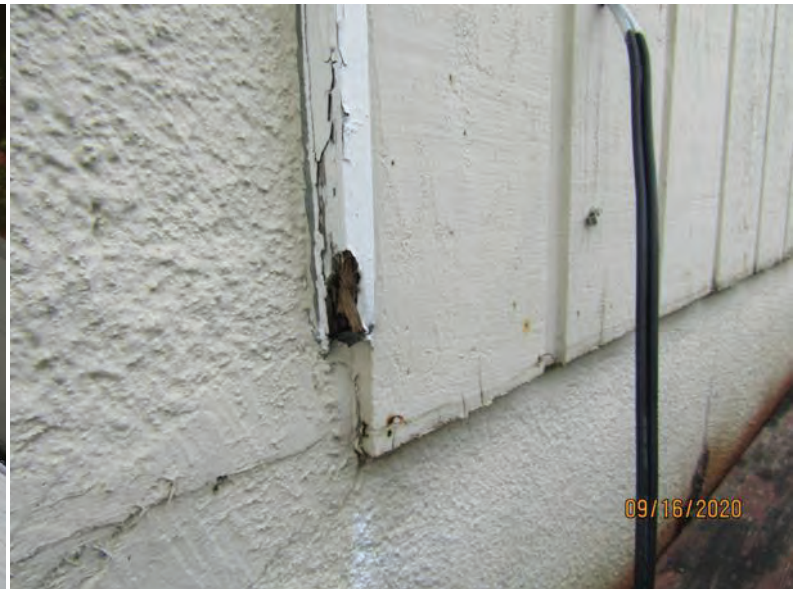
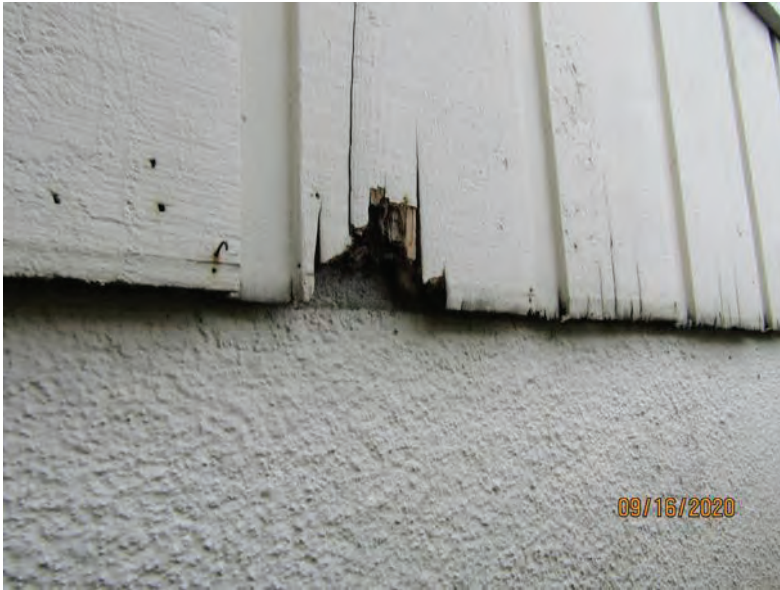
siding and trim wood rot damage noted at several locations around house

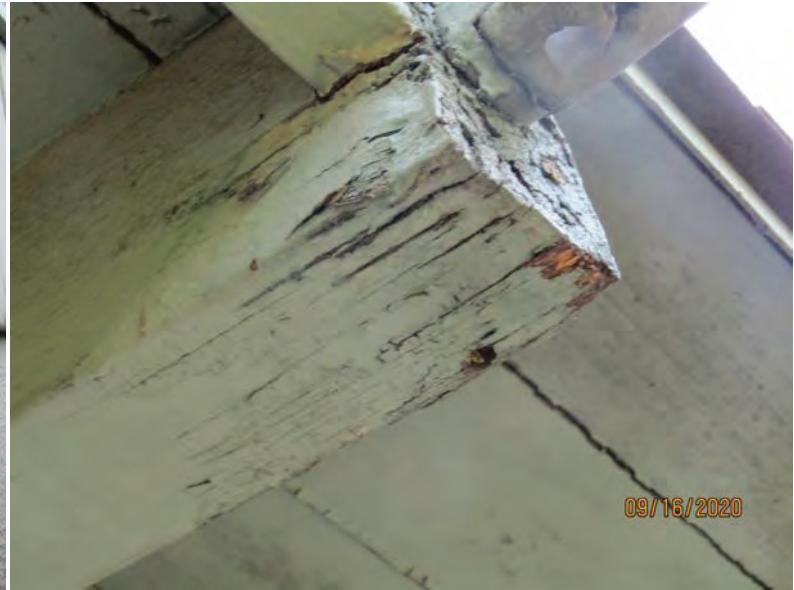
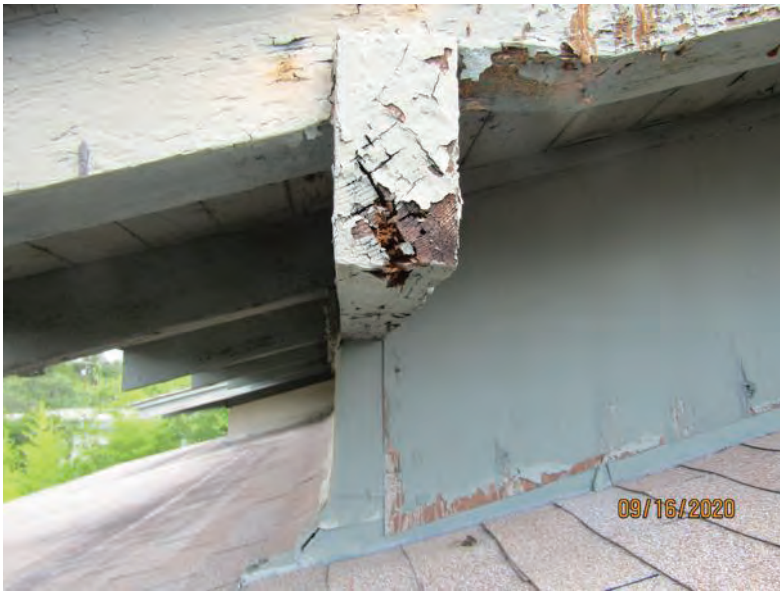
eave rafter tail and bracket wood rot noted at several locations around house

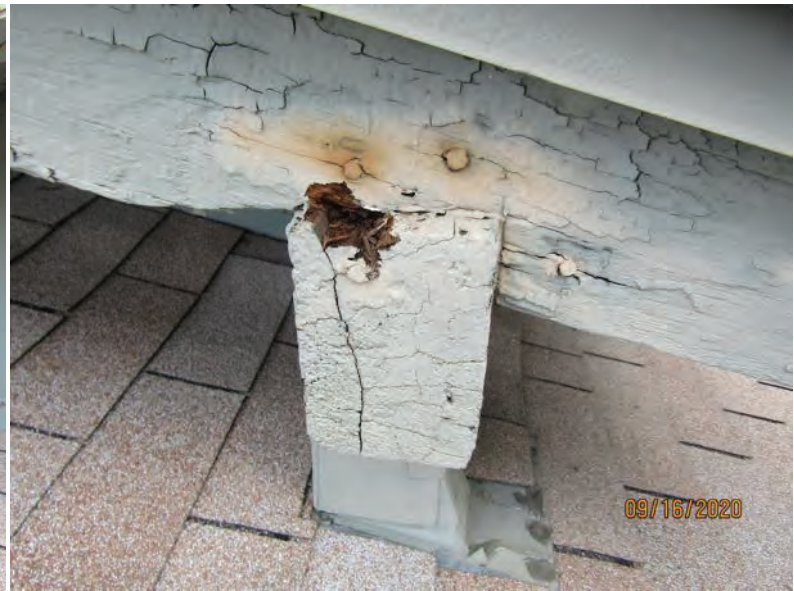
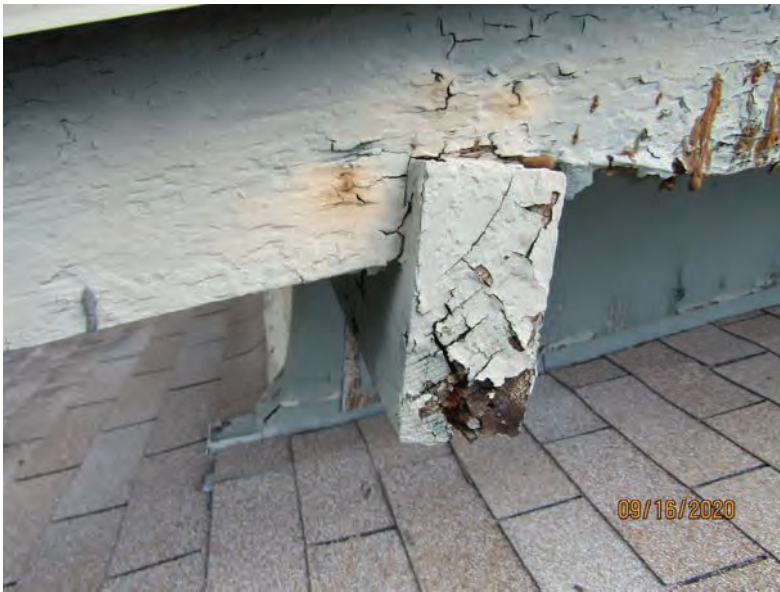
gable barge rafter, eave rafter tail and bracket wood rot noted at several locations around house

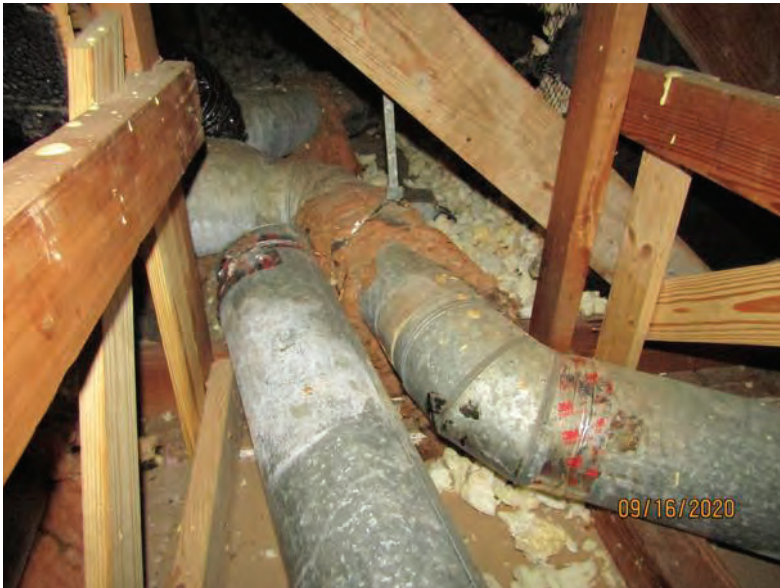
insulation missing or damaged on metal ducting in attic

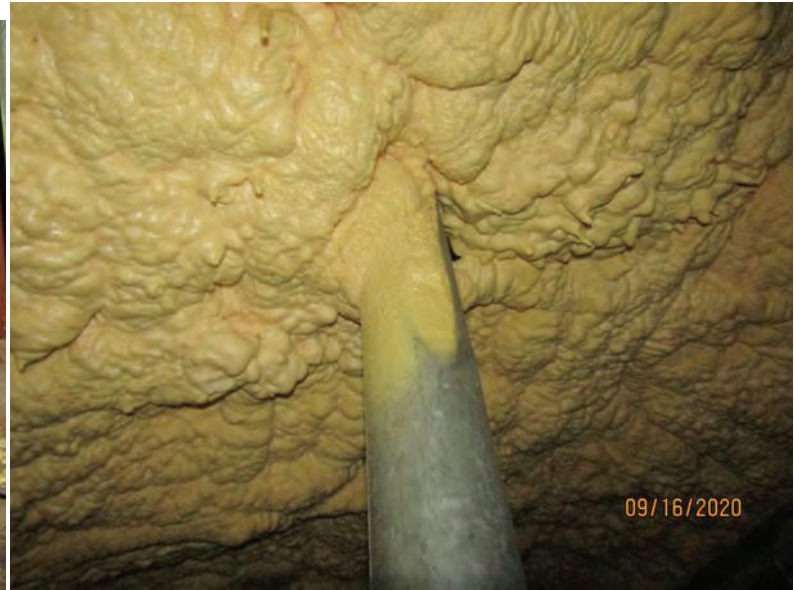
spray foam improperly contacting gas-fired furnace vent piping

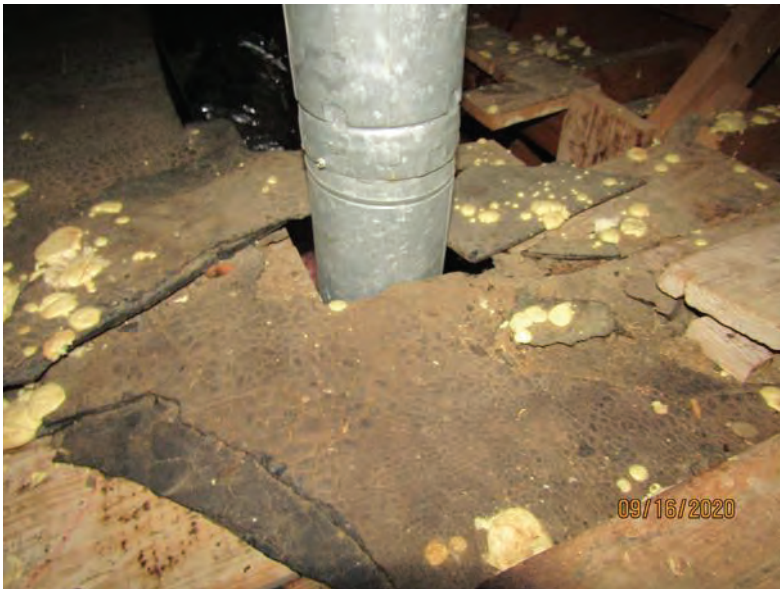
gas-fired furnace vent pipe improperly contacting combustible material over entry foyer furnace closet

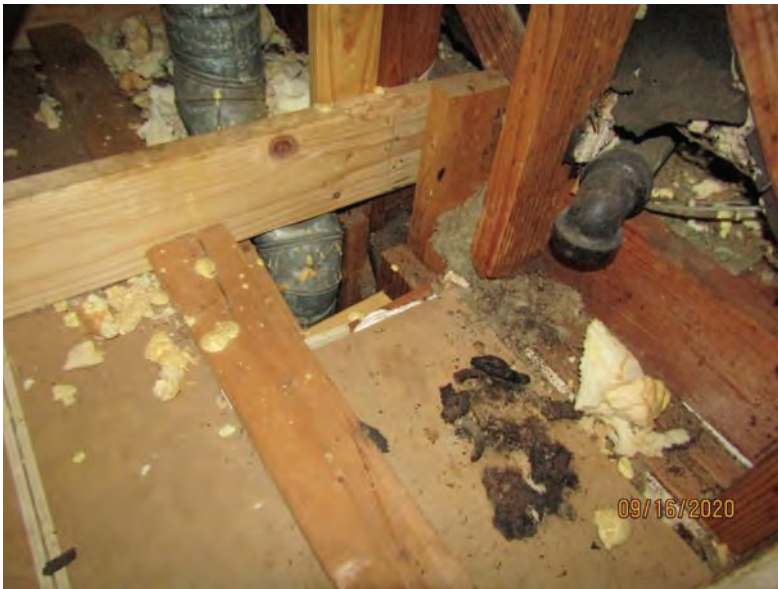
gas-fired vent pipe improperly contacting wood in attic space

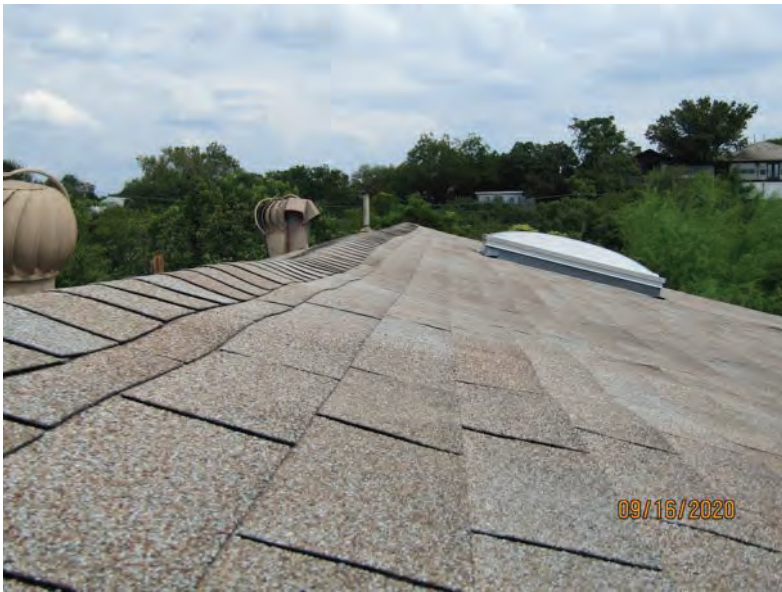
1. Major sag in roof and ridge surfaces at upper left ridge area indicates underlying rafter and ridge framing defect conditions. Spray foam insulation removal would be needed to assess these conditions.
2. No required collar tie framing between rafters or purlin bracing to ensure rafter framing not overspanned.
3. Varmint dropping in attic and damaged HVAC ducting indicate history of major critter infestation to attic area.
4. Spray foam insulation missing over some wall and ceiling surfaces and overall quality of spray foam application poor.
5. Widespread and substantial exterior rafter tail, barge rafter and gable end support bracket wood rot damage noted.

major sag in upper left ridge area roof surface indicates rafter and ridge framing defect conditions

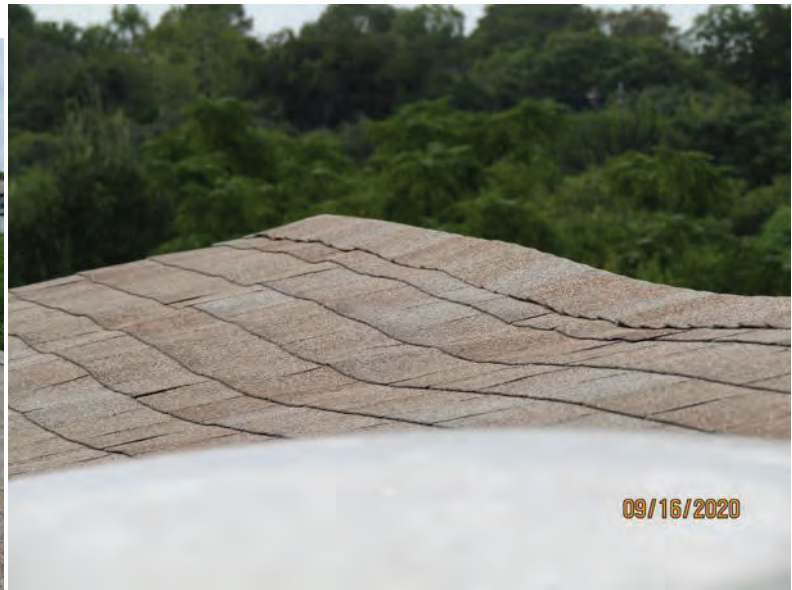
major sag in upper left ridge area roof surface indicates rafter and ridge framing defect conditions (Spray foam covers framing preventing accurate assessment of problem)

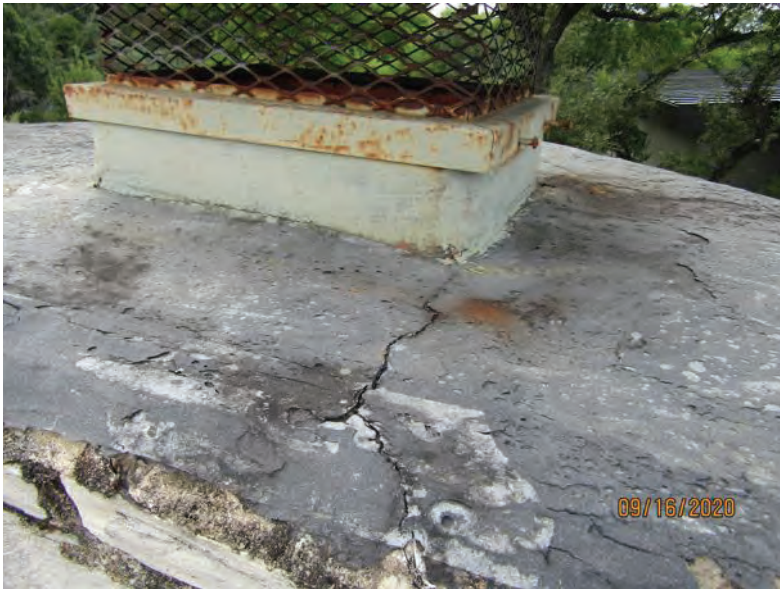
1. The top chimney mortar crown structure is damaged.

chimney mortar crown damaged

A qualified chimney sweep should perform a comprehensive fireplace and chimney inspection and make all needed repairs prior to fireplace use.

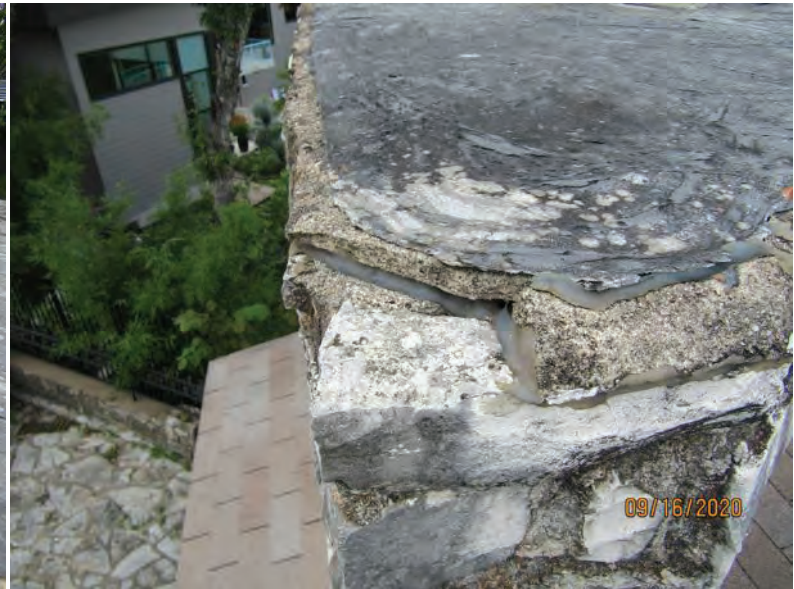
chimney mortar crown damaged

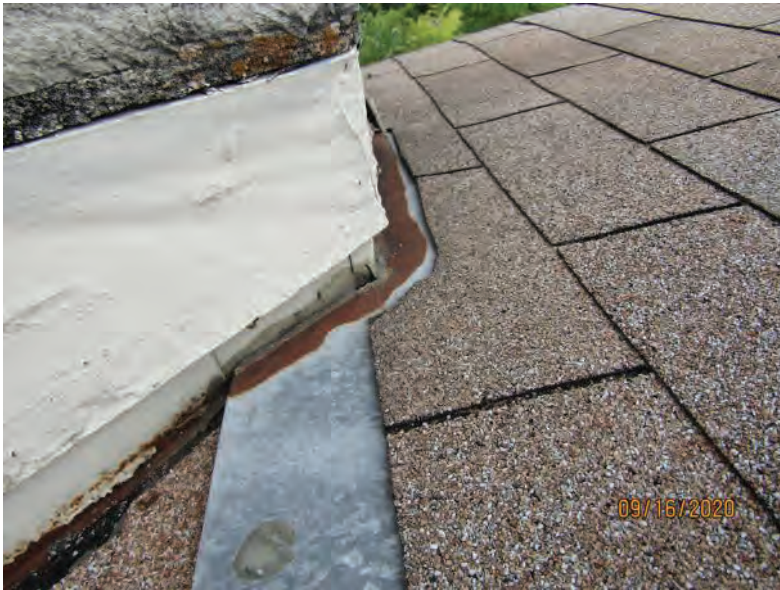
base chimney flashing rust damaged

Recommend qualified roofing contractor make appropriate repairs to correct noted defect conditions and perform a comprehensive roof inspection to determine if any additional defect conditions exist.

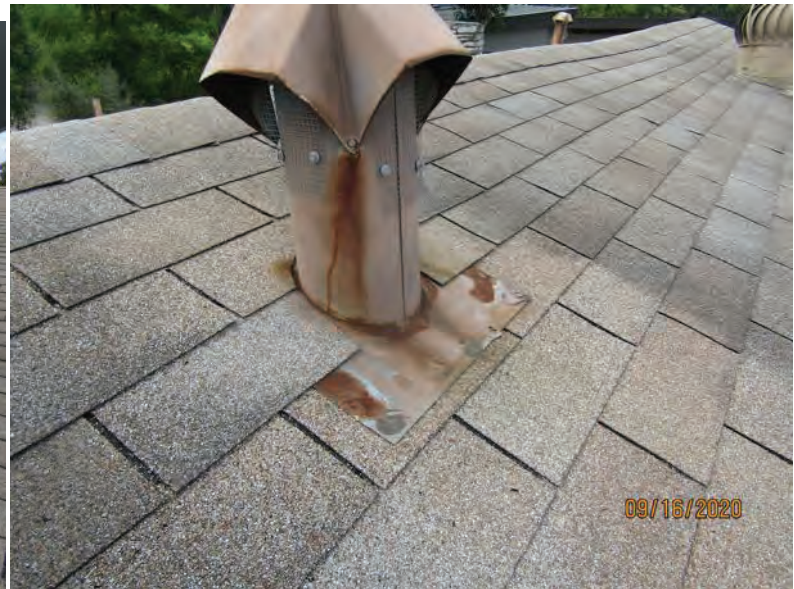
misc. roof vent rust damage noted. Also, gas-fired water heater and furnace vent caps not rated type

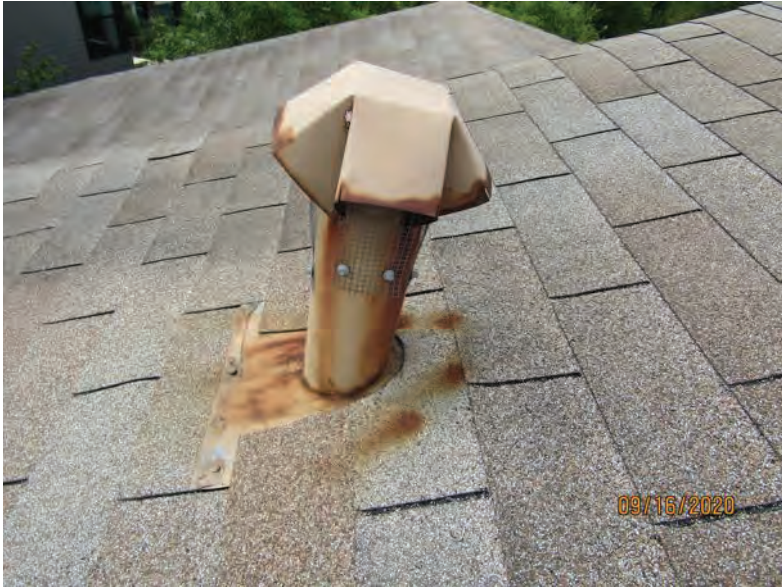
misc. roof vent rust damage noted

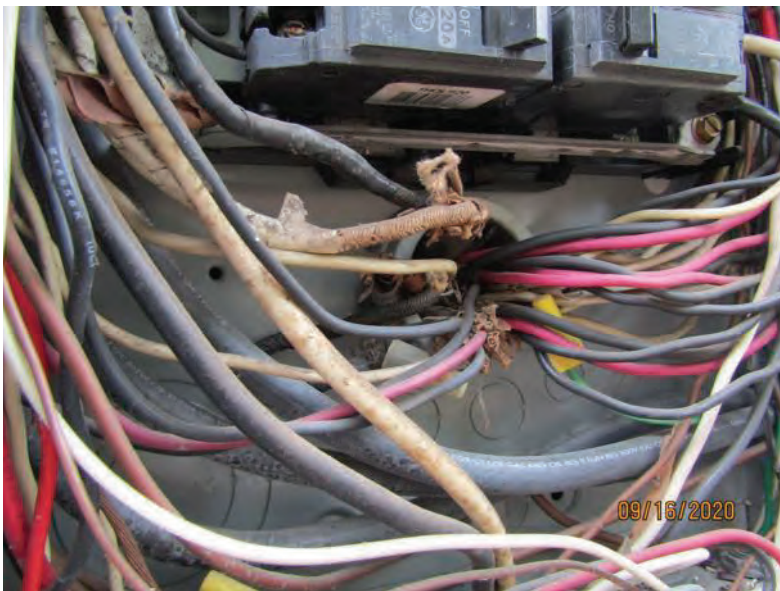
some older cloth wrapped electric cable observed in main electric panel

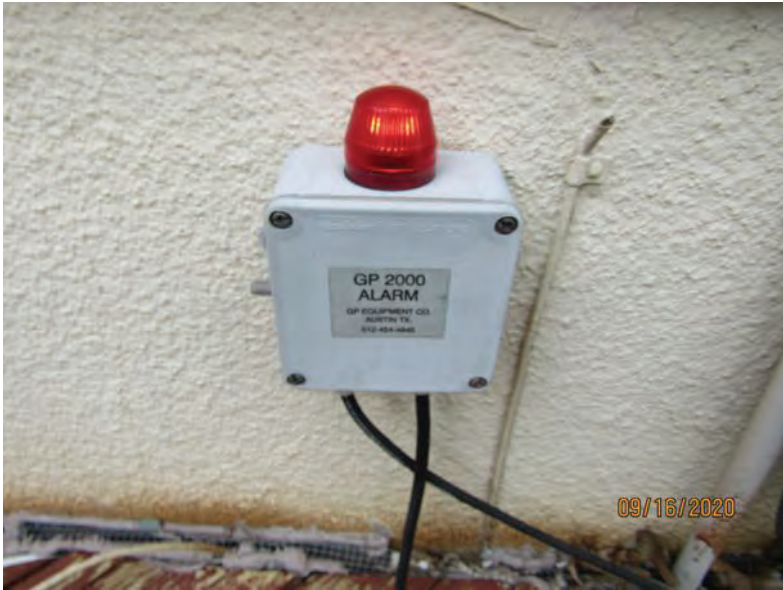
grinder pump failure conditions indicated by alarm light being on

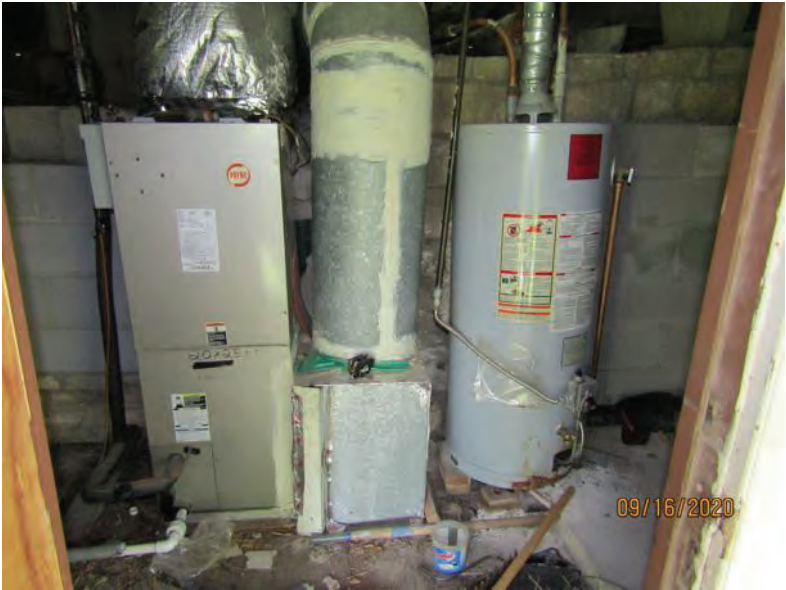
obsoleted Payne HVAC equipment in crawl space adjacent to water heater

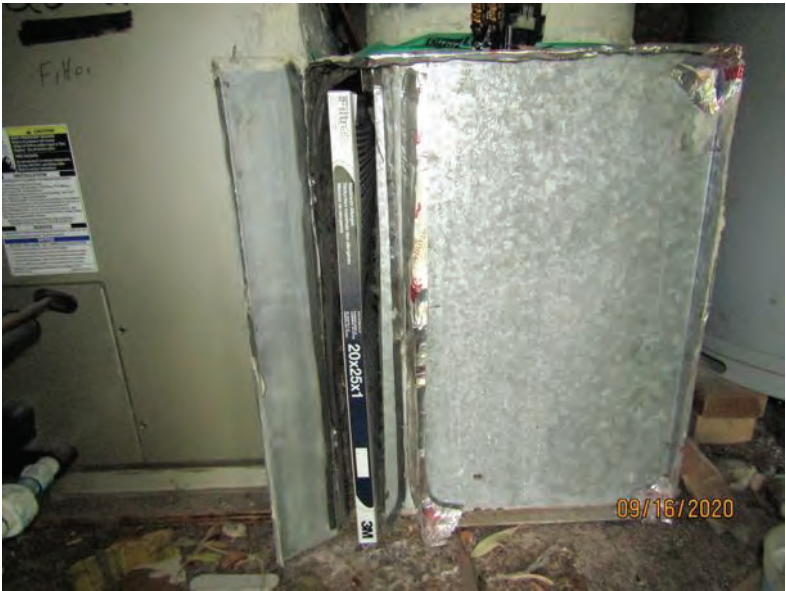
poorly sealed return filter box arrangement at crawl located Payne HVAC equipment will allow crawl space air to be sucked into conditioned air cycle if unit reactivated/brought back into use

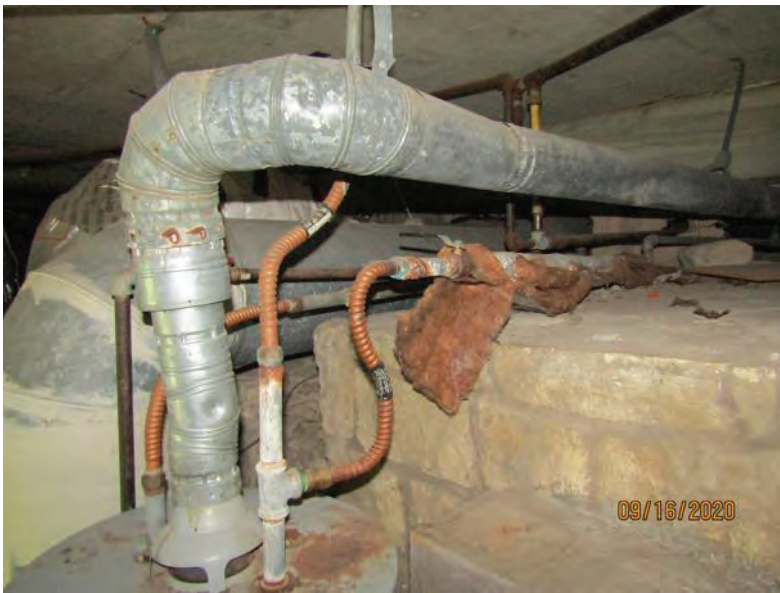
steel water supply piping rust damaged at water heater in crawl area and water heater vent pipe not installed properly \*See report comments
