**Austin 10/26/2020**

**Re: Existing Residential Foundation and Superstructure Assessment**

808 Avondale Rd, Austin, TX 78704

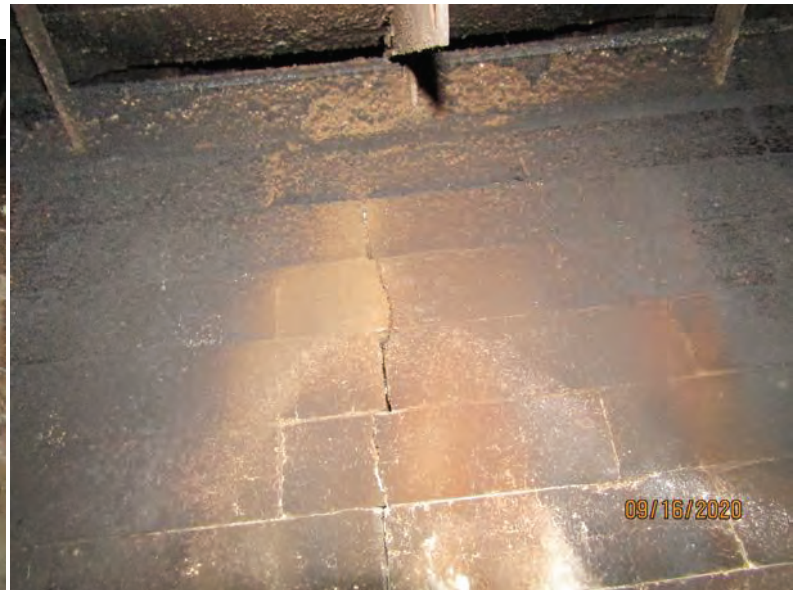
2. There are large cracks in the back firebox bricks.

**cracking through fireplace back wall firebricks and creosote buildup indicates need for professional cleaning before fireplace use**

A qualified chimney sweep should perform a comprehensive fireplace and chimney inspection and make all needed repairs prior to fireplace use.

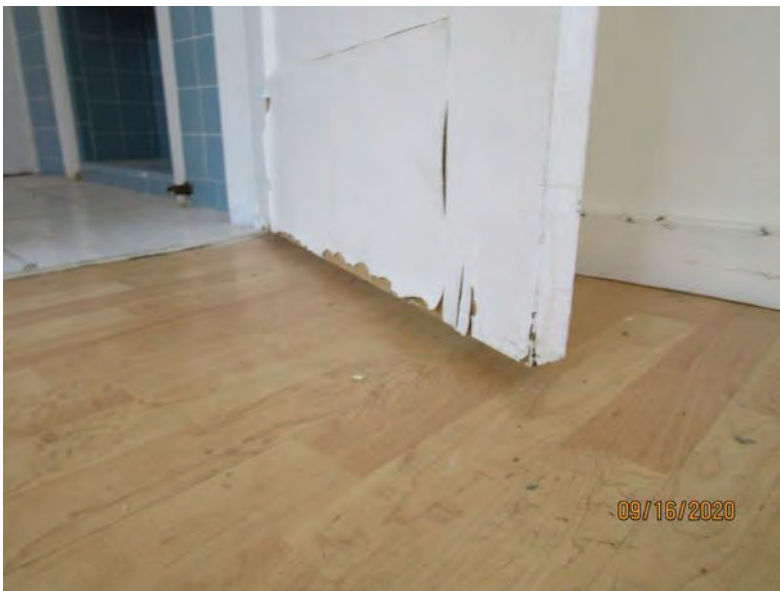
**damaged doors observed at several locations around house**

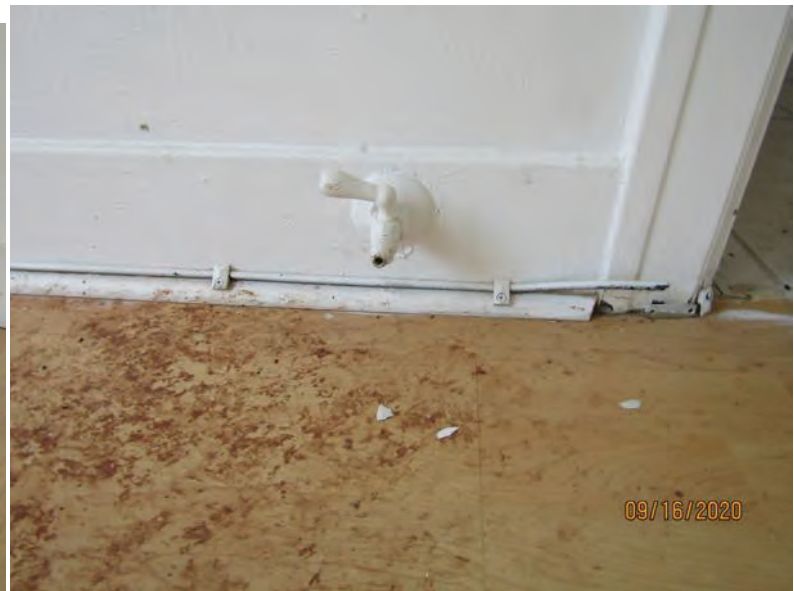
**obsoleted gas cocks (where space heaters were used back in the day) required to be obsoleted, i.e., valve removed and gas pipe capped**

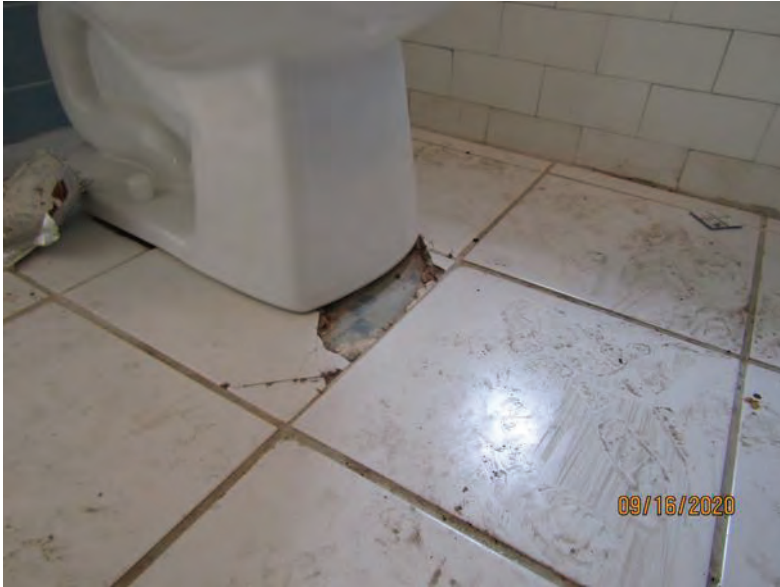
**damage to floor tile in back right bathroom**

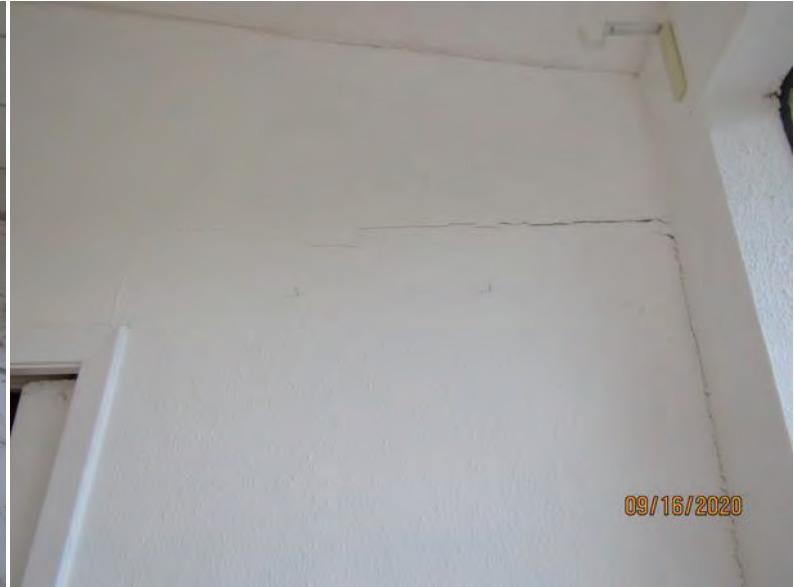
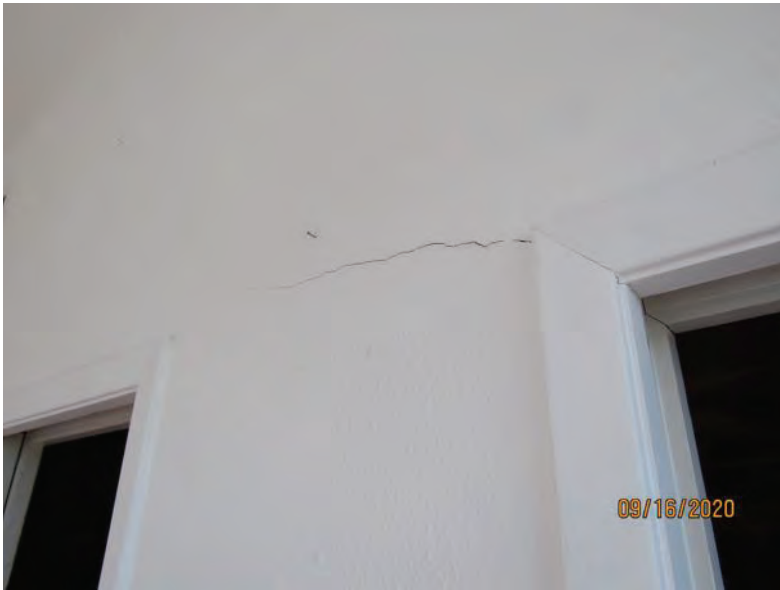
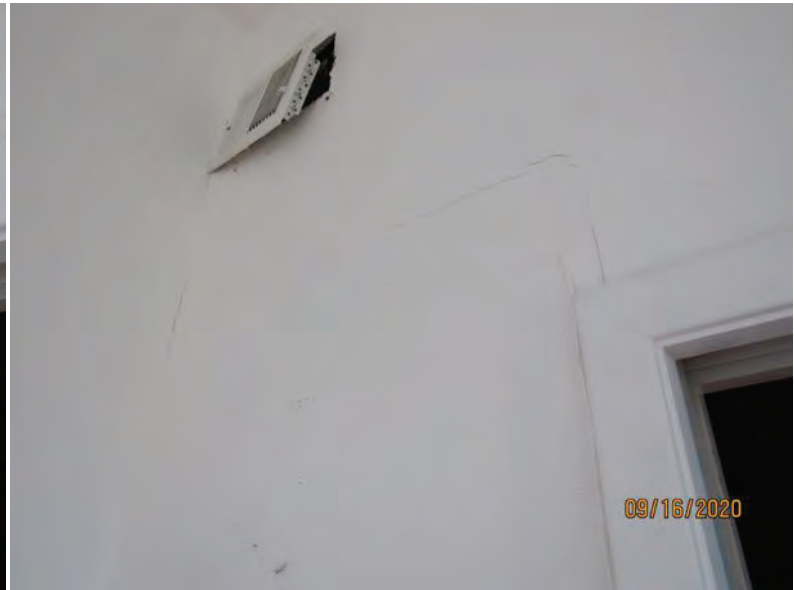
2.2 Major wall sheetrock distress cracks and floor sloping in the back lower right bedroom indicates major area foundation and superstructure movement. Patched ceiling sheetrock cracks were also noted in the same room.

**crack in wall sheetrock at back right lower roof**

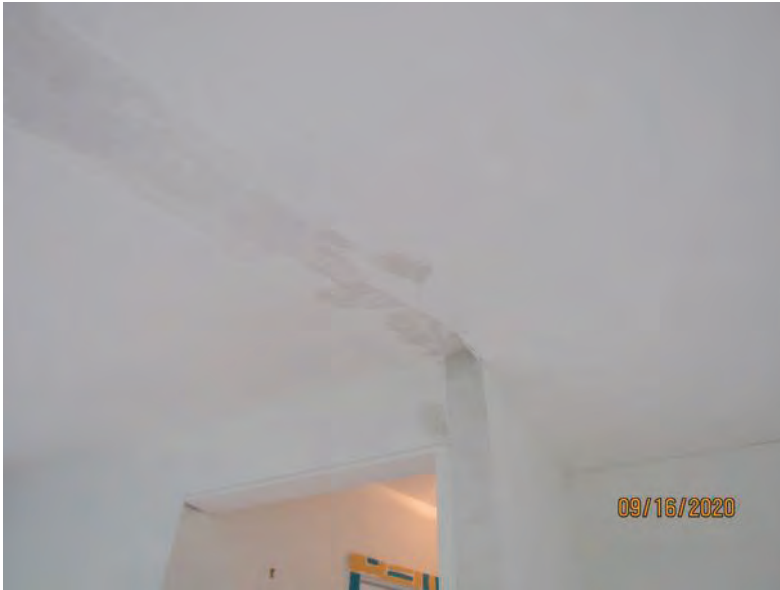
patched ceiling sheetrock cracks in back right lower roof

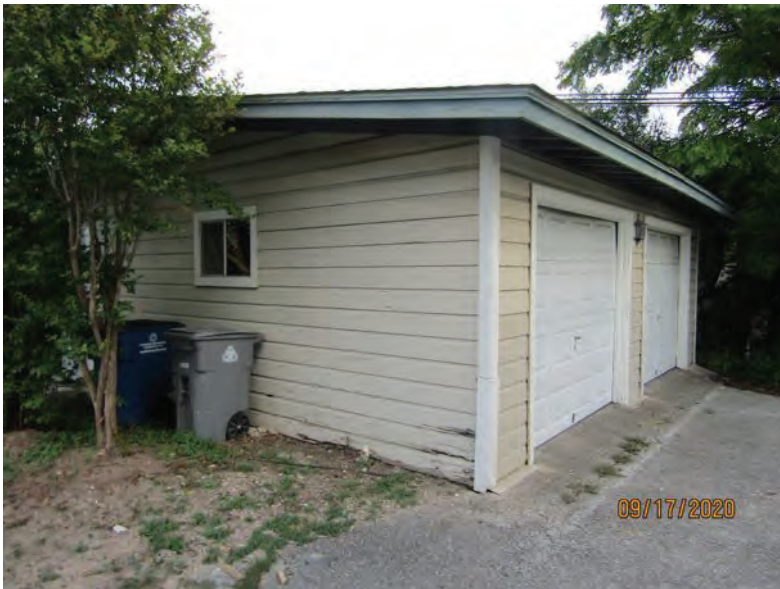
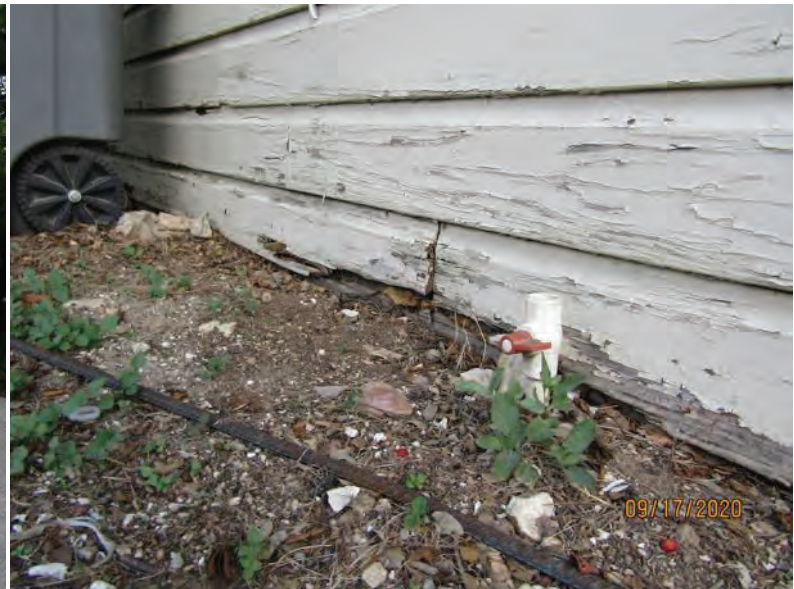
4. The wood lap siding at the left side of the detached garage structure is rot damaged due to ground contact.

garage siding wood rot damaged due to contact with ground

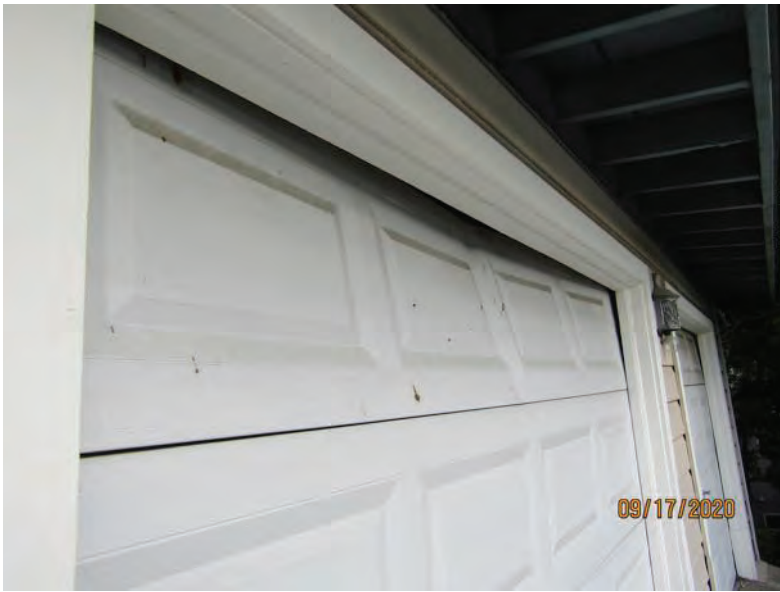
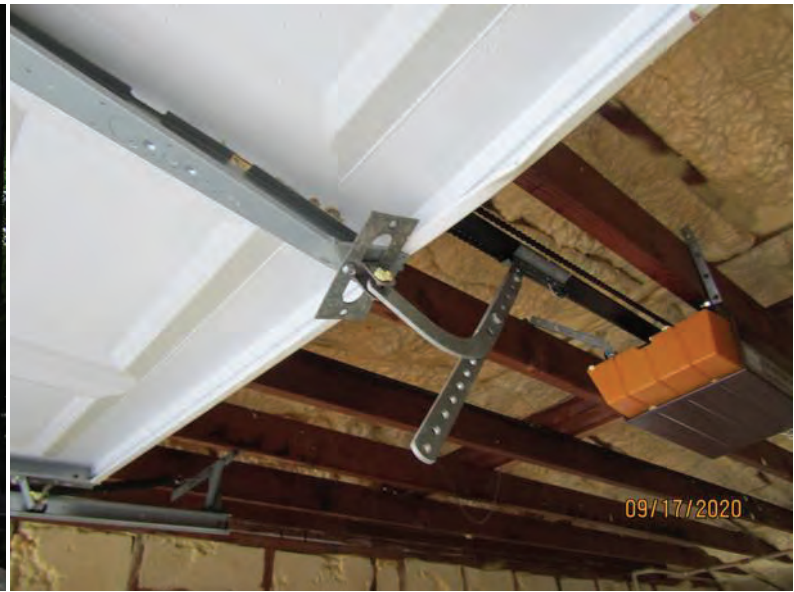
overhead garage door panel damaged due to someone using auto opener when door locked shut and lack of required steel reinforcement bracket where opener bar attaches to garage door
