Austin 10/26/2020

Re: Existing Residential Foundation and Superstructure Assessment

808 Avondale Rd, Austin, TX 78704

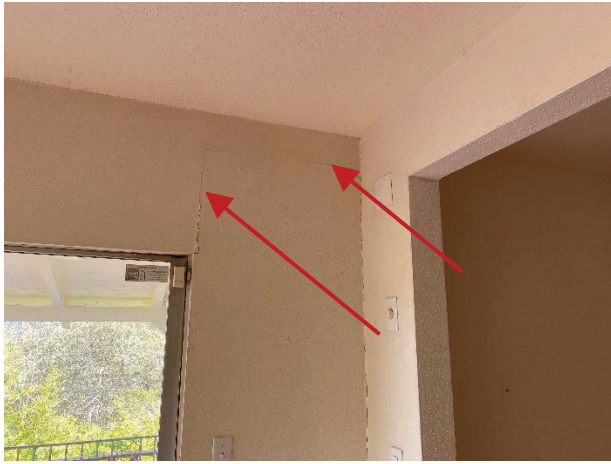
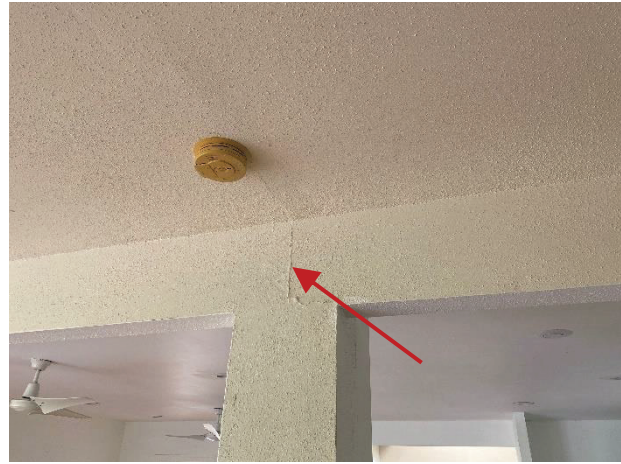
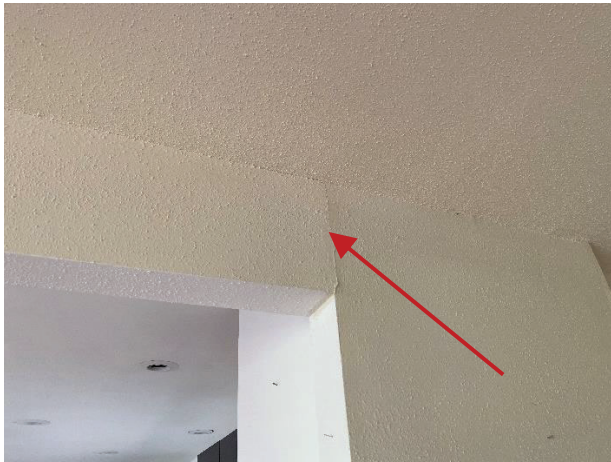
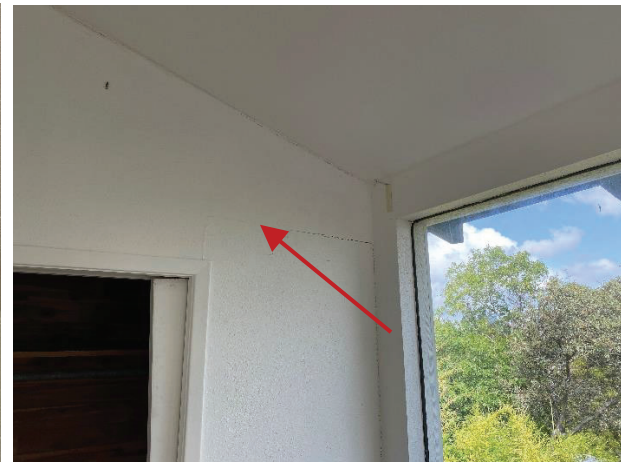
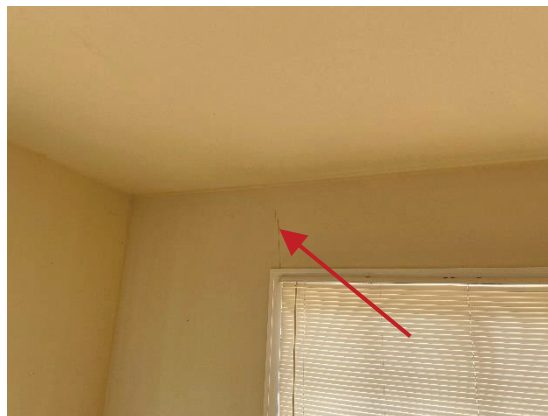
- Several stair-stepped, vertical and horizontal cracks on interior walls. These cracks are common indicators of foundation movement (Figure 3).

Figure 3. Cracks in walls and ceiling

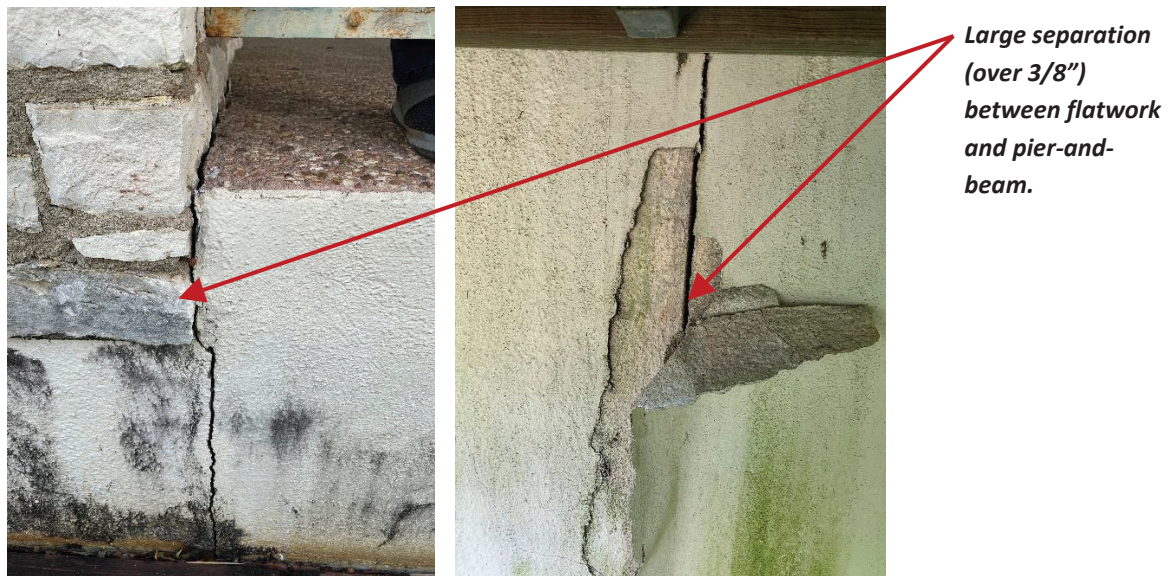
- Dissimilar foundation types: “slab on grade” and “pier-and-beam” and concrete flatwork. The original structure was built on a “pier-and-beam” foundation. The multiple foundation types, when not properly engineered, *are not a good construction practice and most likely contributed to the extensive signs of distress observed*. Flatwork construction is not an engineered slab and has no structural value to support residential structures. Large separations were noticed between slab on grade/pier-and-beam and flatwork areas, Figure 4.

Figure 4. Dissimilar foundation types

The multiple foundation types (pier-and beam; slab-on-grade and suspended slab) and wall construction (wood framing) will not allow a proper retrofitting strategy (e.g., drilled piers/steel piles or isolated concrete footings) without *permanently compromising* the structural integrity of the entire building. In addition, the flatwork and pier-and-beam portions of the foundation are not structurally “sound”² and must be completely removed and replaced with properly engineered foundation.

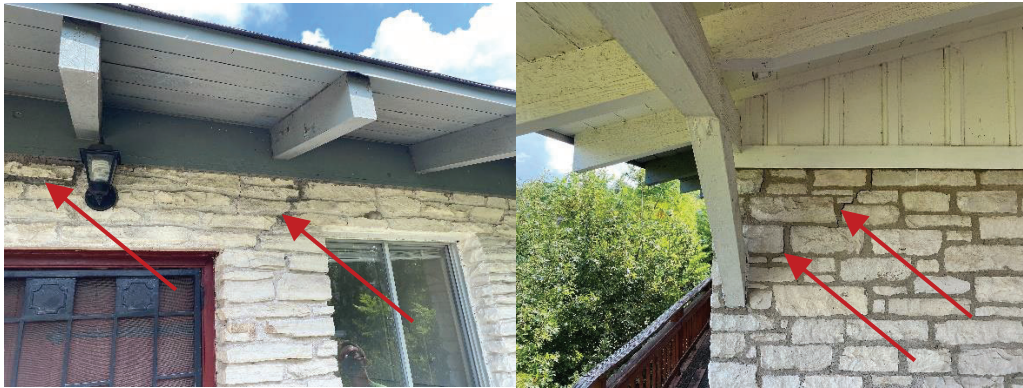
- Interior Floor elevations indicate that the floor is approximately 3" out of level (pier-and-beam). This indicates a high degree of foundation shifting/settlement. Most variations in elevation measurements inside particular rooms are equal or over 2", pointing to excessive movement.
- Extensive cracking observed in the exterior stone veneer, another indication of an underperforming foundation. Figure 5.

Figure 5. *Cracks in stove veneer.*

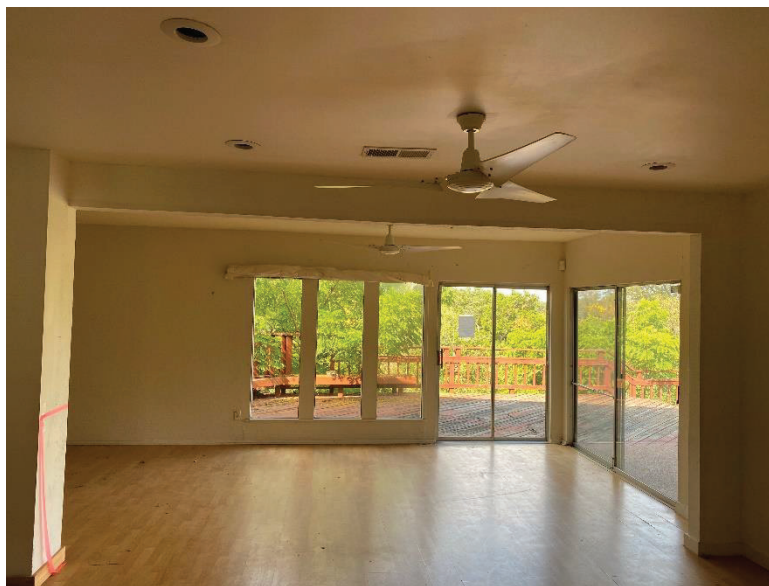
- Several cosmetic repairs still visible throughout the house. These repairs were likely necessary to cover extensive cracking on interior walls and ceiling. This reinforces the previous observation about out-of-tolerance foundation movement.
- Excessive deflection of framing members (Figure 6). Some floor and ceiling beams/headers are visibly undersized for the current span.

Figure 6. *Excessive deflection of framing members.*

In addition to these factors, the lack of information on the existing pier-and-beam “footings” or “piers” (reinforcement, overall depth, material properties) will significantly hinder any attempts to level the structure adequately. Destructive methods can be employed to assess all these items, however the costs involved are appreciably high. Issues involving the superstructure must also be addressed (excessive deflection), with the potential need to replace portions of the wall/ceiling/roof framing structure.
