BPG Inspection, LLC

**2816 San Pedro Street
Austin TX 78705**

Client(s): Joseph
Inspection Date: 9/15/2020
Inspector: Randal Pitts , 9911

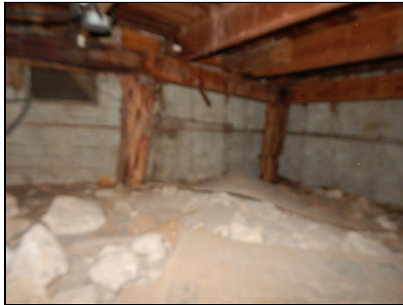
☒ The foundation piers and structure are original to the house. The existing posts are wood (cedar), placed directly into soil with no concrete support or barrier. These posts deteriorate/rot over time and can cause the entire structure to shift and become out of level. The current construction standard is to have the beams supported on concrete pilings that are imbedded in the soil (depth determined by engineer), and the beam structure is then secured to the pilings with metal straps. I recommend this structure be further reviewed by a licensed engineer or foundation contractor to determine the extent of any needed repairs or components replacement, and to obtain an estimate on the cost of those repairs.

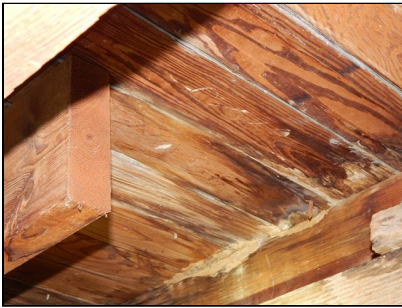
There are signs of fungi growth present on the floor system in crawlspace in several areas. We did not inspect, test or determine if this growth is or is not a health hazard. The underlying cause is moisture. Recommend you contact a mold inspector or expert for investigation or correction if needed.

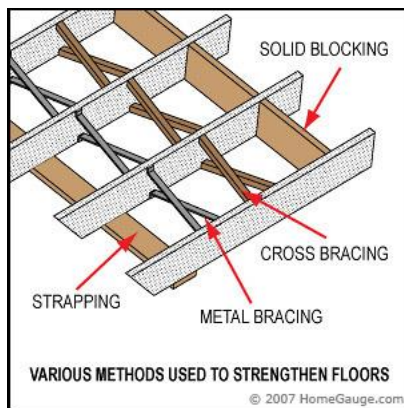
☒ There is no cross bracing between joists were observed as would be found in current era structures. Update as recommended by a foundation contractor.

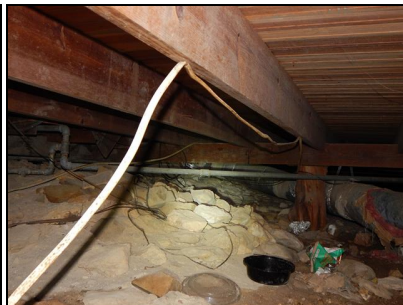
☒ There is wood to ground contact in the crawlspace. Lower all grade minimum 16" below structural components.

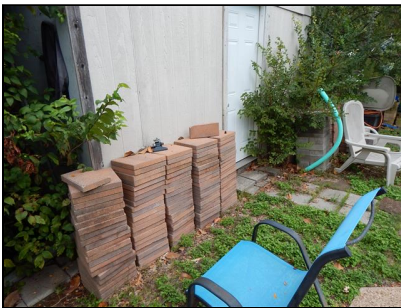
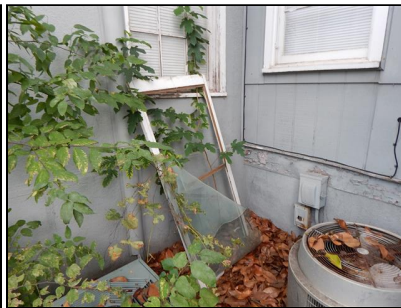
☒ There are areas surrounding the structure where debris is stacked against the main structure. This situation can create a conducive environment for wood destroying organisms to propagate and eventually enter into the structure without being seen. I recommend removing items stored or stacked against walls.

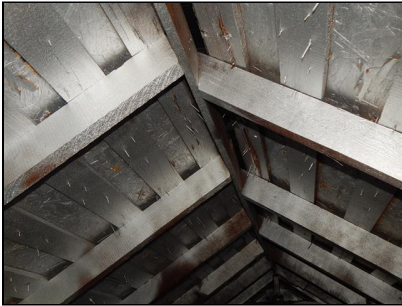
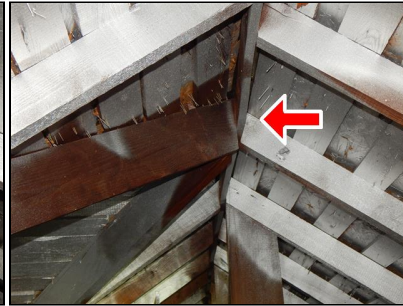
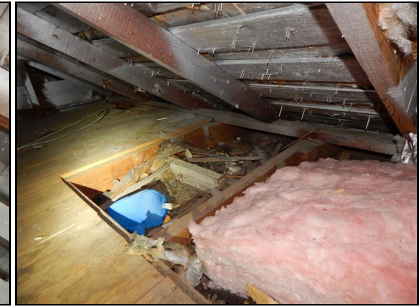
☒ Older structures typically do not have modern standard lateral, vertical or required dimensional lumber as would be found in newer houses. This can include undersized ridge beams, lack of purlin and/or king post supports (vertical). This structure does exhibit some of these older style construction. This structure had undersized and improperly off-set rafters attached the an undersized ridge beam. There was visible deflection of the beams most notably at the valley. Contract a structural contractor or engineer to evaluate for additional support and/or bracing recommendations.

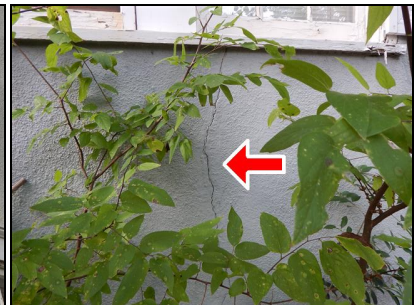
☒ Stucco cracks were observed. These will allow water to penetrate into the interior walls. A qualified stucco contractor should further review the siding installation for repairs or replacement.

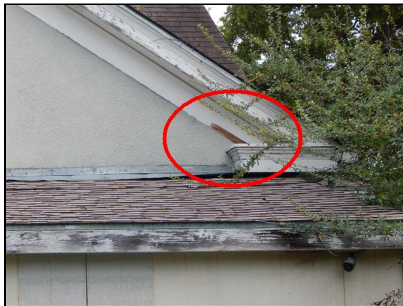
Evidence of vermin damaging siding, trying to enter attic. Repair needed, and screens should be used to fill any gaps in eaves/soffits.

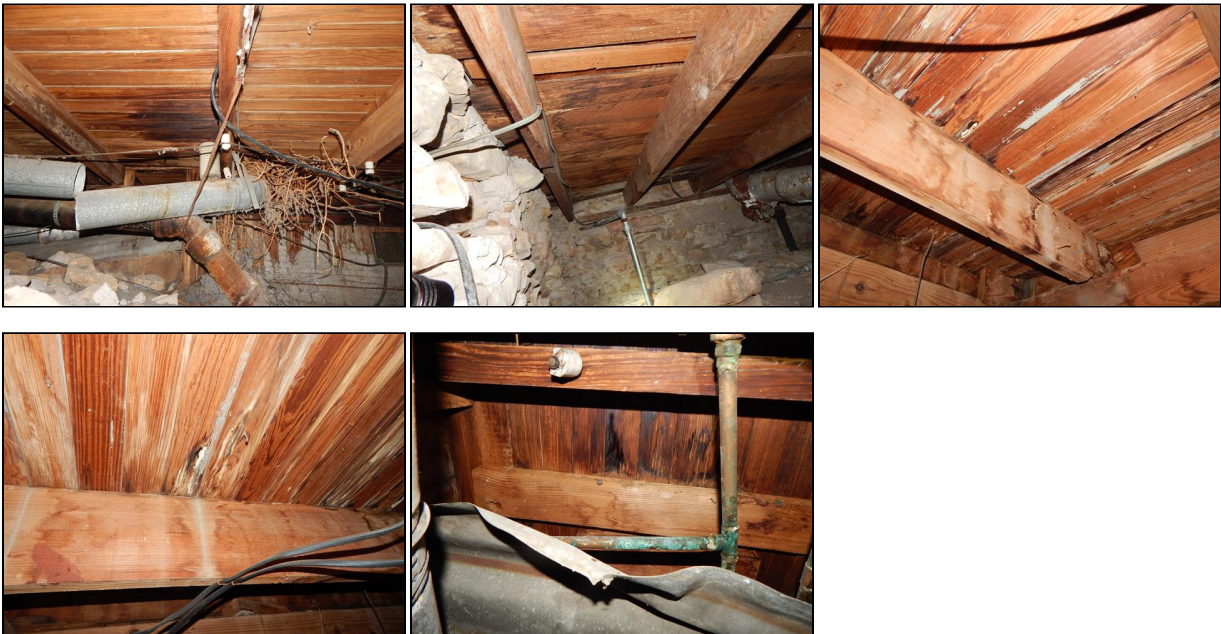
☒ There are signs of previous leaks and damage to the subfloor. I recommend you have the areas further evaluated by a qualified contractor and to perform exploratory to determine the extent of the damage.

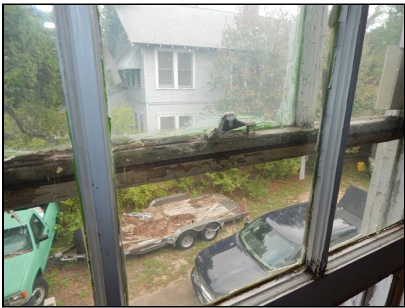
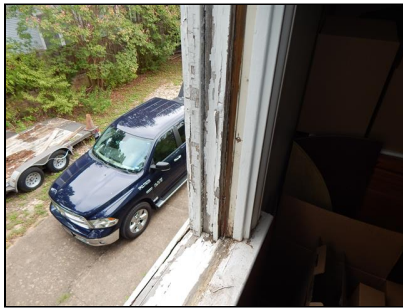
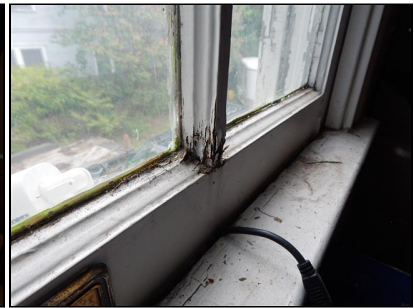
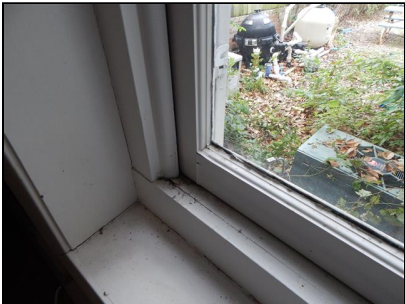
☒ House has original single pane, wood frame windows with weighted ballasts. Due to their age they are dilapidated and most will not function: binding in frames, ballasts detached, rotted frames sashes. The windows will require replacement.

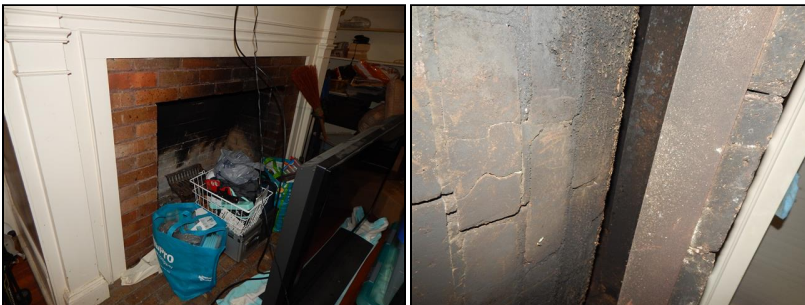
☒ There is soot and creosote buildup in the chimney. Given the age of the fireplace, it will likely require the installation of an interior sleeved flue insert. Recommend having the chimney flue cleaned and inspected by a professional chimney sweep, and any safety upgrades performed.

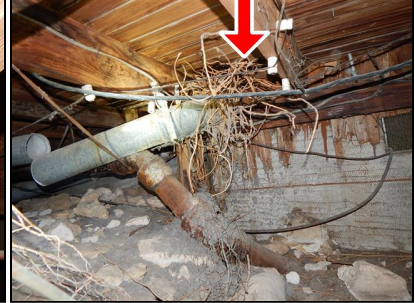
☒ There was original knob and tube electrical system employed throughout the house. This type distribution system has not been employed for several decades as it was a known source for igniting insulation and sometimes structural components. The conductors were also in traffic areas where personnel could come into contact with it, resulting in injury. For that reason we recommend you contract a licensed electrician to remove or disable the system and install modern day non-metallic sheathed conductor distribution system before taking occupancy. Obtain a proposal for this service as it will be expensive.

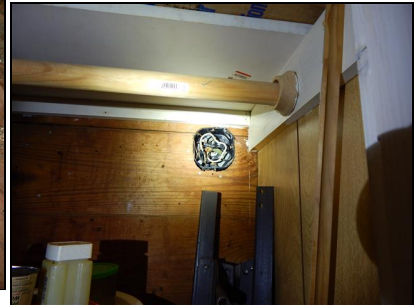
☒ There were exposed connections, open boxes observed in the attic, downstairs closets and in the crawlspace. Secure, enclose in rated enclosures to prevent hazards.

Spliced knob and tube wiring.

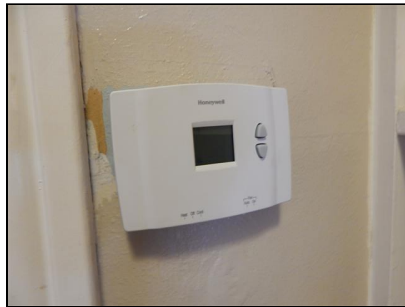
☒ The units were not functional. There was no power to the thermostats. The systems do not appear to have been operated in some time. Further diagnosis for repair or replacement is needed by a licensed HVAC technician.

Thermostats not functional.

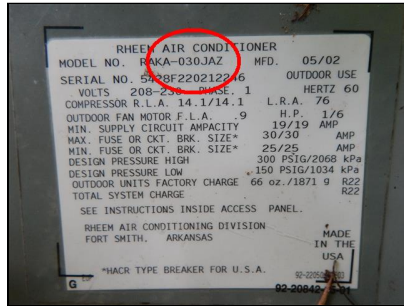
☒ The systems were not functional at the time of construction. A licensed HVAC technician should diagnose the systems for repair or replacement.

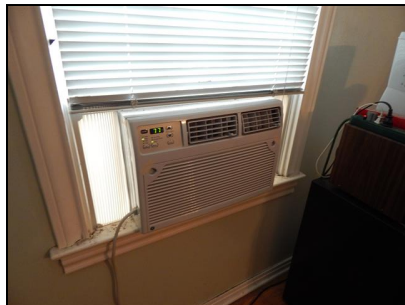
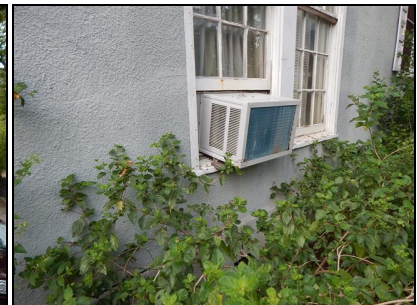
☒ There are no exterior supports for the window A/C units to prevent them from falling from the windows.

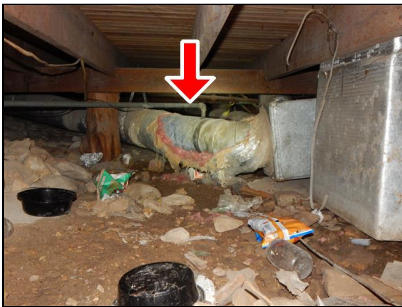
☒ The ducts are aged, the insulation is shedding from the exterior and they are prone to moisture collection and fungal growth in their interior. Consider having an HVAC contractor provide a price quote for their replacement.

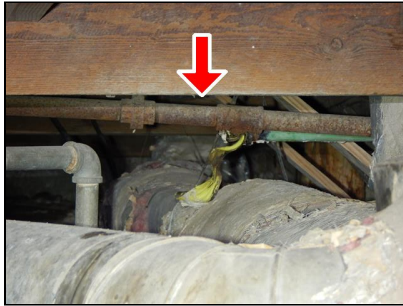
☒ This house has original galvanized supply lines. Lines of this age are known to develop leaks and clogs overtime as they deteriorate i the interior. Supply problems may not be detectable until they actually fail. There was visible rust and corrosion on the pipe system throughout the structure. It also could not be determined if any of these lines had lead content which was common at the time of construction. Active leaks were observed in the basement area. Consult with licensed plumber for replacement options and pricing.

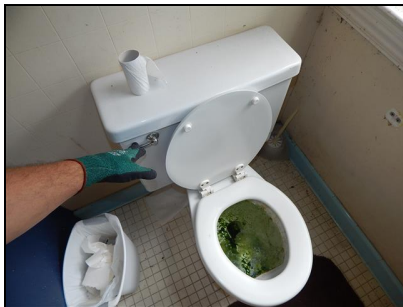
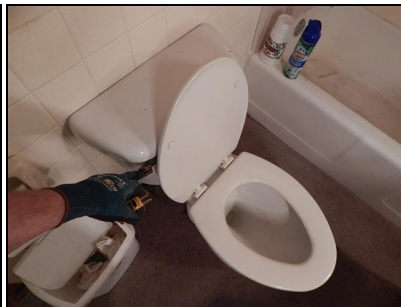
The upstairs and downstairs toilets had been disabled and were not functional.

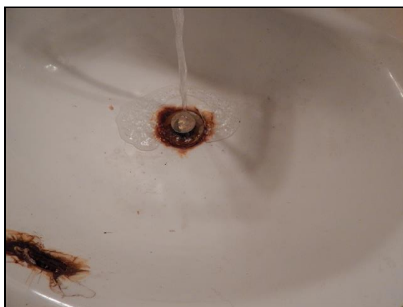
☒ The sink and bath basins were rusted and will require repair ir replacement.

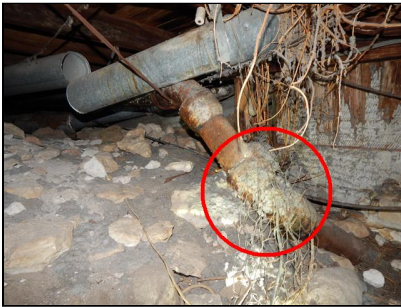
☒ The house has original cast iron drains and vents. Iron lines of this age are known to develop leaks and clogs overtime. Drain problems may not be detectable until the build up becomes too great. There was rust and corrosion observed in the crawlspace, as well as a separation at a minimum one joint. An active leak was observed in the basement underneath the downstairs bathroom. This system will require extensive repairs, or likely replacement. I recommend you hire a licensed plumber to review the drain system and provide a quote on its replacement.

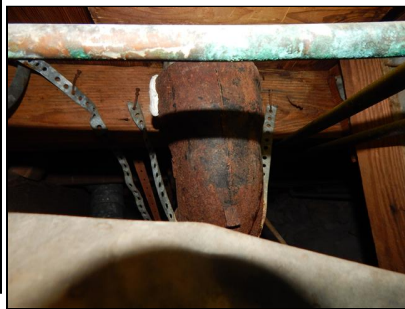
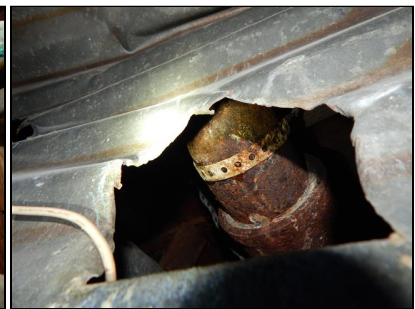
Pipe attachment failed.

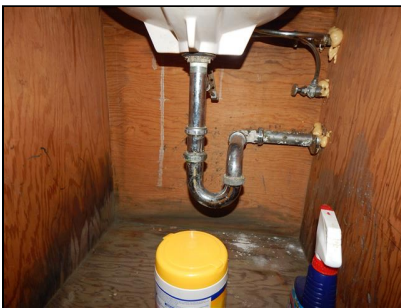
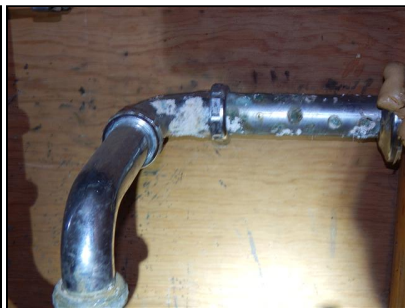
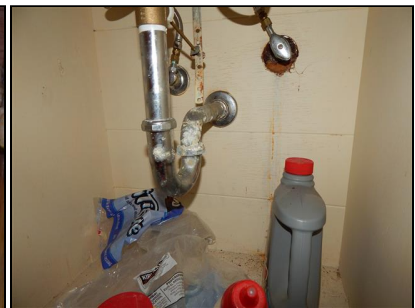
☒ Galvanized pipes were observed on the bath and/or kitchen sink drains. These pipes are known to corrode from the inside out and fail causing leaks. Corrosion was observed on these drains. Replace these with newer PVC drains to prevent this from occurring.

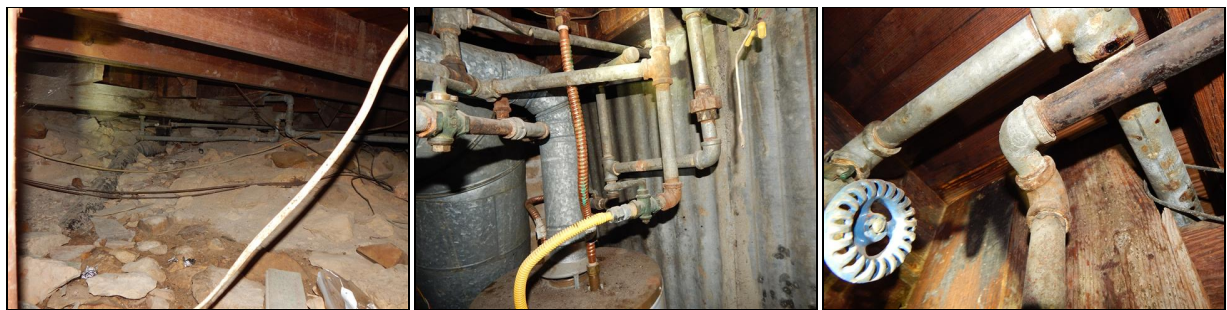
There was visible corrosion on the pipes at various areas. A licensed plumber should be contracted to evaluate the system for replacement.
