SUMMARY OF PROPOSED EXTERIOR WORK

Humanities Texas completed a full restoration of the Byrne-Reed House in 2010. Over the past year, we observed changes at the northeast and southeast corners of the first floor porch, indicating loss of structural continuity—water retention, uneven surfaces, and displaced tiles. Humanities Texas engaged a structural engineer and historic preservation contractor to inspect the areas and assess underlying issues. The proposed exterior work described here will **repair** and **stabilize** the first floor porch at both corners and **mitigate** any future movement. Humanities Texas received a City of Austin Heritage Grant to undertake these repairs and has engaged James Nolan Construction as general contractor.

HUMANITIES TEXAS
1410 Rio Grande Street, Austin, Texas 78701
Historic Byrne-Reed House

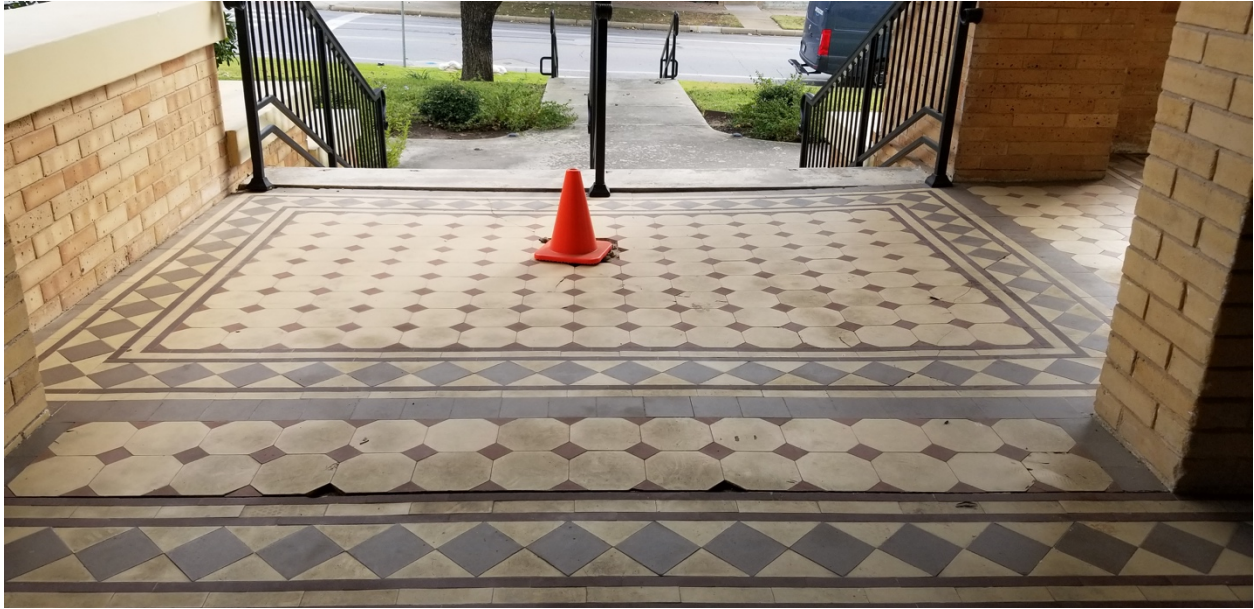
Original encaustic tiles and evidence of displacement at the northeast corner of the first floor porch, November 2020.

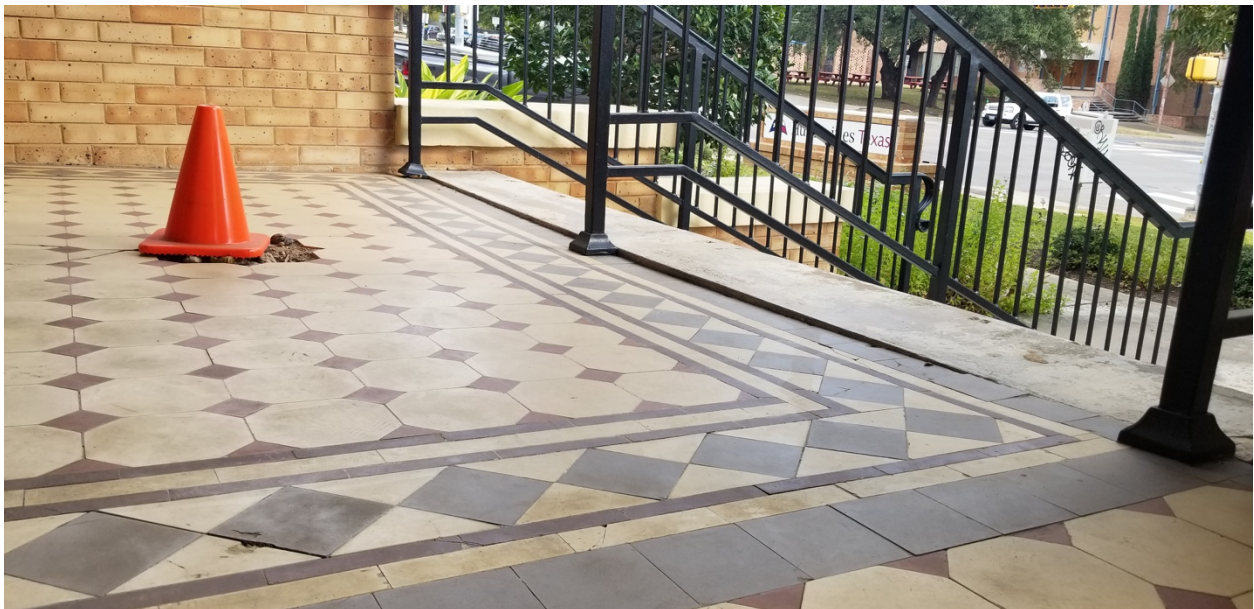
Original encaustic tiles and evidence of displacement at the northeast corner of the first floor porch, November 2020.

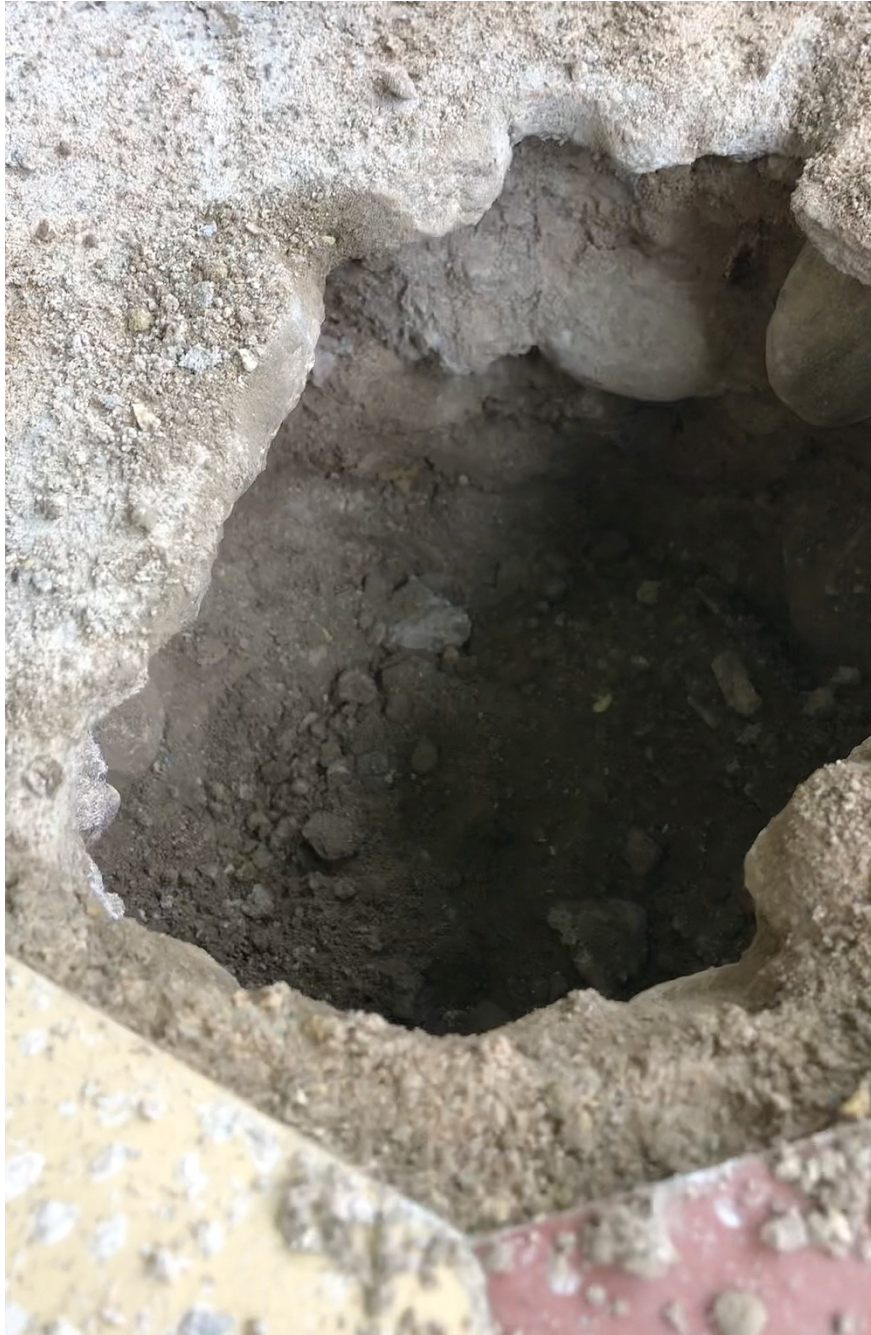
Photo of dirt and gravel base directly below historic porch slab at the northeast corner of the first floor porch, July 2020.

After removing a small section of tile and cutting through the 6" concrete slab, visual inspection confirmed that the northeast corner of the porch was originally constructed by pouring a lime-based slab over rock, sand, and dirt. The dirt and gravel base has destabilized over time due to the constant percussive ground disturbances from nearby traffic.

Visual inspection confirmed that the northeast corner of the porch was originally constructed by pouring a lime-based slab over rock, sand, and dirt. The dirt and gravel base has destabilized over time due to the constant percussive ground disturbances from nearby traffic. To repair this issue, the contractor will remove the original lime-based slab and compact existing soil. Historic encaustic tiles will be carefully removed and cleaned, preserving as many as possible. New steel anchors will be installed into the adjacent porch slabs and concrete steps, and a new slab will be poured. Encaustic tiles will then be reinstalled. Tiles that are missing or broken will be replaced with new tiles custom made to match the original in fit, finish, and form.

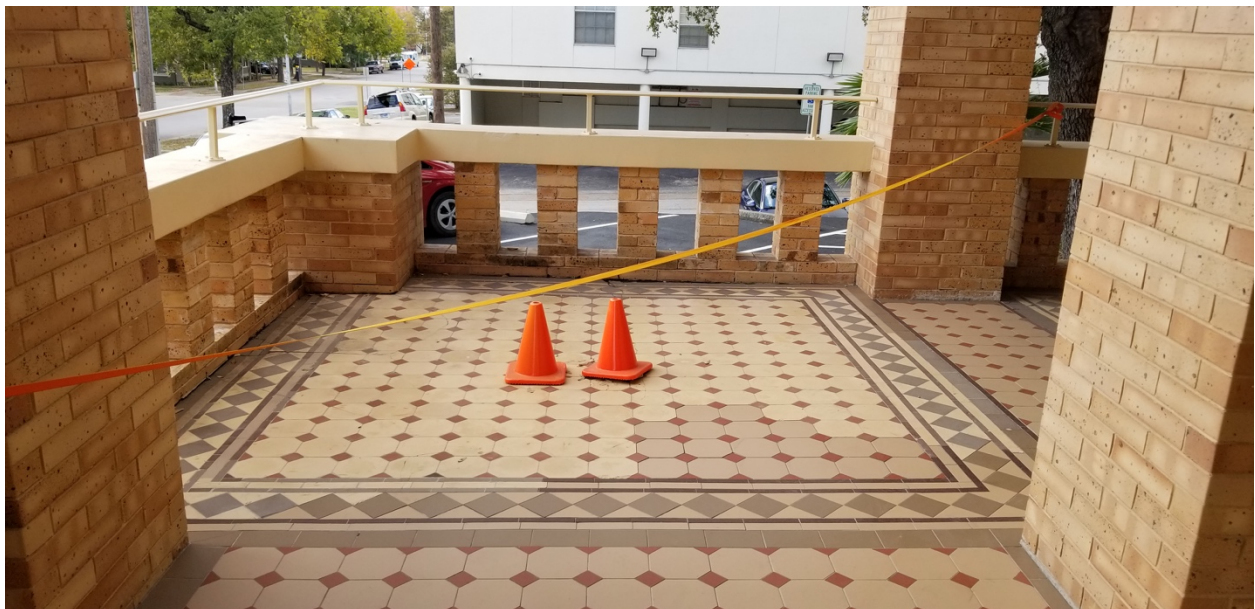
Southeast corner of the first floor porch, November 2020.

This corner of the porch spans an unventilated, 8' high crawlspace.

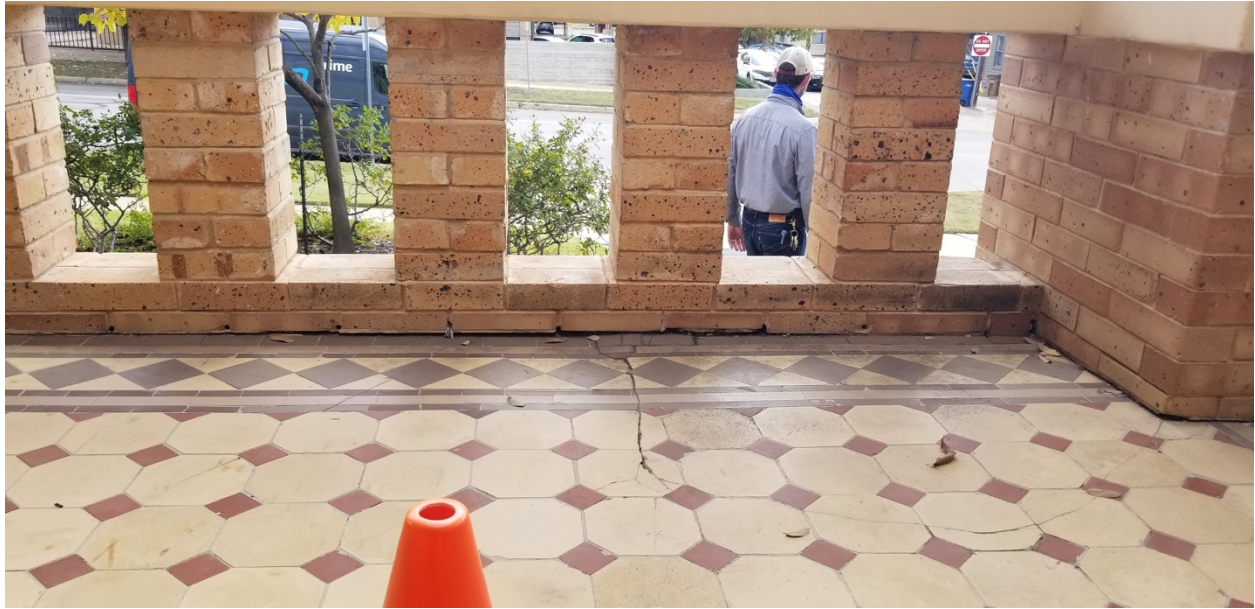
Detail at east side of the southeast corner of first floor porch showing original encaustic tiles and evidence of displacement, November 2020.

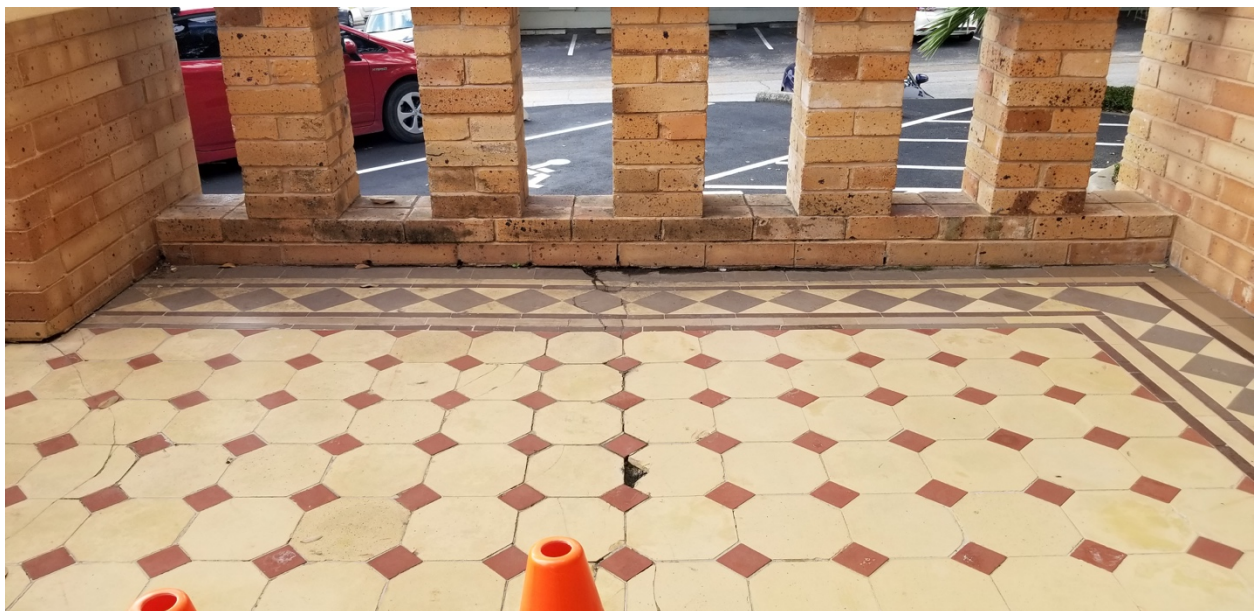
Detail at south side of the southeast corner of first floor porch showing original encaustic tiles and evidence of displacement, November 2020.

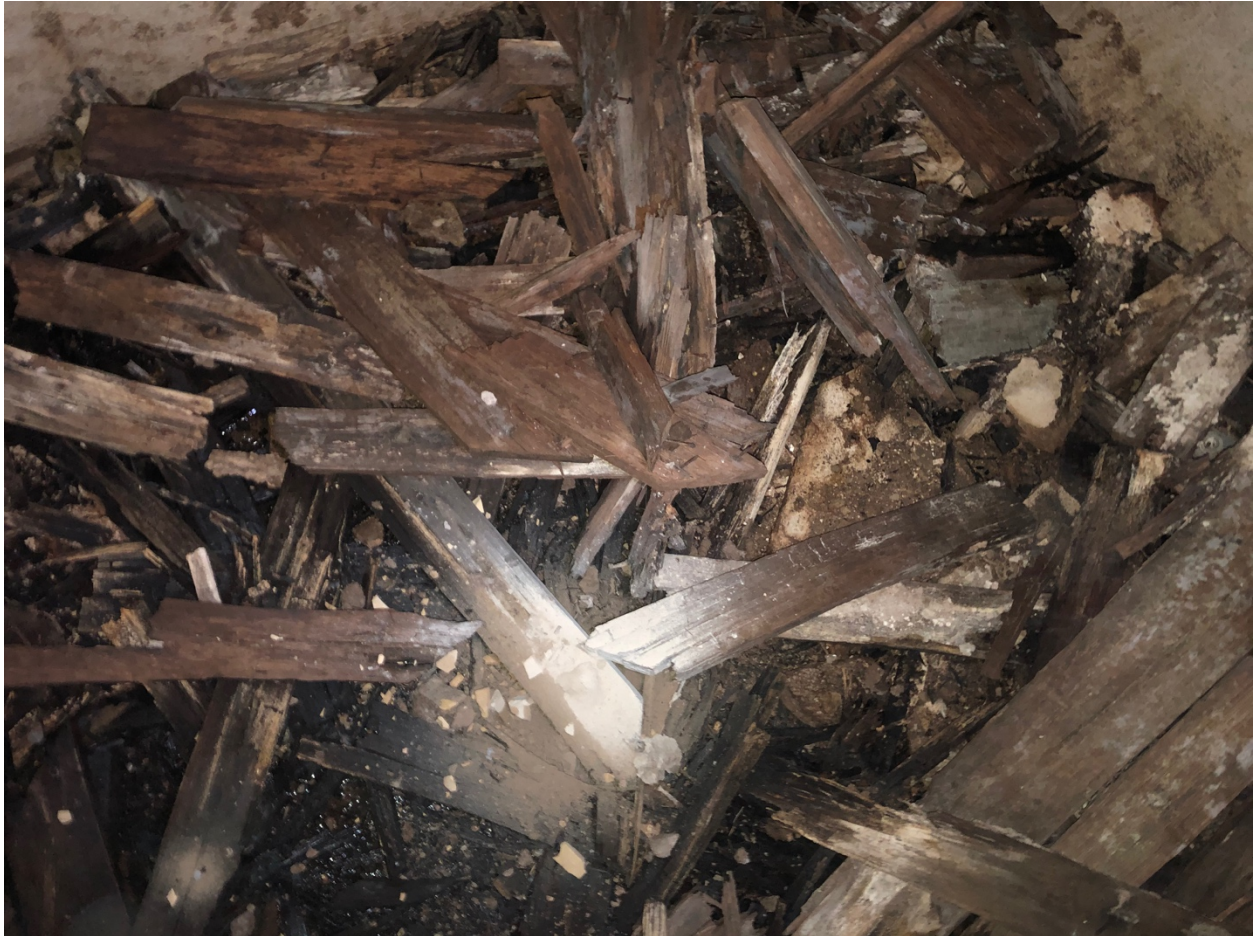
Photo of collapsed floor joists in the cavity below the southeast corner of the first floor porch, July 2020.

Lack of venting caused moisture trapped in the cavity below the southeast corner of the porch to decay the wooden floor joists installed during the 2010 restoration. These joists have collapsed into the cavity below, leaving this section of porch supported only by the surface tension of the historic concrete slab and encaustic tiles.

- Compromised joists will be removed and replaced with steel and pressure-treated wood support system.
- New cast iron foundation vents will be installed in south and east porch skirts (will match existing vents in-kind).
- New bronze floor drain with scupper will be installed.
- Historic brick will be cleaned and reinstalled.
- Any missing or broken tiles will be replaced with new tile custom made to match original.

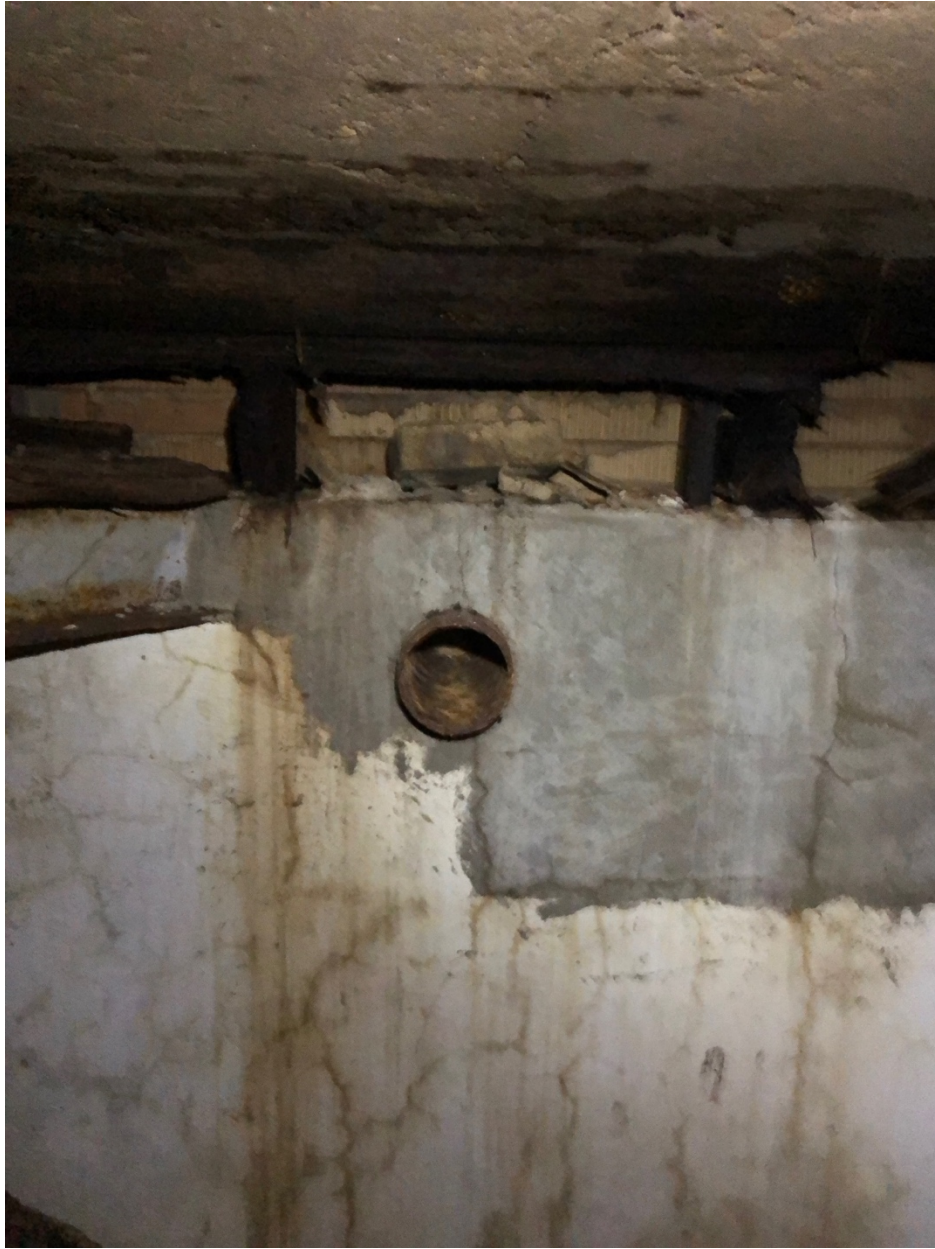
Historic slab at the southeast corner of the first floor porch photographed from below, July 2020.
