# 1510 PALMA PLAZA

## OLD WEST AUSTIN NATIONAL REGISTER DISTRICT

### PROPOSAL

Demolish a triplex at 1510 Palma Plaza

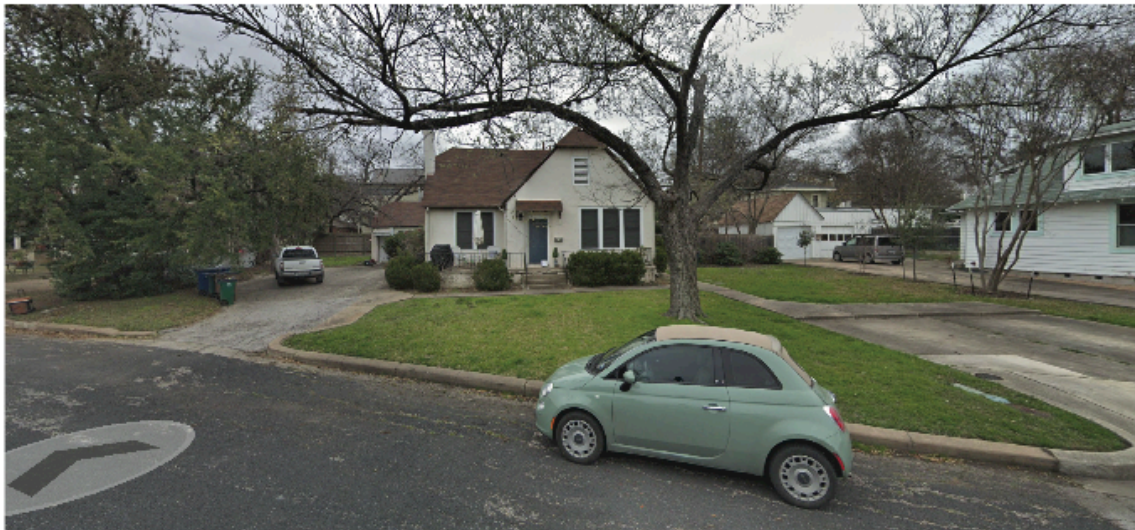
**1510 palma plaza**

**1510 Palma Plaza was originally built as a single family residence. Over time the property has been subsequently subdivided into a makeshift triplex.**

**EXISTING BUILDING DEFICIENCIES** (excerpts from engineering report)

**Undersized/compromised framing members**

2x4 rafters and joists (and possibly headers)  
Rotted studs and headers

**Insufficient foundation support**

cedar posts placed on grade  
CMU blocking placed on grade  
Rotted piers  
Rotted bottom plates, joists and other wood foundation members

**Excessive settling and movement**

Excessive slopping/cracking of floors and ceilings  
excessive cracking around doors and windows  
excessive cracking at random wall sections

**Seeking demolition permit of existing structure in order to build a traditionally styled duplex.**
