Photos of Existing Structure

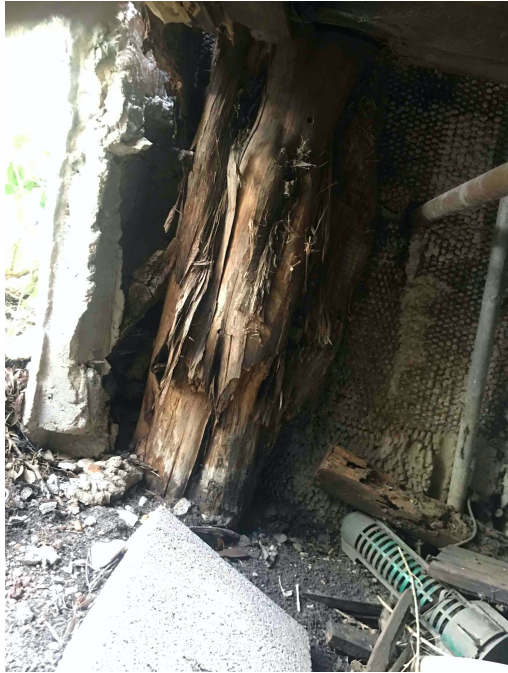
Rotted cedar stump post

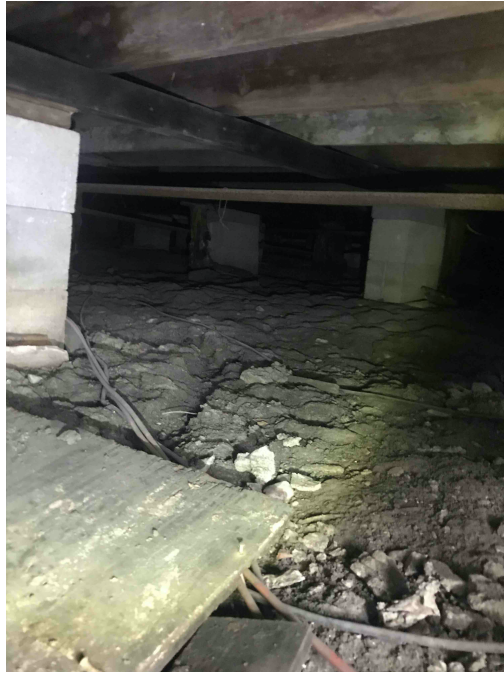
CMU blocks used as posts

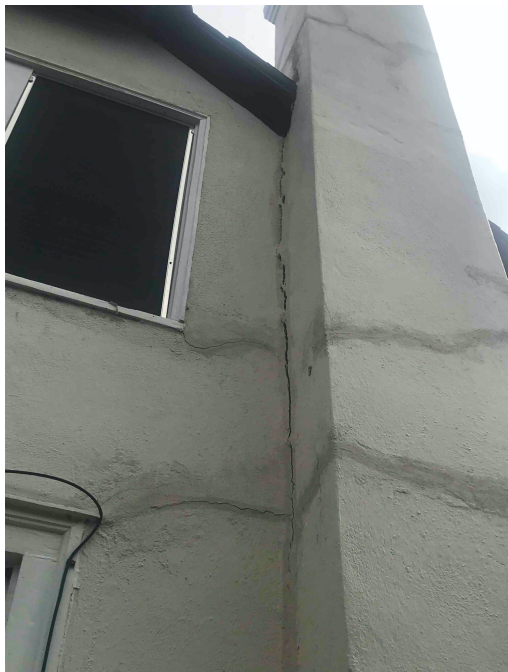
Cracks from shifting foundation

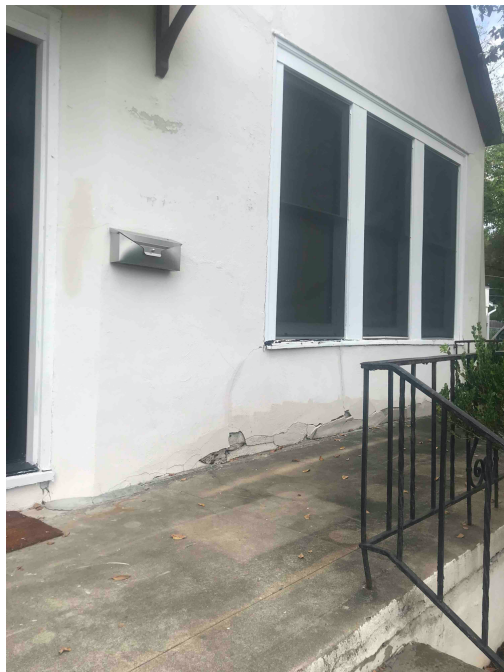
Compromised wall system
