## **ENGINEERS REPORT**

**Subject: Evaluation of Wooden Structural Framing of Residential Structure @  
1601 Brackenridge Street, Austin, Texas 78704  
Legal Description: Lot 1, Block 12G, Fairview Park Subdivision**

### **Existing Residential Wood Frame Structure Evaluation:**

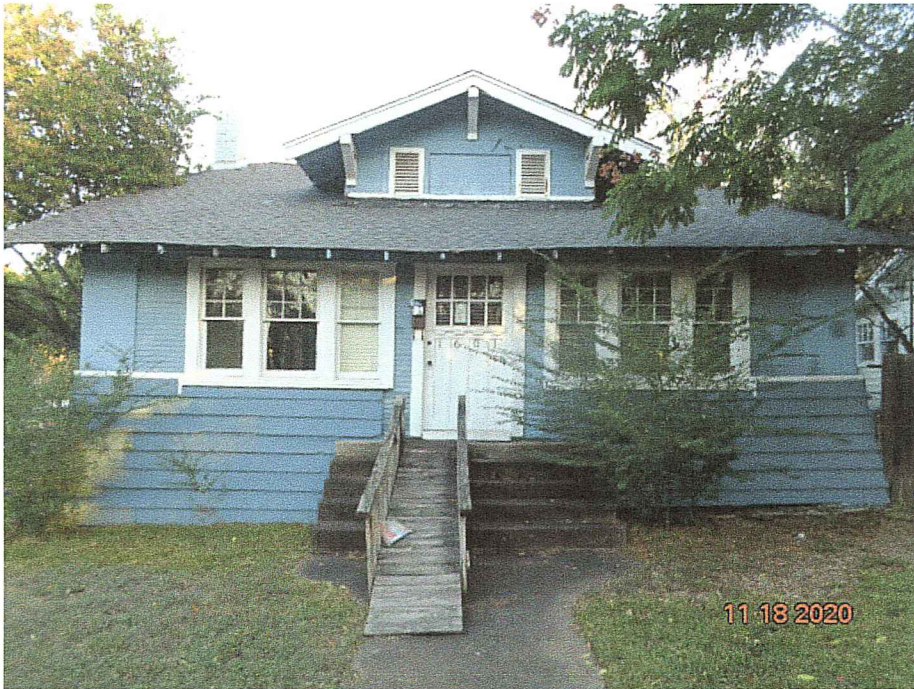
Photograph No. 1-view looking east at front façade of exiting residential structure, Note the unevenness of front road decking

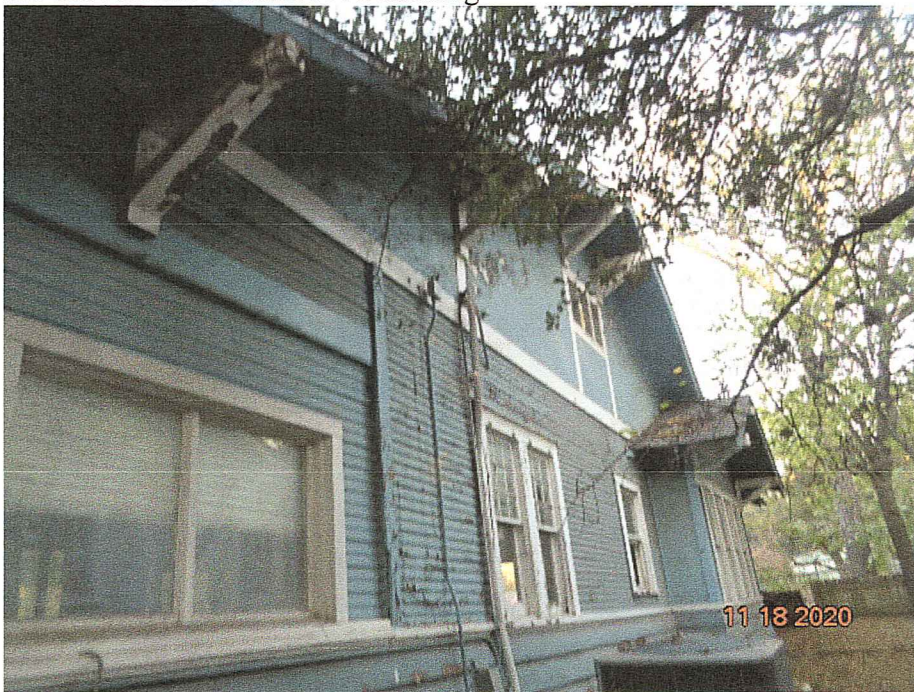
Photograph No 2.-view looking on an eastward direction at the southern wall façade.

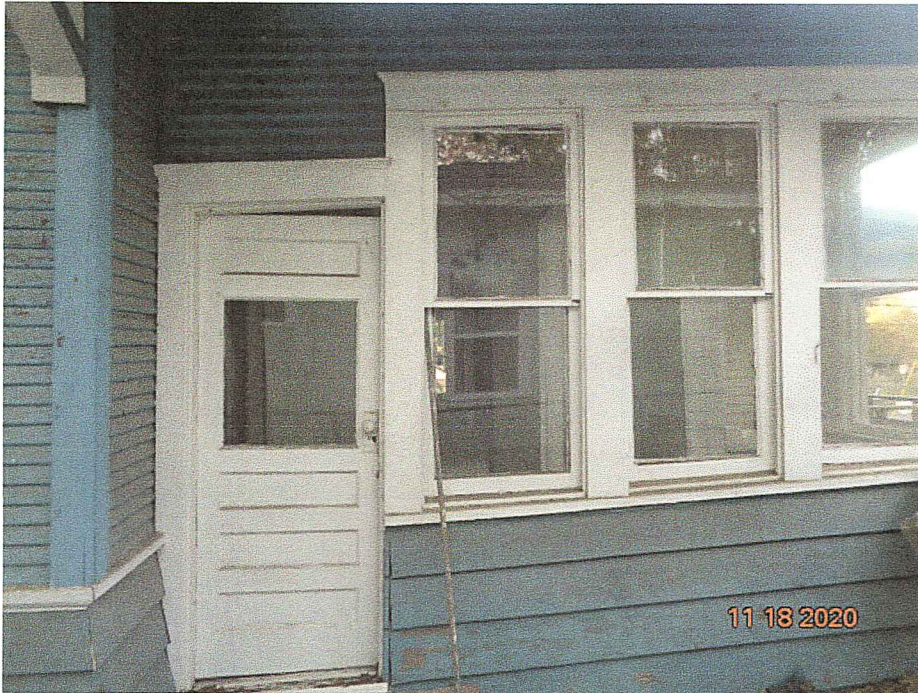
Photograph No. 3-view looking northward at section of southern exterior wall framing and door frame out of square near southeast corner of structure

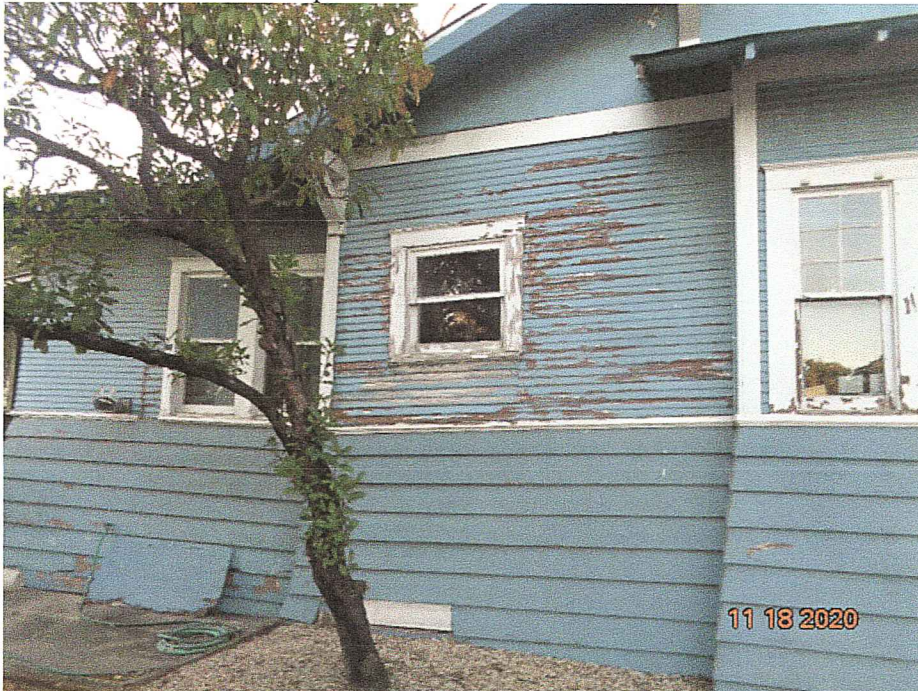
Photograph No. 4-view looking southward at north side wall at eastern portion of north wall. Note uneven siding framing construction at left side of photograph

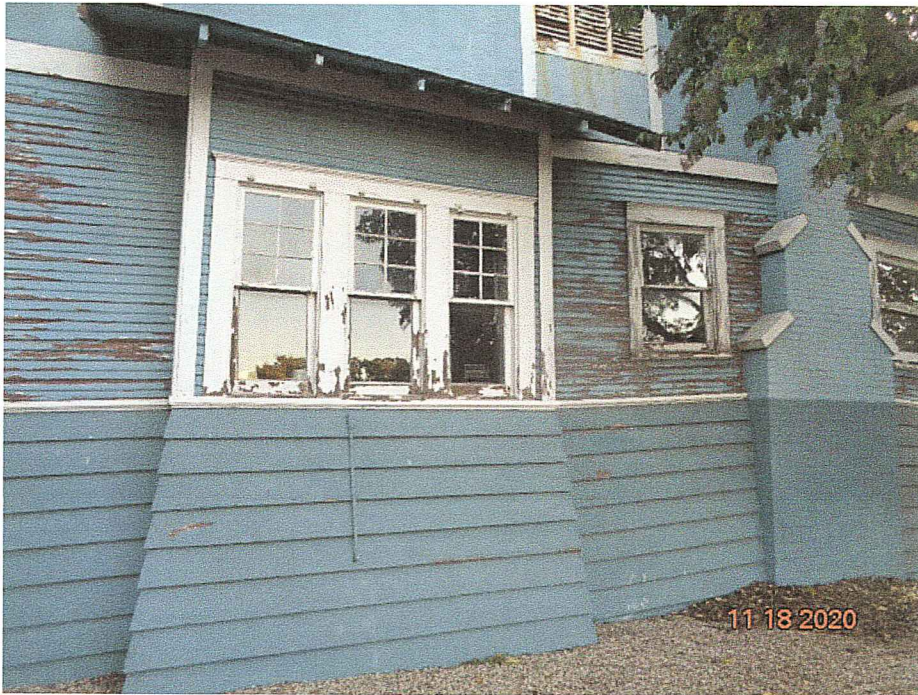
Photograph No. 5-view looking southward at north wall façade at western portion of wall near the main living room and exterior fireplace at right side of photograph. Note uneven level of wooden siding in the immediate vicinity of the windows' framing

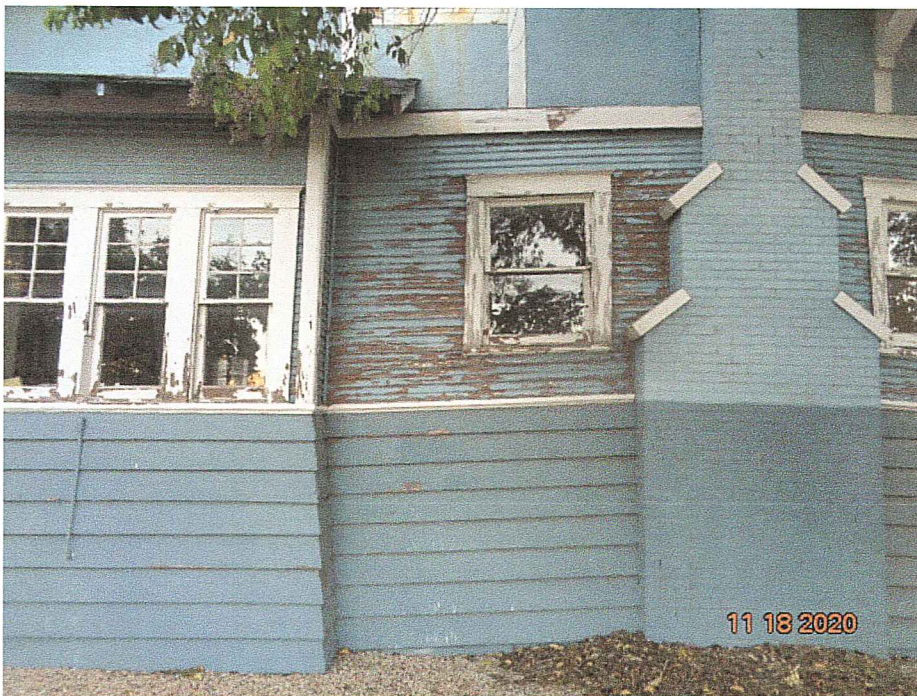
Photograph No. 6-another view from a different angle of Photograph No. 05 above. Note again the uneven level of siding framing at window level

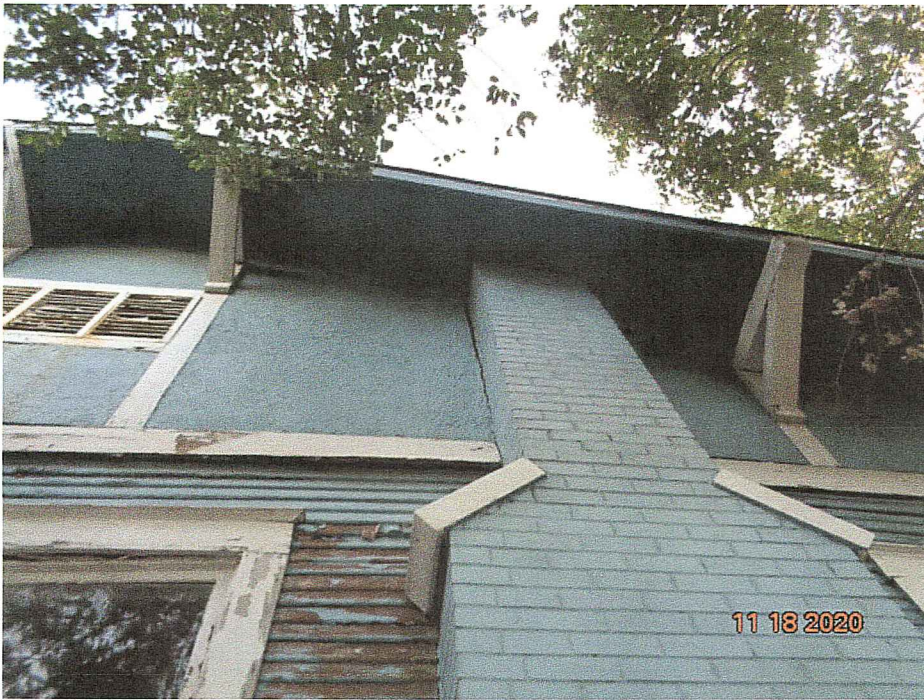
Photograph No. 7-view looking southward and upward at north wall in the area of the exterior brick constructed fireplace. Note wall separation at upper level of fireplace

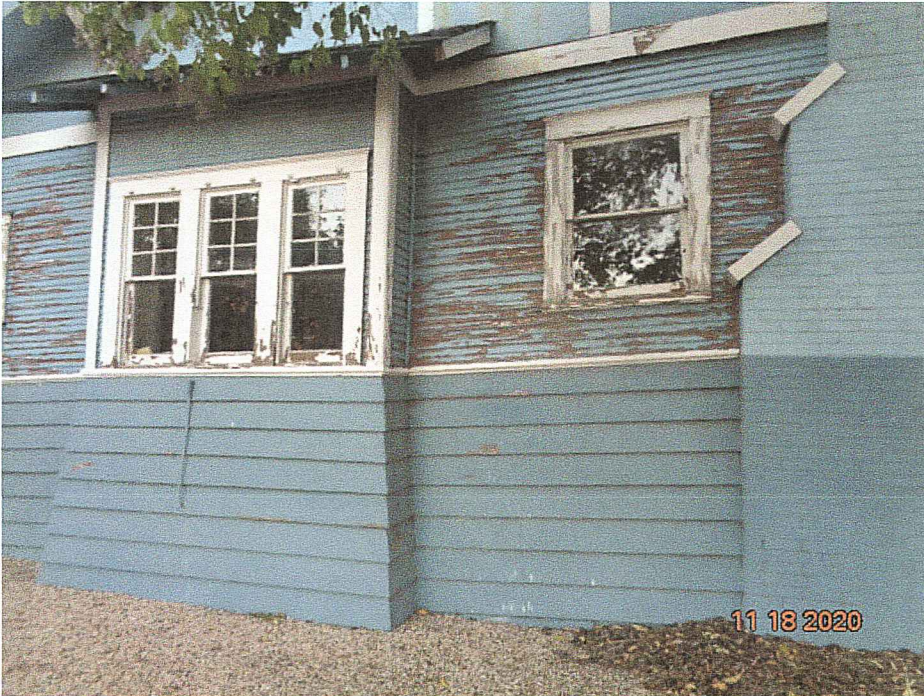
Photograph No. 8-anotehr view like photographs No. 05 and 06 at wall framing at two siding patterns interface

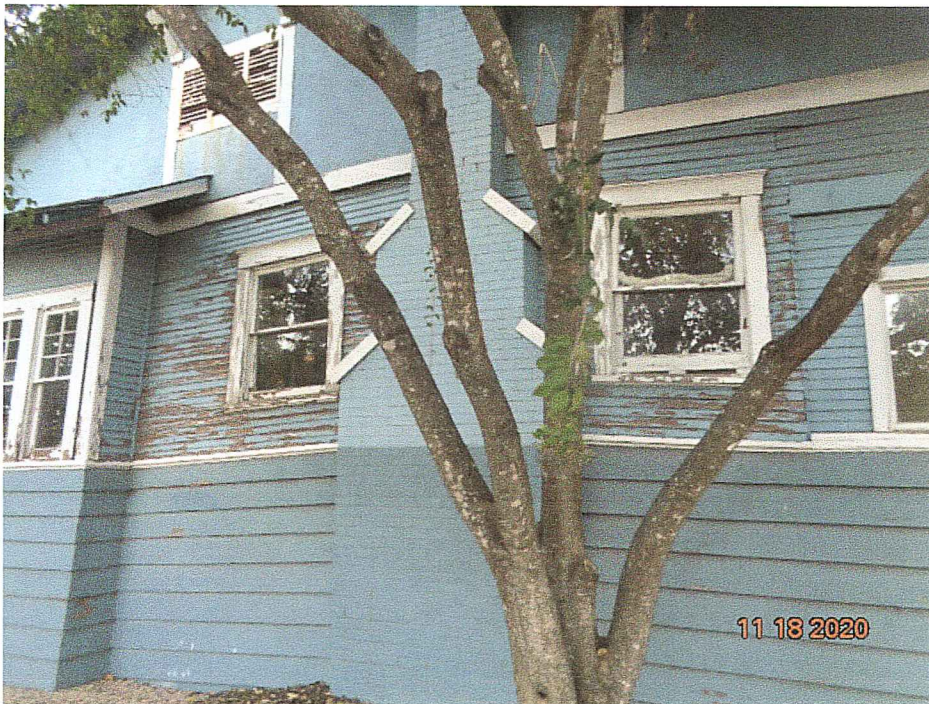
Photograph No. 9-anotyher view like Photographs No. 06 and 07 looking at the western side of the fireplace and the out of level structural framing at siding level

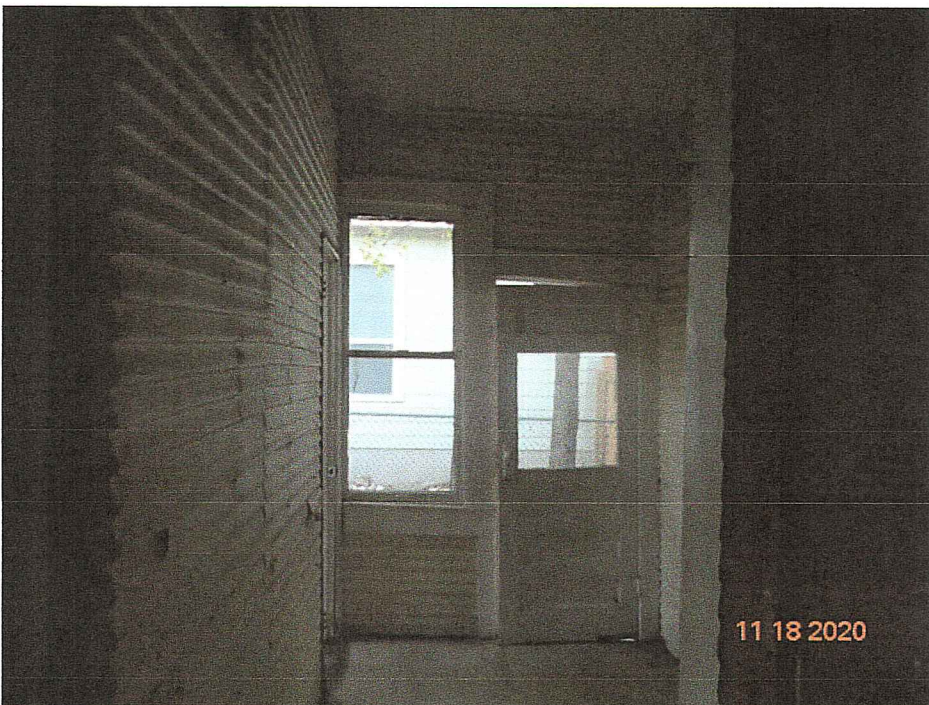
Photograph No. 10-view looking southward at interior of exterior wall described in Photograph No, 03 above. Note out of square structural framing of the exterior door

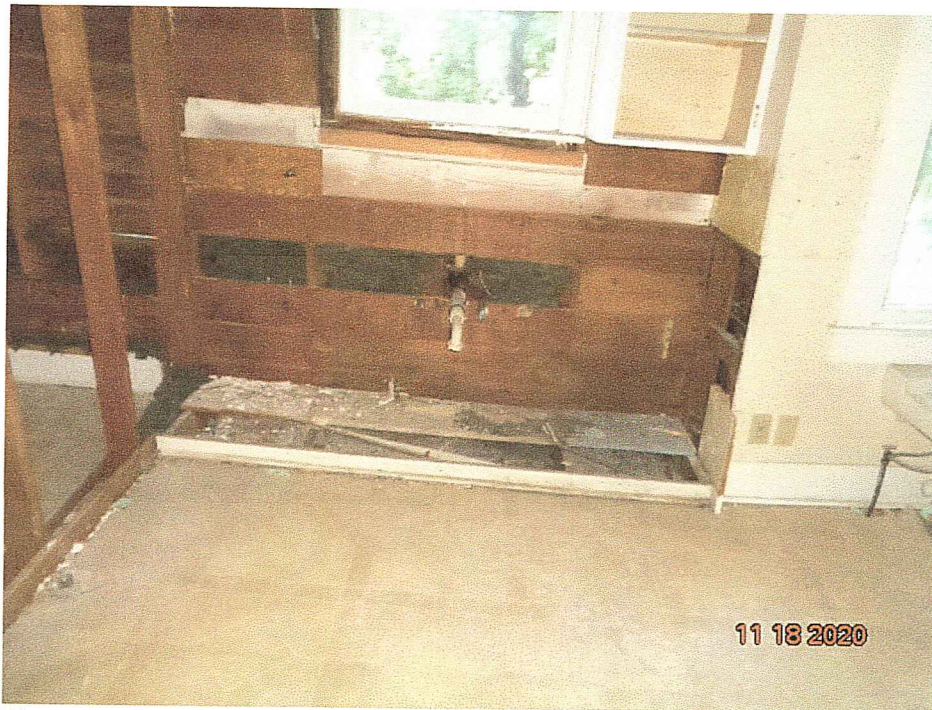
Photograph No. 11-view looking northward and downward at northern exterior wall framing near main living room area

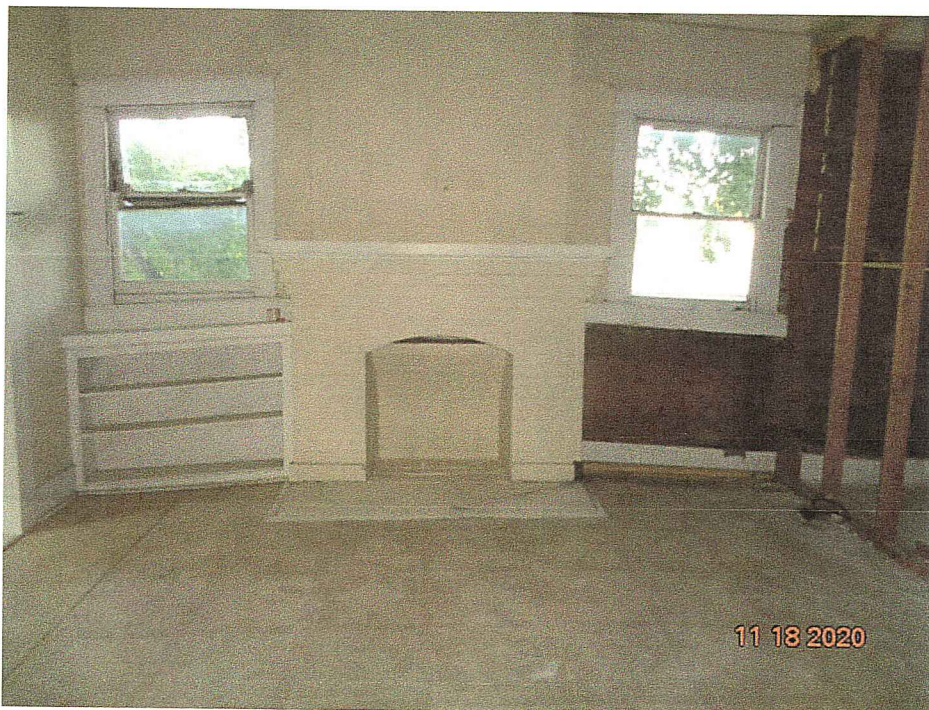
Photograph No. 12-view looking northward at northern exterior wall of main living room the vicinity of the fireplace previously described. Note out level floor elevations at both sides of the fireplace

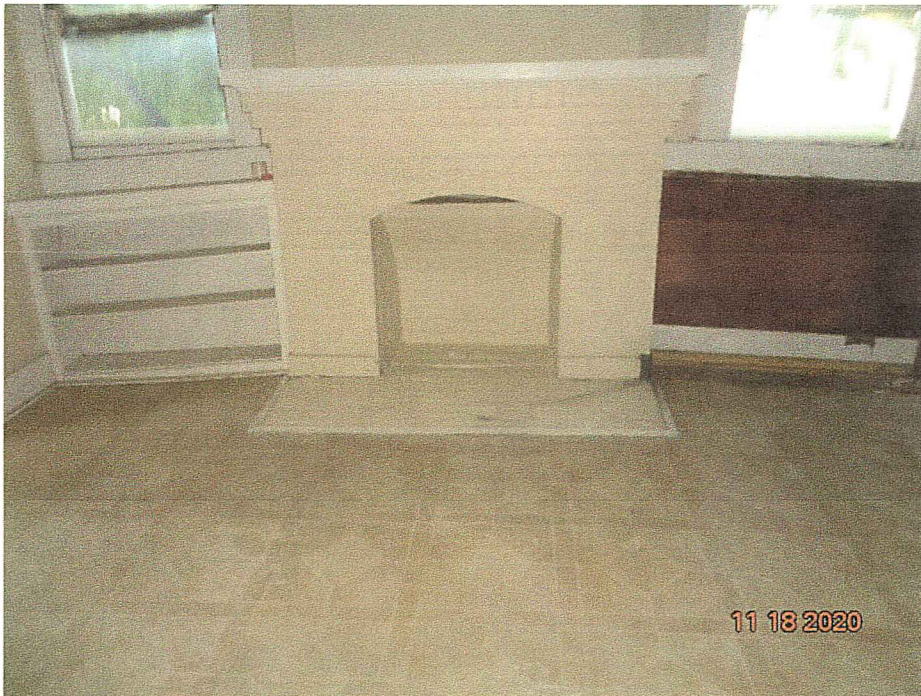
Photograph No. 13-another view like that of photograph No. 12 above

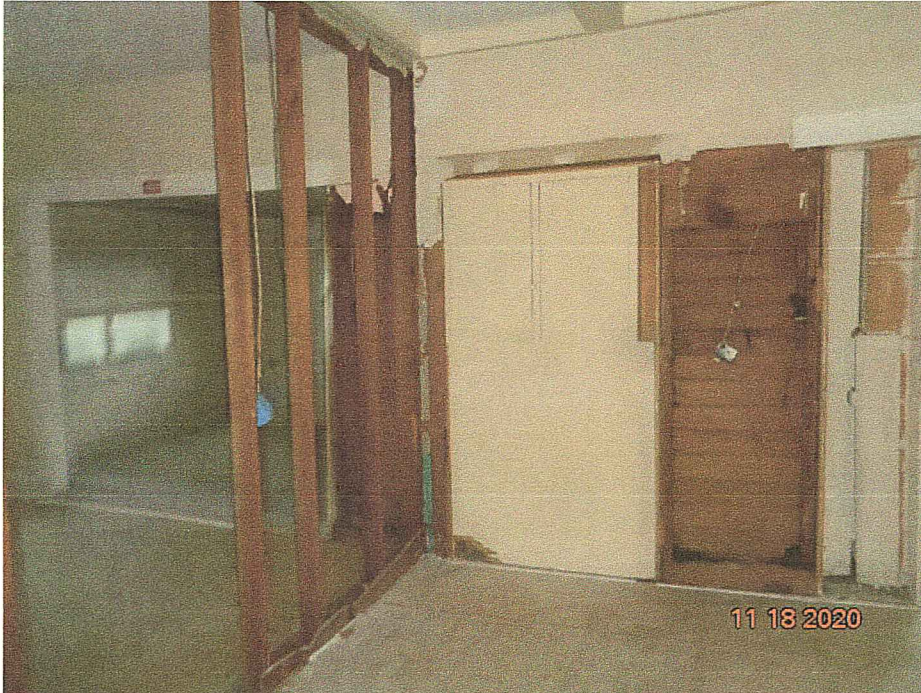
Photograph No. 14-view looking westward at northern section of west wall of main living room. Note the level of the floor at sole plate elevation

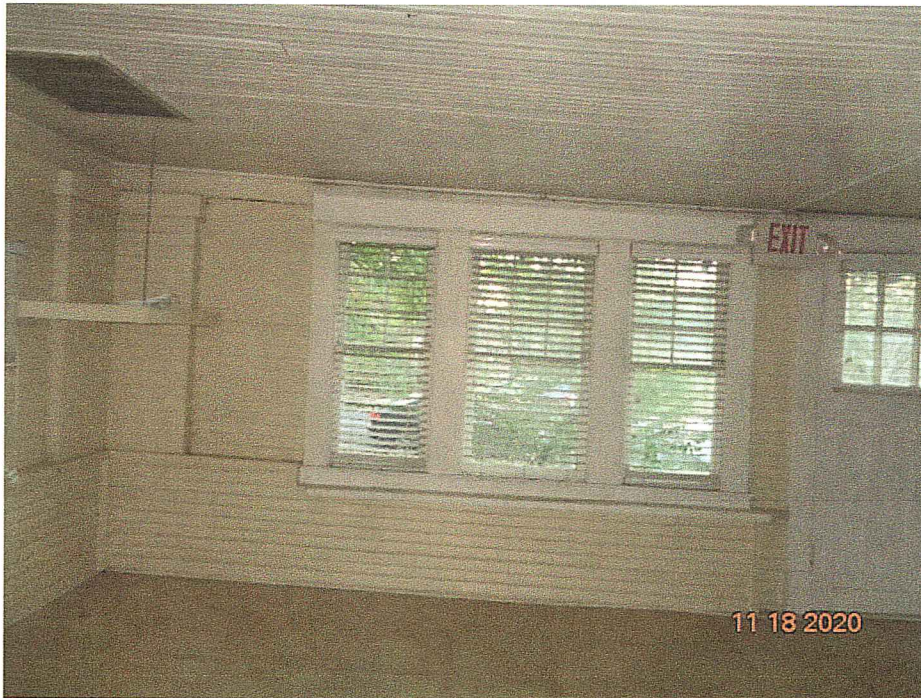
Photograph No. 15-view looking westward at west exterior front wall of residence at main entrance, Note level of ceiling elevation

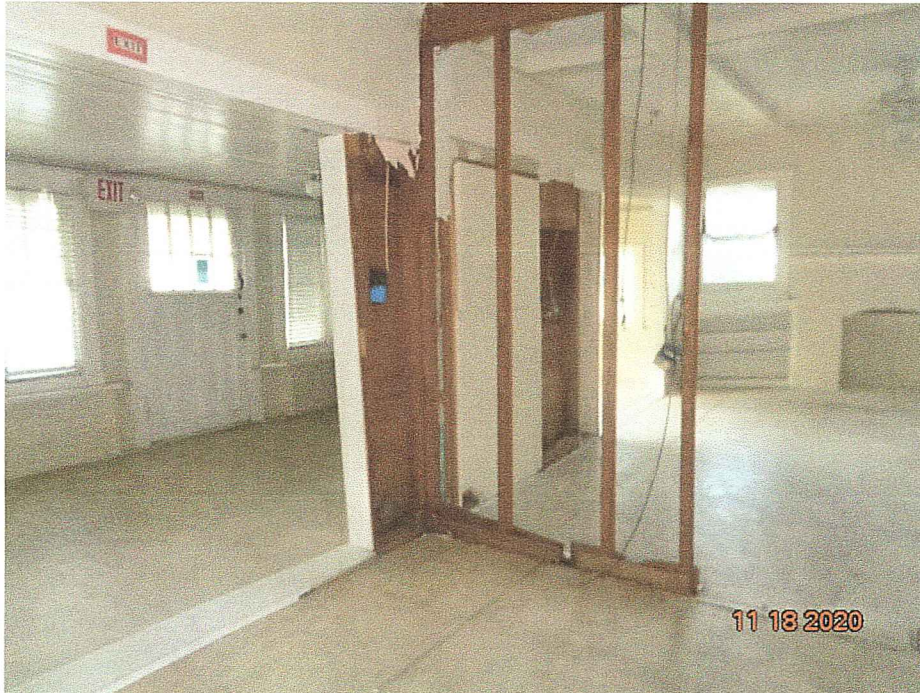
Photograph No. 16-view looking in a northwesterly direction at western part of main living room/front room interface. Note wall framing out of plumb

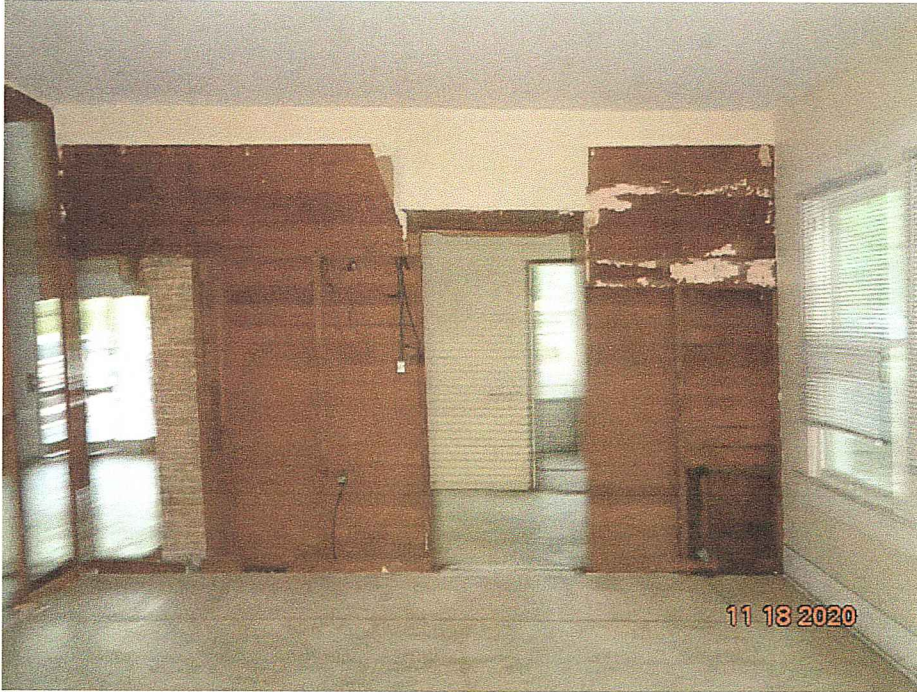
Photograph No. 17-view looking eastward at eastern portion of main living room area.  
Note gyplap construction of interior load-bearing walls and out square framing
