From: Killander, Lisa
Sent: Wednesday, March 17, 2021 10:50 AM
To: Patrick Fulker
Cc: Mars, Keith
Subject: RE: Request to remove 20" Cottonwood tree in ROW of 13213 Villa Park Dr
Attachments: 13213 Villa Park Road risk assessment of 20 inch tree.pdf

Basic Tree Risk Assessment Form

Client _____ Date 3/15/2021 Time 10:45 am
 Address/Tree location 13213 Villa Park Drive Tree no. _____ Sheet 1 of 2
 Tree species Cottonwood dbh 21" Height 40' Crown spread dia. 30'
 Assessor(s) Lisa Killander Time frame 2 yrs Tools used dbh tape

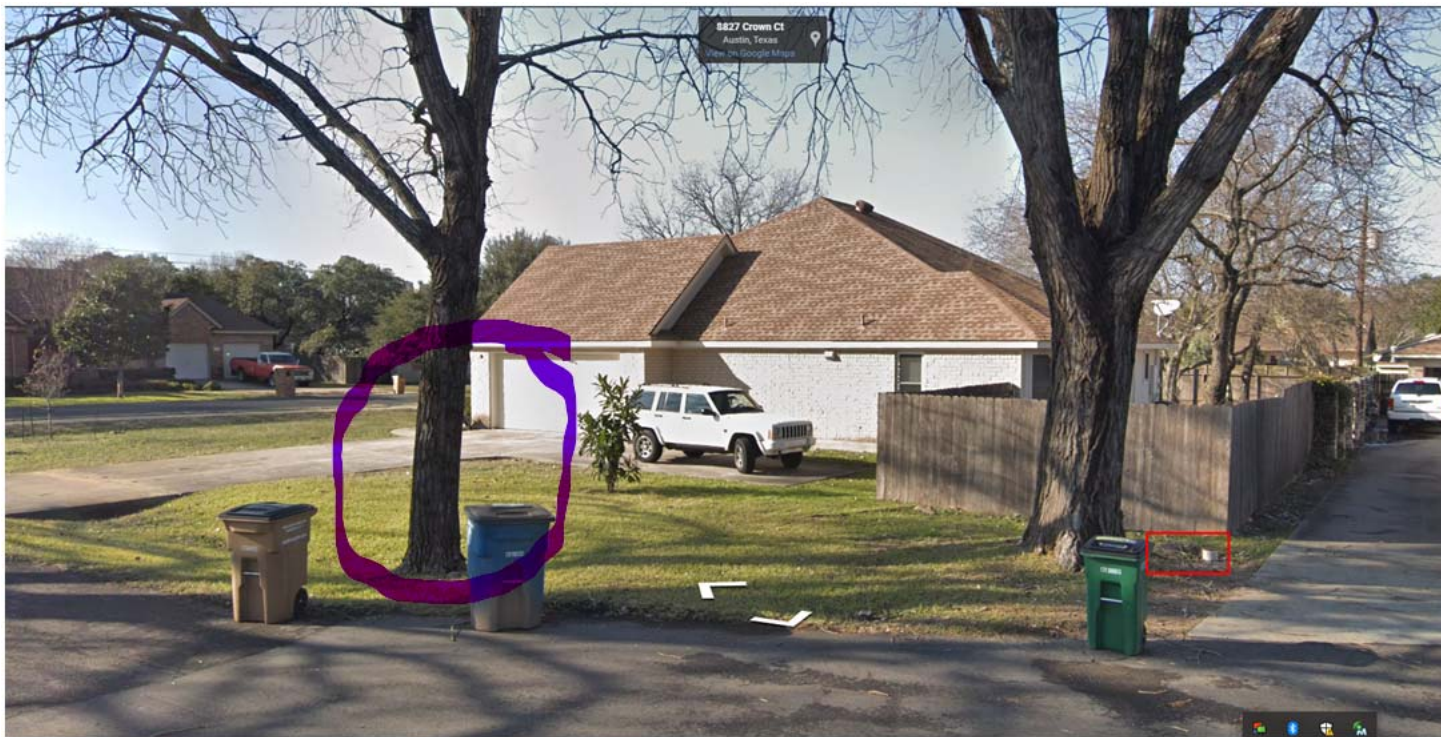
I measured the distance from the water meter (red box next to drive) to the trunk of the 21" diameter tree, circled in purple, as approximately 28 feet. The invoice that you provided from your contractor made no mention of the break in the pipe resulting from a tree root. I have no photos to document your claim that a root caused the break. Hence, I cannot conclude that this tree 28 feet away is the reason for the break in the pipe next to your water meter. I am sorry for the inconvenience this leak caused but the tree will not be removed based on my findings.

Hx2 = 28' from taps meter
