Field Report

Date:	May 10, 2021	Time: 8:30 AM
Project:	2308 Woodlawn Blvd, Austin, Texas	
Project Number:	21821000	
Present:	David Heitman	First Onsite
	Kevin Istas	First Onsite
	Scott Allen	OPN Architects

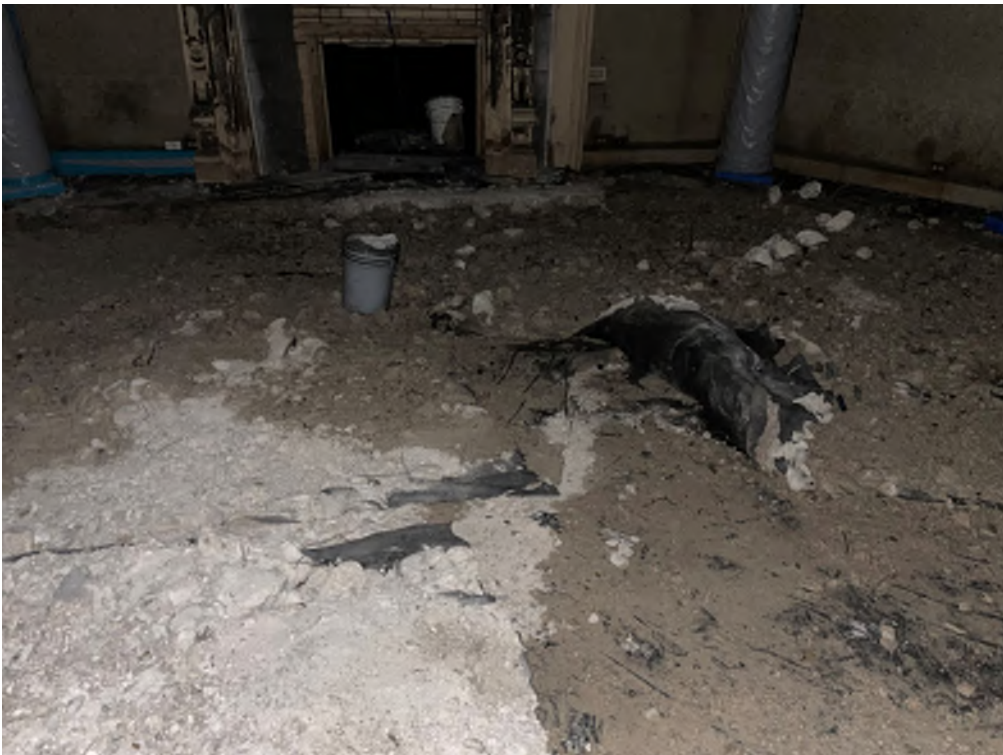
- a. Octagon Art Space – The concrete floor is over precast concrete planks on concrete piles at the perimeter. The floor slab over the precast has failed, water proofing membrane visible and damaged and space has been underwater at least to above the head of the doors. Structural engineer needed to determine if movement has occurred on the upper levels.
- b. Mold on the plaster ceiling and walls surfaces.

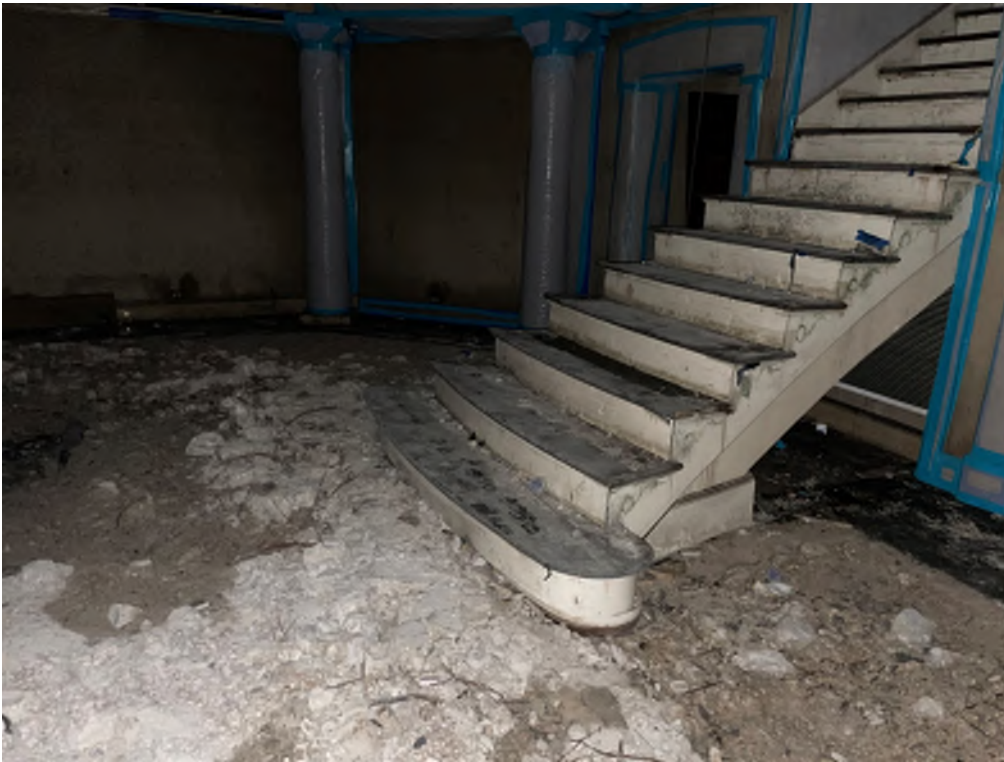
- c. Stair to the Lower Level has moved up and needs complete replacement. Debris is on top of these planks and the stair stringer is too high causing the treads to slope back. Could not view the condition of the concrete planks and the void between the structural precast planks and the earth members below.

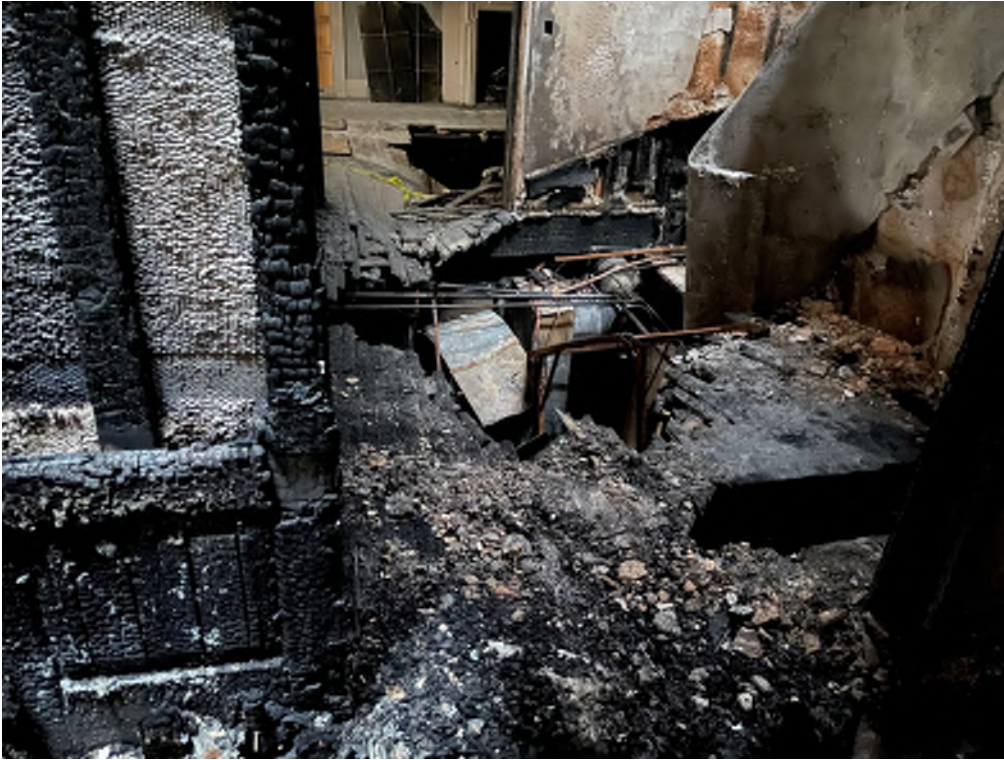
- d. Space not shown on the Lower Level floor plans provided, seen through the damaged floor and located to the east of the elevator.
- e. Water level about an inch below the basement floor as the elevator pit is full of ground water while the pit under the stair is about 12 inches below the basement floor level. Sump pumps do not appear to operational as no temporary lighting is in the building.

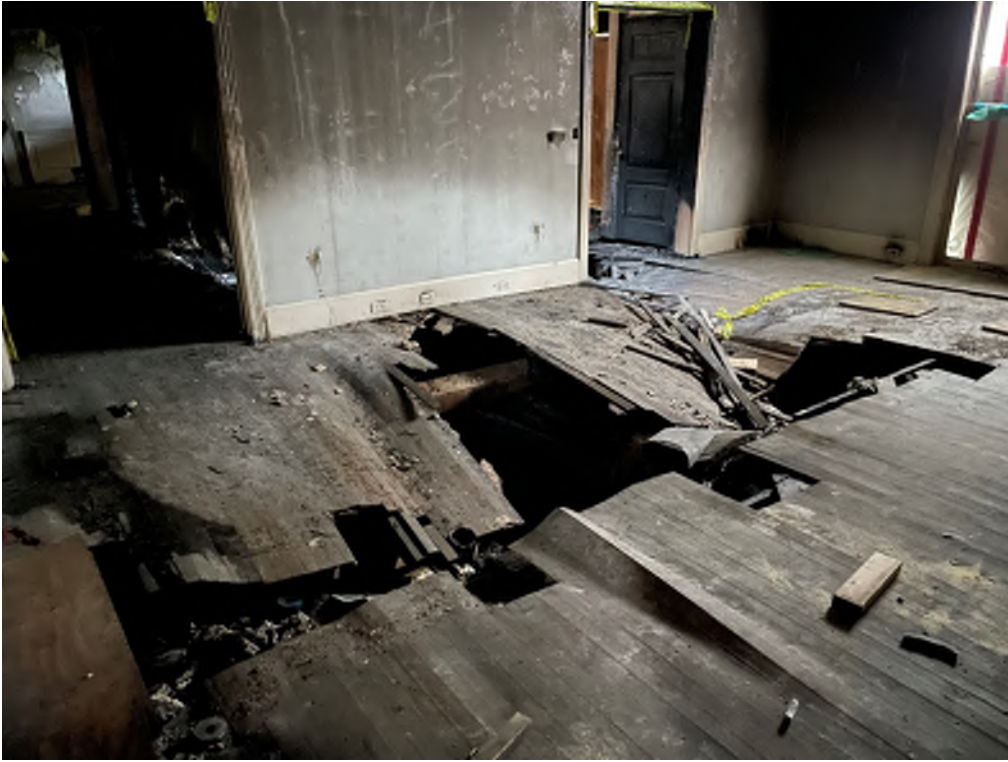
a. Living space – Crawl space below, missing floor joists and collapsed floor structure.

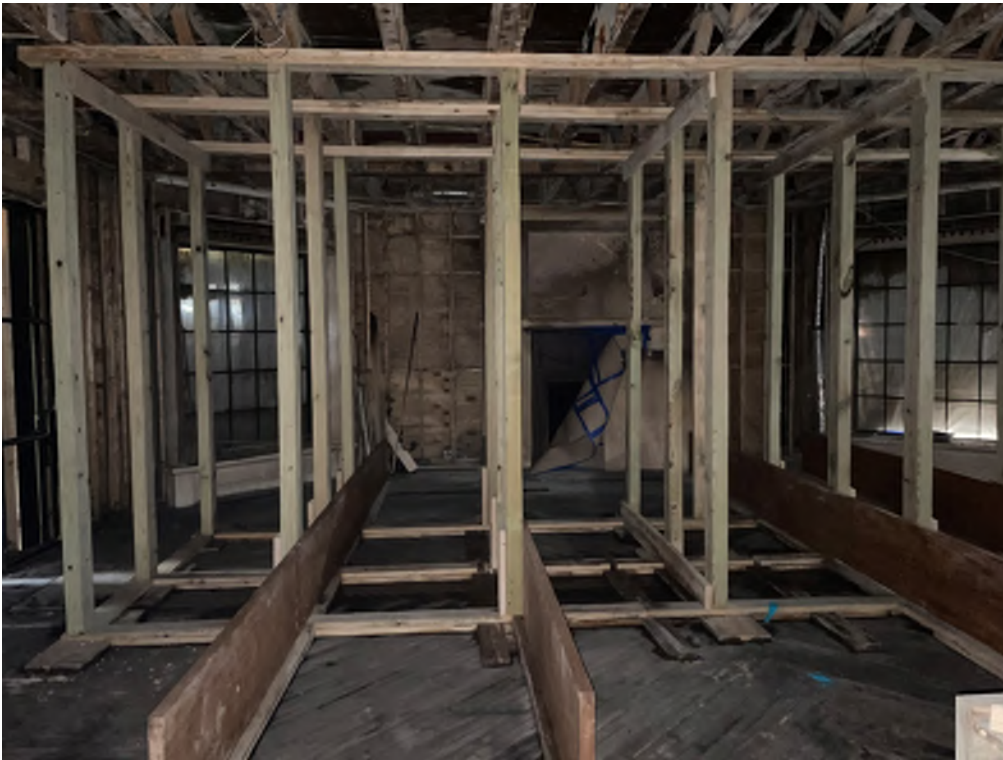
- b. Octagon Music space – LVL's and wood framing used as shoring to support the Second Floor structure. Finishes have been removed from this space, water damaged structure and daylight seen to the exterior. The structural system for the octagon spaces could be compromised until the full exterior stud walls are visible that support the brick masonry.

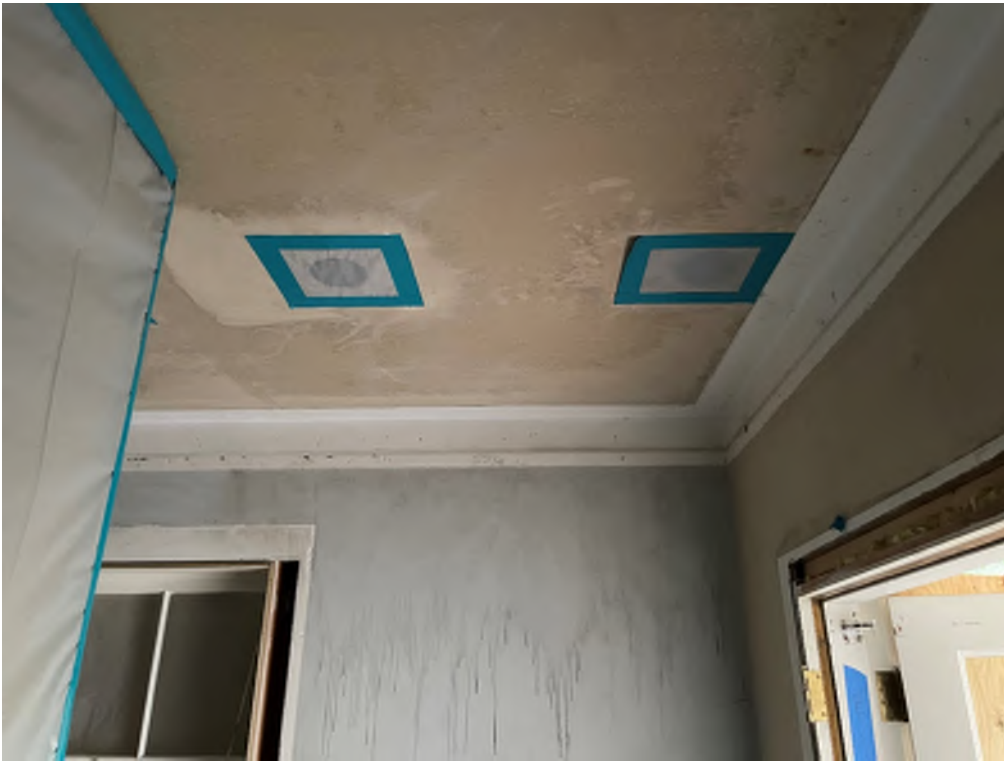
- c. Typical condition of space to the north of center spaces – plaster and gypsum board wall surfaces have mold and water damage. Remove finish material off to inspect the studs for additional water and fire damage.

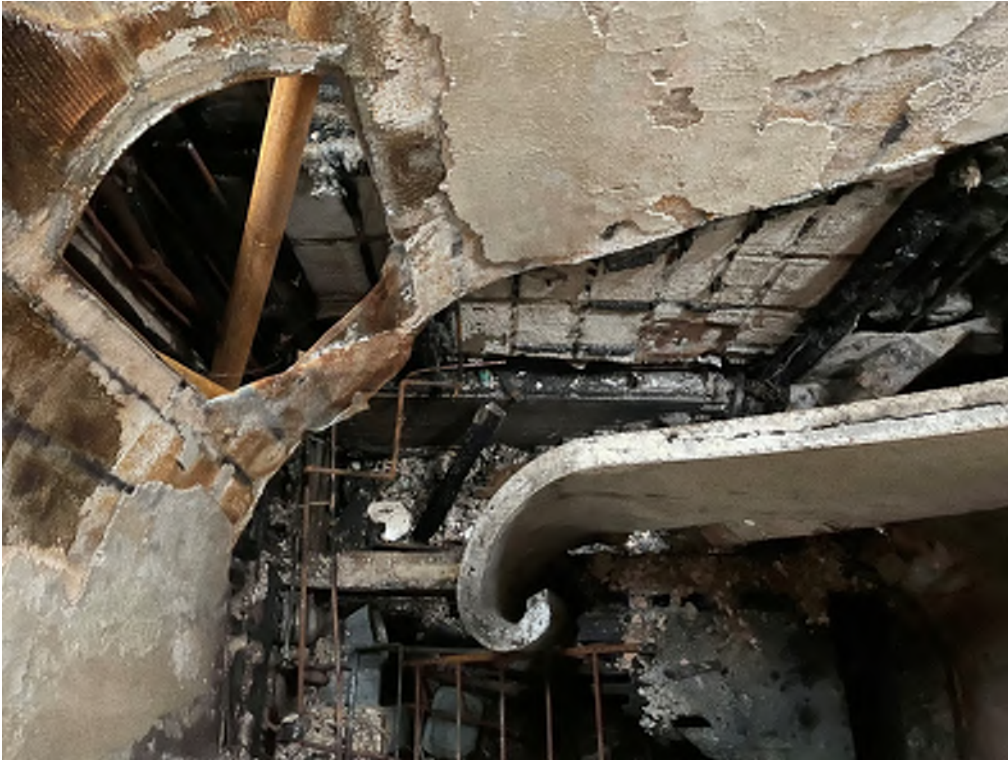
- a. Stair access to the Second Floor is gone, as this was near the location of the fire. Photo from the Second Floor to the Lower Level, structure is damaged completely in the area.

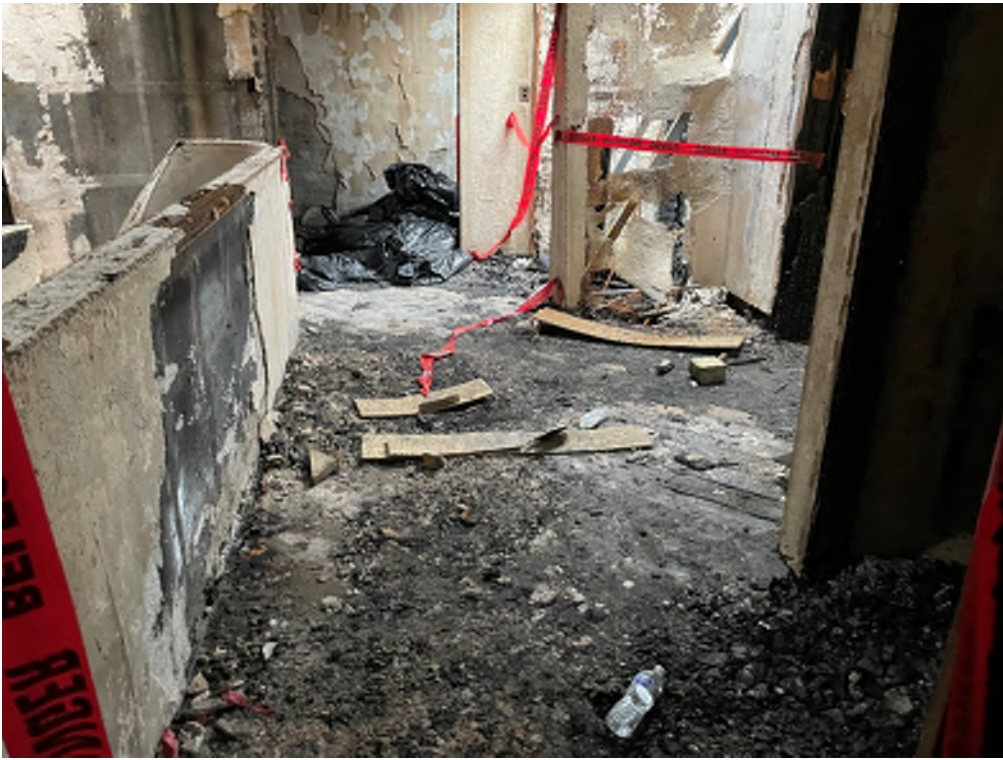
- b. Top of the Second Floor stair – Wood structure is damaged behind the plaster and floors, daylight for this space is open to the exterior, mold is seen on the plaster and wood surfaces.

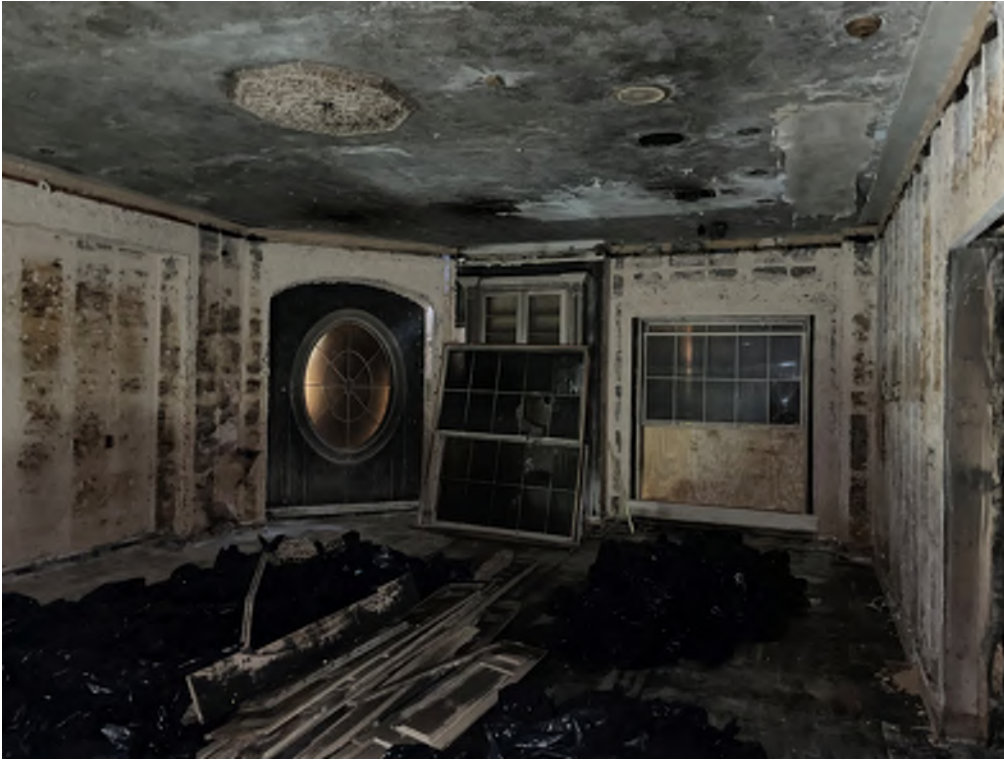
c. Octagon Master bedroom – this space has the floor shored from below with damage in the wall studs to the exterior.

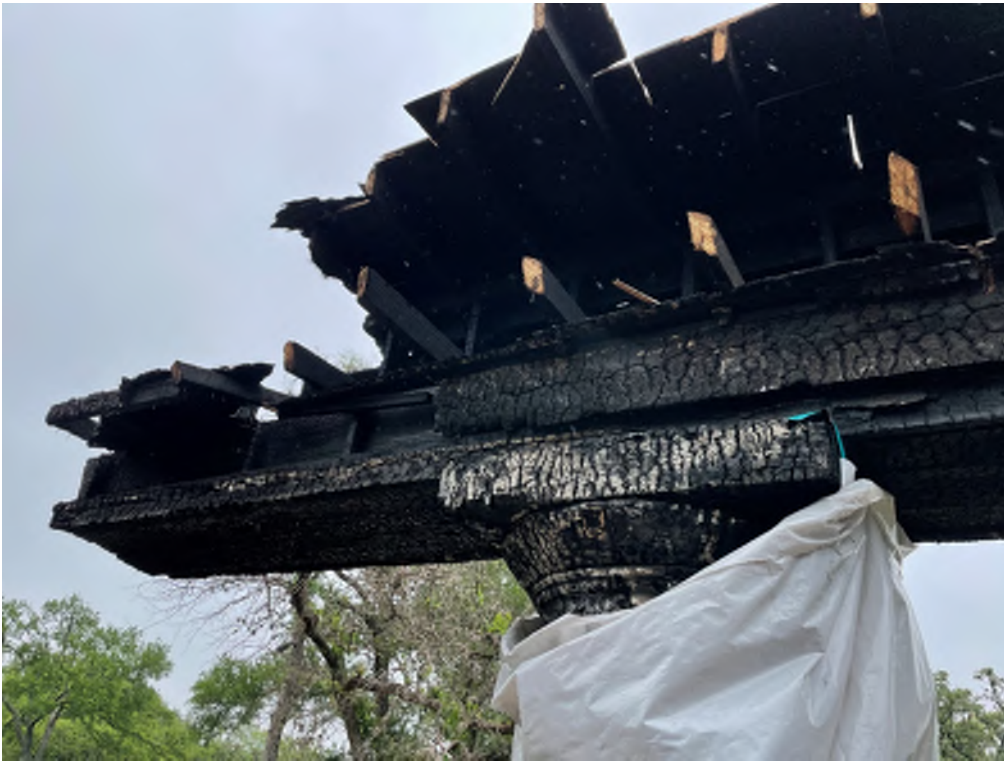
d. Porch and portion of the column capital framing has been cut and removed.

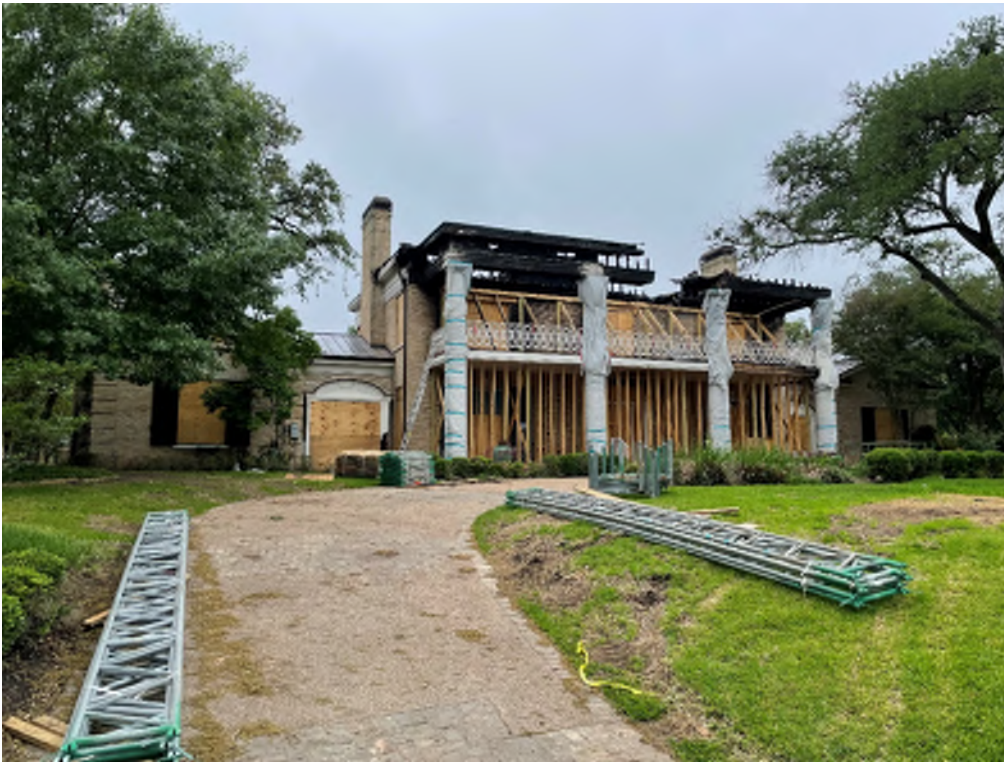
- a. Front columns are covered with a wrap and all have fire damage, reason for the wrap covering the damaged wood not known.

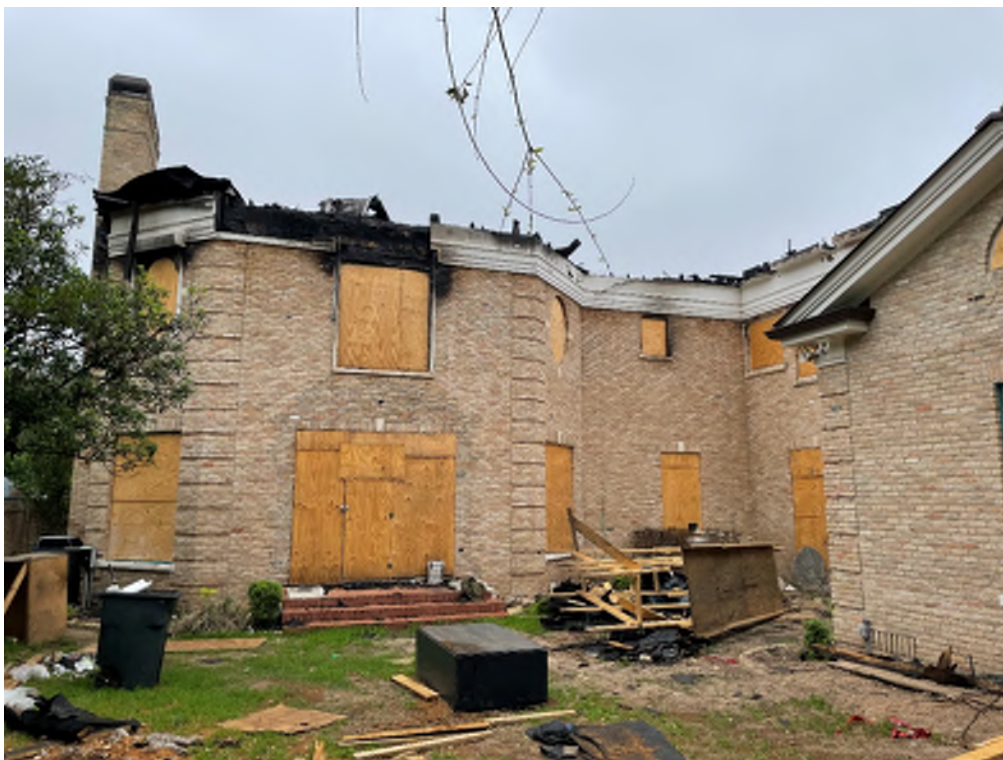
b. Octagon exterior porches north and south from the music space are gone above the stairs.

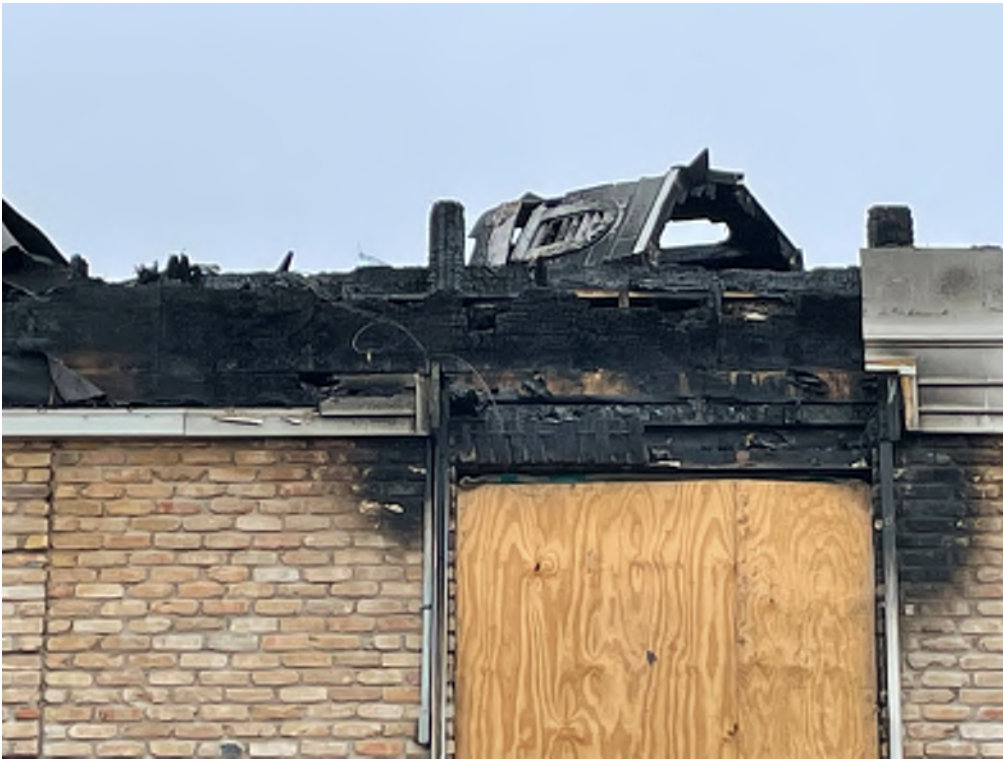
c. Portions of the octagon roof cupola elements are still on the roof.

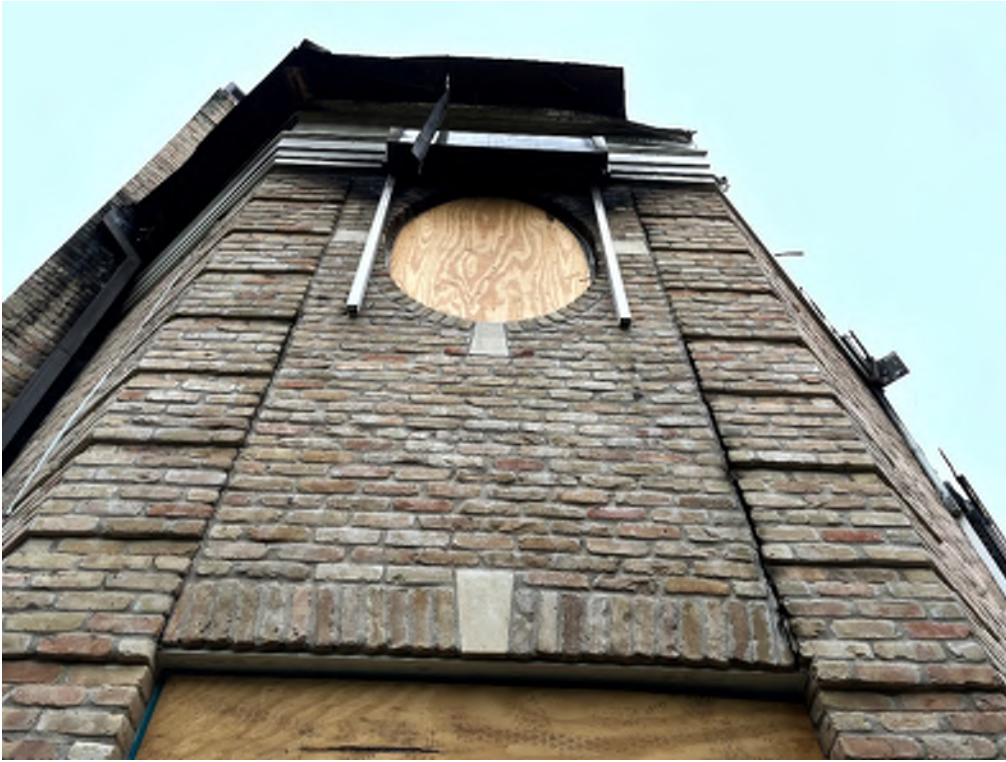
- d. Smoke at masonry joints – concern here that wood studs are damaged that support the brick veneer. Storm louvers have been removed on all elevations of the octagon.
