OWNER'S PETITION OPPOSING ZONING CHANGE

On 05 May 2021, R. Derek Hammond of RDH C&E performed a site observation to view the existing residence located at 2100 Chicon Street in Austin, Texas. Multiple structural issues were encountered during the site visit, the largest issue being the foundations as they are not code compliant. This report details what was encountered during the site visit, conclusions, and recommendations.

Existing Site Conditions

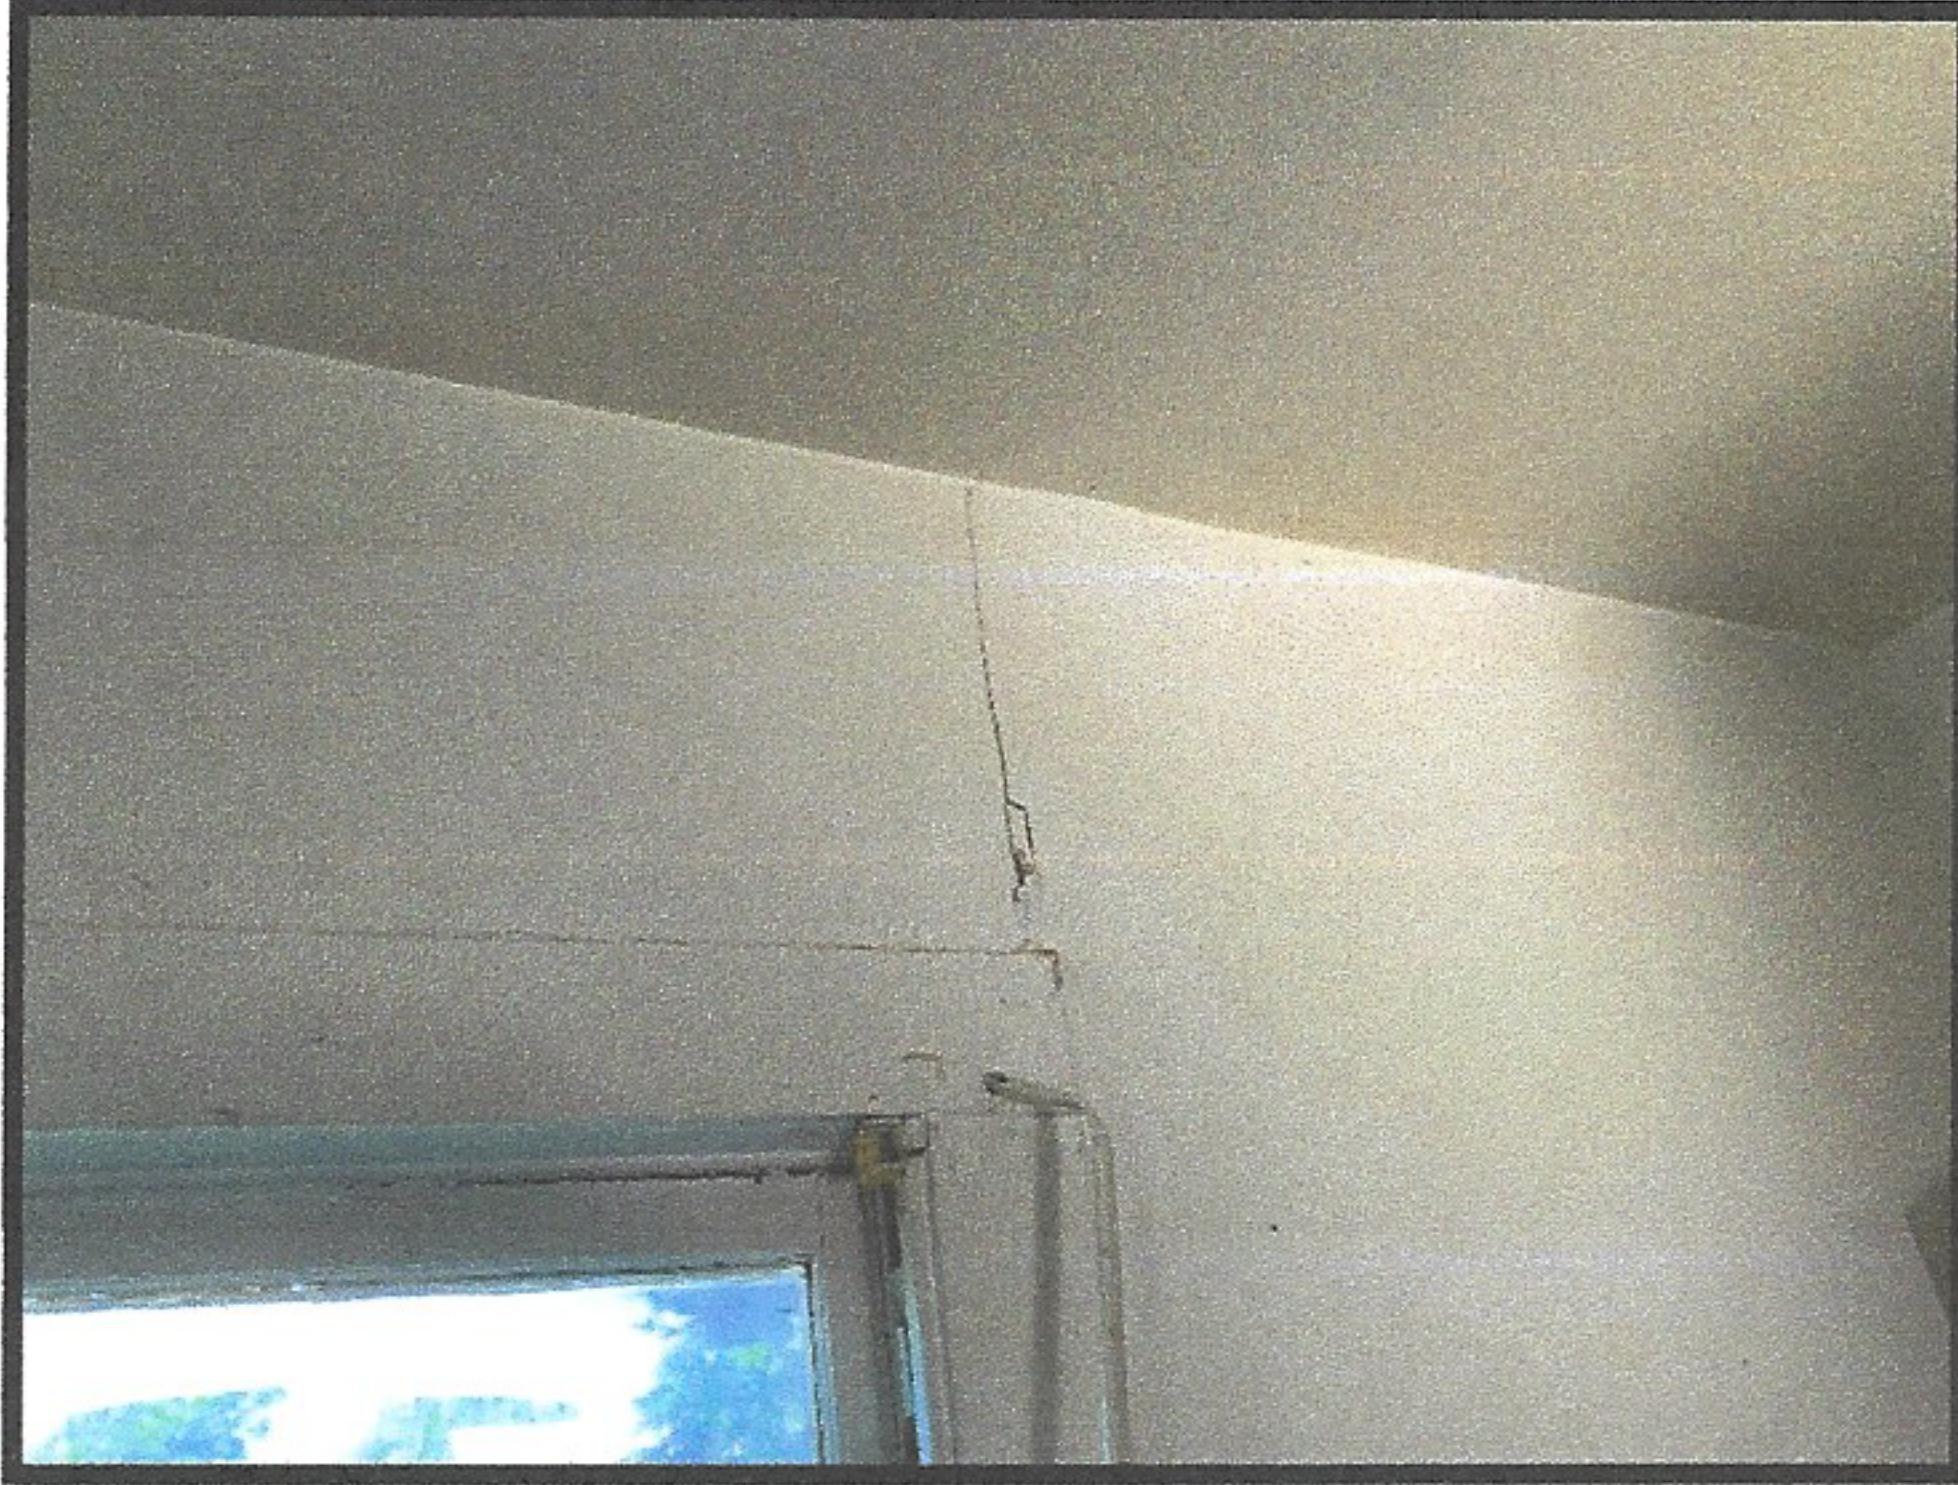
1: Cracking, typical at all exterior openings.

Some windows and doors were operable, but there were signs of racking, and door repair in most areas. Cracking was noted in the gyp board above most doors along the interior and exterior walls, with the most extreme being at the exterior walls. Some staining was noted on the ceiling, and around attic penetrations.

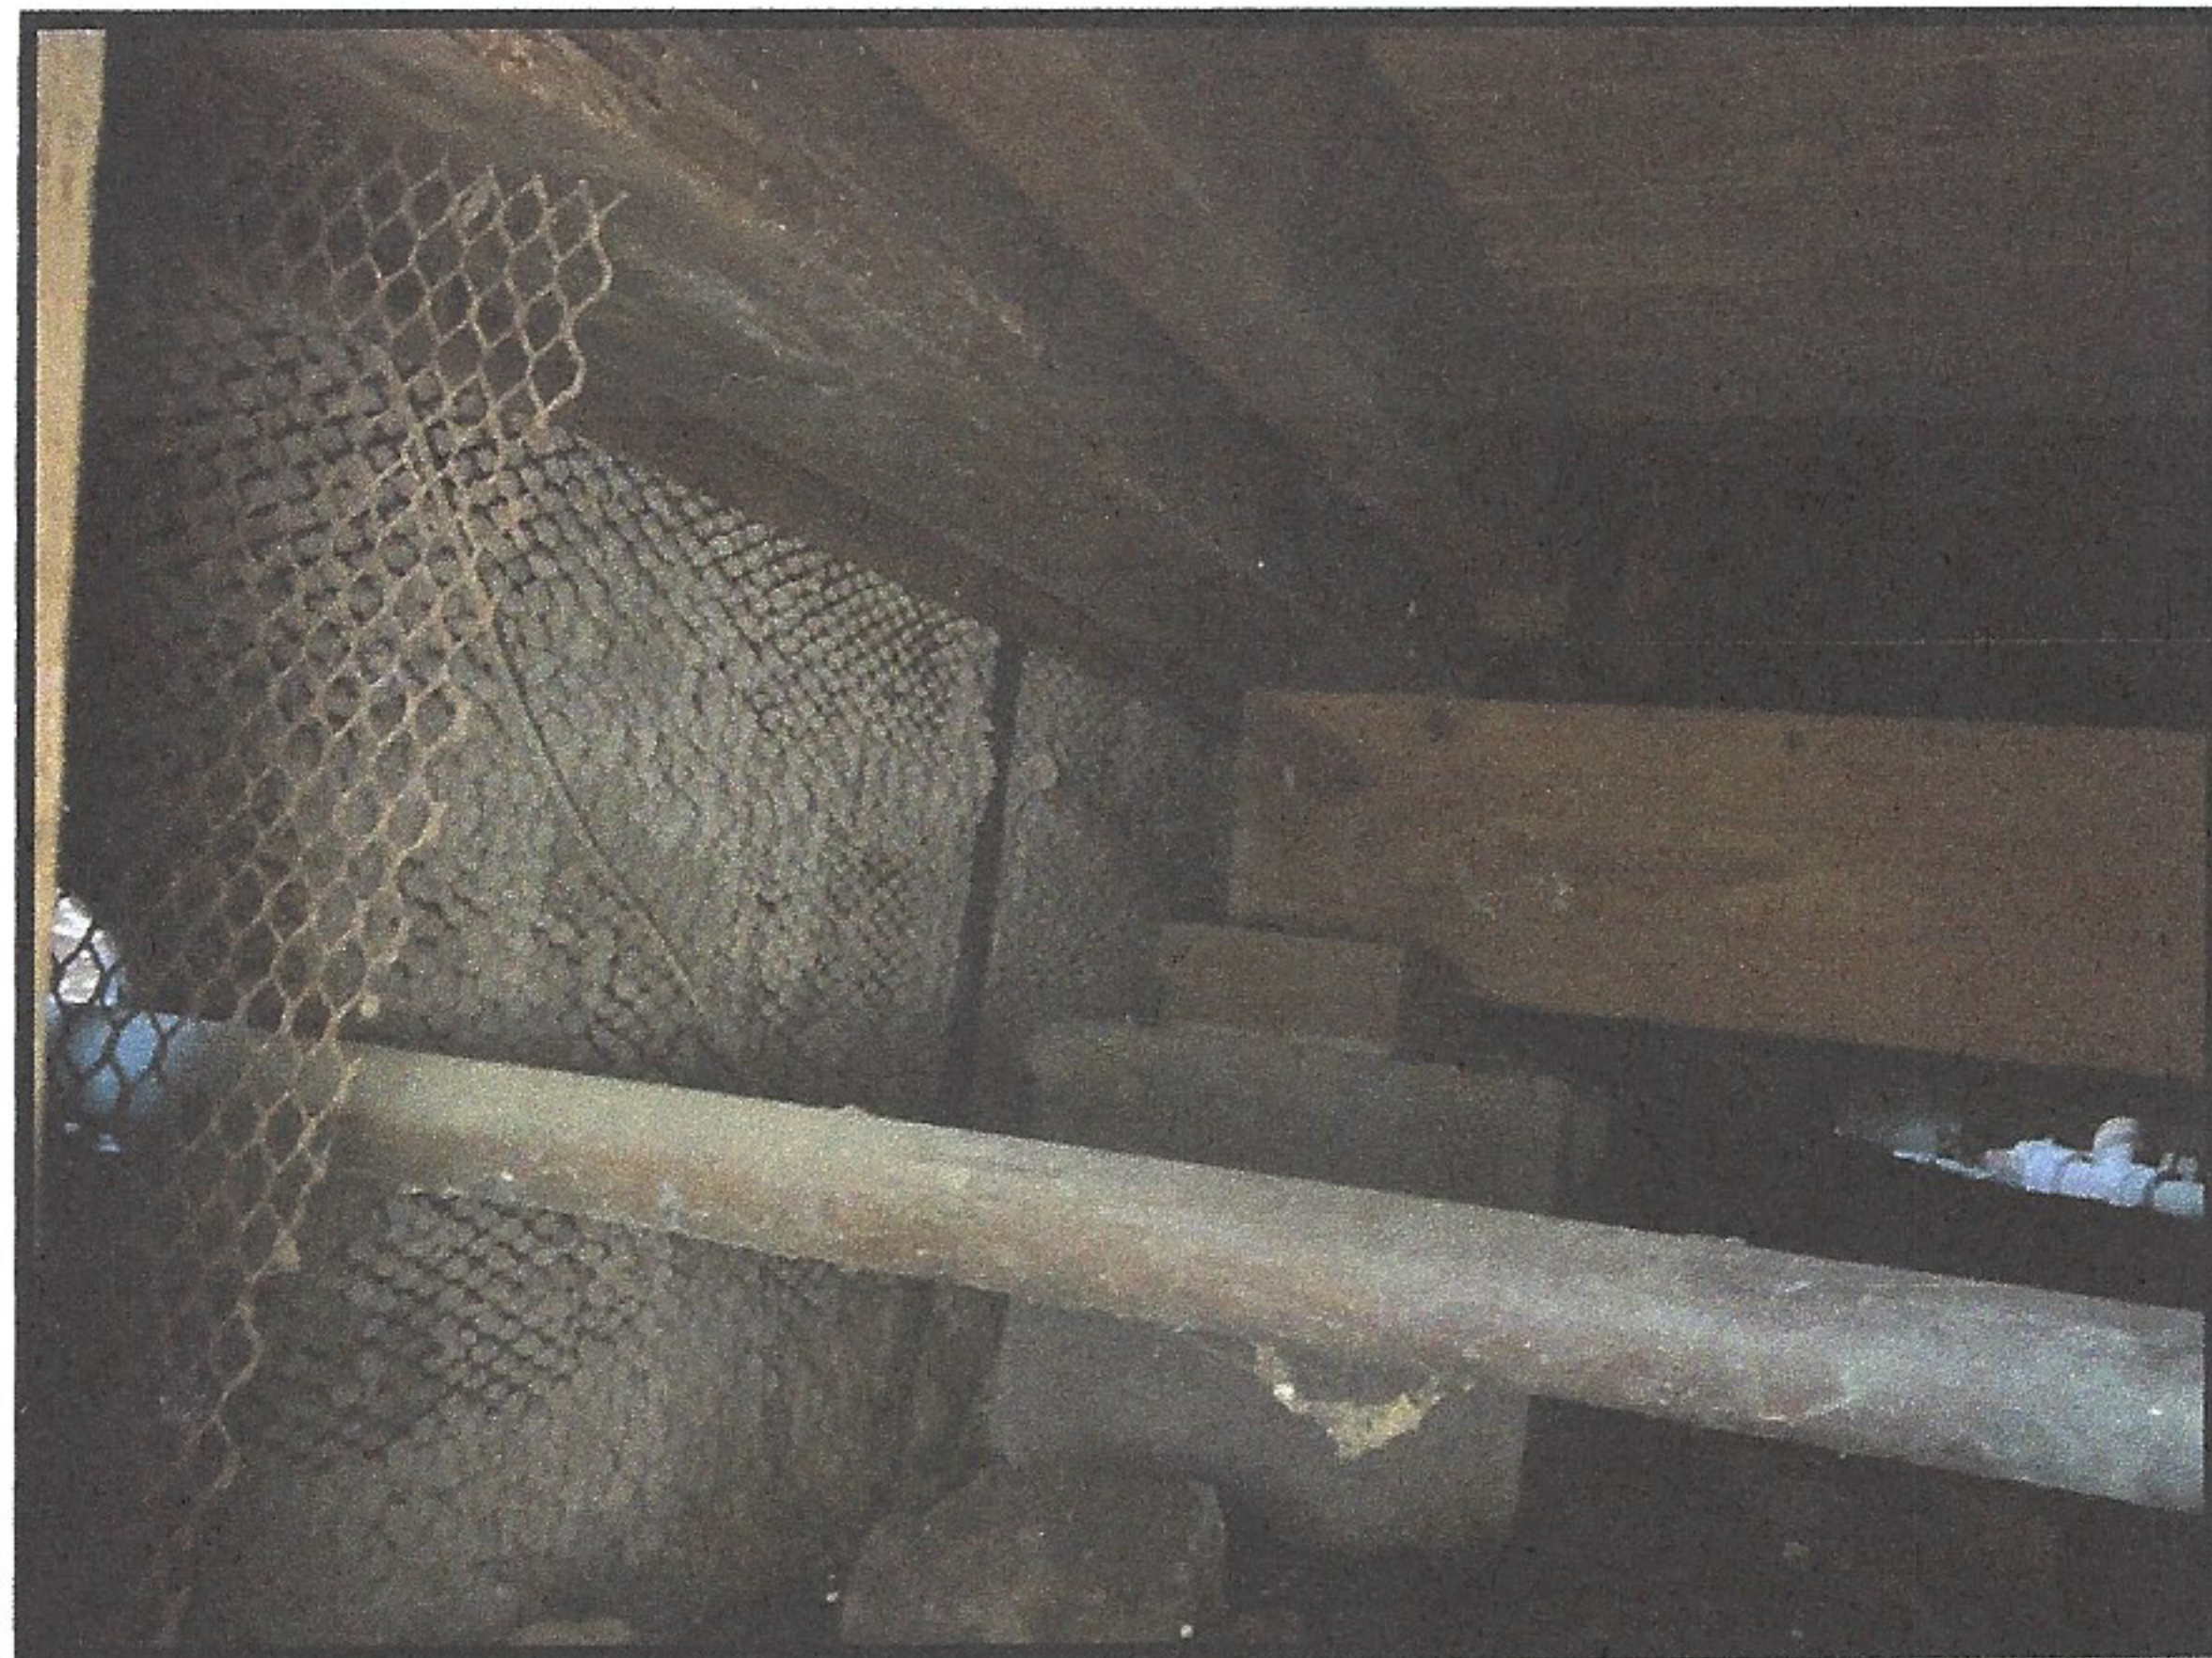
2: Girder beam at exterior resting on blocking

The exterior walls were resting on a foundation that is undersized for the loading, and the skirting is resting on grade allowing rot and corrosion into the cripple wall. Bulging on the interior is not likely as the piers are cedar posts and not masses of concrete which more susceptible to having heaving issues. Rather, the exterior walls are sinking/settling and is the reason for the sloping in

Floor framing attached to exterior walls will likely need to be replaced due to warping created by the settling in order to achieve a level floor. The removal also being necessary to ensure rotted and damaged framing members are eliminated, and to allow the demolition and installation of the new stem wall. The floor framing below the restroom is likely also undersized for the weight of the tile, bathtub, toilet, and sink. However, the issue could be corrected when the restroom is remodeled. It will be required to meet current IRC minimum clearances.

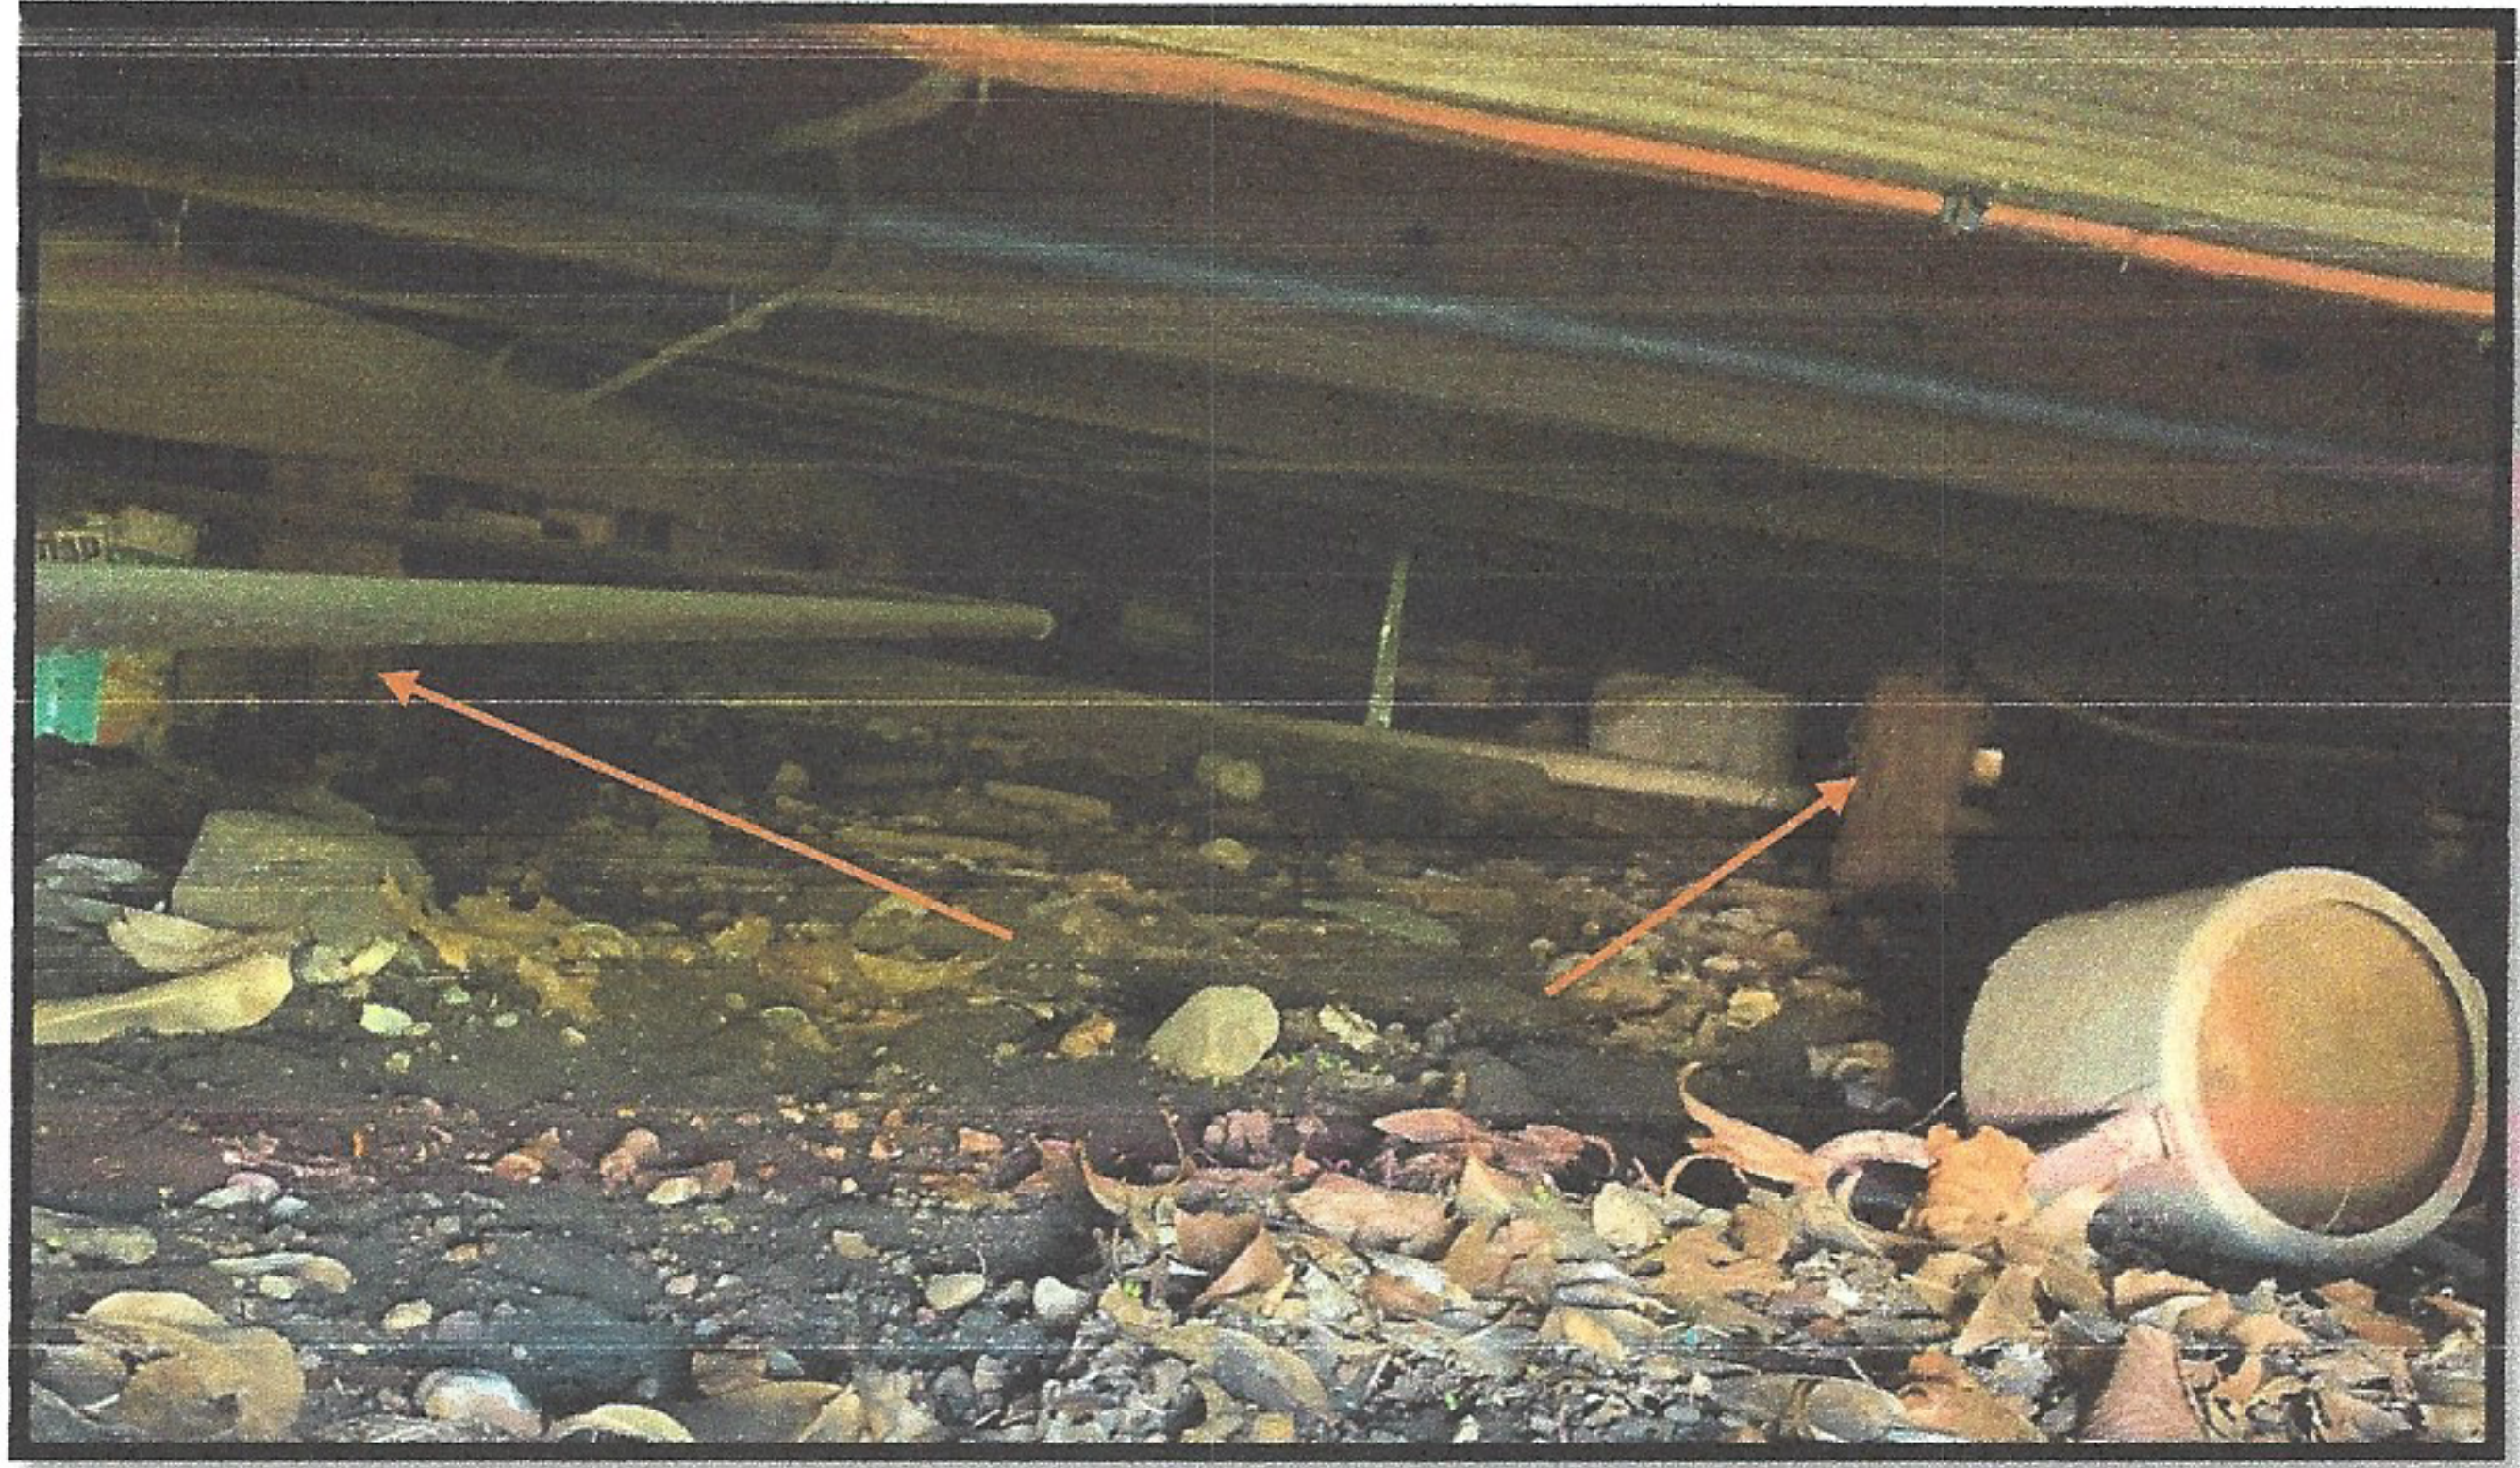
3: Cedar piers

all corners, and exterior walls in the home. The cedar posts should be replaced as well as the exterior stem wall. They are likely past their intended life span & are susceptible to corrosion and infestation.

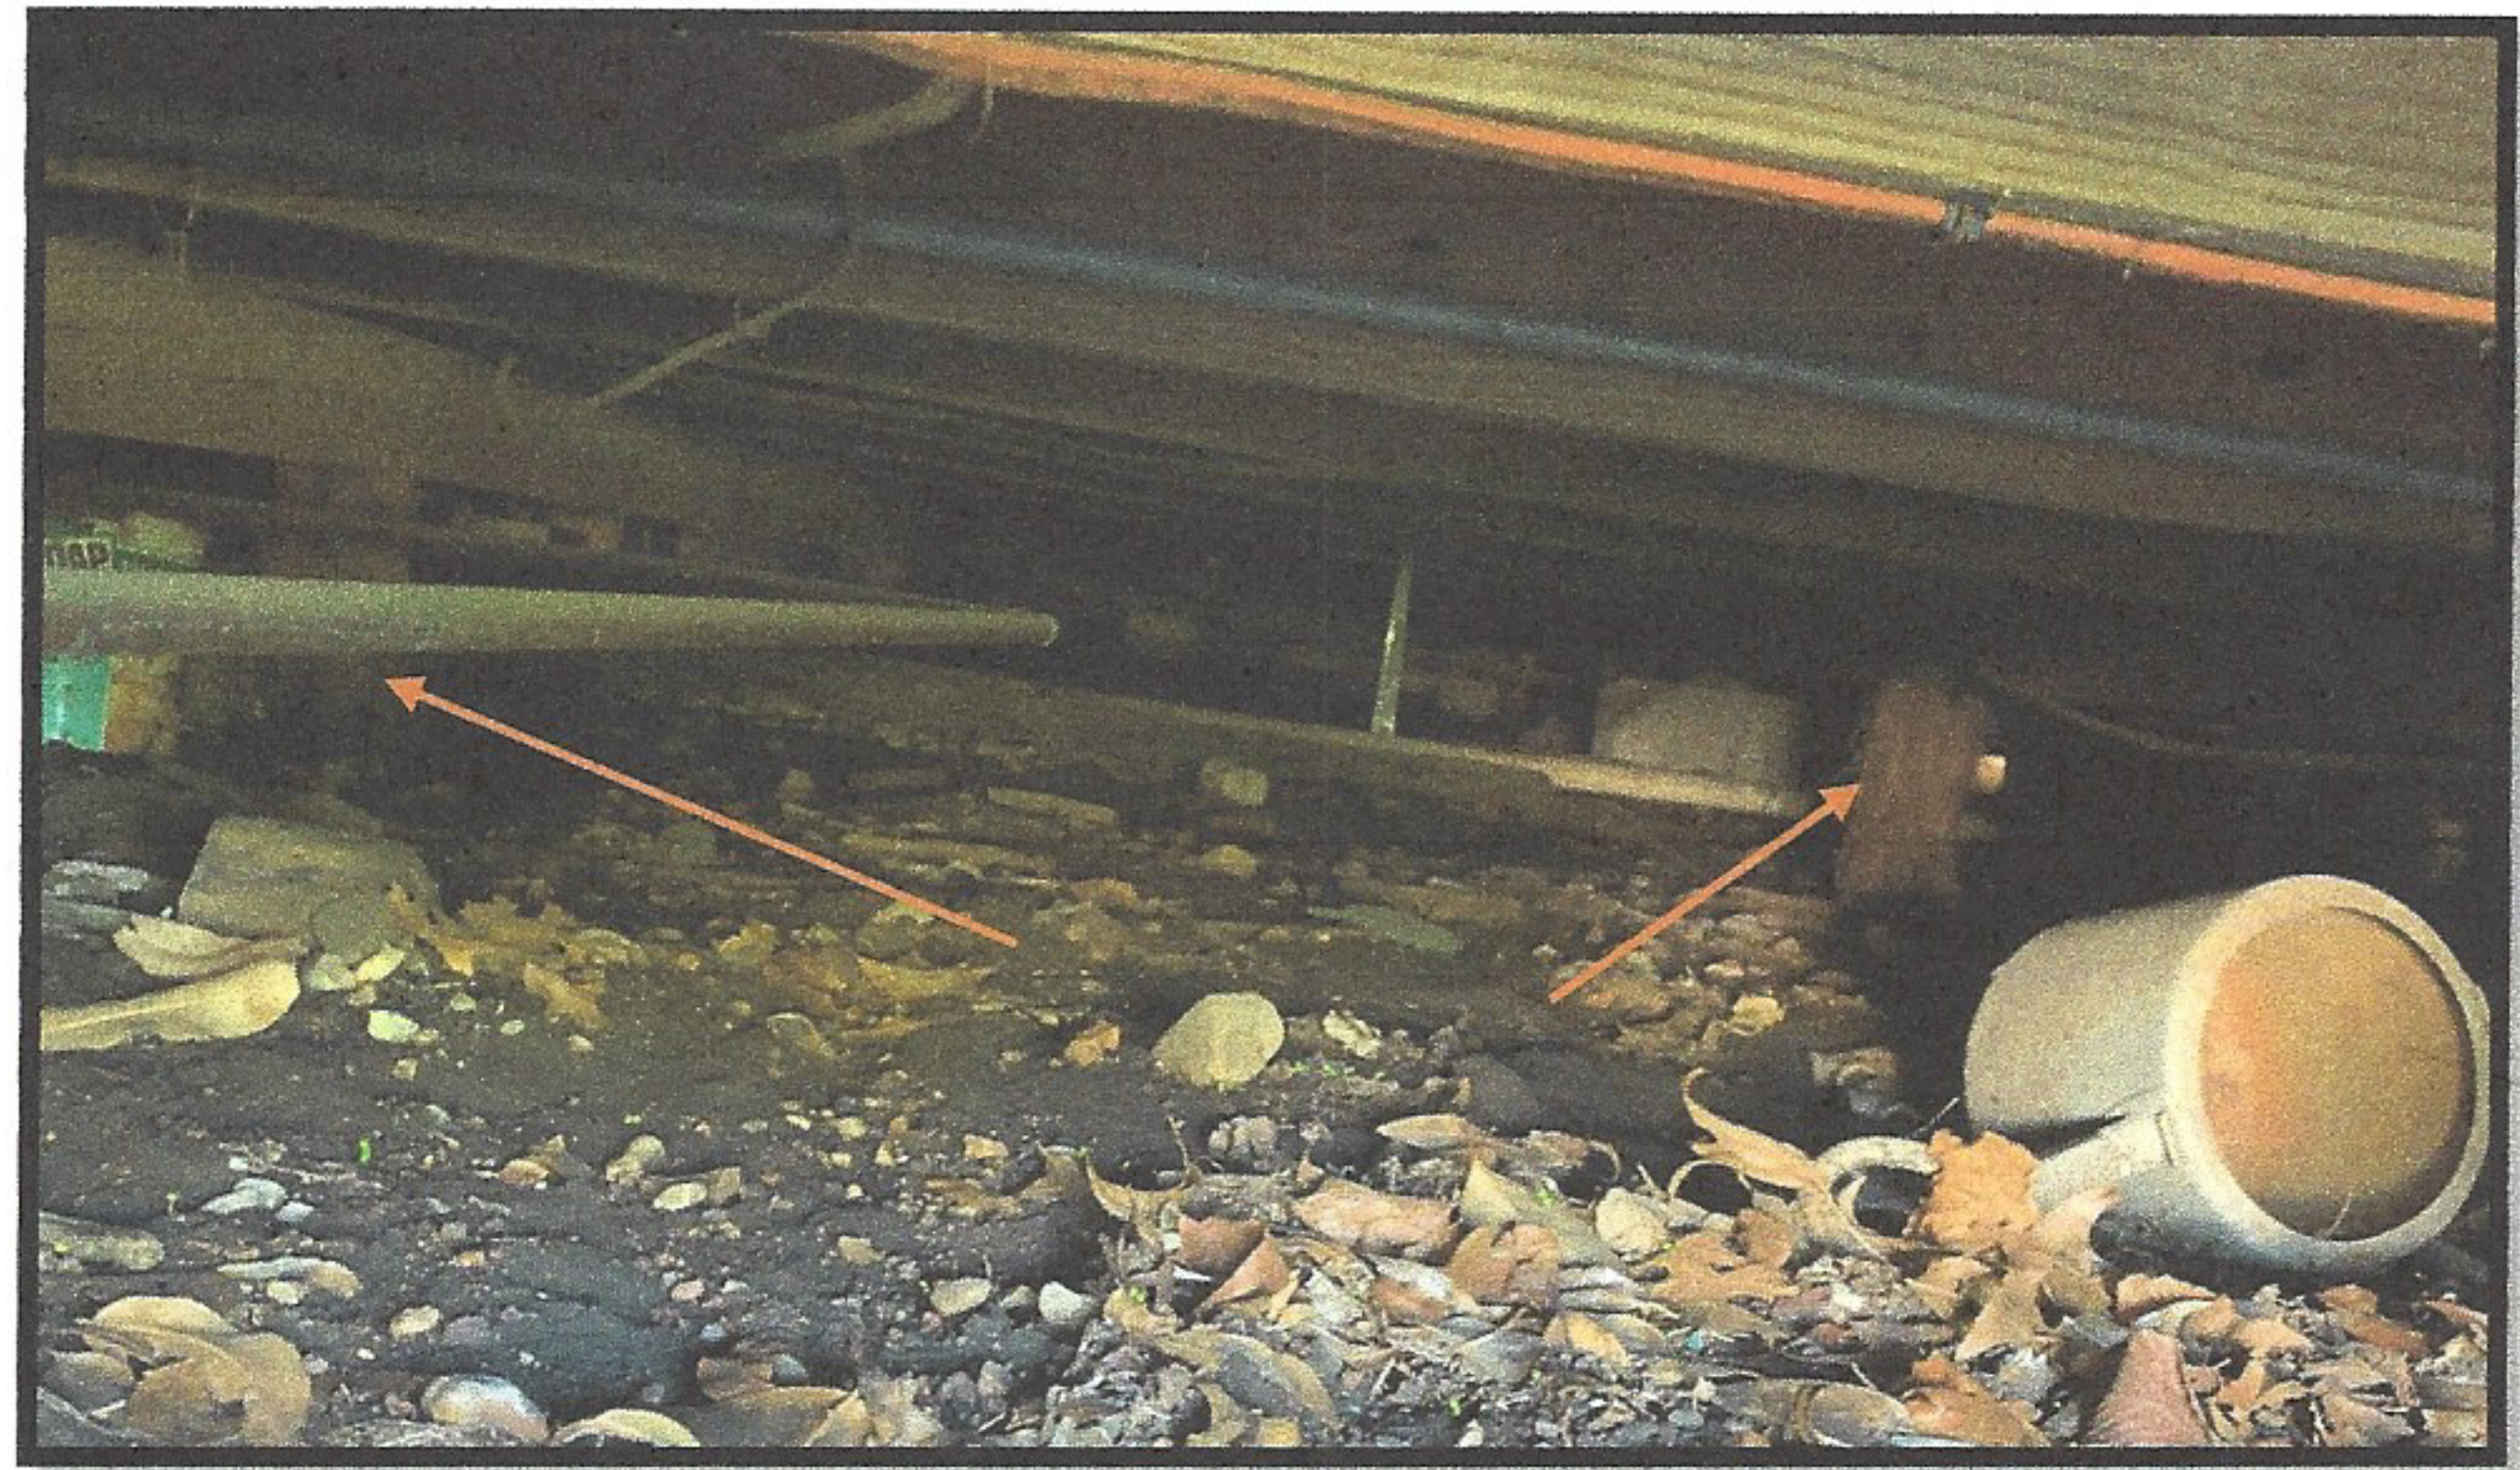
3: Cedar piers

all corners, and exterior walls in the home. The cedar posts should be replaced as well as the exterior stem wall. They are likely past their intended life span & are susceptible to corrosion and infestation.
