DESSAU LUTHERAN CHURCH

A UNIQUE PRESERVATION OPPORTUNITY

PHOTO DOCUMENTATION PREPARED FOR AUSTIN HISTORIC LANDMARK COMMISSION

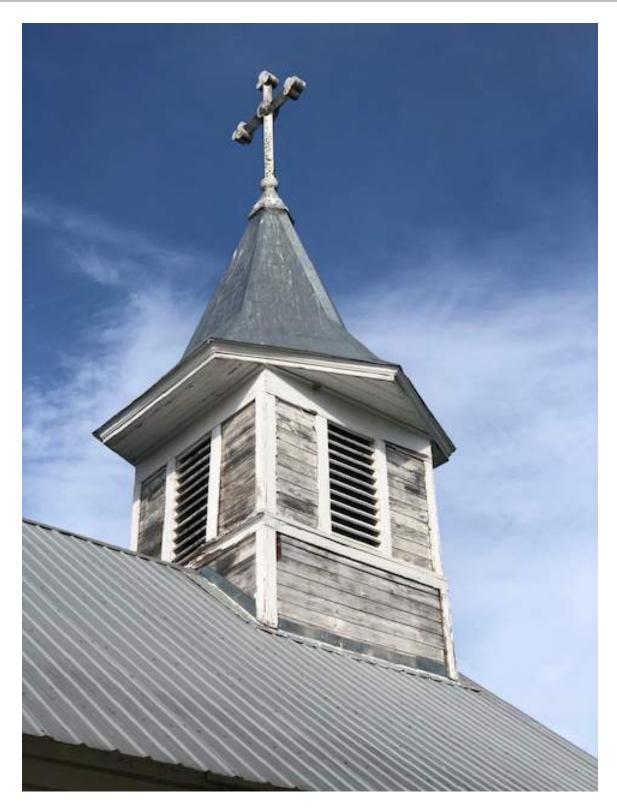
Belfry detail shows current condition.

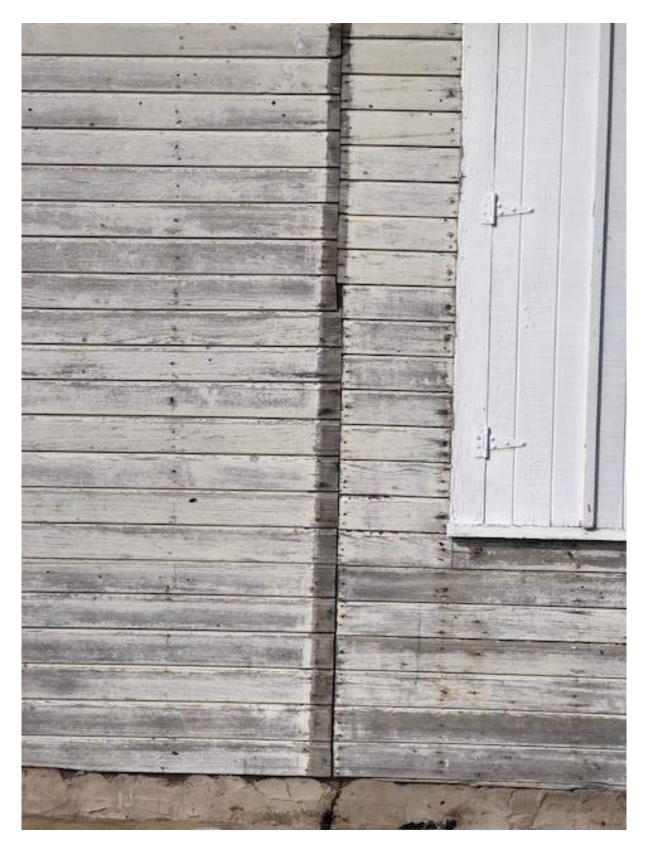
Siding joint shows where front was added on in 1890s

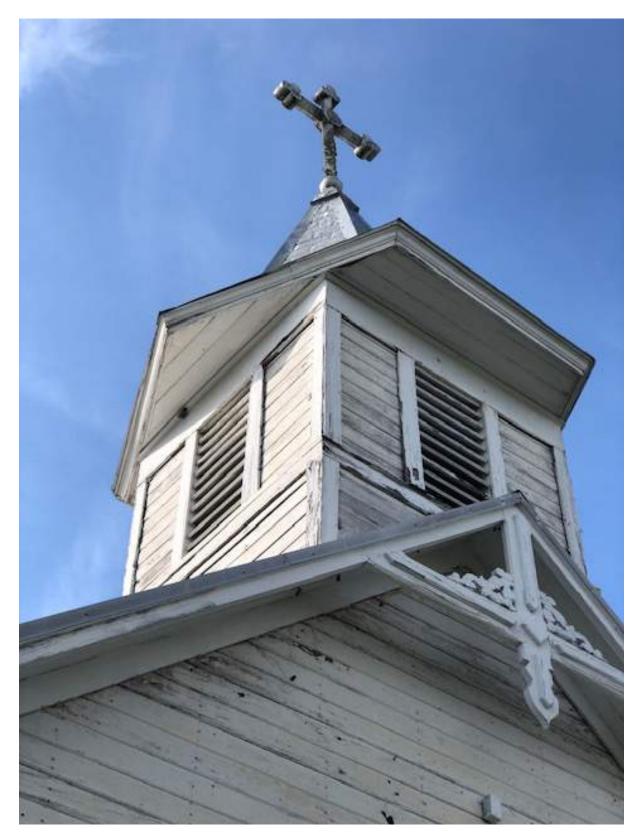
Belfry detail shows louvers, fretwork and cross.

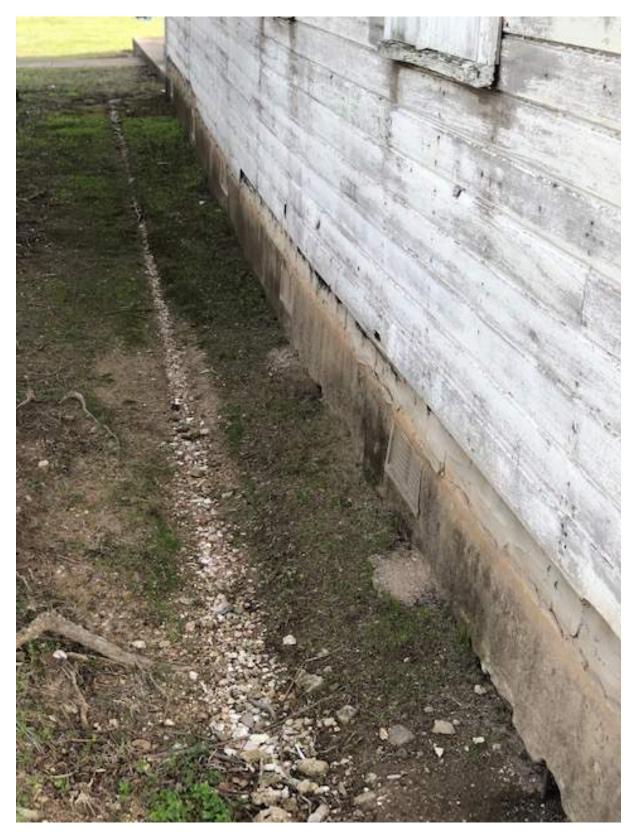
South side view shows drainage issues, current condition of siding.

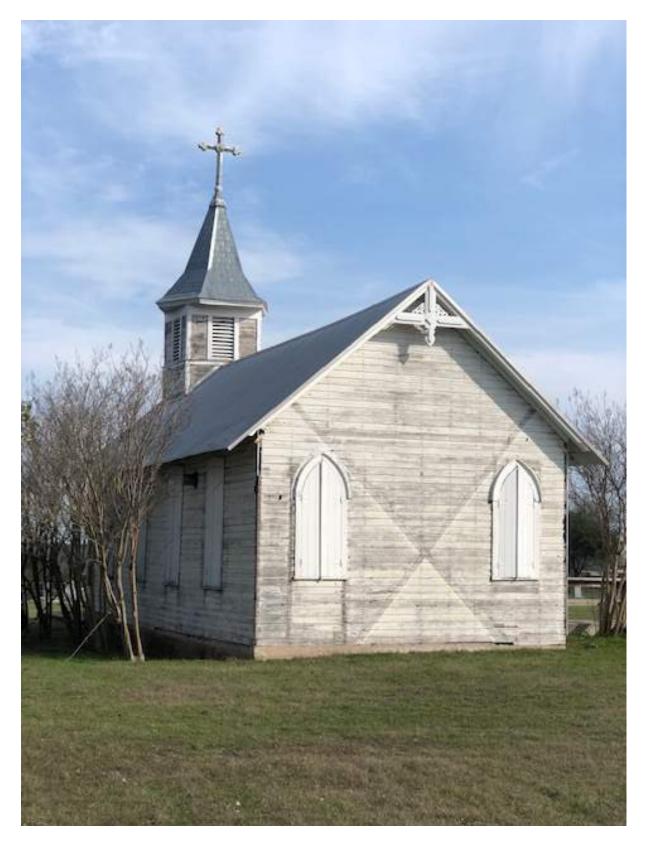
Rear elevation shows shadow from onetime braces, original location of back door.

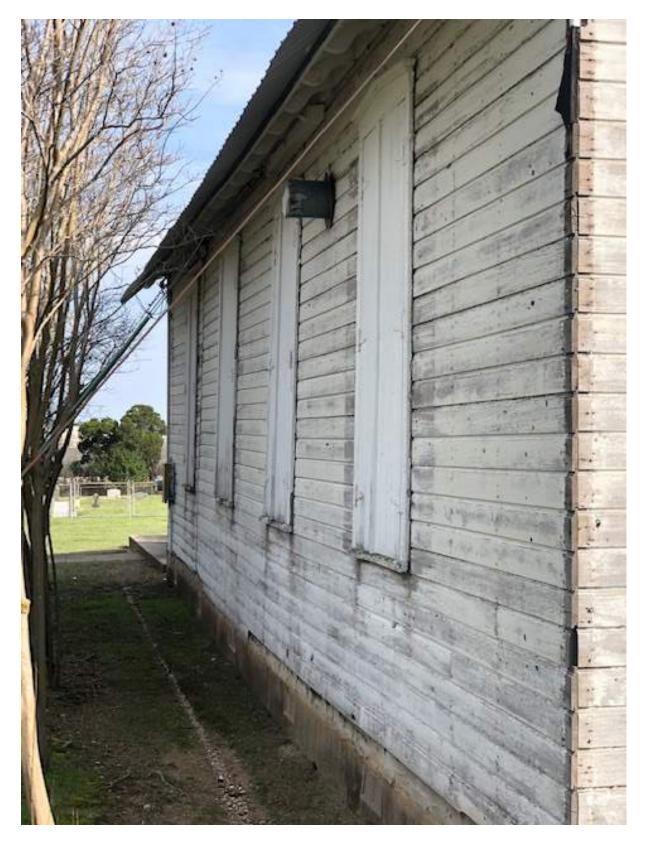
North side view shows steel bracing, stove chimney flue.

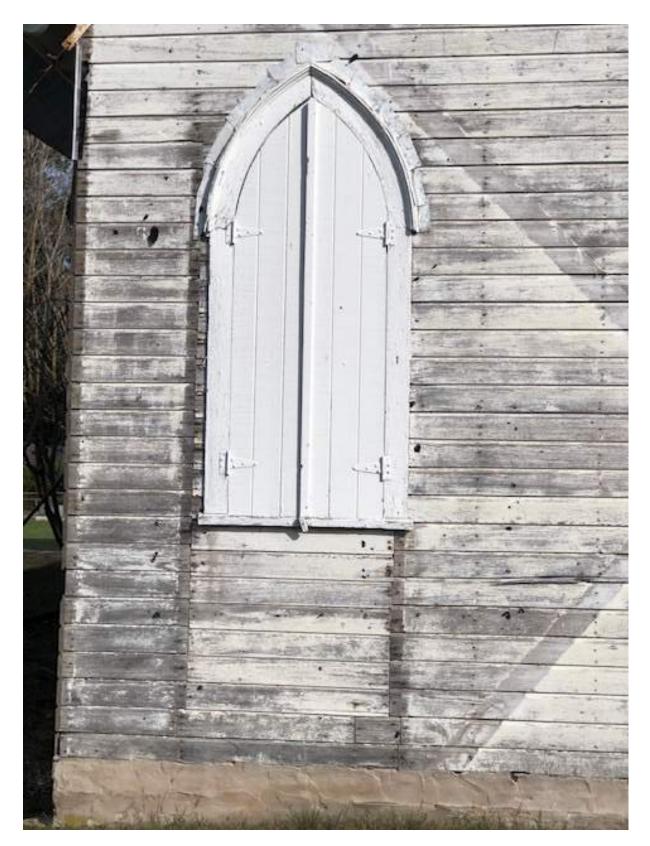
Detail of rear shows where window was moved to replace a back door.

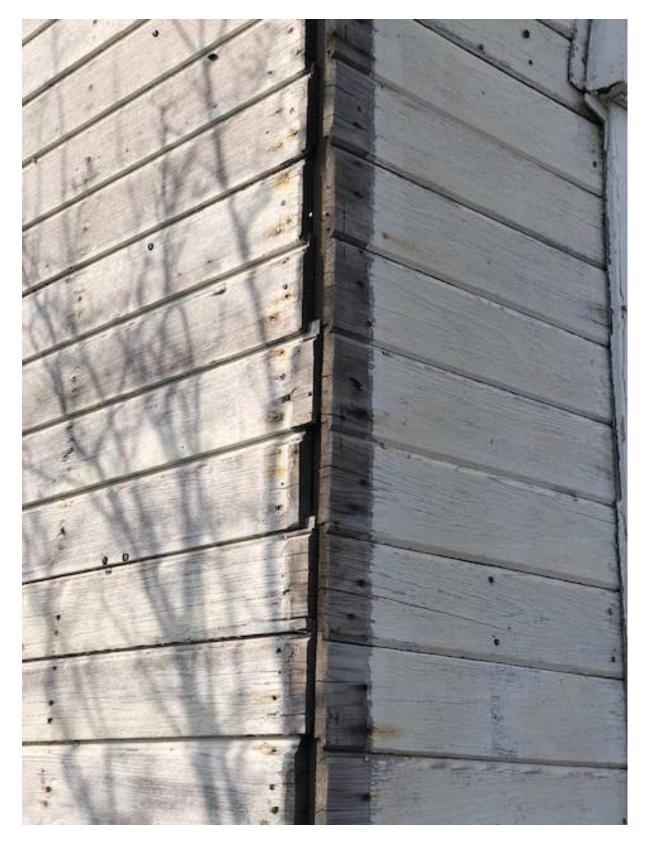
Missing trim at the left front corner.
