July 20, 2021

**RE: Structural Assessment of Historic Masonry
907, 909 and 911 Congress Avenue**

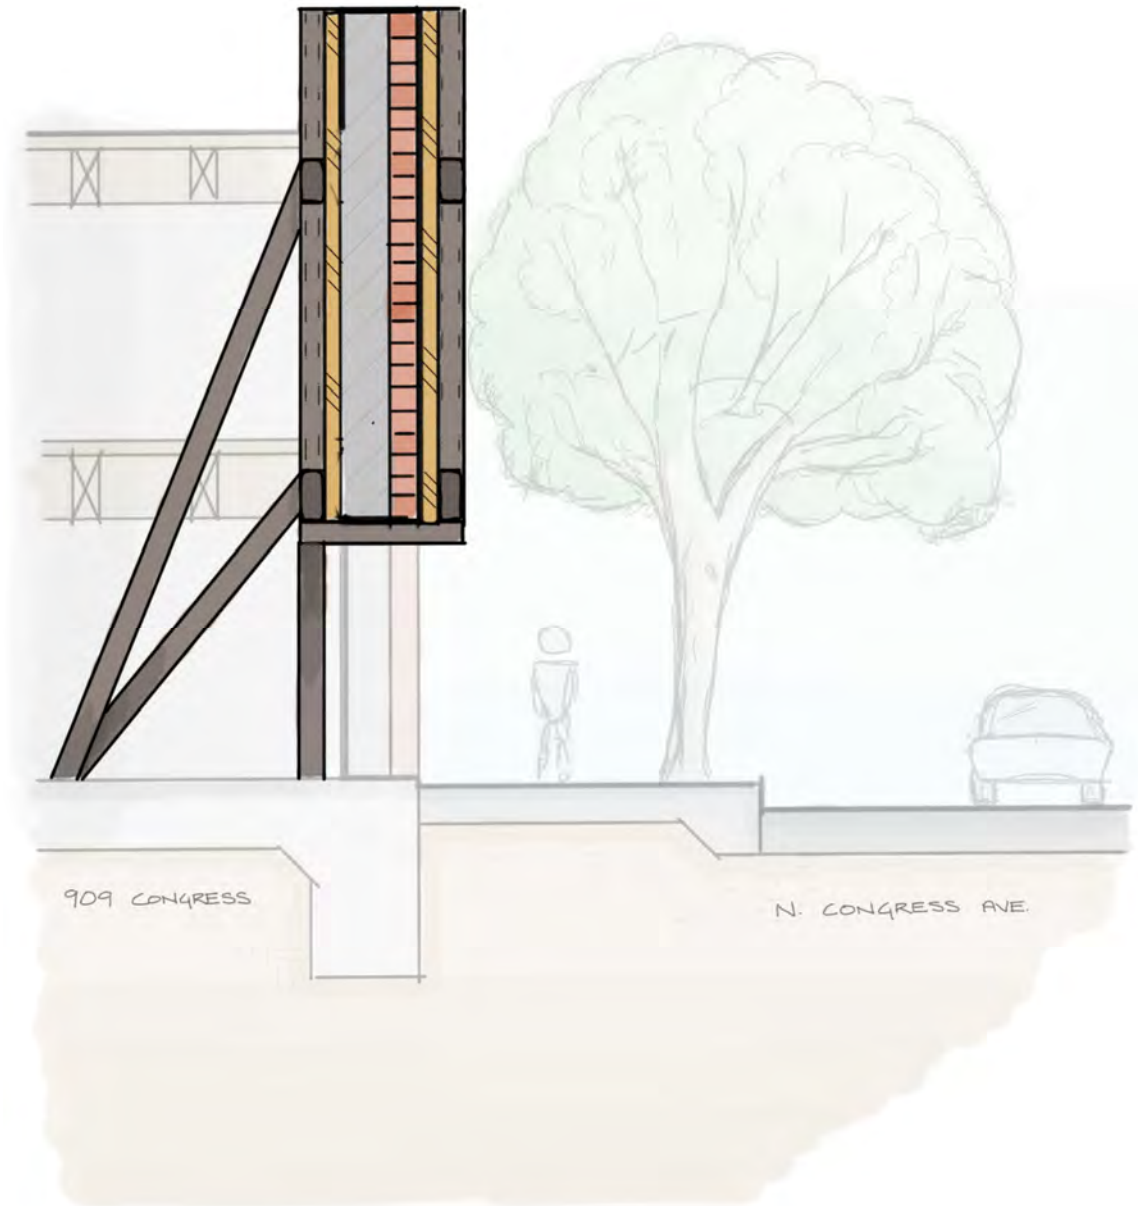
Option 1 - Brace into Lot

A steel frame structure with plywood sheathing could be utilized to sandwich the area of brick façade to be saved. This would allow for a structure that is stiff enough to not cause irreparable damages to the brittle façade. This steel structure would then have to be laterally braced towards the lot and away from Congress Avenue using steel diagonal members that would bear on new foundations within the extents of the existing buildings to provide gravity and lateral support of the brick façade as demolition and construction occurs around it. Due to the extent of demolition required in and around this particular building, this option will likely not be feasible as contractors would likely not be able to complete their scope of work around the proposed bracing elements.

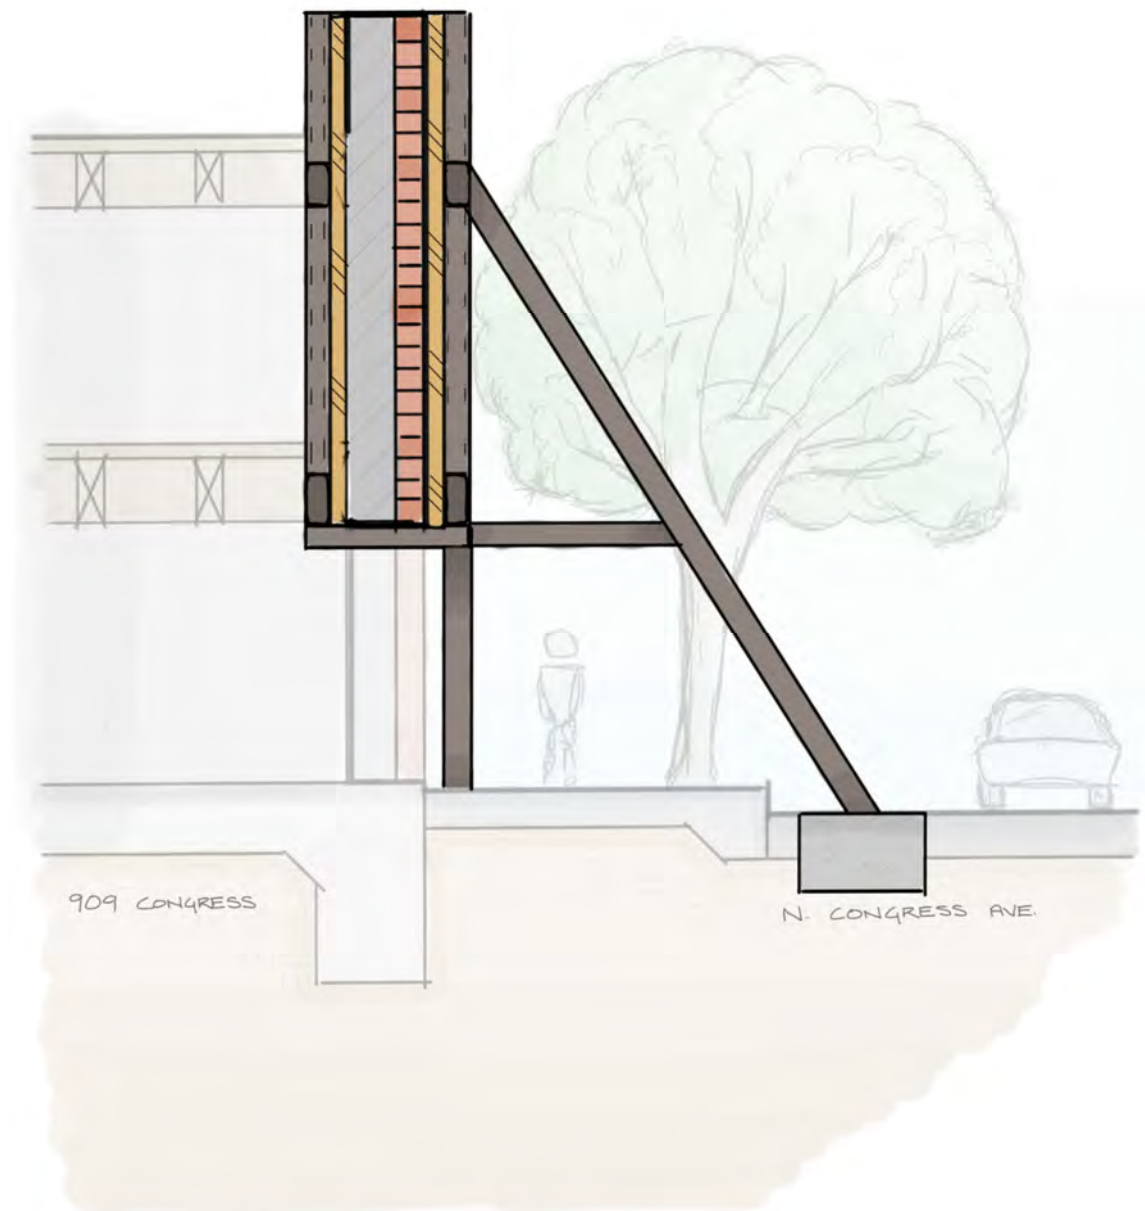
Option 2 - Brace toward Congress Avenue

Similar to Option 1, a steel frame structure with plywood sheathing could be utilized to sandwich the area of brick façade to be saved. This would allow for a structure that is stiff enough to not cause irreparable damages to the brittle façade. This steel structure would then have to be laterally braced towards Congress Avenue using steel diagonal members that would bear on new foundations within the sidewalk or parking areas to provide gravity and lateral support of the brick façade as demolition and construction occurs around it. Bracing elements would have to be attached down through the sidewalk and/or the street parking spots for an extended amount of time until demolition and new construction are completed. This solution would cause significant interruptions to Congress Avenue and may incur excessive fines for impeding the right of way making this option improbable. Additionally, having the bracing elements in the public domain could increase the risks of accidents occurring that would cause distress and potential damage to the masonry.

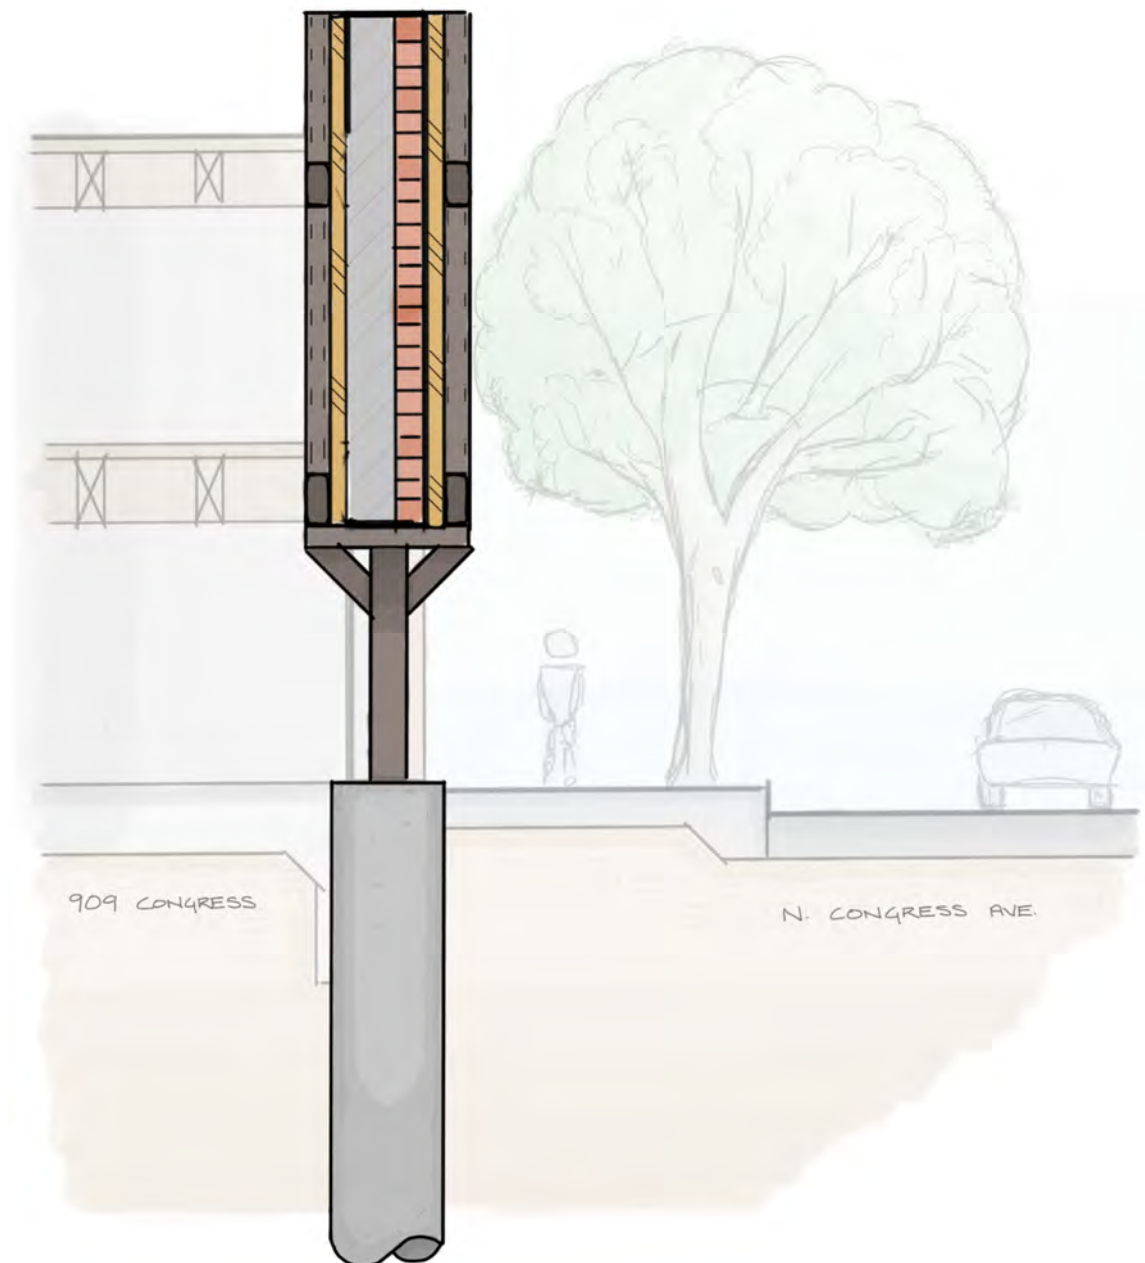
Option 3 - Brace with Cantilevered Columns

A similar steel frame structure as described in Options 1 and 2, but with far stiffer vertical elements as this option will not require any additional steel diagonal bracing for support. This steel frame will be supported from below with steel columns that are supported by a series of new concrete piers socketed into limestone. All steel elements will have to be designed to resist wind loads and provide adequate stiffness to prevent compromising the suspended masonry. Concerns with vibration during construction of the forthcoming development present a significant concern to the weakened masonry that might not be able to withstand consistent disturbance that is standard for a construction site. It is the opinion of this office that the vibration and general disturbance caused during construction may very likely cause irreparable damages to the masonry while it is being suspended in place. Additionally, drilling the concrete piers directly below this brick façade as part of the bracing installation may also cause vibrations that damage the façade.
