Public Works Department

April 19, 2021

Re: Elisabet Ney Museum
304 East 44th Street, Austin Texas, 78751
Existing Exterior Balcony

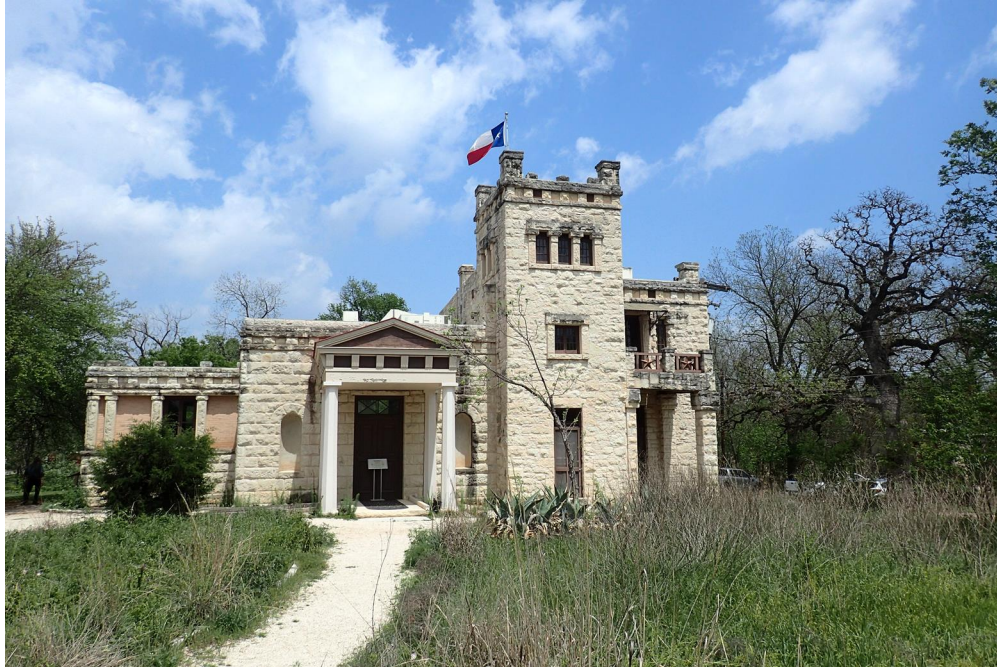
This letter is in regard to the structural integrity of the existing elevated balcony. A site visit was conducted on April 7, 2021, to perform a structural observation of the exterior balcony located to the east of the main entrance. See photo A

Photo A: Building Front View

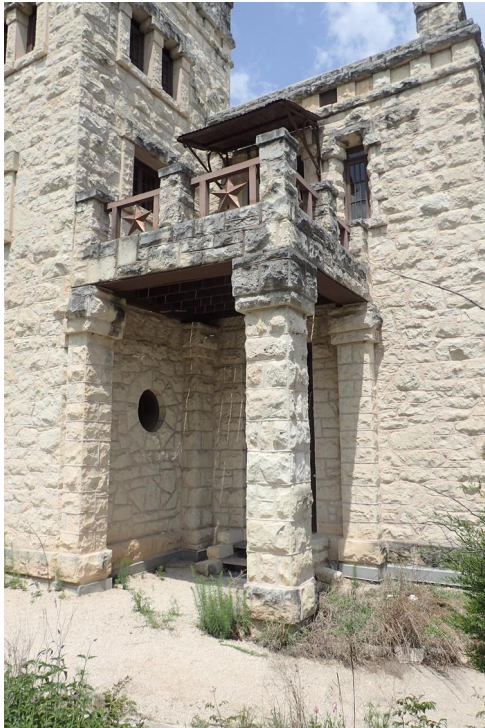
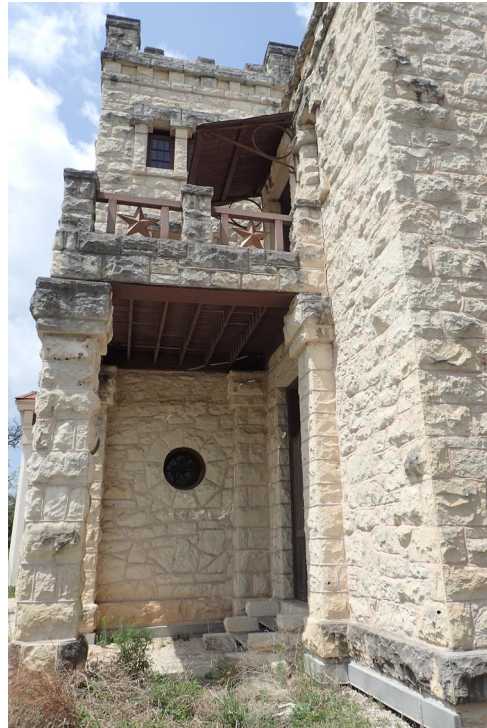
The existing building appears to be a stone structure, a full assessment of the building was not made at the time of our site visit. The existing balcony is located to the east of the main entrance of the museum. See photo B. The balcony floor system consists of wood floor joists that are supported by a double wood member beam at both supporting ends. See photos C and D. The joist sizes and supporting wood members were not measured during the site visit. There are two (2) steel lintels that support a low stone guard rail wall on along the south and east side of the balcony, the steel lintels are supported by stone columns. At the time of our site visit the two (2) steel lintels were rusted and were delaminated. See photos E and F. The stone column support located against the building along the east side of the balcony is leaning southward away from the building and a limestone block has split in the stone capital. See photos G and H.

Photo B: Exiting Balcony

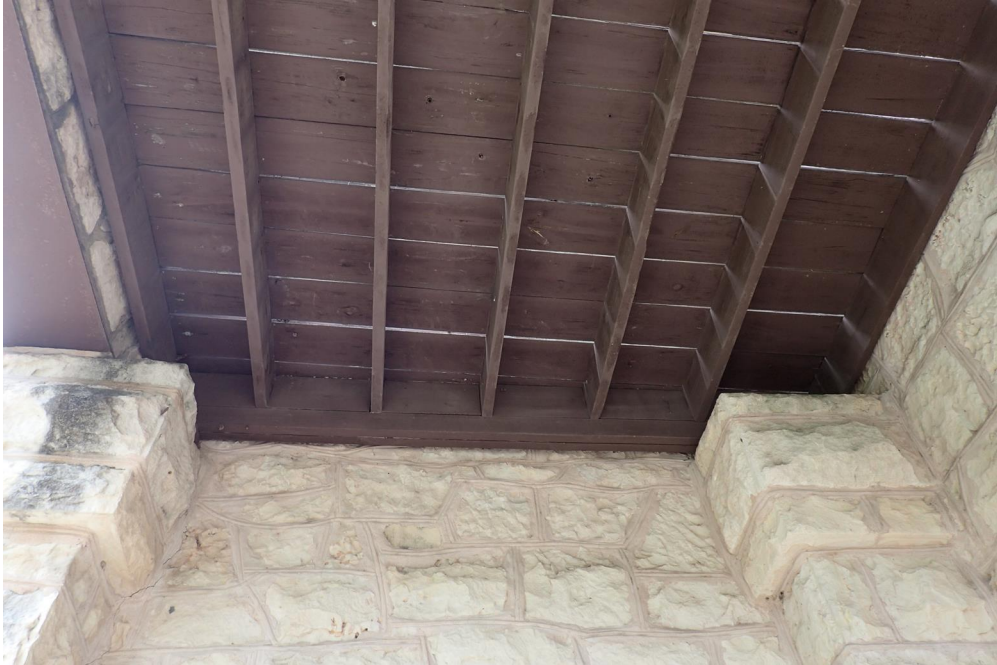
Photo C: Balcony Wood Framing

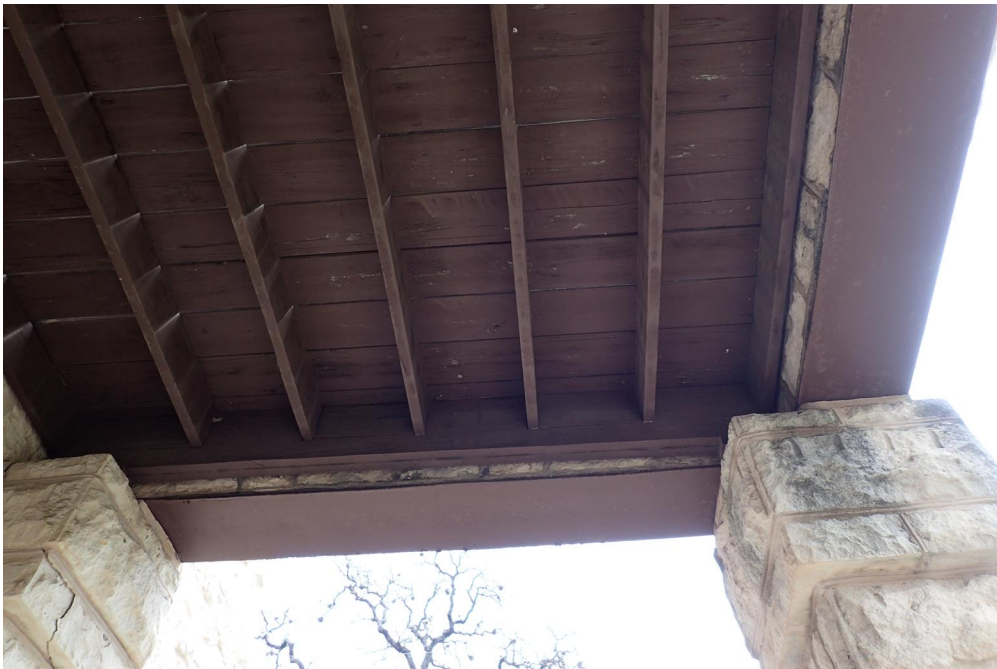
Photo D: Balcony Wood Framing

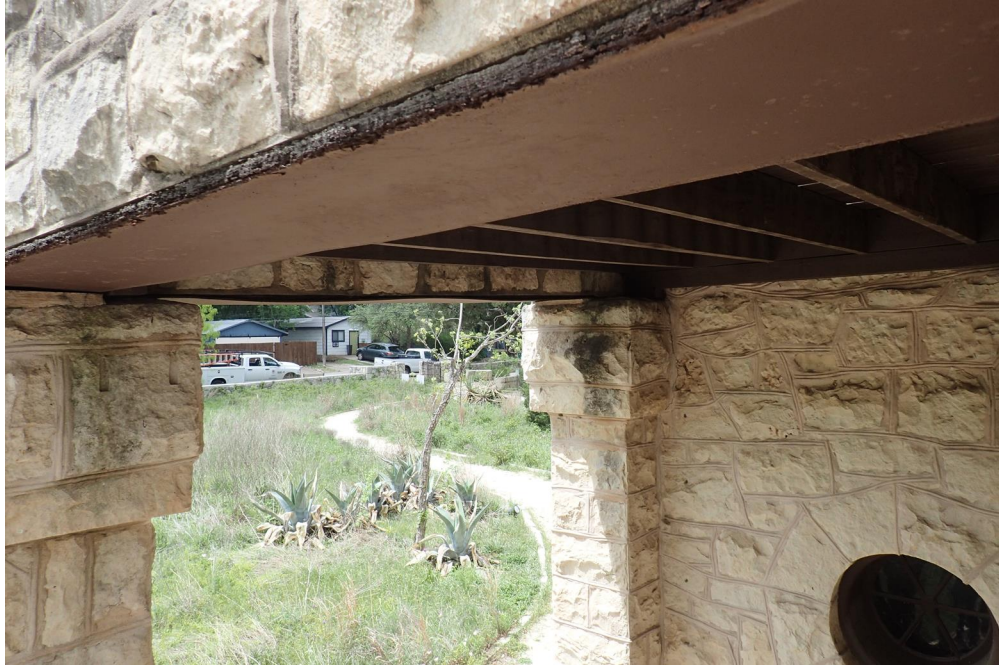
The structural integrity of the existing stone column capital and the two (2) steel lintels have been compromised, creating imminent hazard and danger to the health, safety and welfare of the public. The balcony is not to be accessed and the area needs to be roped off. It is my professional recommendation that this be addressed immediately to minimize any further damage.

Photo E: Existing Steel Lintel

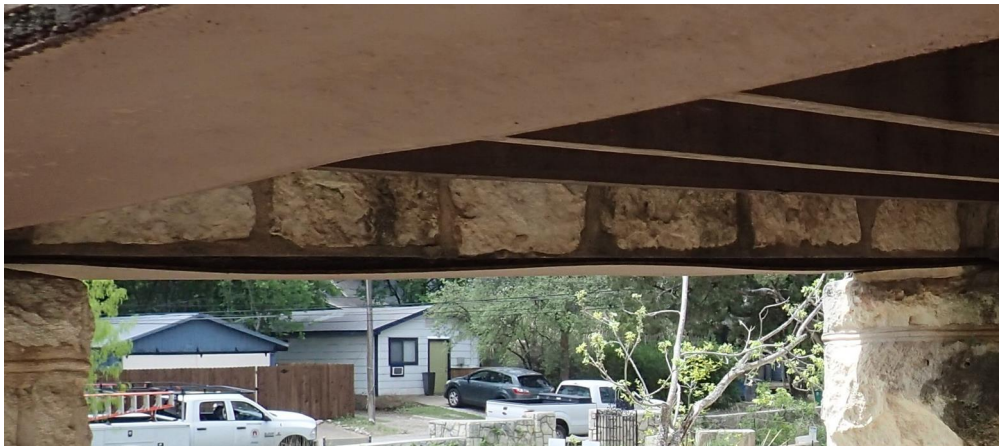
Photo F: Existing Steel Lintel

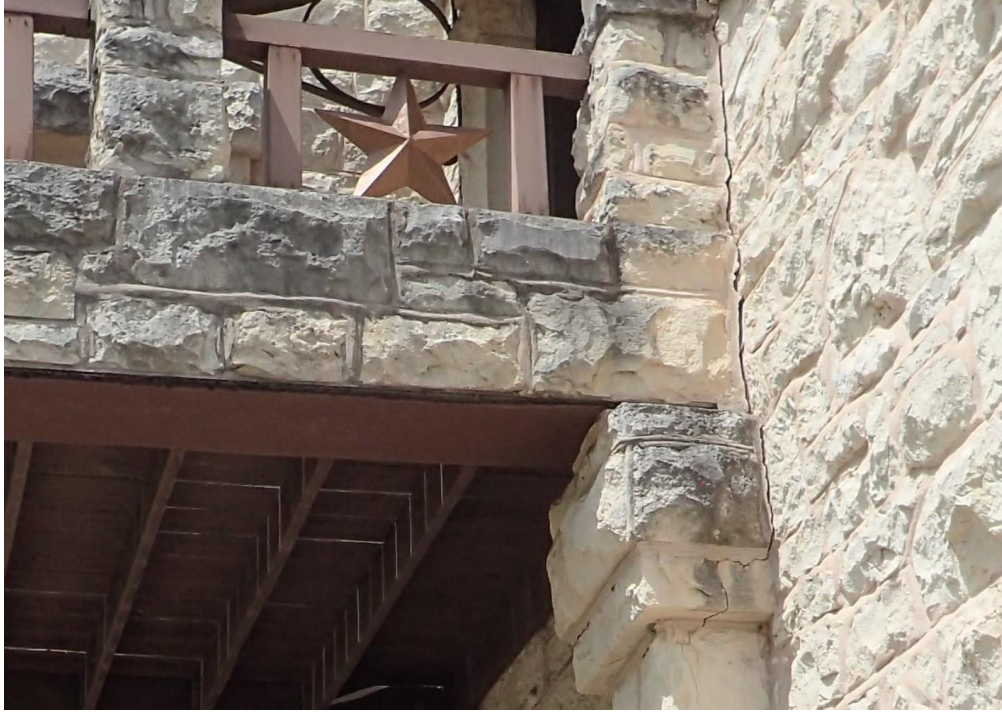
Photo G: Existing Stone Column

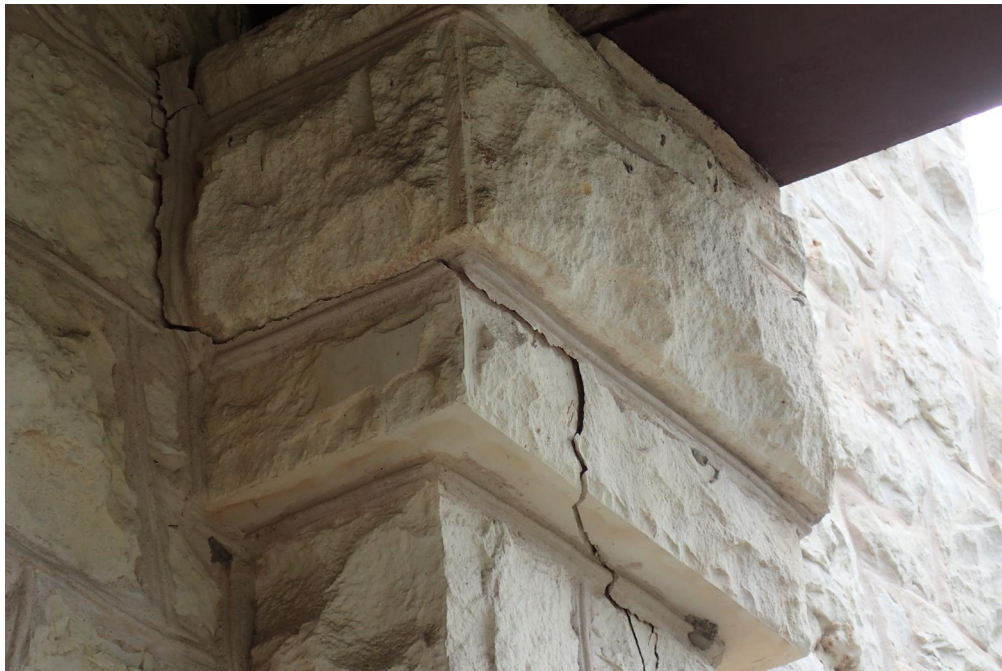
Photo H: Existing Split Stone Capital
