The Herrera House
1805 East 3rd Street, Austin, Texas

Historic Condition Assessment Report
December 18, 2019

SOUND HISTORICAL RESOURCES, LLC
Seattle, Washington • 206-582-9989 • adam@soundhistorical.com

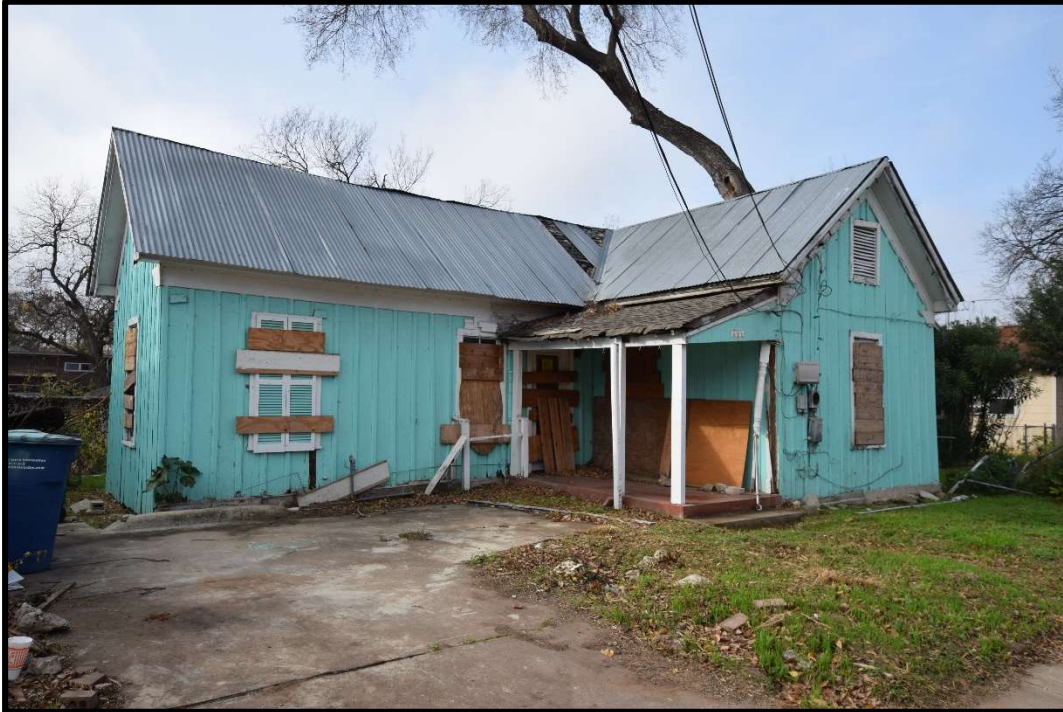
Figure 4.3: Oblique view showing the north and east facades.

It appears that the grade surrounding the house has been raised over time. This condition is frequently observed at older properties, since the addition of landscaping around the house over the years contributes to the build-up of soil and mulch around the perimeter of the house. A large concrete paved parking area has also been added at the northeast corner of the house, which is built up almost to the face of the north wall of the house. The raised grade, in combination with natural settlement of the house over time, has resulted in the lower edge of the exterior wall cladding to rest almost at grade level. **[Figures 4.3 – 4.5]**

Two tall trees are located along the east property line of the adjacent property immediately to the west of the subject property. One of these trees is close to the southwest corner of the house, and the other tree is about twenty to thirty feet south of the tree closest to the house. The tree closest to the house appears to hang over the house on the subject property. Both of these trees appear to be old and may not have much life left, so the owner may consider hiring an arborist to evaluate the condition and estimated life of these two trees, with the permission of the adjacent property owner. [Figures 4.1, 4.2, 4.3, 4.18, 4.19, and 4.21]

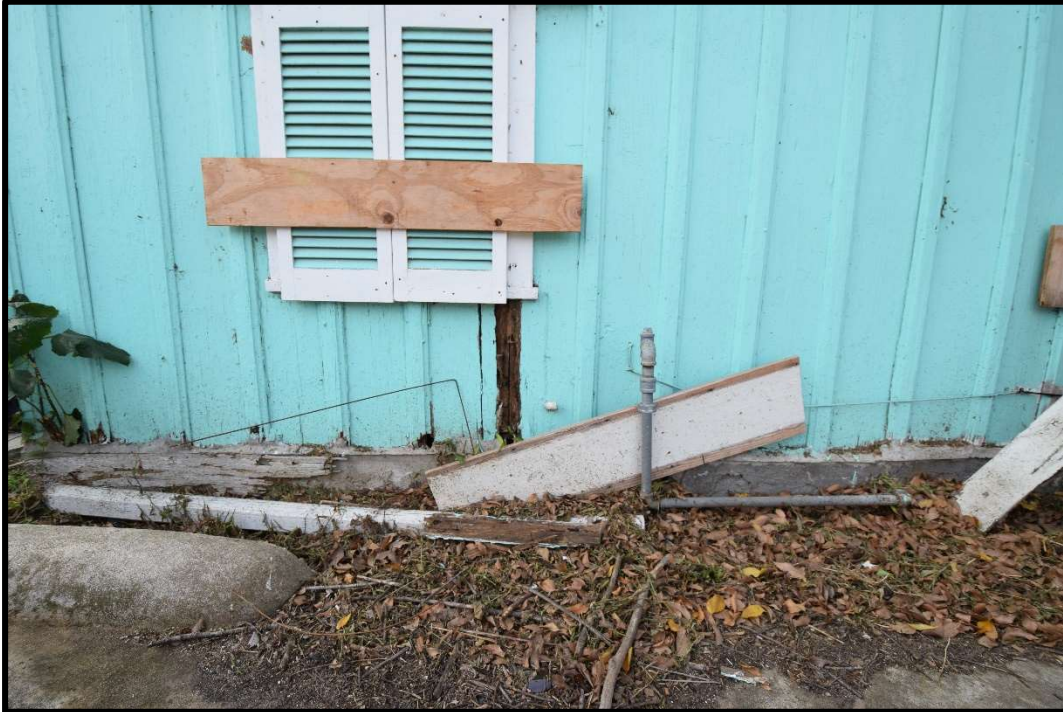
Figure 4.5: Close up view of north façade of the main wing of the house.

According to the Sanborn fire insurance maps, the foundation crawlspace under the house was open until at least 1935. Skirting was added at some point after 1935 to enclose the perimeter of the main L-shaped footprint of the house. This skirting was constructed of a stucco plaster parge coat over wire lath. A thick parge coat of concrete has been added to cover this skirting at the east, north, and west walls of the original house. The light gray color of this thick concrete parge coat suggests that it contains a high percentage of Portland cement binder, and the visible aggregates suggest that this parge coat was made of packaged concrete mix (i.e. “Sakrete”) and hastily applied. **[Figures 4.5 and 4.13]**

Natural gas service to customers in the neighborhood is furnished by the Texas Gas Service. According to permit records, natural gas service to this house was retired in April 2019. The gas meter has been removed. The meter was located at the north side of the house approximately nine feet to the east of the front porch. It is likely that the Texas Gas Service would require a completely new domestic natural gas supply line from the main to the meter. Additionally, any existing domestic natural gas piping within the house would also likely need to be completely replaced during the future rehabilitation of the house. **[Figure 4.5]**

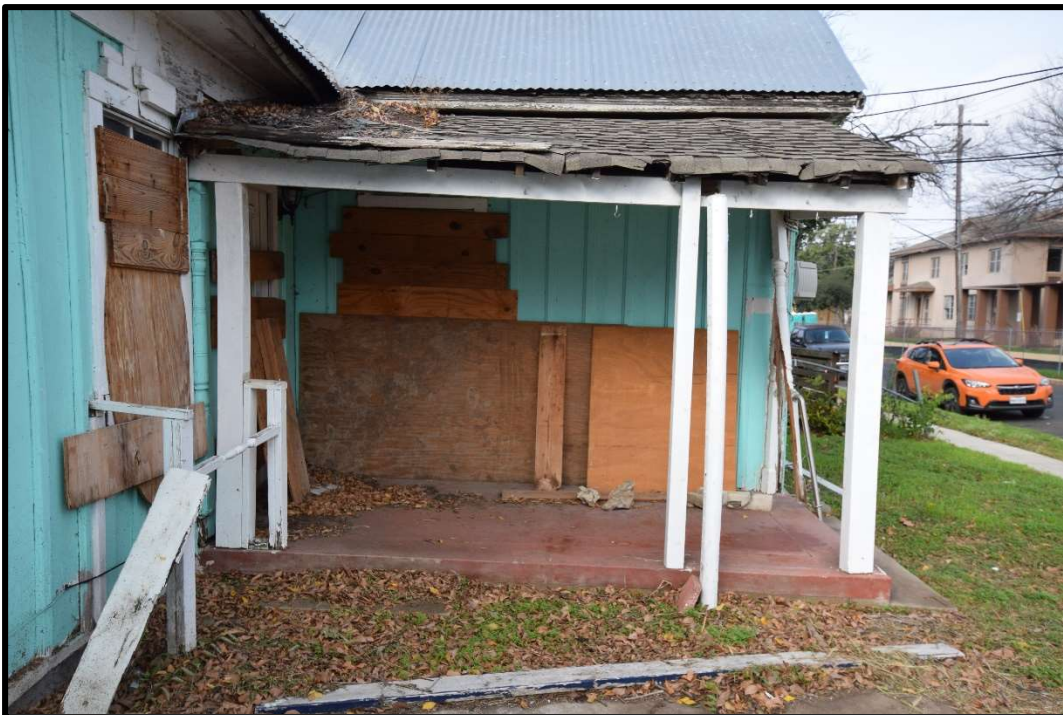
Figure 4.6: Detail view of the front porch, looking west.

The front porch has a concrete slab floor, which has been stained or painted. The slab features a lightly incised joint which is cut into the slab about one-foot inboard from all four edges of the slab. This slab serves as the foundation for the front porch roof, which is discussed in Section 3.3 of this report. The slab appears to be in good condition, with no major cracks or failures visible. [Figures 4.6 and 4.7]

The front porch roof is a simple shed form that pitches down in an east west direction. The high point of this roof is tucked under the boxed soffit of the north wing roof overhang, and the roof is sloped at about a 3:12 pitch or 4:12 pitch. While the porch roof is an original feature of the house, the original roof framing has been replaced at some point with widely spaced modern 2x4 rafters. This shed roof is sheathed in plywood, which is severely deteriorated from water damage. The porch ceiling is sheathed in painted plywood, which is a non-original feature. Historically, the porch roof rafters would have been either left exposed or covered with simple, narrow painted wood shiplap boards. The porch roof is supported by painted wood 2x6 beams along the low east edge and north end of the roof. Two non-original, painted wood 4x6 columns support the northeast and southeast corners of the porch roof, and a third painted wood 4x6 is located about three feet to the south of the column at the northeast corner of the porch. Two historic decorative wood pilasters (or engaged columns) still exist at the front porch. One is located on the east face of the north wing, and the other is located on the north face of the main wing of the house. The pilaster located at the north face of the main wing of the house is intact, but the other pilaster has been partially broken off from the wall. Both of these pilasters appear to be historic features of the house and should be preserved. Additionally, the vertical painted wood siding on the triangularly shaped, north facing end of the porch shed roof also appears to be a historic feature of the house and should be preserved. [Figures 4.6 – 4.12]

The roofs of the front porch and the rear additions are clad in composition shingle roofing material. The roofing material appears to have been laid over asphalt-impregnated building paper. The roofs of the rear addition are severely deteriorated and falling in. These roofs overhang the exterior walls by about one foot, and the painted wood rafter tails are exposed. [Figure 4.6]

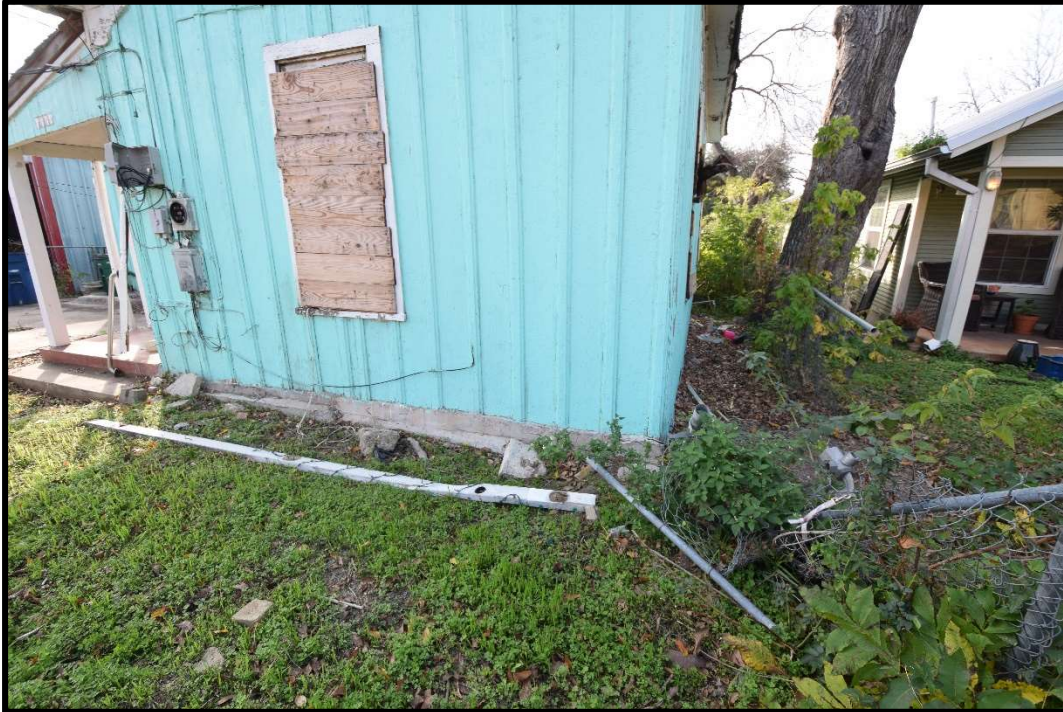
Figure 4.13: Detail view of the north facade showing the foundation condition at the grade level, the north façade of the front wing, and the side yard to the west of the house.

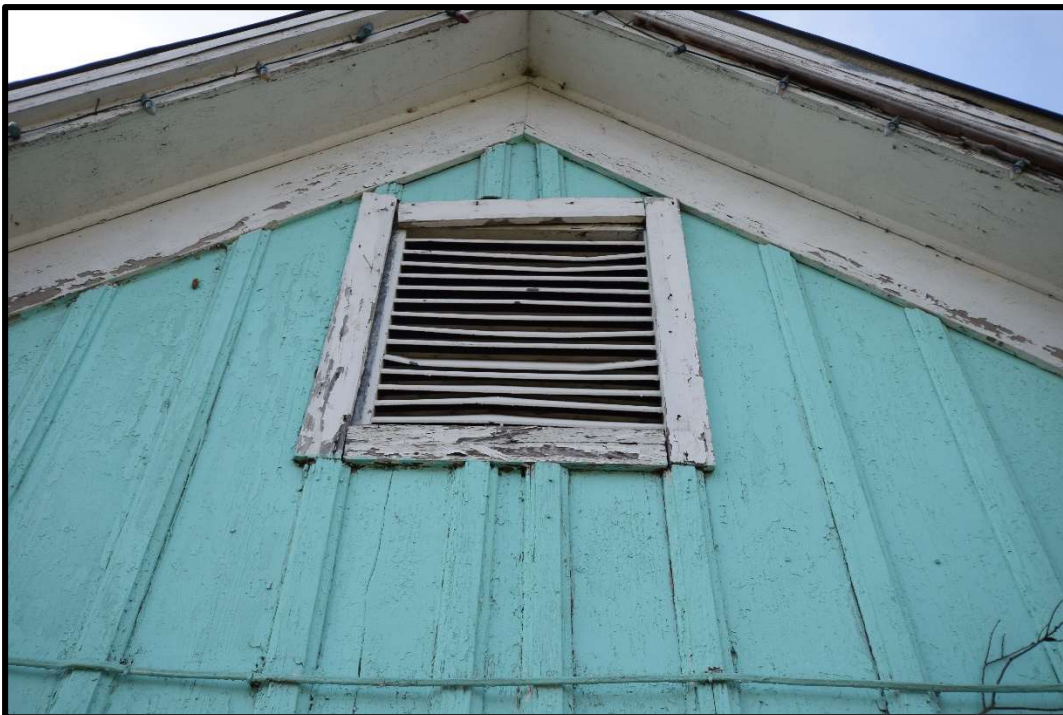
Figure 4.14: Close up view of painted metal louvered vent at gable end of front wing.

Attic ventilation is provided by two vents located in the gable ends. The painted metal louvered vent at the gable end of the front wing measures approximately 24 inches wide by about 30 inches tall. This vent is trimmed with painted 1x4 wood flat trims. The gable vent at the east gable end of the main wing of the house is no longer extant. No roof ridge or soffit vents were noted. [Figures 4.14, 4.23, and 4.25]

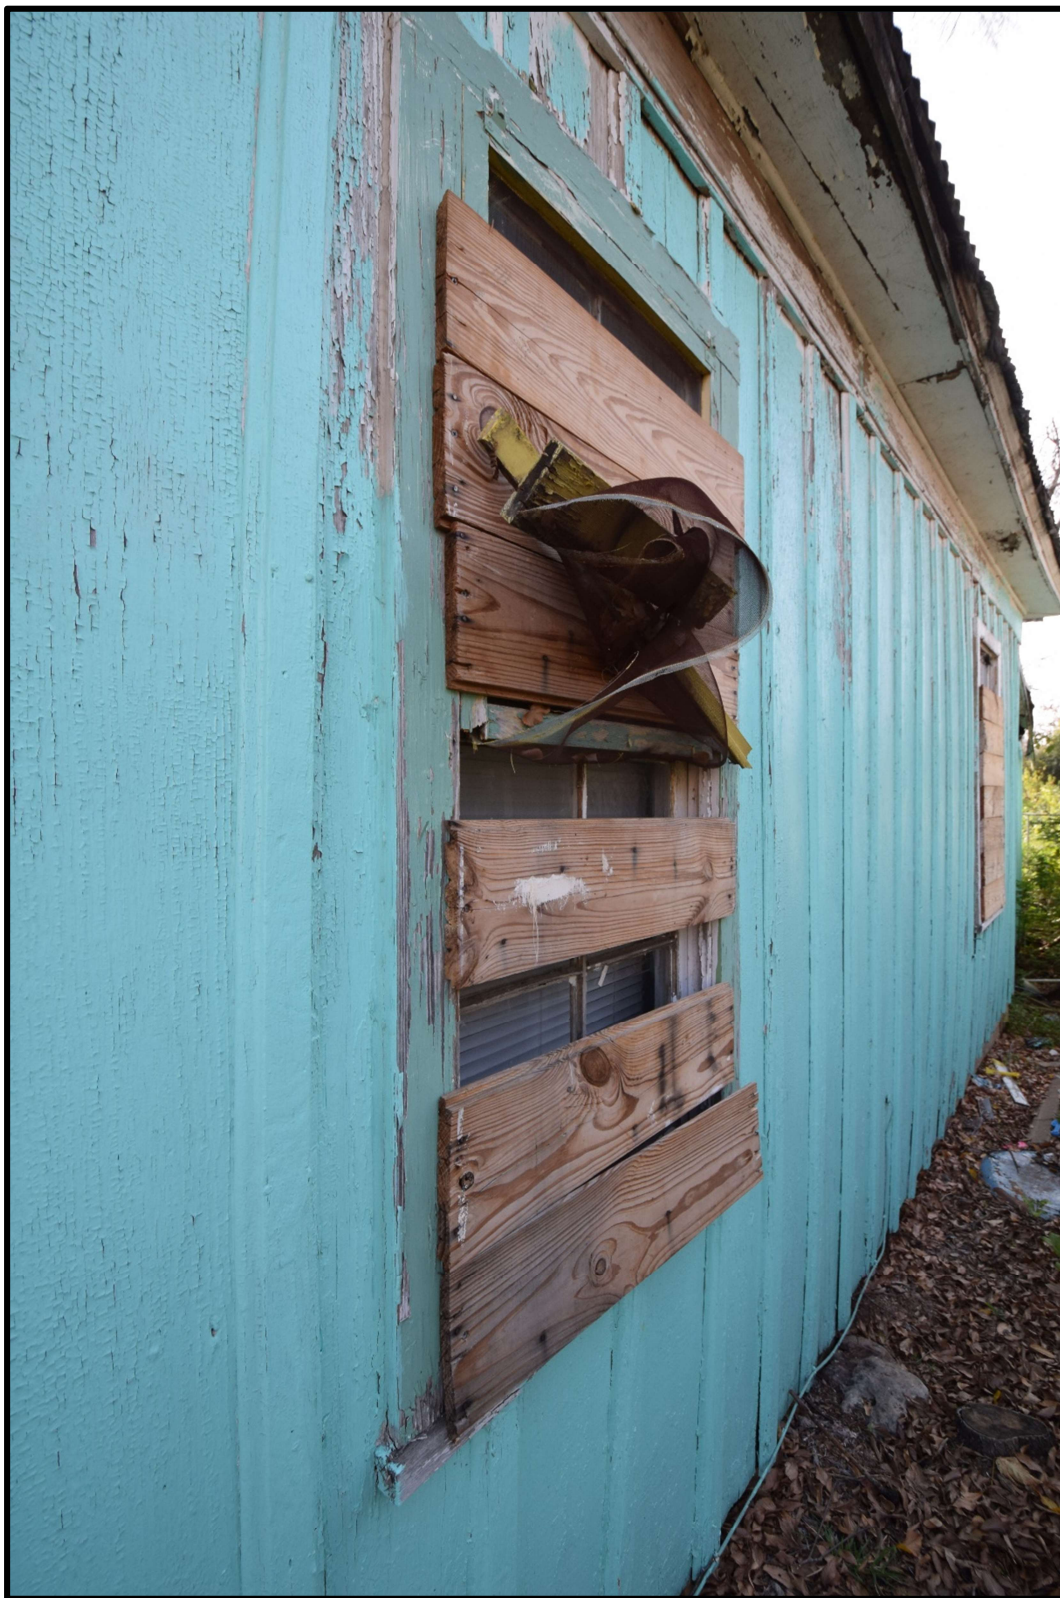
Figure 4.15: Detail view of the west façade of front wing and main wing of the house.

One of the existing double hung wood windows still has a painted wood frame insect screen in place. The frame of this screen is built of 1x2s which are mounted so that the face of the window screen frame is flush with the adjacent jamb and head window trims. The remnants of the screen hanging hardware on the head trim above the other double hung wood windows suggests that all the windows on the house had painted wood frame insect screens. The insect screens are character defining features of the house and should be preserved, restored, or recreated at locations where they are missing. [Figure 4.15]

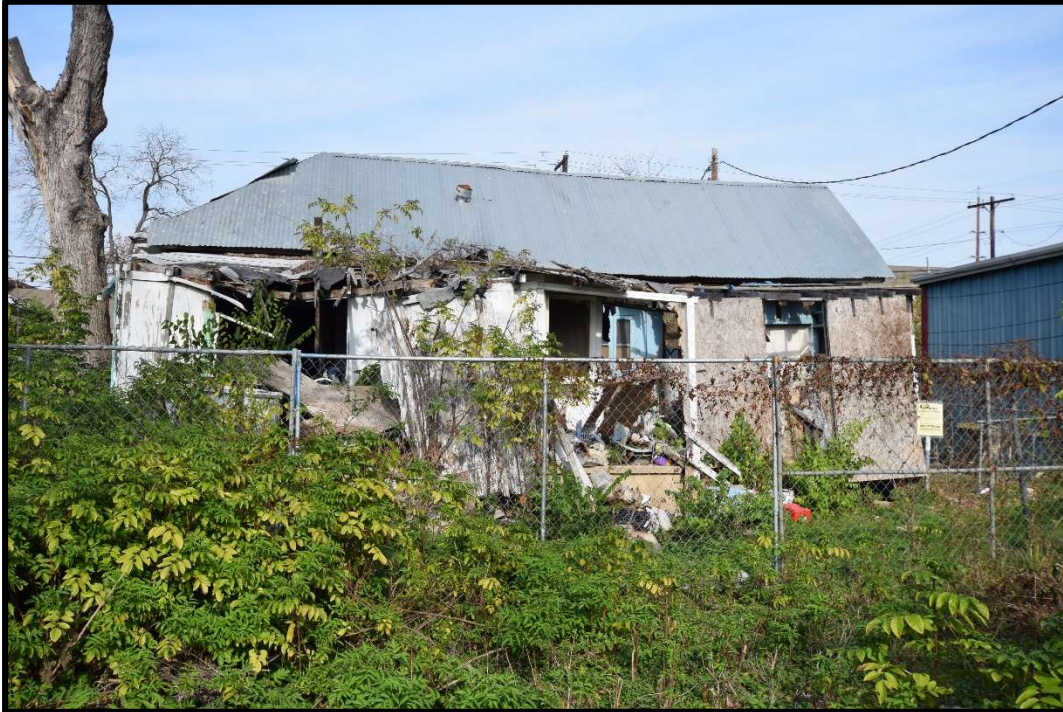
Figure 4.18: General view of the south façade of the house.

skirting that remain in place. Furthermore, according to building permit applications, the bathroom addition of 1955 and the utility room addition of 1973 are both supported on pier and beam foundations. Due to the severely deteriorated condition of the rear additions and large amount of debris and trash at the rear of the house, visual inspection of the foundation at the south side of the original L-shaped main house was not possible during our site visit on December 9, 2019. [Figures 4.18 – 4.21]

The shed roofs of the rear additions are framed with 2x4 rafters laid at what appears to be 18 to 24-inch centers. The roofs of these additions are severely deteriorated and are either completely missing or caved in. The roof sheathing that remains appears to be either plywood or oriented strand board (OSB). [Figures 4.19 – 4.21]

most of the cladding is completely missing.¹⁸ The 1973 utility room addition to the west of the circa 1921-1935 rear porch addition and 1955 bathroom addition is clad in painted plywood sheathing with painted wood battens applied to the outside face with a spacing similar to that of the historic board and batten siding on the main house.¹⁹ This plywood cladding is severely deteriorated, and a large section of the south wall of this addition is missing, likely due in part to damage from the collapsed roof of the addition. [Figures 4.18 – 4.21]

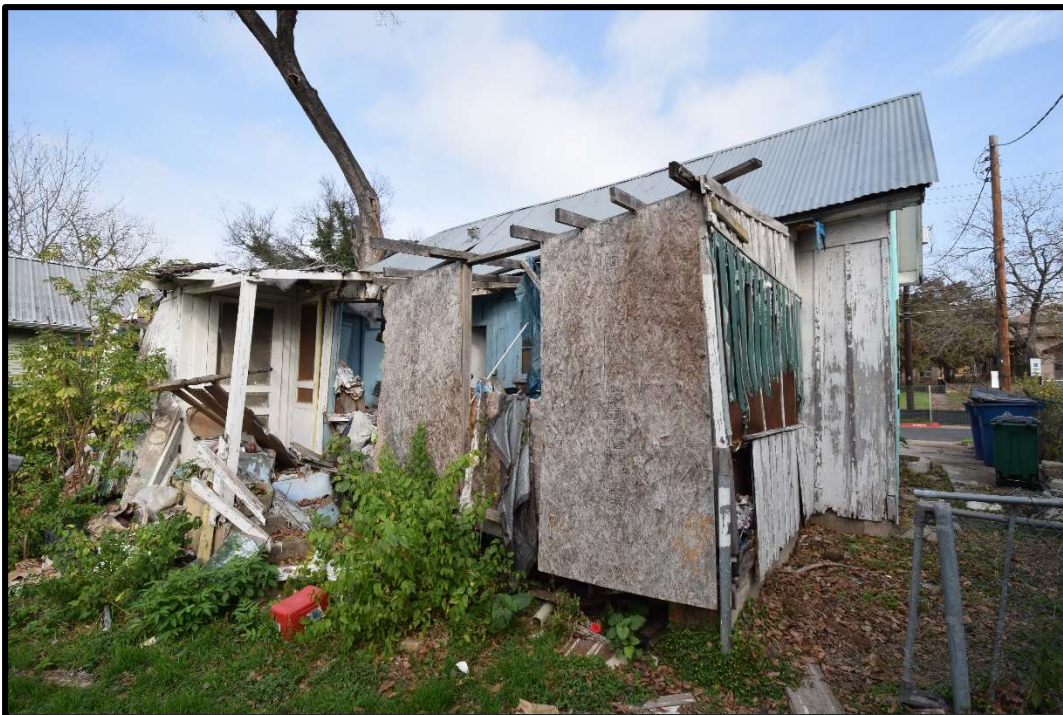
Figure 4.19: Oblique view of south façade of the house showing the rear additions.

In addition to the exterior doors at the main L-shaped house, there are two exterior doors located at the south side of the rear addition. One door is located at the east wall of the 1973 utility room addition, which is outside the historic period of significance for the house. The other door is located on the south side of the circa 1921-1935 addition and appears to be a more modern replacement door unit. Further study of these two doors does not appear to be warranted. **[Figures 4.19 and 4.20]**

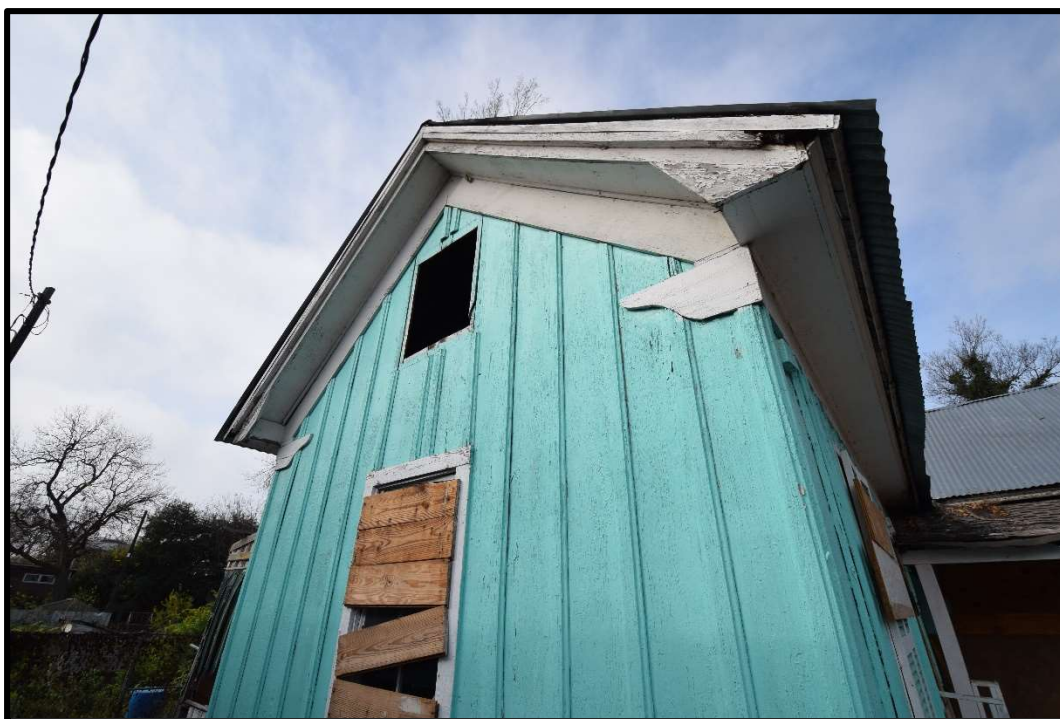
Figure 4.23: Detail view of upper portion of east façade of main wing of the house.

The corners of the house are simply trimmed with two painted wood battens butted together along their vertical edge. These battens also feature the same molded double-ovolo edge detail noted above. This corner trim condition is a character defining feature and should be preserved or restored. [Figures 4.23 and 4.24]

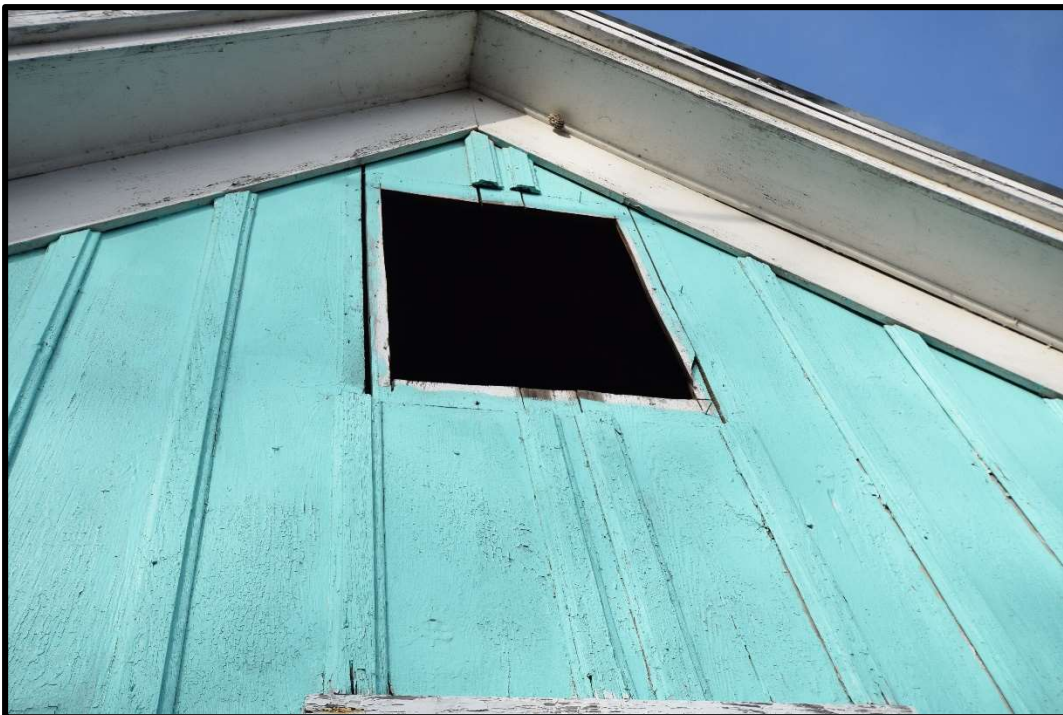
Figure 4.25: Close up view of missing vent at east gable end.

The framing of the main roof was observed through a missing gable-end vent at the east side of the house. It appears that the roof framing is comprised of 2x4 rafters at about 24 inches on center, with 1x4 skip-sheathing (also known as purlins) laid perpendicularly to the rafters at about 12 inches on center. The mitered ends of the rafters meet at the ridge, which appears to have no continuous ridge beam. Based on the limited view through the missing gable-end vent, there do not appear to be any additional roof framing members

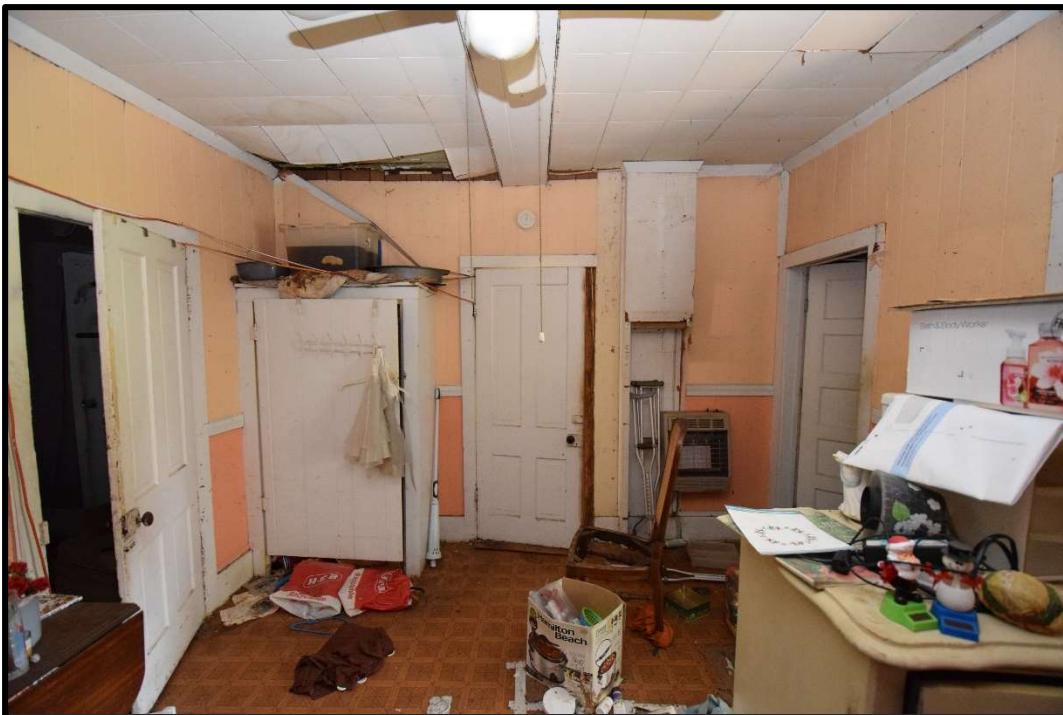
Figure 4.35: View of east wall of Room 3.

The house was originally heated by either wood or coal-burning heating stoves. The only built-in heating apparatus noted during our December 9, 2019 site visit was a gas-fired wall heater mounted on the east wall of Room 3. [Figure 4.35]
