VINCENT GERARD & ASSOCIATES, INC.

McMath House

Property Evaluation

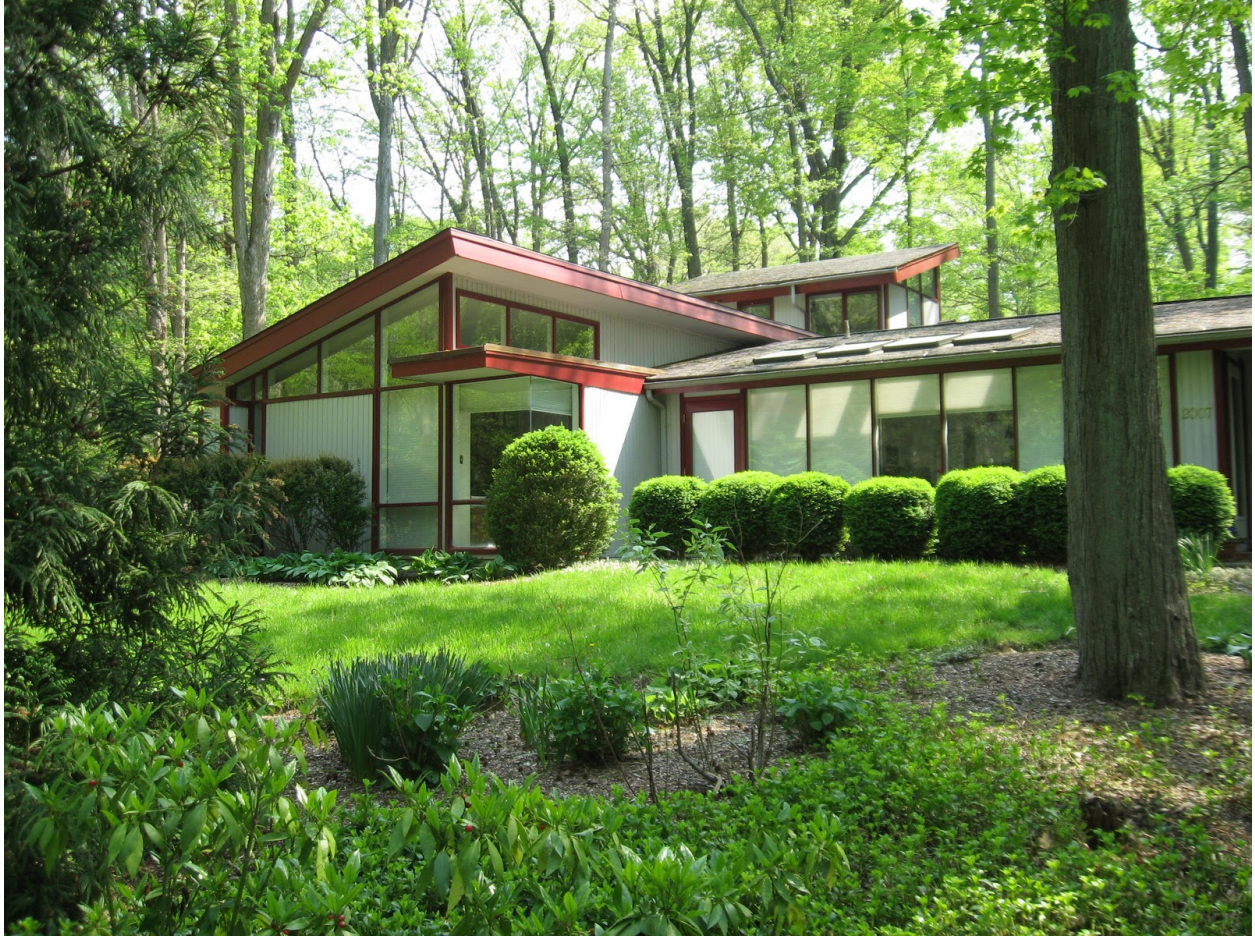
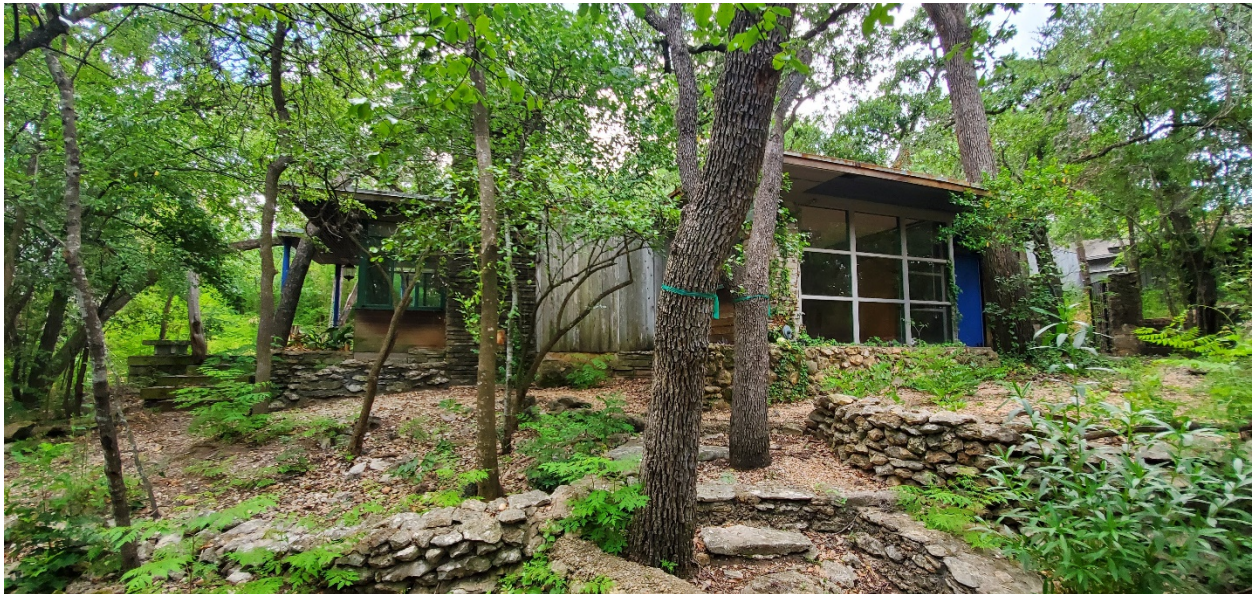
Example of nonconforming floor to ceiling glass windows of 2501 Inwood, the lack of glass elsewhere and split level/ Clerestory pitched roof

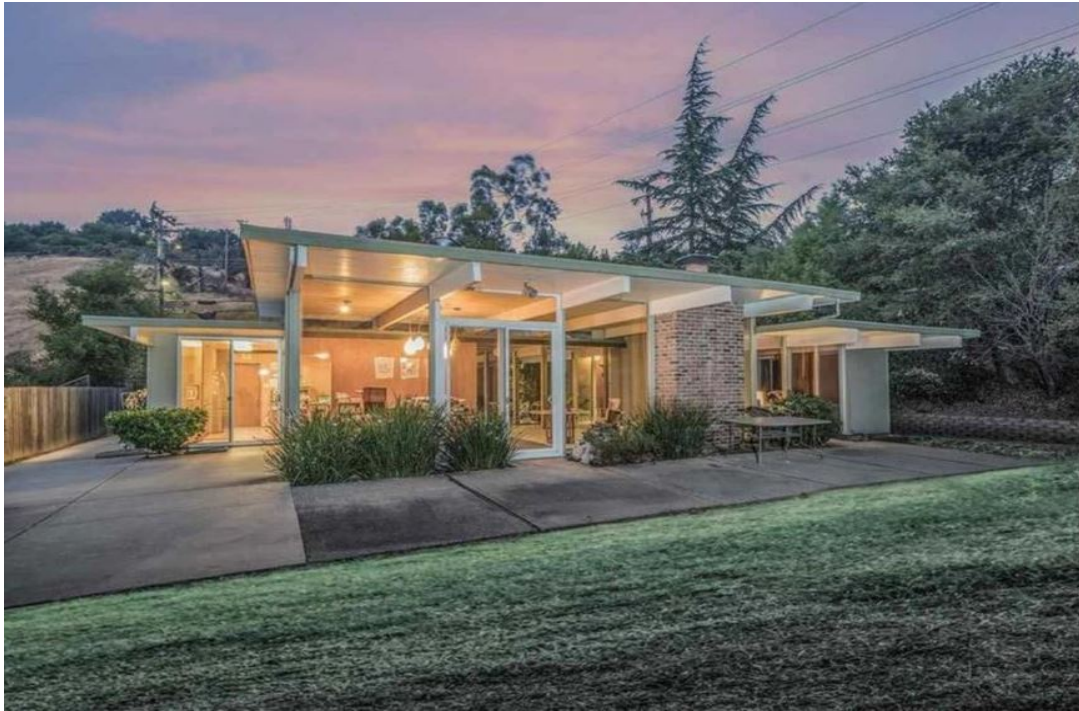
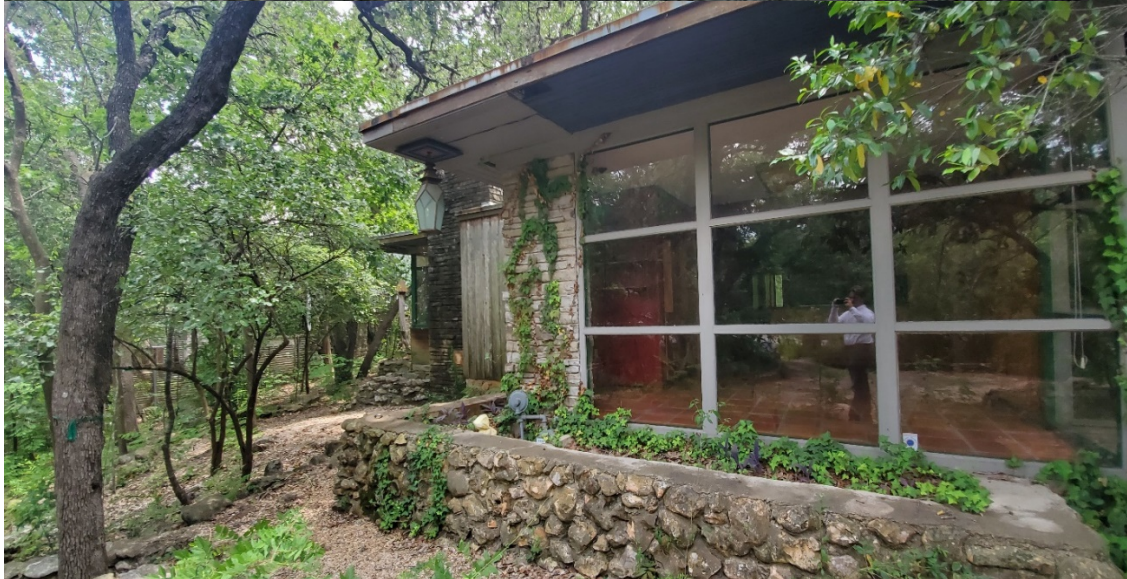
The irregular stone work, deteriorating wood siding, Spanish Gothic ornamentation, and 9-grid windows are strikingly different from the featured Mid Century Modern homes single pane floor to ceiling glass, and clean, minimal exterior features

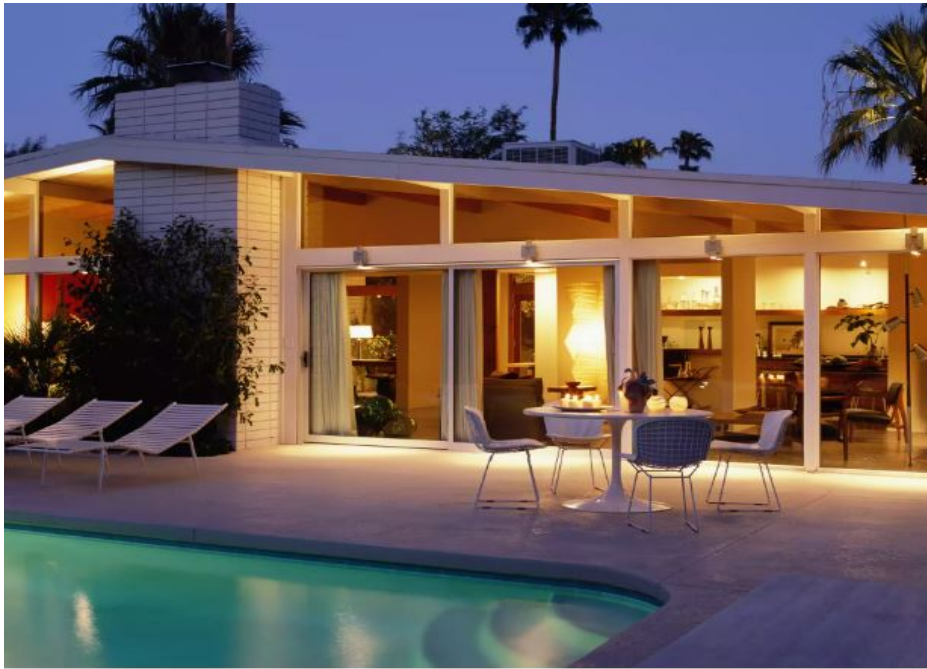
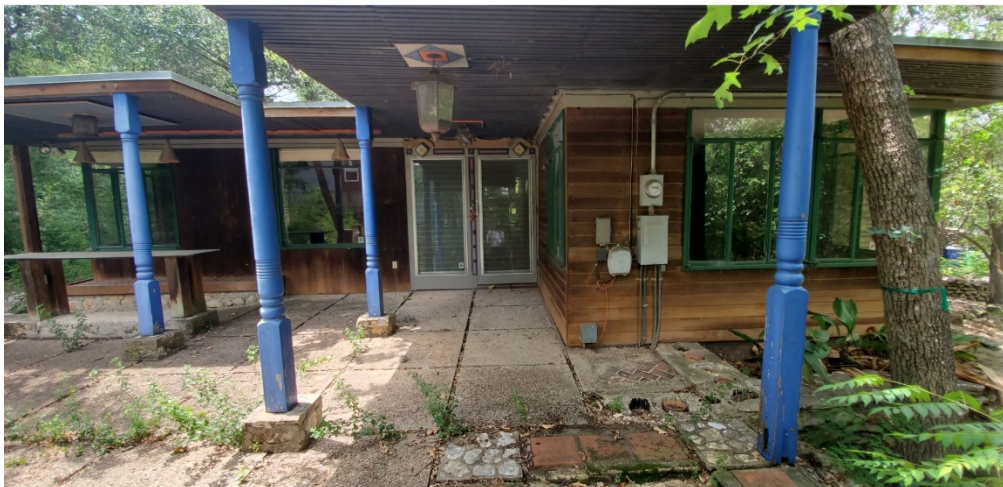
The back addition has a little connectivity to the outside with one working door and no floor to ceiling windows. There are what seem to be international windows but lacks the feel of “architecture of the machine age” that industrial steel or any other supporting critical features would have provided.

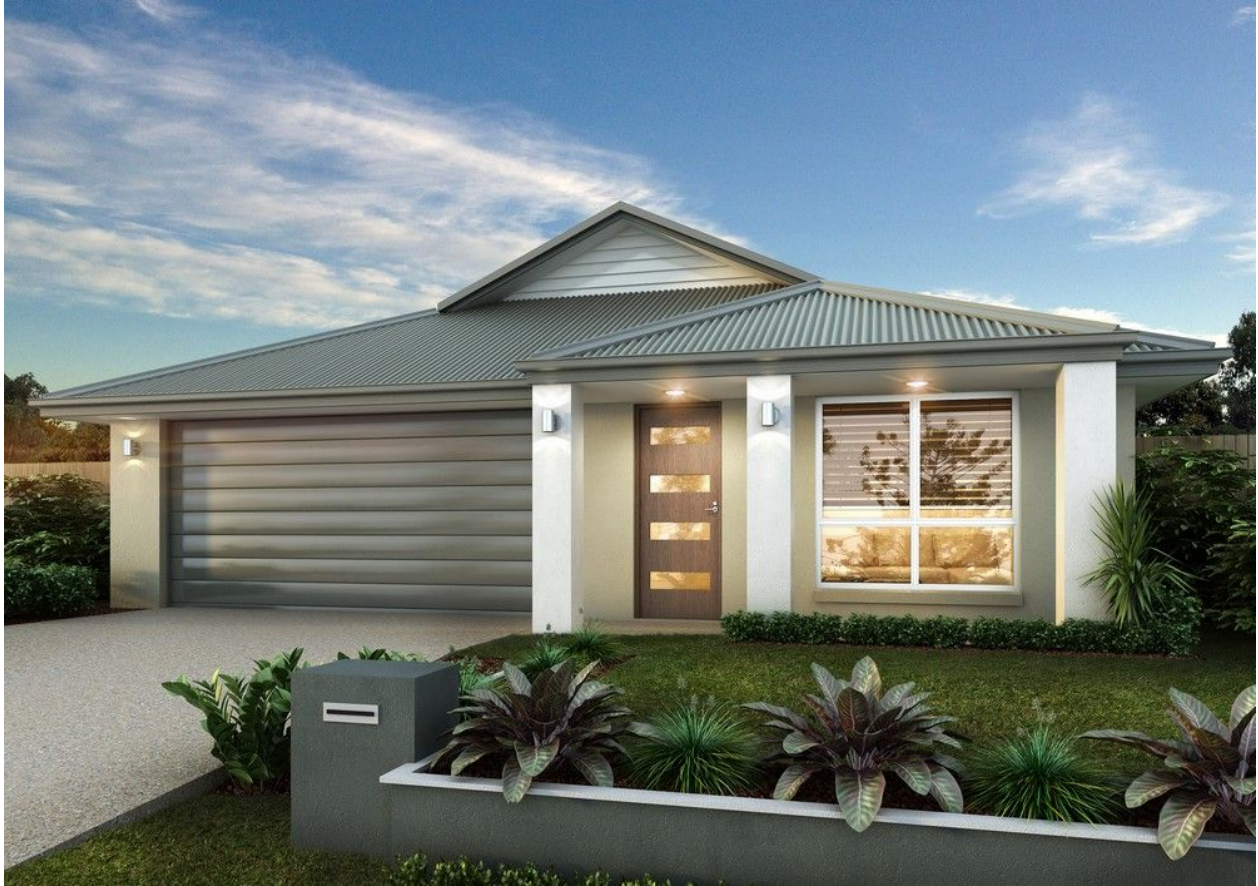
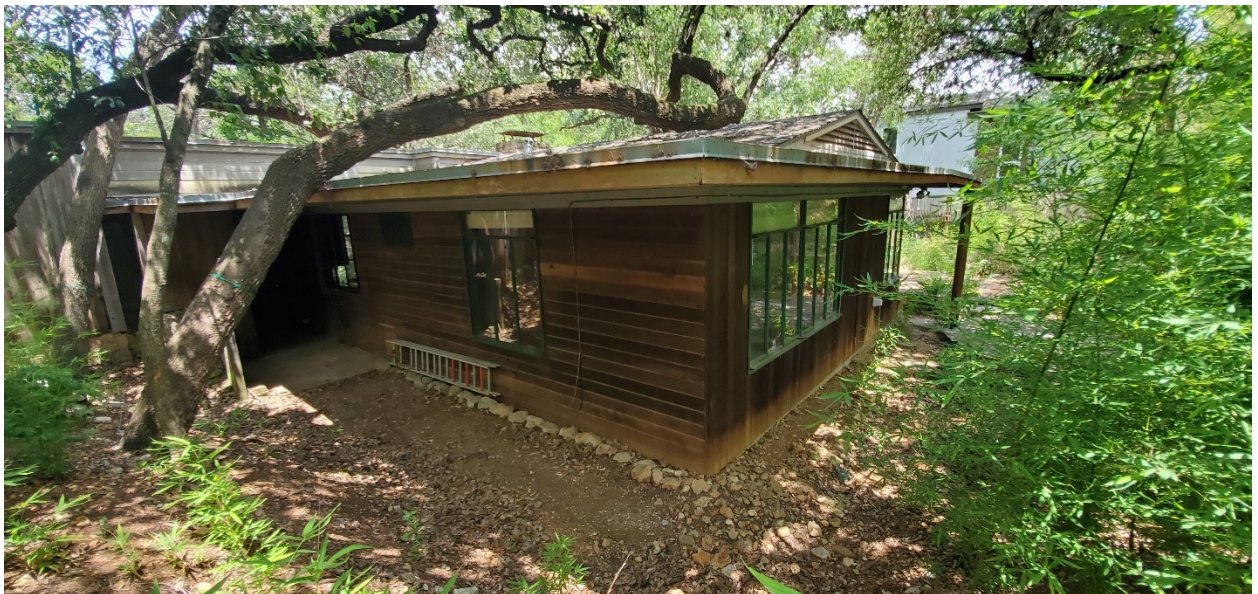
On the rear addition of this building applied for in 1954 there was added a flat roof with Dutch gable running its length strangely enough.

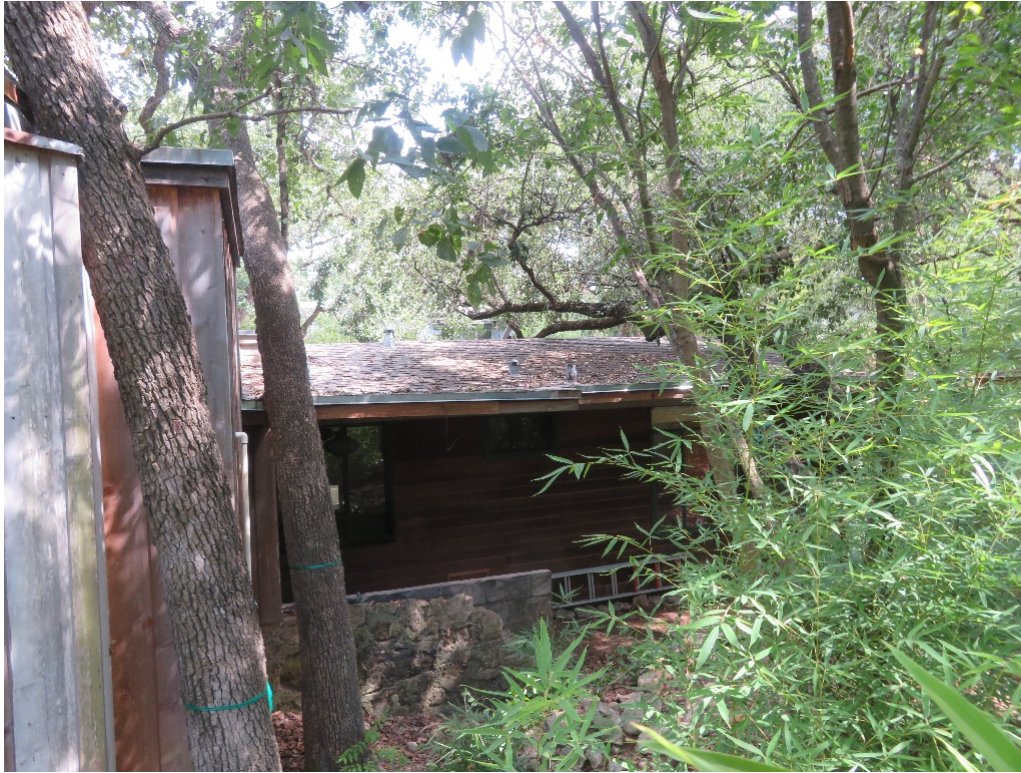
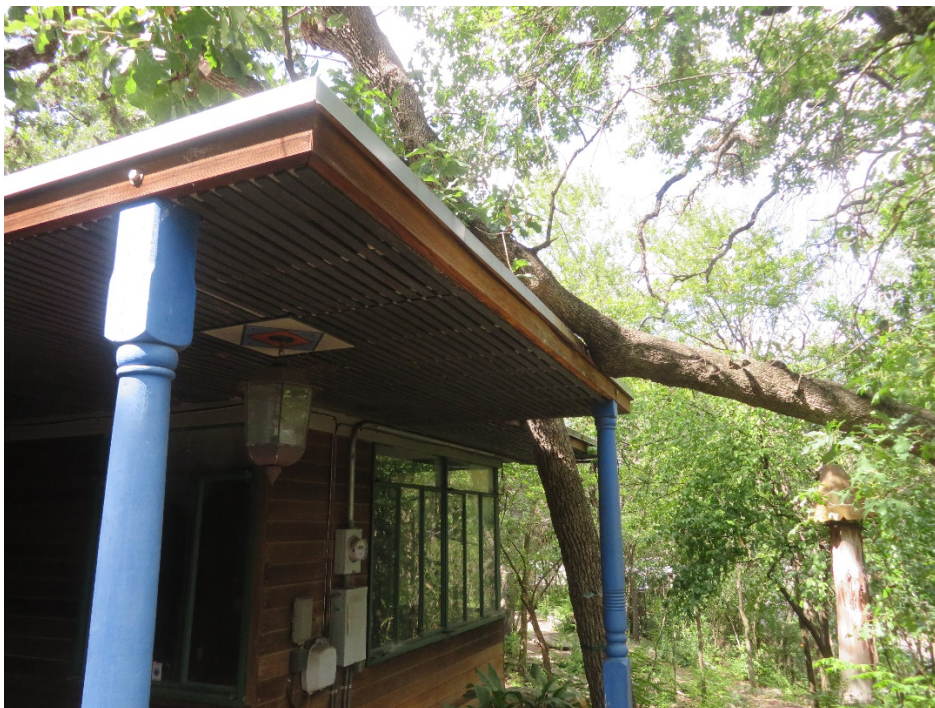
- Nonconforming
- There is no doubt that this home is immersed in Nature, it is barely visible from the road, but the amount of overgrown foliage has allowed for damage to the roof and foundation in certain areas where a tree is resting its load on the building. There is also a great deal of erosion from lack of grass, the property is in desperate need of demolition and rebuild with close attention to existing trees.

Tree's placing extra load on walls and roof.

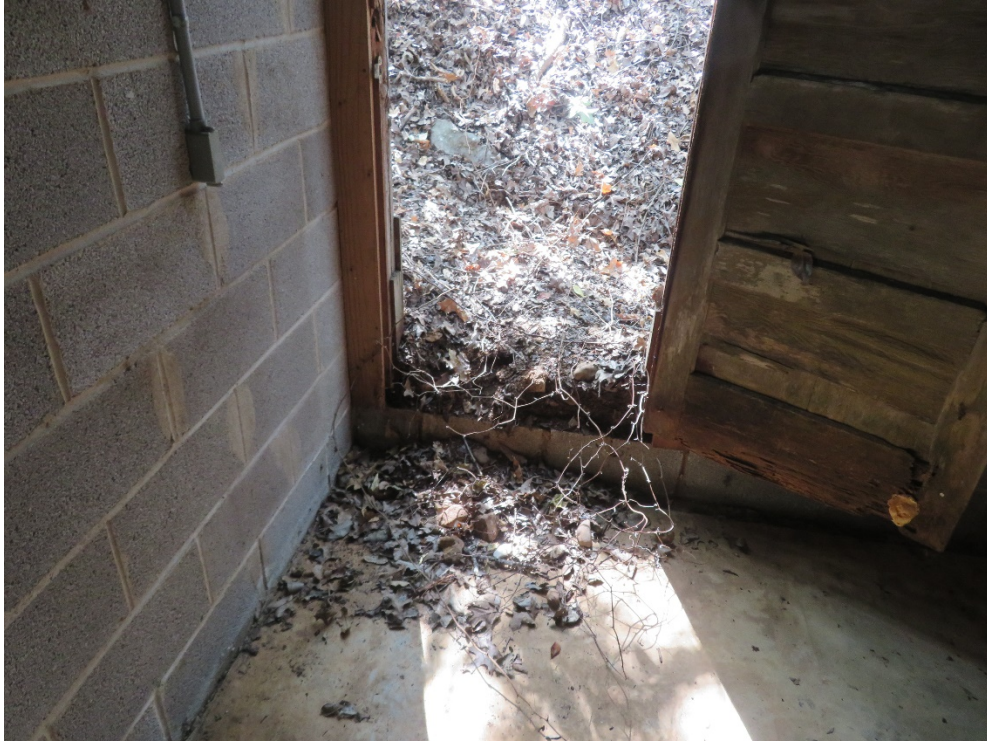
Extensive erosion into detached garage due to lack of landscaping.

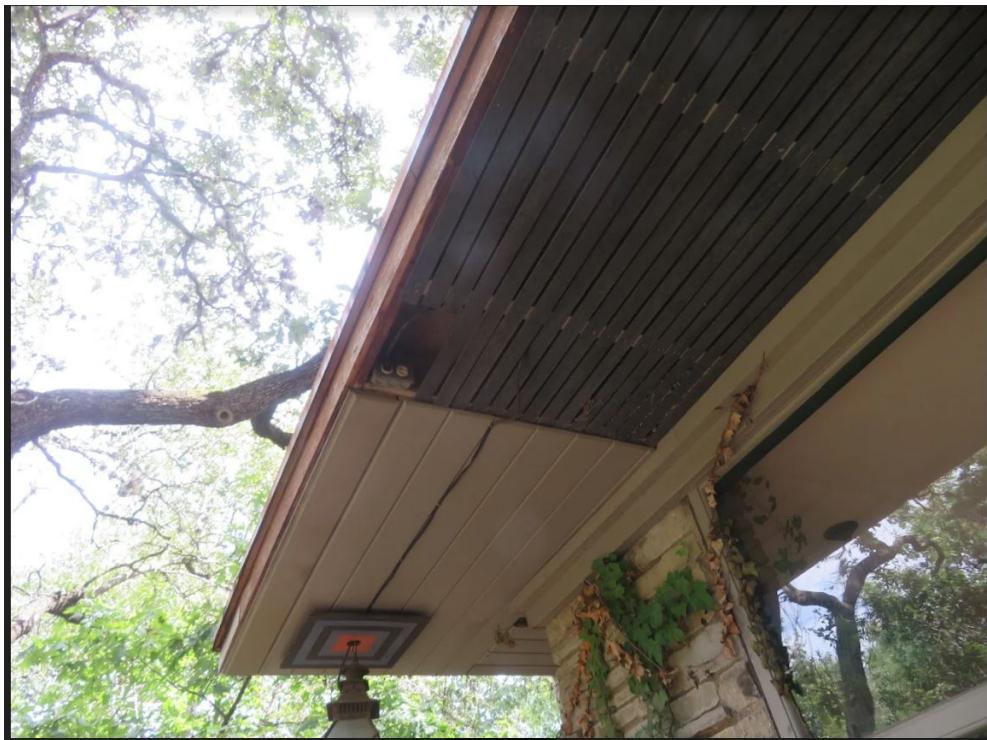
- Nonconforming
- There are quite a few built in cabinets in the home creating open space. There is a plethora of Vintage Spanish Gothic Wrought Iron chandeliers that ornament the home one nearly every corner of the building, with noncomplying electrical work exposing holes in the soffit. This is not only architecturally not congruent with Midcentury Modern but also a potential code violation.

Self-installed lighting, code violation

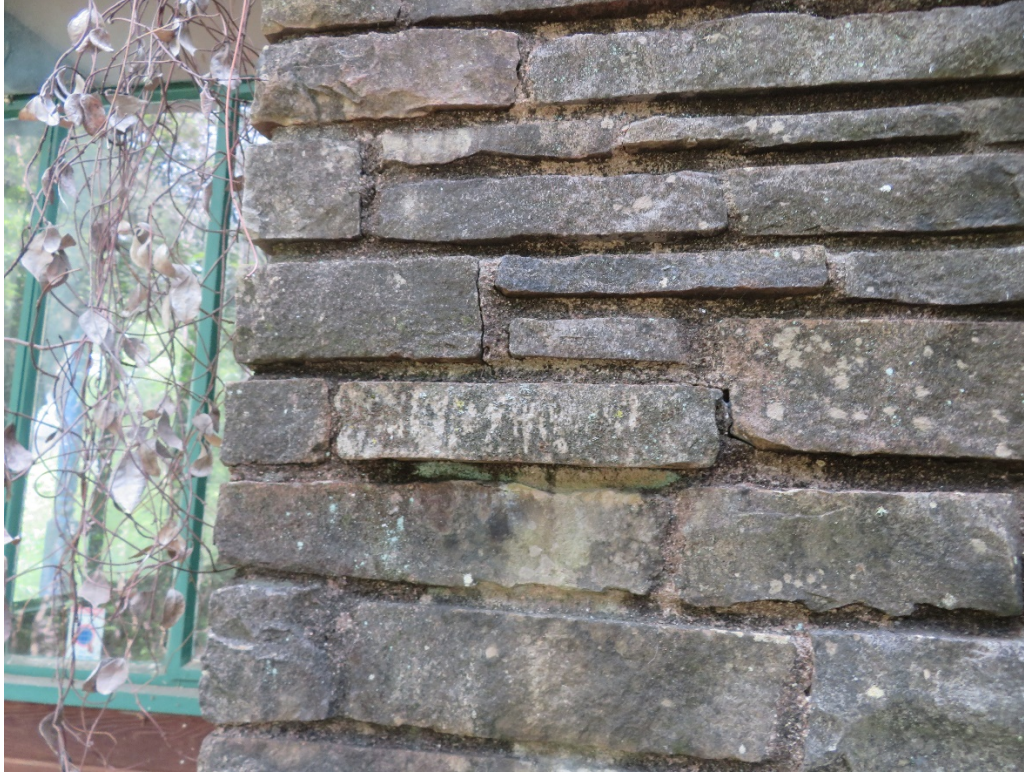
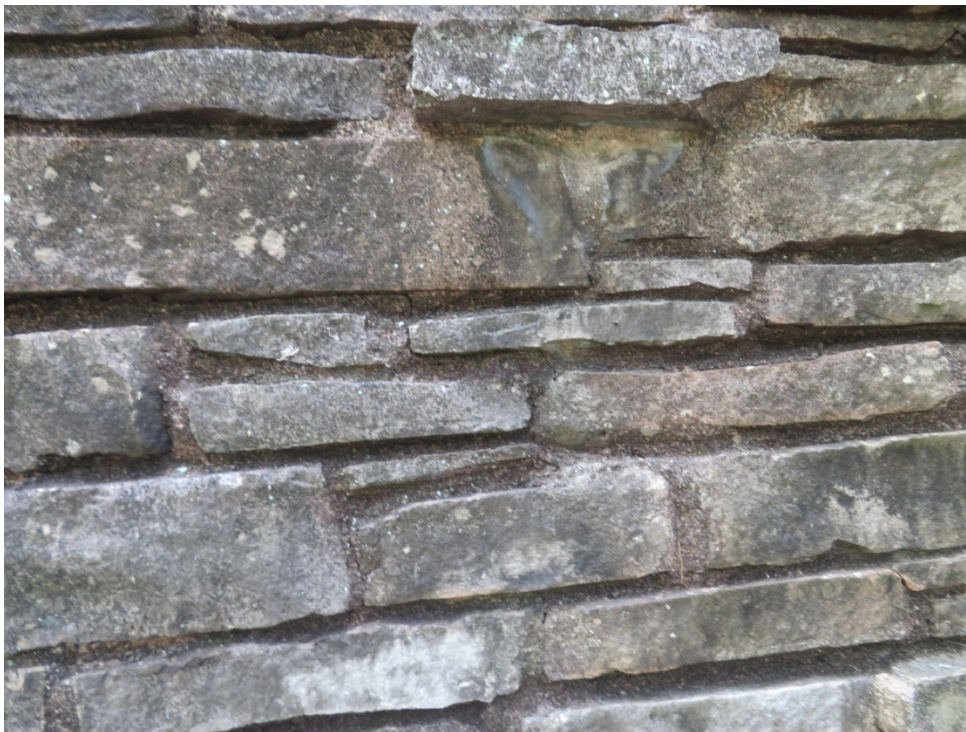
Cracked mortar indicates foundation movement or mortar failure

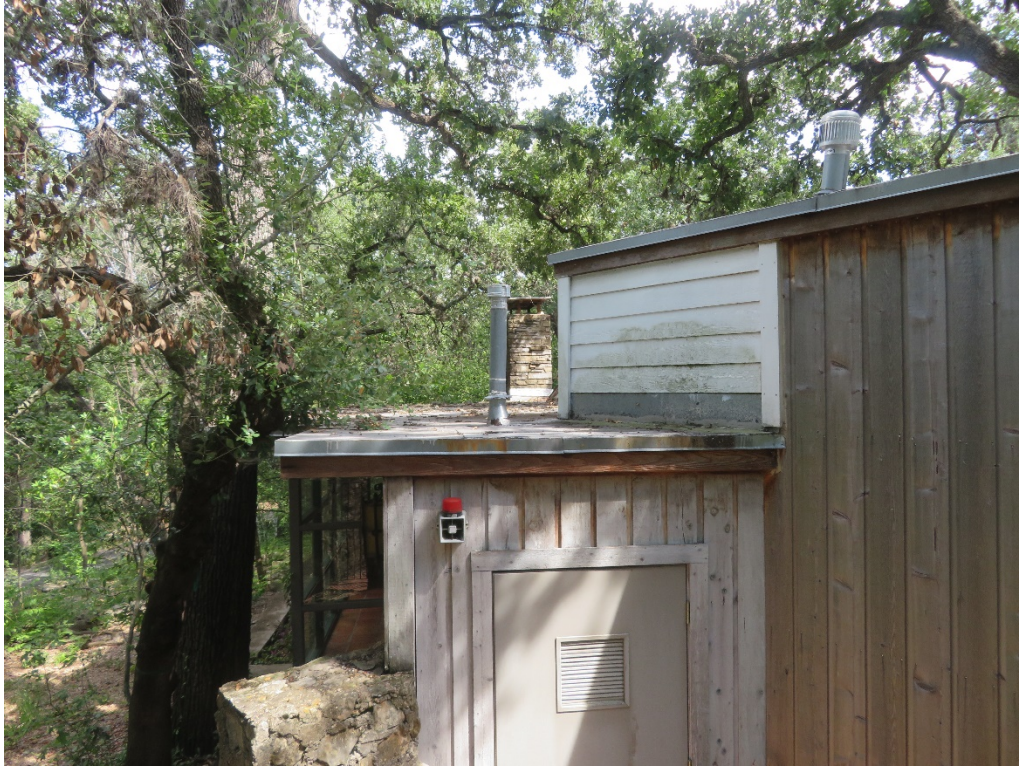
Siding from the addition

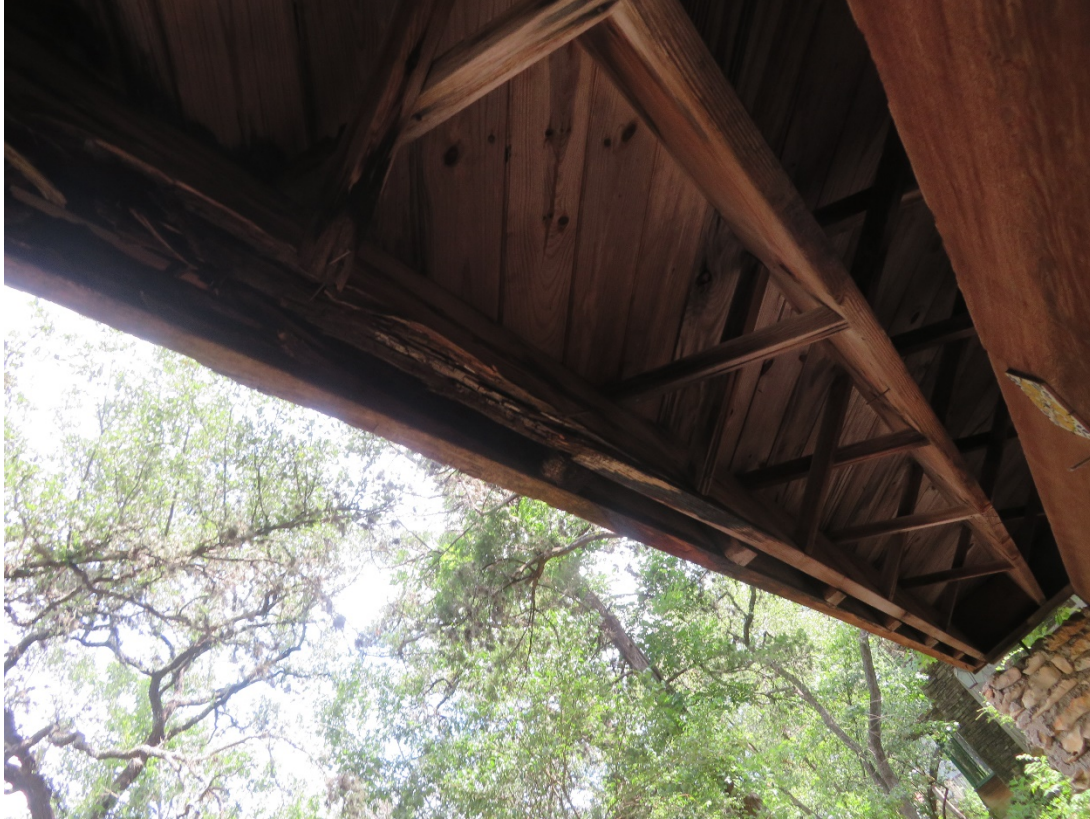
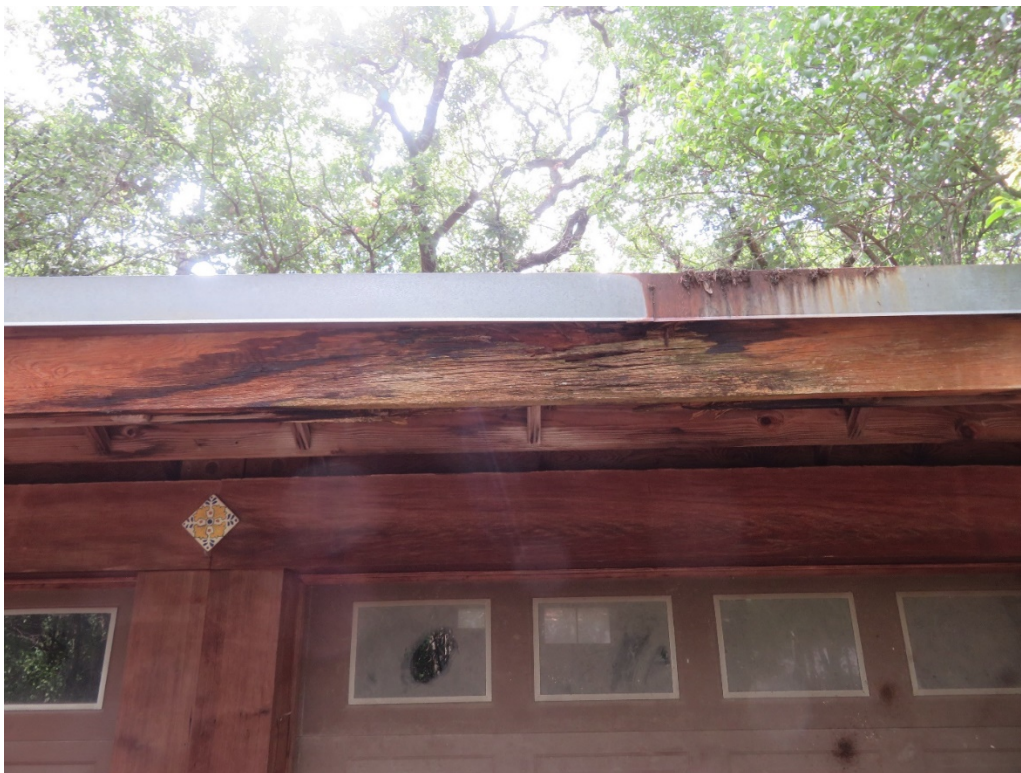
Detached garage water damage of main support cross beam.

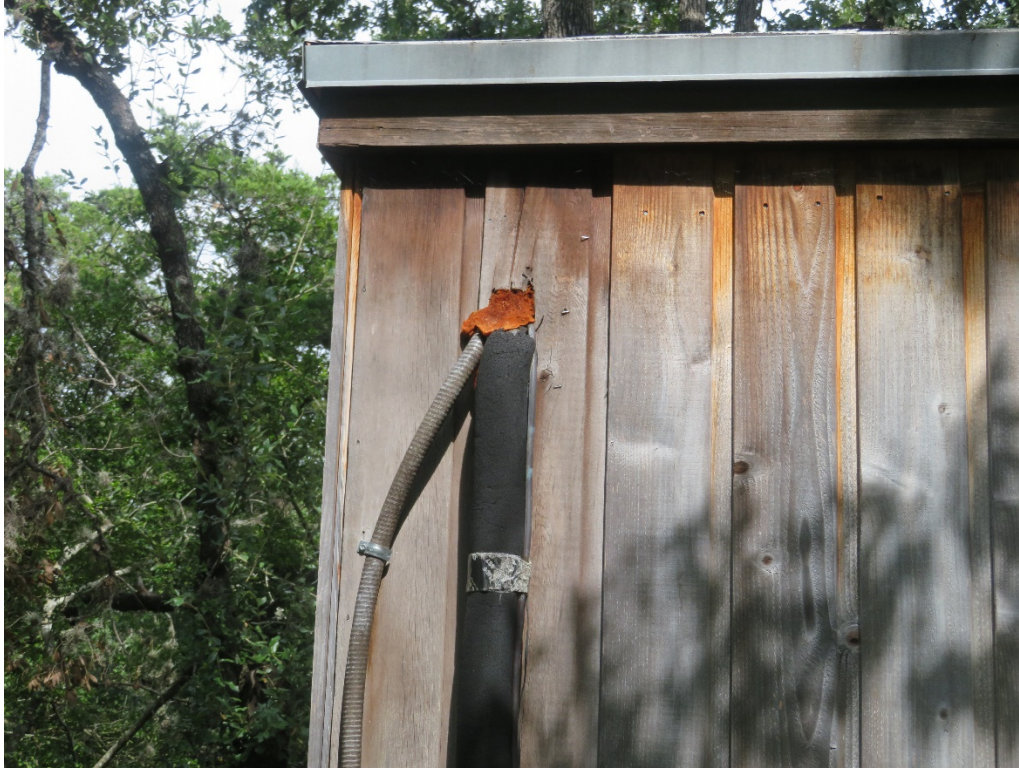
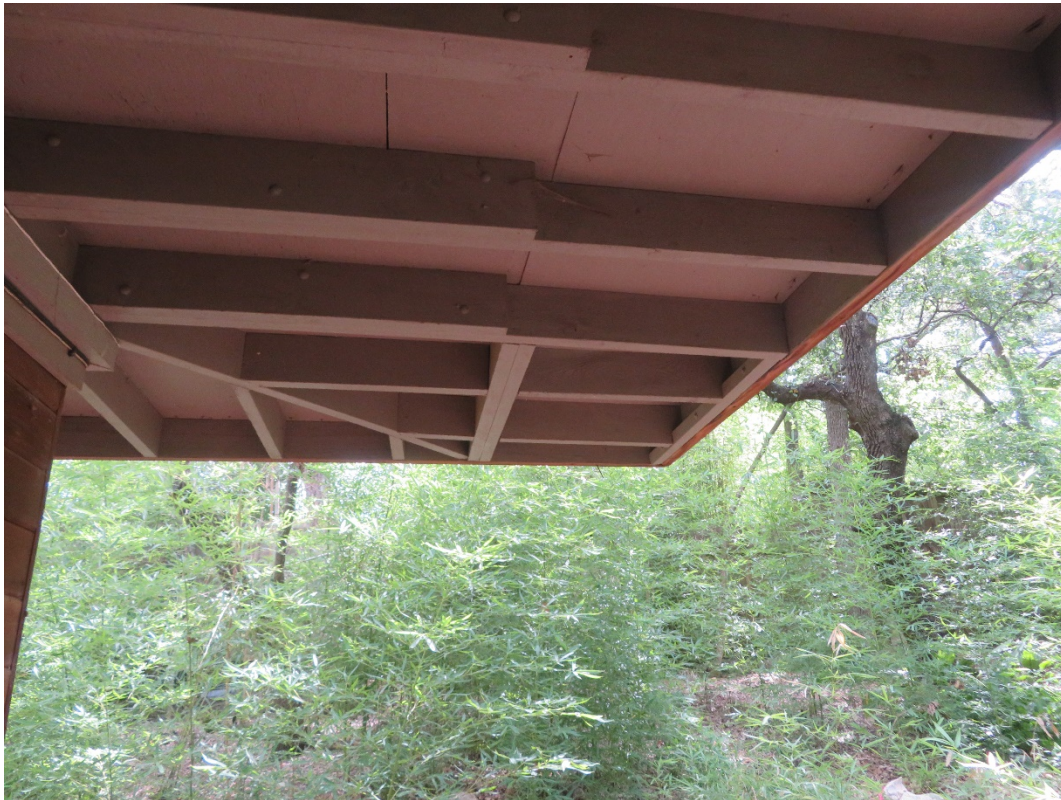
Wiring and Roof extension

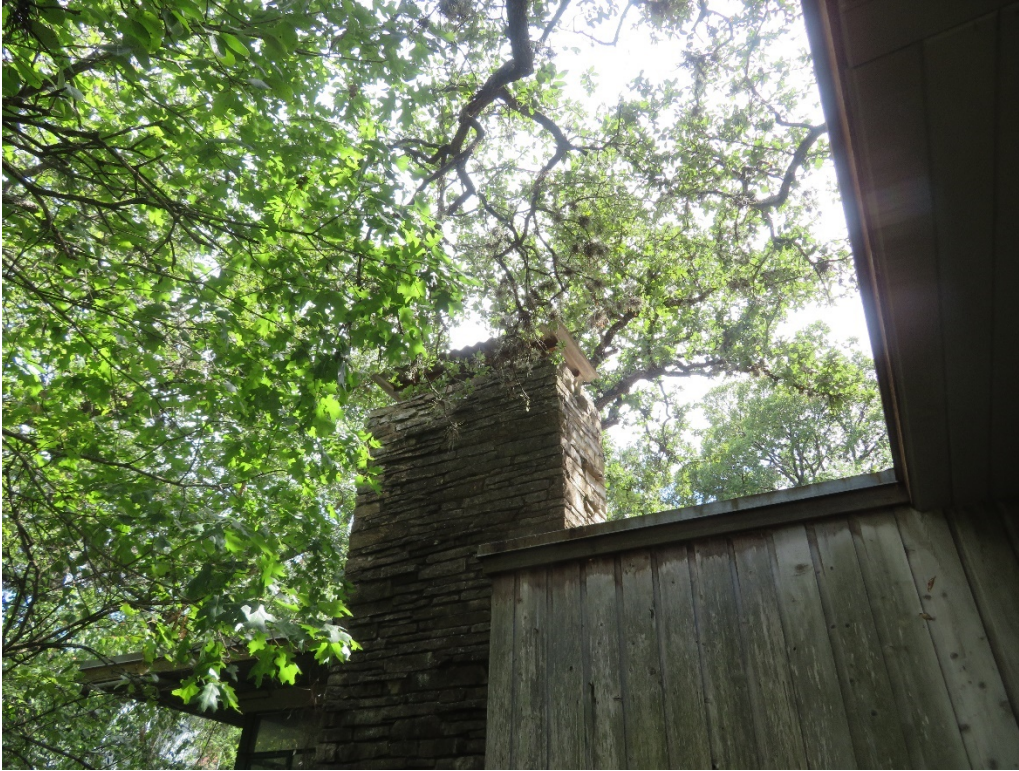
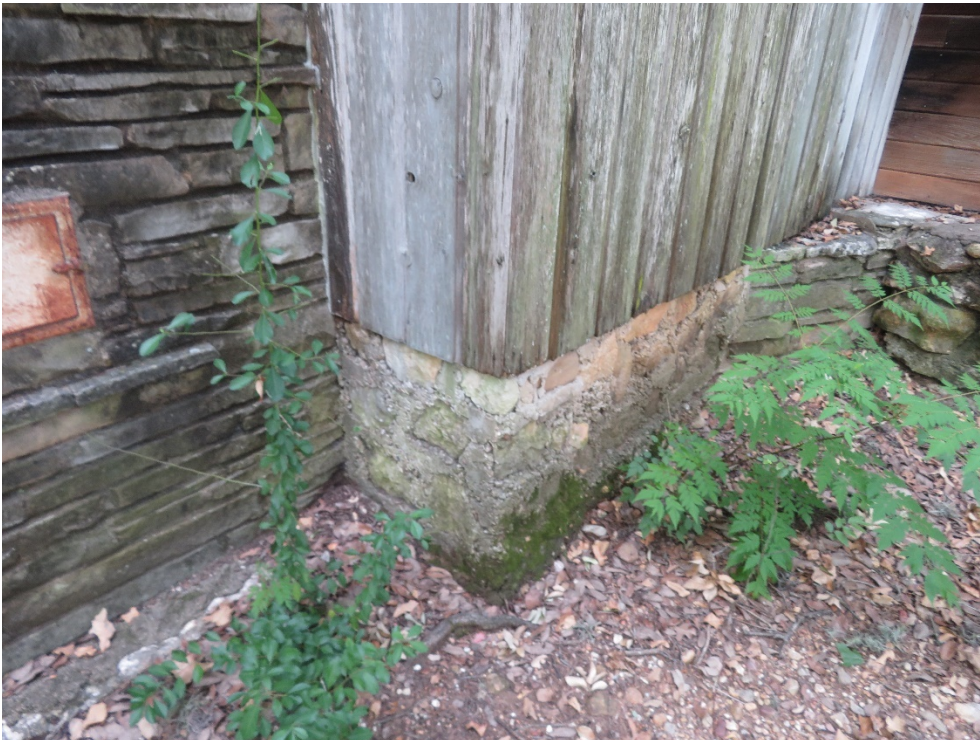
Addition's foundation next to chimney is built of stone and mortar, must be demolished
