On 18 August 2021 R. Derek Hammond on behalf of RDHammond Consulting & Engineering (RDH C&E) performed a site visit to 3400 Hillview Road to view the condition of the existing structure. The following details what was encountered, conclusions, and recommendations.

### **Existing Site Conditions**

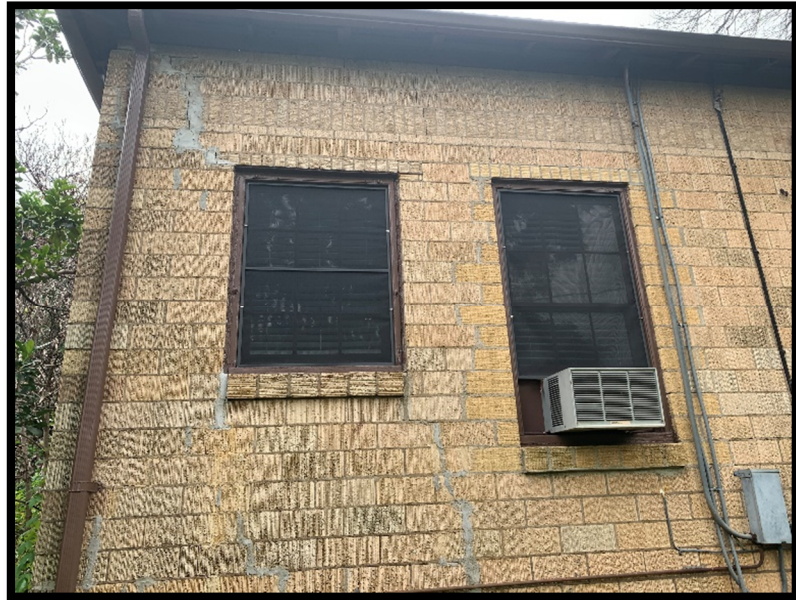
Multiple locations around the exterior had stair step cracking occurring. Most openings had stair step cracking to some degree. Walls were noted as bulging on the north end of the building and the south west of the structure. Large cracks and faulting was also noted in the crawl space within the ribs of the floor support system. Large cracks was also noted on the terrazzo flooring on the interior, radiating outward from interior wall corners. It was also noted that the living room floor had sunken down approximately 18" during the 80's.

Figure 1: Stair Step cracking on West wall

The soils were black in nature, and likely high in clay content and/or organic material. When wetted the soils have a high potential of heaving up, and when dried the soils settles down. Stair step cracking, consistent around the entire structure is common where settlement and heaving are issues. Typical construction methods recommend the removal and replacement of poor soils, the conditioning of the soils, or foundations that bear deep enough, and that have enough separation from the soils to prevent cracking issues created by high expansive soils.

Damage was encountered in multiple locations within the stem walls, likely due to movement with the foundation system. Damaged cells would need to be removed in their entirety due to their brittle nature. Repair methods are not available for structural clay tile. Also, to remove, replace, and repair the damaged cells, the floor and roof would all be required to be shored and floor removed in its entirety. The clay tile material is brittle by nature, and would not be easily replaced, so a substitute may be required. Concrete or traditional CMU would be recommended in these circumstances. Caution should be taken if repairing as the weight of the floors, walls, etc. is high.

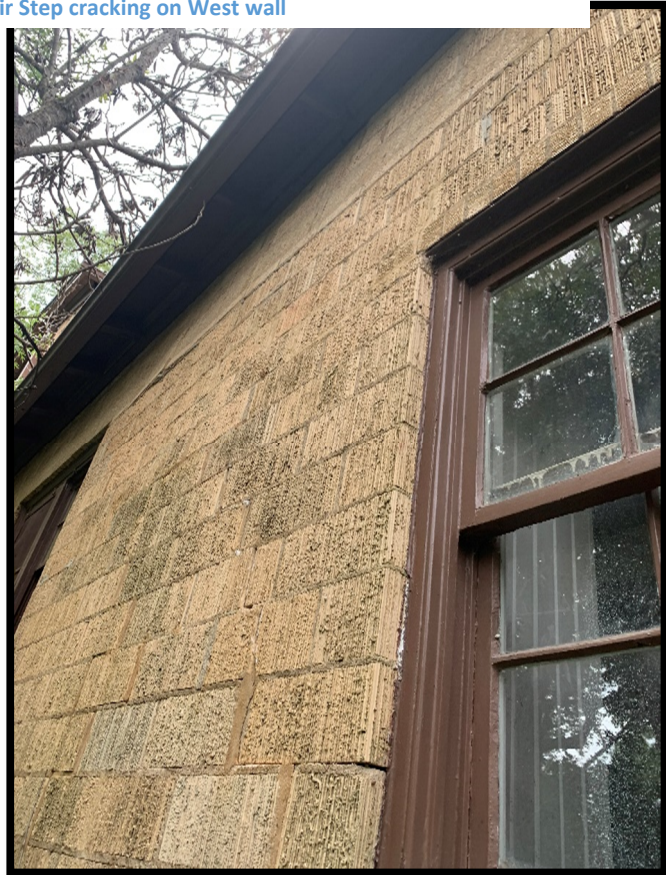
Figure 2: Bulging wall on north end

The bulging walls would also not be easily replaced as the wall would need to be torn down and replaced to repair the damage within the wall, and to get the plumb wall perpendicular.

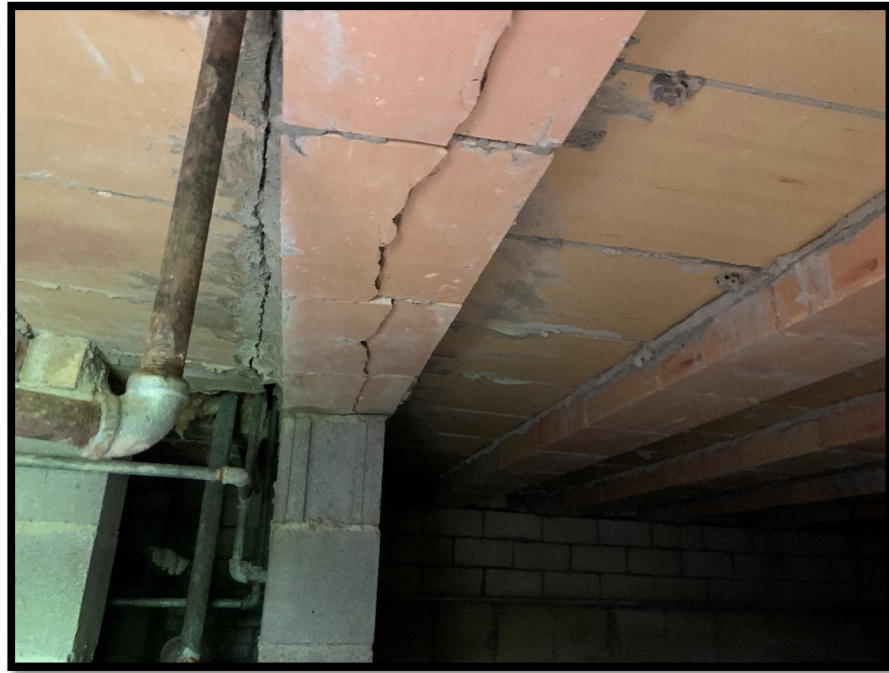
Figure 3: Cracked beams and floor in crawl space.

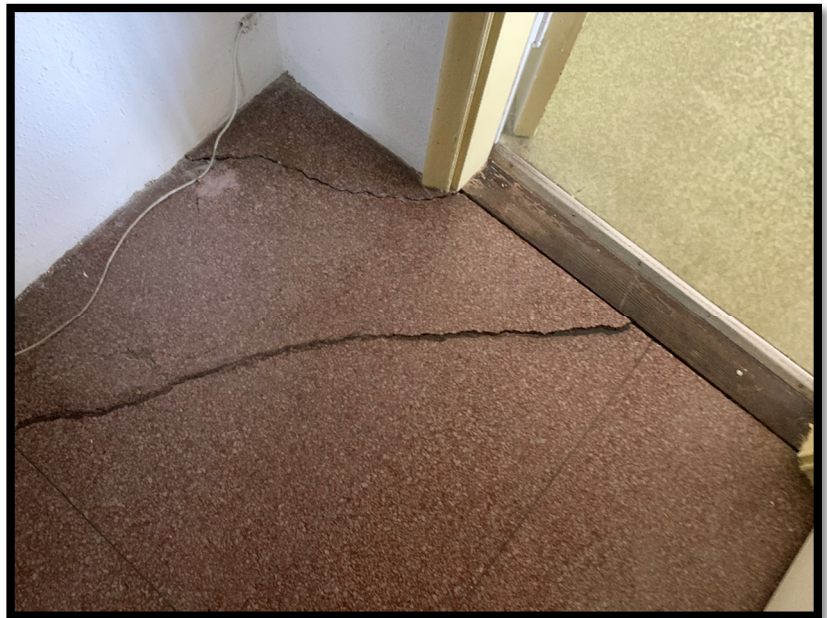
Figure 4: Cracking in terrazzo in interior.

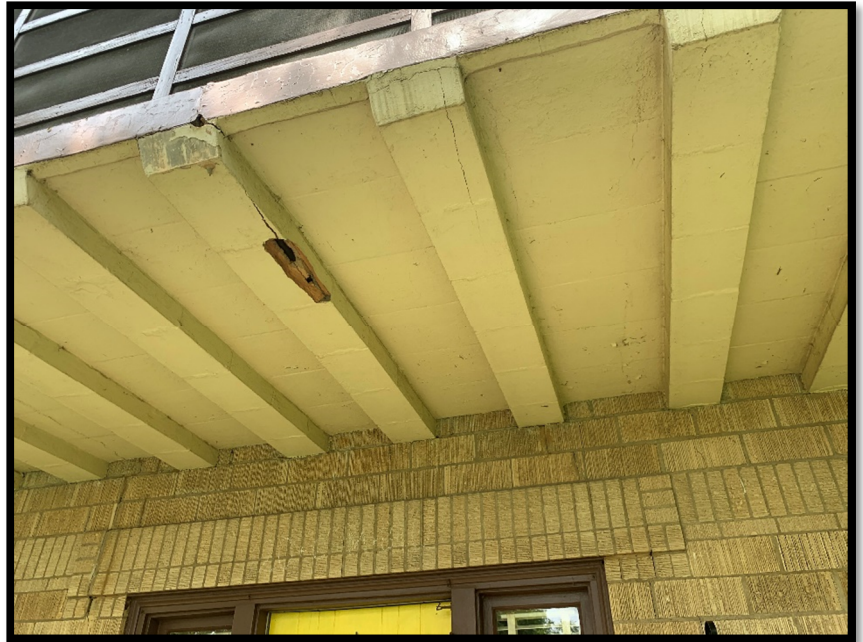
Exposed rebar was noted on multiple locations on the front cantilevered portion of the second floor above the entry. Cracks had formed off the ends of several of the cantilevered beams, had opened up and

allowed moisture within the concrete beams, and some rebar had shown signs of blooming, an

Figure 5: Cracked concrete at cantilevered second floor above main entry

Additional safety concerns were noted at the front entry, due to the degree of the corrosion and damage, it would be recommended that the balcony is temporarily shored to reduce the risk of injury to the owners and visitors. Repairs are possible, but are labor intensive and costly. Repairs would involve the cleaning of the existing rebar, removal of loose debris, epoxy injection into small cracks, and forming and repouring with high strength concrete after some selective demolition to the beams, to allow the repair.

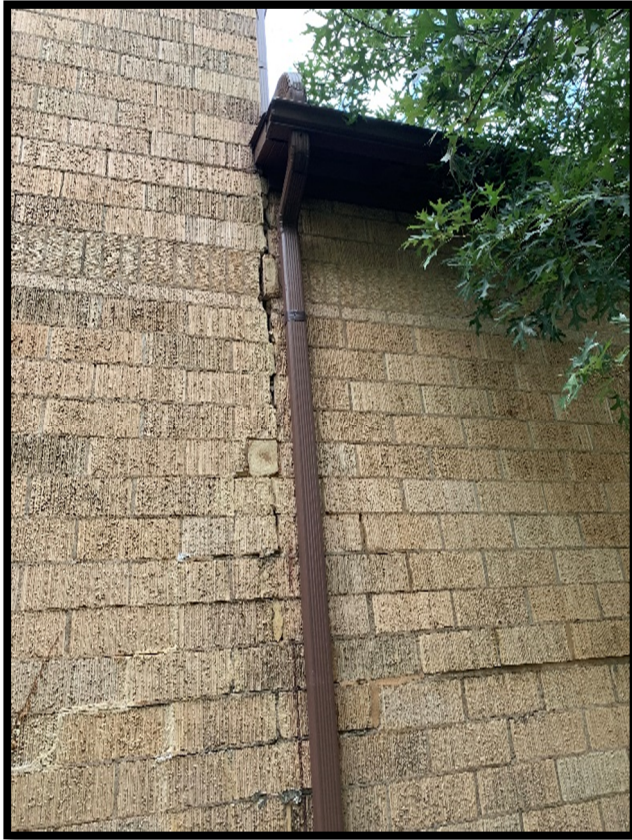
Figure 6: Large crack at interface from 1<sup>st</sup> to 2<sup>nd</sup> floor.

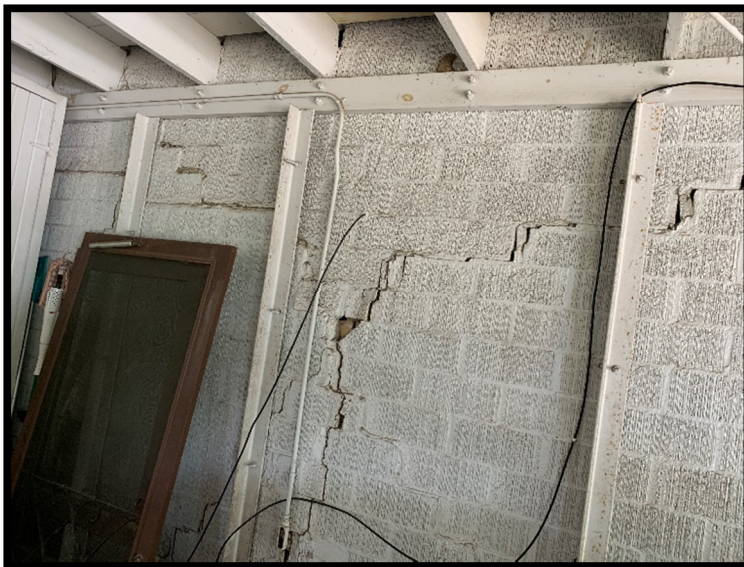
Figure 7: Cracking on interior garage wall, shore with steel angles and expansion anchor.

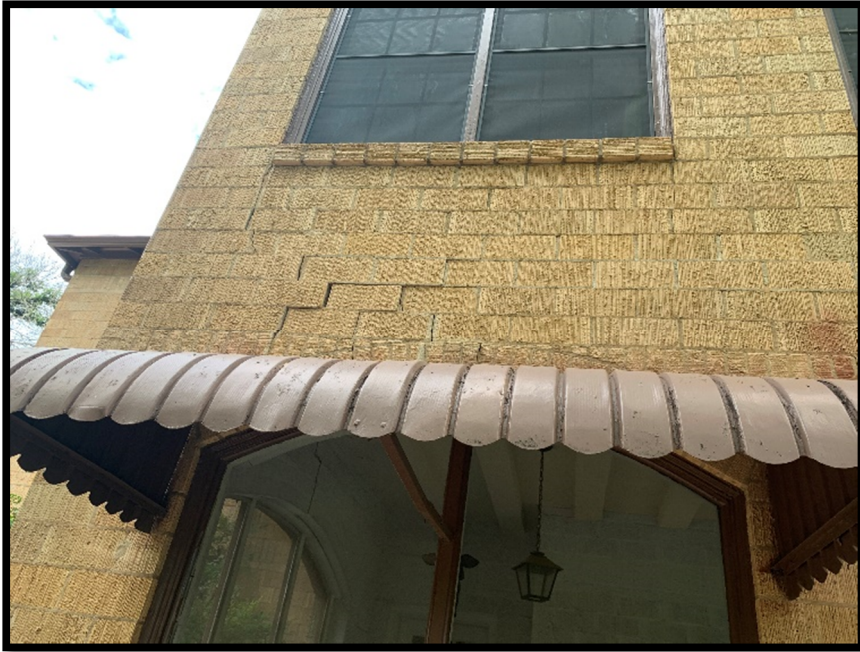
Figure 8: Stair step cracking on South mesh screen room

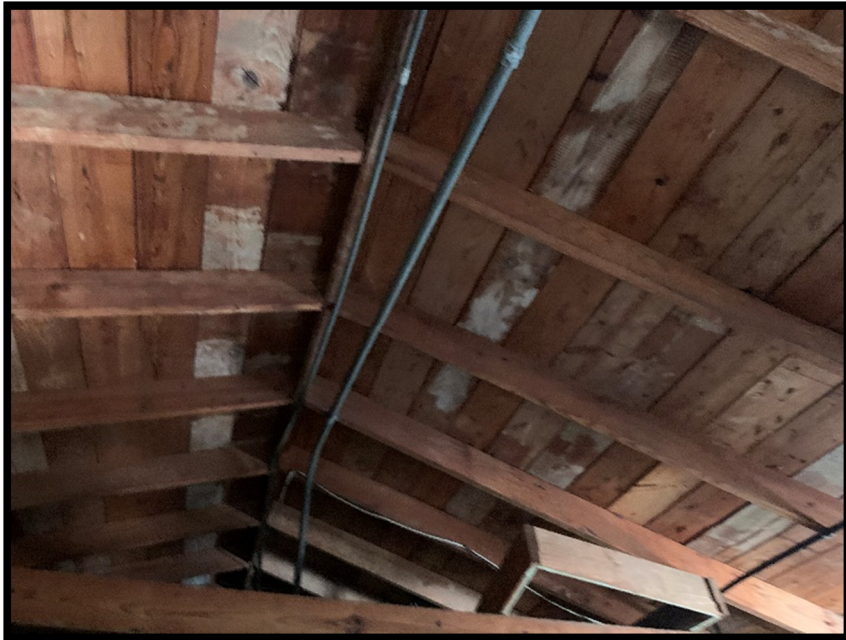
Figure 9: Over spanned ridge beam.

The corrective measures necessary to repair the damage would involve the removal and replacement of the floors, walls, and ridge framing as it was over spanned in most areas. Given the extensive amount of work required, the safety hazards present to the public, home owner, and construction crews it is of the opinion of RDH C&E that the structure should be demolished in its entirety.
