# McIntyre & McIntyre Incorporated

## McMath Residence 2501 Inwood Place Austin, Texas 78703

## Condition Observations

MMI Job #: 21031

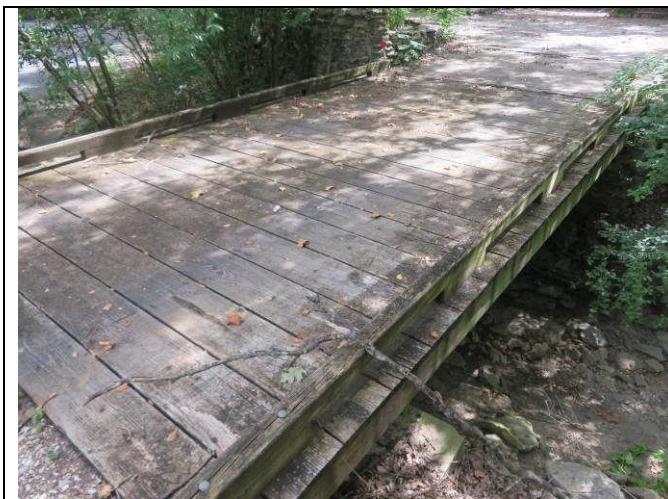
**Bridge:** The surface planking at the wooden driveway bridge entering this property is near the end of its useful lifetime and should be replaced. The stone masonry abutments supporting each end of the driveway bridge has missing mortar and erosion and should be repaired prior to imposing loads on the bridge.

1. Wooden drive bridge

The bridge at the drive entrance requires substantial abutment and deck repair to be safe and serviceable for the intended use.

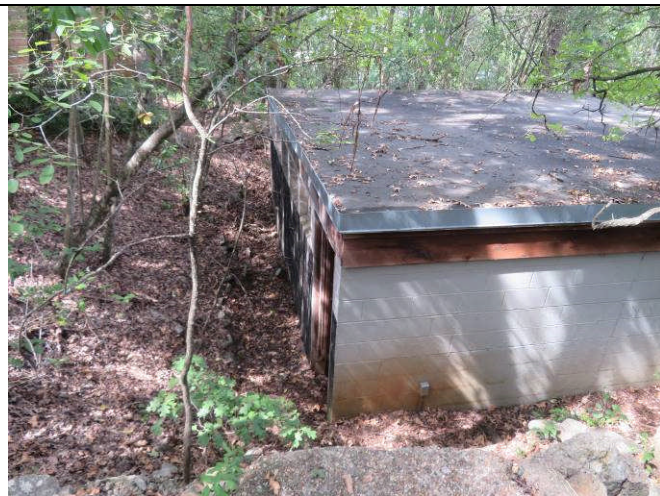
**Garage floor/grade separation:** Soil grade is above the finish floor on three sides of the garage (photo 7-8). Water stains on the walls and floor and rot at the base of all walls within the garage (photo 9) indicate long term water infiltration to the garage interior. There is rot at the garage overhead door as well (photo 3).

7. Soil above garage floor grade on 3 sides

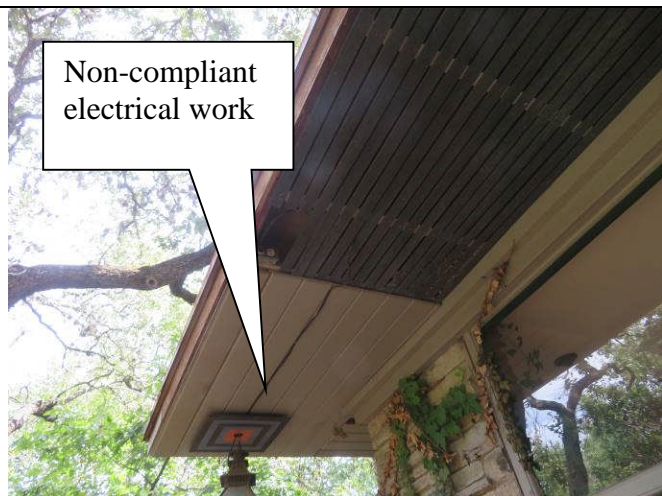
13. Varying soffit materials

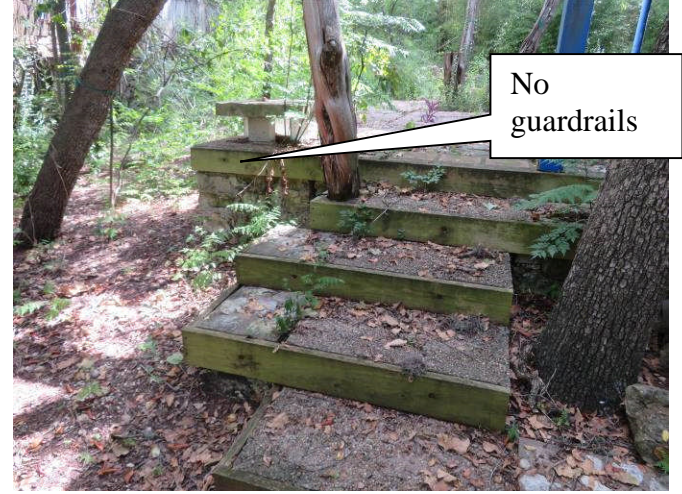
There is no handrail at the four step fight up to the left rear patio from the left front of the house. Badly rusted bolts protruding from the left side of the left rear patio indicate that the guard rail at the patio to grade drop (over 24" in some places) is missing. The existing bolts are so badly deteriorated, they cannot be reused to a new guard attachment.

<p>23. No handrail at steps</p>	<p>24. Improper post bearing</p>

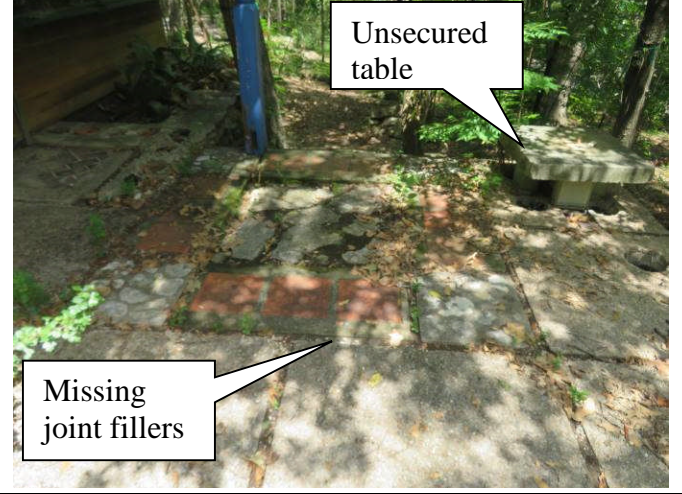
**Patio:** The patio at the left rear side of the house appears composed of square concrete sections that used to have 2x lumber in the section joints (photo 25). There are holes for what appears to have been column anchors (photo 26) that pose a safety hazard. This creates a very uneven and unsafe walk surface.

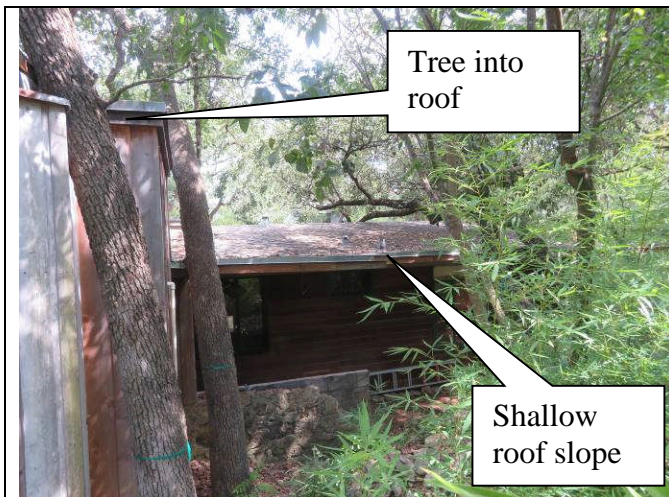
**Roofs:** The sloped and shingled roof at the rear portion of the house has a very low slope. It is likely that this roof was originally installed as a low slope "tar and gravel" roof that was later shingled. The slope appears minimal for shingle application which typically requires at least a 3:12 pitch or steeper.

33. Shallow pitch roof at rear

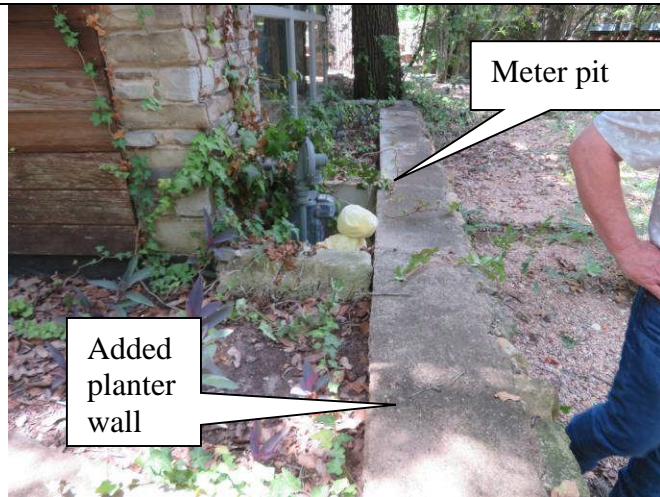
**Natural Gas:** The gas meter is located at the left front corner of the house in a submerged hole that appears to have no drainage (photo 41). The gas meter configuration indicates that the masonry planter was added after original construction (photo 42). The original foundation edge is visible at the hose side of the gas meter recess.

41. Gas meter at added planter

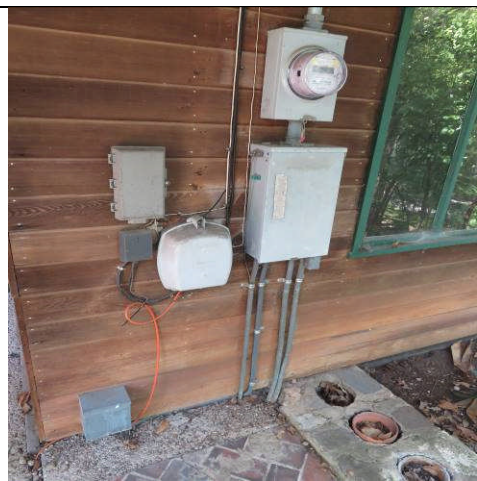
**Service Entrance:** The electric service enters near the left front corner of the house (photo 43). The overhead service entrance does not comply with current AE requirements and will have to be revised during remodeling (insufficient ground clearance).

43. Electrical service entrance

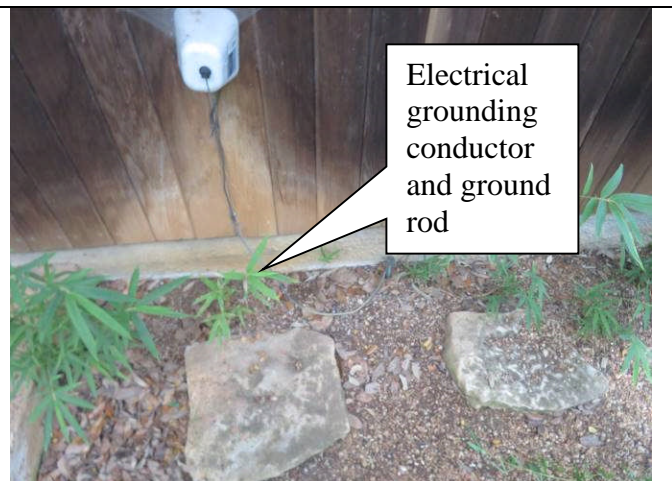
**Grounding Electrode:** There is a ground rod and copper wire attached to a hose bibb at the rear of the house (photo 44). This is not in conformance to NEC requirements and can lead to potential energizing of the copper water pipes throughout the house.

44. Ground rod at rear hose bibb

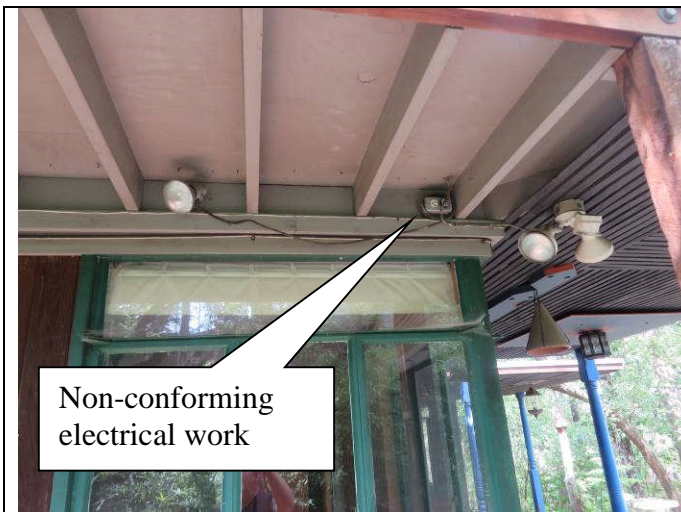
**Wiring:** There is much DIY wiring (photo 45-46) and lighting (photo 45, 48) present at the roof soffits that does not conform to NEC requirements. Junction boxes, wiring devices, wiring and fixtures are not damp rated or installed to outdoor conditions (photo 45-48).

45. DIY electrical wiring and fixtures

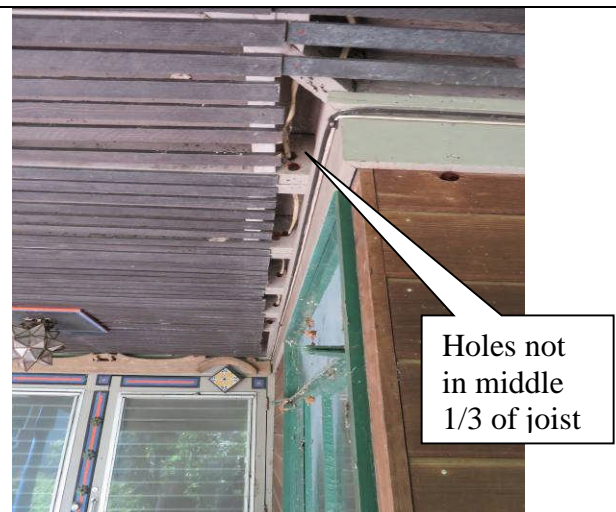
46. improper joist boring

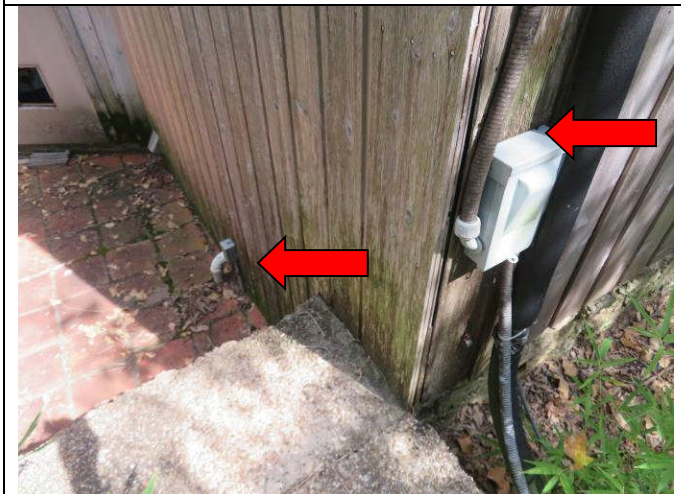
**Siding:** The wood siding is in poor condition around the exterior of the house from long term neglect (Photo 55, for example). For example, the siding is rotted at the room addition adjacent to the fireplace (photo 14, 16). There is, additionally, a roof leak at this room corner (photo 69). The bottom edge of siding is rotting where it is not held off the adjacent flatwork (photo 47).

There are several wall penetrations that are improperly flashed (photo 37, 47) and are allowing moisture penetration.

47. Improper wall penetrations

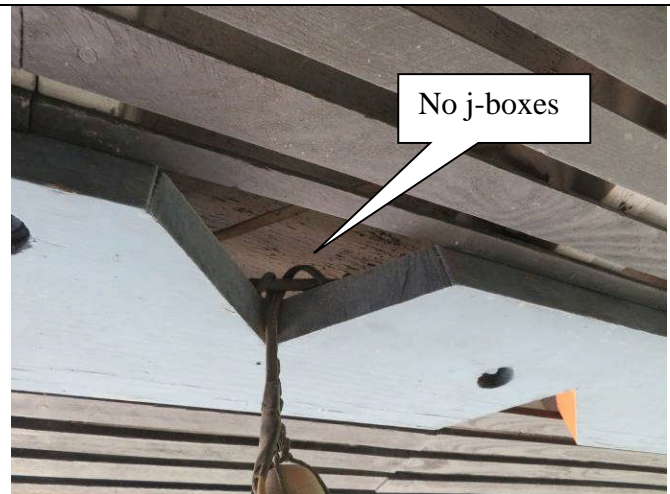
48. Improper wiring methods and materials

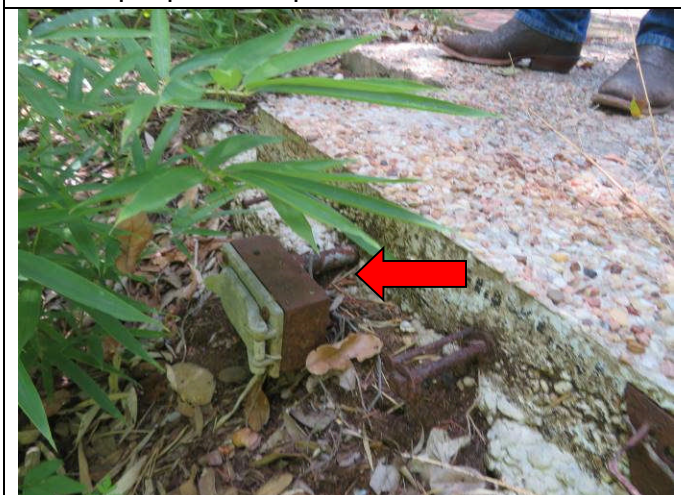
An outdoor receptacle at the SE side of the patio is badly rusted and does not conform to current NEC requirements (wrong cover, badly rusted box, not waterproof installation).

49. Badly rusted j-box at patio edge

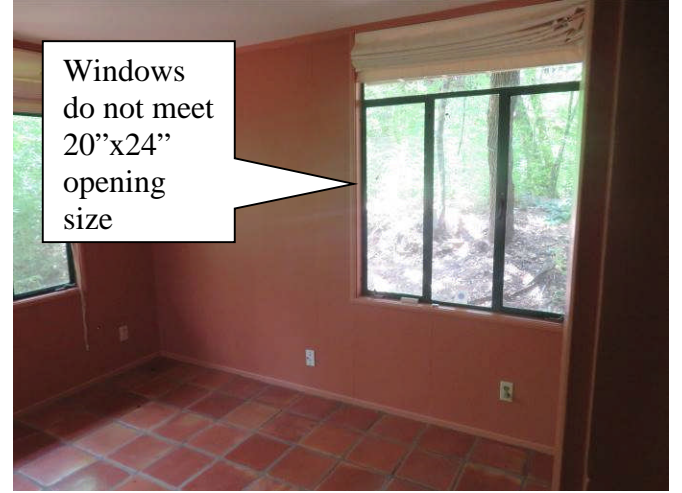
A number of the windows do not meet the minimum 20"x24" opening required for safety exit in case of an emergency.

<p>Windows do not meet 20"x24" opening size</p>

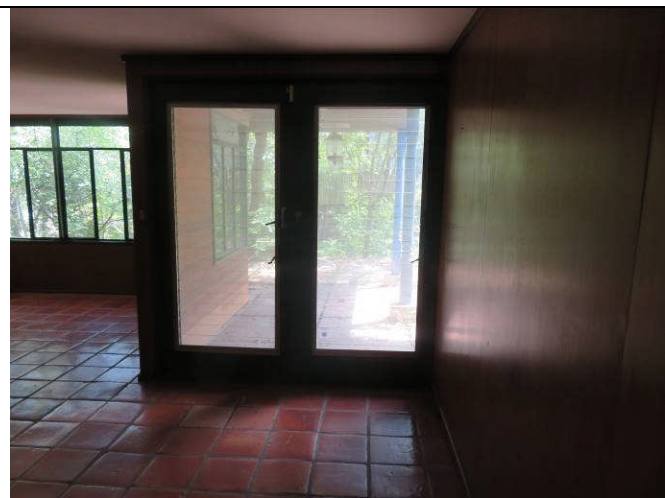
**Windows:** Windows are all single pane clear lites set in metal frames without thermal breaks (photo 59-60). There are jalouse windows and doors at the left side of the house (photo 61). None of the windows conform to current IECC requirements for a conditioned house space.

61. Jalouse window and door

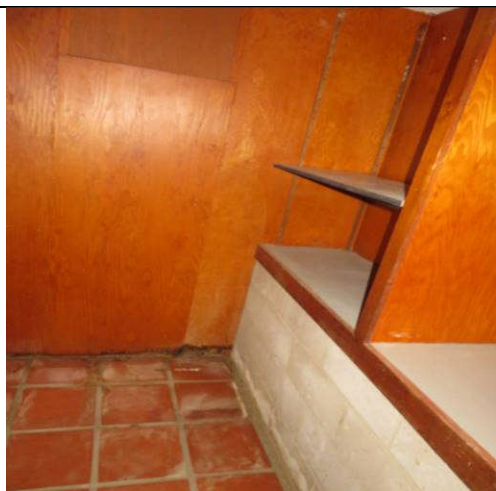
**Walls:** There is rot and a water leak in the room addition next to the chimney (photo 69). There is rot in the wall outside the chimney and there is likely mold present at this location. There is a roof leak at the room to the NW corner of the chimney (photo 69). There are water stains that indicates leaks at the utility/laundry room (photo 63-66) and the hall bathroom (photo 67-68).

63. Water stain in utility

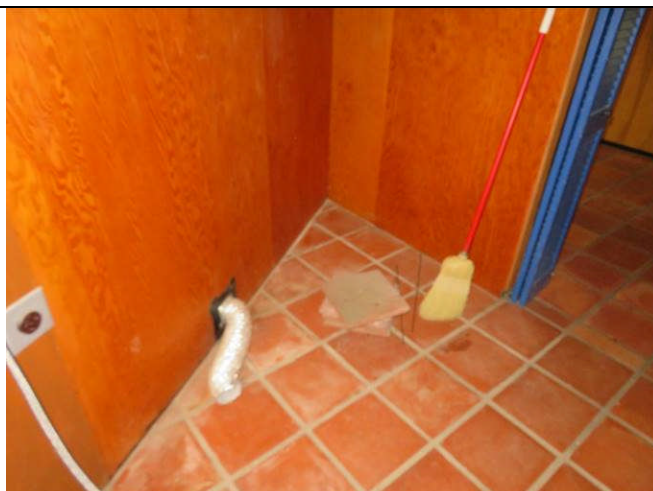
64. Water stain in utility

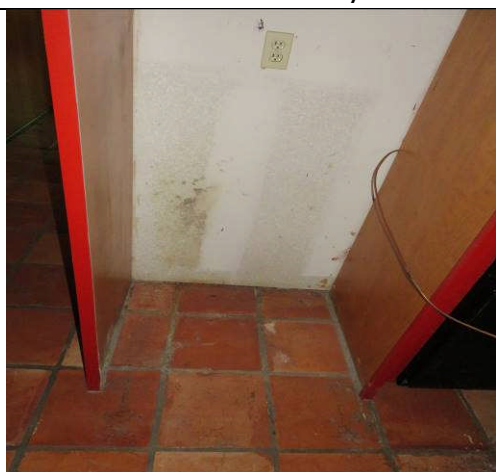
65. Water stain in utility

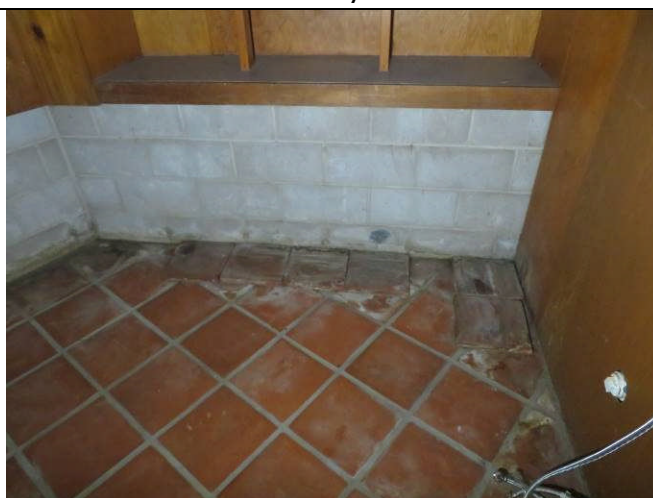
66. Water leaks at exterior wall - utility

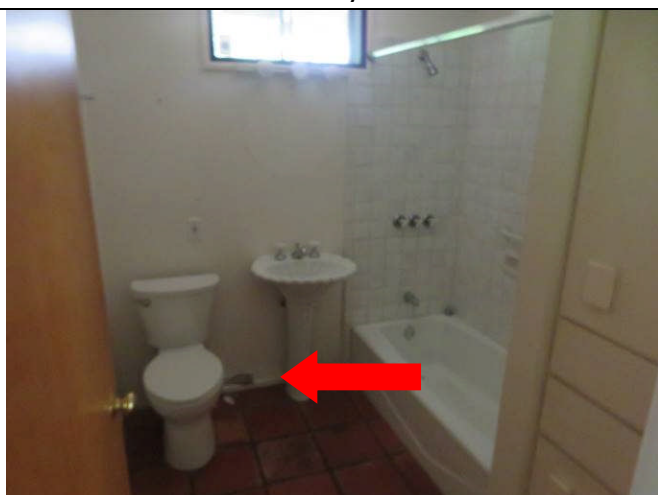
67. Water leak at bathroom ext'r wall

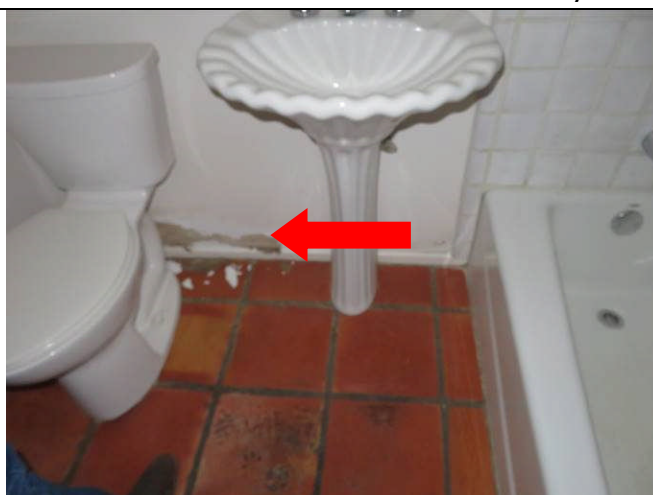
68. Water damage at bathroom ext'r wall
