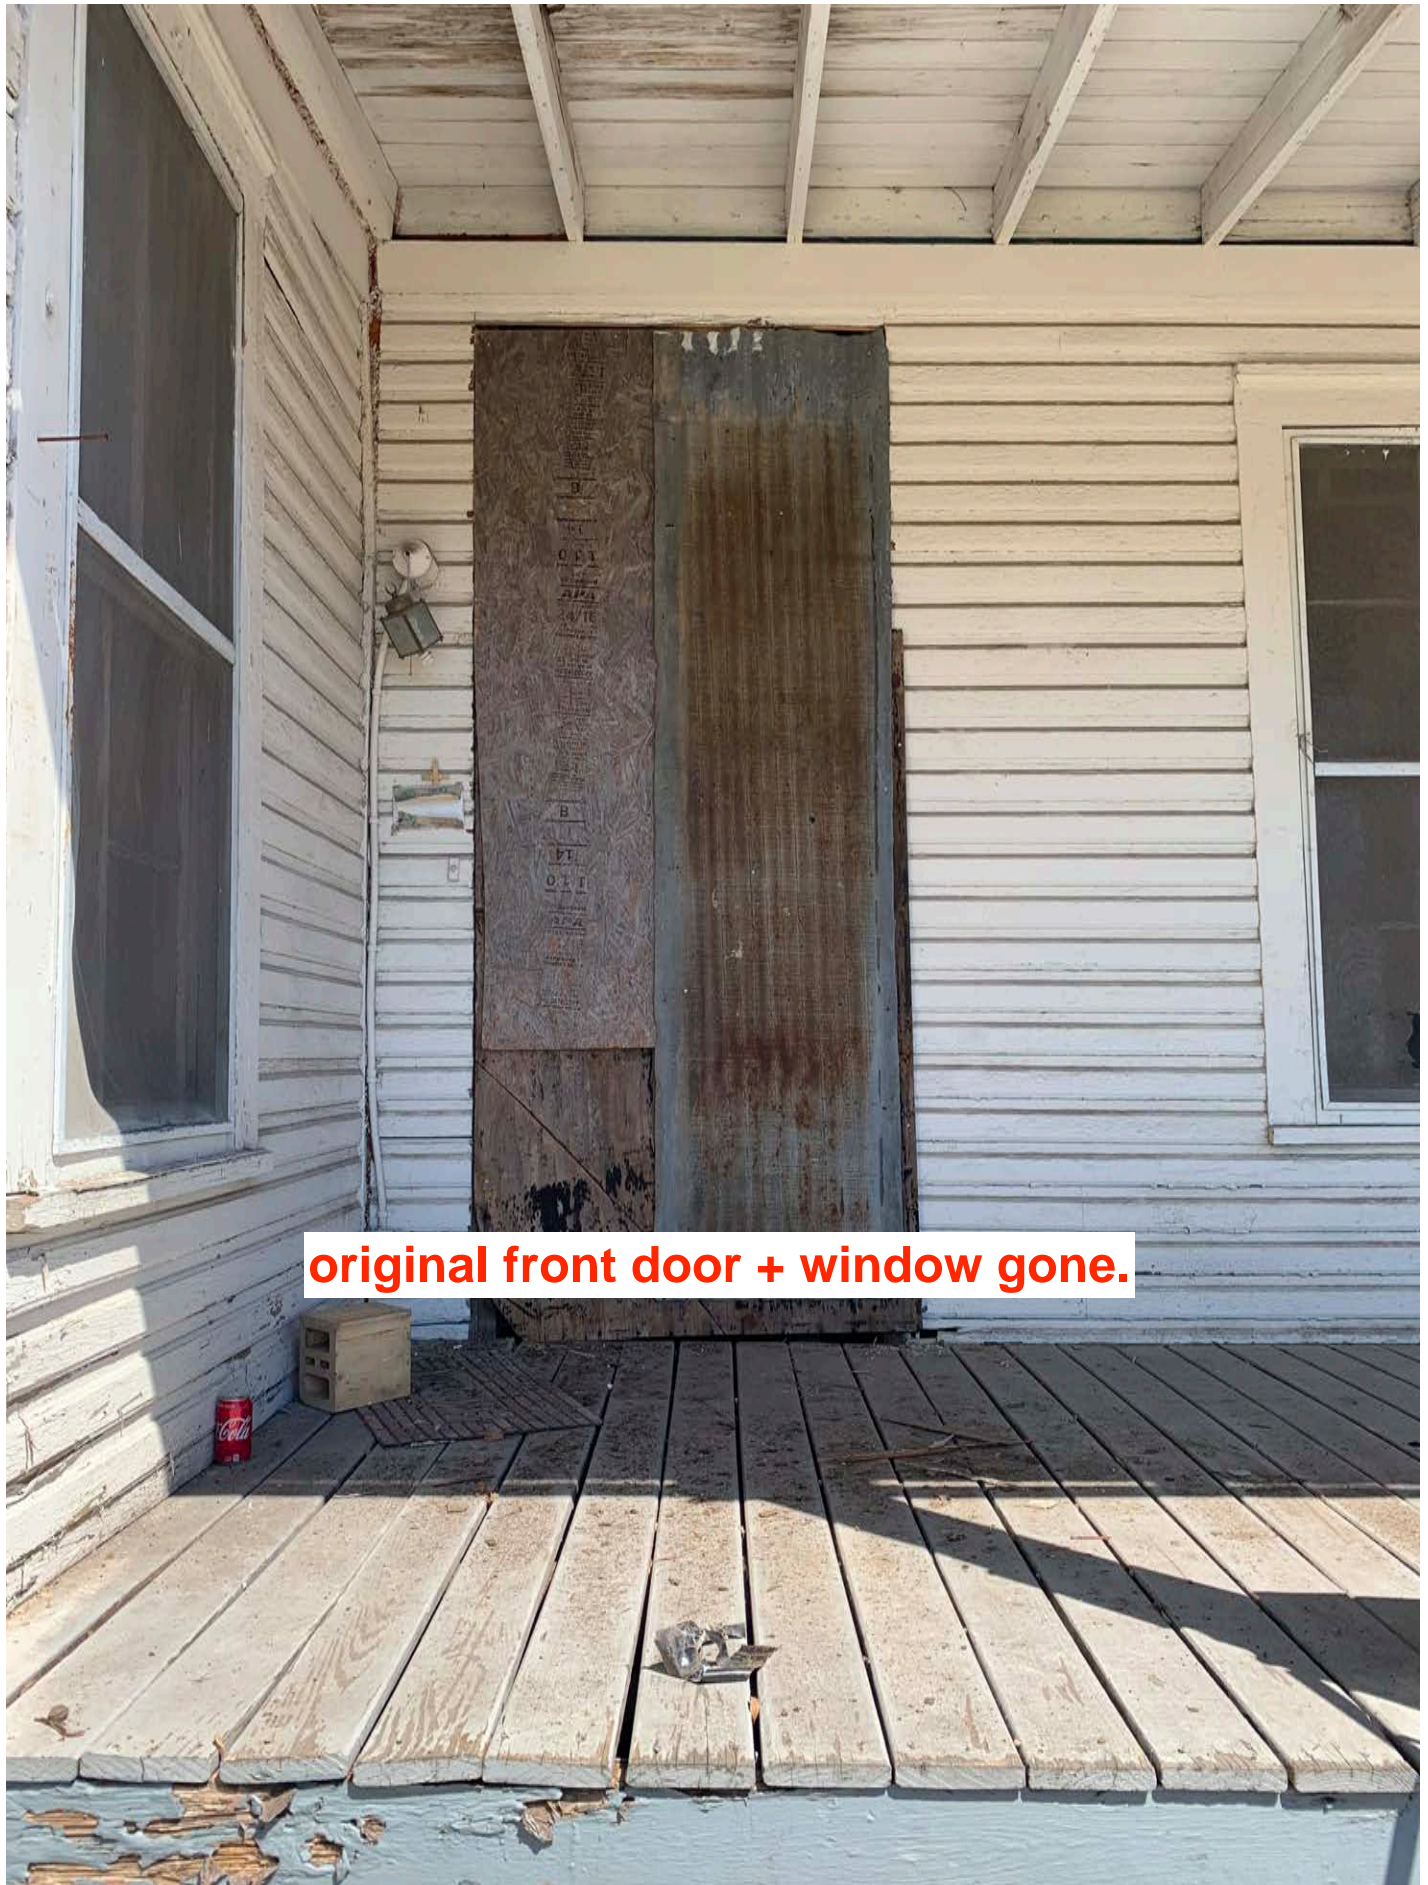
original front door + window gone.

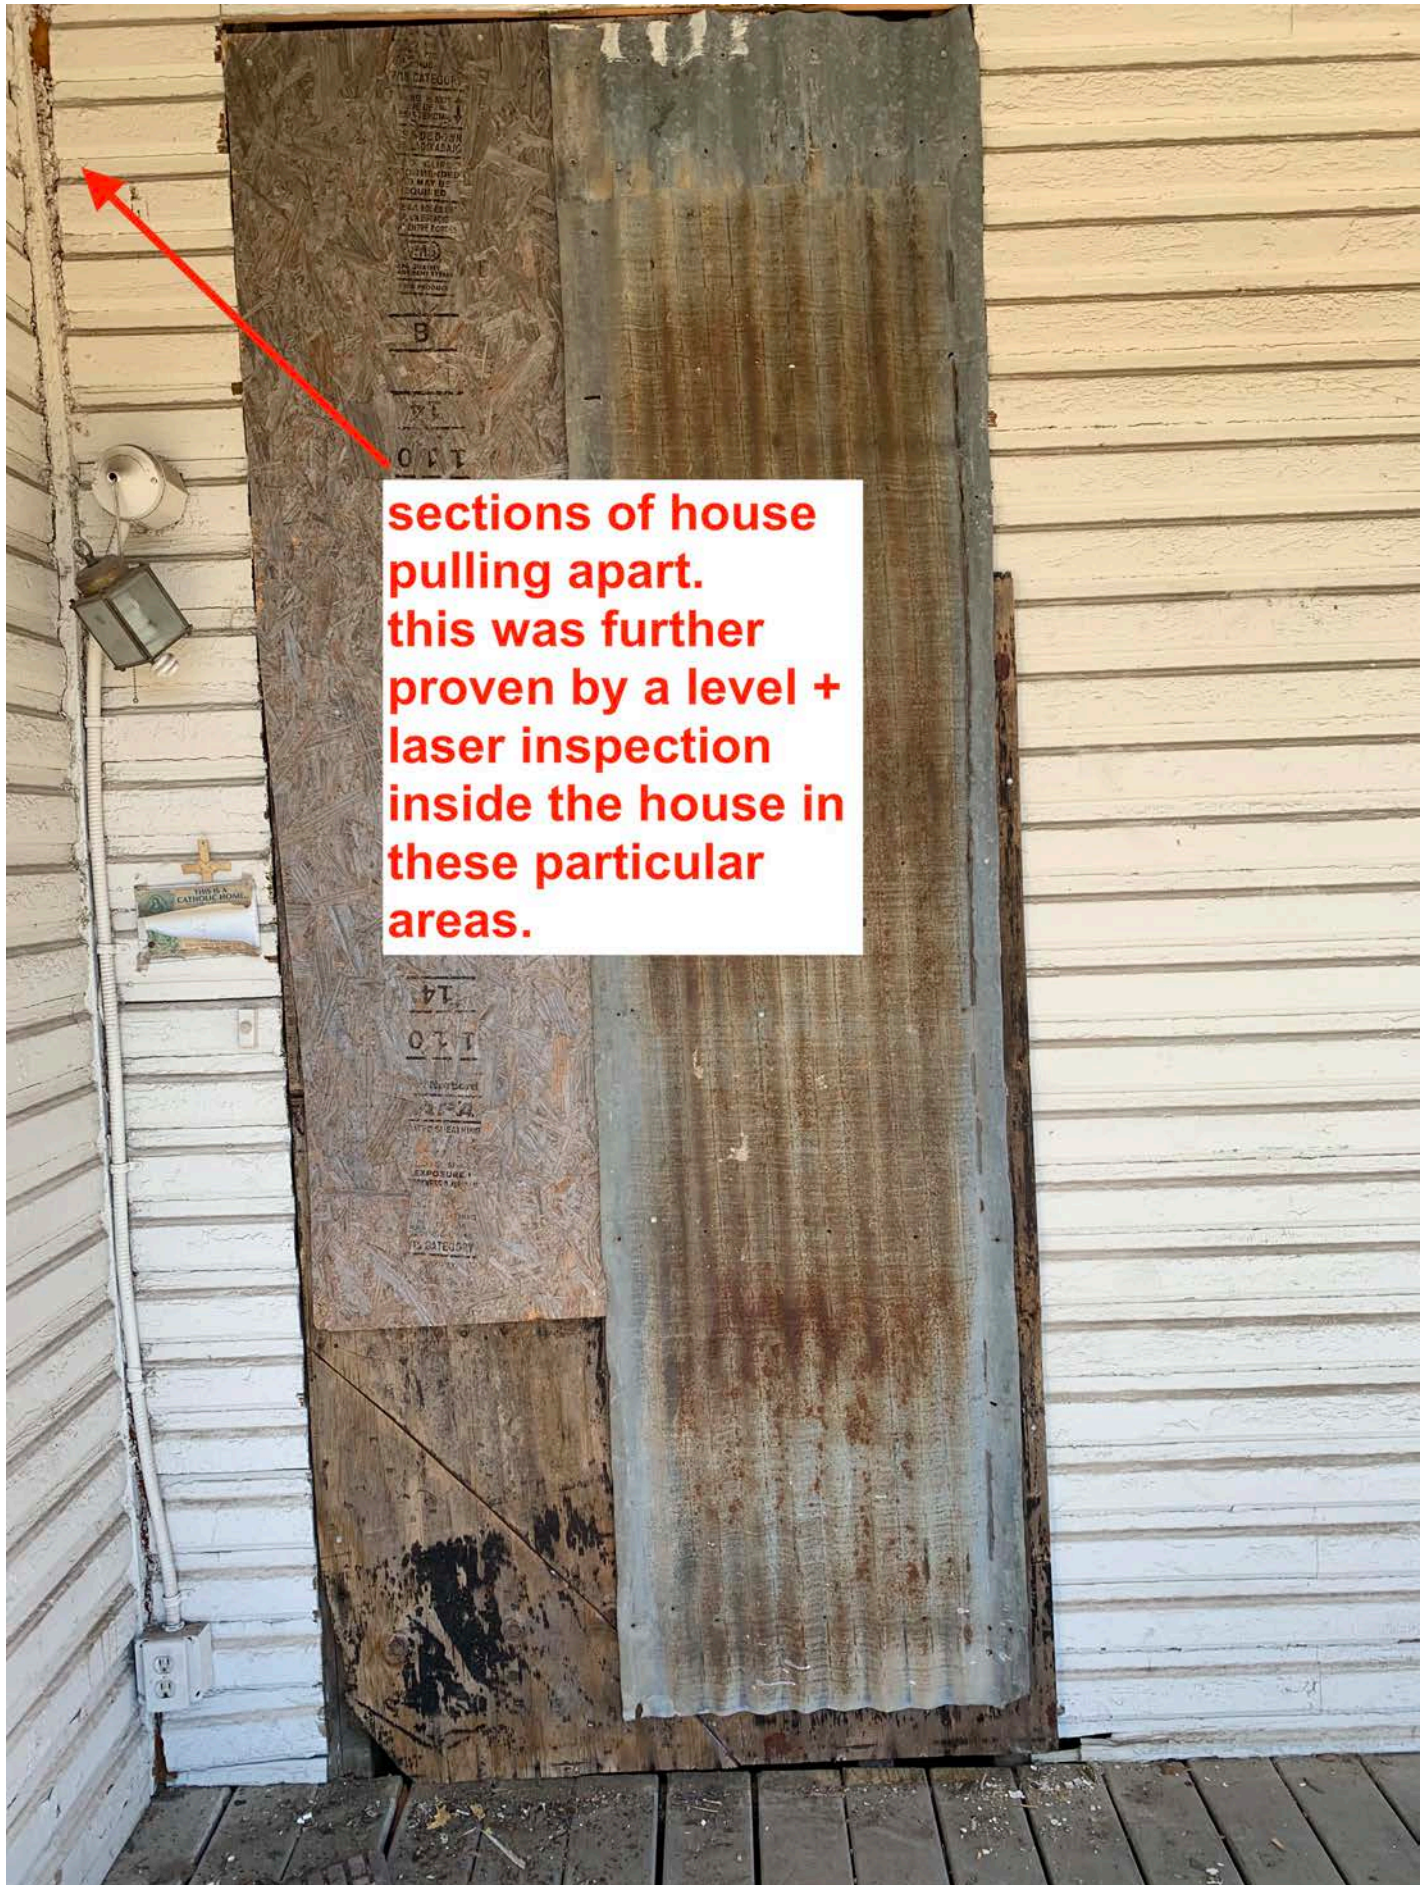
sections of house
pulling apart.
this was further
proven by a level +
laser inspection
inside the house in
these particular
areas.

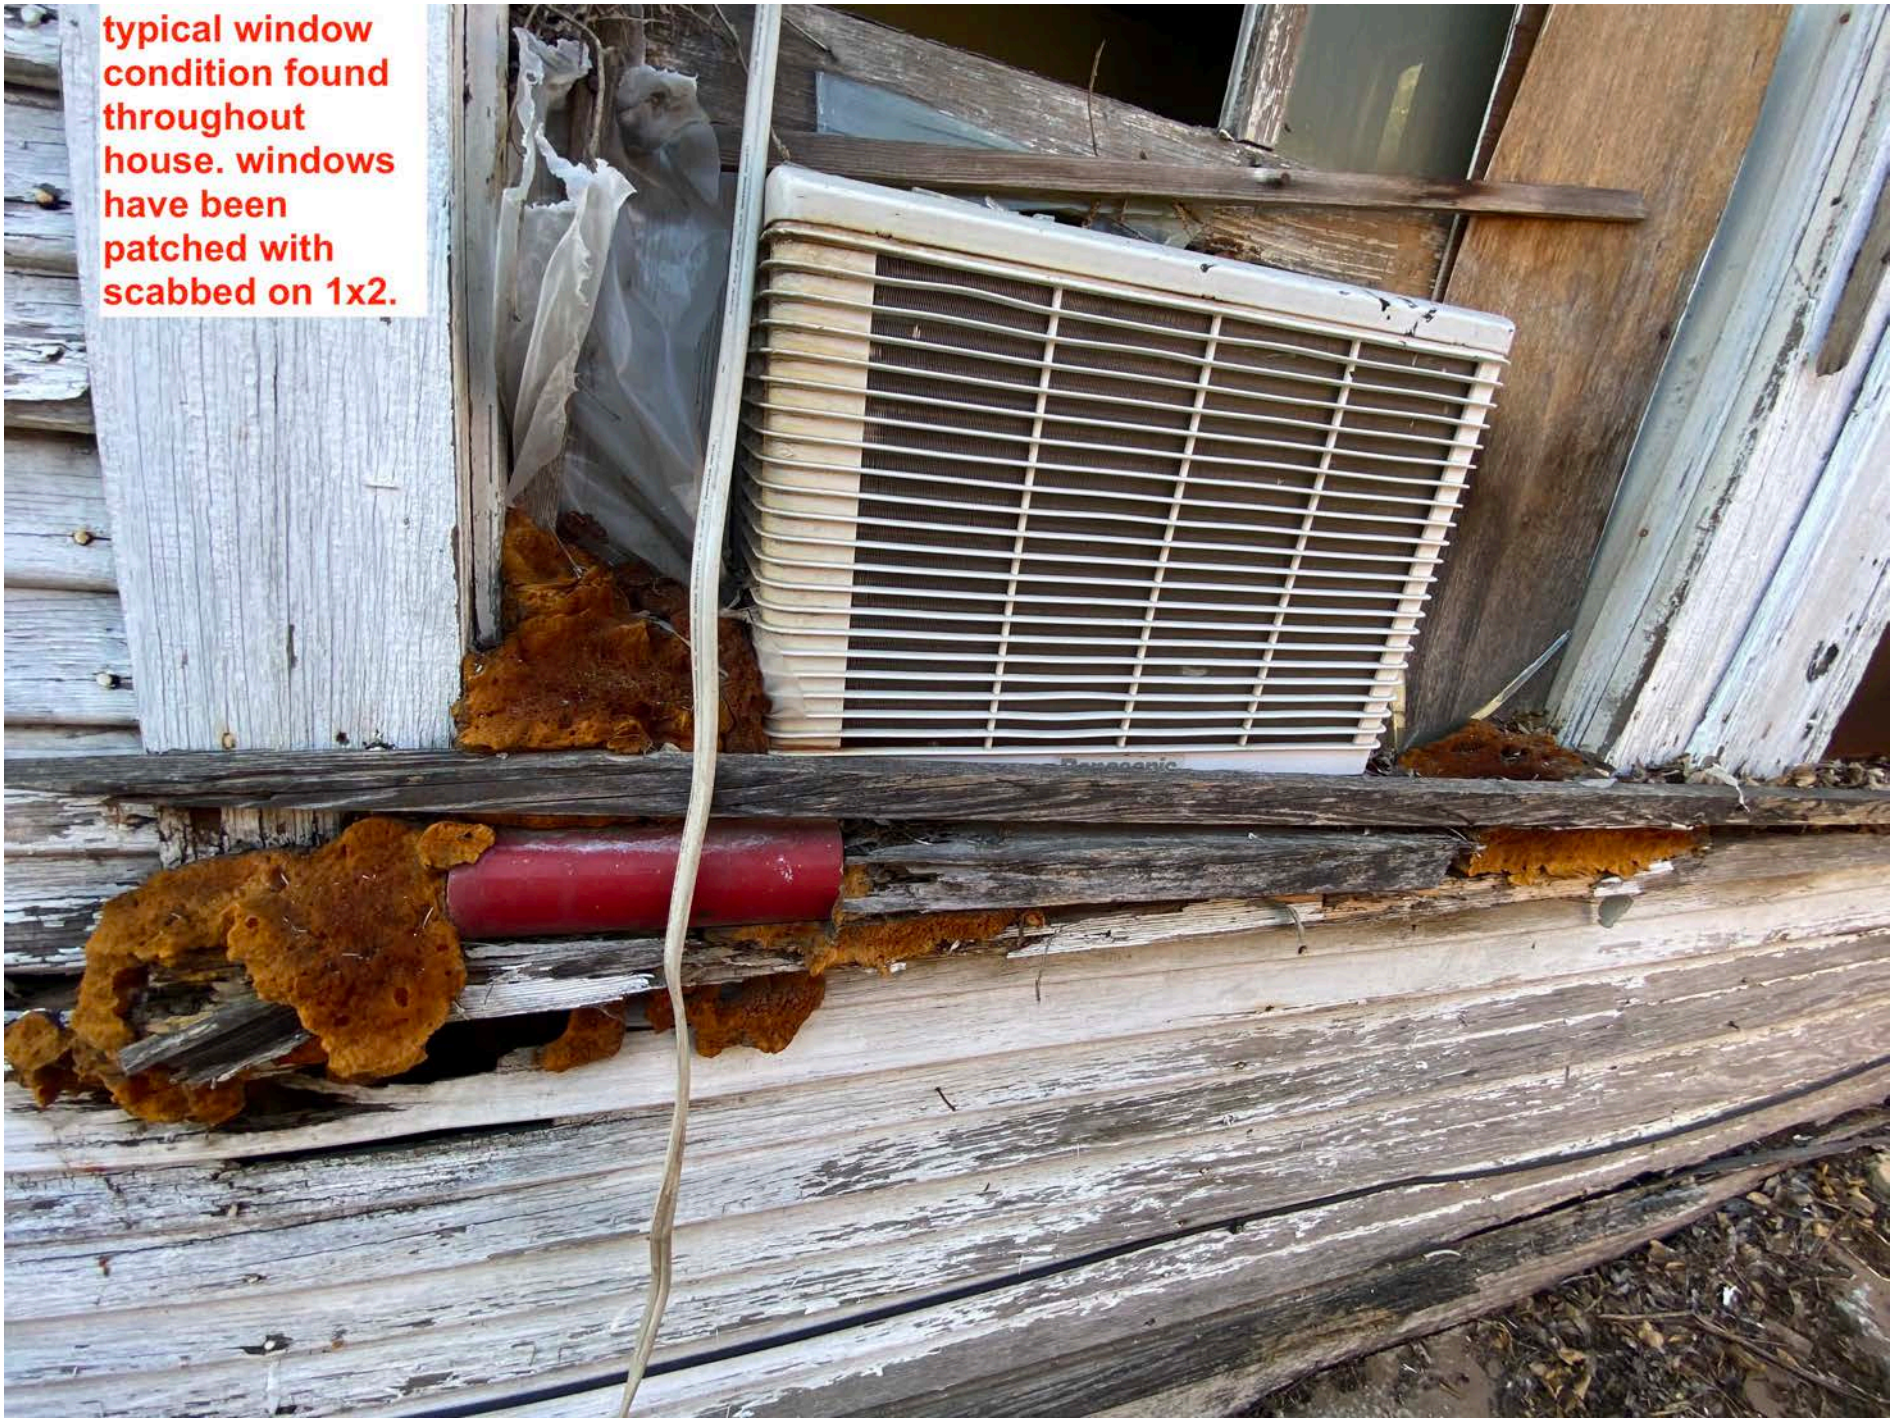
typical window
condition found
throughout
house. windows
have been
patched with
scabbed on 1x2.

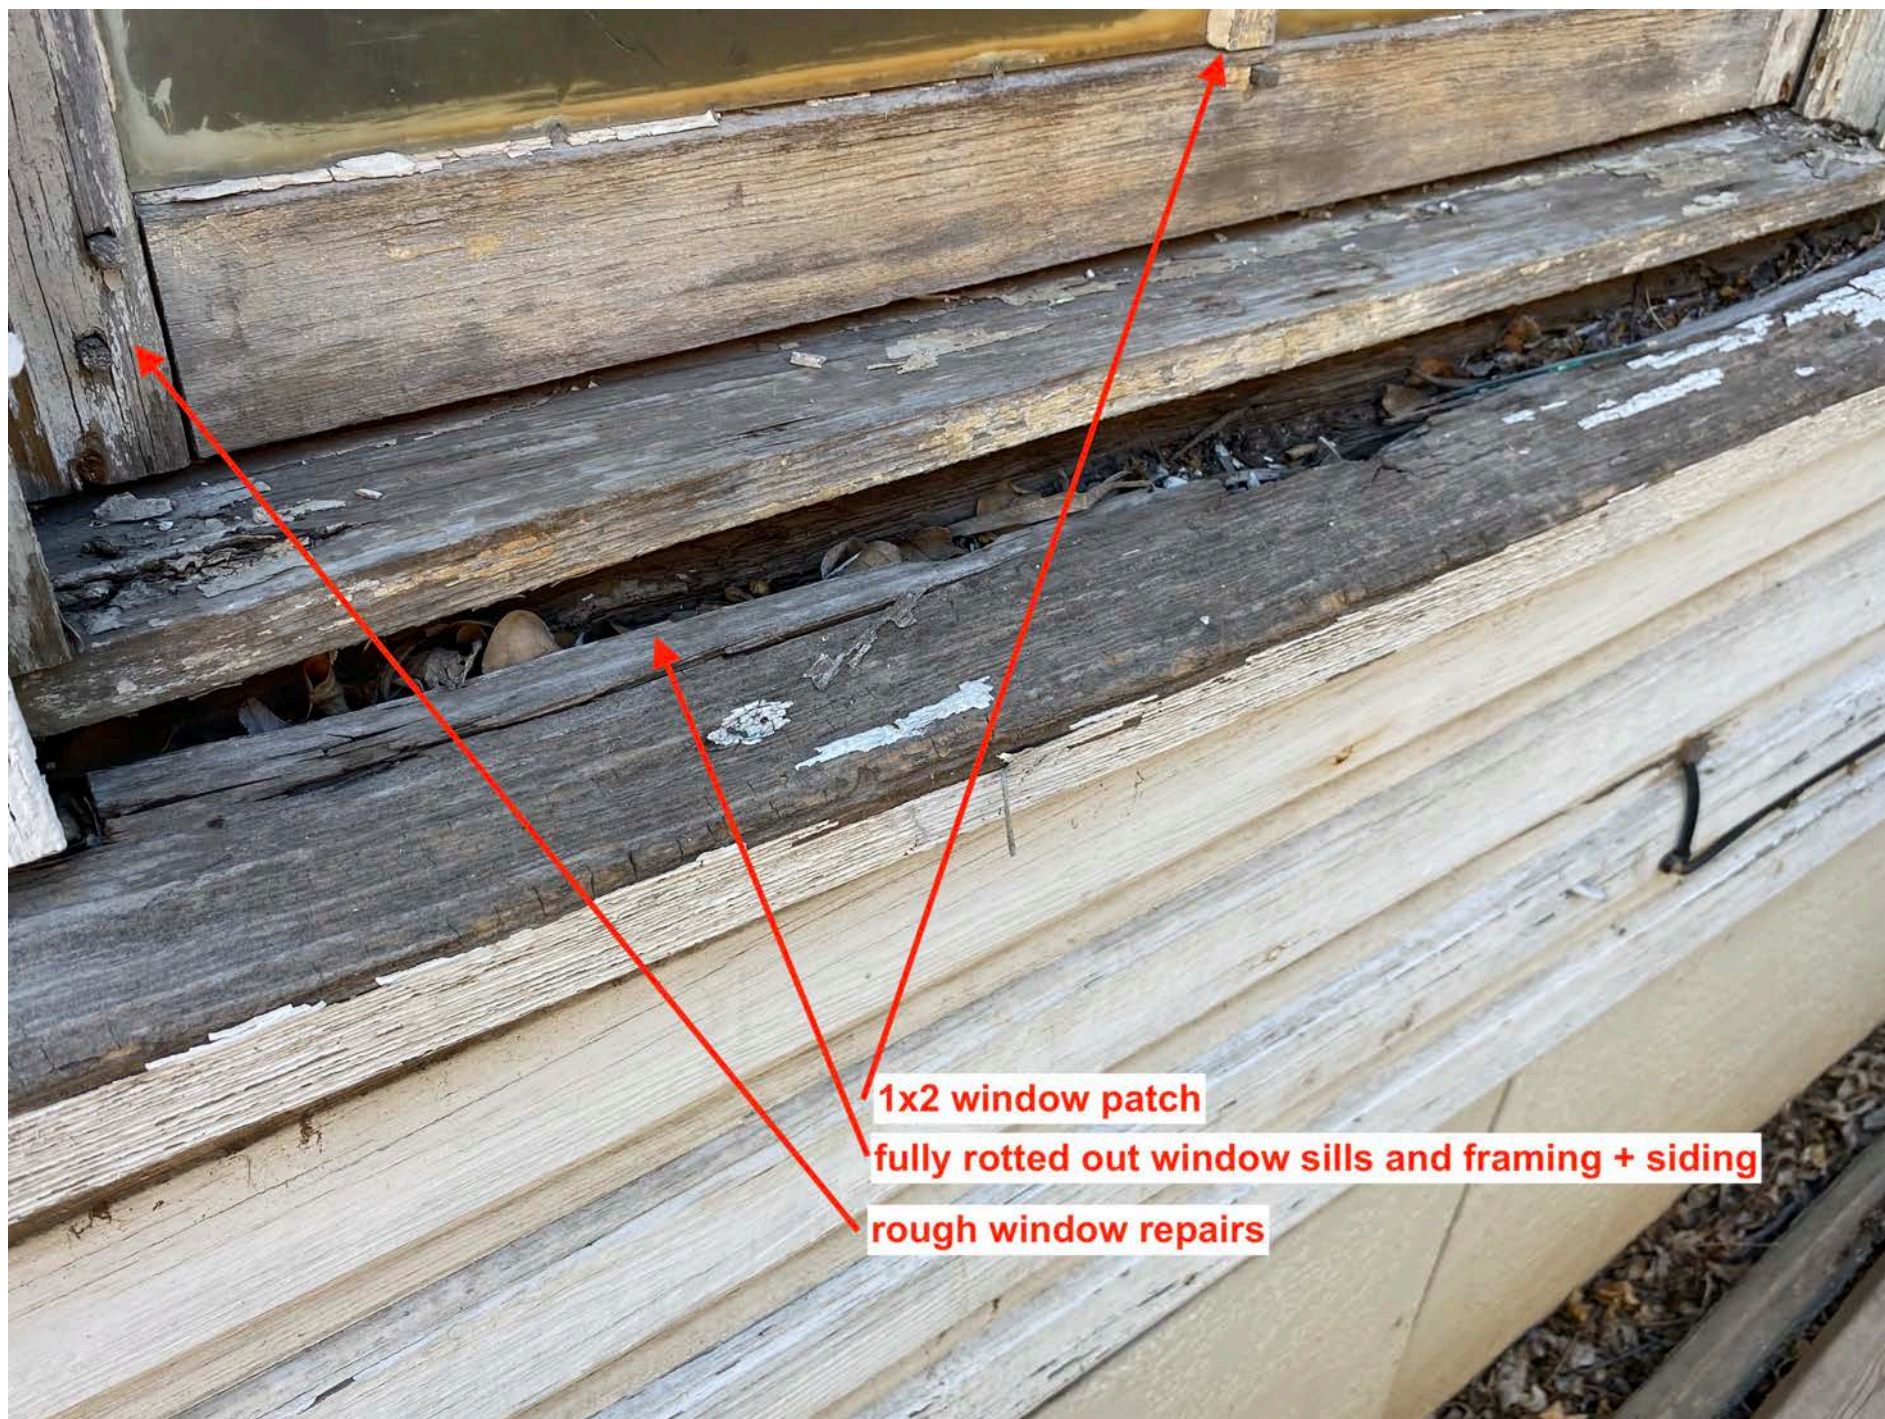
1x2 window patch

fully rotted out window sills and framing + siding

rough window repairs

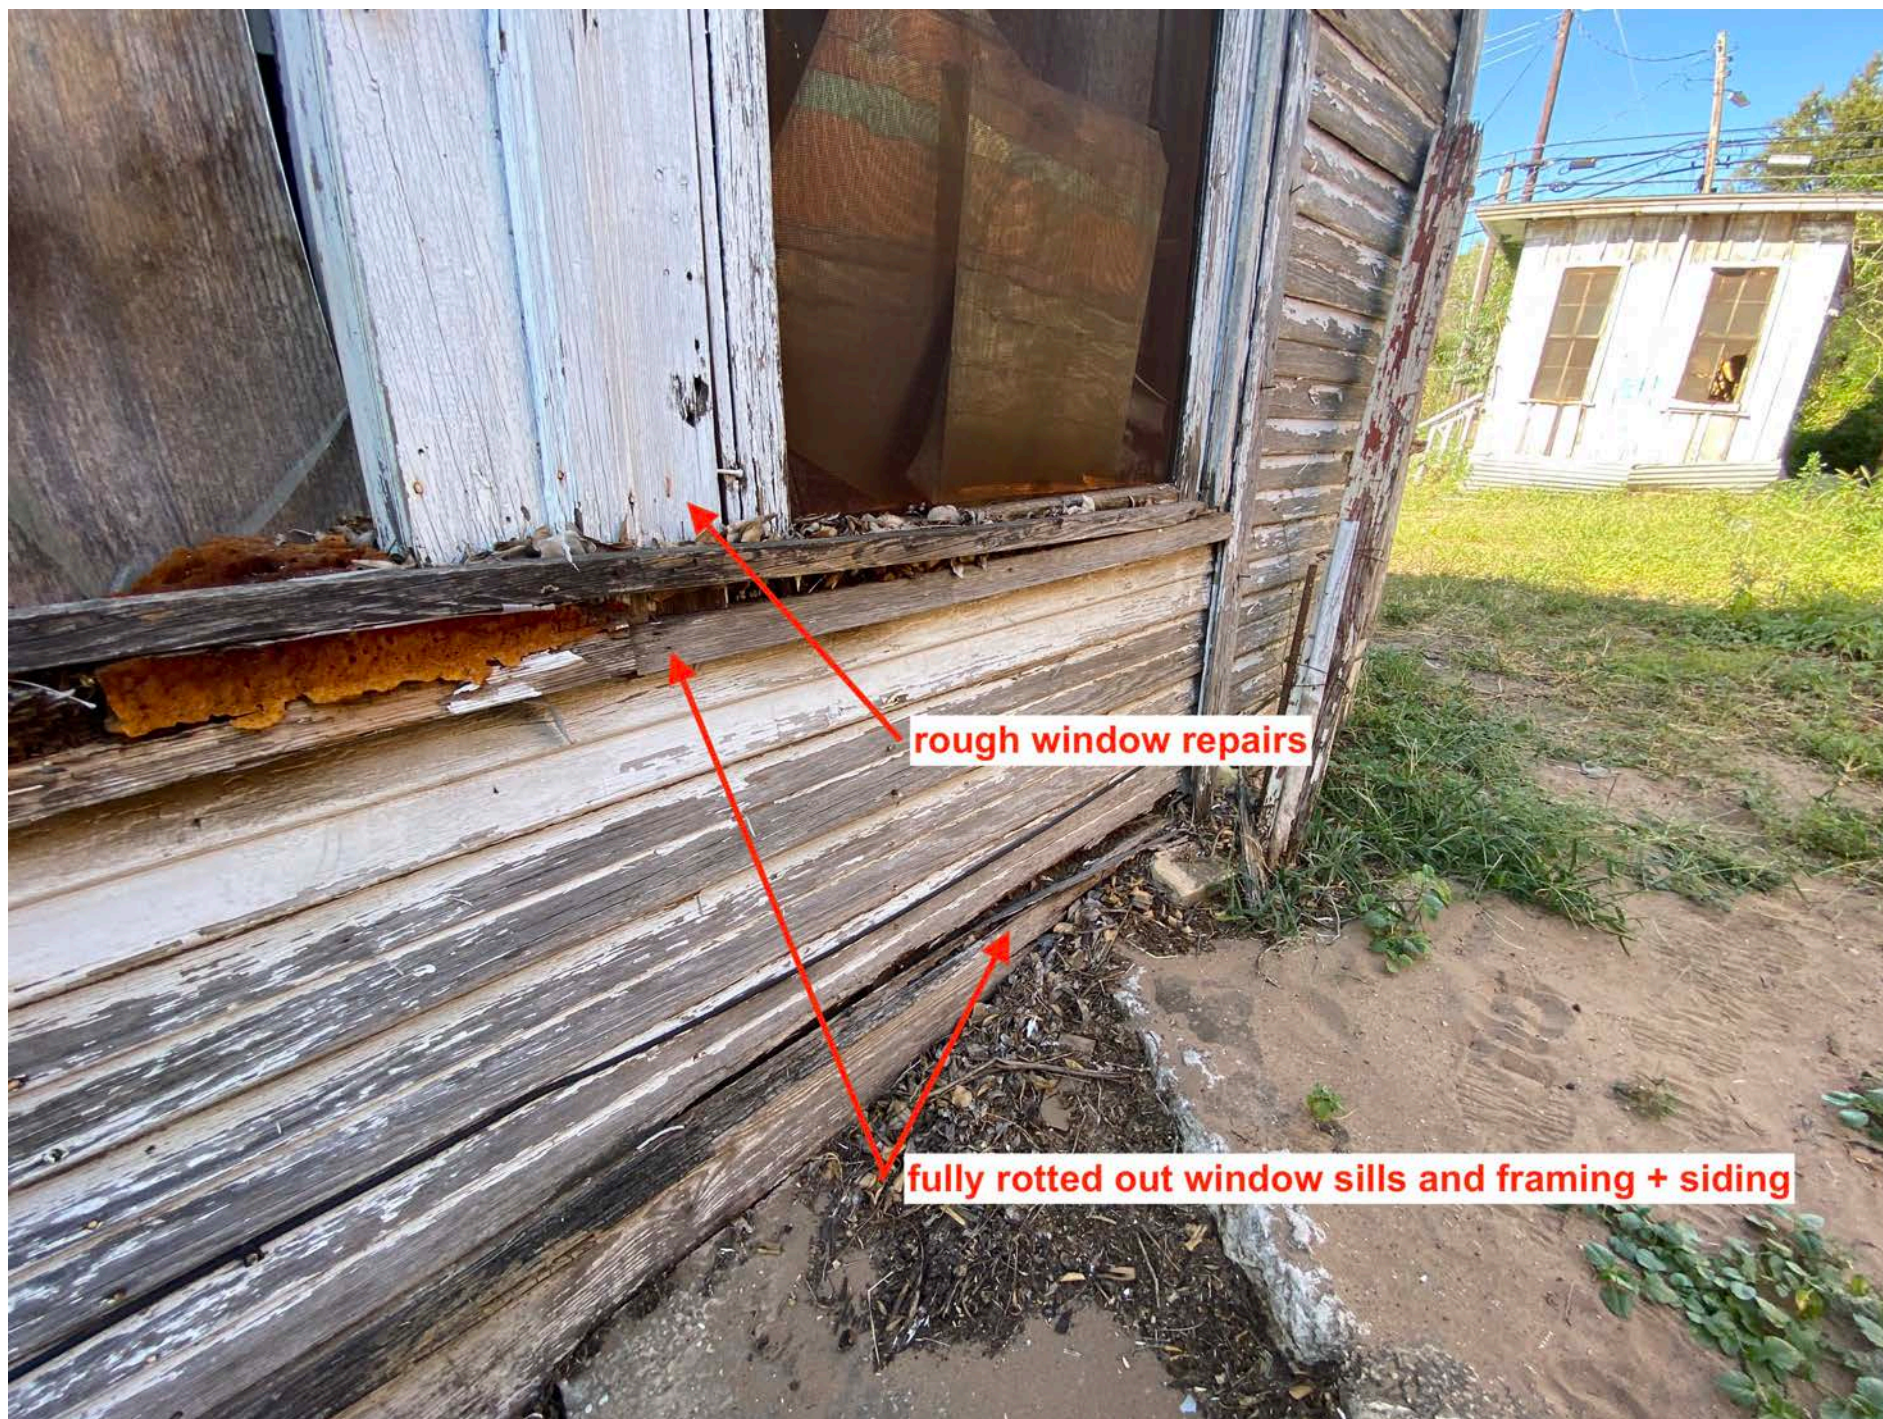
rough window repairs

fully rotted out window sills and framing + siding

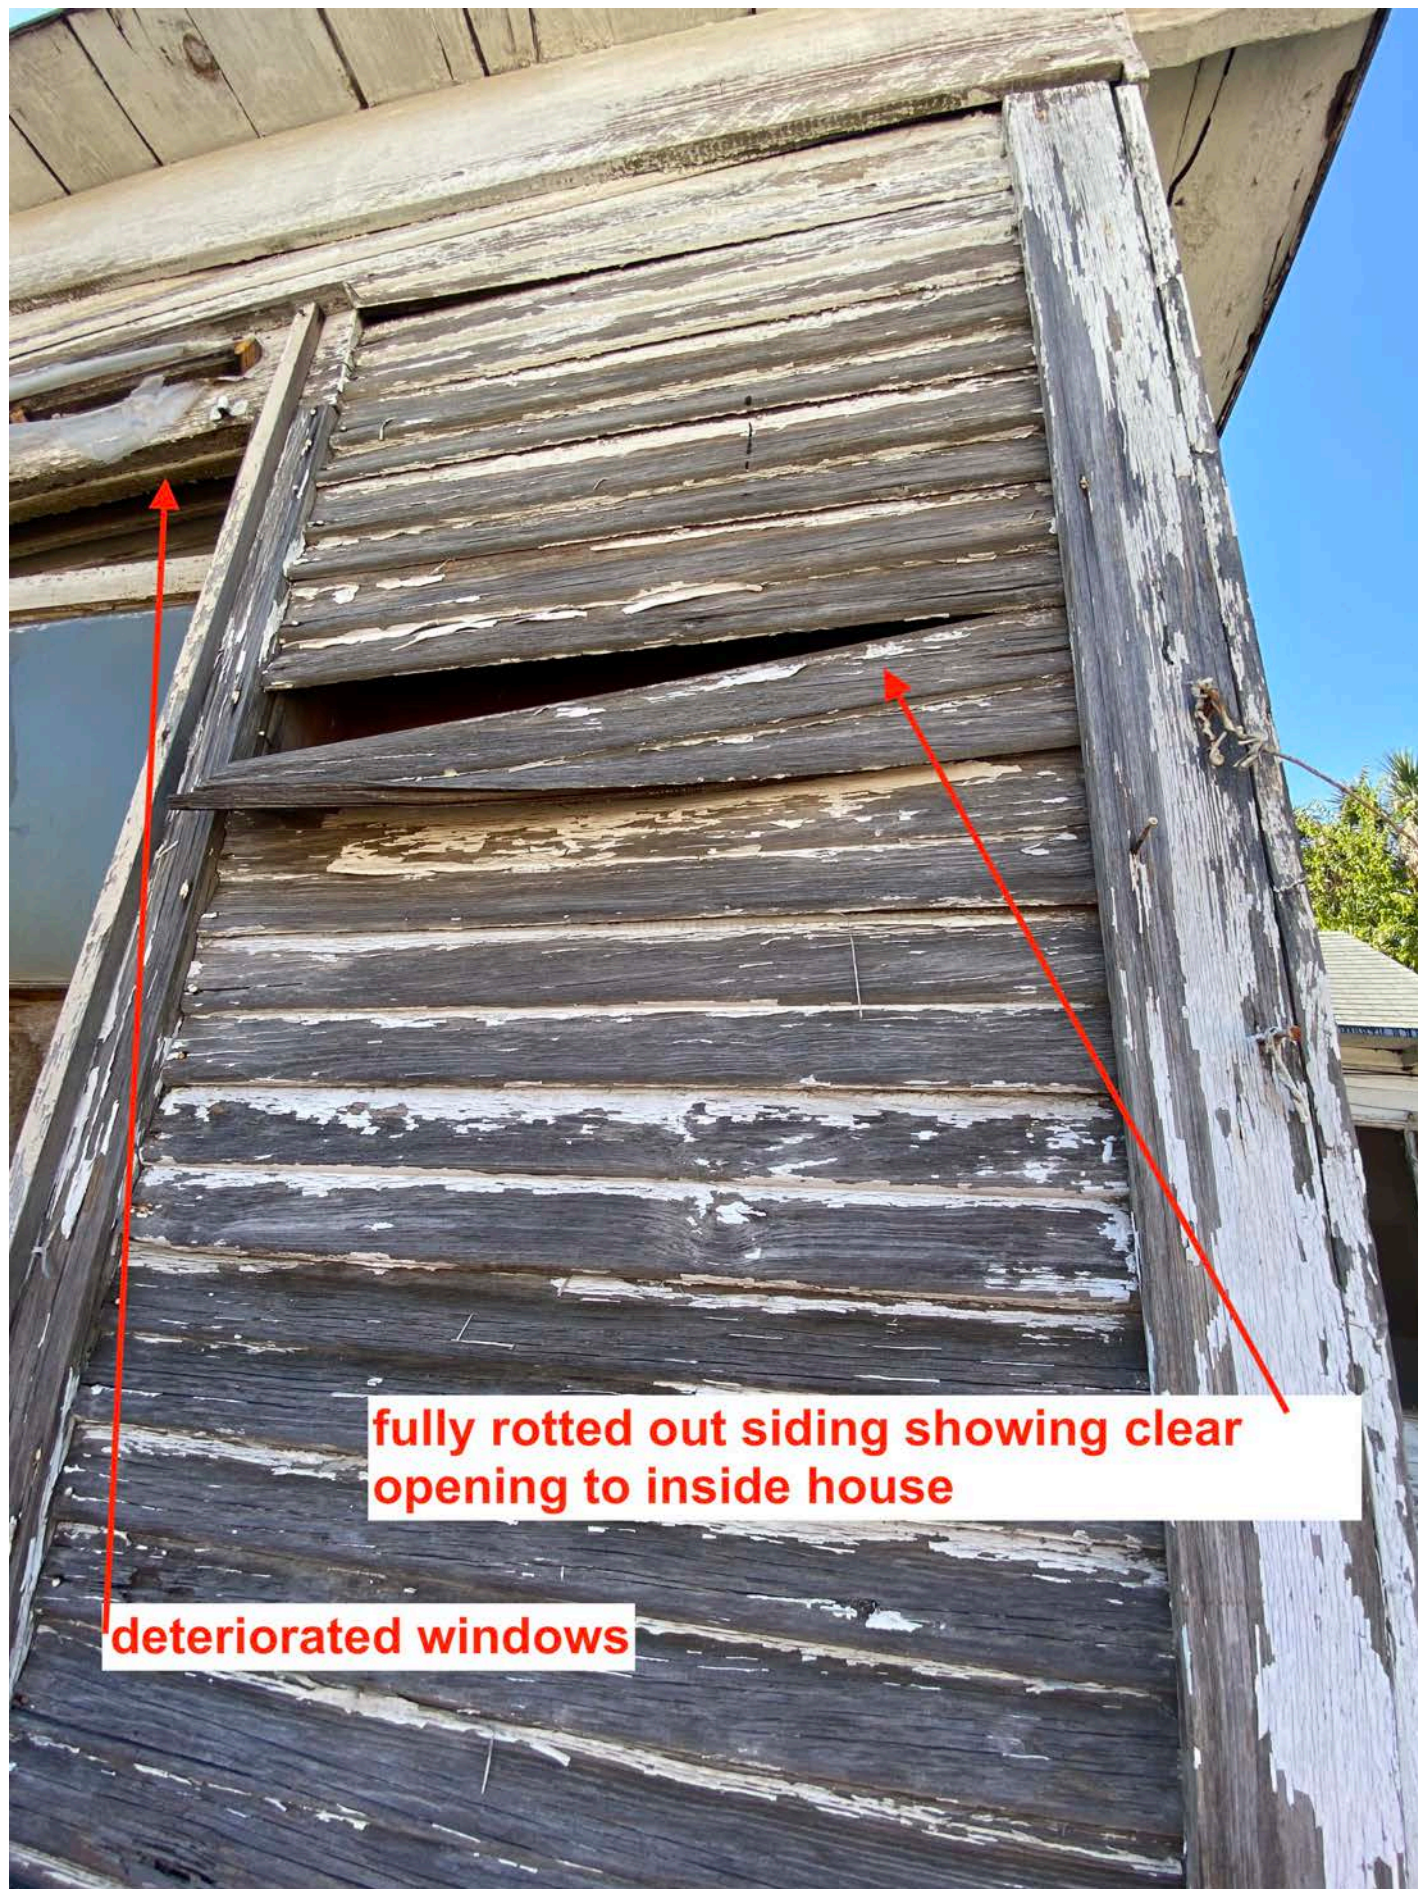
fully rotted out siding showing clear opening to inside house

deteriorated windows

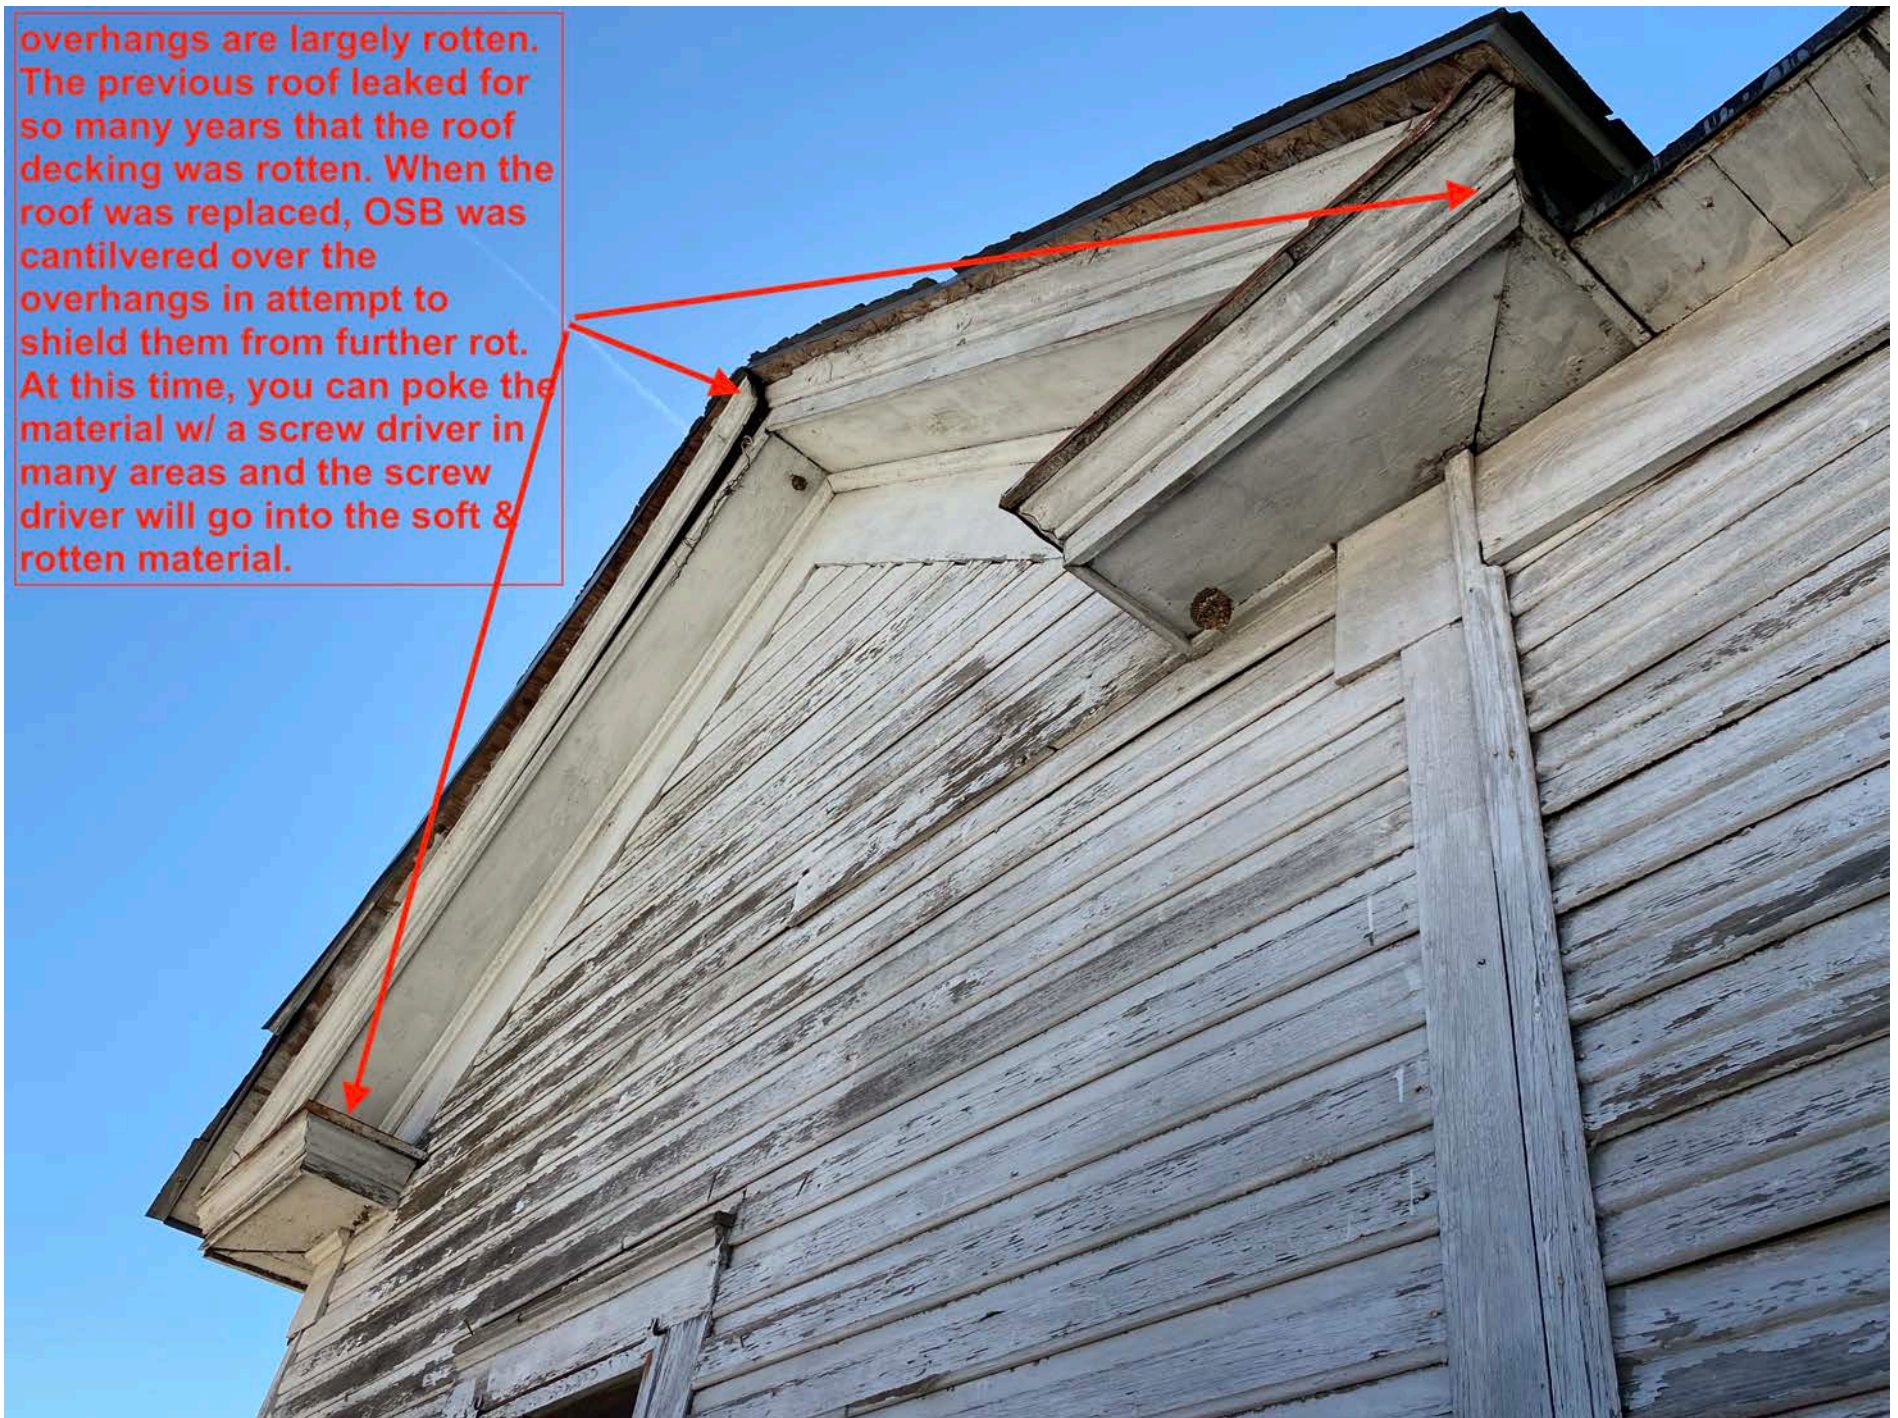
overhangs are largely rotten. The previous roof leaked for so many years that the roof decking was rotten. When the roof was replaced, OSB was cantilvered over the overhangs in attempt to shield them from further rot. At this time, you can poke the material w/ a screw driver in many areas and the screw driver will go into the soft & rotten material.

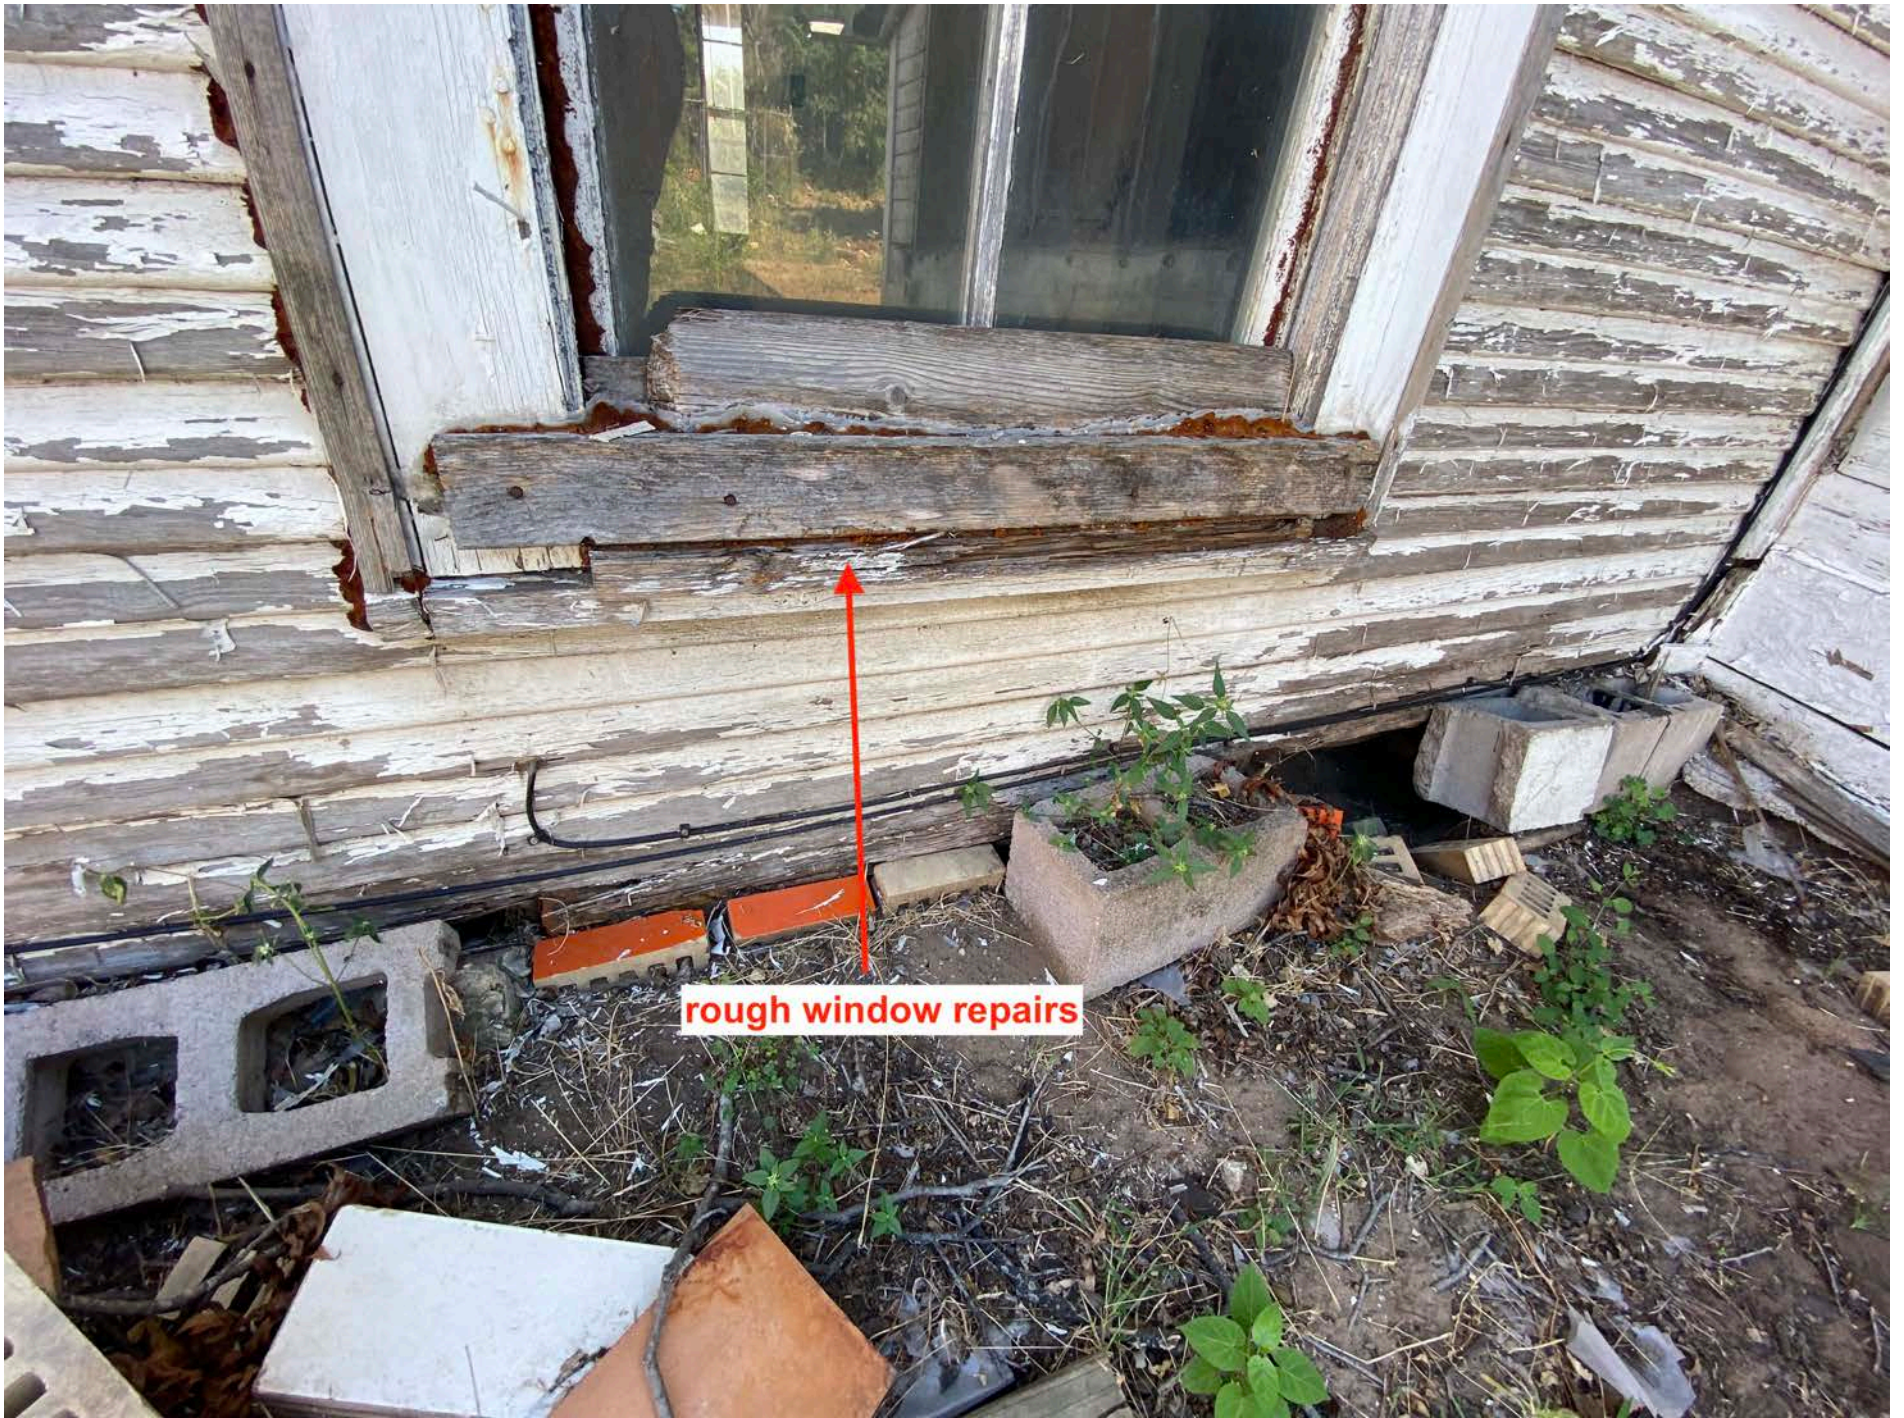
rough window repairs
