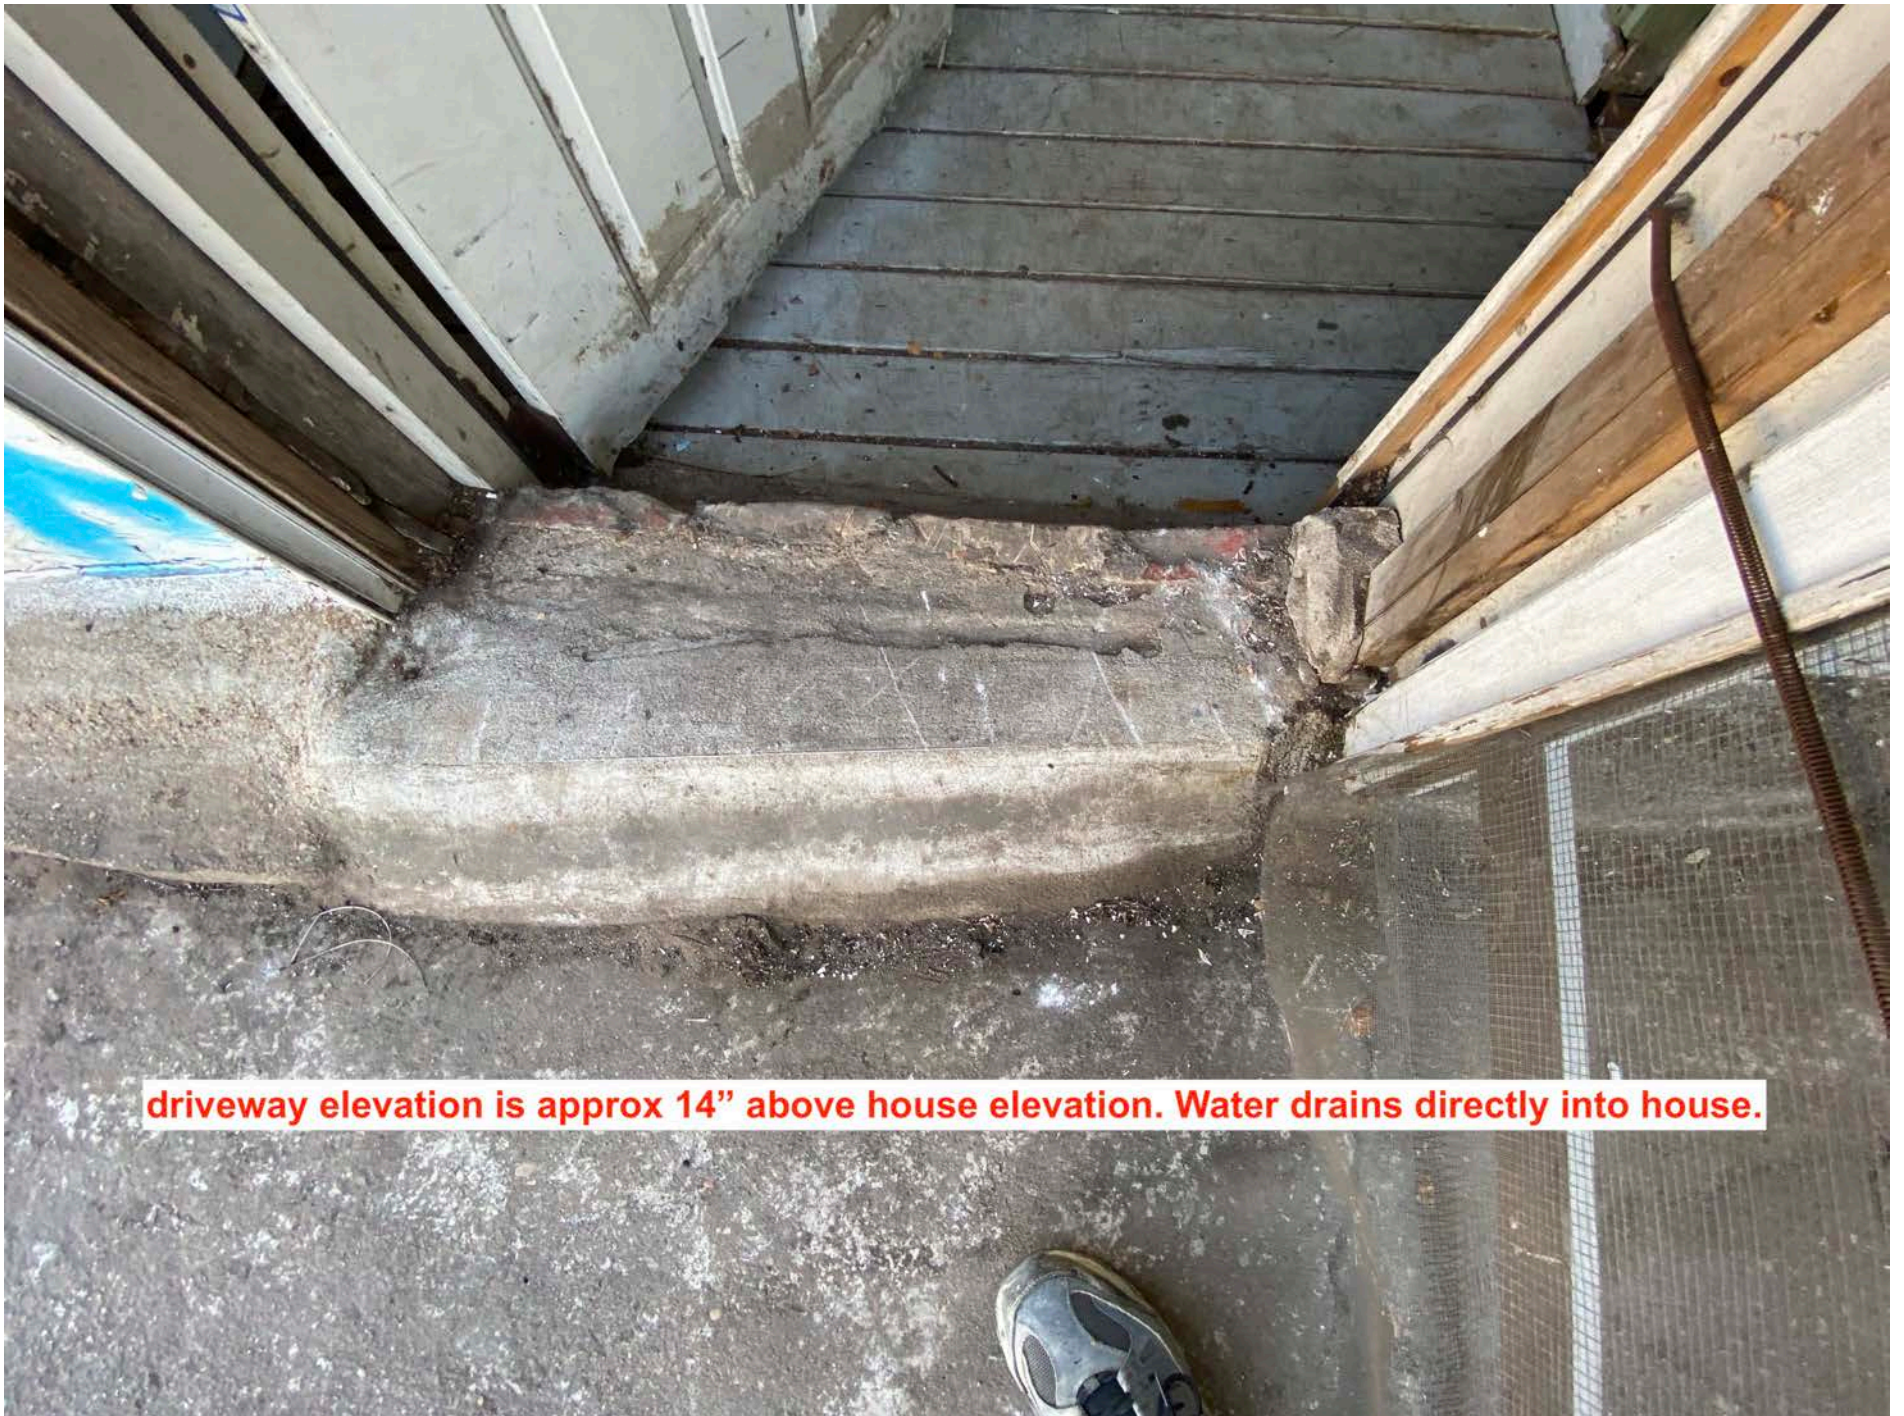
driveway elevation is approx 14" above house elevation. Water drains directly into house.
