Structural Evaluation Report

1204 East 6th Street.

Austin, Texas 78702

Report Issued: September 23th, 2021

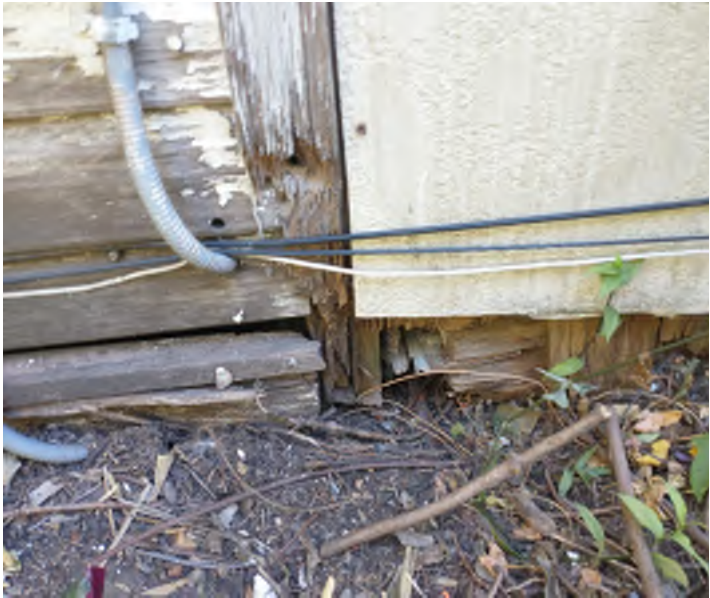
Rotted Wood in Contact with Ground

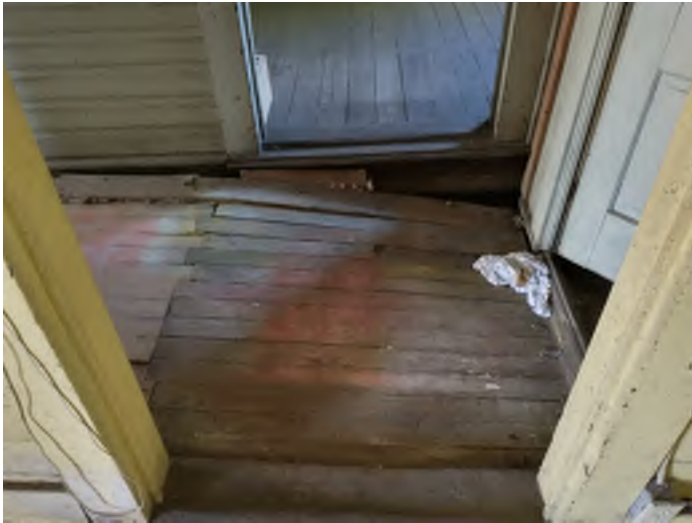
- **Extremely High levels of floor foundation movement** were recorded throughout the structure. Many of the floors are significantly sloping which indicates **foundation support system has failed, is not structurally stable**, and will likely continue to deteriorate

High Levels of Foundation Movement

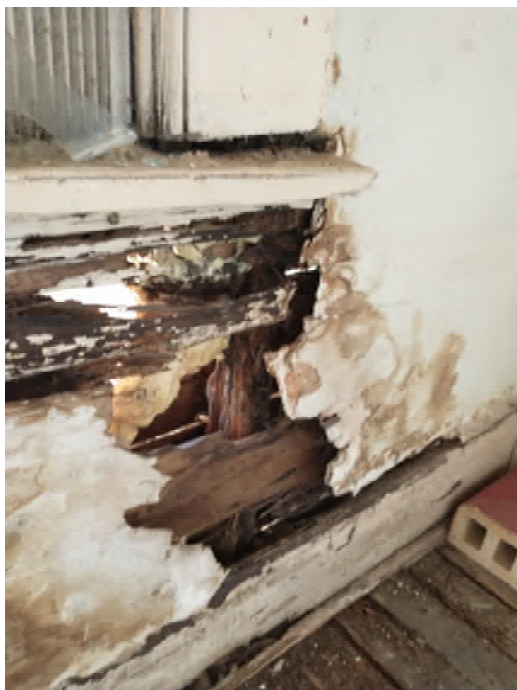
- There is **widespread evidence of water damage** at the building exterior walls. Evidence of water infiltration was observed at windowsills at the building exterior throughout the structure. There are numerous water damaged sheathing and structural studs that compromise the integrity of the structure. There are widespread areas of water staining, chipping/peeling paint. Though not directly observed, there is likely widespread framing rot and deterioration at the exterior walls and foundation framing at areas prone to water intrusion.

Water Damaged Studs and Sheathing

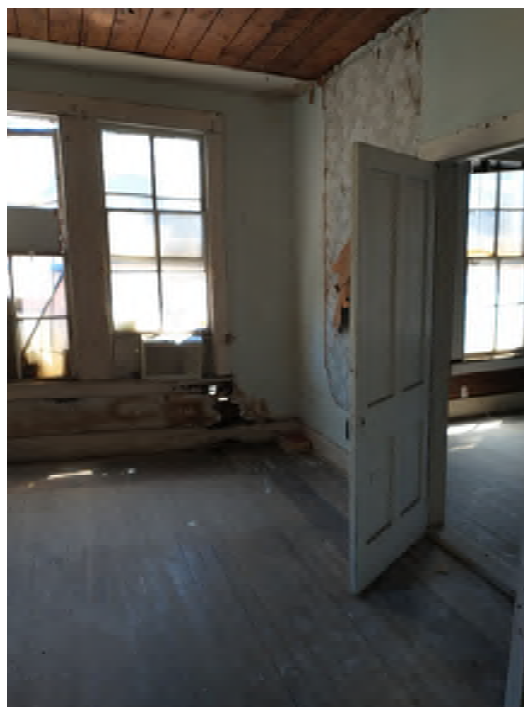
Water Damaged Studs and Sheathing

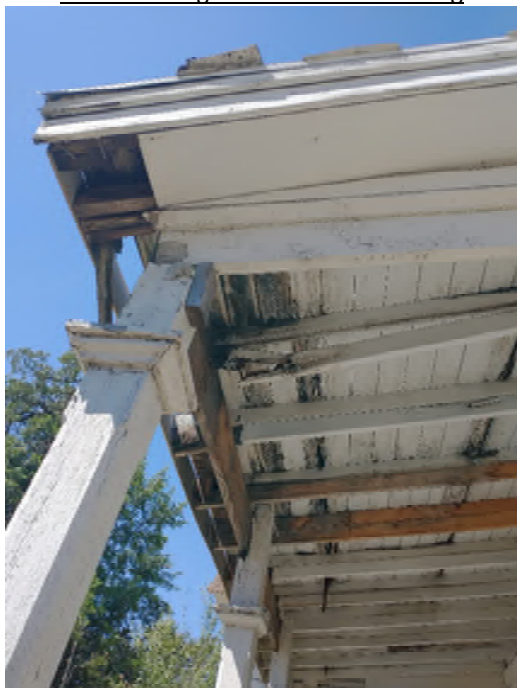
- Multiple portions of the roof are show signs of **rot and deterioration**
- The screen porch framing at the rear of the structure is **structurally inadequate**. The structure framing is extremely weathered and shows signs of deterioration and does not meet the requirements of the International Residential Code.

Rotted and Damaged Roof Framing

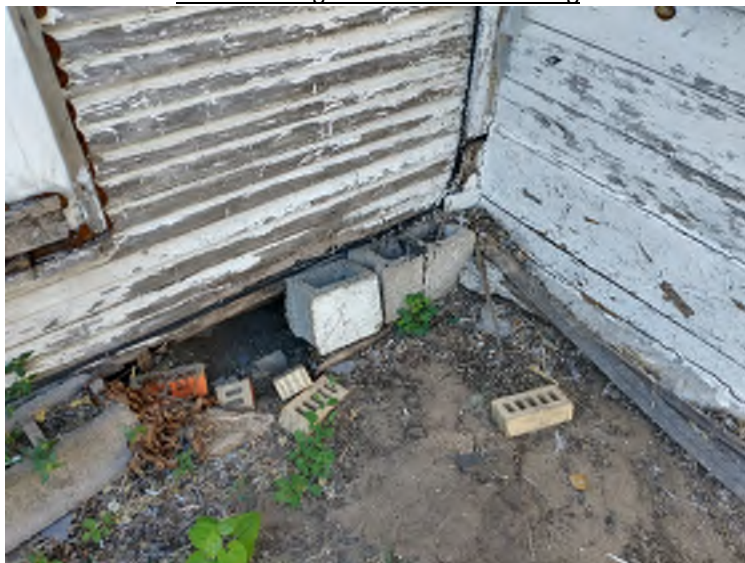
Peeling Paint, Damaged Wood, Ground Contact
