Proposed Demolition Permit 2501 Inwood Austin Texas

## McMath Residence 2501 Inwood Place Austin, Texas 78703

## Condition Observations

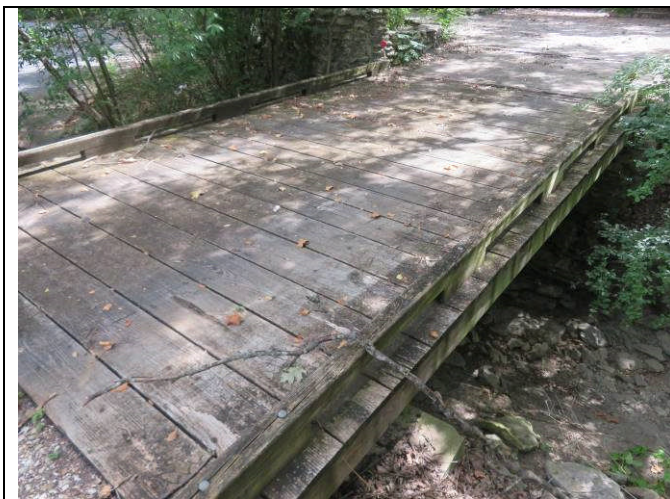
**Bridge:** The surface planking at the wooden driveway bridge entering this property is near the end of its useful lifetime and should be replaced. The stone masonry abutments supporting each end of the driveway bridge has missing mortar and erosion and should be repaired prior to imposing loads on the bridge.

1. Wooden drive bridge

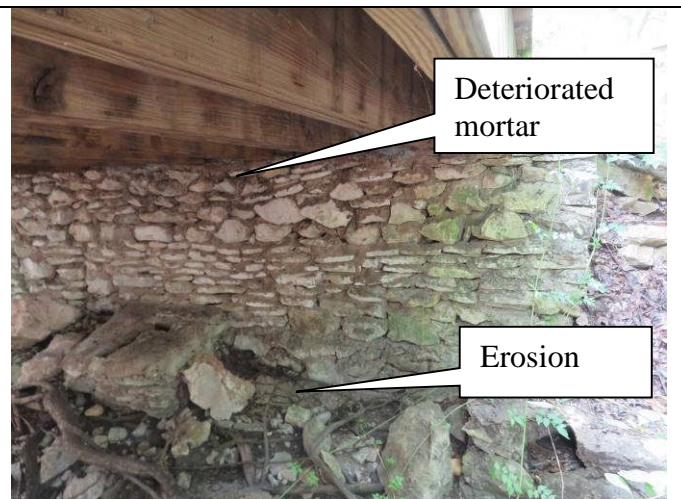
2. Bridge abutment with erosion

The bridge at the drive entrance requires substantial abutment and deck repair to be safe and serviceable for the intended use.

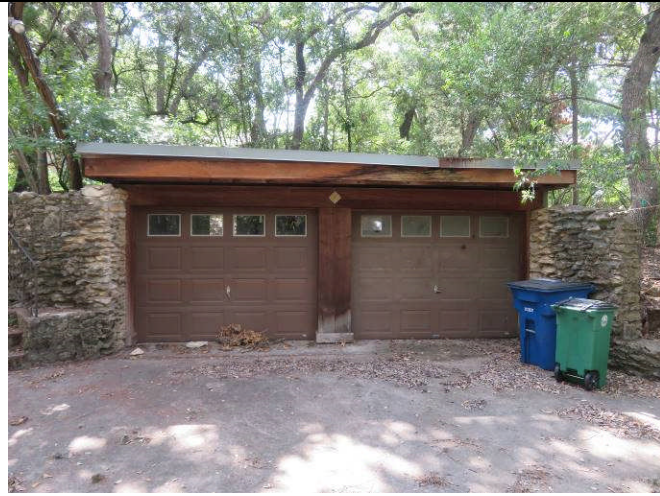
**Garage floor/grade separation:** Soil grade is above the finish floor on three sides of the garage (photo 7-8). Water stains on the walls and floor and rot at the base of all walls within the garage (photo 9) indicate long term water infiltration to the garage interior. There is rot at the garage overhead door as well (photo 3).

3. Rot at garage front

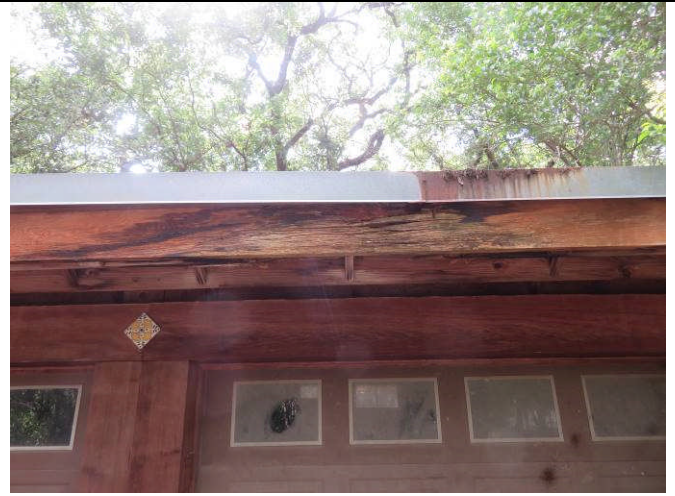
4. Rot at garage front

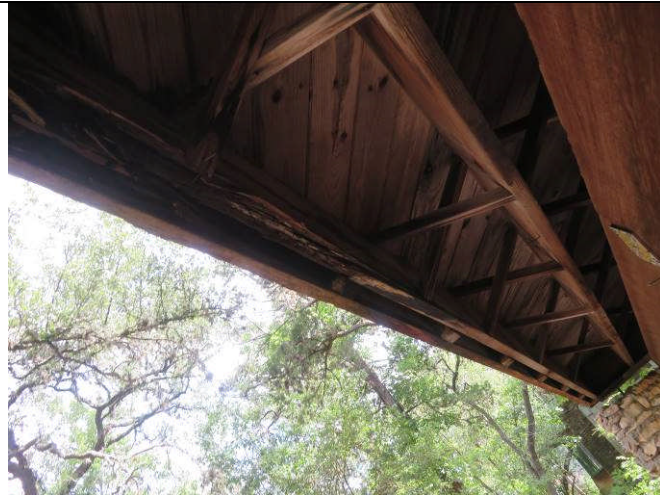
**Roof:** There is readily visible rot at the center of the garage roof overhang. There was active water ponding in the roof above this rot area. The overhead door is in need of repair as well. From casual observation, it appears that water is ponding at several locations on the garage roof.

5. Rot under garage roof overhang

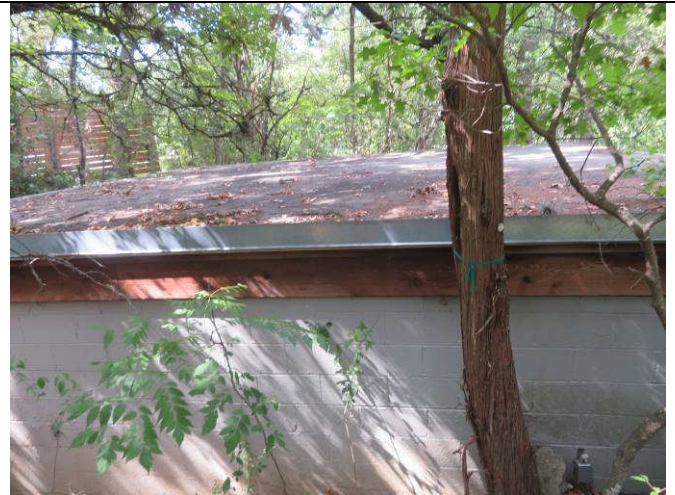
6. Garge roof ponds water

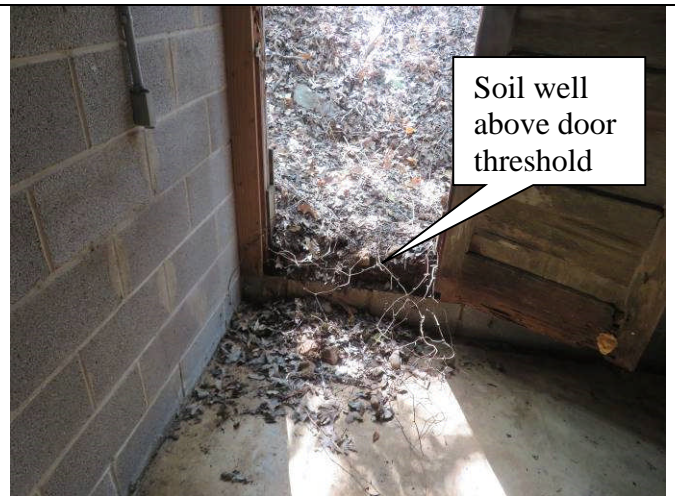
8. Soil above garage floor / water leaks

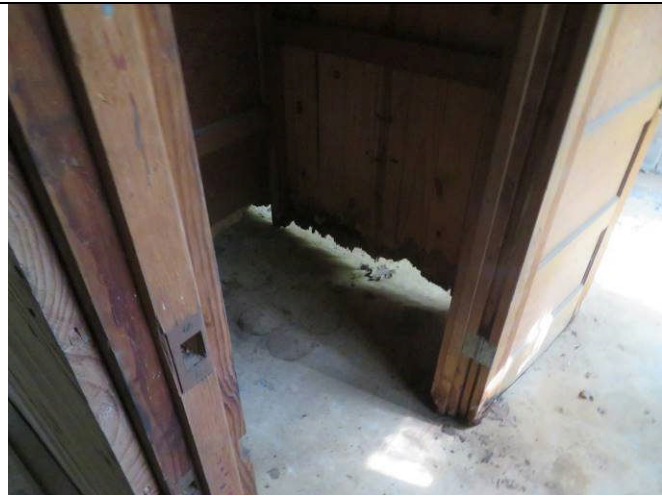
9. Rotted garage walls - typical

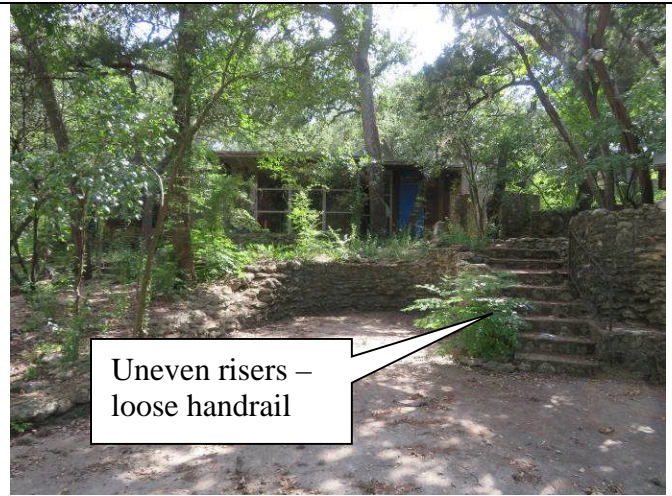
10. Steps and handrail – garage to house

**Steps:** Steps from the garage to the front door are not uniform and the handrail is deteriorated (and very loose). The steps do not conform to code uniformity requirements.

Uneven risers –  
loose handrail

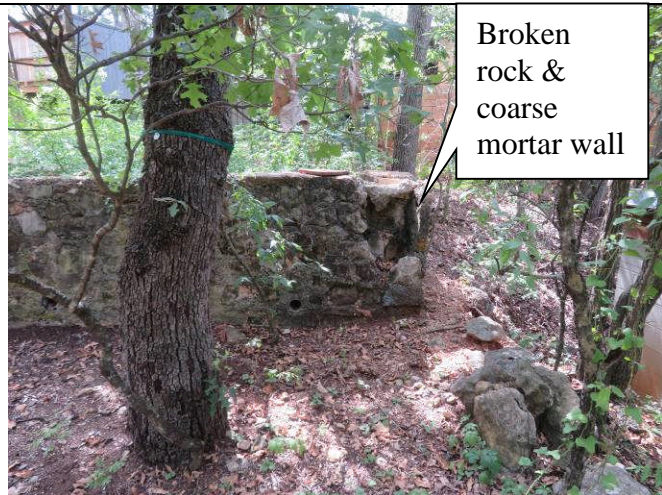
11. Typical stone rubble wall construction

Broken  
rock &  
coarse  
mortar wall

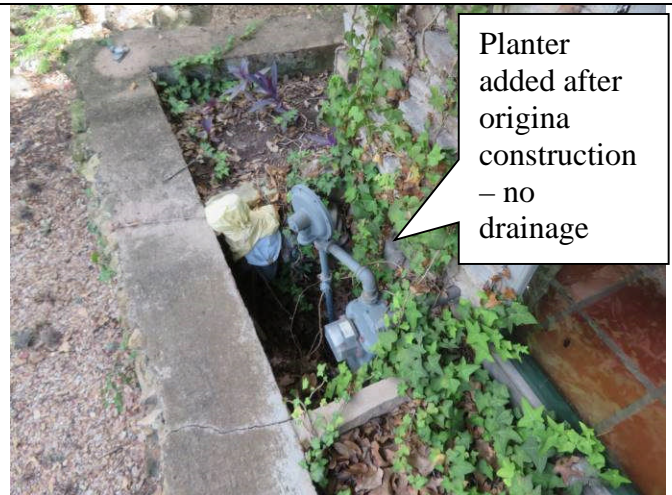
12. Gas meter at original grade

**Natural Gas:** The gas meter is located at the left front corner of the house in a submerged hole that appears to have no drainage (photo 41). The gas meter configuration indicates that the masonry planter was added after original construction (photo 42). The original foundation edge is visible at the hose side of the gas meter recess.

Planter  
added after  
origina  
construction  
– no  
drainage

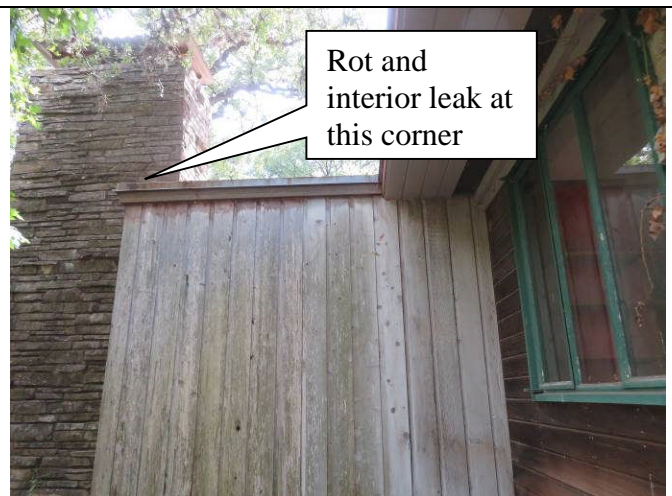
14. Non permitted addition at fireplace

**Siding:** The wood siding is in poor condition around the exterior of the house from long term neglect (Photo 55, for example). For example, the siding is rotted at the room addition adjacent to the fireplace (photo 14, 16). There is, additionally, a roof leak at this room corner (photo 69). The bottom edge of siding is rotting where it is not held off the adjacent flatwork (photo 47).

Rot and  
interior leak at  
this corner

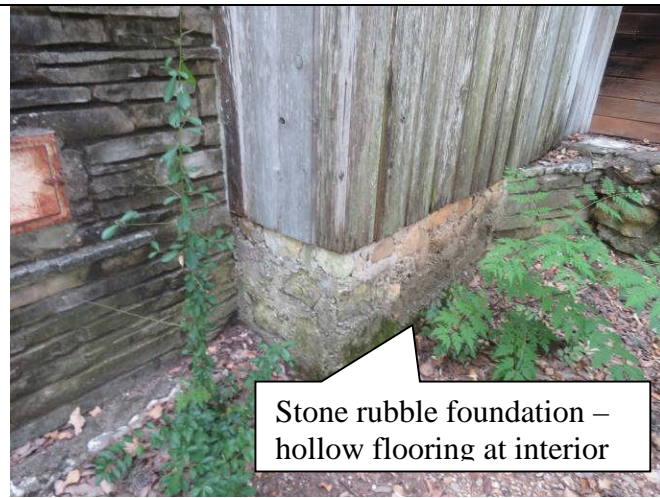
**Foundation:** The foundation is a conglomeration of a concrete slab on grade (presumed to be conventionally reinforced because of the age as casting) plus several additions that appear to be composed of (unreinforced) stone rubble masonry (such as under the chimney, for example – photo 15).

15. Foundation next to chimney

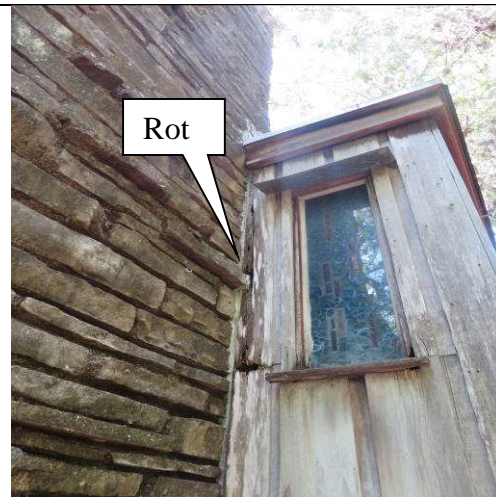
16. Wall rot & leak at "chimney" addition

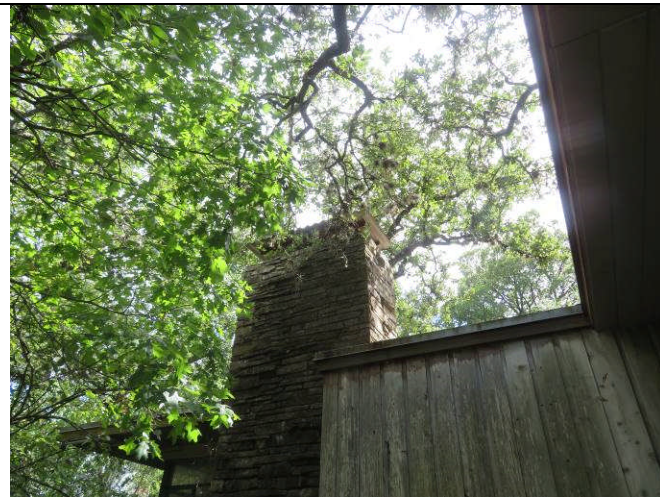
17. Chimney at front left

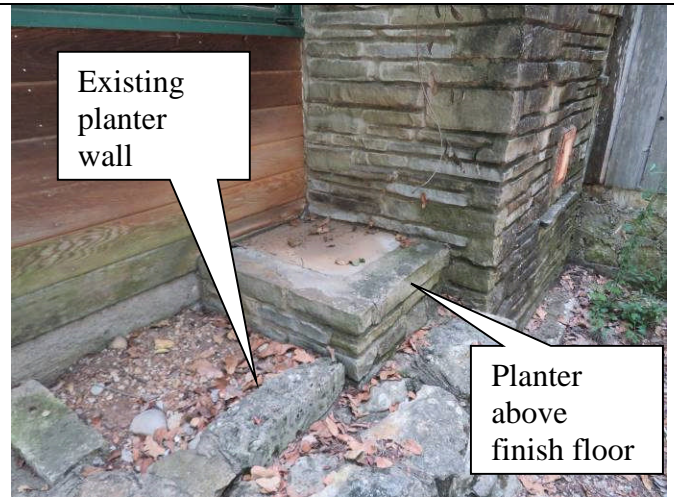
18. Planter extension at chimney

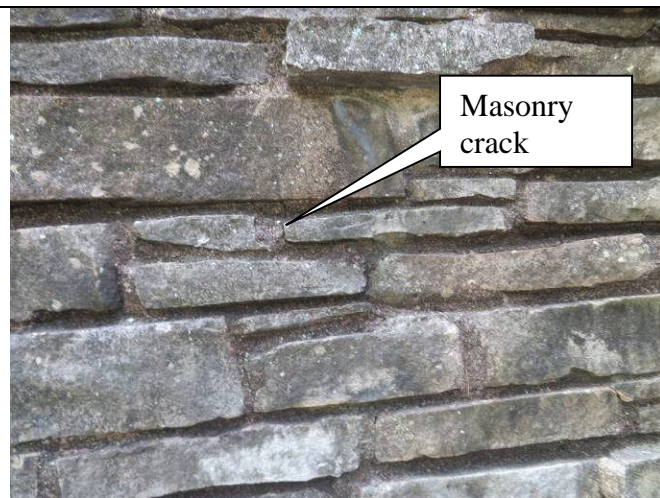
**Chimney:** There is settlement and cracks in the fireplace and chimney foundation and stone masonry. The fireplace foundation addition appears to have been built over the concrete planter wall that was in place at the time of this (unpermitted) addition.

19. Masonry cracks at chimney

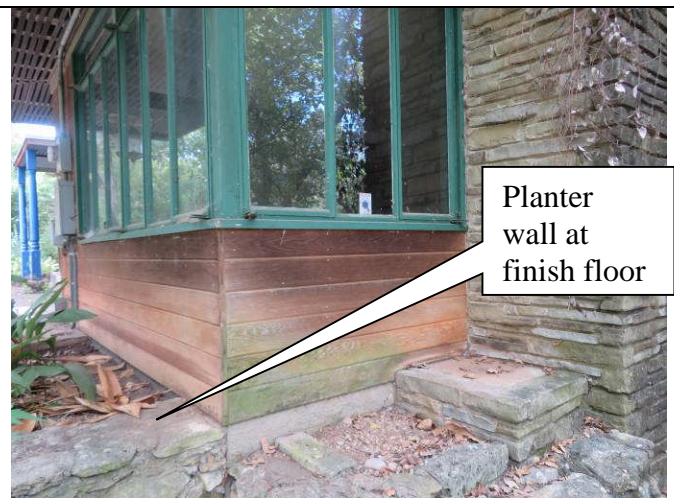
20. Deteriorated siding

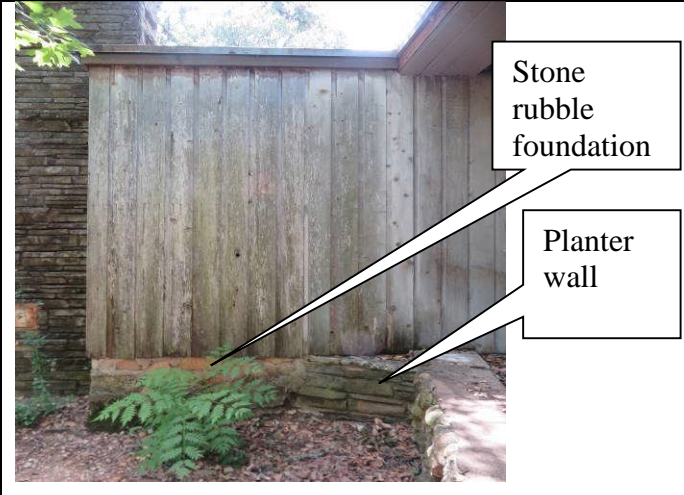
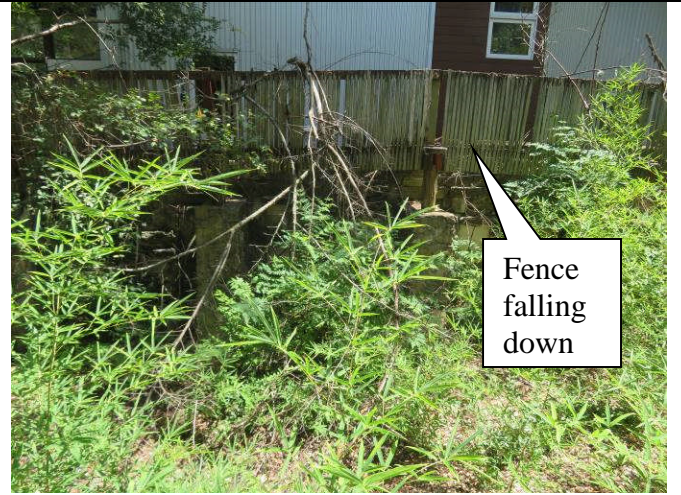
<p>21. Room addition left of chimney</p>	<p>22. Rotted and falling down left side fence</p>

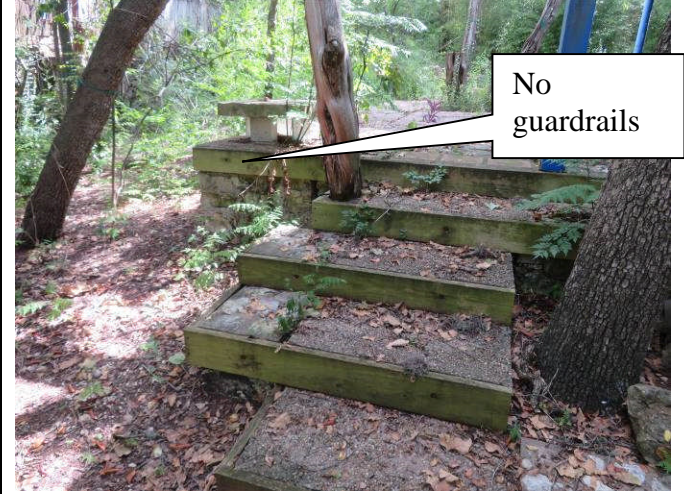
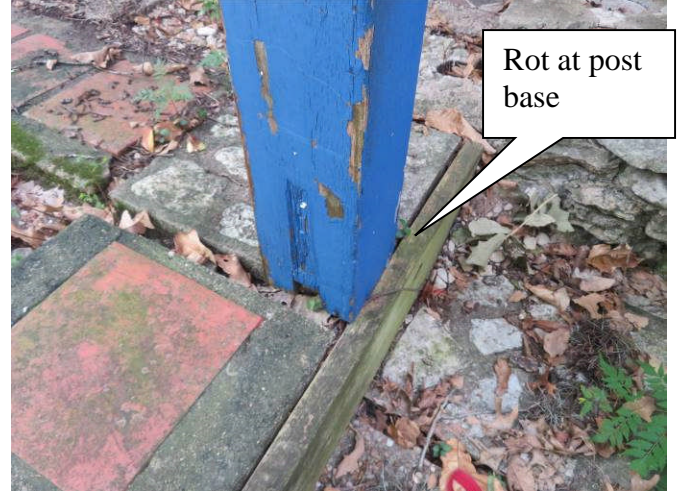
<p>23. No handrail at steps</p>	<p>24. Improper post bearing</p>

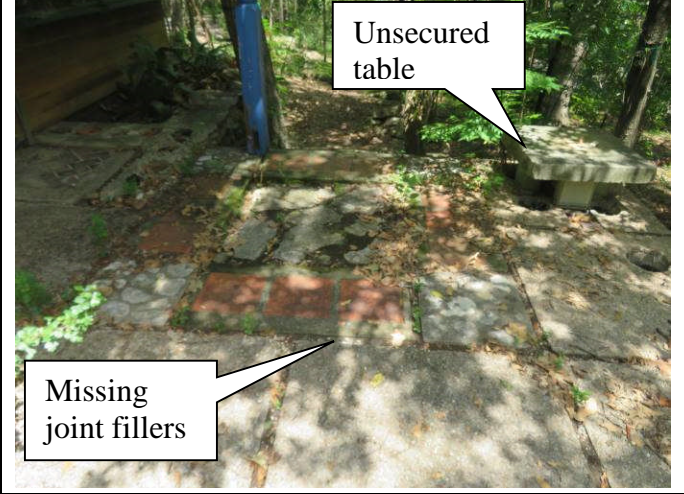
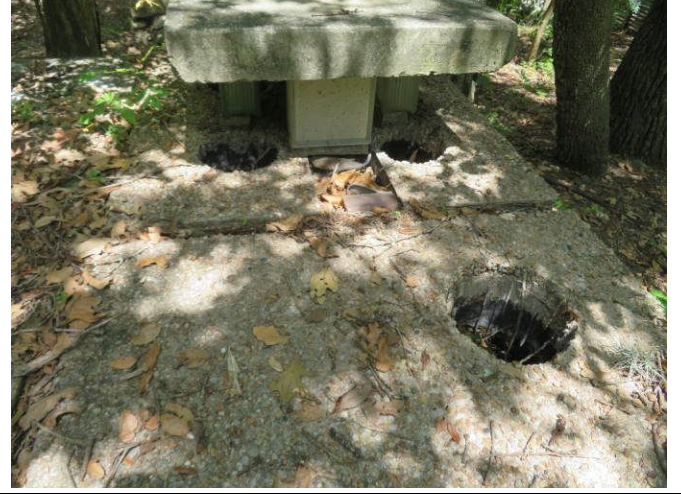
**Patio:** The patio at the left rear side of the house appears composed of square concrete sections that used to have 2x lumber in the section joints (photo 25). There are holes for what appears to have been column anchors (photo 26) that pose a safety hazard. This creates a very uneven and unsafe walk surface.

<p>25. Uneven patio and missing joint fillers</p>	<p>26. Voids at column (?) bases</p>

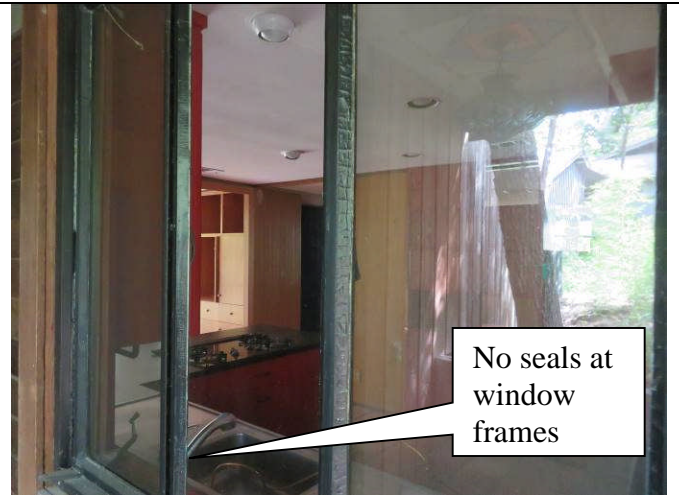
**Windows:** Windows are all single pane clear lites set in metal frames without thermal breaks (photo 59-60). There are jalouse windows and doors at the left side of the house (photo 61). None of the windows conform to current IECC requirements for a conditioned house space.

<p>No seals at window frames</p>
<p>31. Typical casement windows</p>	<p>32. Single un-insulated frame windows -typ</p>

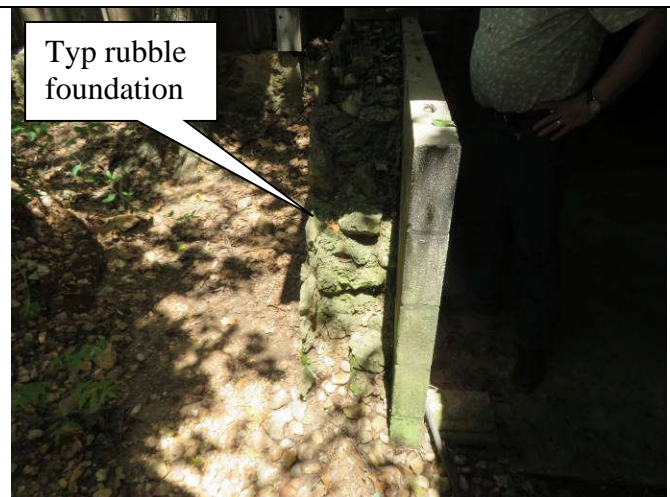
34. Typ rubble filled foundation wall

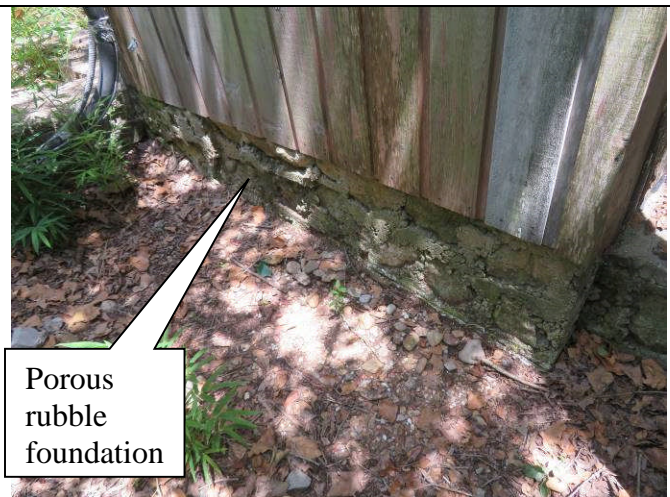
**Additions:** The foundation is a combination of several additions. There are no plans to indicate the reinforcing and thickness of the slab on grade foundation. There are no permits listed for the various additions on the City of Austin AB+C permit portal. Several of the foundation additions appear to be DIY "old world" stone rubble and mortar style configurations (photo 36).

36. Utility room – rubble foundation

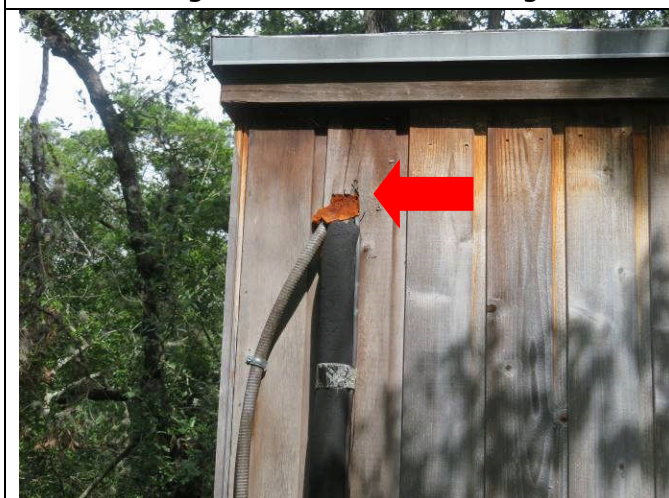
There are several wall penetrations that are improperly flashed (photo 37, 47) and are allowing moisture penetration.

37. No flashing at wall penetration

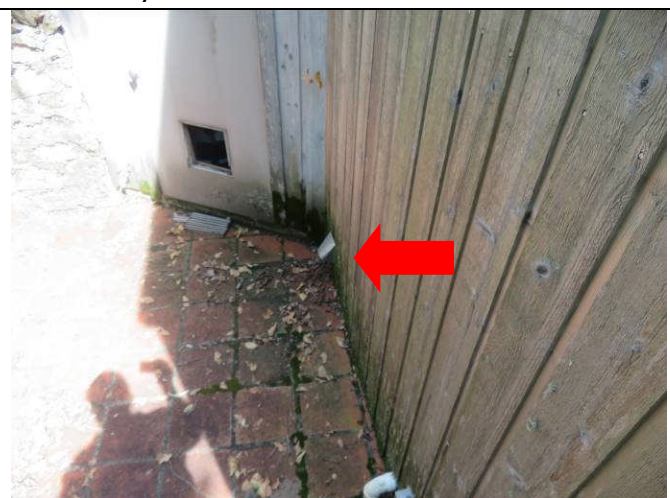
38. Rot / leaks at utility room wall base

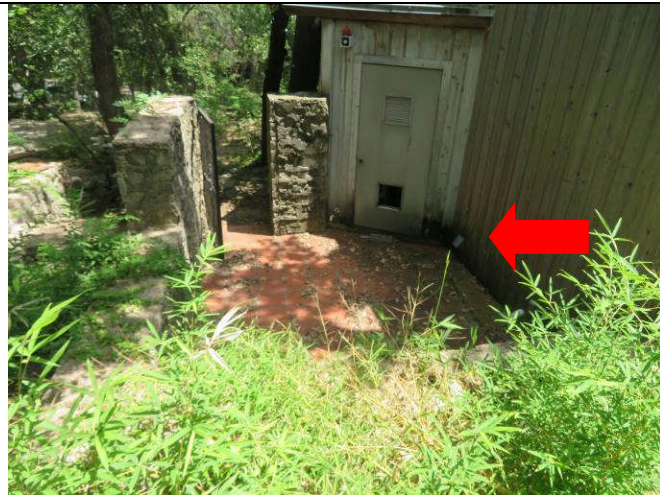
39. Rot / leaks at water heater closet

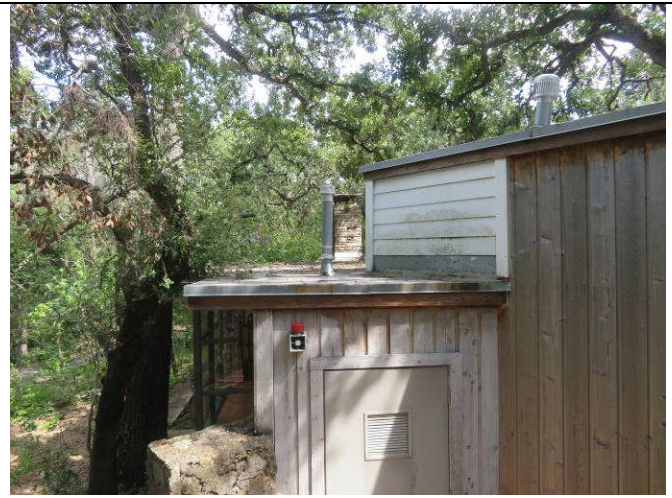
40. Roof flashing at flat roof

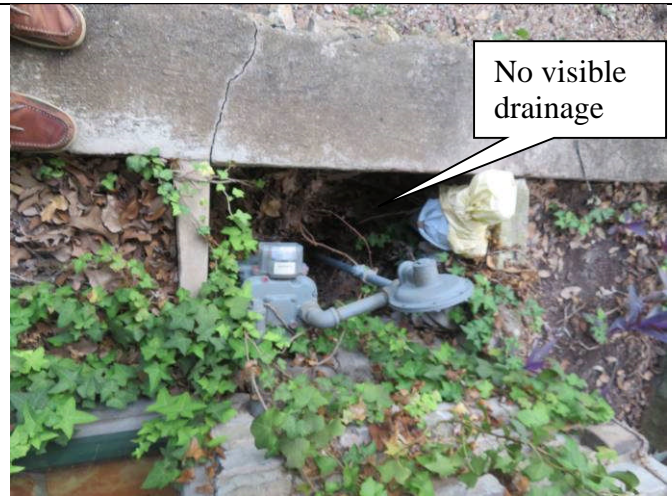
42. Gas meter pit (looking down)

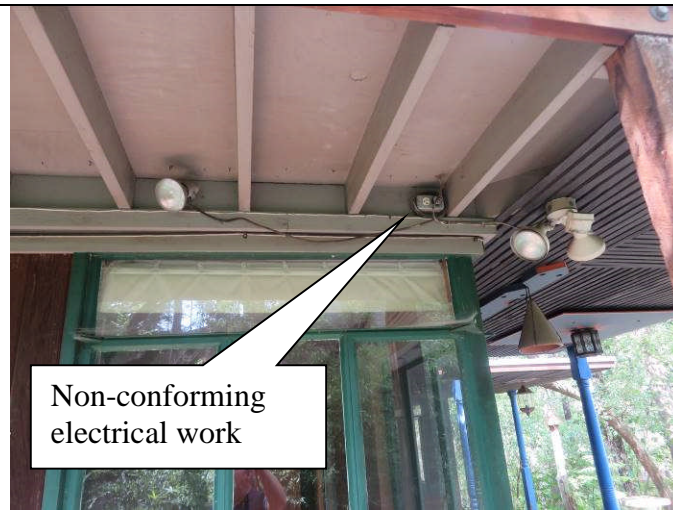
**Wiring:** There is much DIY wiring (photo 45-46) and lighting (photo 45, 48) present at the roof soffits that does not conform to NEC requirements. Junction boxes, wiring devices, wiring and fixtures are not damp rated or installed to outdoor conditions (photo 45-48).

45. DIY electrical wiring and fixtures

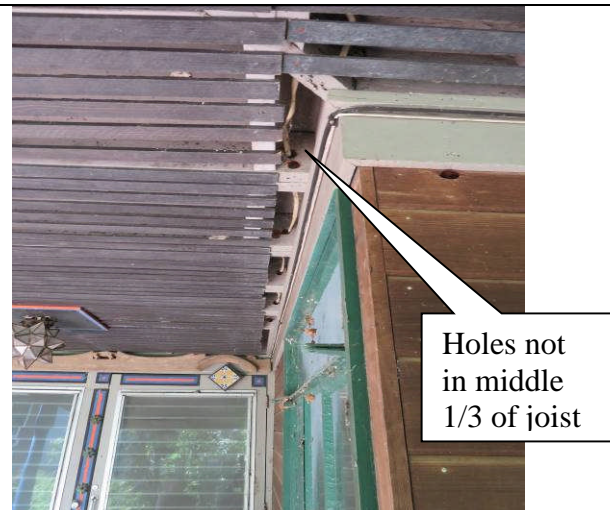
46. improper joist boring

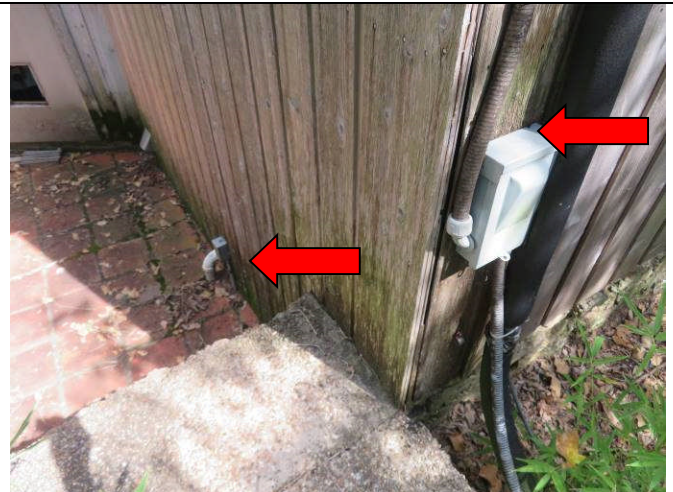
47. Improper wall penetrations

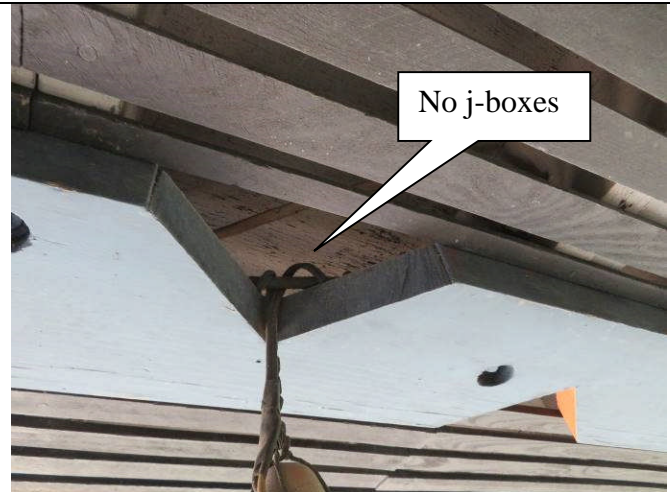
48. Improper wiring methods and materials

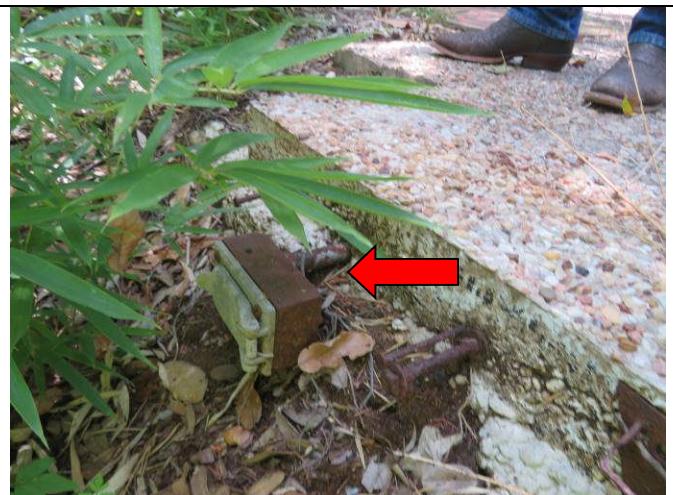
An outdoor receptacle at the SE side of the patio is badly rusted and does not conform to current NEC requirements (wrong cover, badly rusted box, not waterproof installation).

49. Badly rusted j-box at patio edge

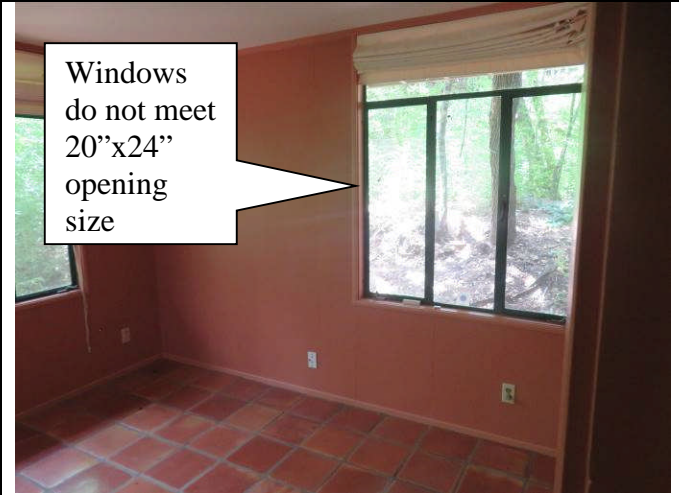
<p>Windows do not meet 20"x24" opening size</p>

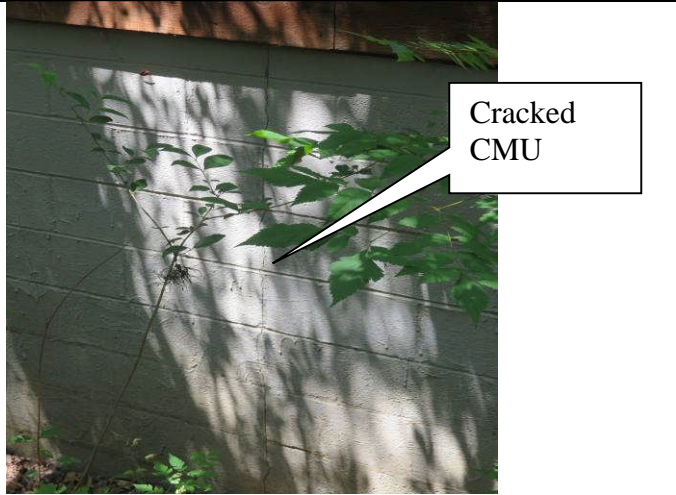
<p>Cracked CMU</p>
<p>51. No arc fault protection at bedrooms</p>	<p>52. Crack at garage wall</p>

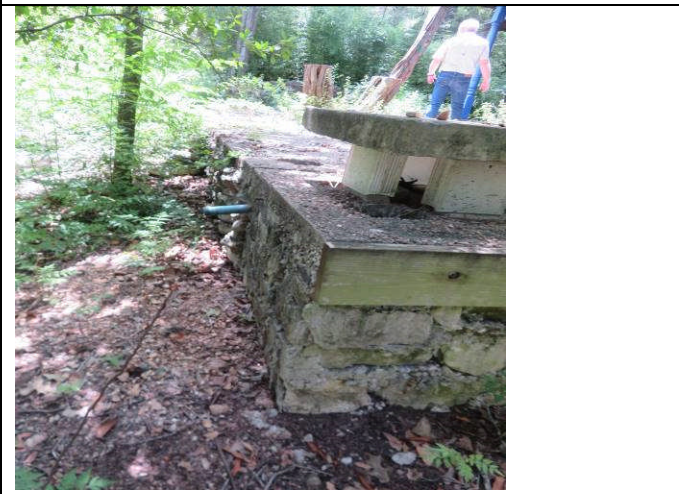
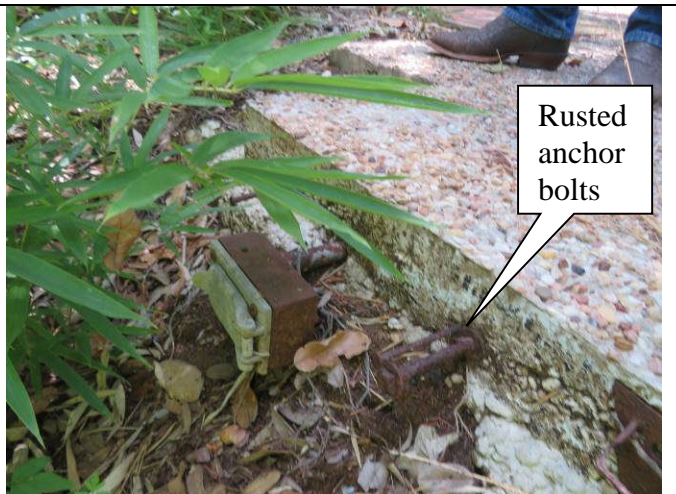
There is no handrail at the four step fight up to the left rear patio from the left front of the house. Badly rusted bolts protruding from the left side of the left rear patio indicate that the guard rail at the patio to grade drop (over 24" in some places) is missing. The existing bolts are so badly deteriorated, they cannot be reused to a new guard attachment.

Guardrails around the southeast perimeter drop off are missing (photo 53-54). A column at the left rear of the property has already been patched at the base (photo 29), is rotting again and no longer bears on the ground.

<p>Rusted anchor bolts</p>
<p>53. No guardrail at patio edge</p>	<p>54. Rusted anchor bolts at patio edge</p>

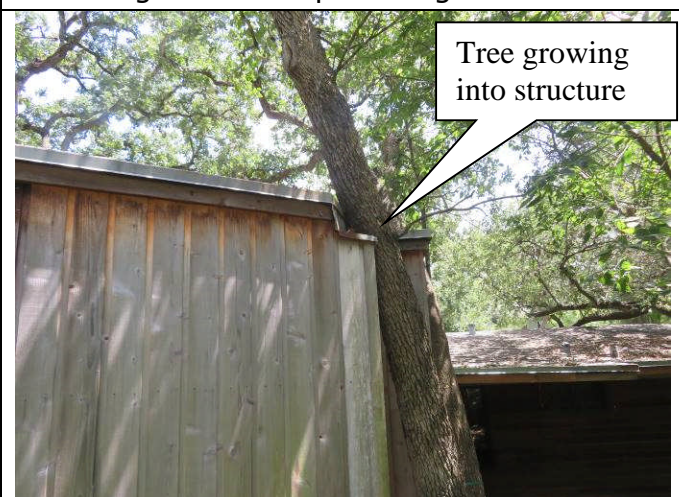
<p>Tree growing into structure</p>

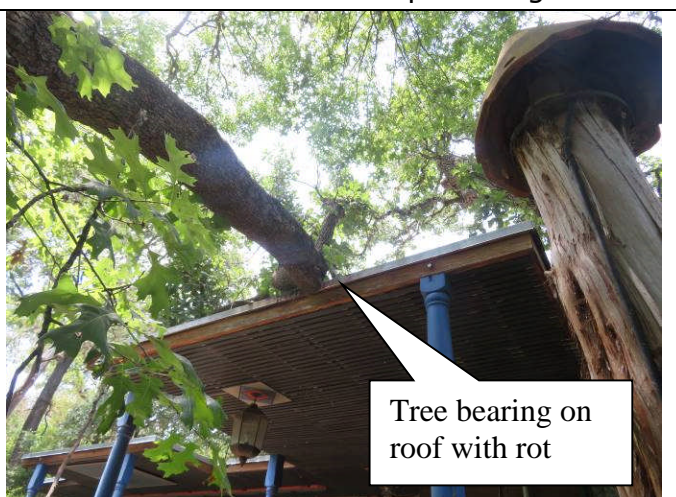
<p>Tree bearing on roof with rot</p>
<p>55. Tree into roof/wall structure</p>	<p>56. Tree bearing on roof</p>

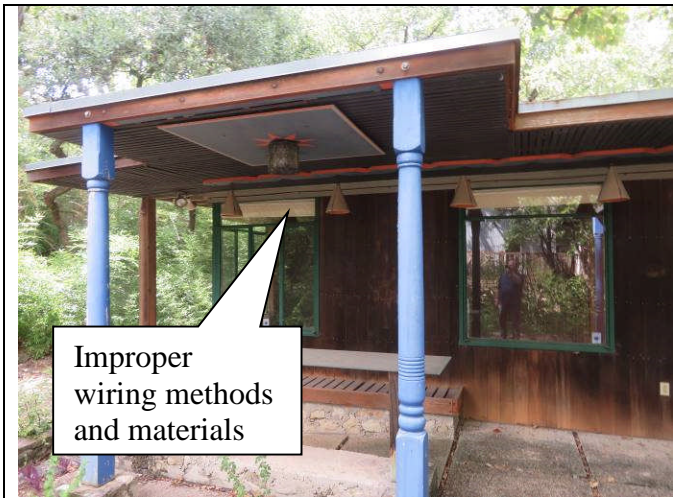
57. Light fixtures not rated for outdoor use

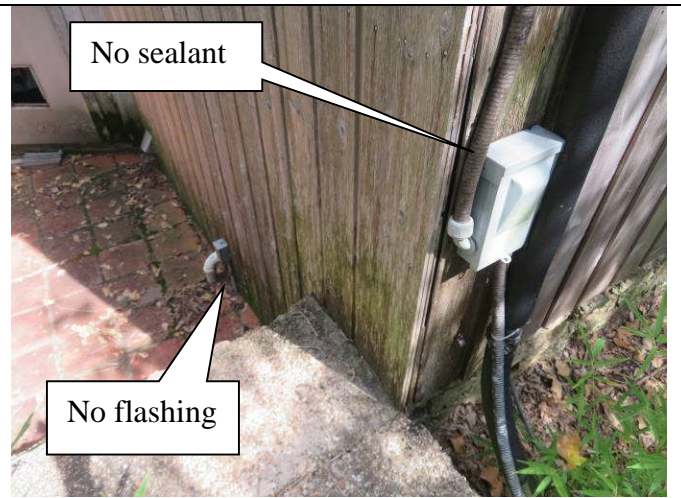
58. improper wall penetrations

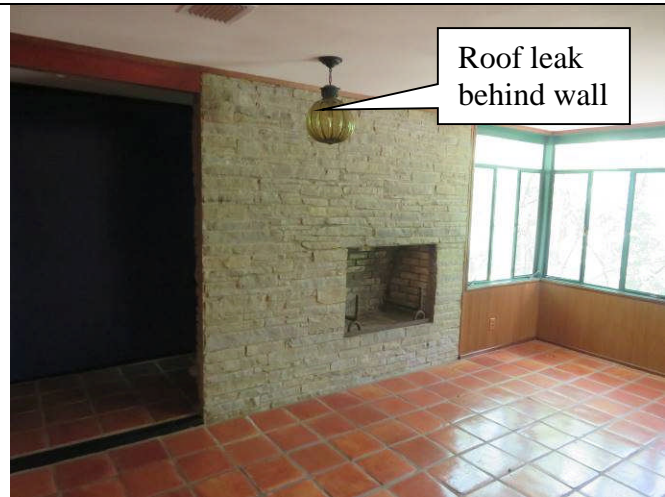
59. Settlement at fireplace

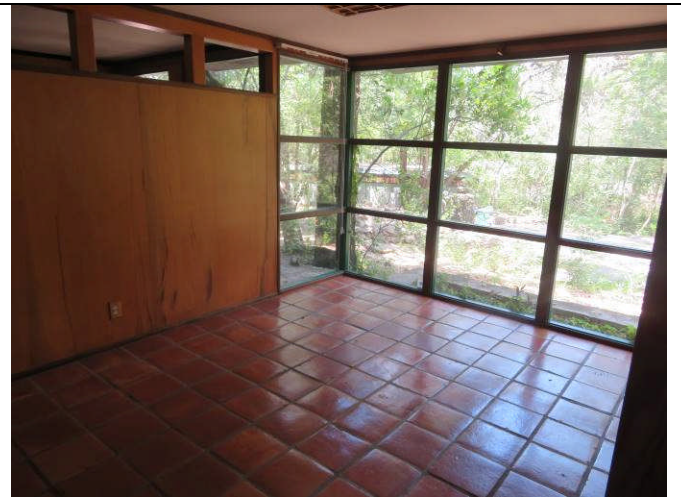
60. Single pane uninsulated window

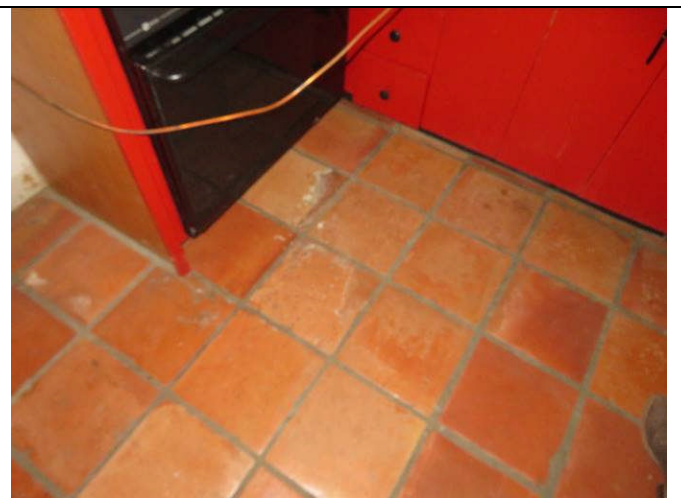
62. Water stain in kitchen

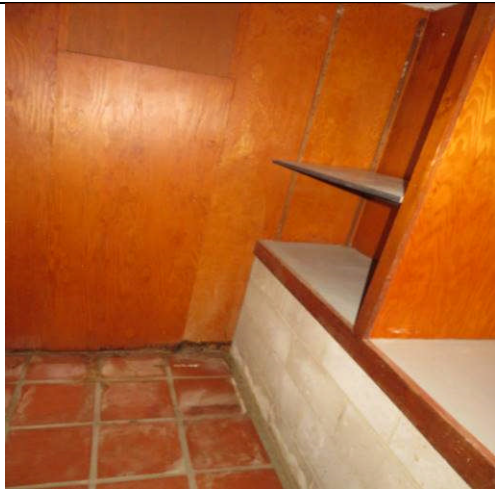
**Walls:** There is rot and a water leak in the room addition next to the chimney (photo 69). There is rot in the wall outside the chimney and there is likely mold present at this location. There is a roof leak at the room to the NW corner of the chimney (photo 69). There are water stains that indicates leaks at the utility/laundry room (photo 63-66) and the hall bathroom (photo 67-68).

63. Water stain in utility

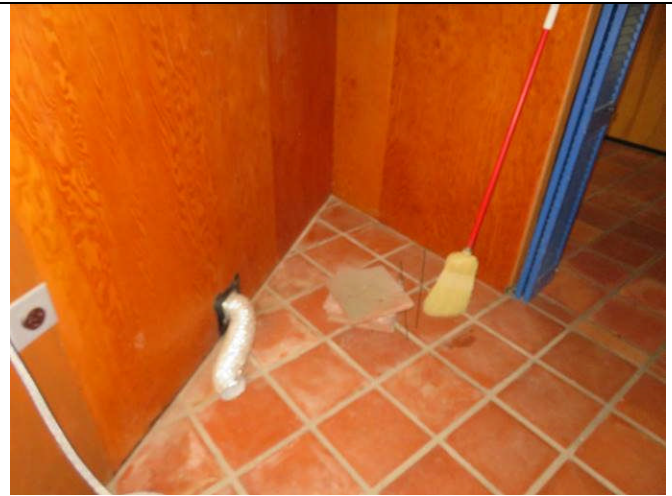
64. Water stain in utility

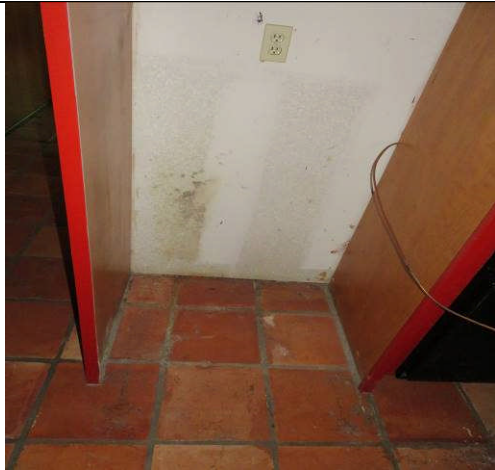
65. Water stain in utility

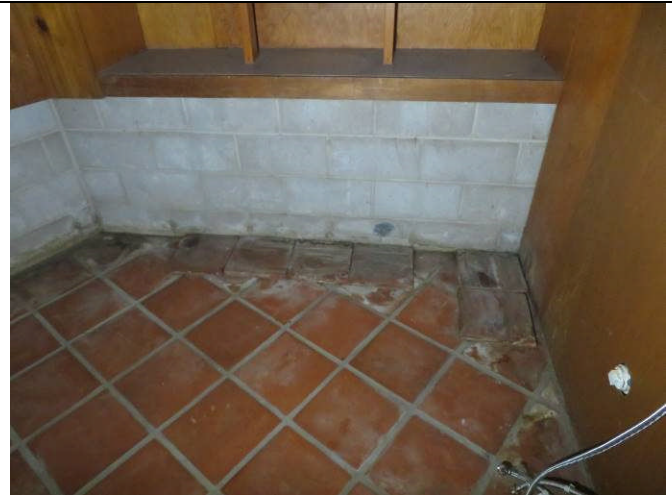
66. Water leaks at exterior wall - utility

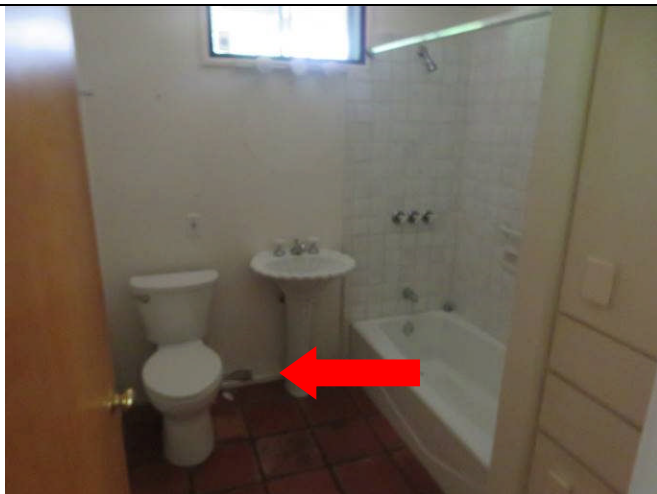
67. Water leak at bathroom ext'r wall

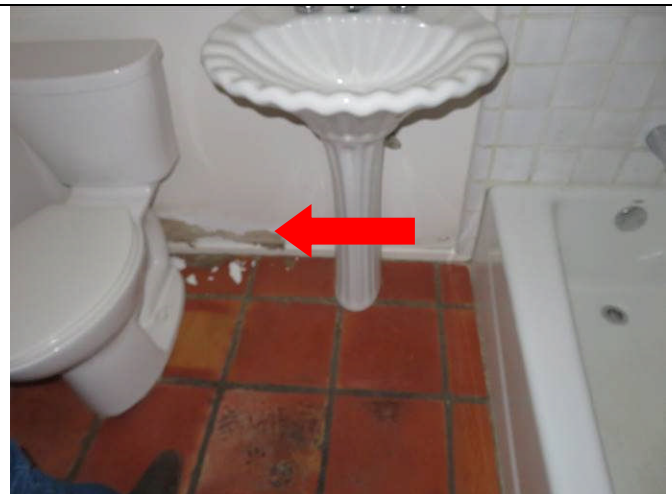
68. Water damage at bathroom ext'r wall

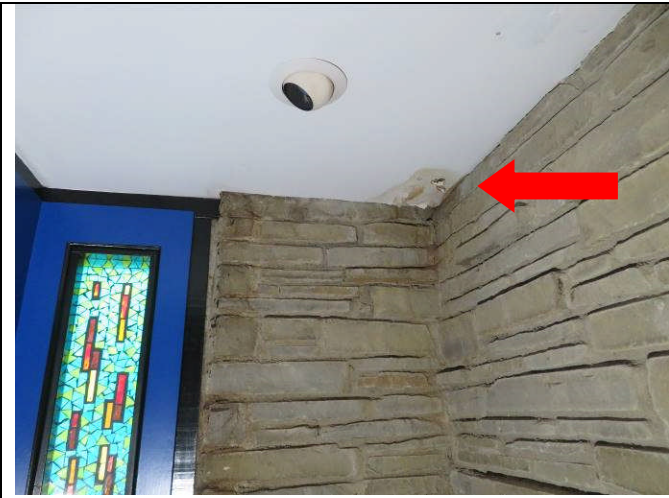
69. Water leak at room next to chimney
