1700 Lavaca

- Built: ~1889
- Structure Size: Approx. 1,126 SF
- Current Use: Restaurant
- Historical Use: Cleaners

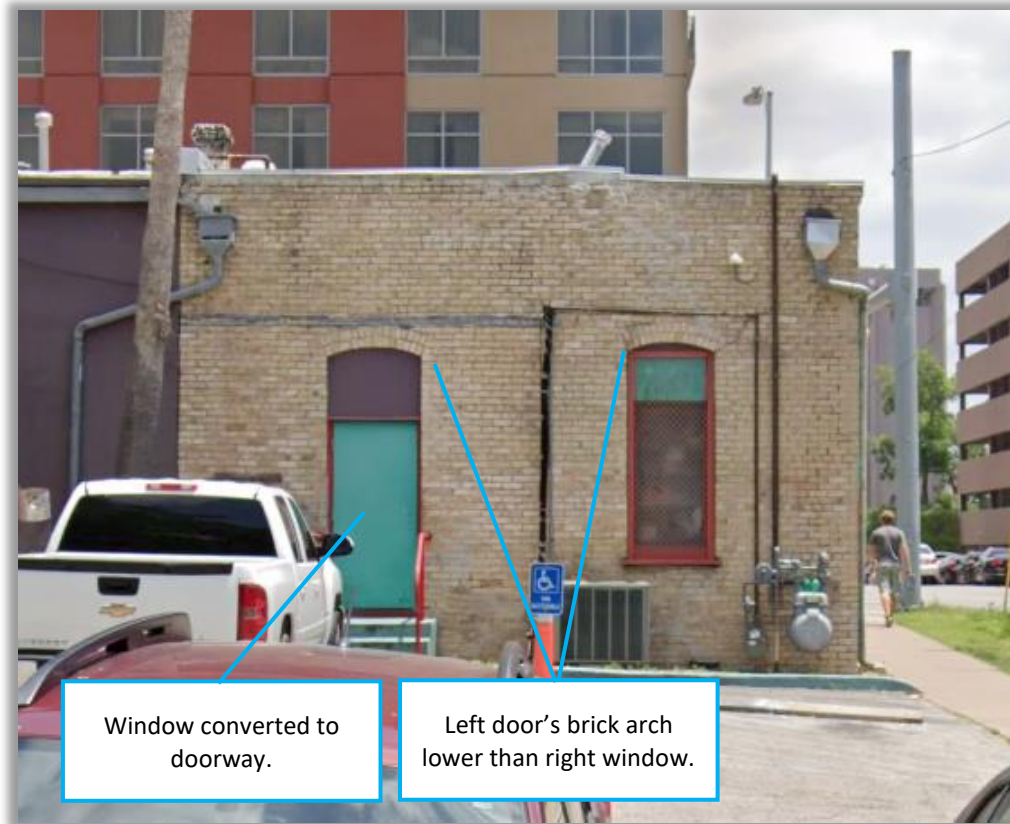
Current Day, West Wall of Brick Structure

Window converted to doorway.

Left door's brick arch lower than right window.
