Analysis of Existing Building at  
**1403 EAST CESAR CHAVEZ STREET**  
Historic Landmark Commission Hearing

==== MAY 04, 2022 =====

## 1403 EAST CESAR CHAVEZ STREET STRUCTURAL CONDITION ASSESSMENT – DATUM ENGINEERS

RE: 1403 E. Cesar Chavez – Initial Structural Assessment

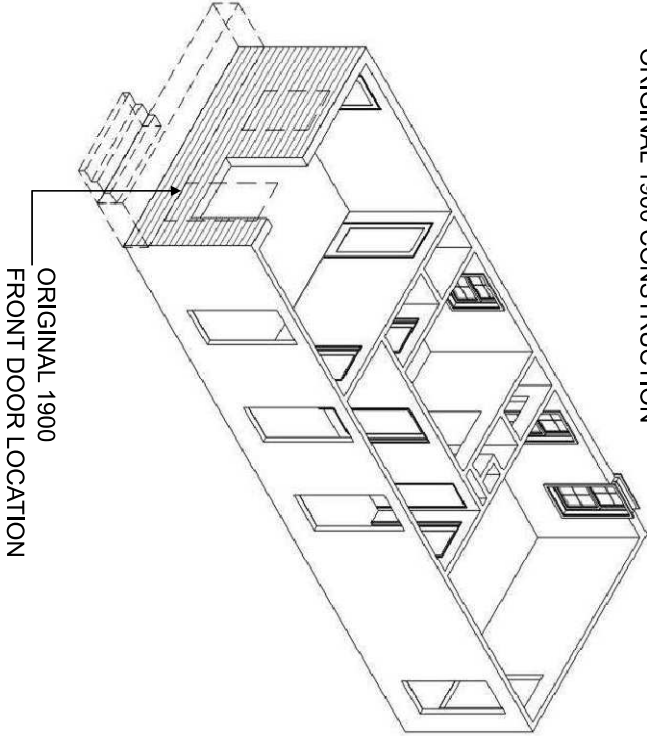
REMAINING FABRIC FROM  
ORIGINAL 1900 CONSTRUCTION

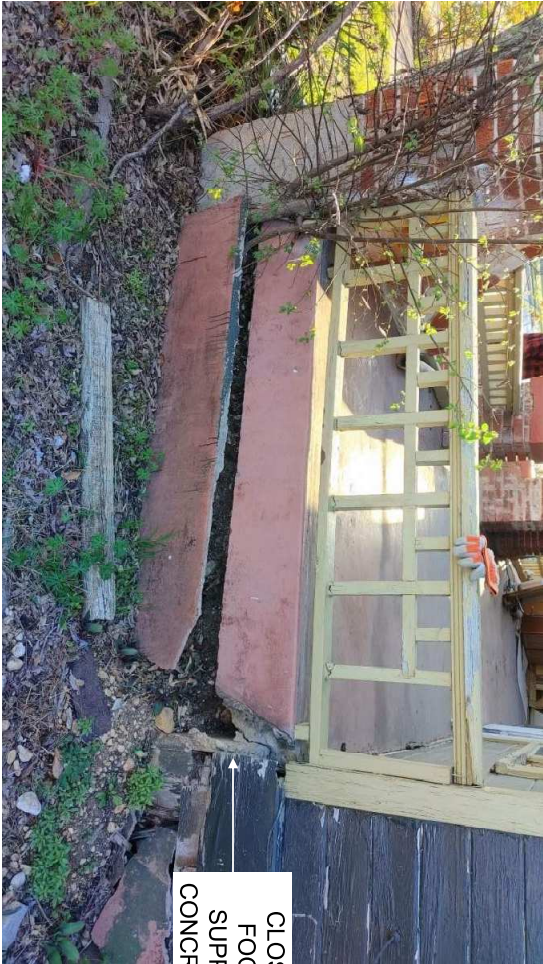
FRONT PORCH ADDITION – VIEW FACING EAST

The front porch is concrete with brick pilasters and partial walls. We suspect this may have been added later in the life of this house. The connection of the concrete porch slab to the house appears to have integrity issue. The projecting area at the rear of the house has a more recent made plywood siding indicating that some portion of the house may have been added later. The two large trees in front and one on the east side are located too close to the house. As a result, the roots have probably spread under the brick foundation pad and has caused severe movement.

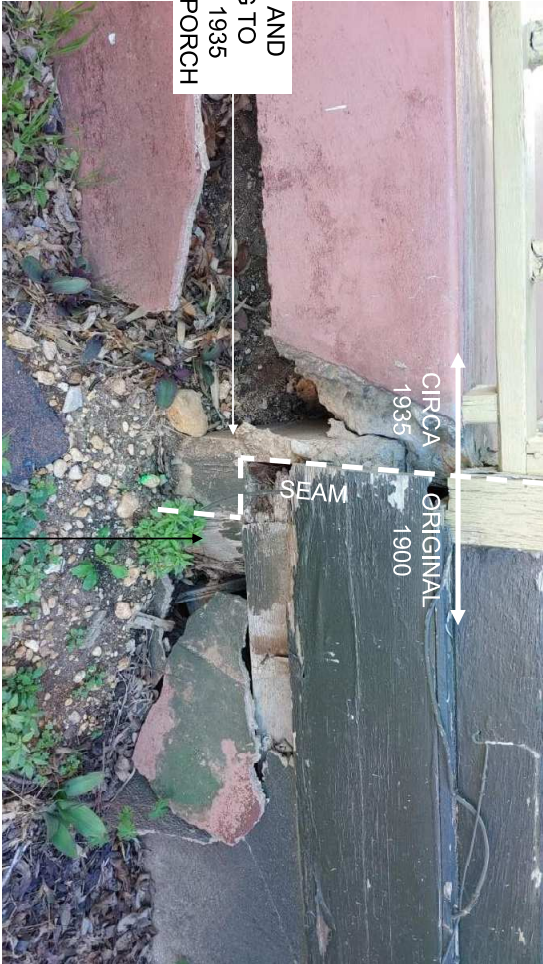
ENLARGED VIEW OF FRONT PORCH SEAM

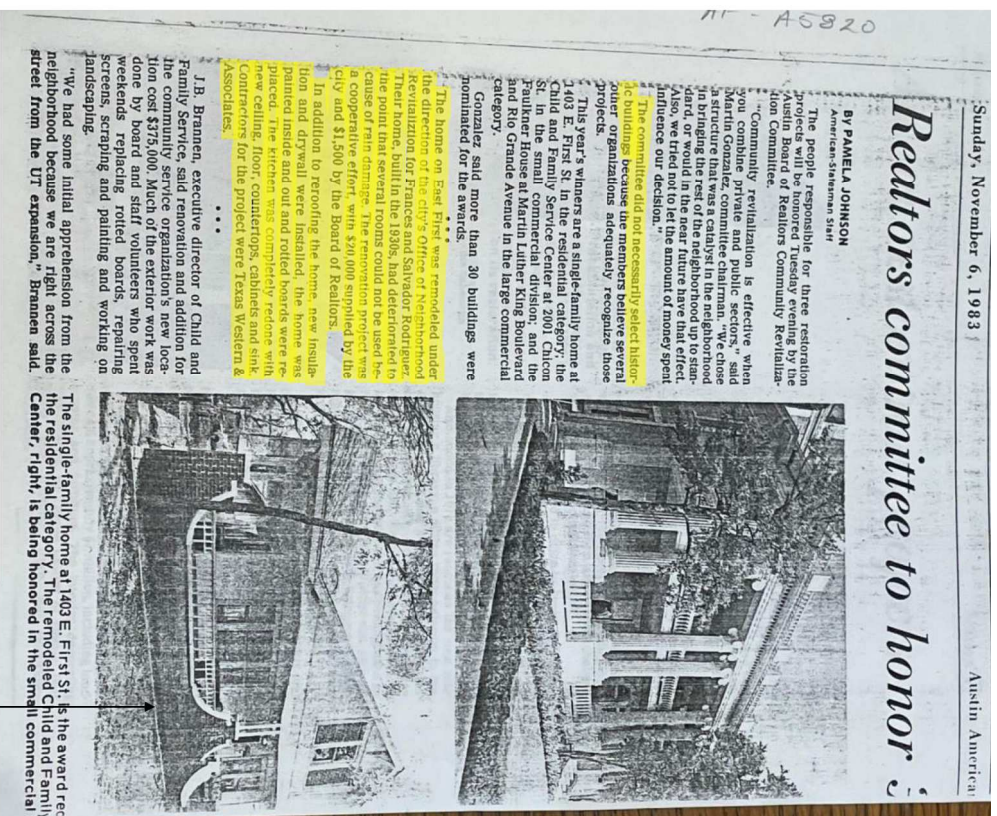
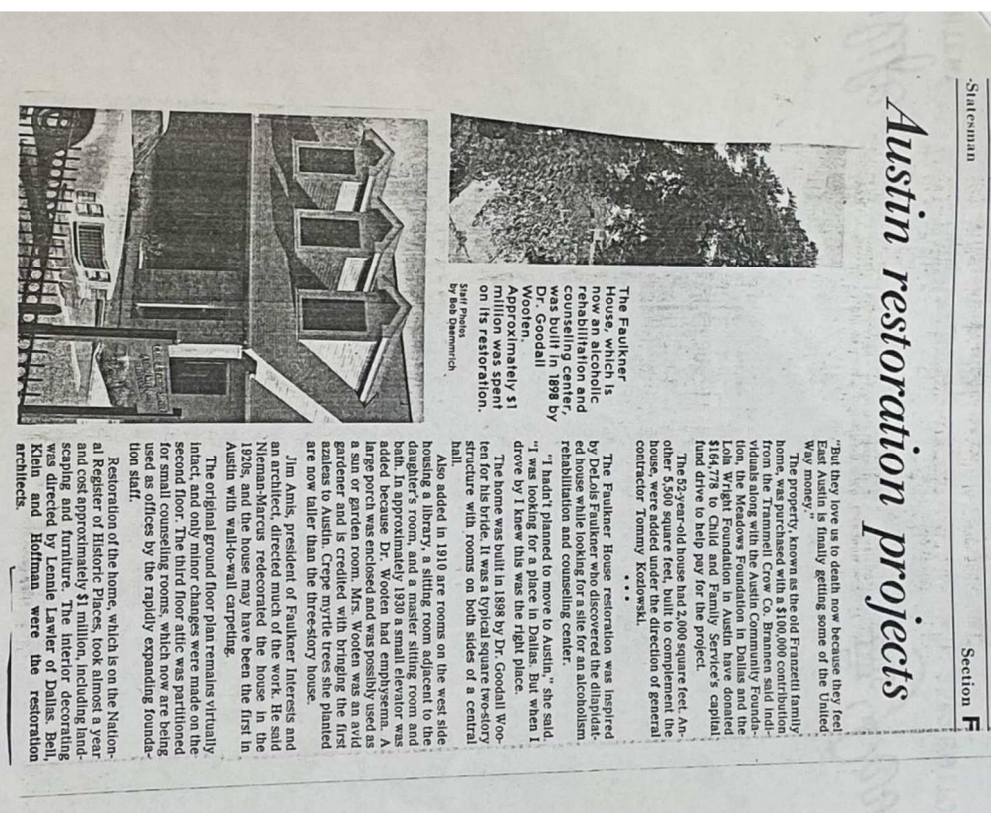
1983 PHOTO DOES NOT NECESSARILY REFLECT  
1935 APPEARANCE. NO 1935 PHOTOS EXIST.

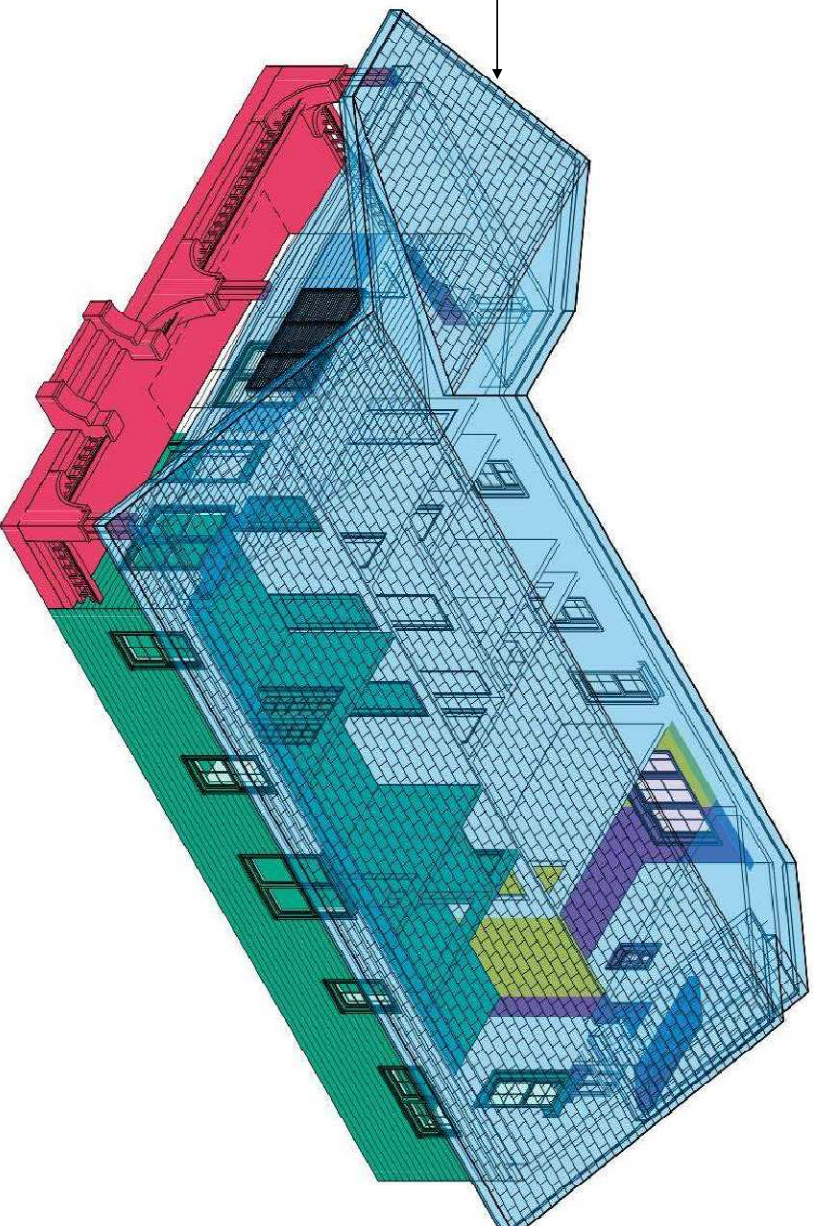
■ ROOF RENOVATION  
(approximately 1983)

1403 EAST CESAR CHAVEZ STREET  
ROOF RENOVATION
