813 Park Blvd.
ca. 1929
Miller-Long House

XINESI Holdings, LLC Owner

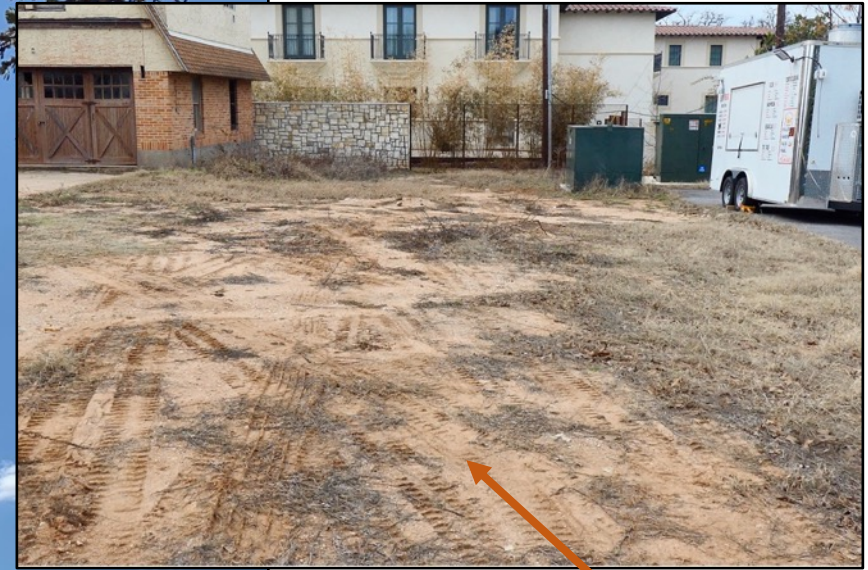
Main House and Garage

SITE CONDITION

REPLACE ROOF

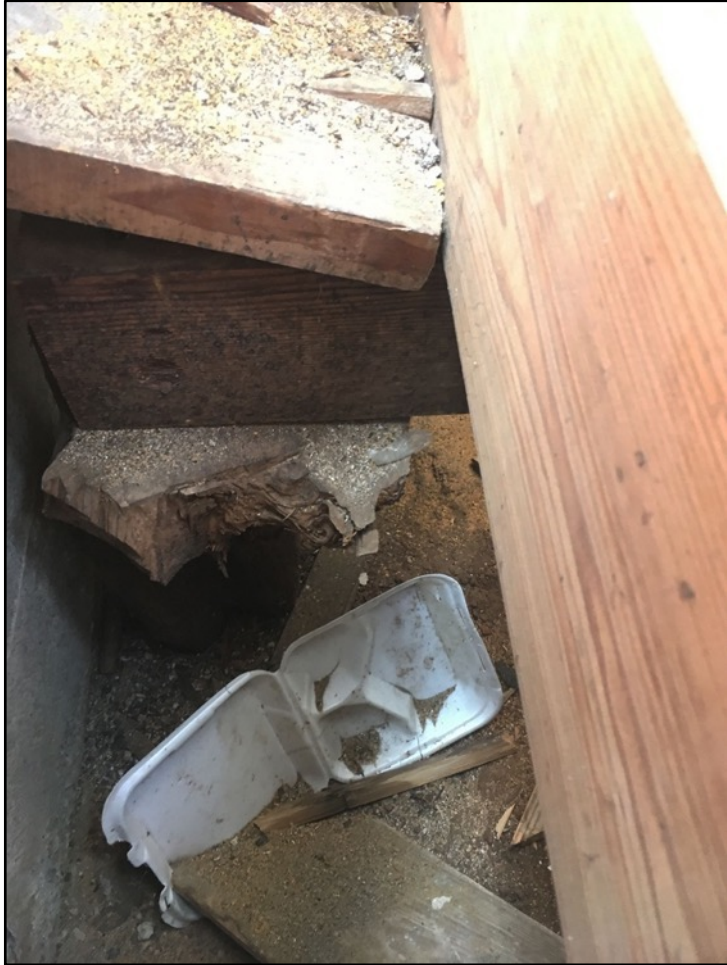
Sun porch

Structural issues in Main House

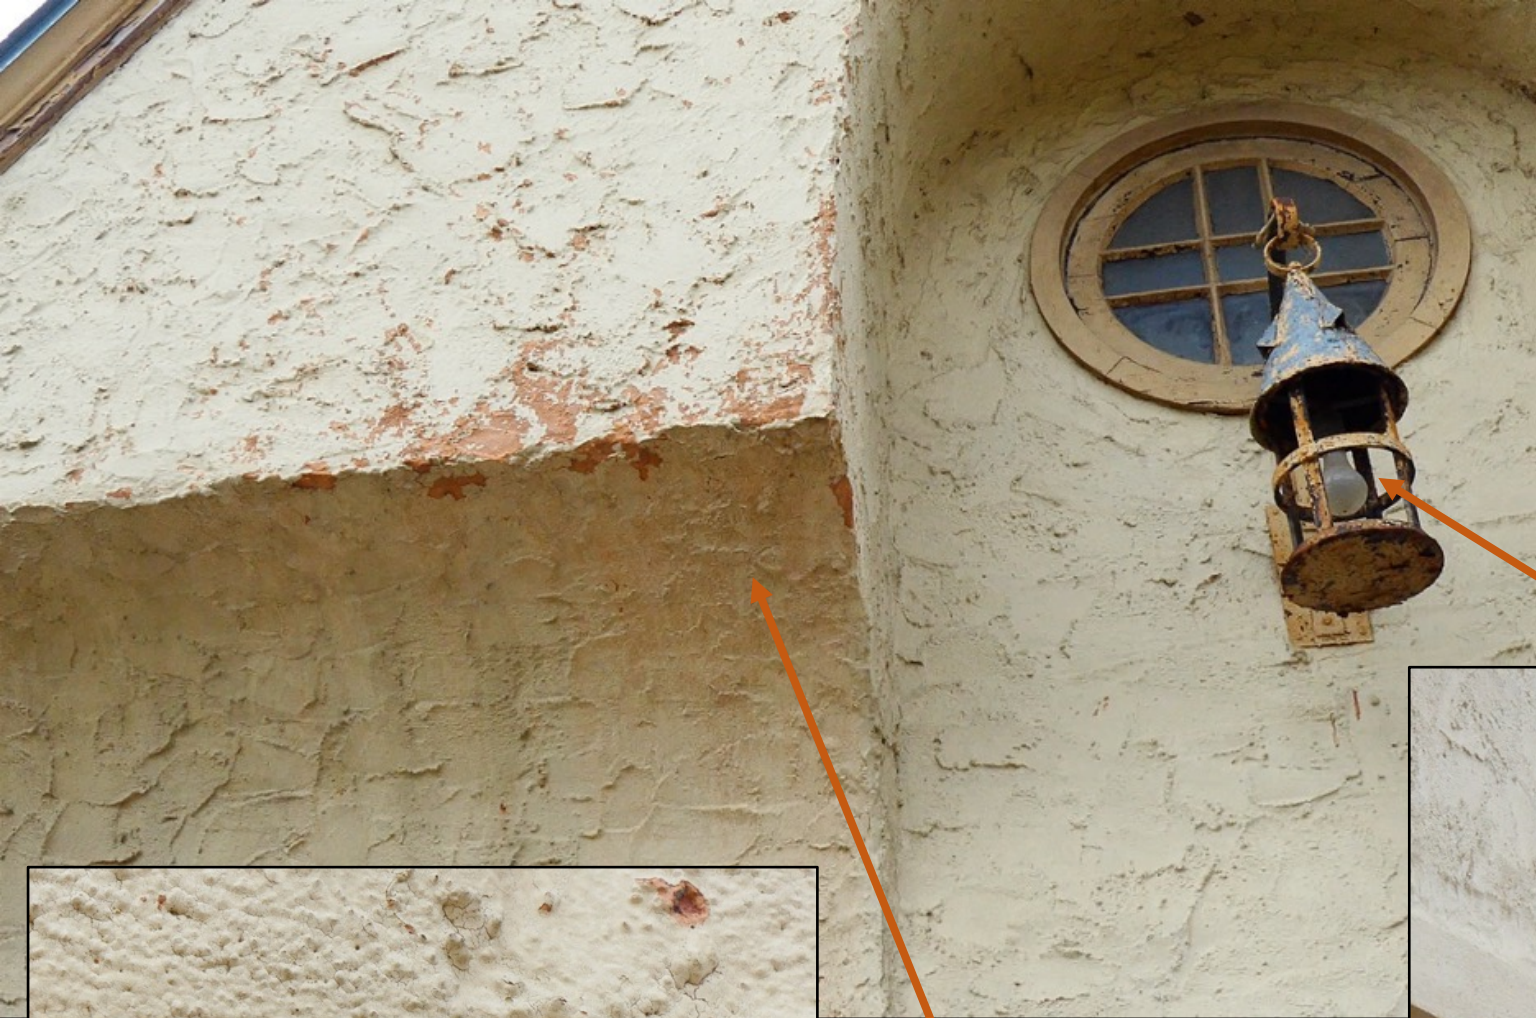
INTERIOR SIDE
OF STUCCO

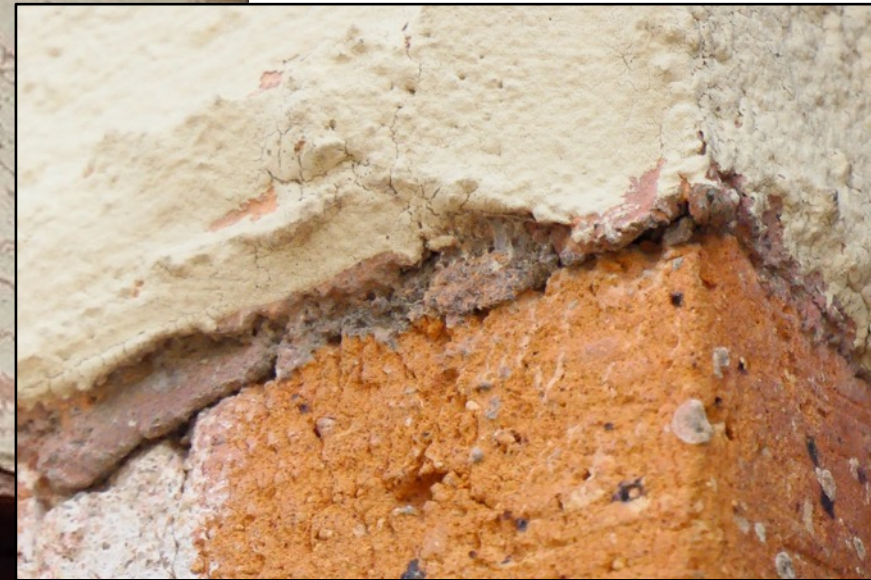
Garage – Stucco and evidence of original awning

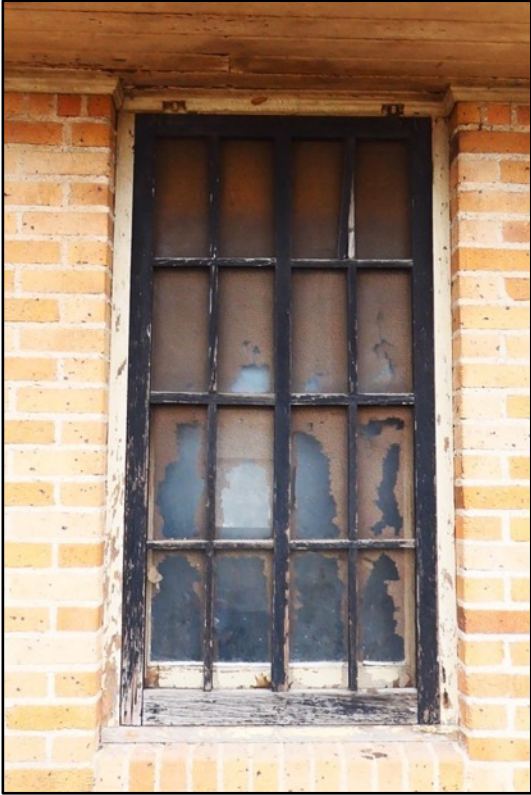
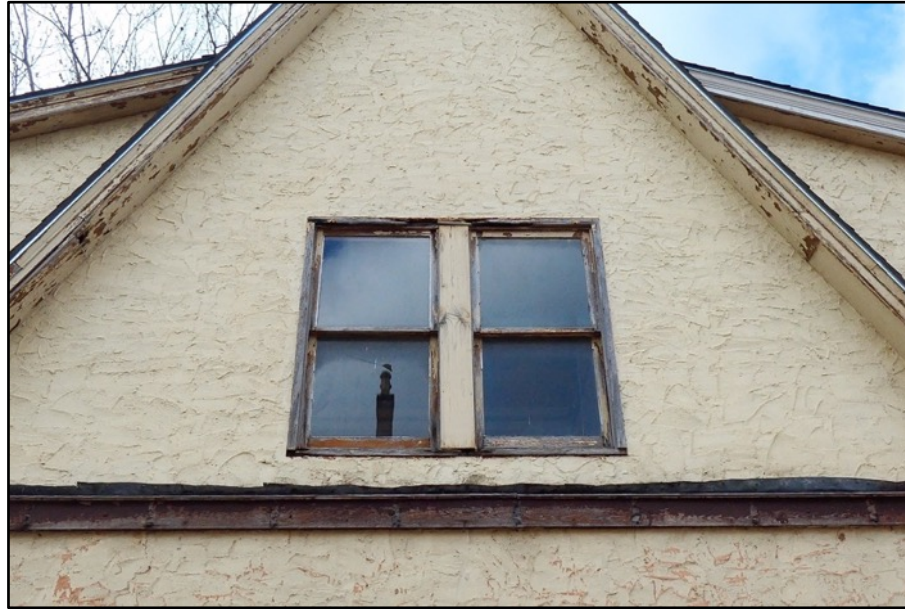
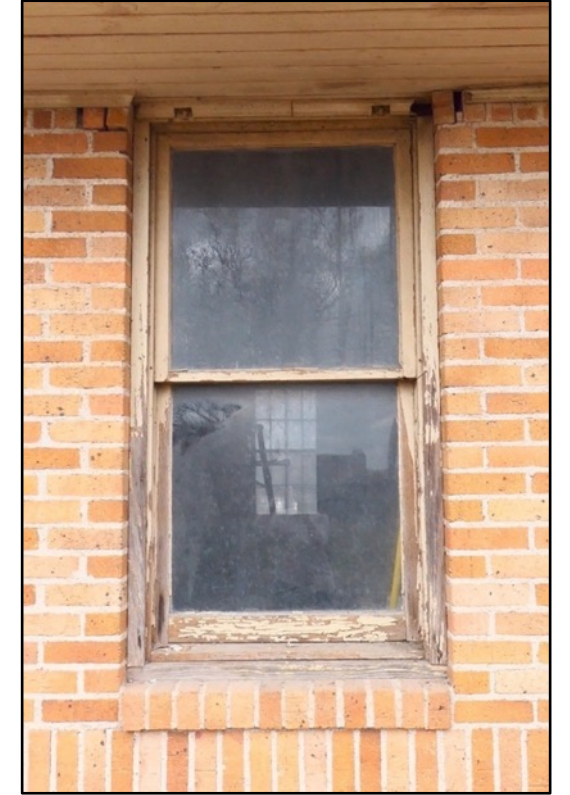
Garage - Double hung windows

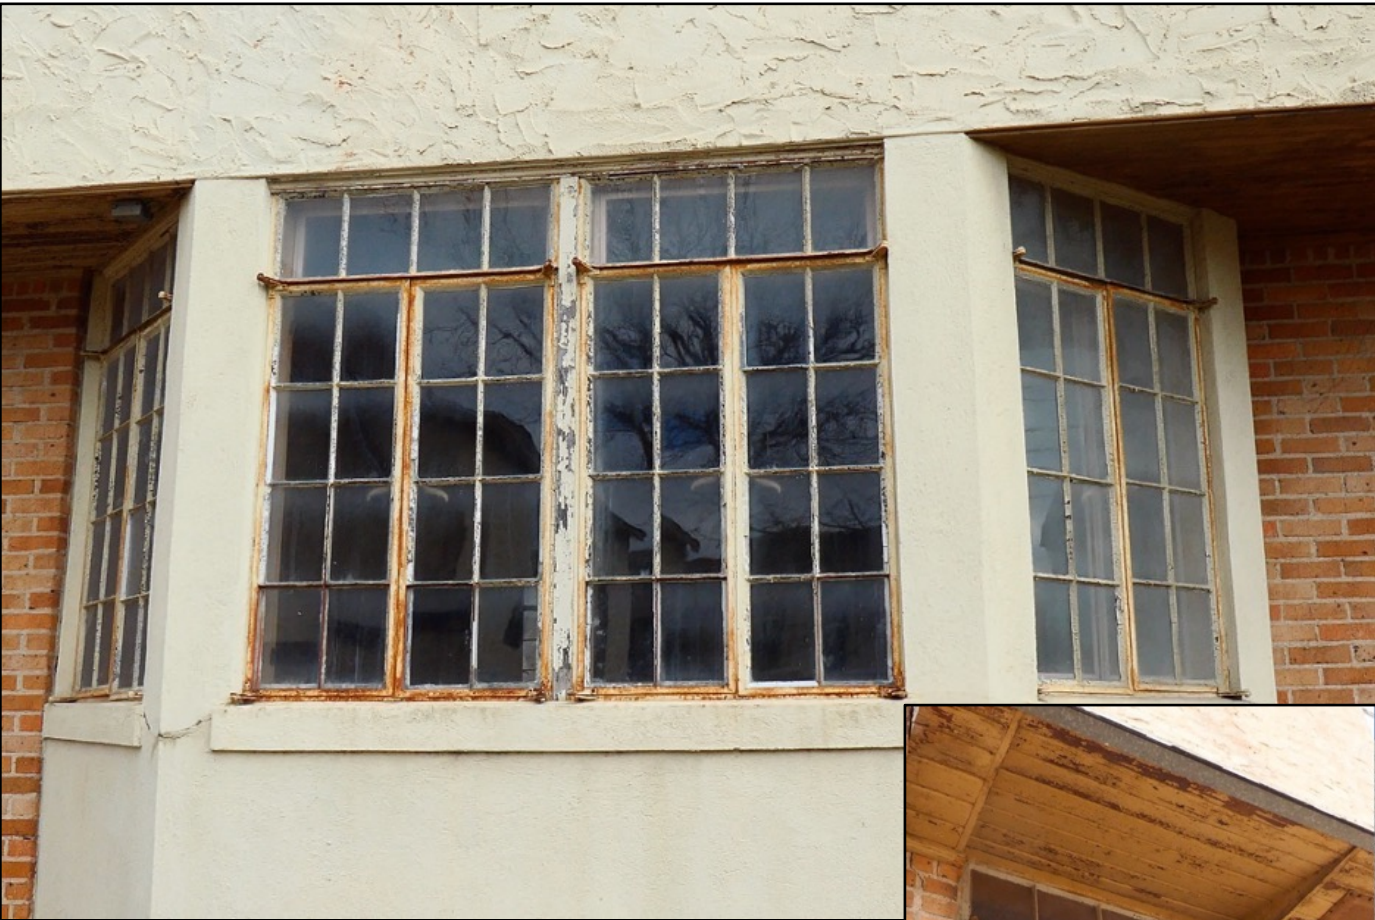
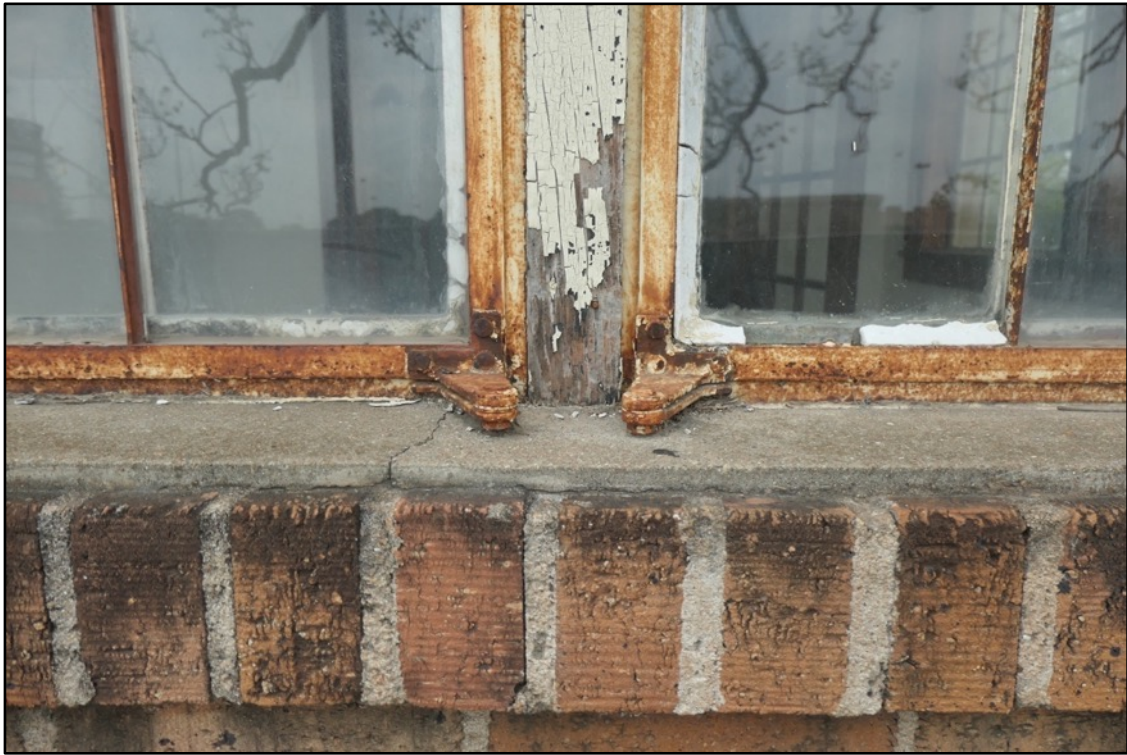
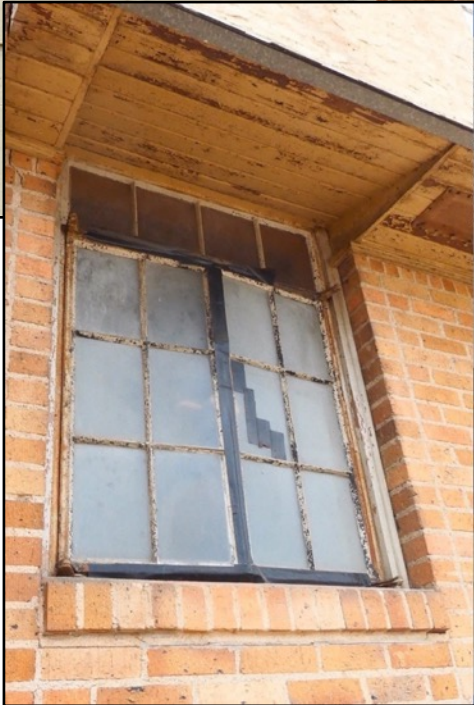
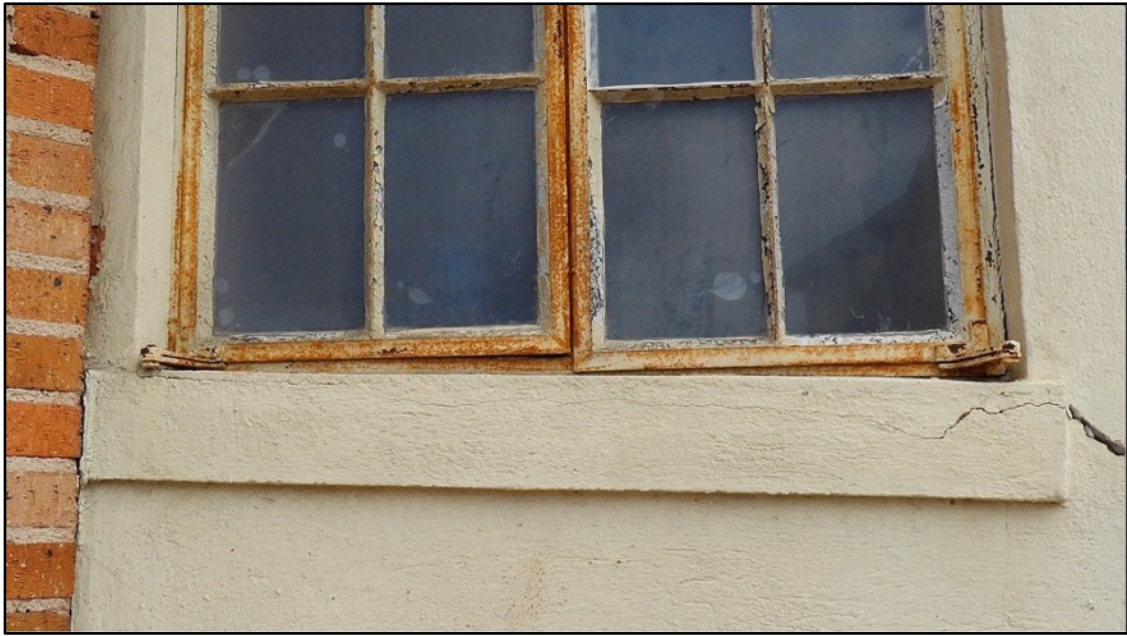
Main House – Steel sash
casement windows
