# THOMAS HOUSE

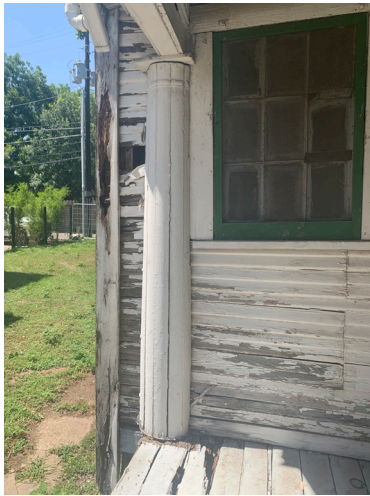
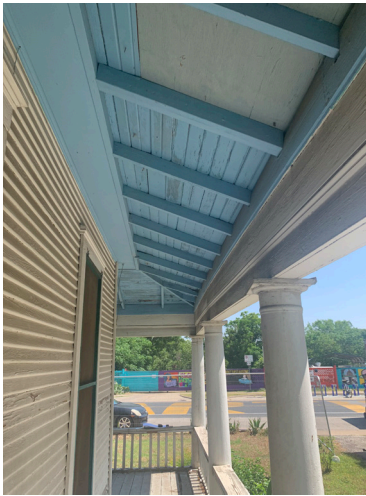
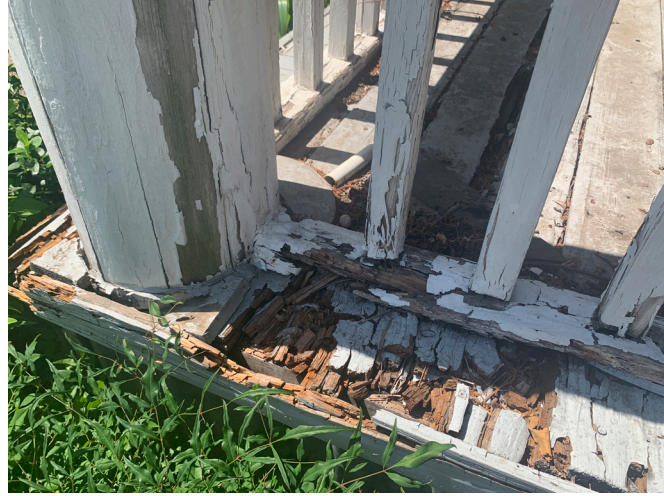
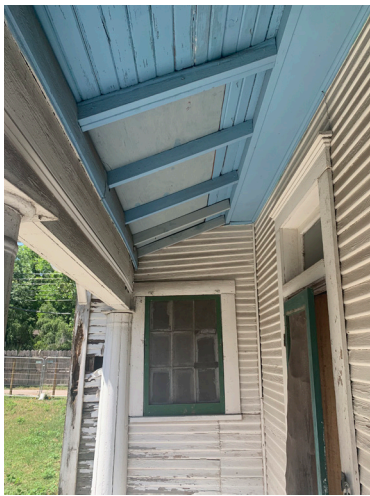
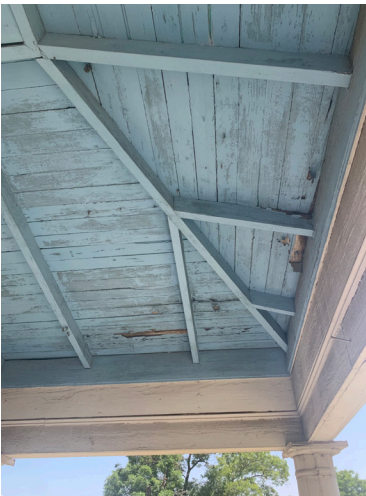
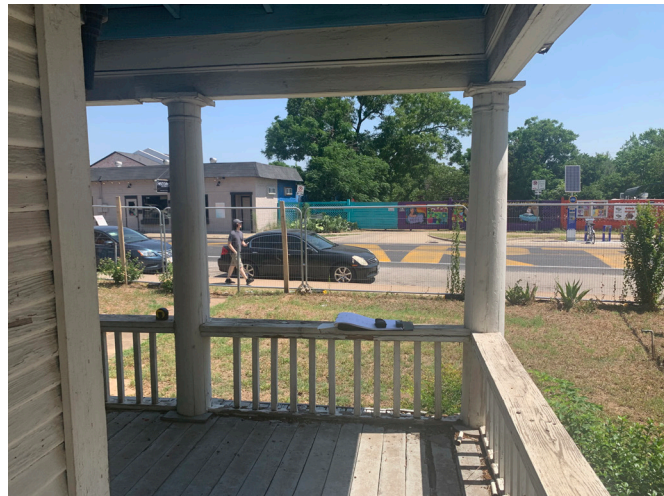
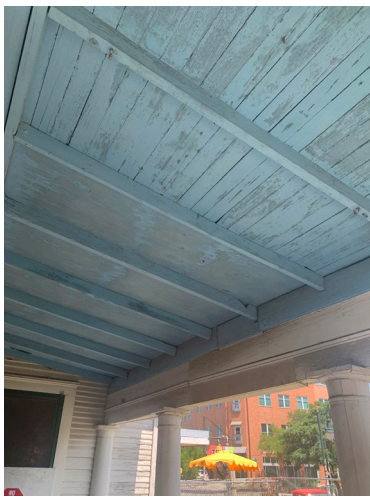
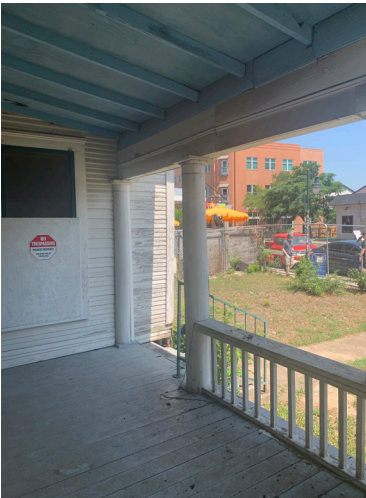
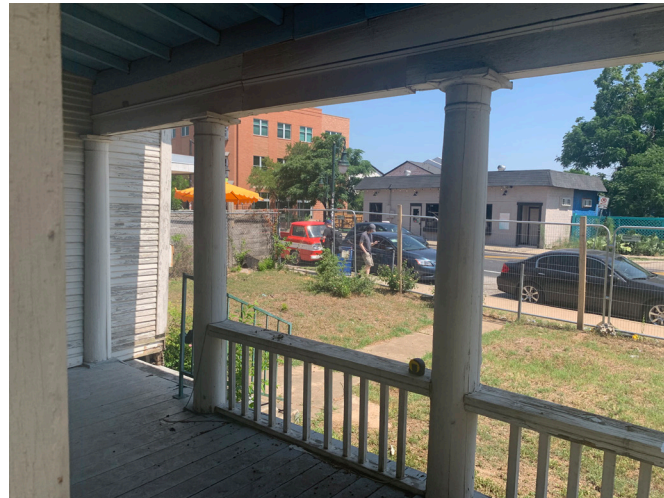
NON-ORIGINAL ALTERATIONS AT DEEPER COVERED PORCH ROOF SUPPORT BEAMS, SHORTENED COLUMNS AND PLYWOOD AT COVERED PORCH CEILING.

- 14. Raise existing bottom of beam elevation and remove detailing not original to structure. Repair existing Doric Columns as required and re-align columns with structural beam at porch edge. Refer to attached additional exhibit photographs for existing beam conditions and detailing.

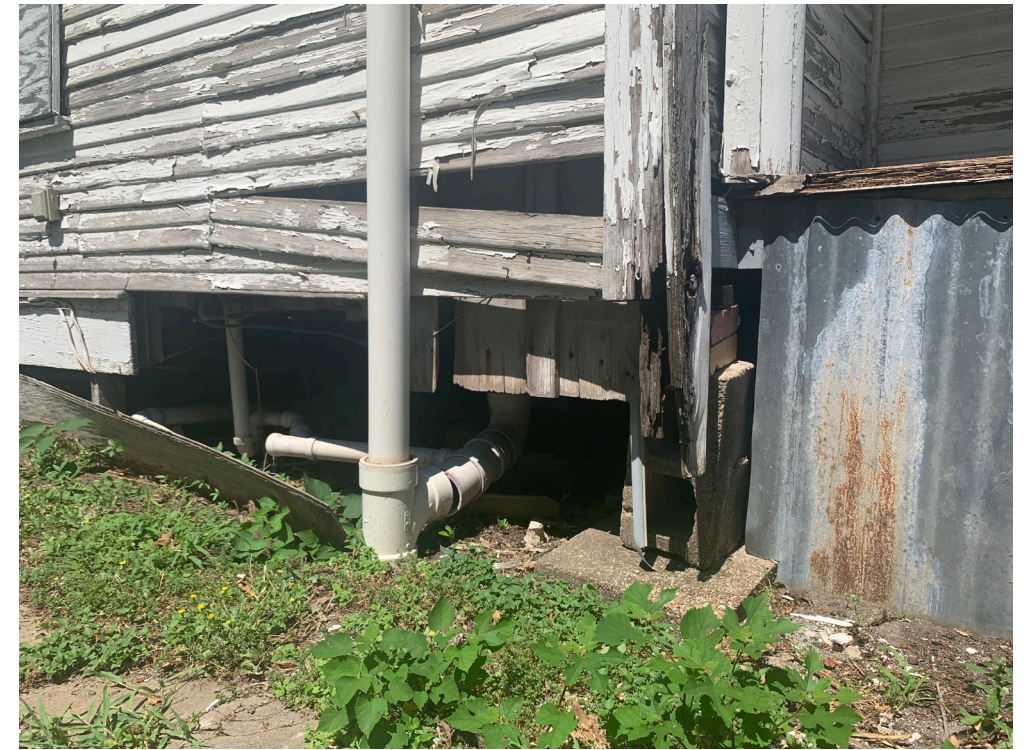
DETERIORATING FOUNDATION, METAL SKIRT AT PORCH DECK AND EXPOSED SOIL STACK.

- 1. Existing wood siding to remain. Repair existing siding.
- 2. Existing period moulding details to remain. Repair existing gable shingles.
- 3. Replace corrugated metal skirt with wood lattice painted to match siding to not detract from home aesthetic.

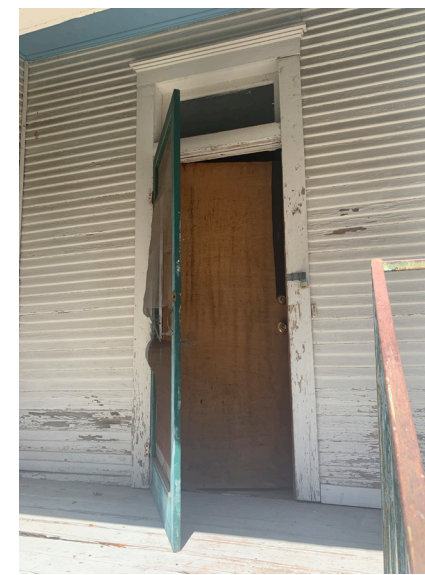
REPLACE NON-ORIGINAL SIDE ENTRANCE DOOR

- 15. Replace existing door. Door is falling apart and not original to home.
- 16. Remove existing concrete steps and replace with wood to match porch. New steps relocated to accommodate ADA compliant lift.

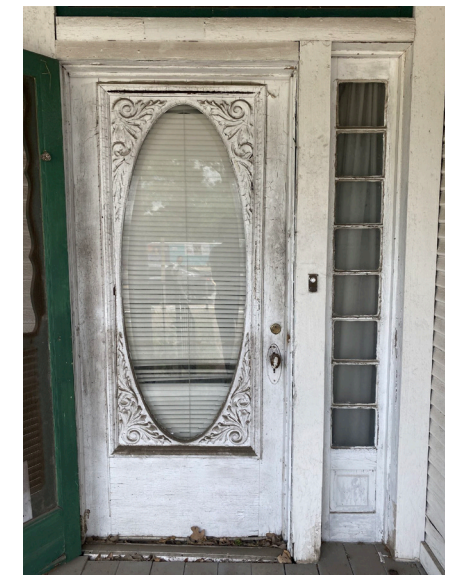
REFRESH FRONT ENTRANCE DOOR

- 12. Strip, repair and repaint existing front door to reflect Late Queen Anne period. Swap door swing to open out.
- 13. Repair existing windows where possible. Replace with wood windows to match existing style/size/ material when necessary.
