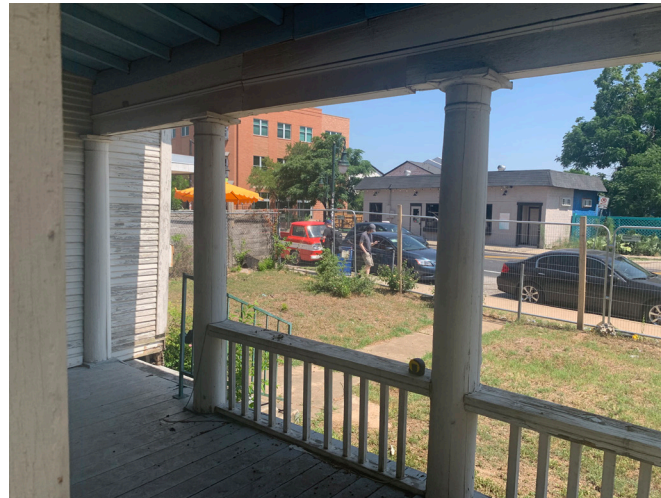
NON-ORIGINAL ALTERATIONS AT DEEPER COVERED PORCH ROOF SUPPORT BEAMS, SHORTENED COLUMNS AND PLYWOOD AT COVERED PORCH CEILING.

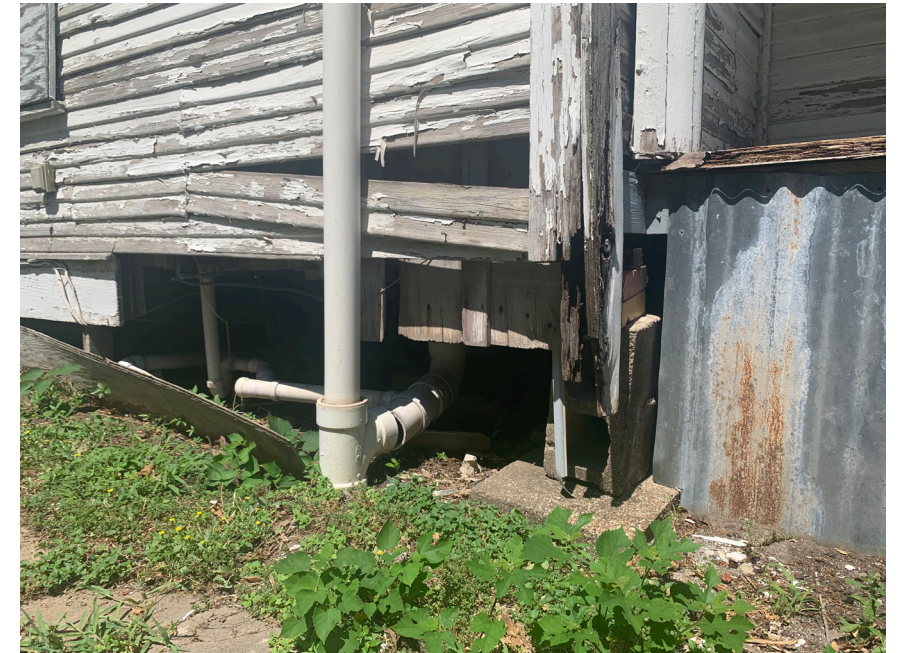
DETERIORATING FOUNDATION, METAL SKIRT AT PORCH DECK AND EXPOSED SOIL STACK.
