RYAN STREET
ARCHITECTS

2002 SCENIC DRIVE RESIDENCE, EXISTING CONDITIONS | JUNE 28, 2022

2002 SCENIC DRIVE
EXISTING CONDITIONS

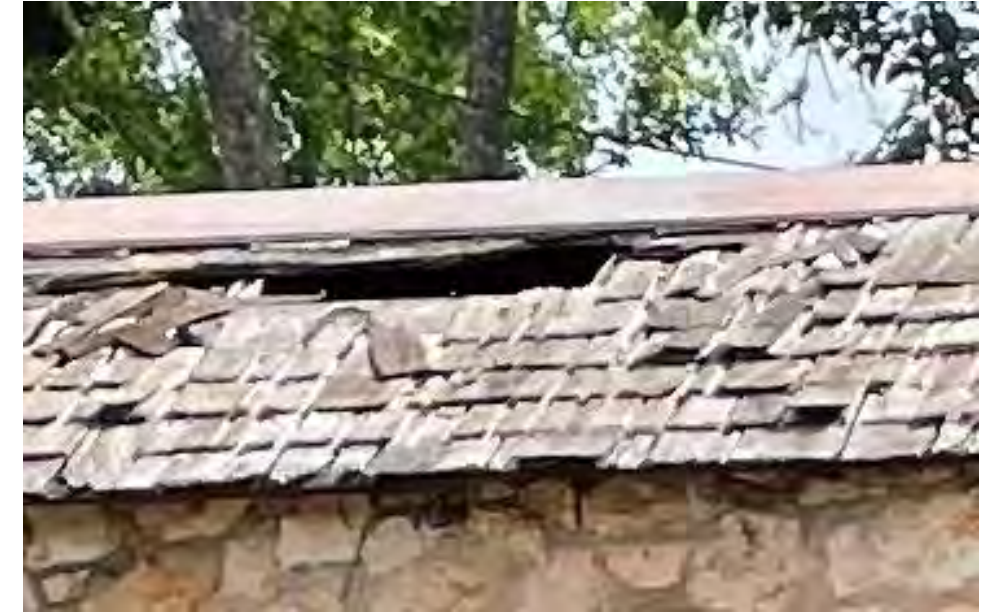
1. ROOF DAMAGE INDICATED BY DISPLACED, DAMAGAGED AND MISSING SHINGLES. HOLES IN THE ROOF POINT TO BROAD WATER DAMAGE WITHIN AND POTENTIAL DAMAGE TO STRUCTURE.
2. WOOD WINDOWS - JAMBS, SILLS, AND FRAME ARE ROTTED. BROKEN PANES THROUGHOUT.

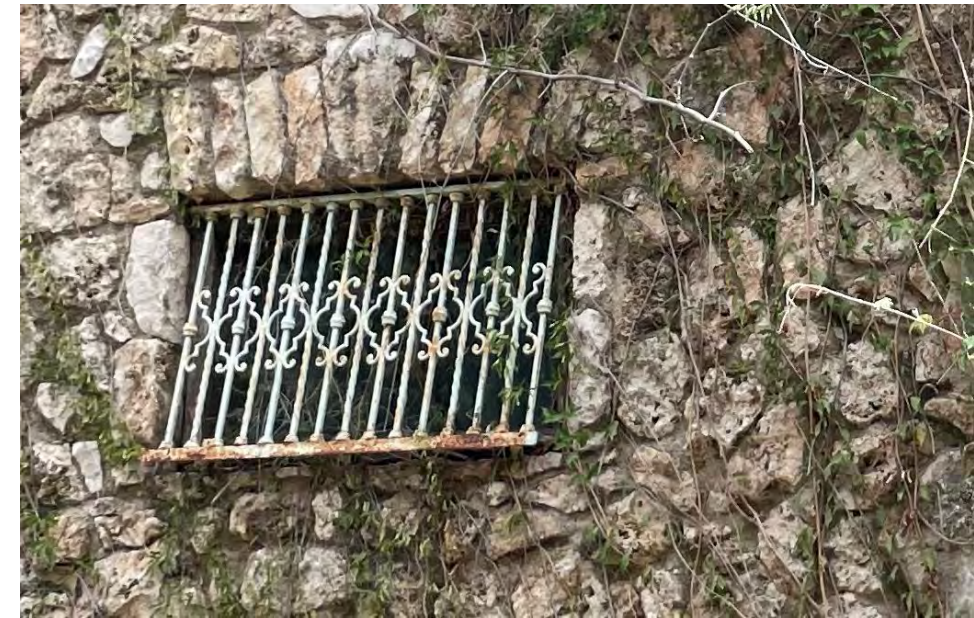
1. METAL IS RUSTED AND VINES ARE ENTERING INTO APARTMENT.
2. WOOD WINDOWS - JAMBS, SILLS, AND FRAME ARE ROTTED. BROKEN PANES THROUGHOUT. VINES ARE OVERGROWN AND ARE ENTERING INTO THE INTERIOR.

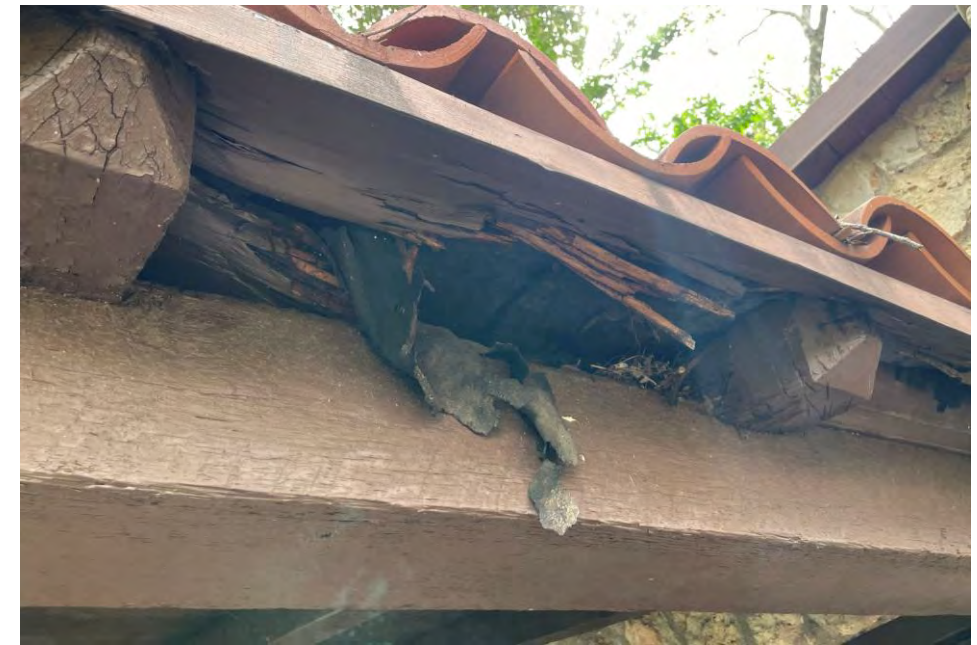
1. THE ROOF IS FALLING APART AND IS SHOWING SIGNS OF WATER DAMAGE.
2. THE ROOF IS SLANTING, WHICH IS A SIGN OF STRUCTURAL FAILURE AND MATERIAL DETERIORATION.

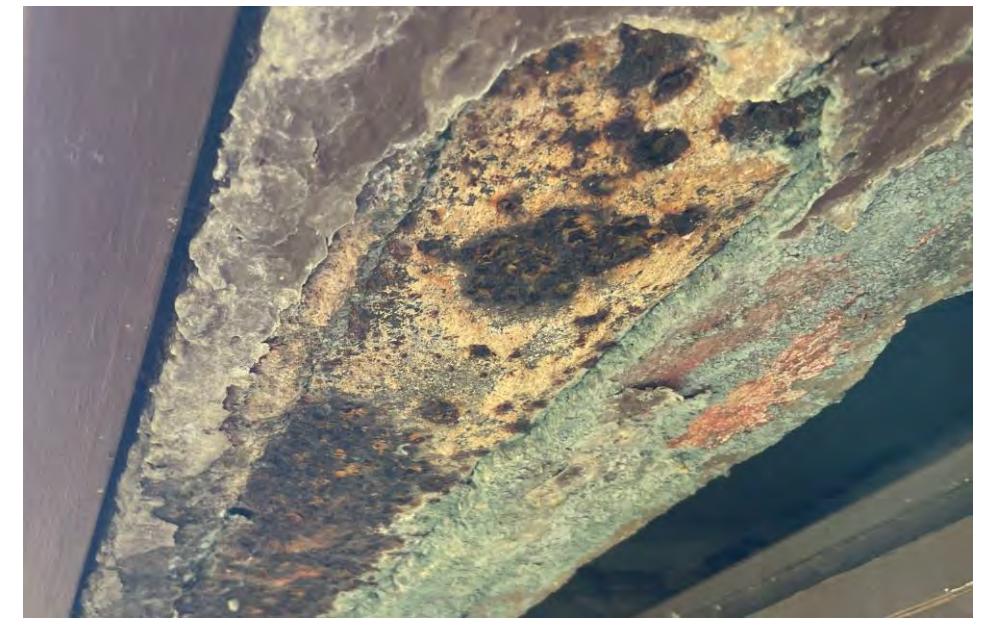
1. THE UNDERSIDE OF THE GARAGE ROCK WALL IS SHOWING SIGNS OF MOLDING.
2. THE ROOF OF THE GARAGE IS MOLDING AND HAS WATER DAMAGE.

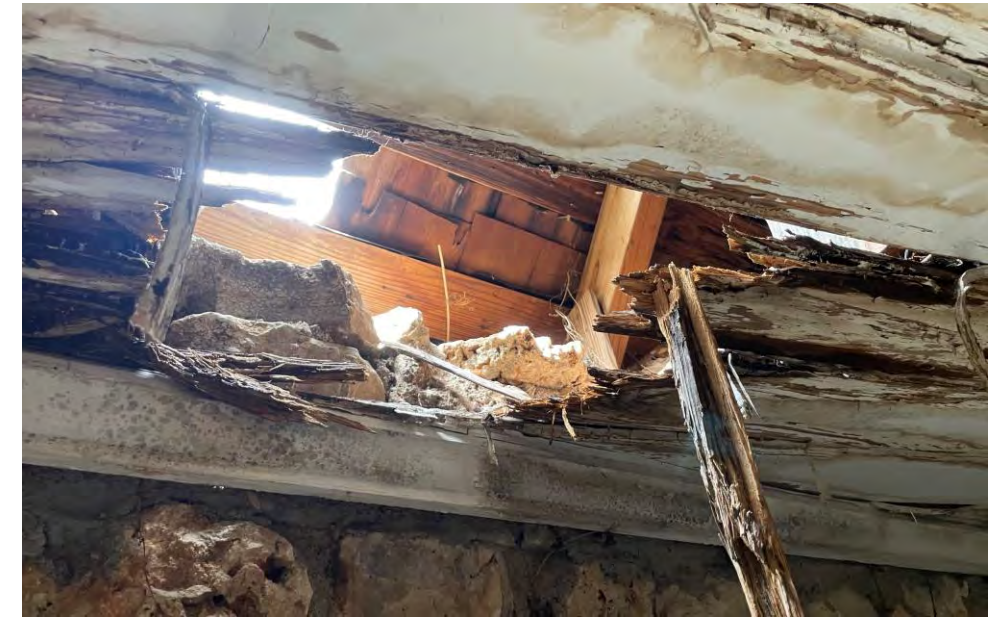
1. HOLES IN CEILING AND ROOF – SKY VISIBLE THROUGH INTERIOR CEILINGS AND ROOF. VINES HAVE INVADDED STRUCTURE THROUGH BOTH ROOF AND BROKEN WINDOWS.
2. WATER DAMAGE – EVIDENCE OF LONG-TERM WATER DAMAGE APPARENT ON CEILINGS, WALLS, AND FLOORS.

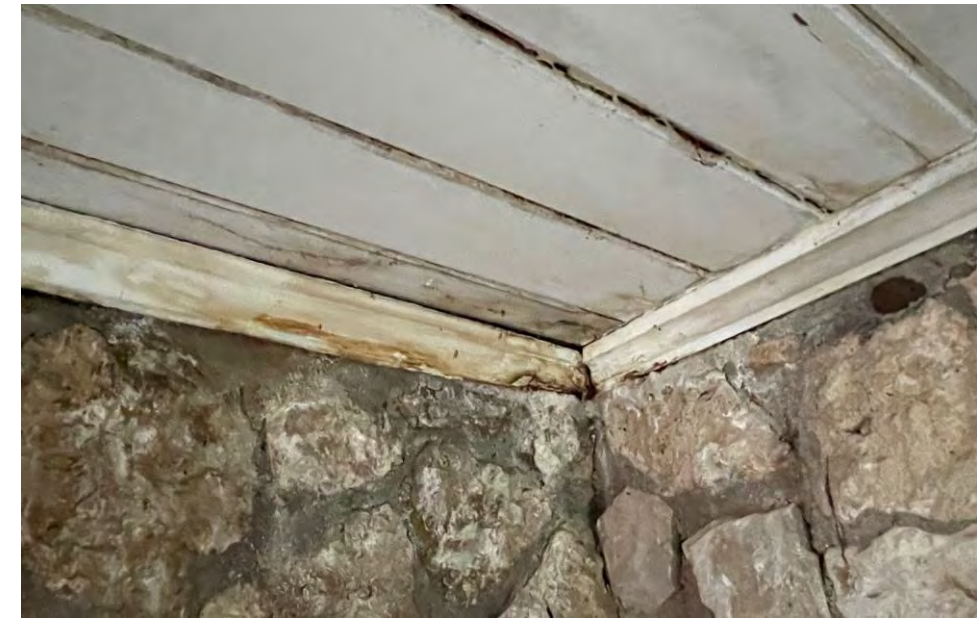
1. DISCOLORATION AND ROT SHOWS SIGNS OF WATER DAMAGE.
2. WATER DAMAGE - DISCOLORATION AND DEBRIS INDICATE LONG-TERM WATER DAMAGE ON CEILINGS, WALLS, AND FLOORS.

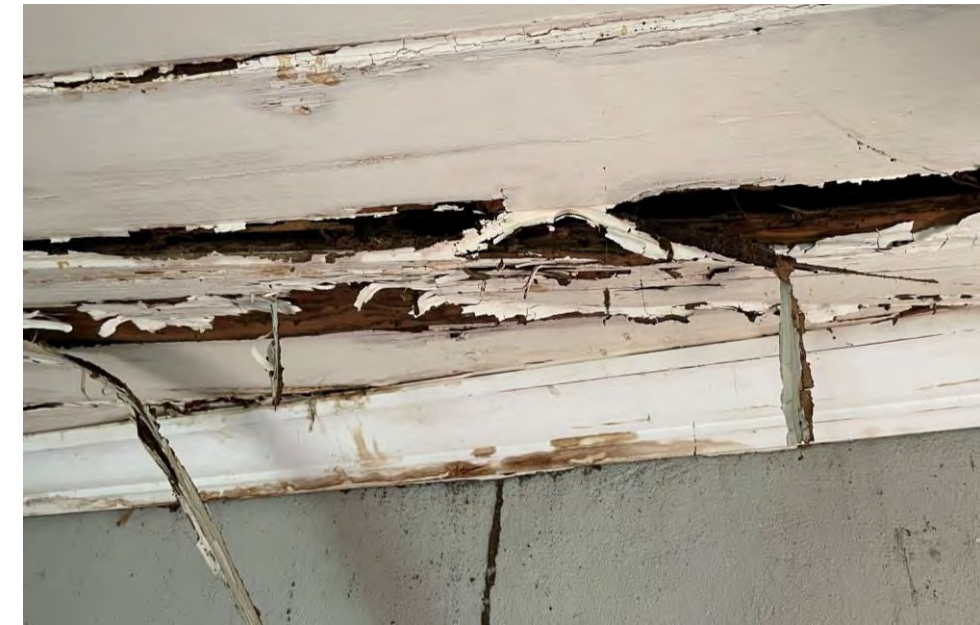
1. THE CEILING IS BOWED AND SHOWS SIGNS OF WATER DAMAGE AND DETERIORATION.
2. DUE TO THE CEILING FAILURE, DIRT AND DEBRIS ARE COLLECTING ON THE FLOOR BELOW.

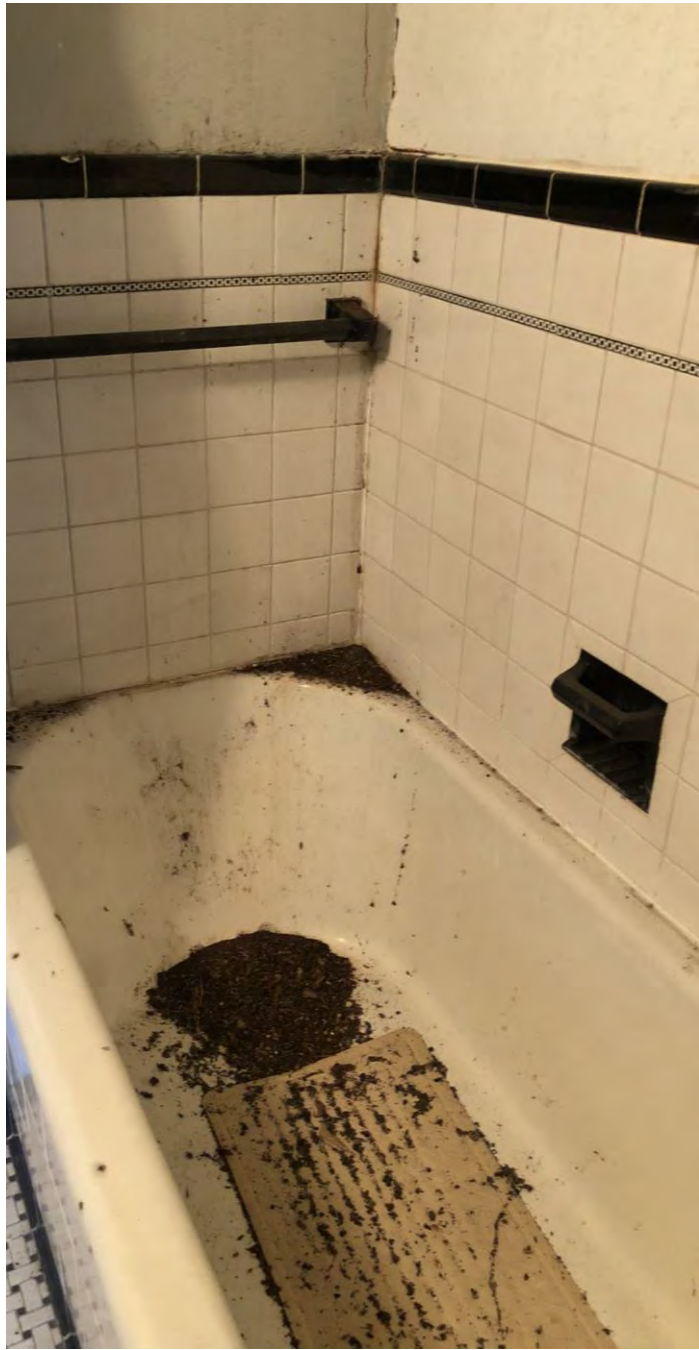
1. DEBRIS HAS COLLECTED INSIDE THE BATHTUB, SHOWING WATER DAMAGE AND CEILING FAILURE.
2. THE CEILING HAS MOLD GROWING ON THE SURFACE OF THE WOOD, WHICH IS CAUSING FAILURE AND COMPROMISING THE MATERIAL.

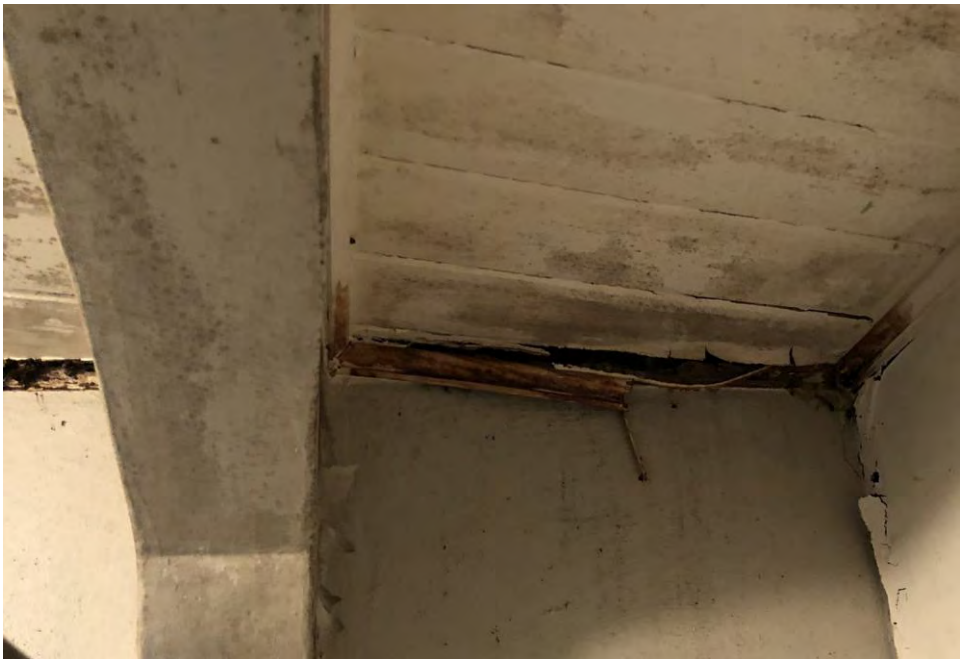
3. THE CEILING IN THE BATHROOM IS DETERIORATING AND MOLDING.
4. THE CEILING OVER THE BATHTUB IS DETERIORATING AND ALLOWING DEBRIS TO COLLECT IN THE TUB.

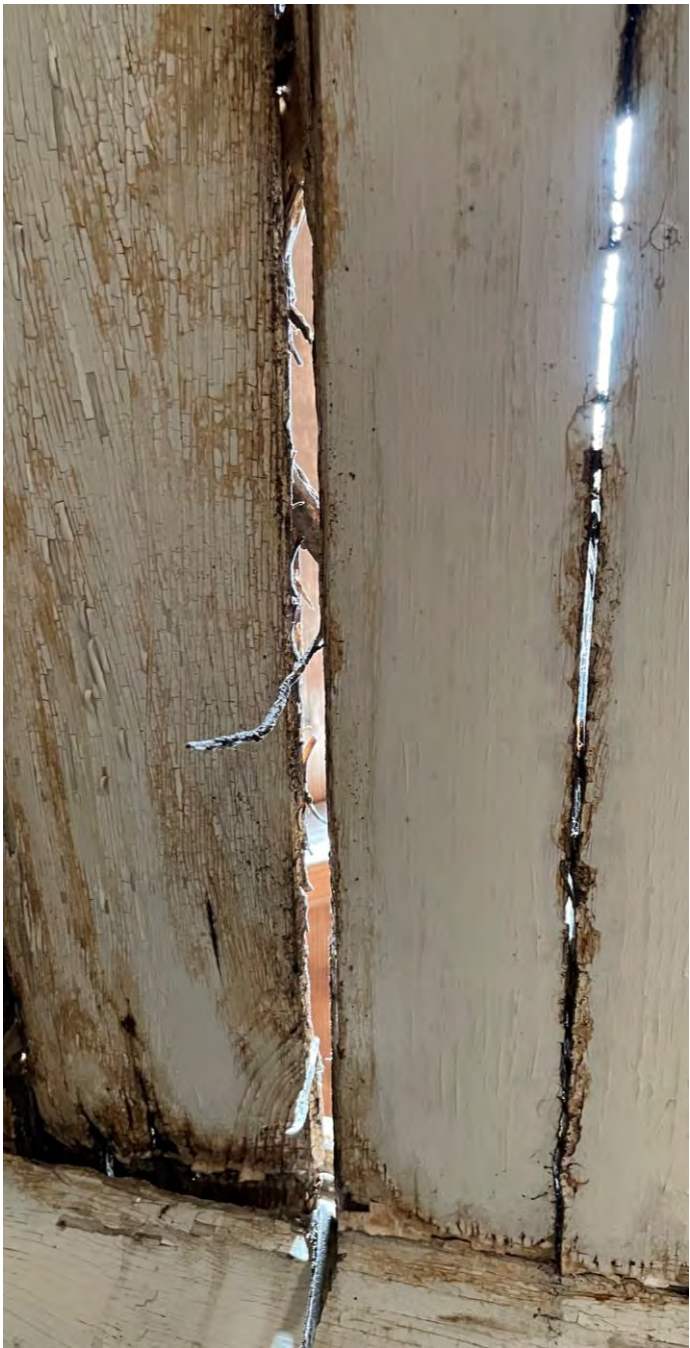
1. WOOD CEILING IS ROTTED, FALLING APART, AND SEPERATING.
2. CEILING FAILURE HAS OPENDED THE INTERIOR UP TO EXTERIOR LIGHT, WATER, AND AIR. WATER DAMAGE CAN BE SEEN ON THE WALL AND CEILING.
3. THE KITCHEN CEILING AND STRUCTURE HAS DETERIORATED AND IS FALLING APART.

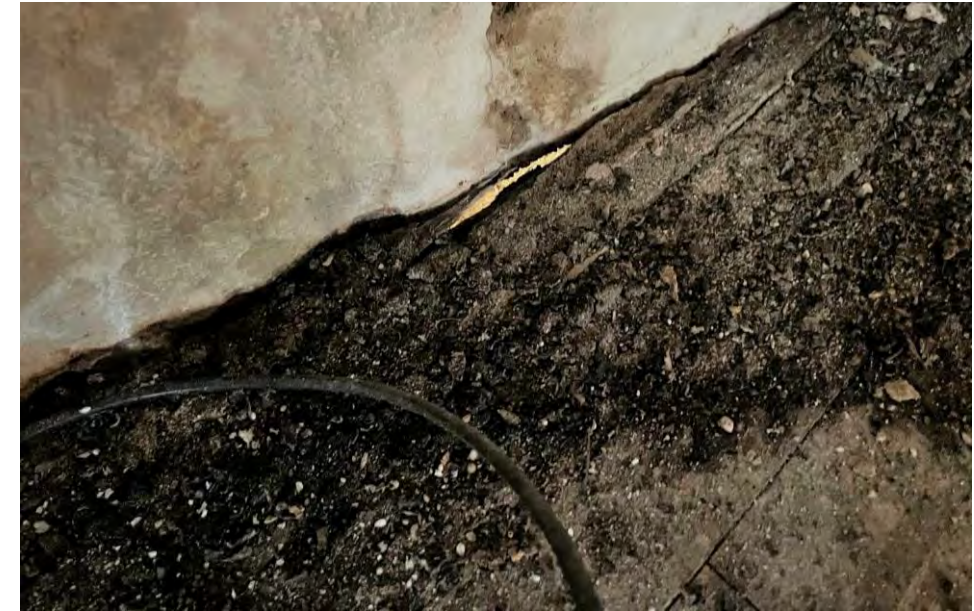
1. CEILING FAILURE HAS ALLOWED DEBRIS AND DIRT TO COLLECT INSIDE THE APARTMENT. THE WOODEN FLOOR IS CRACKING AND DETERIORATING FROM WATER DAMAGE.
2. THE WOODEN FLOOR IS FALLING APART AND SEPERATING FROM THE WALL.

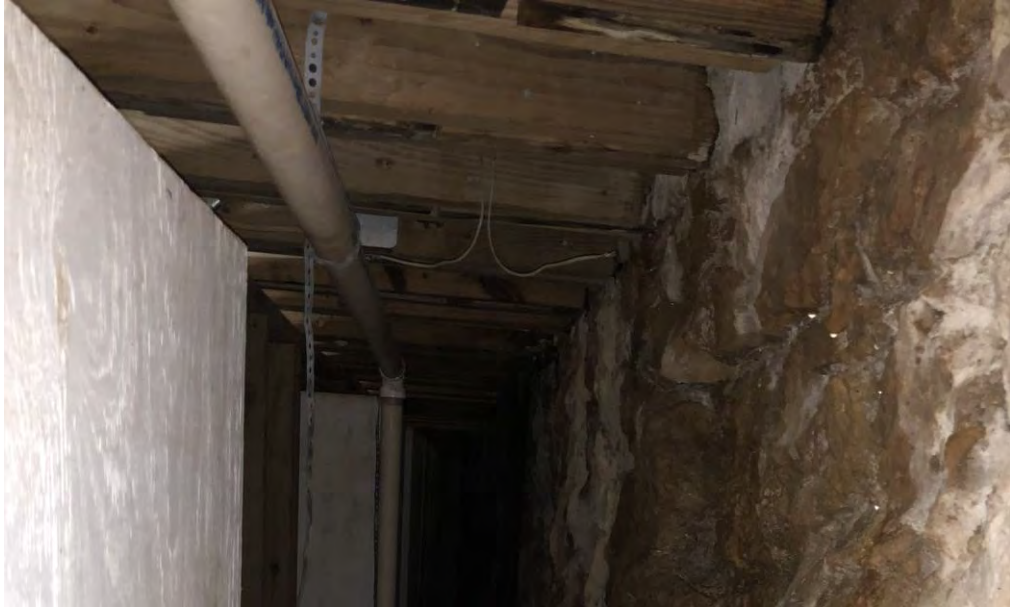
1. WATER IS LEAKING THROUGH THE RETAINING WALL AND INTO THE APARTMENT. WATER CAN ACTIVELY BE SEEN DRIPPING DOWN THE ROCK WALL.
2. IN ORDER TO HOLD UP THE SECOND FLOOR, RAILWAY TIES ARE USED AS STEEL BEAMS.
3. WATER IS DRIPPING DOWN THE ROCK AND FINDS ITS WAY TO THE STRUCTURE'S CONCRETE BASE.

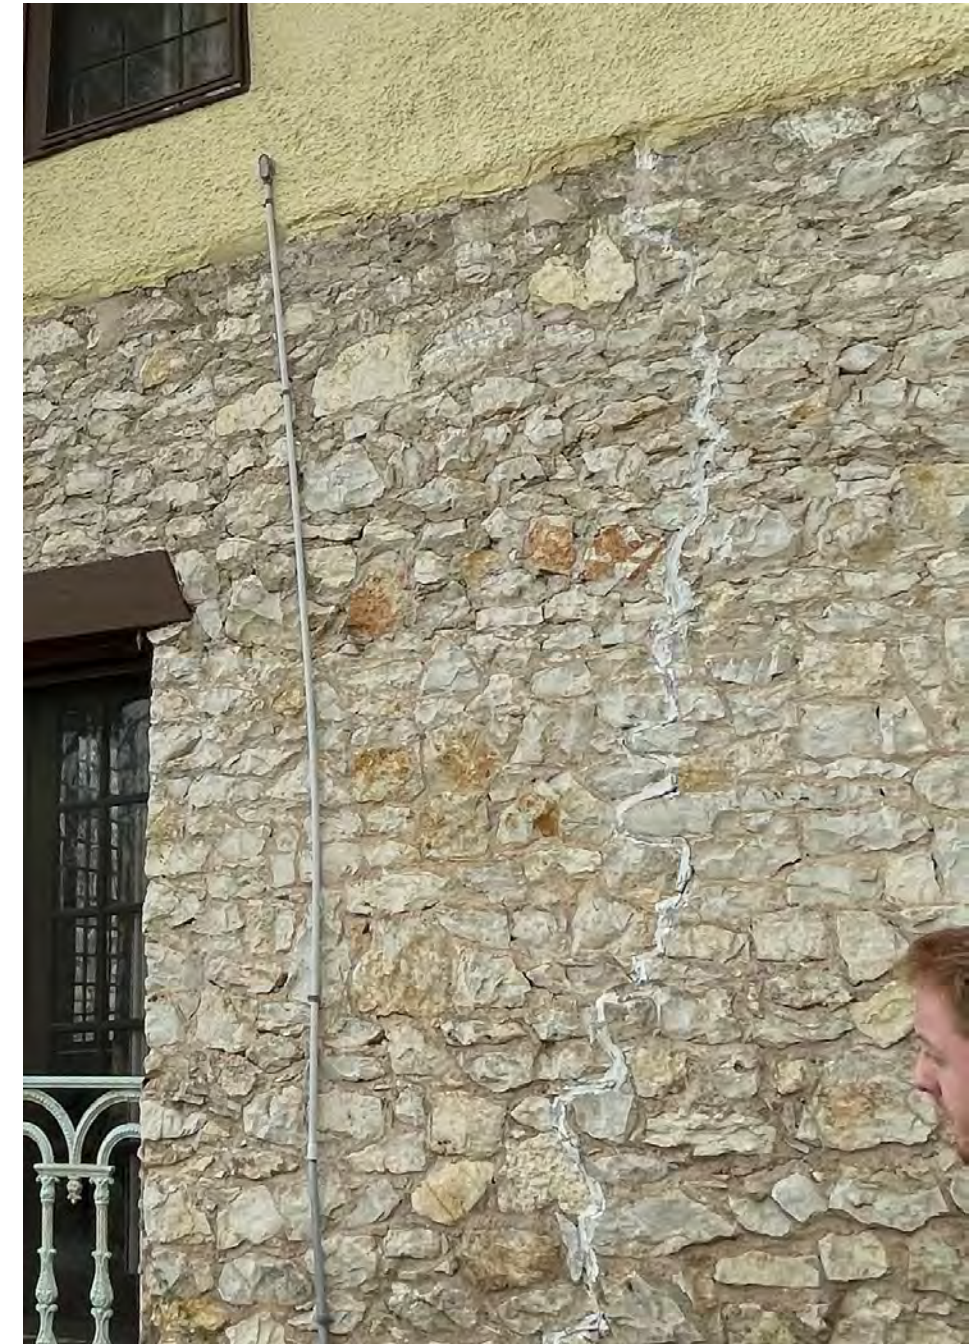
1. THERE IS A CRACK THAT STARTS AT THE ROOF, GOES THROUGH THE STUCCO SECOND FLOOR, AND CONTINUES THROUGH THE STONE WALL TO THE GROUND. IT HAS BEEN FILLED AND COVERED WITH PLASTER. THE BOTTOM OF THE STONE WALL SHOWS WATER DAMAGE.

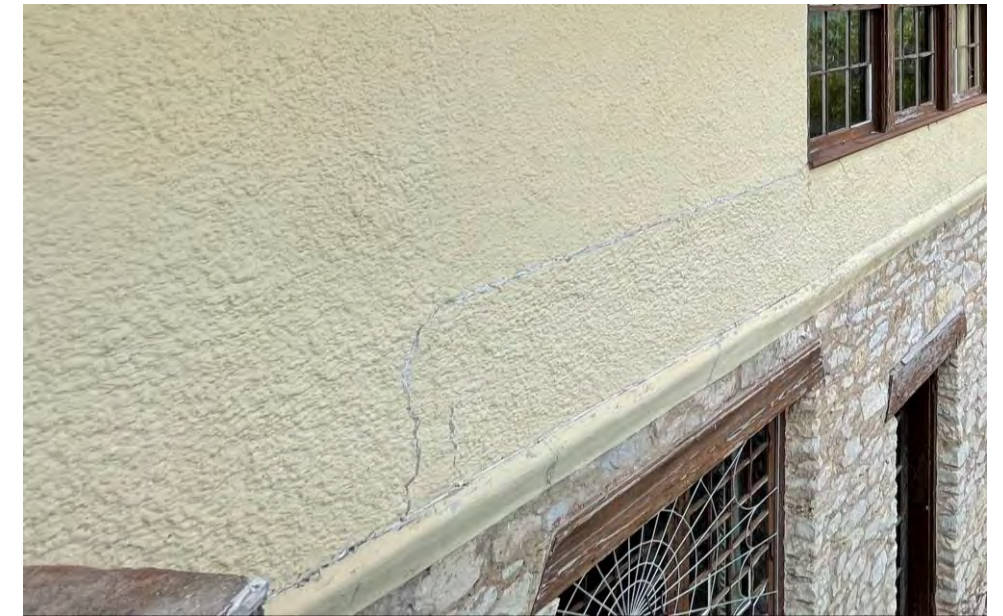
1. THERE IS A CRACK THAT STARTS AT THE STUCCO SECOND FLOOR WALL AND RUNS DOWN FROM THERE.
2. THE CRACK CONTINUES THROUGH THE ROCK FIRST FLOOR WALL. THE WATER DAMAGED STONE CAN BE SEEN AT THE BOTTOM OF THE WALL.

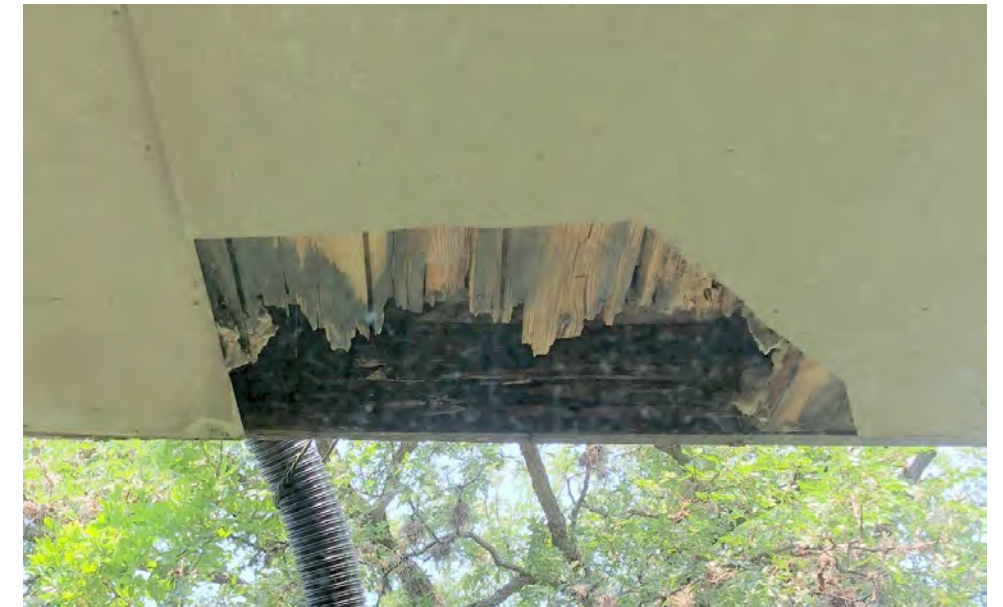
1. THE ROOF SOFFIT IS DETERIORATING AND FALLING APART.
2. THE WOOD STRUCTURE WITHIN THE ROOF IS EXPOSED.

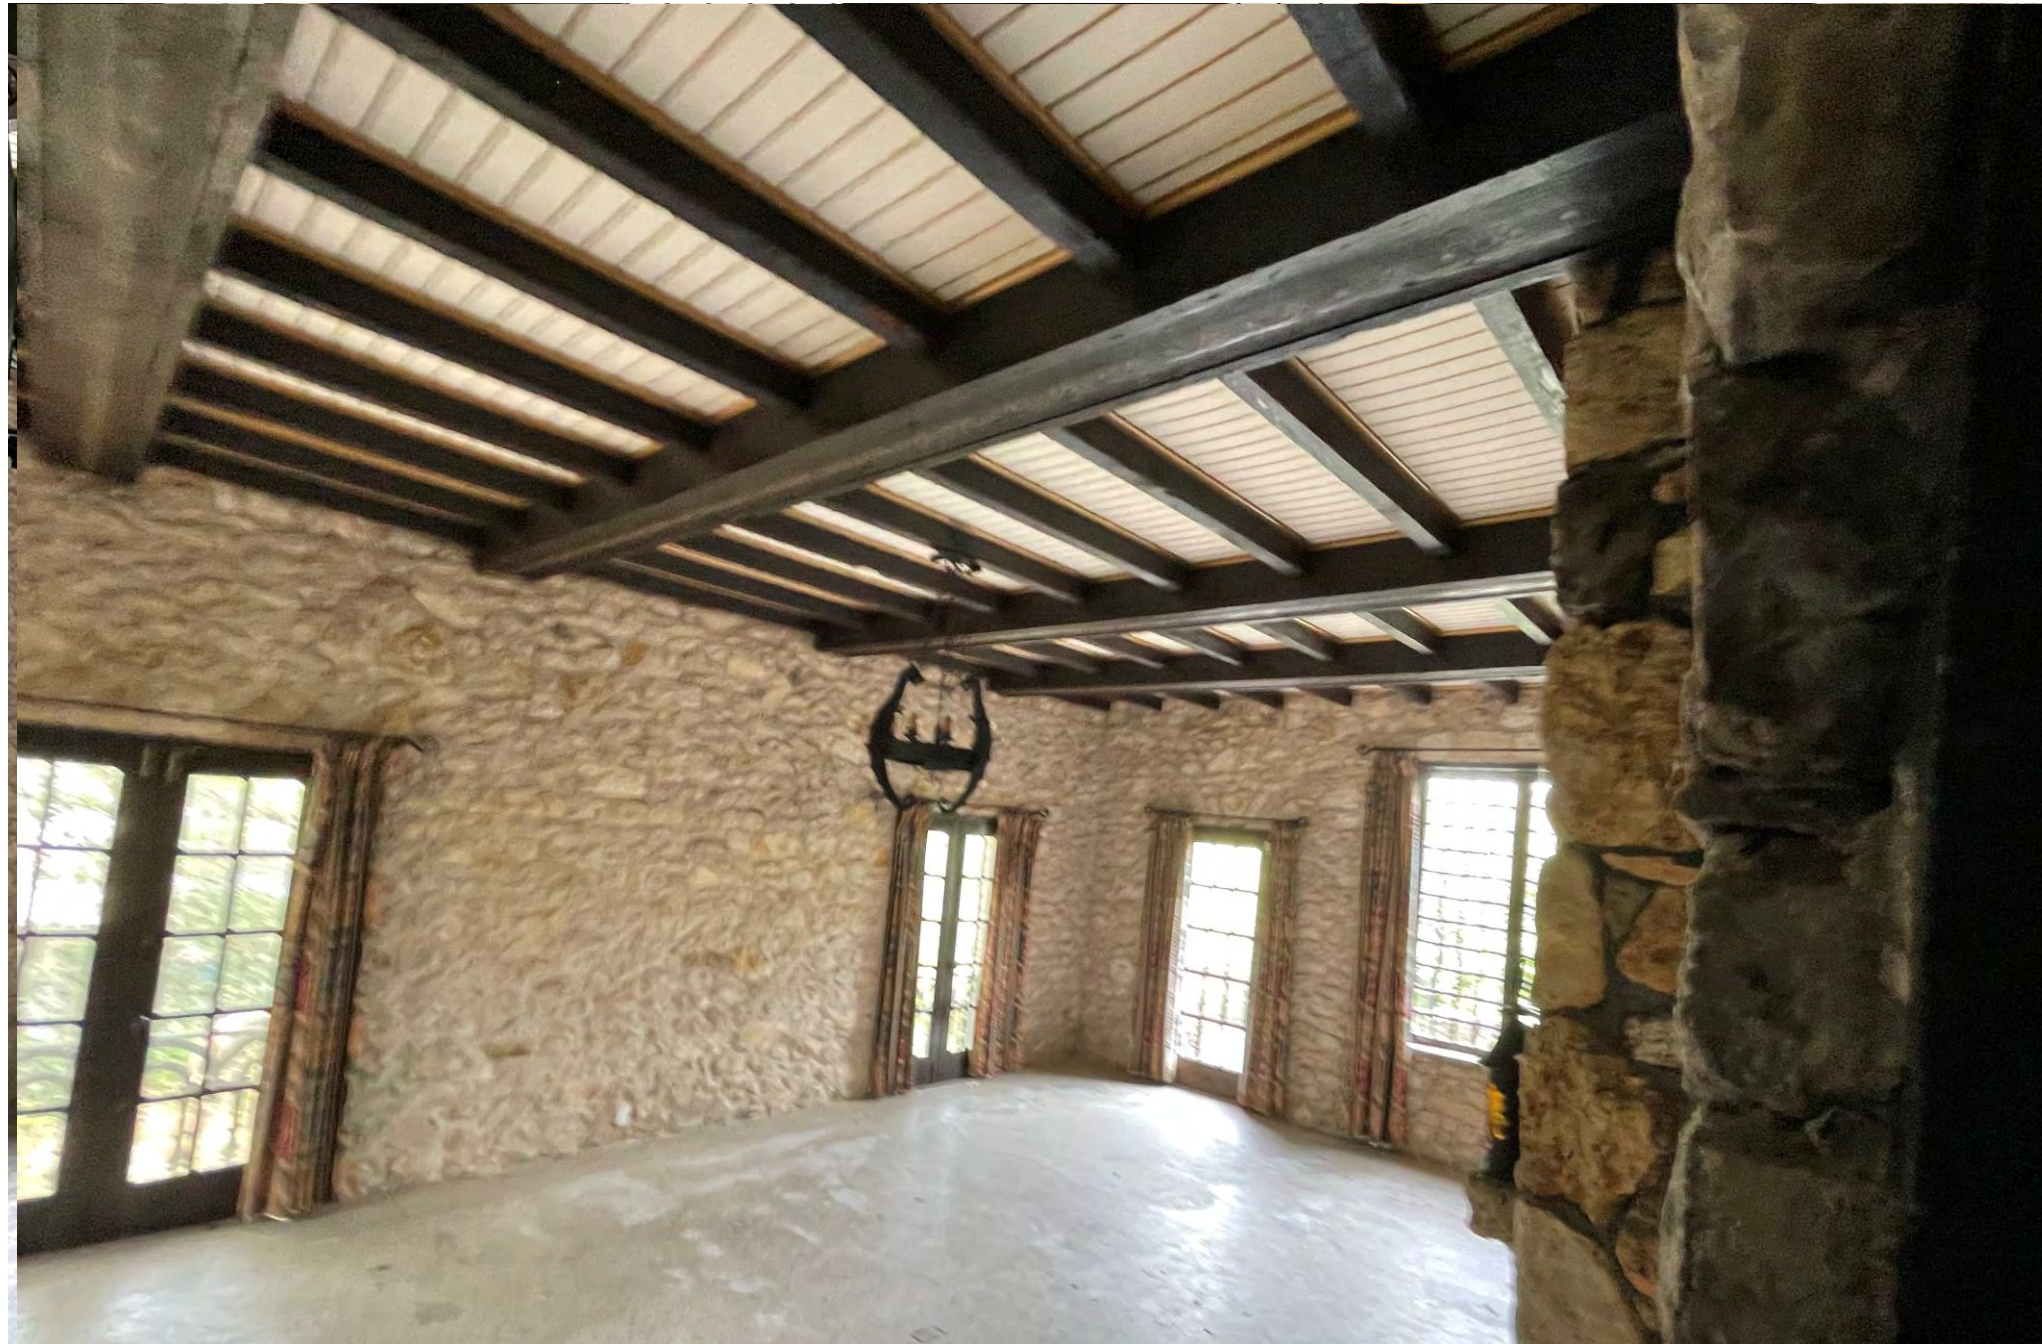
1. A STRUCTURAL ENGINEER HAS INDICATED THAT THESE BEAMS ARE INADEQUATE OF BEING STRUCTURALLY CAPABLE TO HOLD THE LOAD OF THE SECOND FLOOR.

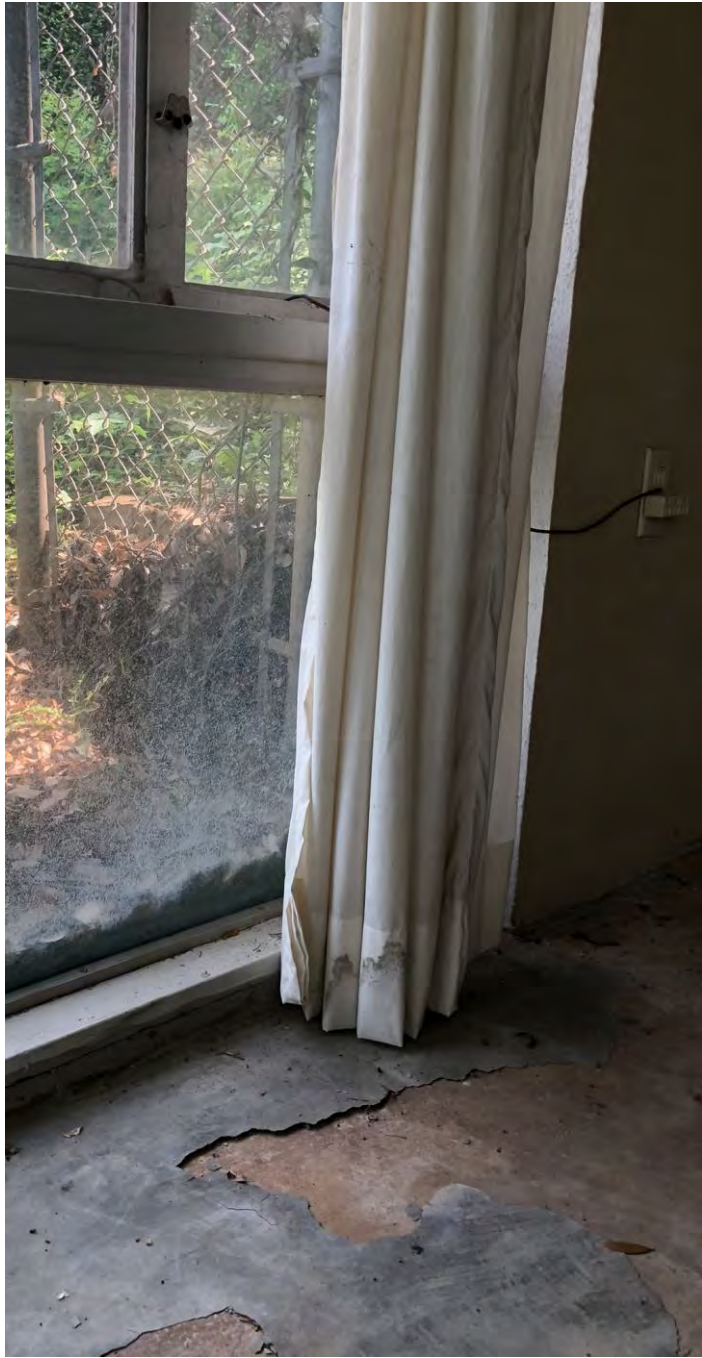
1. THE FLOOR IS DAMAGED AND FLAKING. ON THE EXTERIOR, THE HEIGHT OF THE GROUND IS HIGHER THAN THE HEIGHT OF THE WINDOW SILL, ALLOWING WATER TO FLOW INTO THE HOUSE.
2. WATER IS DAMAGING THE CEILING IN LARGE AREAS. BLACK MOLD IS EVIDENT IN MULTIPLE LOCATIONS.
3. IN THIS LOCATION THE WATER DAMAGE IS ESPECIALLY EVIDENT AND DESTRUCTIVE. MOLD IS A POTENTIAL HEALTH HAZARD AND WOULD REQUIRE AN EXTENSIVE MITIGATION EFFORT.

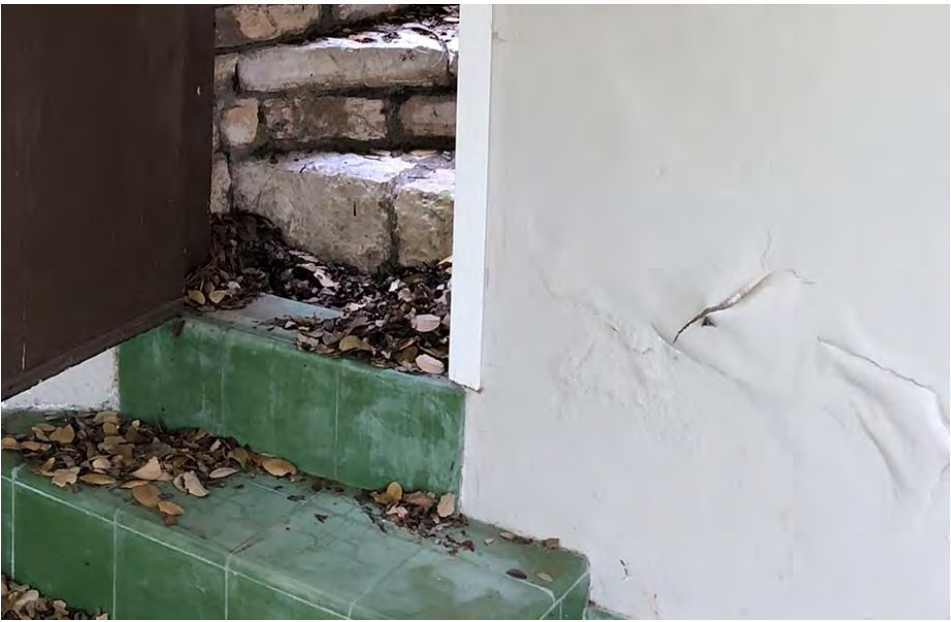
1. THE PLASTER DRYWALL IS FALLING APART AND CRACKING. THE DOOR IS TOO SMALL AND IS UP AGAINST STONE STAIRS.
2. THE PLASTER IS CRACKED AND FALLING APART.

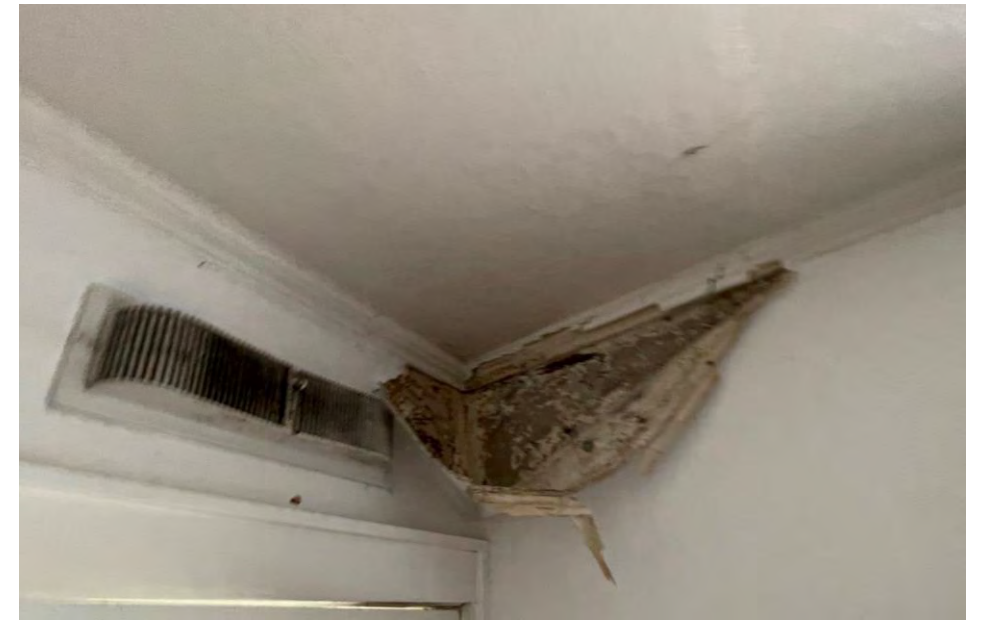
1. THE PLASTER AND THE TRIM ARE FALLING APART AND EXPOSING THE WALL BENEATH.
2. THE PLASTER IS CRACKING.

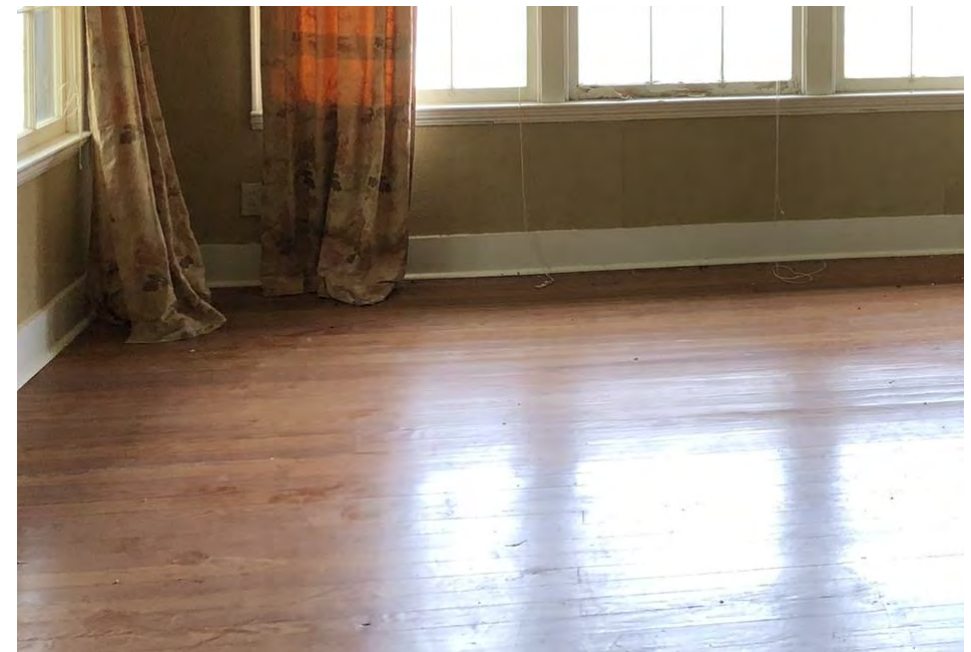
1. THE WINDOWSILL IS FALLING APART AND IS DROPPING DEBRIS ONTO THE WINDOW SILL AND FLOOR.
2. THE FLOOR IS BOWING DUE TO THE LACK OF STRUCTURAL SUPPORT BELOW.

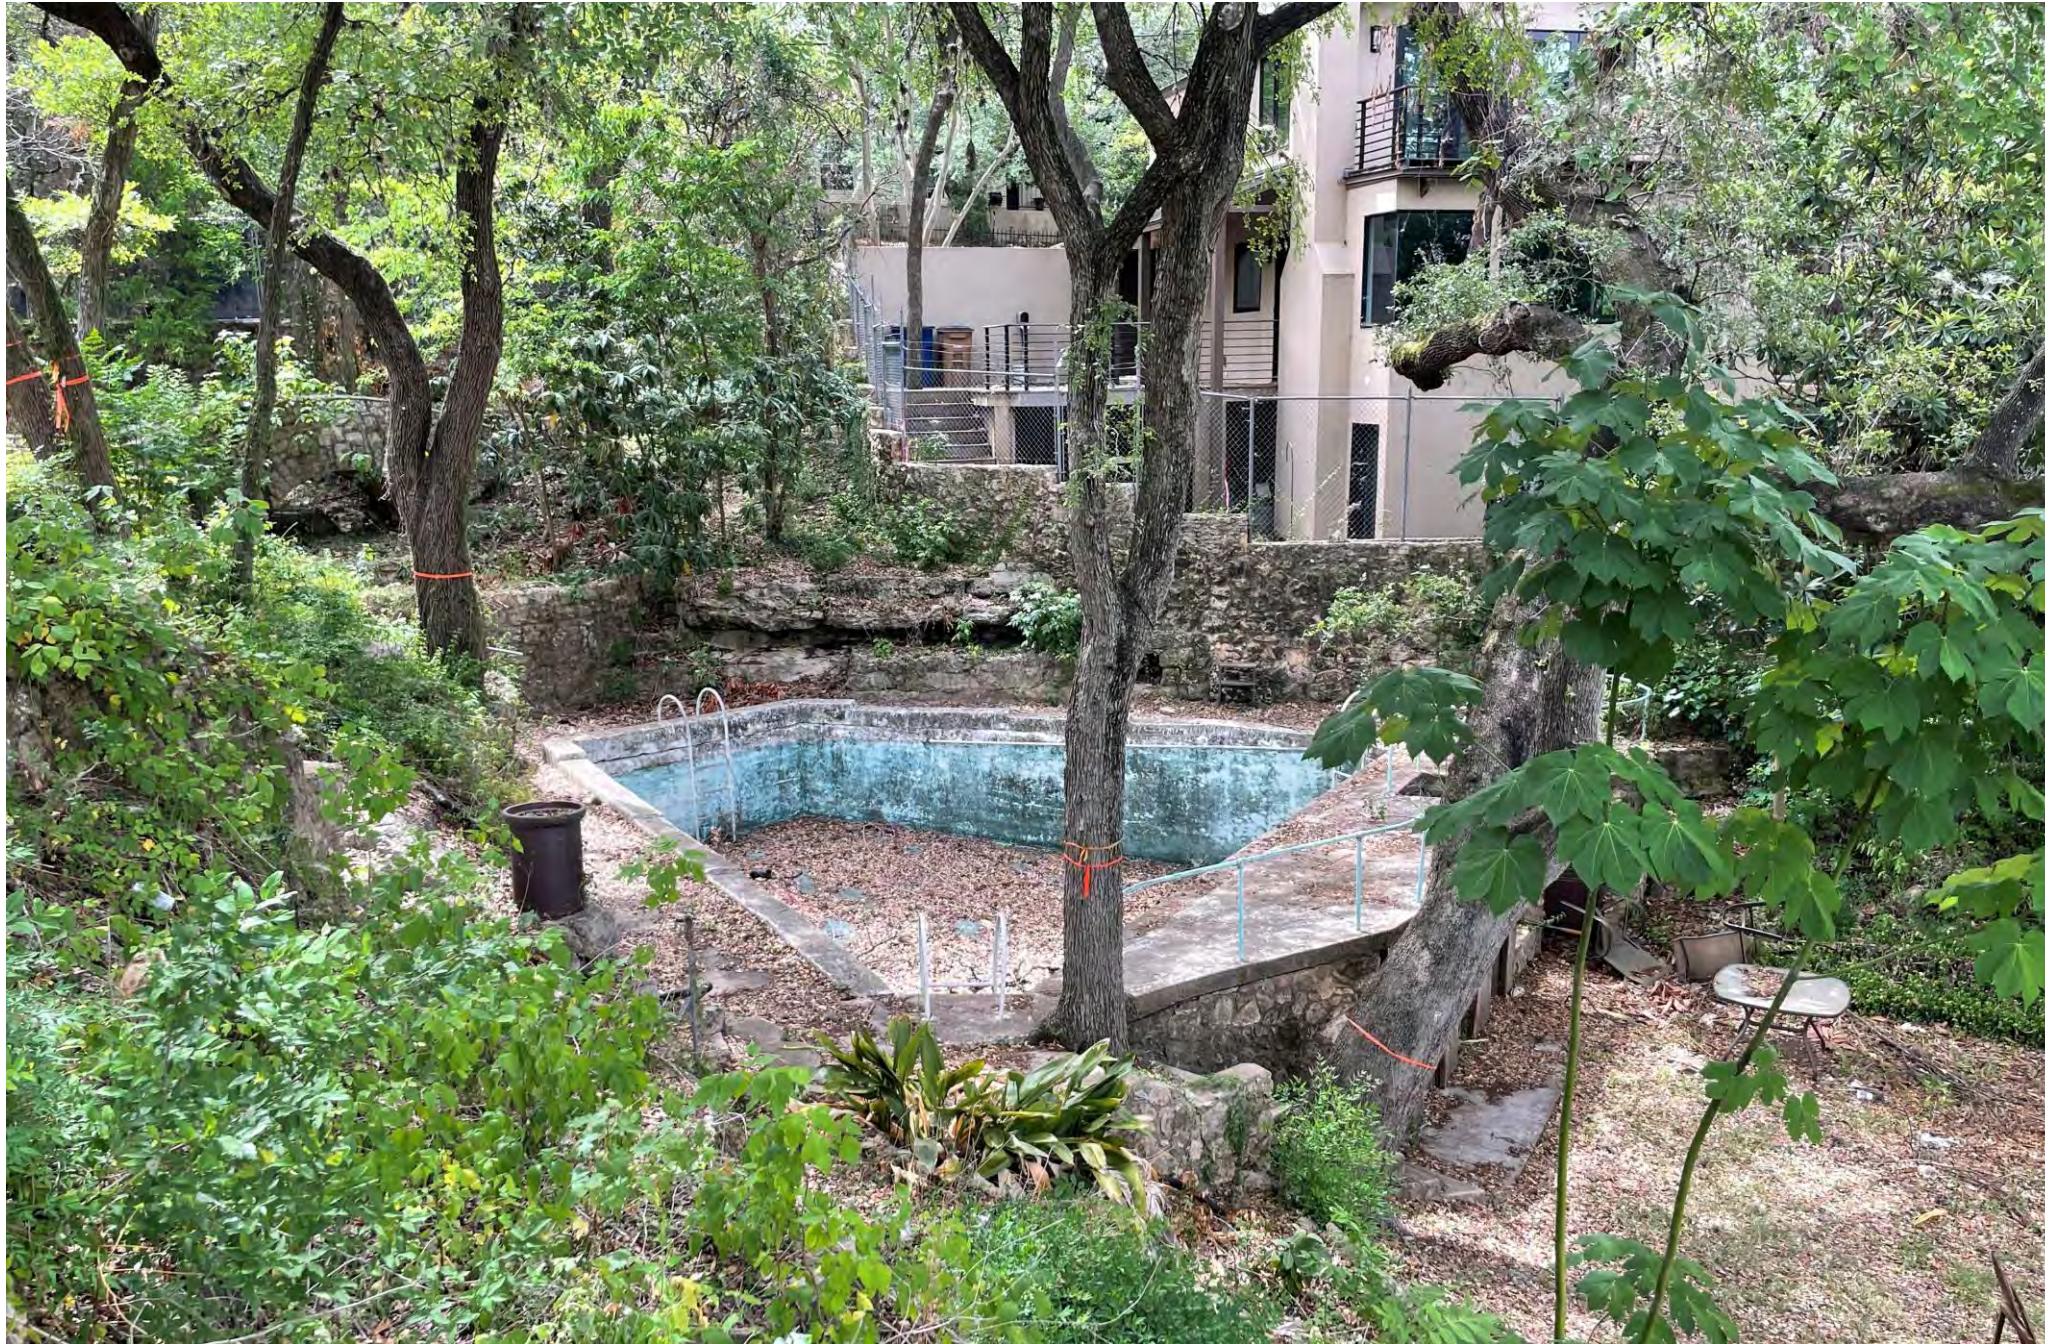
1. THE POOL'S STONE AND CONCRETE ARE SPLITTING APART AND CRACKING.

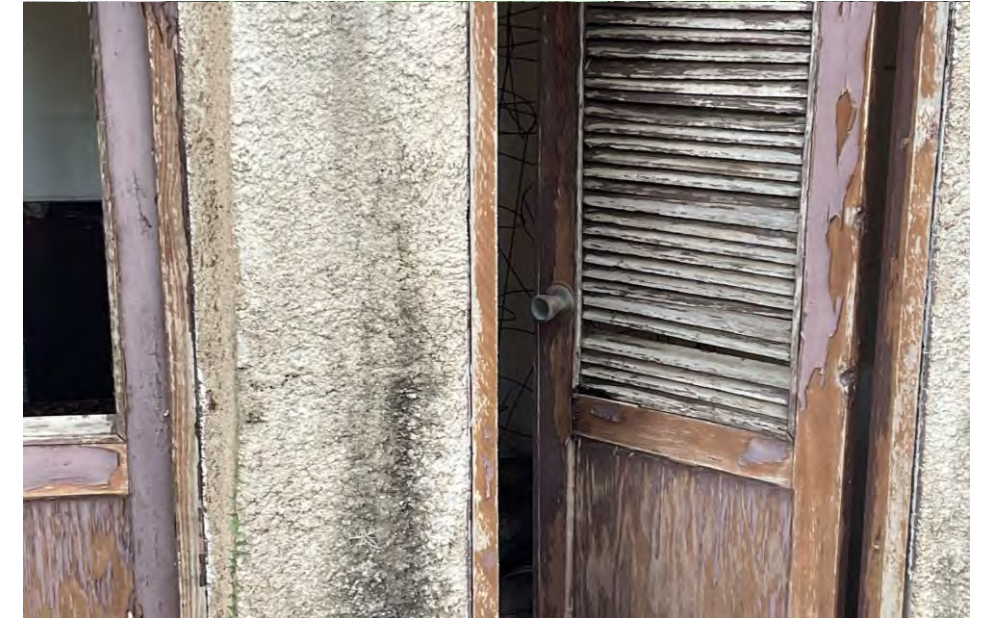
1. CHANGING ROOMS - THE CONCRETE WALLS ARE SHOWING SIGNS OF WATER DAMAGE. THE WOOD DOORS ARE FALLING APART.
2. CHANGING ROOMS – ON THE INSIDE OF THE CHANGING ROOMS, THE WALLS ARE CRACKING AND THE FOUNDATION IS DAMAGED. DEBRIS IS COVERING THE FLOOR.

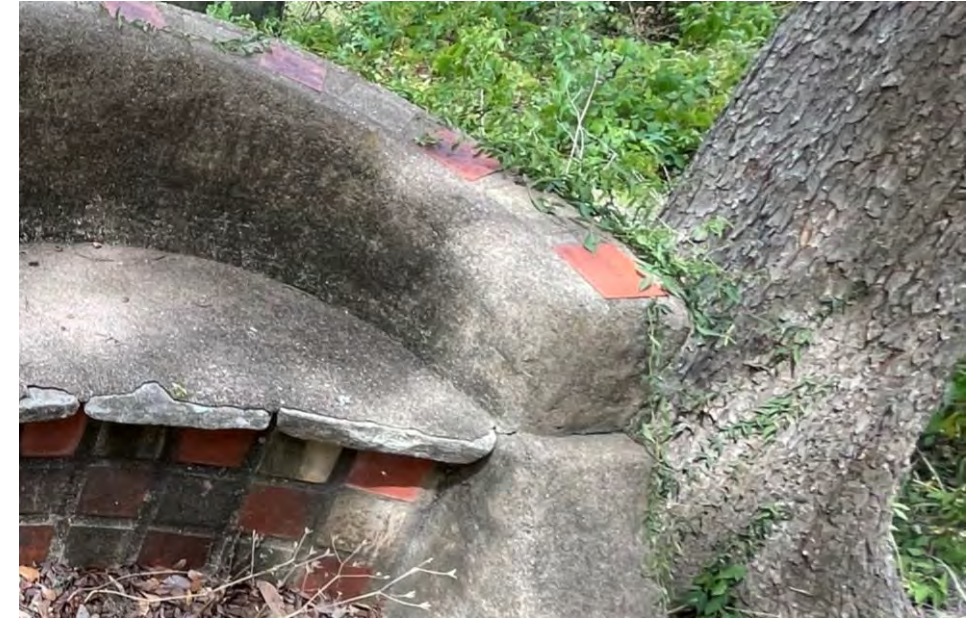
1. FRONT OF BENCH – THE FINISH OVER THE CONCRETE BENEATH IS PEELING OFF.
2. BACKSIDE OF BENCH – THE BENCH IS CRACKED AND IS IN DISREPAIR.
