RYAN STREET
ARCHITECTS

2002 SCENIC DRIVE RESIDENCE, EXISTING CONDITIONS | JUNE 28, 2022

2002 SCENIC DRIVE
EXISTING CONDITIONS

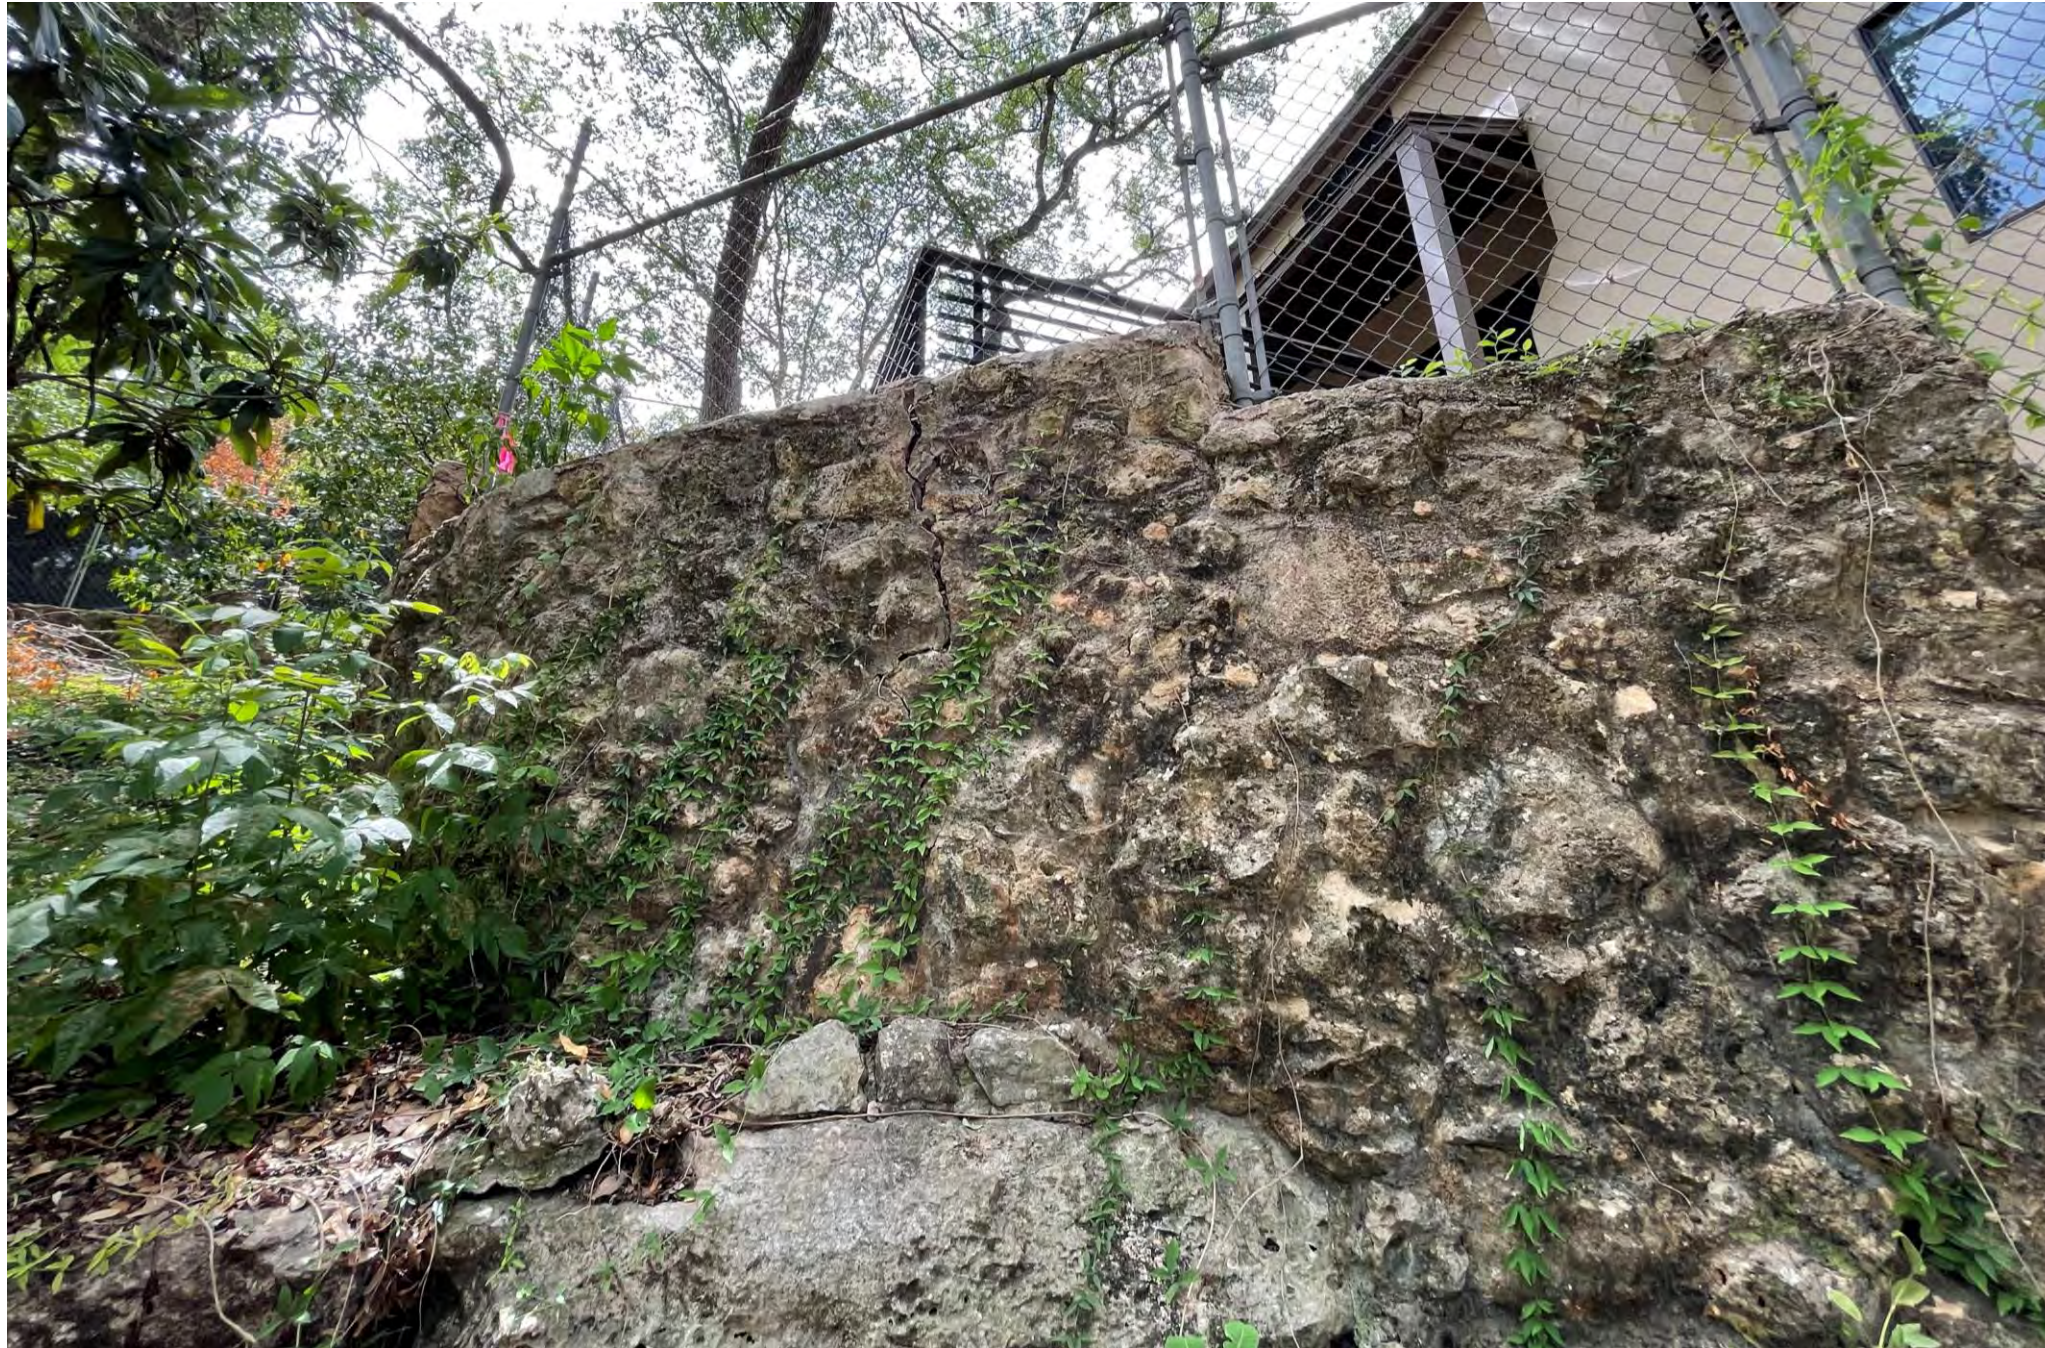
1. WALL IS CRACKING AND SPLITTING APART IN THIS LOCATION.

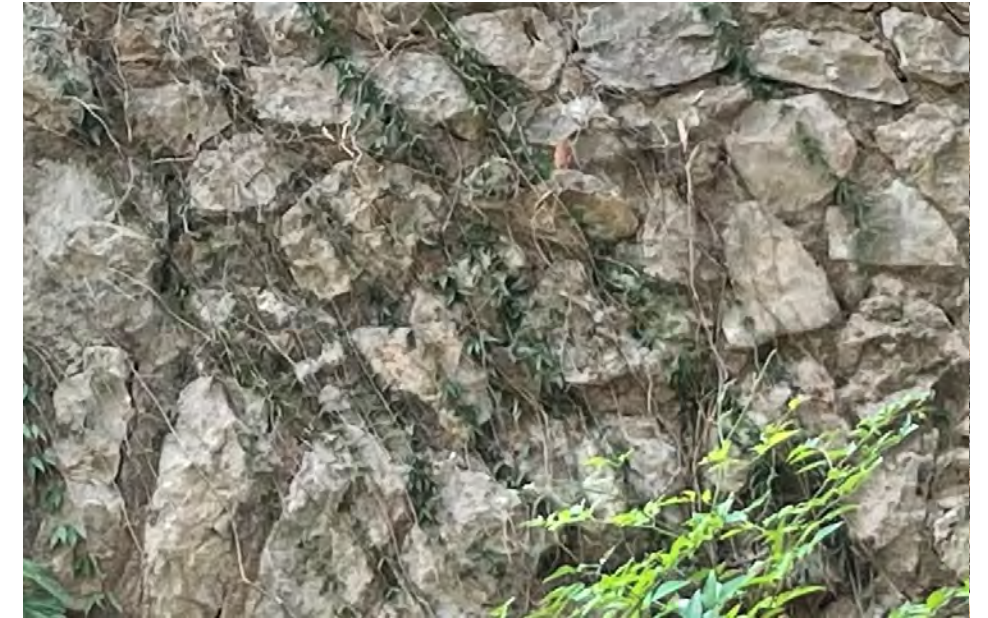
1. THE BRIDGE IS CRACKING AND IS UNSAFE TO WALK OVER.
2. THE WALL IS CRUMBLING APART IN SEVERAL AREAS.

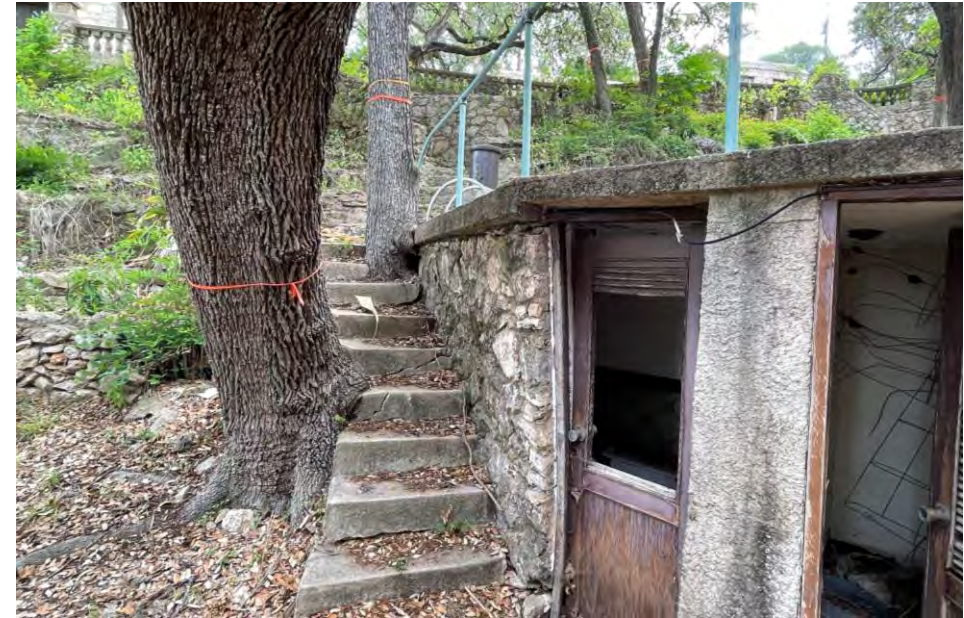
1. THE CONCRETE STAIRS ARE CONSTRICTING THIS SIGNIFICANT TREE.
2. THE STAIRS ARE CRACKING AND MOVING DUE TO THE TREE'S GROWTH.
