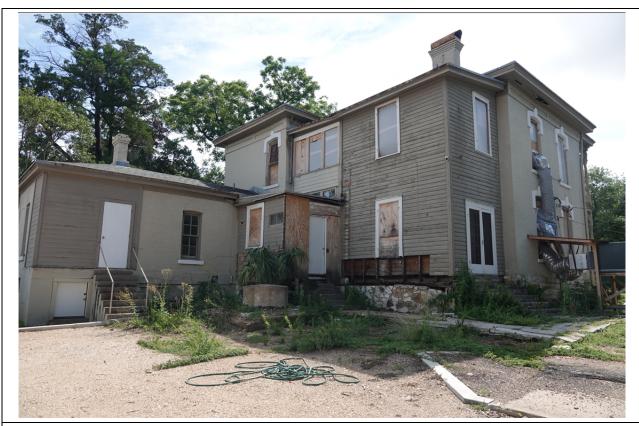
OBLIQUE SOUTH AND WEST ELEVATIONS – AREA OF NEW STAIRS AND WOOD STRUCTURE REPAIR

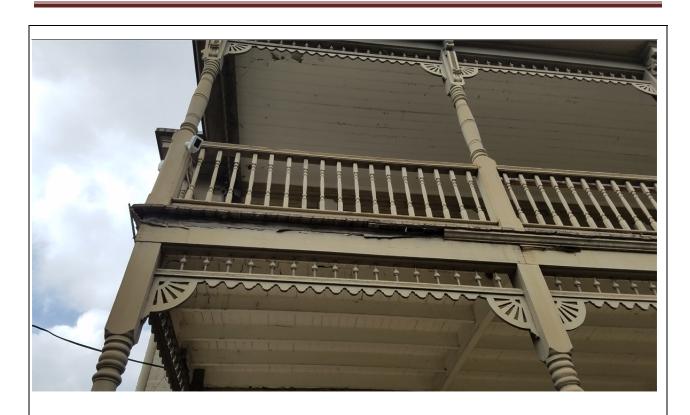
DAMAGE TO STRUCTURE AND DECKING OF UPPER GALLERY

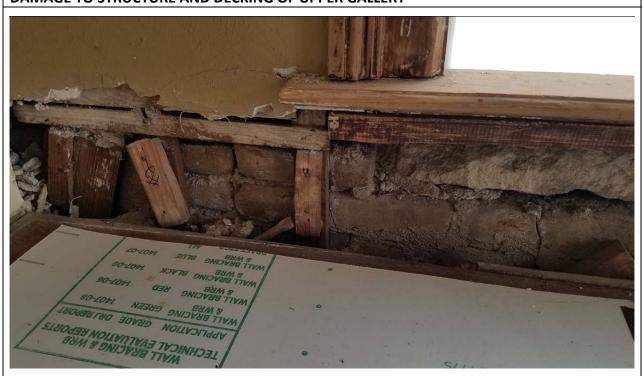
INTERIOR DAMAGE TO BE REPAIRED – TYPICAL AT WINDOWS AND BASEBOARDS

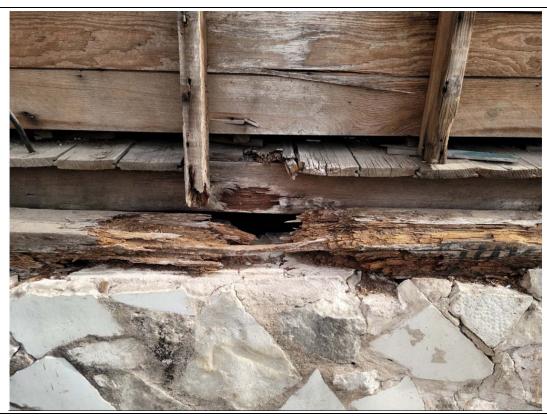
SW SILL, DECK, STRUCTURE AND WALL DAMAGE – TYPICAL WEST WOODEN STRUCTURE

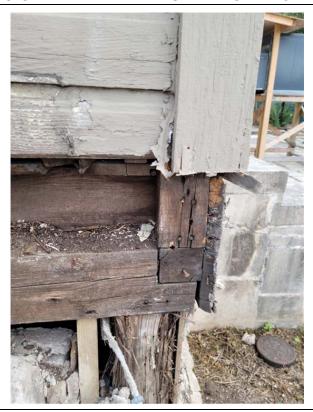
FOUNDATION DAMAGE – SOUTH WEST CORNER

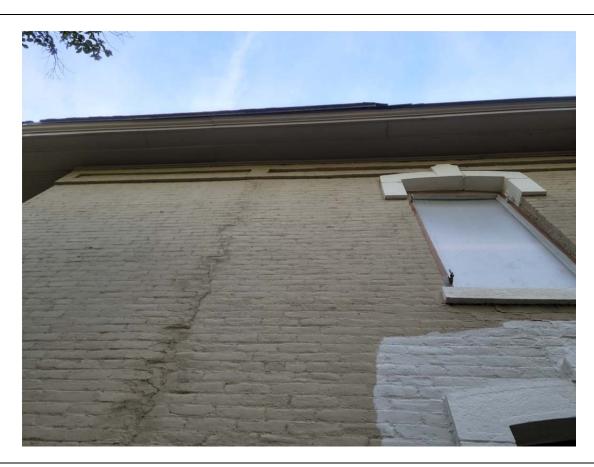
SEALANT AND INAPPROPRIATE MORTAR TO BE REMOVED AT HISTORIC BRICK ADDITION

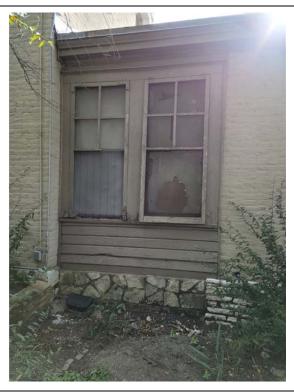
DETERIORATED WOOD INFILL ON WEST. NEW WINDOWS AND SCREENS TO MATCH EXISTING
