Project: 407 E. Monroe Austin, TX 78704

**HR-2022-070860/2022-065132 PR**

**Cost Prohibitive Rehabilitation**

# Current State of Property

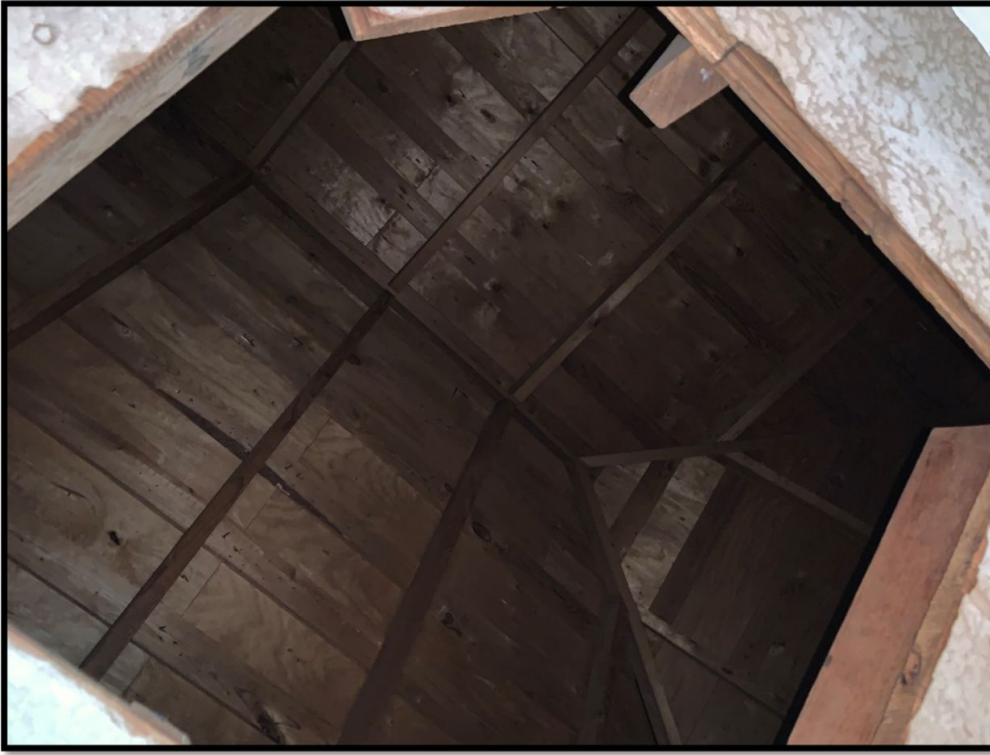
Figure 1: 2x4 roof framing at 24", 2x4 ridge beam, and 2x4 hip beam, note lack of vertical support at hip to ridge connection.

- Framing and Roofing is considered to be deficient and needs to all be replaced
  - Termite damage confirmed within the walls
  - Rotting Soffit and cracked veneer

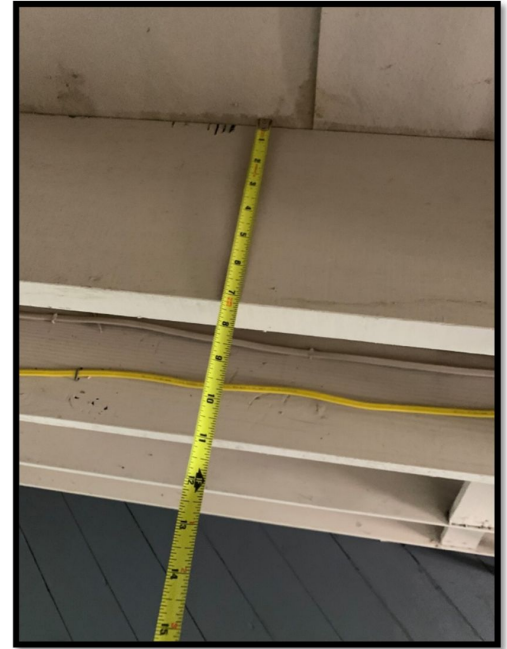
Figure 2: 2x8 floor framing at 16".

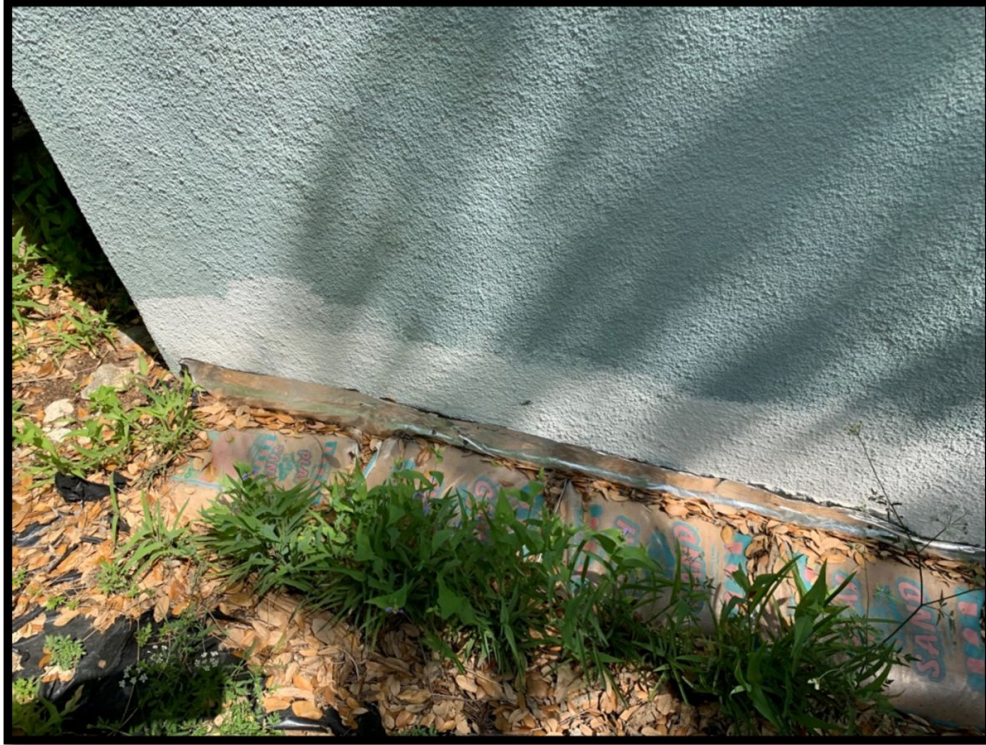
- Back wall has sand bags and soil build up most likely causing rotting in the wall framing
- Exhibit 6 - Neighboring house encroaches onto the property in 2 areas.

Figure 3: Rear wall, SW corner, sand bags, and soil built up above bottom plate.

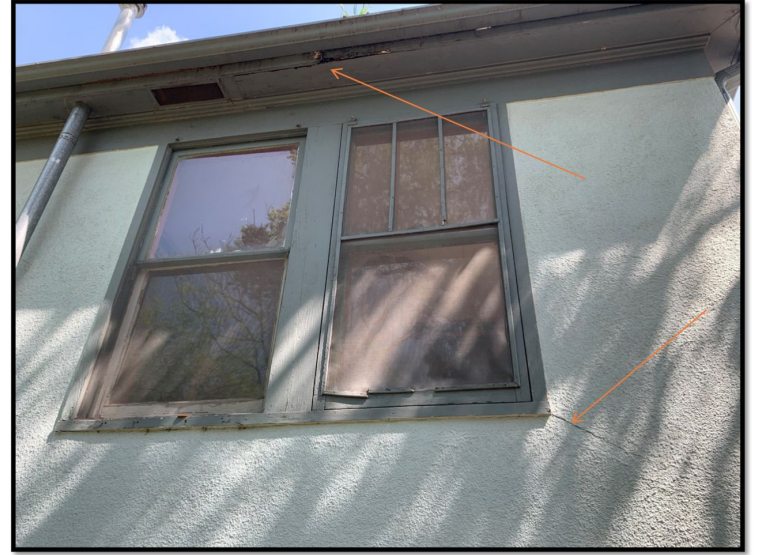
Figure 4: Rotting soffit and crack stucco veneer on rear wall
