MONROE RESIDENCE

407 E MONROE AUSTIN, TX 78704

On 05 April 2022, R. Derek Hammond of RDH C&E performed a site observation to 407 E. Monroe Street in Austin, Texas to view the condition of the existing ADU. Based on the site observations, and calculations it appears the roof, attic, and portions floor framing are over spanned and insufficient for code required loading. Sagging in framing, cracking within the veneer, and rotting within the soffit and around the bottom plate were also observed. Roof & upper attic framing would all need to be removed and replaced or reinforced with additional framing and bracing. The 4x6 2nd floor framing support was also found to be deficient and would need to be reinforced or removed and replaced. Rotting was noted around the perimeter of the building due to the proximity of grade to the bottom plate of the wall. Termite damage was confirmed, and all wall framing at was damaged would need to be replaced.

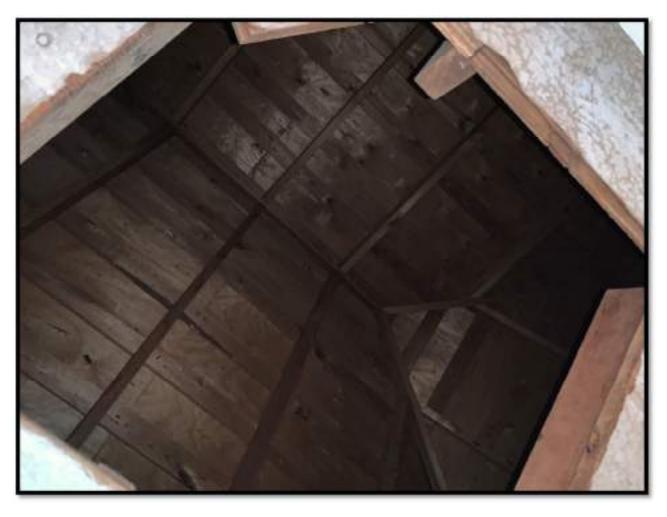
Roof framing and attic framing (2x4's at 24") were determined to be deficient for code required live and dead loading. Ridge and hip beams were also undersized and would need to be increased in size, or braced from walls below. The 2x8 floor framing is adequately sized provided no additional point loading is added to it from the roof above. The 4x6 framing carrying the 2x8's however were undersized for the required loading. The 4x6 beam center support was concealed from view and unable to be confirmed, a 4x4 post and foundation would be required for the loading.

Figure 1: 2x4 roof framing at 24", 2x4 ridge beam, and 2x4hip beam, note lack of vertical support at hip to ridge connection.

Roof framing, sheathing, attic framing and wall framing are deficient for current code required loading and likely water and/or termite damaged, respectively. Roof framing members and attic framing would need to be upgraded to 2x6 framing at the roof, 2x10's at the attic, and ridges would need to be reinforced, and possibly braced off of the interior walls. Bracing off of walls would require the 2x8 floor framing to be upgraded to support the added point loading from the roof bracing. The 4x6 framing

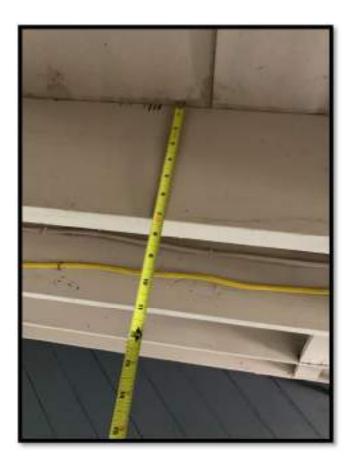
Figure 2: 2x8 floor framing at 16".

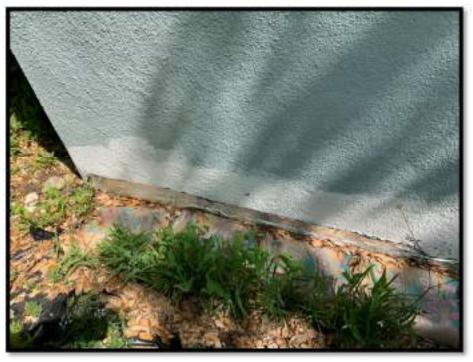
Soils around the South and West sides were observed to be above the bottom plate of the wooden portions of the exterior wall framing. Cracking was observed in the skirting around the base of the home and sand bags were present to mitigate water infiltration. Wall framing was obscured from view, but is likely rotted due to the evidence of water infiltration over a long period of time. Rotting soffits were also noted around the perimeter of the ADU as well as evidence of settling, namely cracking around openings.

Figure 3: Rear wall, SW corner, sand bags, and soil built up above bottom plate.

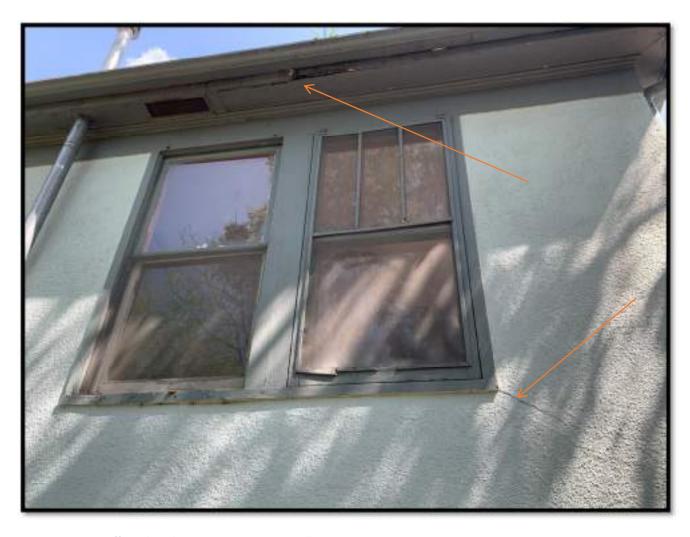
Figure 4: Rotting soffit and crack stucco veneer on rear wall

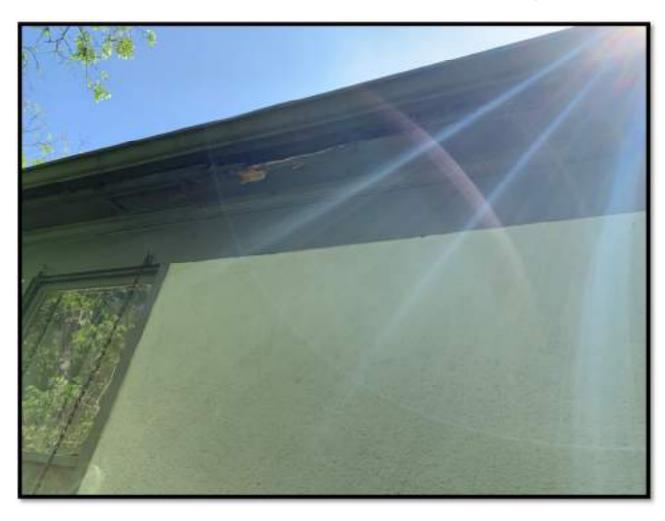
Figure 5: Rotted soffit on West side of ADU.
