Analysis of Existing Building at
1403 EAST CESAR CHAVEZ STREET
Historic Landmark Commission Hearing

MAY 04, 2022

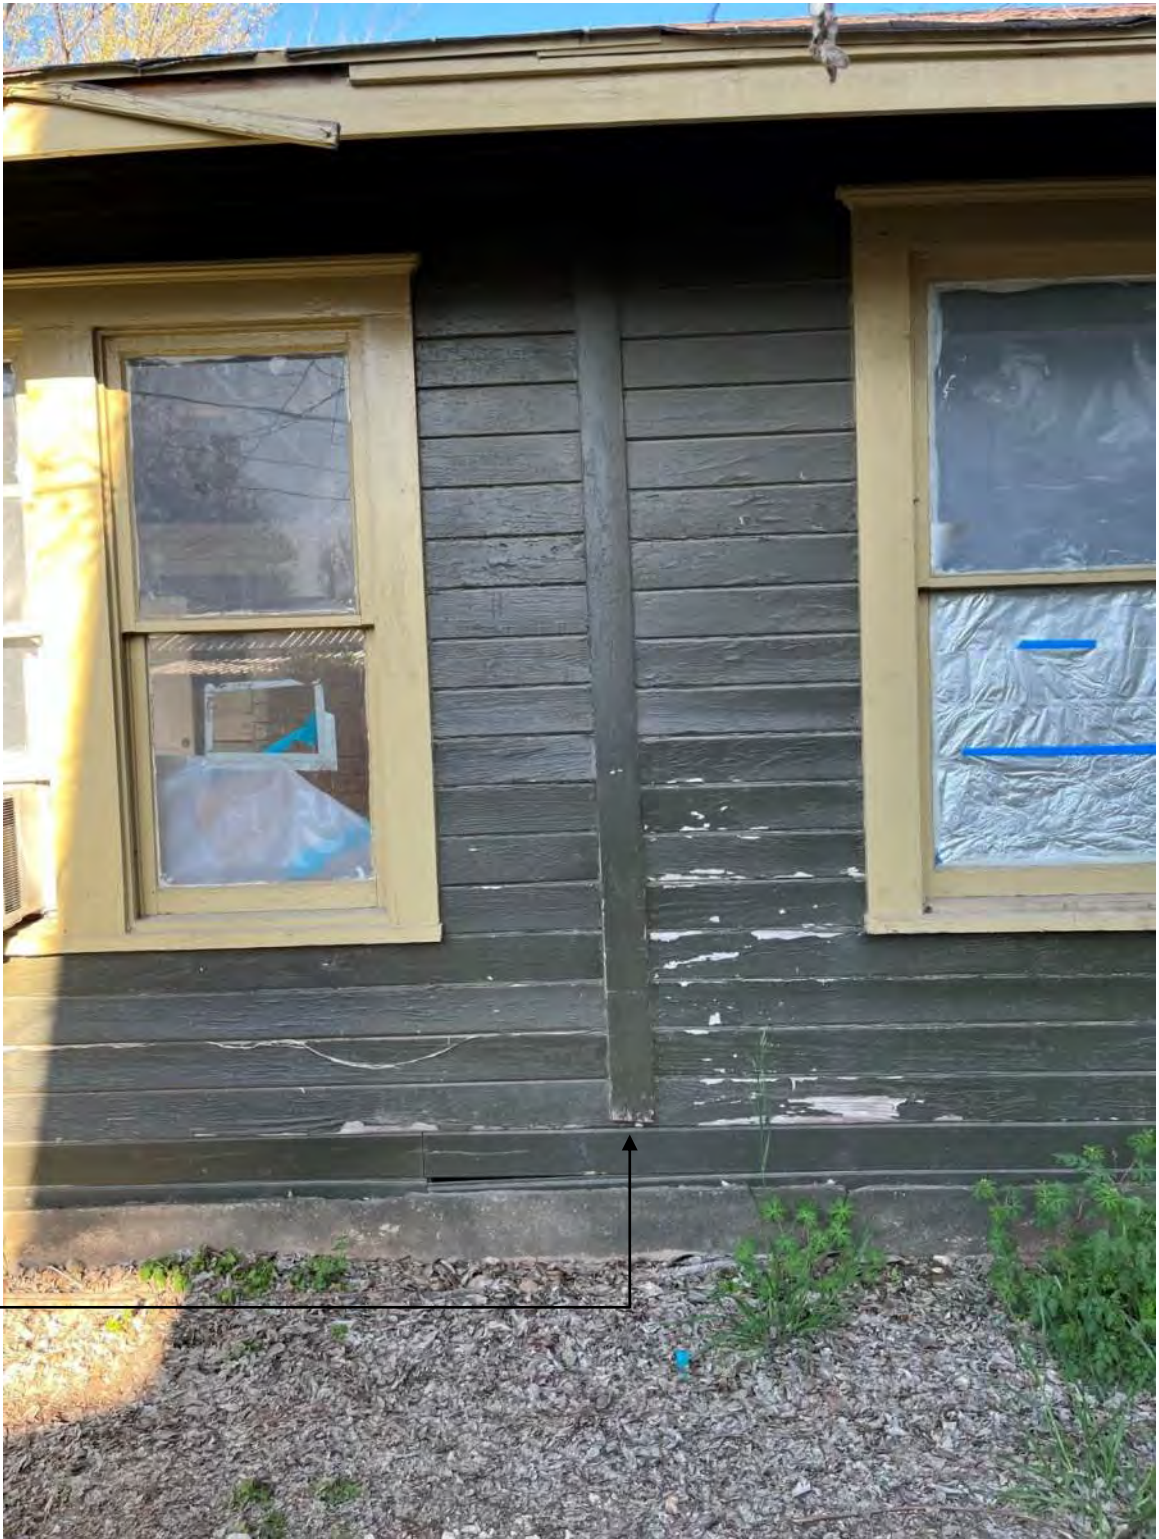
ENLARGED VIEW OF SEAM

EXTERIOR SIDING
MISALIGNED ON
EITHER SIDE OF SEAM

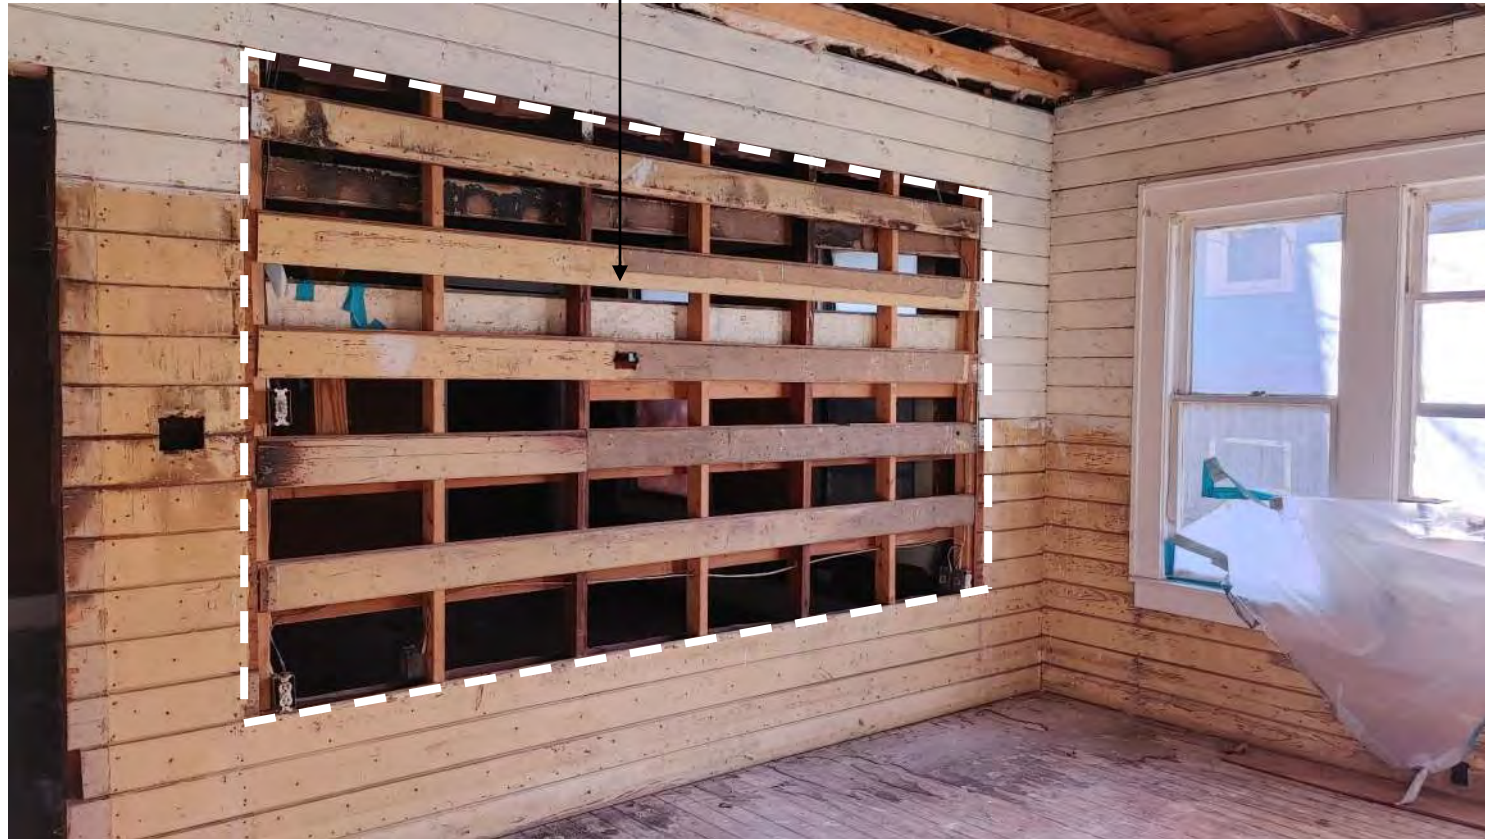
ORIGINAL BACK PORCH ABSORBED INTO HOME (ESTIMATED 1900-1935)

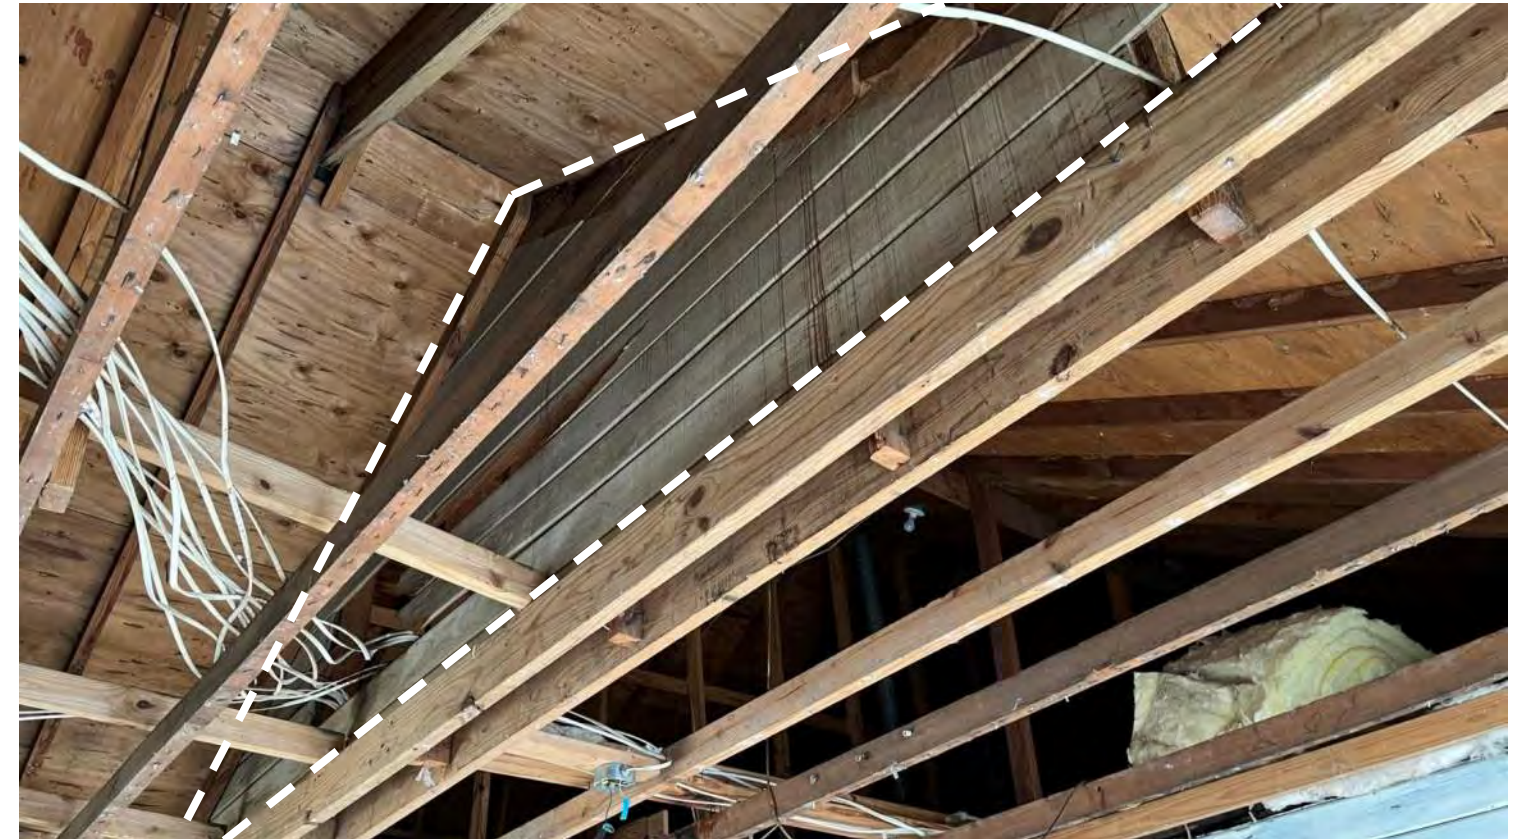
REMNANT OF ORIGINAL 1900 ROOF LINE AT REAR OF ORIGINAL HOME

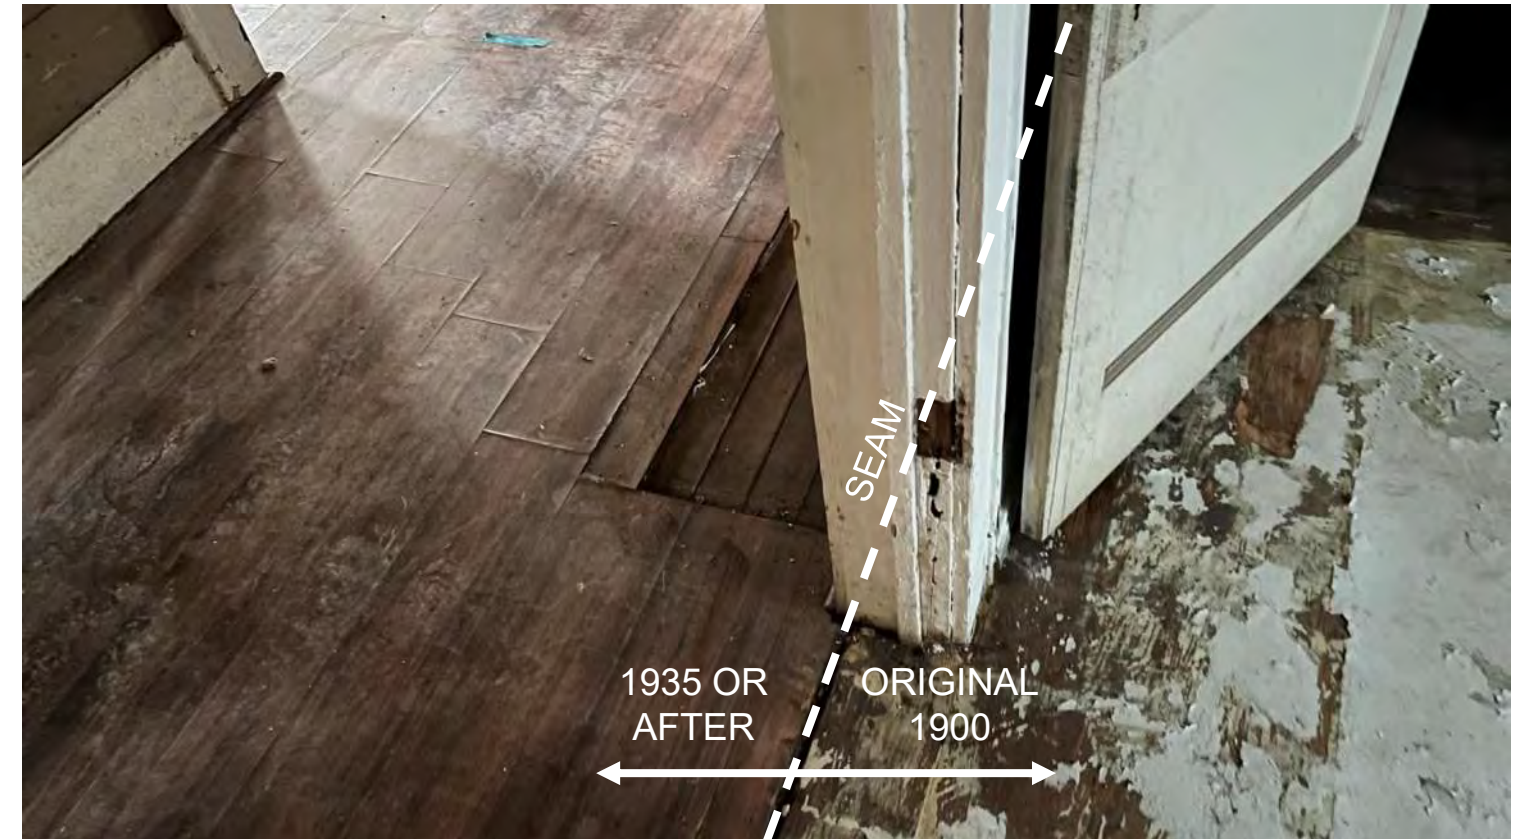
SEAM AT SIDE ADDITION

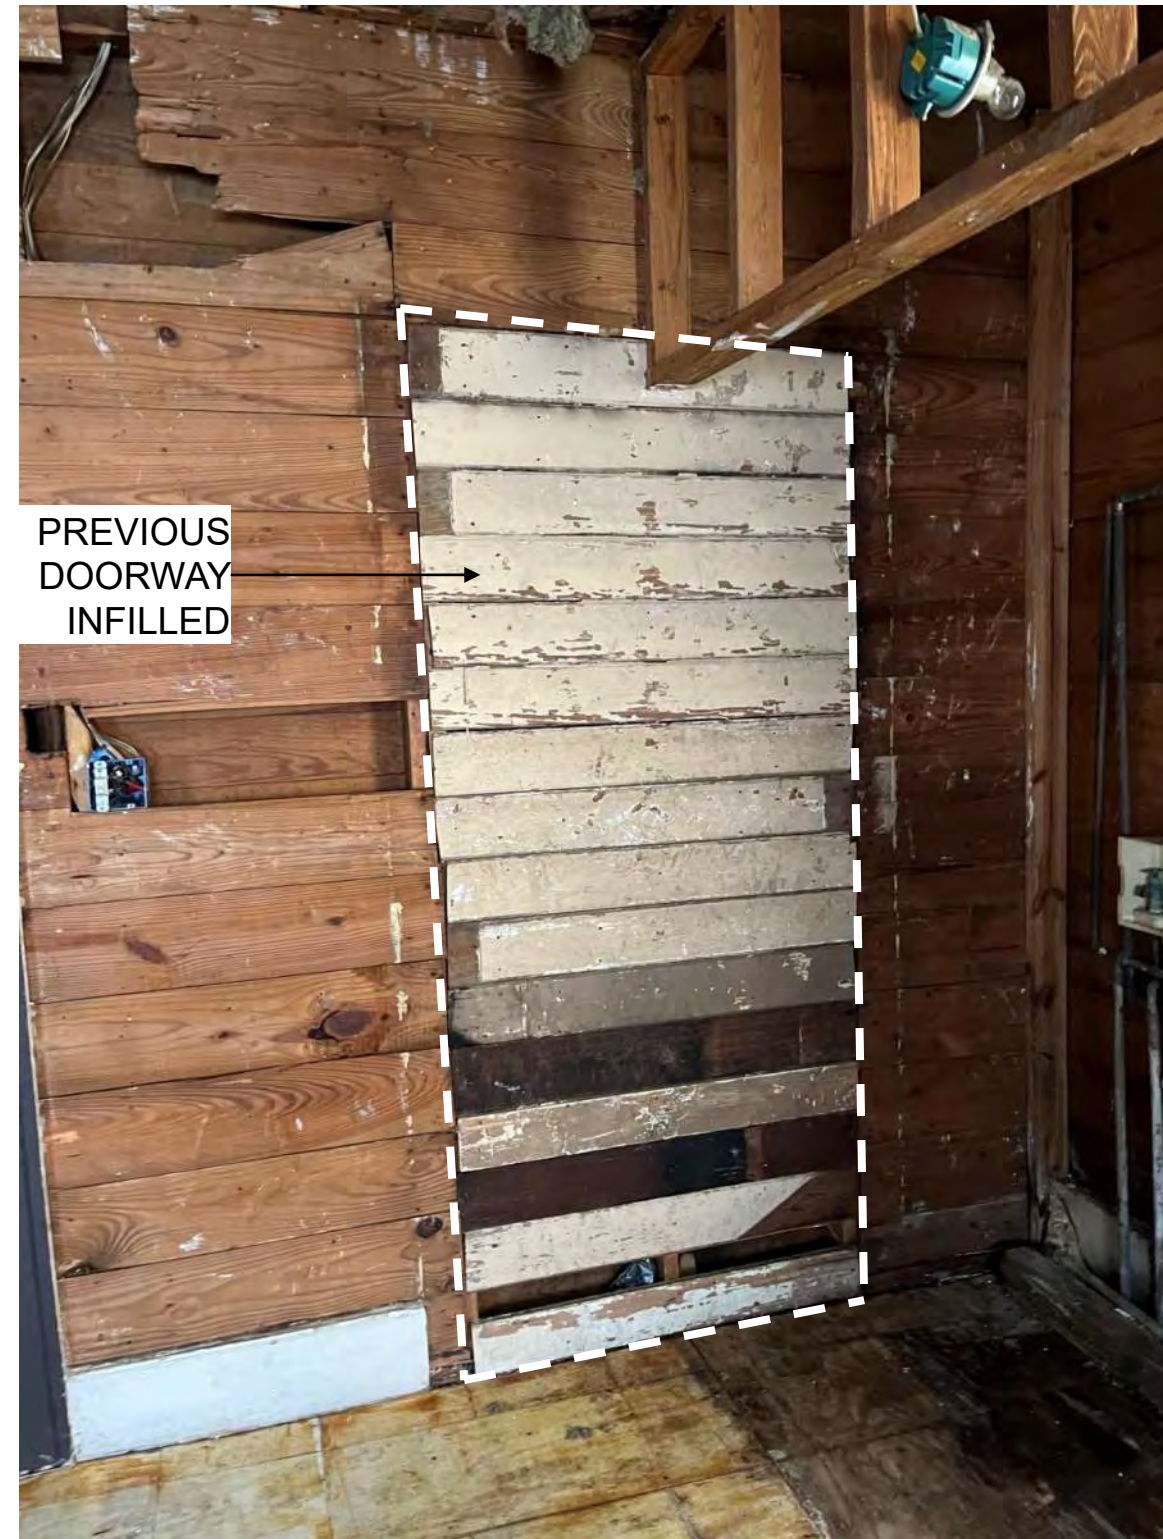
INFILLED DOOR AT BACK ROOM / KITCHEN

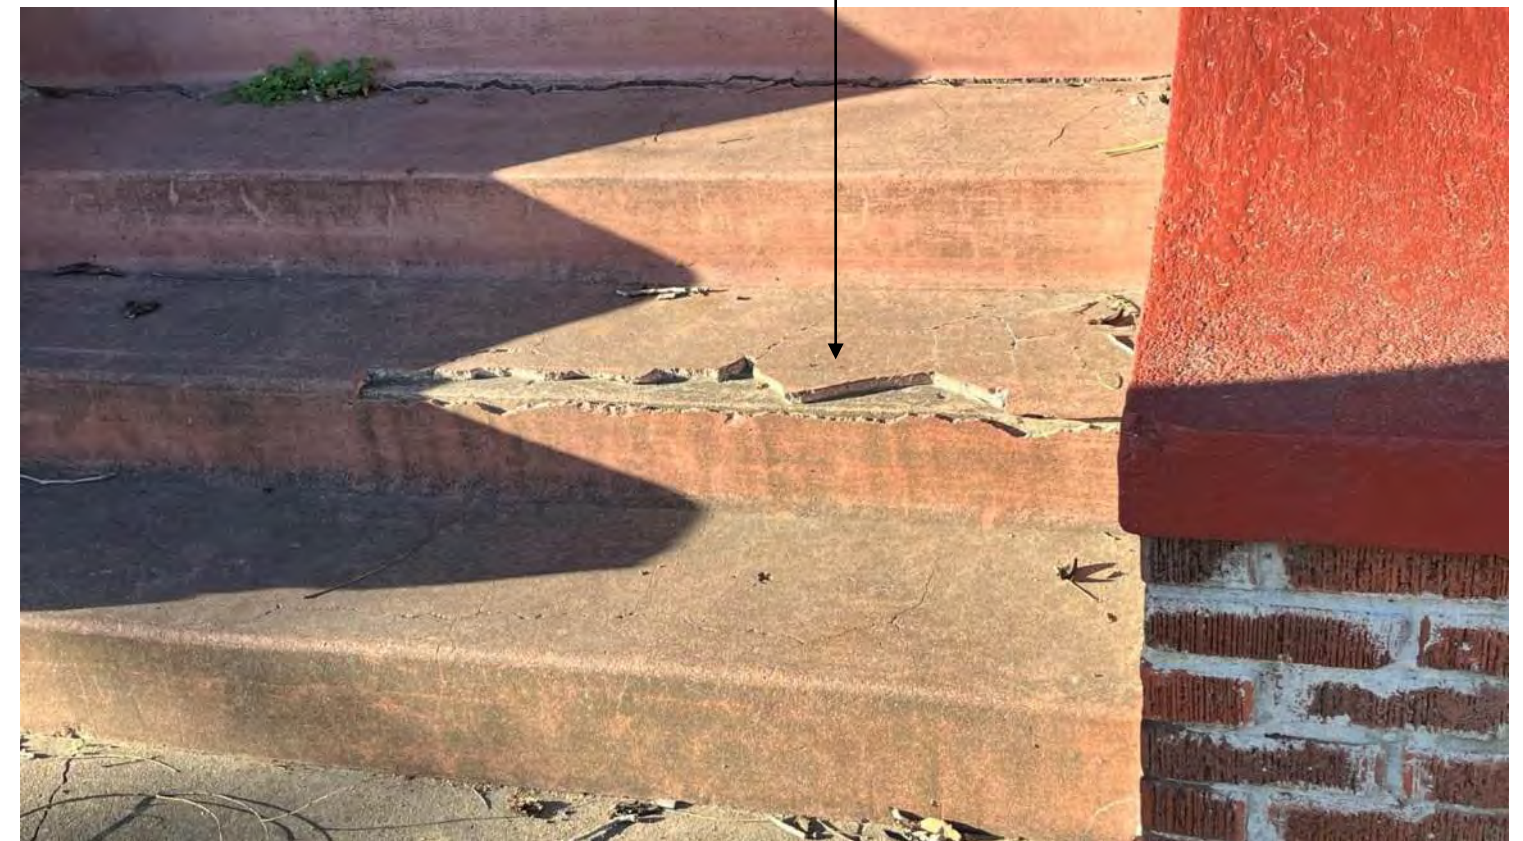
ENLARGED VIEW OF FRONT PORCH STEPS

PORCH TOPPED WITH
COLORED CONCRETE REPAIR,
LIKELY CIRCA 1983

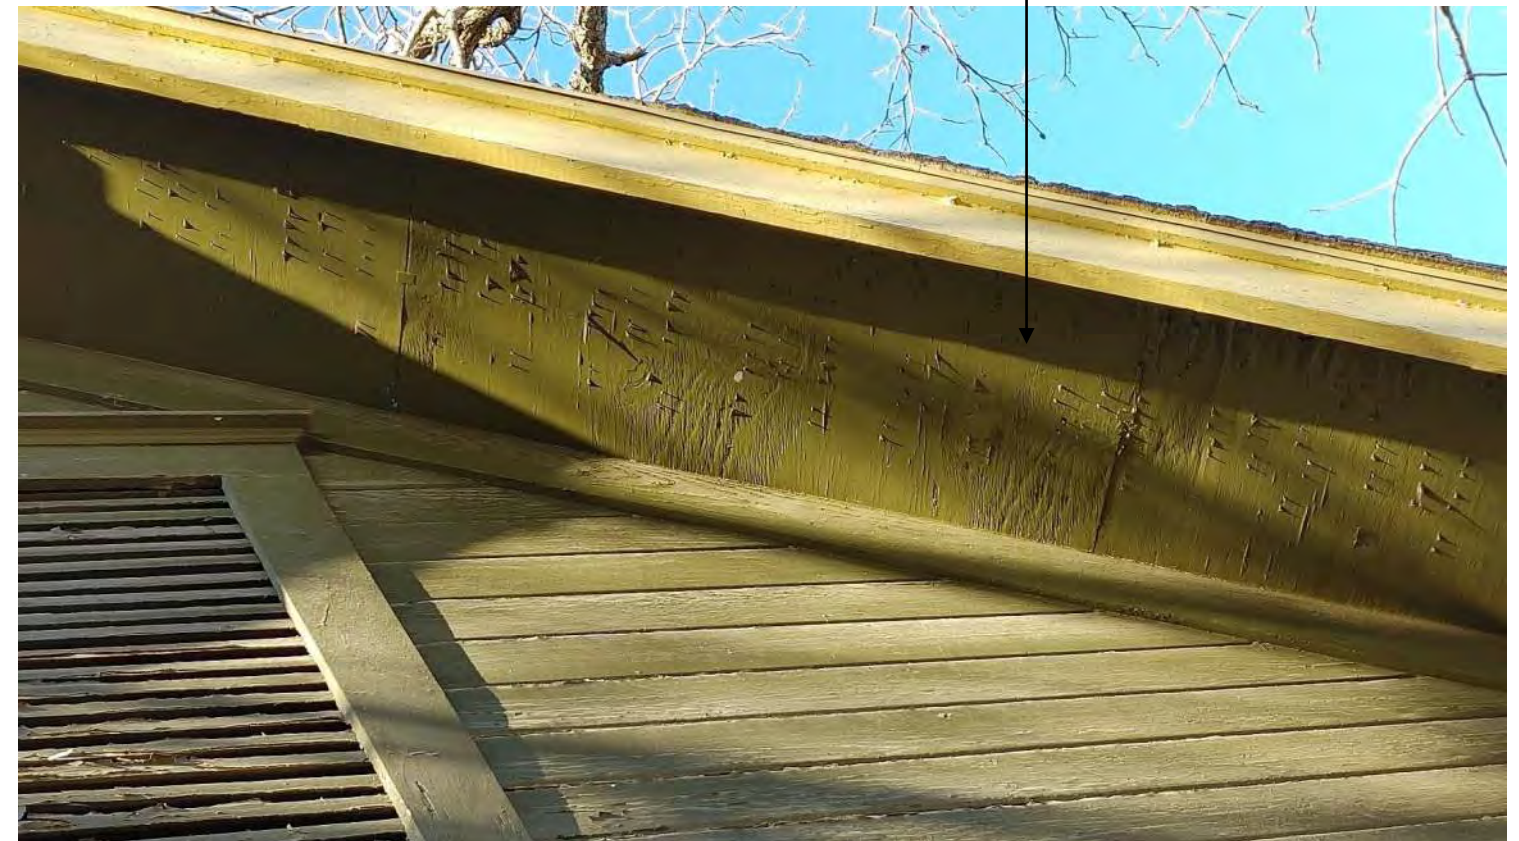
- c. The entire current roof is sheathed with modern plywood and has been reframed with new and old lumber. A house of this vintage would have had been decked with shiplap. **(See pages 39-45)**

MODERN PLYWOOD
ROOF SHEATHING

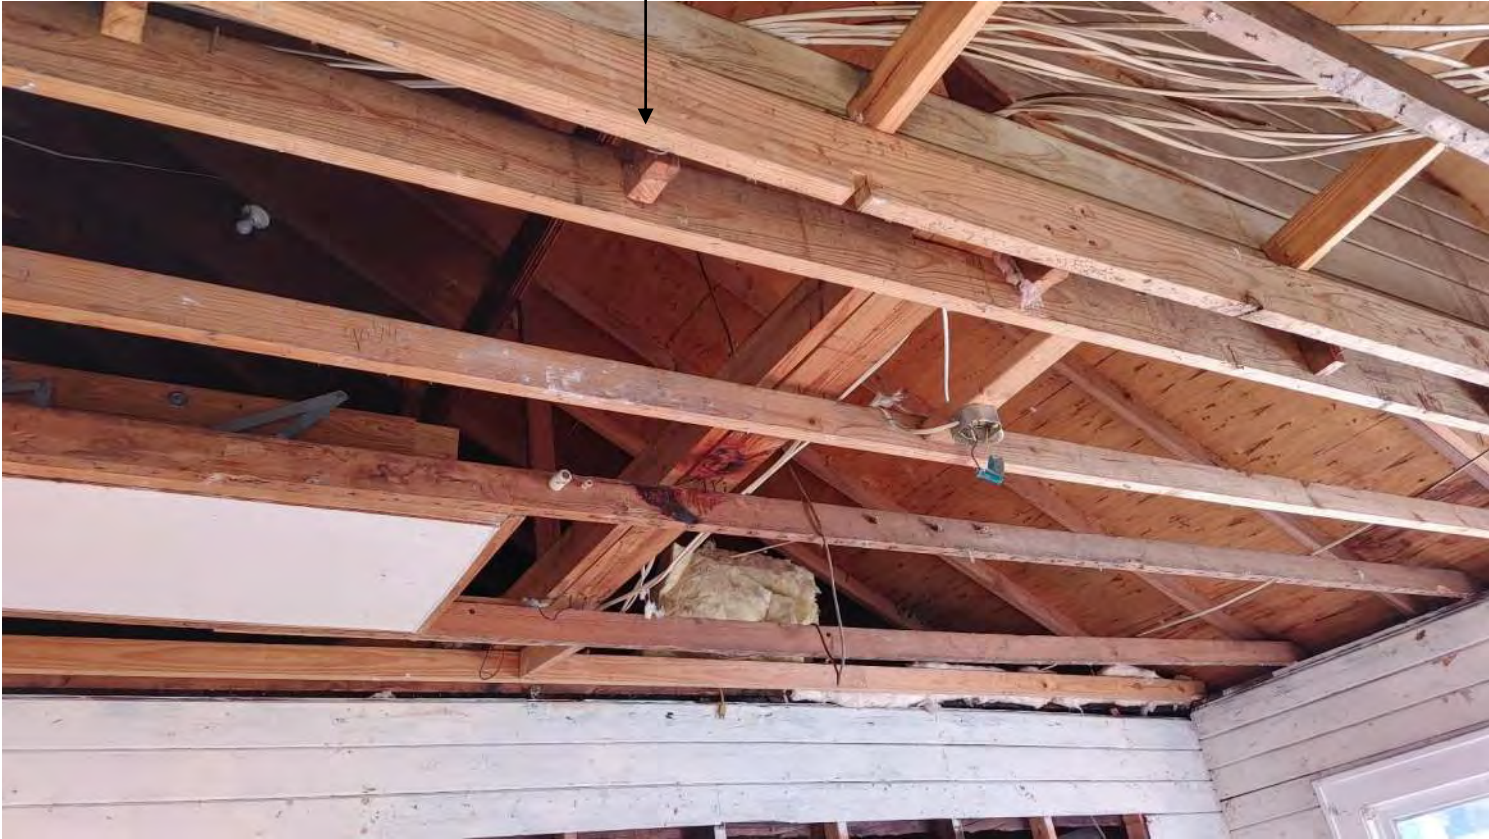
INTERIOR OF ROOF RENOVATION AT REAR ADDITIONS

CONTEMPORARY WOOD ROOF
FRAMING AND PLYWOOD
SHEATHING, CIRCA 1983 OR LATER

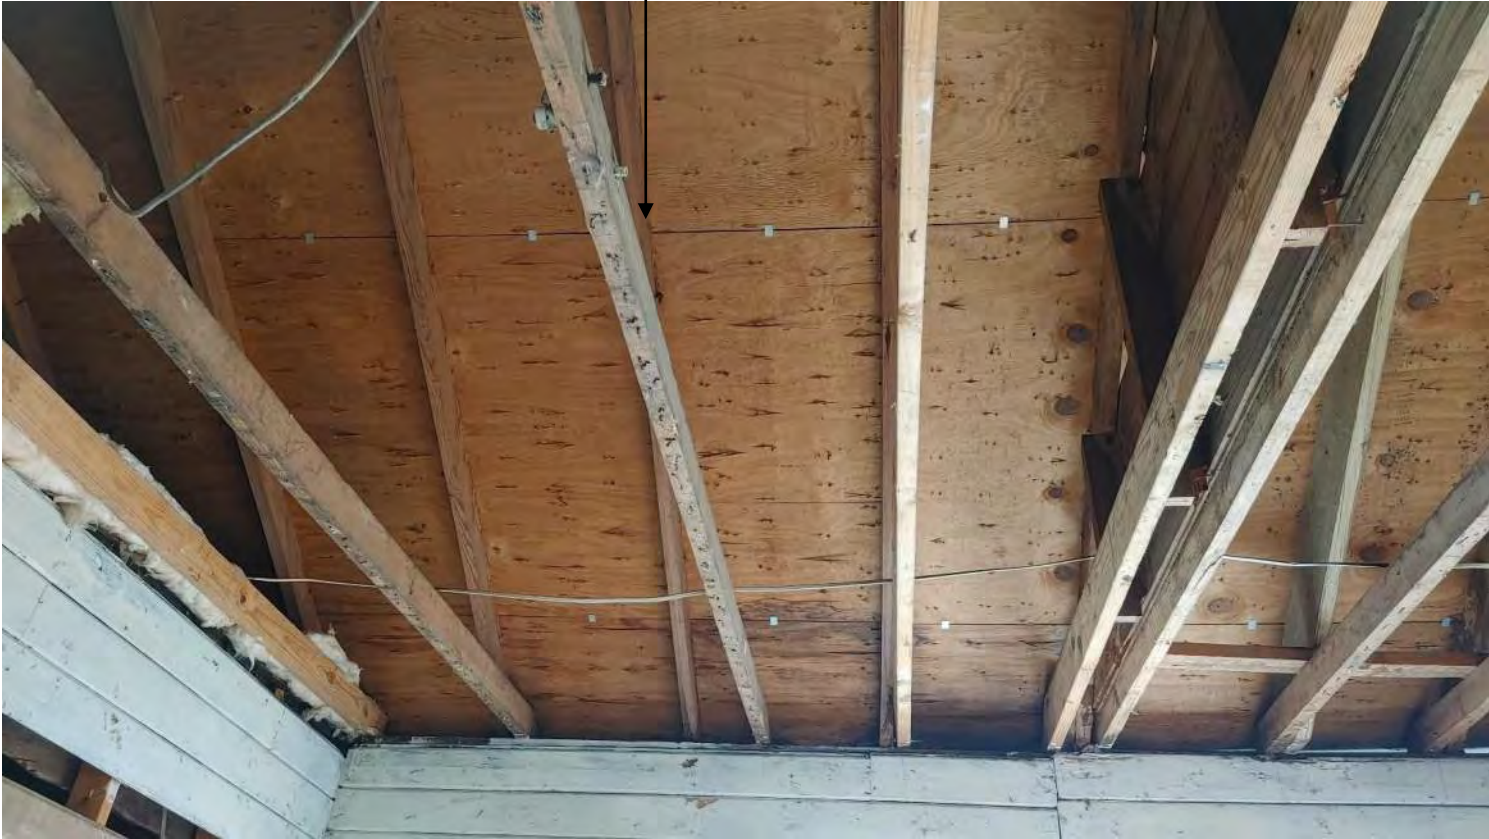
INTERIOR OF ROOF RENOVATION AT REAR ADDITIONS

CONTEMPORARY WOOD ROOF
FRAMING AND PLYWOOD
SHEATHING, CIRCA 1983 OR LATER

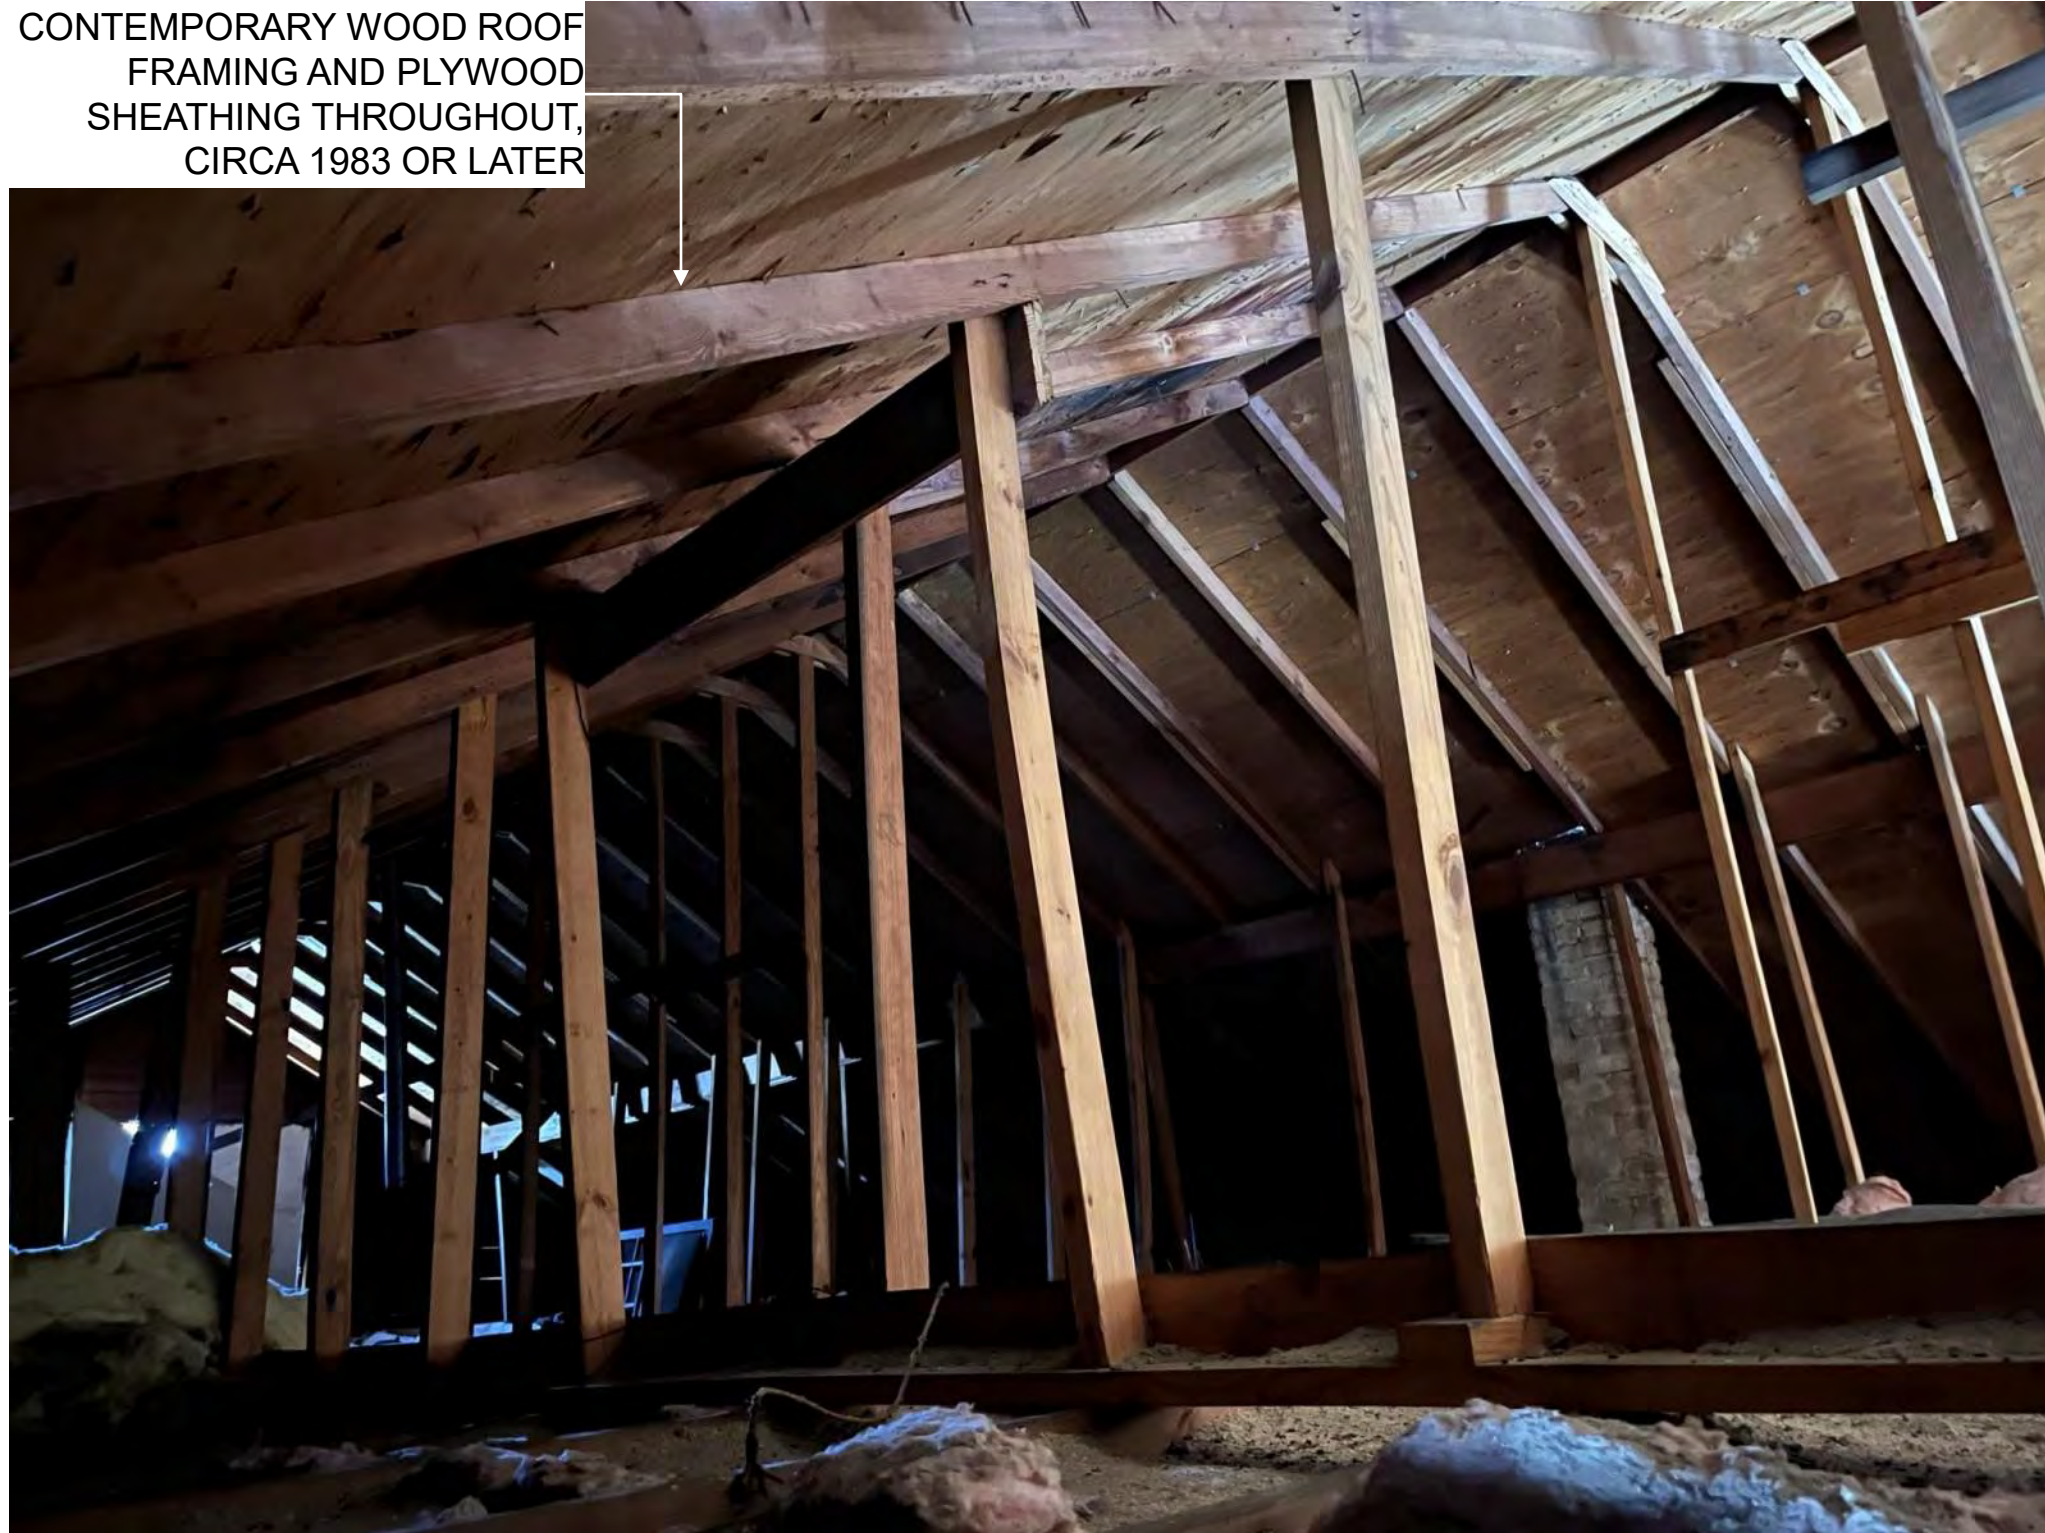
ROOF RENOVATION ATTIC SPACE

CONTEMPORARY WOOD ROOF
FRAMING AND PLYWOOD
SHEATHING THROUGHOUT,
CIRCA 1983 OR LATER
