STRUCTURAL CONDITION ASSESSMENT

1403 Cesar Chavez

March 14, 2022

Datum Engineers, Inc.

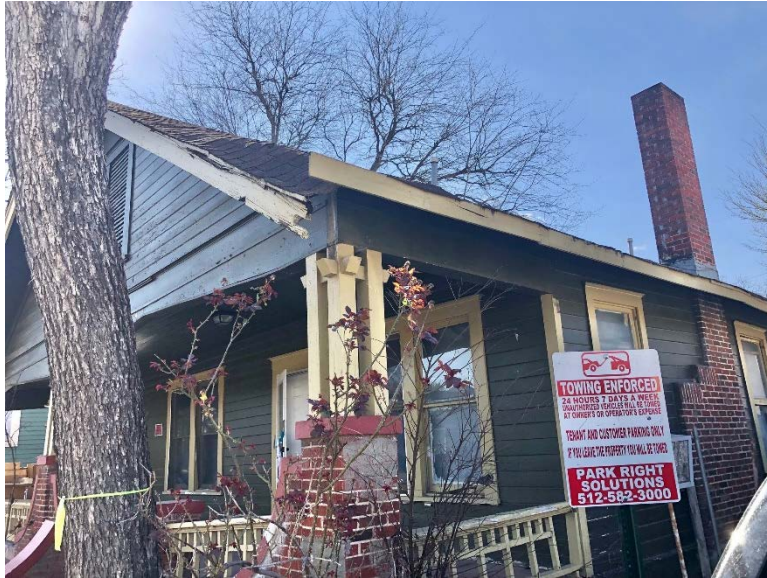
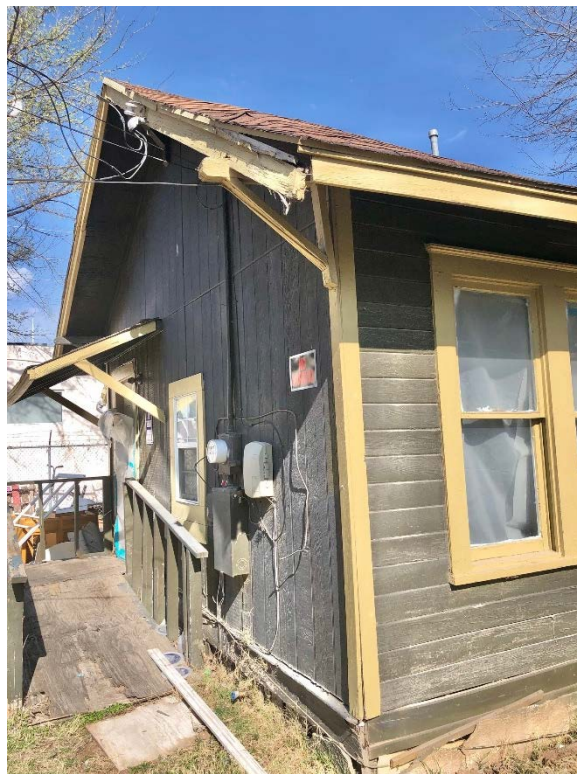
Photo 1

Eaves around the house are severely damaged. Eave fascia boards have wood rot in numerous places and are sagging. The north and south eaves were not built correctly, since they do not have 2x wood outriggers. Instead, the plywood roof decking cantilevers out from the exterior wall and is sagging in numerous places.

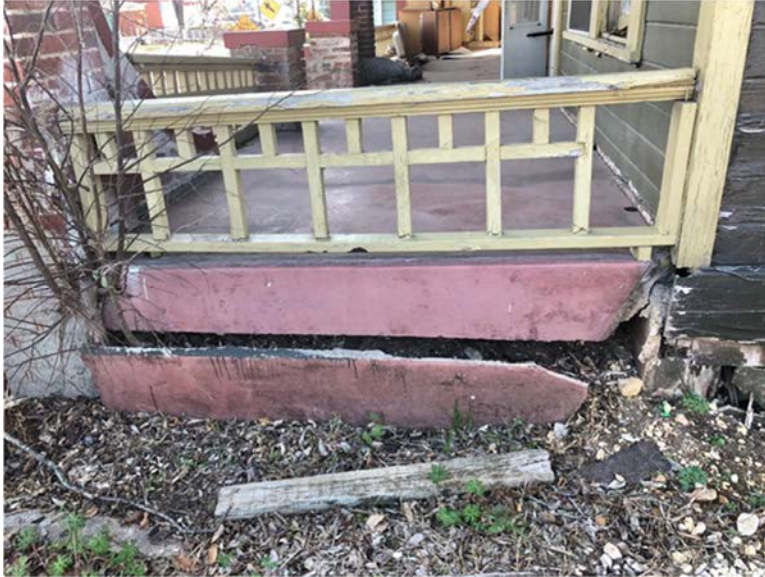
Photo 3

The front porch is concrete. It's suspected that the concrete porch is not original and may have been added later. Concrete slab edge has broken off on the west side of the porch. Slab connection at the house appears to have integrity issues.

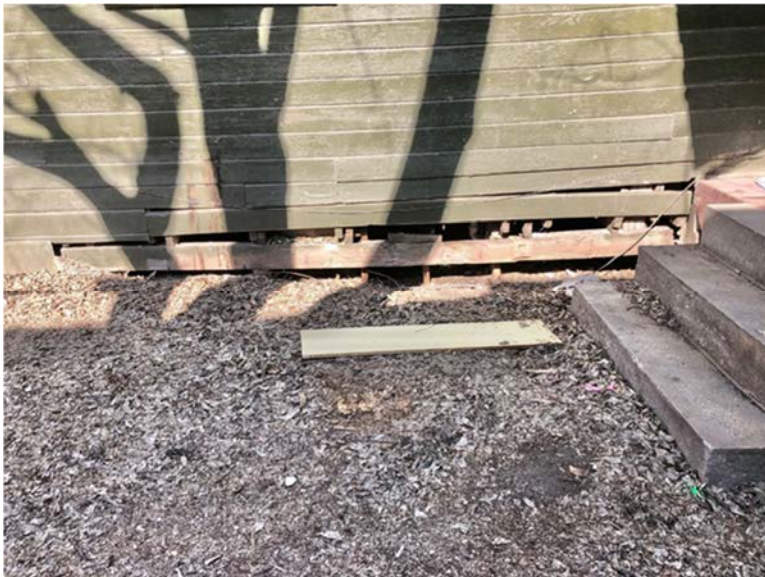
Photo 4

The floor of the house is on wood pier and beam. The crawl space was not visible and is not large enough to make foundation repairs. Wood siding slopes indicating the foundation is moving by settling and/or rising due to highly expansive clay in this area.

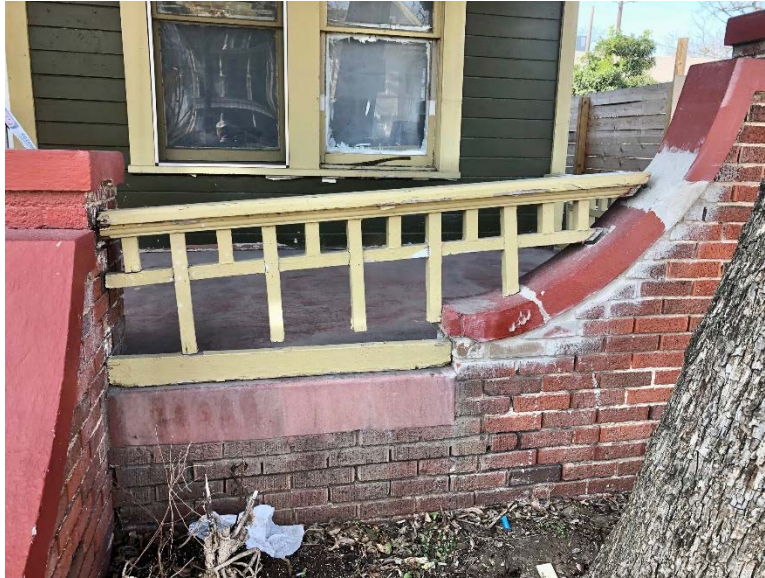
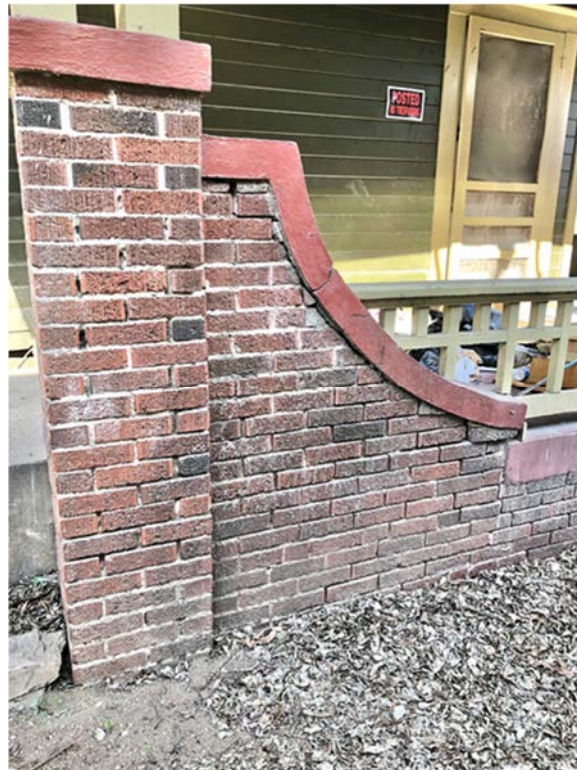
Photo 5

Brick on two sides of the porch is damaged with cracks in several locations. Obvious attempts were made to patch the brick cracks. There are several large trees located too close to the house. The roots are probably under the wall footing causing movement of the brick wall, thus the cracks. Cracks will continue to open as long as the trees exist. The wood railing is also severely damaged and unsupported in some locations.

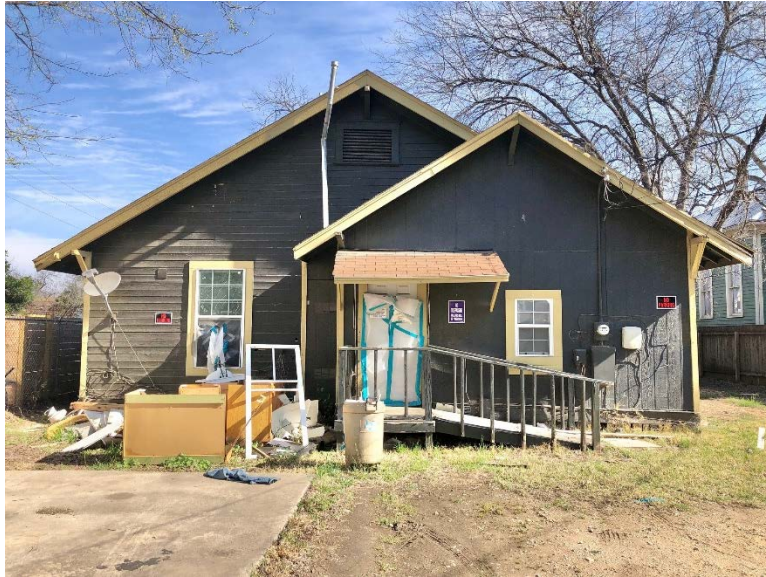
Photo 7

Parts of the smaller projection on the rear of the house may not be original. The siding is a more recent version of plywood siding. The handicap ramp is likely not original and needs repair due to severe rot.

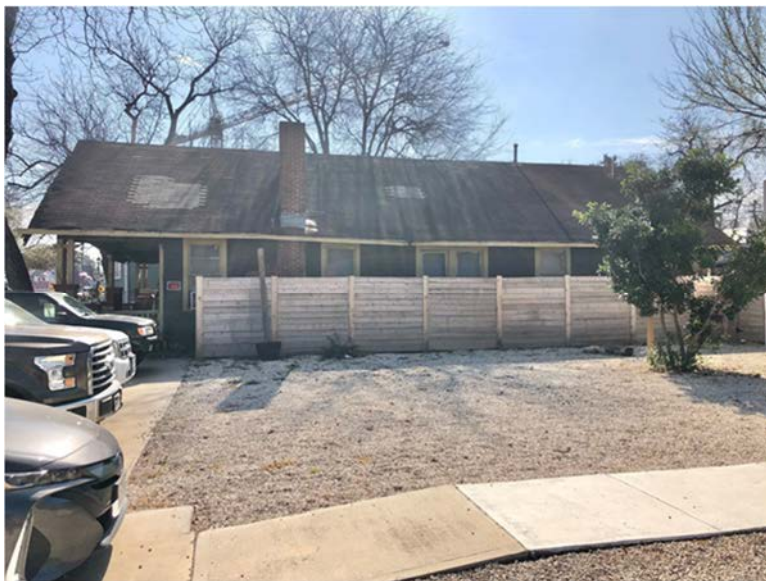
Photo 8

The roofing of the house has been patched in a number of locations. Wood decking has rotted where the patches were made.

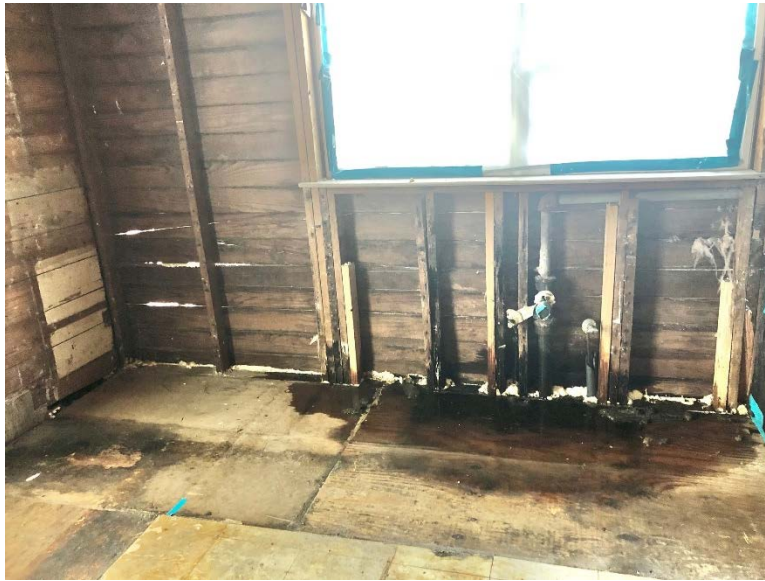
Photo 9

Plumbing leaks have deteriorated the wood floor and wall framing in this kitchen area and in the bathroom. Photo 10 is the closet behind the bathroom sink where the wood is deteriorated due to plumbing leaks. In the kitchen in photo 9 you can see daylight through the wood siding of the house. The siding boards are nailed directly to the wall studs without DensGlass or exterior gypsum sheathing. This means you would not be able to waterproof the exterior of the house. The wall studs will continue to rot over time through gaps in the wood siding.

Daylight can be seen through the wood siding of the house in the kitchen. The siding boards are nailed directly to the wall studs without DensGlass or exterior gypsum sheathing. This means you would not be able to waterproof the exterior of the house. The wall studs may continue to rot over time through gaps in the wood siding.

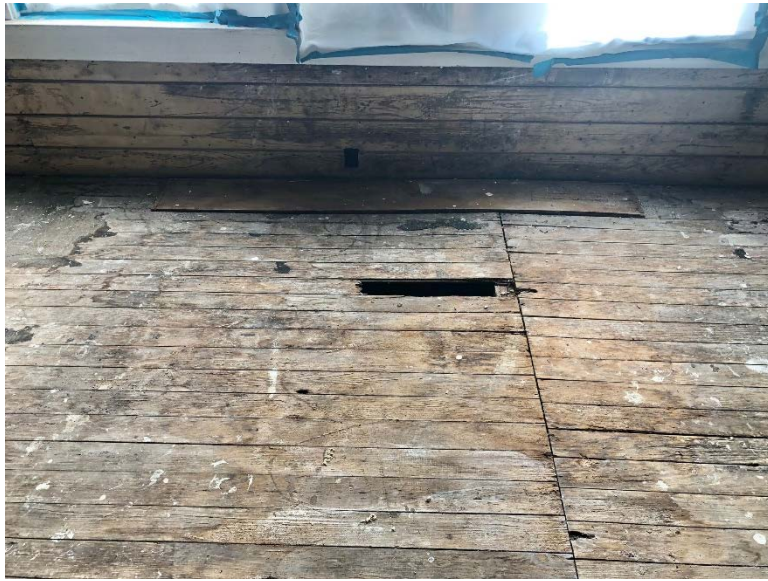
Photo 11

The wood floor boards have holes in them. The floor is very soft and spongy in numerous locations indicating problems with the support boards under the house. Underfloor joists and beams could be rotting or have termite damage.

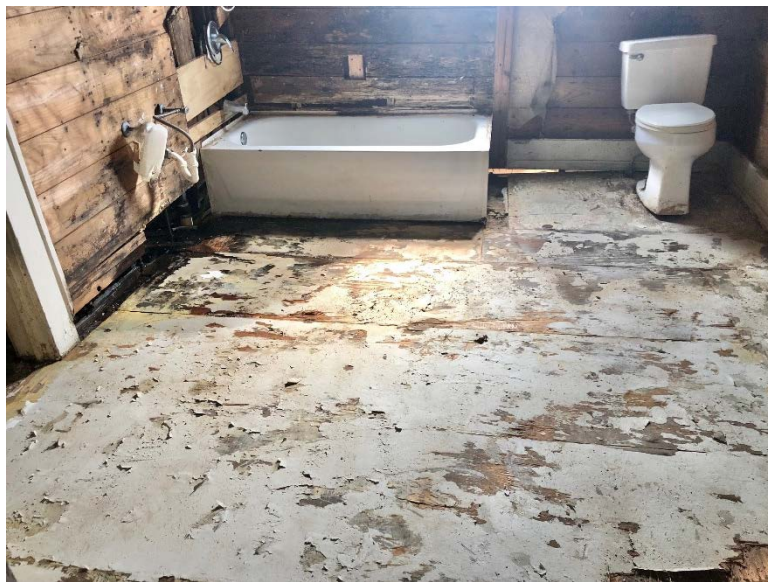
Photo 12

The floor deck in the bathroom and kitchen is plywood which is not consistent with floor boards in the rest of the house.

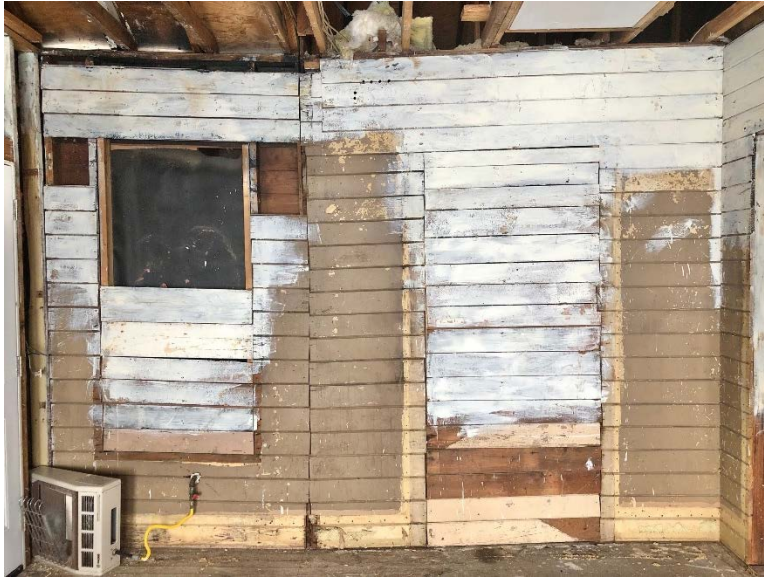
Photo 13

The interior walls of the house sag and have shifted indicating that the foundation has settled in numerous locations. Repair of the foundation is not feasible since there is not enough clear crawl space to access the foundation.

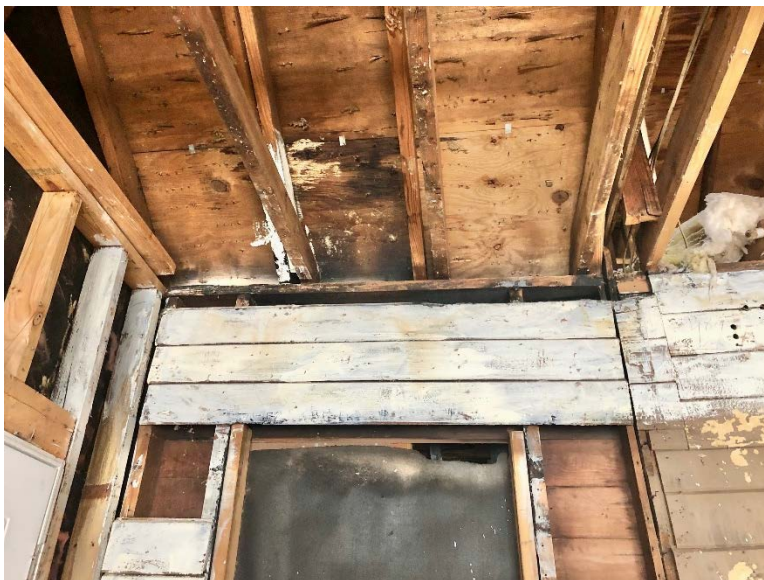
Photo 14

The plywood roof deck has rotted out due to roof leaks and is sagging in a number of locations.

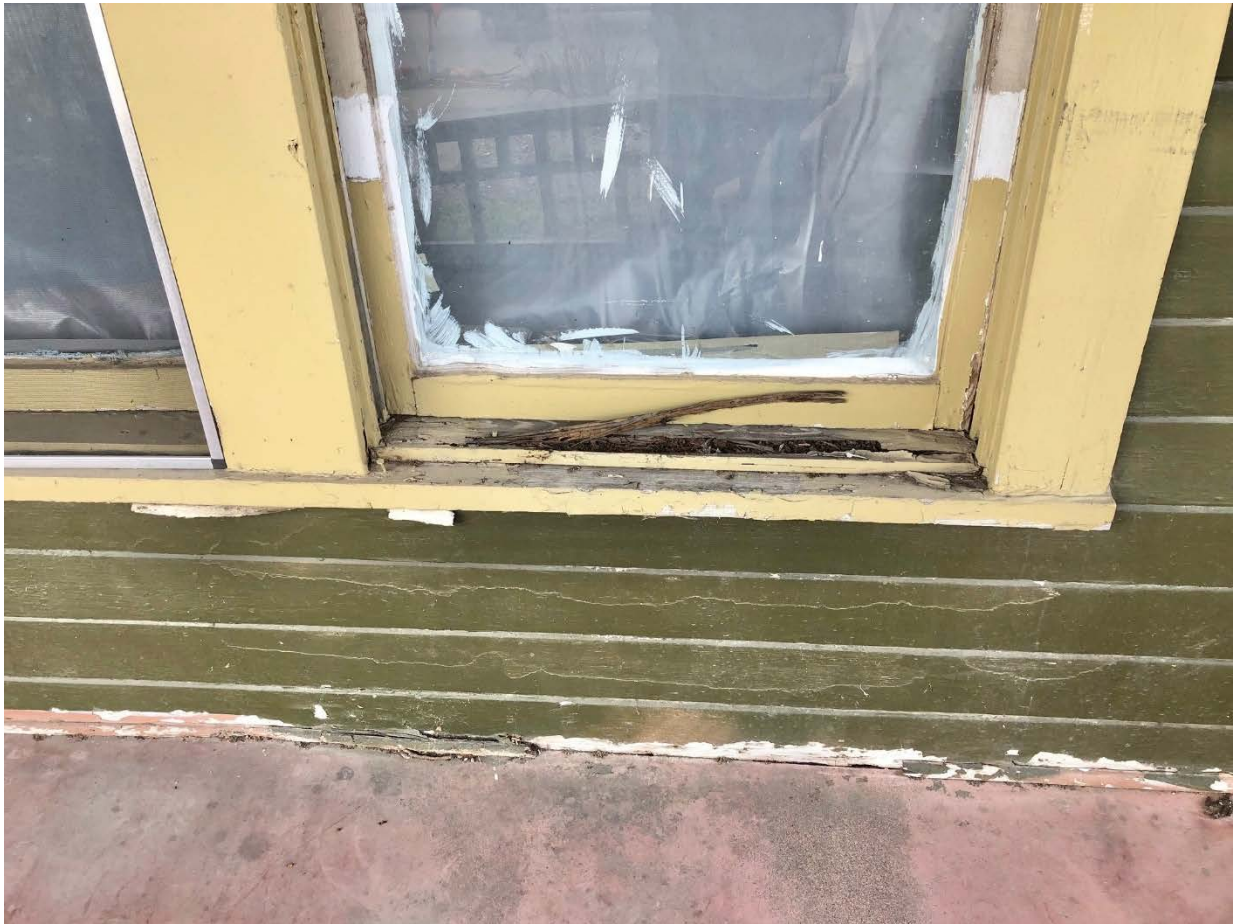
Photo 15

Some of the window sills have severe wood rot and will be hard to repair.
