ITEM FOR ENVIRONMENTAL COMMISSION AGENDA

NAME & NUMBER OF PROJECT: Shoal Cycle, SP-2021-0350C

MEMORANDUM

REQUEST: The applicant is requesting removal of a Heritage tree with a single stem over 30 inches in diameter.

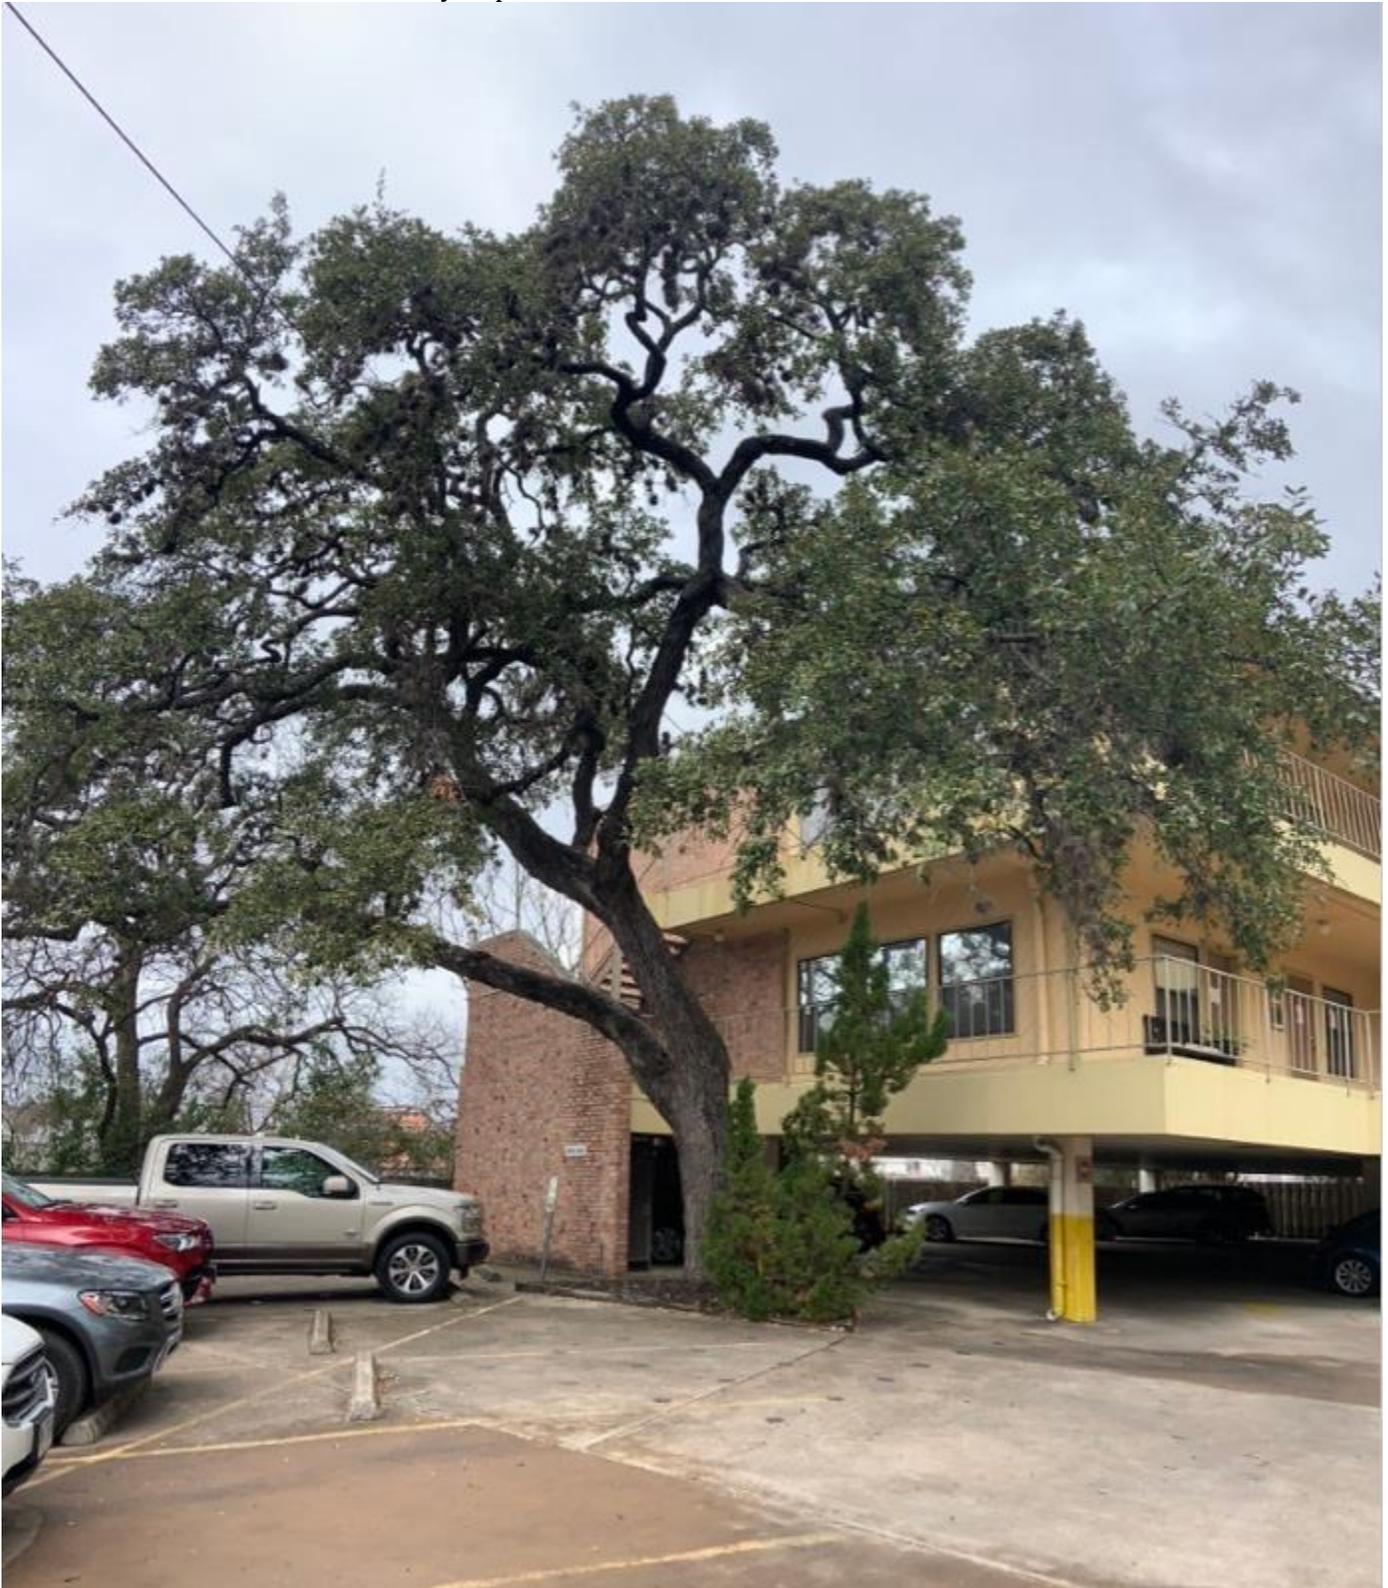
Buried root flare; approximately 95% of the critical root one is covered by impervious surfaces – concrete parking and existing office building.

Exhibit 1: Whole tree surrounded by impervious cover

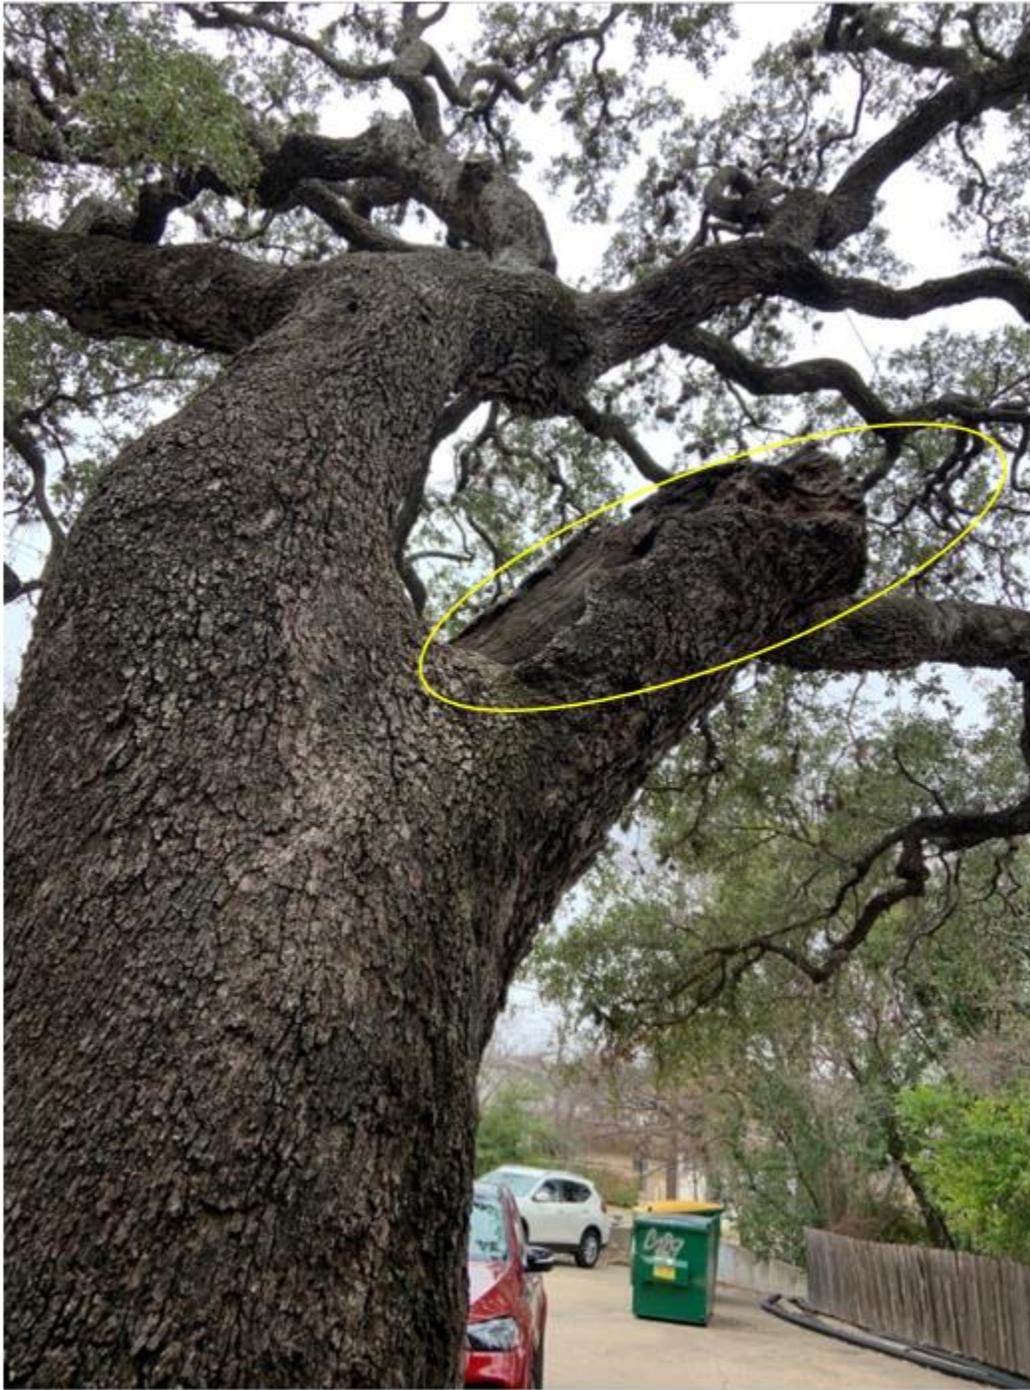
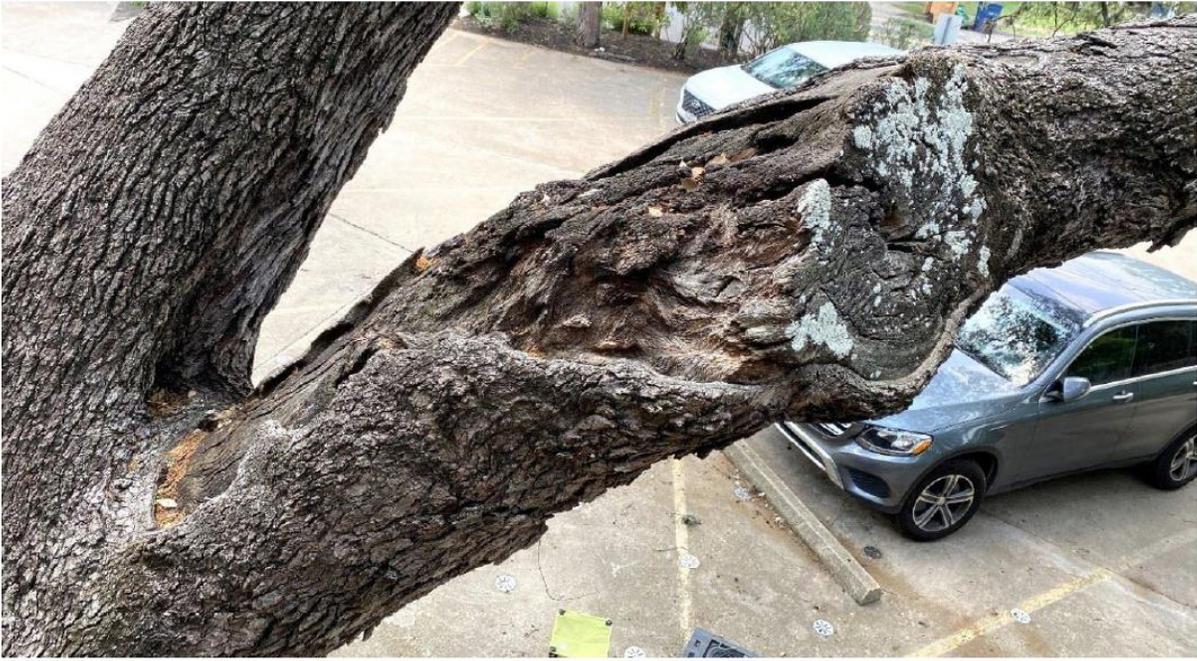
Trunk leans over the parking lot. Sonic tomography was conducted of the trunk indicating moderate decay at three different vertical planes with the tree – estimates 22-24% loss in structural integrity of the tree. Large decay pockets on upper side of two scaffolding limbs observed.

Exhibit 2: Large scaffold leader decay - west stem

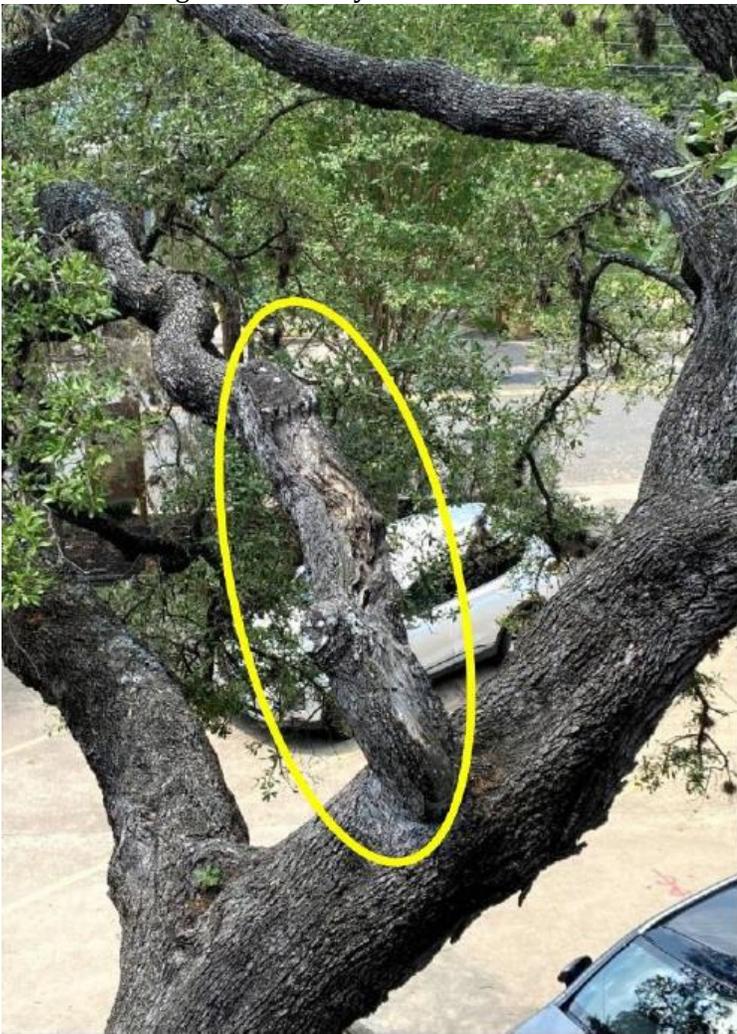
Exhibit 3: Large leader decay – east stem

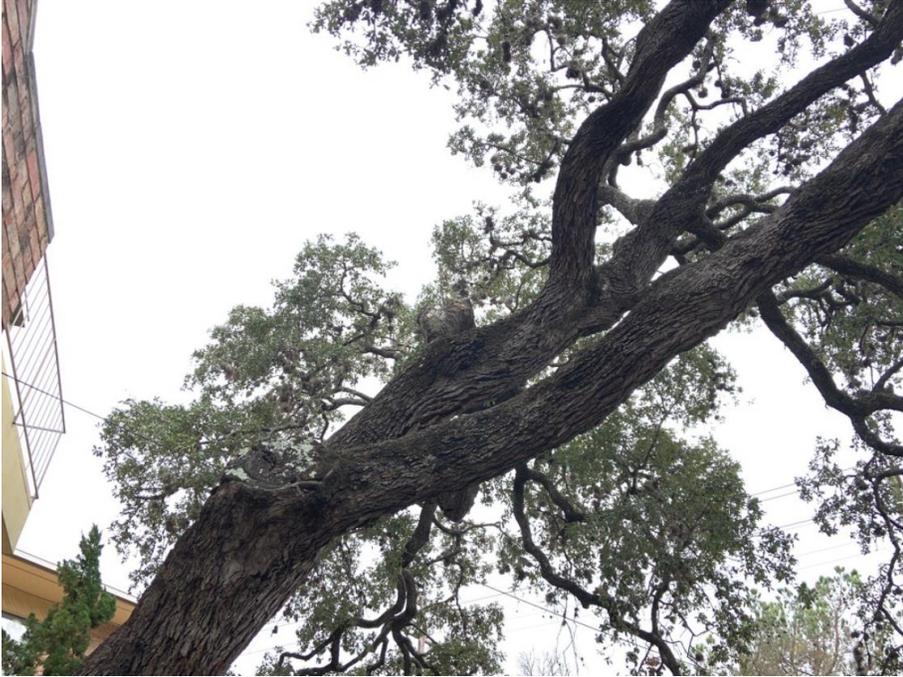
Asymmetric crown; thin canopy; chlorotic (likely due to nutrient deficiency); copious amount of epiphytic ball moss usually prevalent on declining trees; leans southwest due to existing location of existing building; overhead utility lines run through the canopy.

Exhibit 3: Thin Canopy; ball moss, chlorosis
