Questions and Answers Report

**FACILITY HVAC ASSESSMENT REPORT - DRAFT
VOLUME 1 OF 1**

Stanley Consultants (Stanley) was retained by the City of Austin (COA) – Austin Public Health (APH) to perform an assessment of the heating, ventilating, and air-conditioning (HVAC) systems in the following buildings:

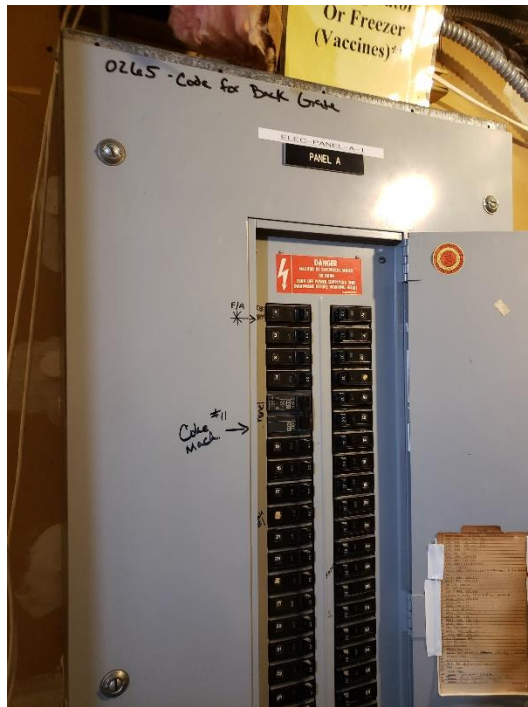
Figure 8 – Panelboard “A”.

1. Provide new main panelboard “MS-1” and disconnects for associated condensing units CU-1, CU-2, and CU-3.
2. Provide new panelboard “A” and new disconnects for associated air handling units AHU-1, AHU-2, and AHU-3.
3. Provide short circuit and arc flash hazard assessment study.
4. Provide arc flash labels at all panelboards per NFPA 70E requirement.
5. Provide new surge protective devices at panelboards to protect new HVAC system components.

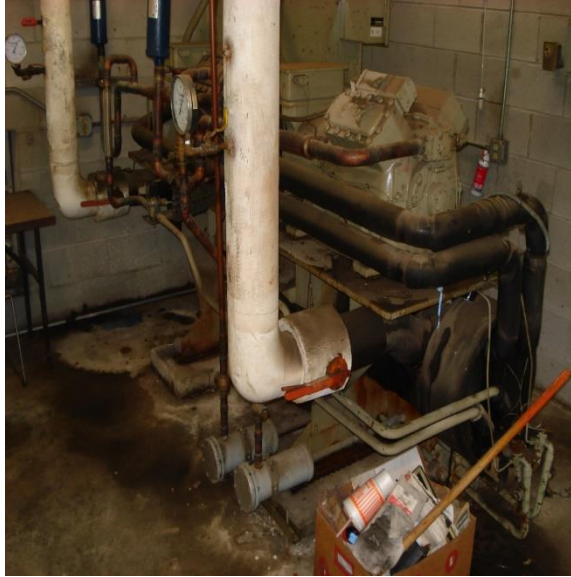
1. The Building Heating, Ventilation, and Air Conditioning (HVAC) system consists of an air-cooled chiller (with remote condensing unit) to produce chilled water. Heating water is produced by a natural gas fired boiler. Chilled water and heating water serve six roof mounted Air Handling Units (AHU).
2. The air-cooled chiller has dual compressors with a total capacity of 70 nominal tons. The air-cooled chiller appears to be building original, which is 46 years of service. The chiller shows deficiencies as follows: corrosion, oil leaks, torn insulation and subsequent condensation formation. Industry expected equipment service life for reciprocating air-cooled chillers is 20 years. The chiller has exceeded useful life expectancy.

Figure 1 – Chiller

1. Replace the chiller and the associated remote condensing unit.
2. Replace the two chilled water and two heating water pumps along with associated strainers, check valves and isolation valves.

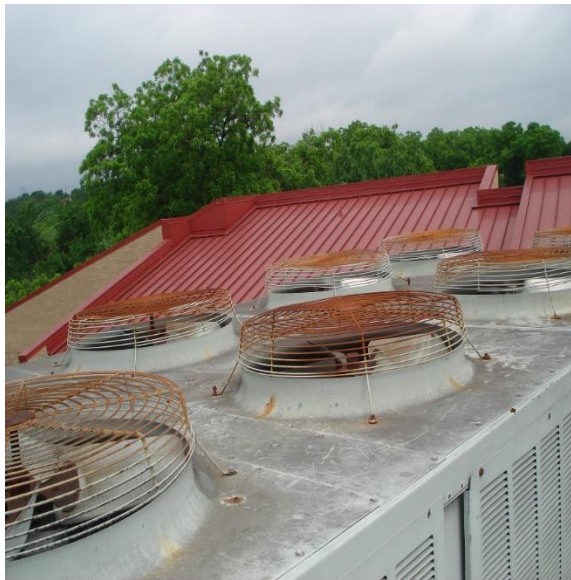
The remote condensing unit is located on the roof of the mechanical room. It was observed with noticeable rust on the casing and fan shrouds.

Figure 2 – Chiller Condensing Unit - Corrosion

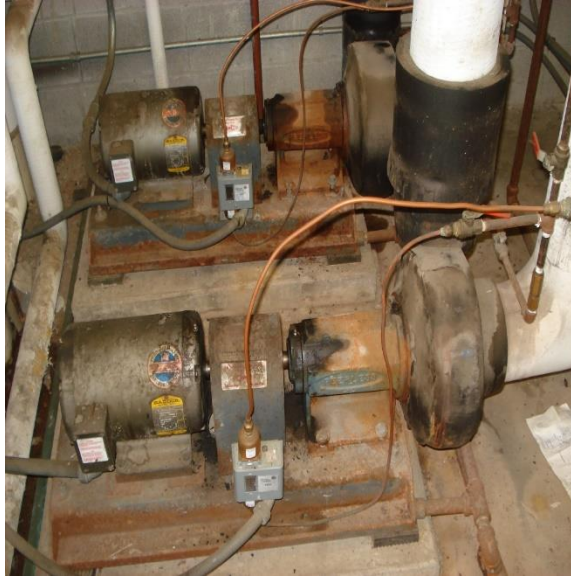
3. Chilled water is transported by two base-mounted, end-suction pumps. The pumps were observed to be in poor condition with large amounts of corrosion and rust on the base and around the pump body. Date information was not found on the pump nameplates, but industry expected equipment service life for base-mounted, end-suction pumps is 20 years.

Figure 3 – Chilled water pumps

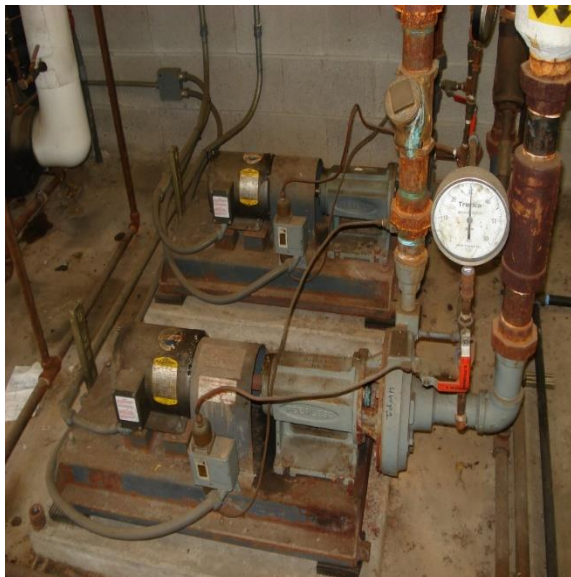
Figure 4 – Heating Water Pumps

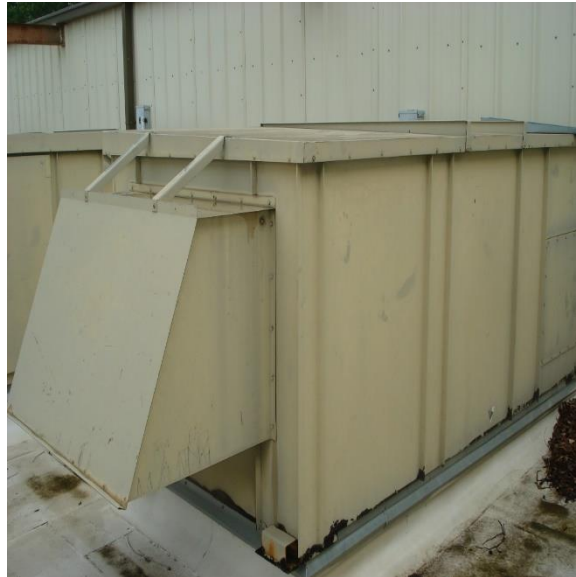
8. Airside systems for the facility consist of six constant volume air handling units located on the roof. The air handling units all have chilled water and heating water coils. The AHU's date of manufacture is unknown but can be estimated to be in the early 1990's at the latest, putting the machines age at around 30 years. Industry expected equipment service life for roof mounted AHU's is 15 years. The AHU's exterior and interior were observed with rust. AHU fans appear in poor condition with about half experiencing excessive bearing or winding noise.

Figure 5 – Typical Roof Mounted AHU

3. Replace the primary pump associated with the heating water boiler along with associated strainers, check valves and isolation valves.
4. Replace the six, roof mounted air handling units. Provide replacement units with Variable Speed Drives (VSD) for the fan motors. Employ a single zone VAV control sequence for energy savings.

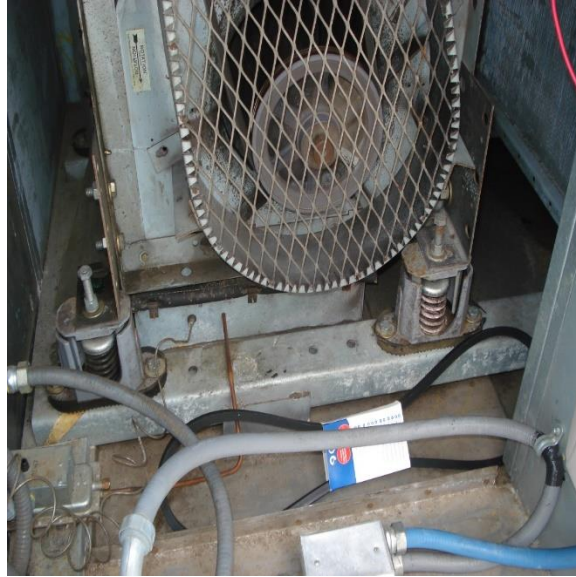
Figure 6 – Typical AHU Fan Section

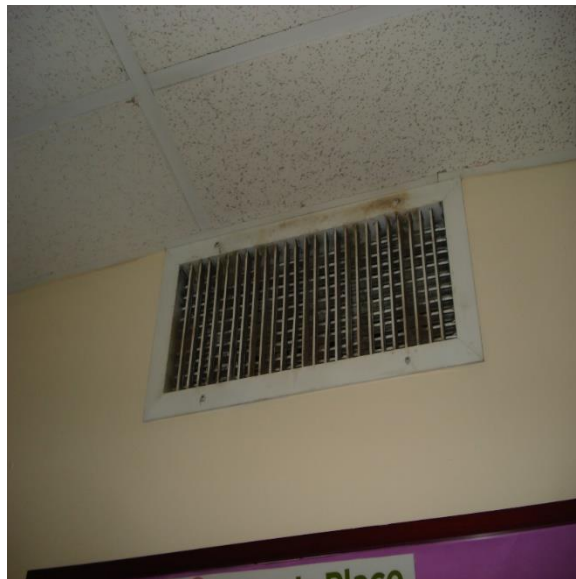
9. Other roof mounted equipment includes six exhaust fans and two relief fans. The fans appear to be in good working condition.
10. Air devices in the facility were observed to be dirty.

Figure 7 – Typical Air Device

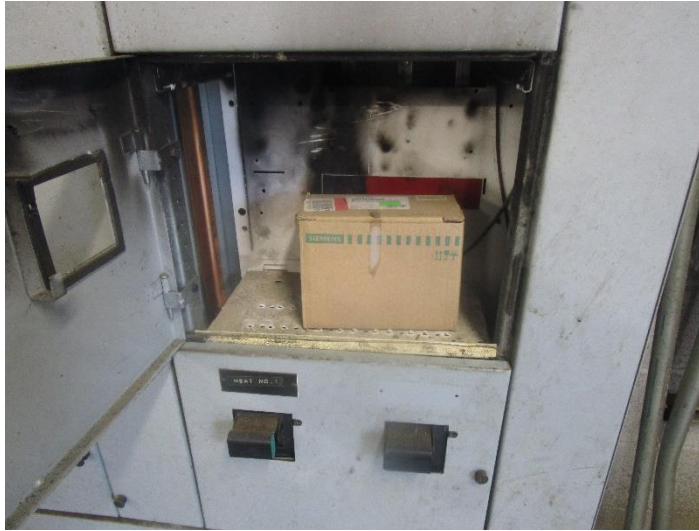
Figure 12 – MCC-1 Arc Flash Damage

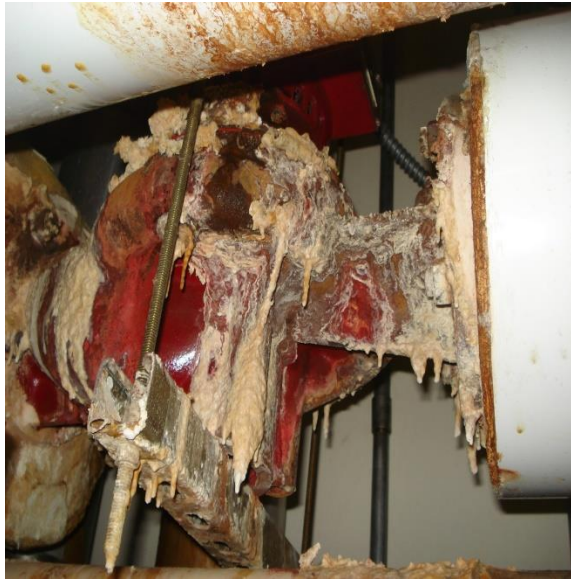
3. The natural gas fired boiler and associated heating water pumps have install dates of 1992. The boiler has a listed input of 1,500 MBh. Nameplate data for the heating water pumps was not legible. Industry expected equipment service life for water tube boilers is 25 years. Industry expected equipment service life for pumps is 25 years. Both the pumps and boilers are beyond their life expectancy. The pumps are showing signs of leaking and subsequent rust as indicated in Figure 1.

Figure 1 – Heating Water Pump Casing Corrosion

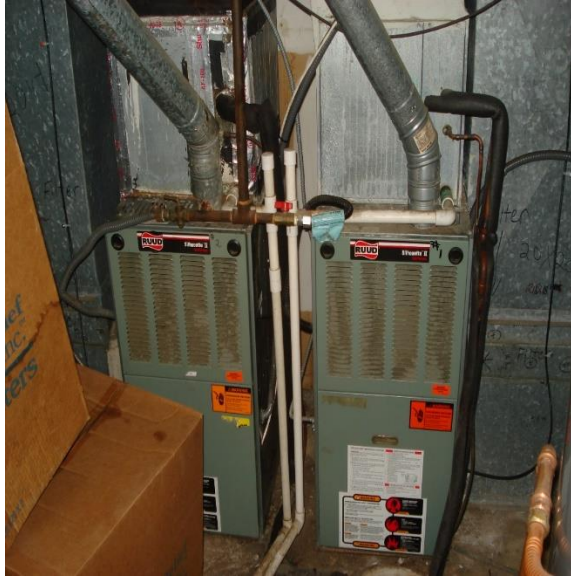
The remaining three AHUs (1,2, and 3) are in a mechanical room with exterior access located at the northeast corner of the building. AHU-3 and the associated condensing unit have been replaced and indicate a manufacture date of 2001. All other AHUs and associated condensing units are original to the building (1984). Industry expected equipment service life for residential DX split system AHUs is 15 years. All AHUs have been in service for 19-34 years and are beyond their useful life expectancy.

Figure 1 – Typical AHU

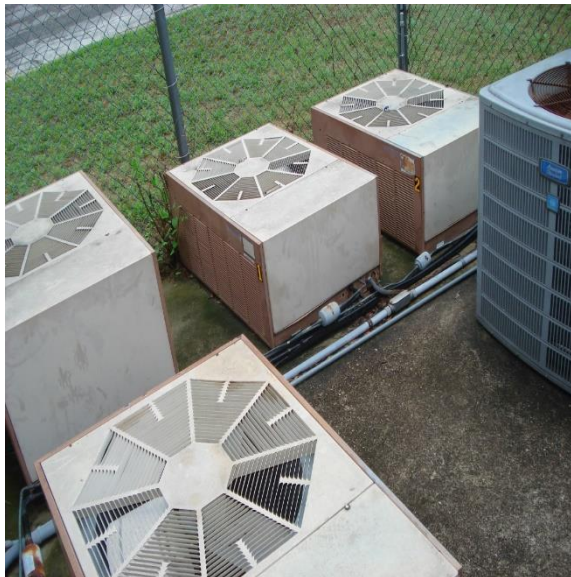
Building original AHUs and condensing units were observed with areas of rust developing on equipment casings. Refrigerant pipe insulation was observed to be in poor condition.

Figure 2 – Condensing Units

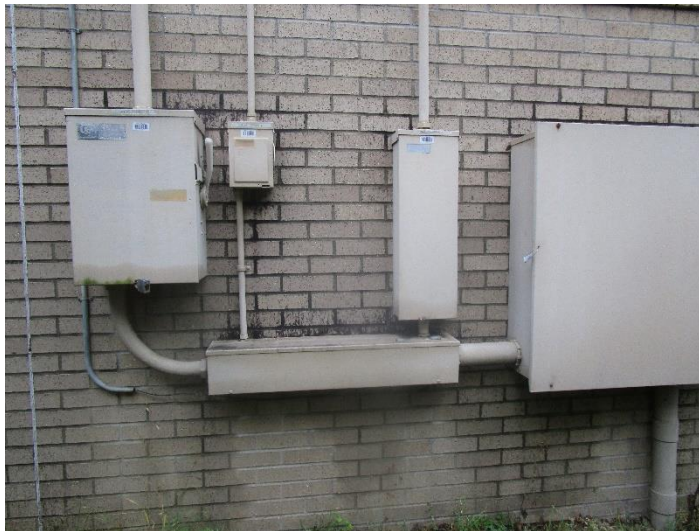
1. The main electrical service is fed from Austin Energy's 12.47kV distribution to two pole mounted single phase with one 75kVA transformer and one 25kVA transformer. The configuration is an open Hi-Leg Delta configuration providing 120/240V three phase electrical service. The secondary transitions to underground 4" conduit into a wireway located in the fenced electrical yard. We were not able to access due to this area as no keys were available. It is assumed at the wireway there is a 200A exterior disconnect which serves panelboard "Elec-panel-1" located in the mechanical yard. There was also a second panelboard "Elec-panel 2" that appears to be a 100A panelboard. There is also associated metering and current transformer enclosure (Figure 3).

Figure 3 – Main Electrical Service in Electrical yard.

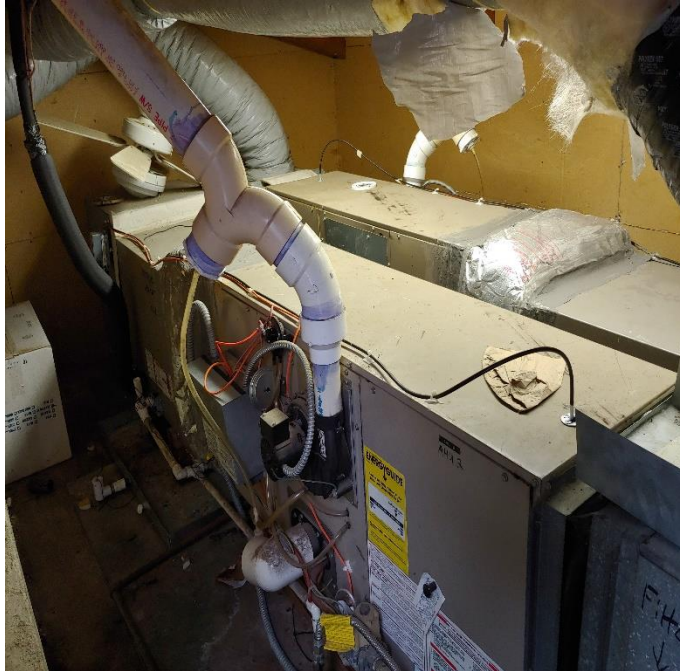
1. The Building Heating, Ventilation, and Air Conditioning (HVAC) is provided by three residential-type Direct Expansion (DX) split system Air Handling Units (AHU) manufactured in 2009. AHUs are in an attic mezzanine accessed via exterior doors in the building rear. Industry expected equipment service life for residential DX split system AHUs is 15 -20 years. The AHUs have been in service for 11 years. The AHUs are in good condition. The AHUs are controlled by wall-mounted Schneider touch-screen programmable thermostats. The AHU DX cooling coils, refrigerant pipe, and insulation were replaced in 2017. Associated condensing units are in an enclosed mechanical yard exterior to the building.

Figure 1 – AHU-2 and AHU-3 (Typical 3 AHUs)

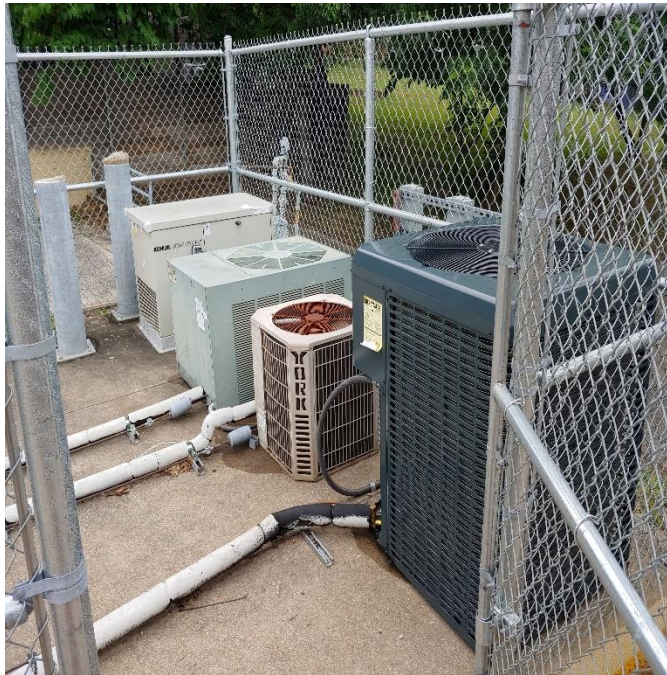
3. The enclosed equipment yard contains three (3) DX condensers, one condensing unit per AHUs, and one (1) natural gas-fired generator. Condensing unit #1, associated with AHU-1, was manufactured in 2017. Condensing unit #2 and condensing unit #3 were manufactured in 1997 and 1996, respectfully. Industry expected equipment service life for residential DX split system AHUs and their associated condensing units is 15 – 20 years. Condensing units #2 and 3 are 23 to 24 years old and are beyond their life expectancy. Areas of rust have developed on the condensing unit casings and the refrigerant pipe insulation has begun to deteriorate. Some of the insulation has fallen off the refrigerant piping.

Figure 3 – DX Condensing Units and Generator

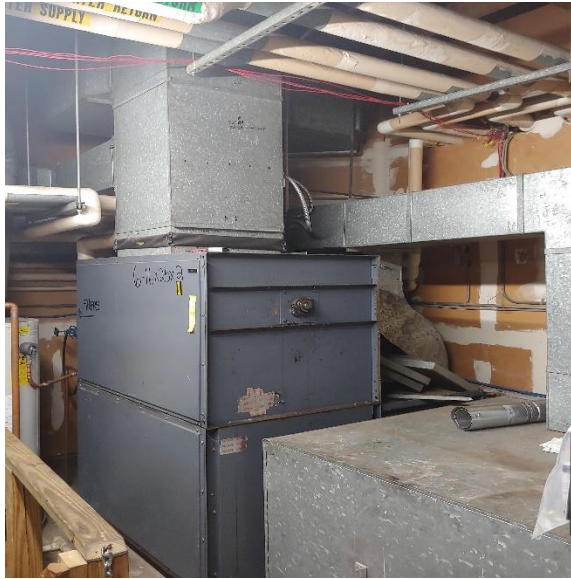
1. The Building Heating, Ventilation, and Air Conditioning (HVAC) is provided by nine (9) constant-volume Air Handling Units (AHU) with chilled and heating hot water coils located in attic mechanical room #1. All the AHUs are manufactured by Trane in 1979 and are comprised of the following components: Mixing section, filters, cooling coils, heating coils, and a belt-driven fan section. Each AHU serves a different area of the building. Building occupants report that different areas are either hot or cold and the building does not have a uniform temperature throughout. Industry expected equipment service life for commercial central AHUs is 20 - 25 years. All nine of the AHUs are 41 years old and beyond their useful life.

Figure 1- Typical AHU.

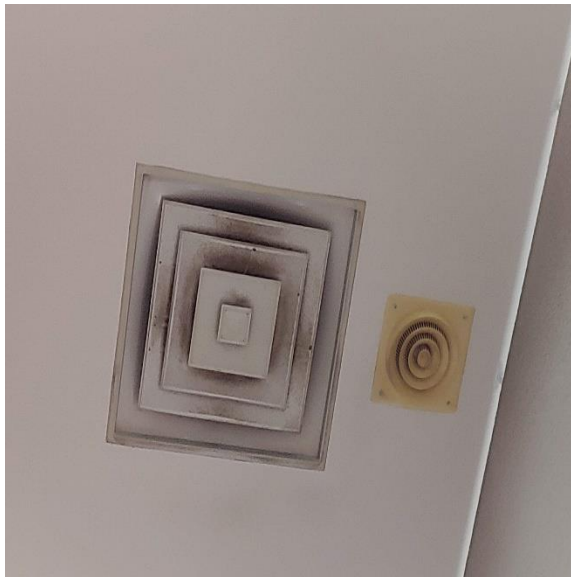
2. The ductwork and air devices (grilles, registers, and diffusers) in the Building are observed to be in poor condition showing areas of rust, dirt, and possible biological growth. All devices are original to the building from 1979. Industry expected equipment service life for grilles, registers and diffusers is 20 - 25 years. All grilles, registers, and diffusers are 41 years old. Industry expected equipment service life for ductwork is 30 years. All ductwork is 41 years old.

Figure 2 – Typical diffuser with rust, dirt and possible biological growth.

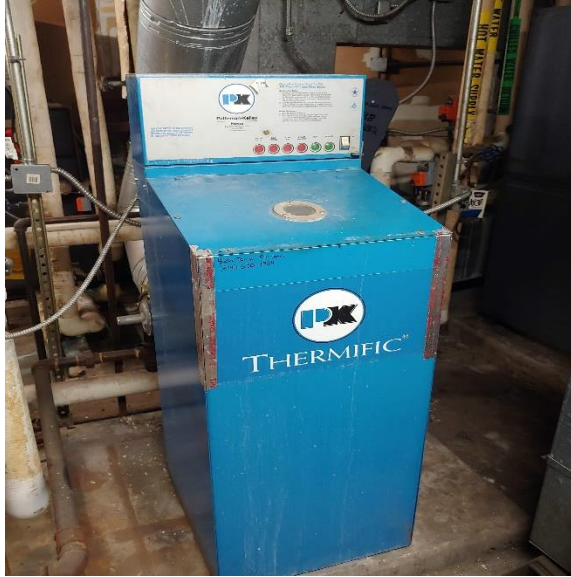
3. Heating water is produced by a Patterson-Kelly gas-fired boiler manufactured in 2006. The boiler is in the attic mechanical room with AHUs 1 through 6. The boiler appears to be in fair condition with some areas of rust and wear on the casing. Industry expected equipment service life for a boiler is 25 - 30 years. The boiler is 14 years old and within its useful service life.

Figure 3 – Heating Water Boiler

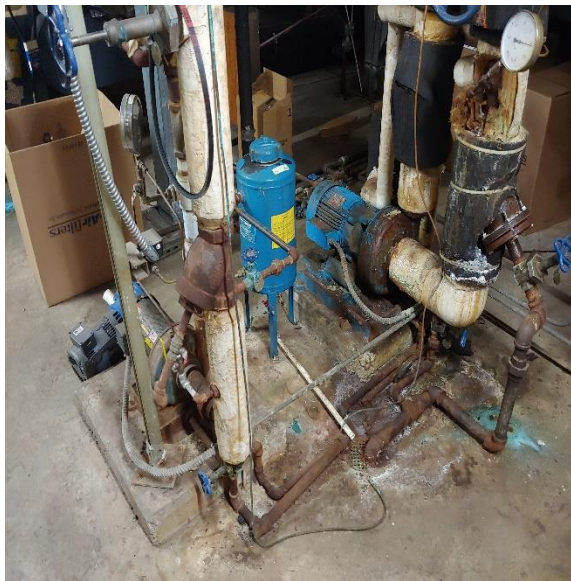
4. Heating water is circulated to the AHUs by a centrifugal pump located adjacent to the boiler. The pump casing and data tag were corroded and could not be read. Estimated pump size is 70 gpm based on the boiler size. There is evidence of water stains and pump casing leaks. The pump age could not be determined. Industry expected equipment service life for a boiler is 20 years.

Figure 4 – Heating Water Pump (left) and Chilled Water Pump (right)

6. Chilled water is circulated to the AHUs by a centrifugal pump located adjacent to the heating water pump, see Figure 4. The pump casing and data tag were corroded and could not be read. Estimated pump size is 60 gpm based on the chiller size. There is evidence of water stains and pump casing leaks. The pump age could not be determined. Industry expected equipment service life for a boiler is 20 years.
7. Chilled water piping and heating water piping is covered with fiberglass insulation. The pipe fittings (elbows) have hard mastic covering the insulation which typically indicates possible asbestos insulation. All the insulation is in poor condition and is damaged.

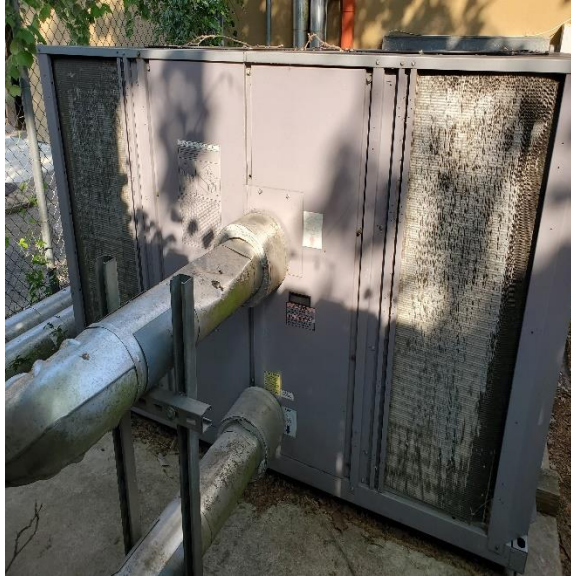
5. Chilled water is produced by a Carrier Aquasnap 30-TON air-cooled chiller manufactured in 2005. The chiller is in the exterior mechanical yard. The chiller coils have several areas where the coil fins are bent (light areas in Figure 5) which reduces coil airflow and chiller capacity. Additionally, the coils are coated in dirt / debris (dark areas in Figure 5) which also reduces the chiller capacity. Industry expected equipment service life for an air-cooled is 20 - 25 years. The air-cooled chiller is 15 years old, reaching the end of its service life, and in poor condition.

Figure 5 – Air-Cooled Chiller

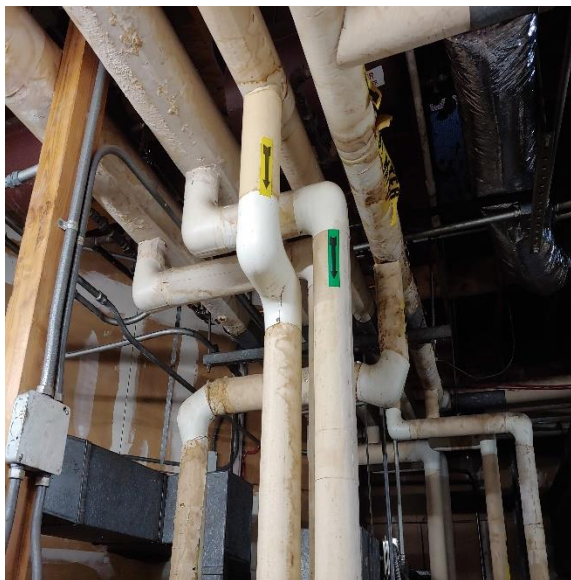
Figure 6 – Typical Pipe Insulation.

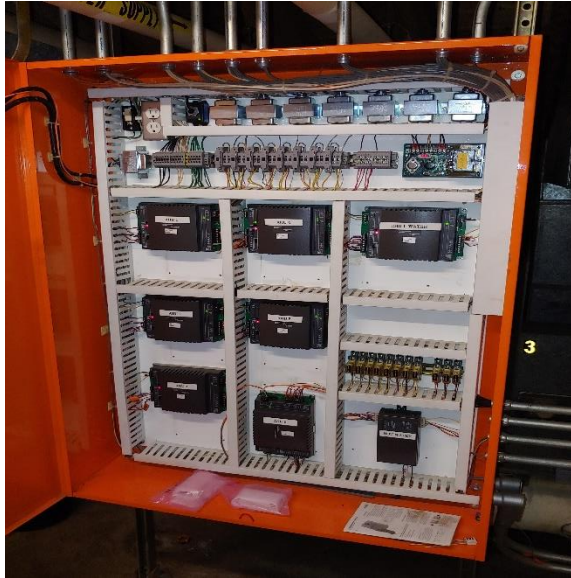
8. A Schneider Electric Andover Continuum building control system is in place for service of all equipment installed in 2011 and is in good condition. Industry expected equipment service life for a control system is 20 years.

Figure 7 – Typical Controls Cabinet.

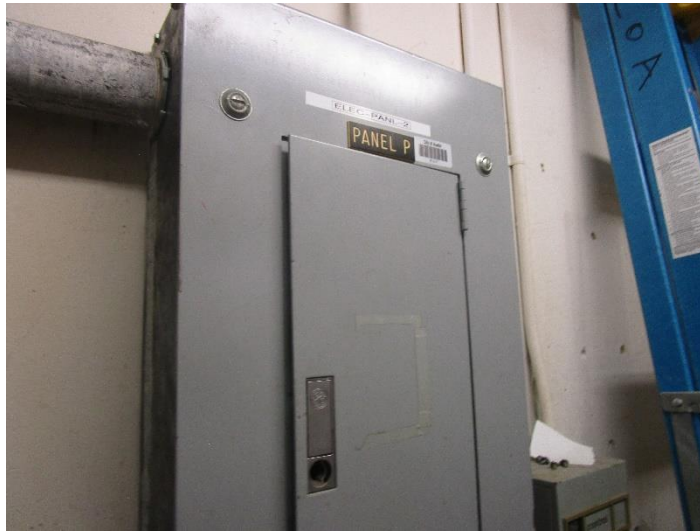
3. Existing Panelboard P is a 100A GE 3 Phase 4 Wire panelboard which serves condensing units “CU-1” and “CU-2” with 40A/3P breaker and 50A/3P breaker (Figure 8).

Figure 8 – Panelboard “P”

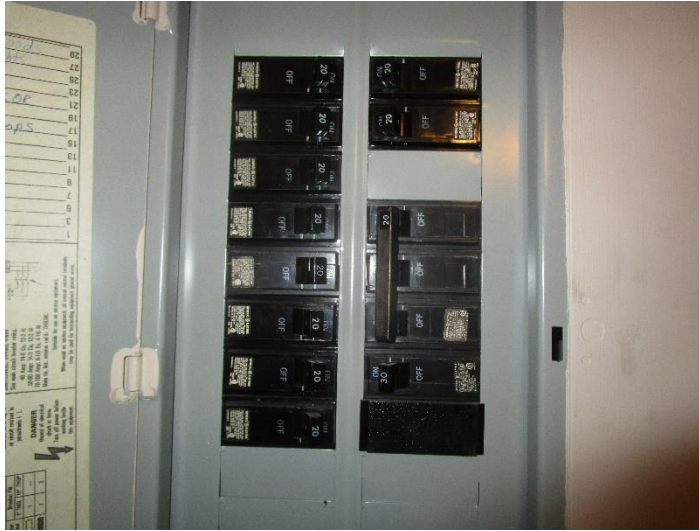
2. The interior panelboard is a 200A GE load center 120/208V 3 Phase 4 Wire panelboard. There is a 20A/3P breaker that serves the condensing unit on the exterior of the building (Figure 5). No arc flash or short circuit labels were posted on any of the panelboards as required per NFPA 70E.

Figure 5 – Interior Panelboard.

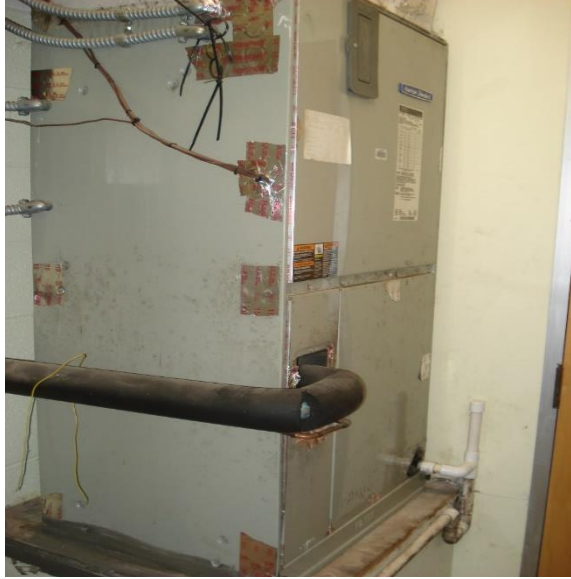
1. The Building Heating, Ventilation, and Air Conditioning (HVAC) is provided by two residential-type Direct Expansion (DX) split system Air Handling Units (AHU), three Direct Expansion (DX) 'Mini-Split' systems, and one Direct Expansion (DX) thru-wall system. All DX equipment is observed to utilize R-22 refrigerant. The primary building HVAC system is an American Standard Direct Expansion (DX) split system of approximately 3.5 nominal Ton capacity. The nameplate indicates a manufacture date of May 2003. Heat is provided by a 15-kW duct heater. Corrosion is observed on the AHU casing. The associated condensing unit is located exterior to the building. Areas of rust have developed on the condensing unit casings and the refrigerant pipe insulation has begun to deteriorate. Industry expected equipment service life for residential DX split system AHUs is 15 years. The AHU and condensing unit have been in service for 17 years and is beyond its useful service life.

Figure 1 – ‘American Standard’ AHU

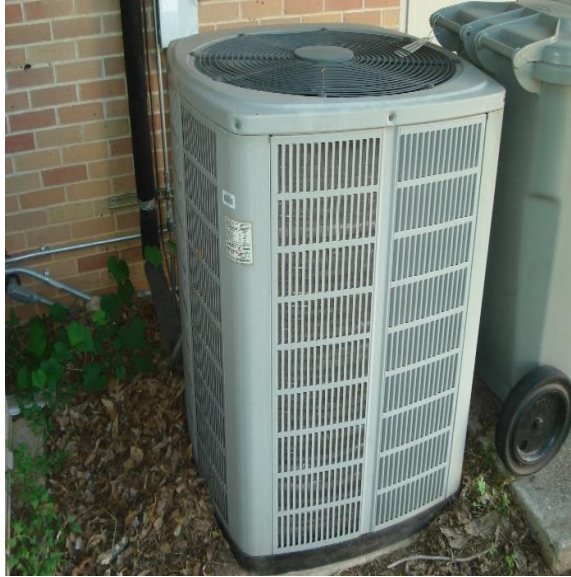
3. A secondary building HVAC system is as follows: Addison Direct Expansion (DX) split system of approximately 6 nominal Ton capacity. The nameplate indicates a manufacture date of October 2003. Heat is provided by a separate duct heater of unknown capacity. The associated condensing unit is located exterior to the building. Areas of rust have developed on the condensing unit casings and the refrigerant pipe insulation has begun to deteriorate. Industry expected equipment service life for residential DX split system AHUs is 15 years. The AHU and condensing unit have been in service for 17 years and is beyond life expectancy. It was observed that this AHU system was disabled at the outdoor condensing unit disconnect.

Figure 2 – AHU condensing unit (typical of 2)

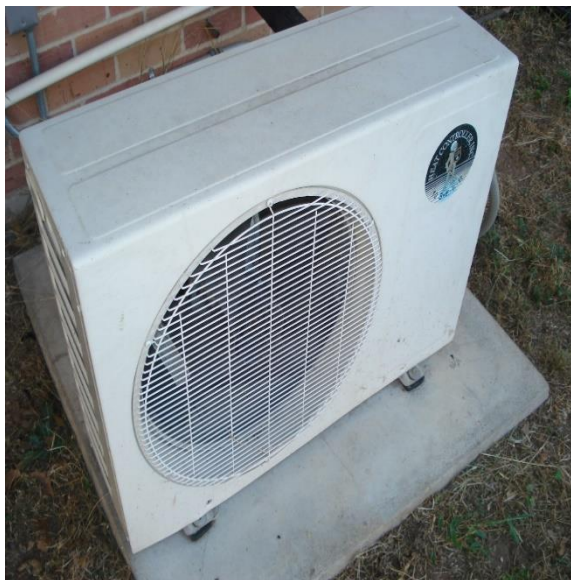
4. Air distribution associated with the Addison unit is by underfloor ductwork directing air to floor mounted air devices. The air devices appear to be in good working condition with no notable deficiencies.
5. Three Direct Expansion (DX) ‘Mini-Split’ heat pump systems serve the south end of the building. They each have around 1 nominal Ton cooling capacity and 12,000 BTU/h heating capacity. Associated condensing units are located outside. Both indoor units, condensing units, and associated refrigerant piping and insulation appear to be beyond their life expectancy. A thru-wall DX unit serves a server room adjacent to the mechanical room. It also appears to be beyond life expectancy.

Figure 3 – Mini-Split condensing unit (typical of 3)

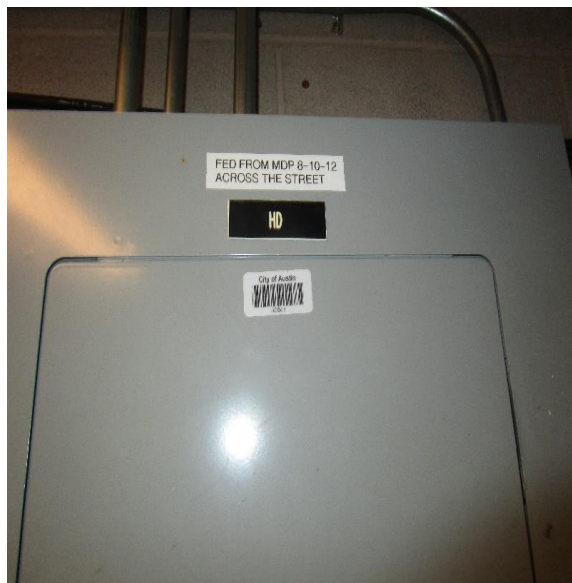
1. The main electrical service is fed from building D Main Distribution Panel "MDP" circuit 8, 10, 12 with a 200A/3 pole breaker. The main panelboard in the building "HD" 250A, 480/277V SIEMENS 3 Phase, 4 Wire Panelboard (Figure 4). The panelboard was manufactured in 2003 and is 17 years old and appears in good condition. No arc flash labels were present as required per NFPA 70E.

Figure 4 – Panelboard "HD"

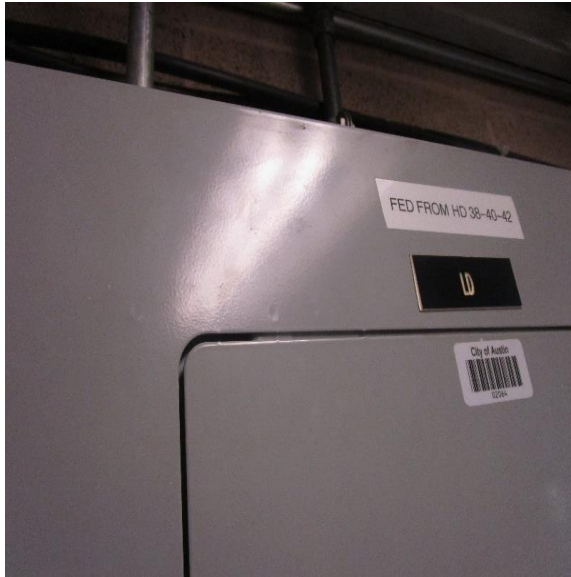
2. The downstream 120/208V, 3 Phase, 4 Wire Panelboard "LD" SIEMENS type P1 250A with 150A/3 pole main breaker (Figure 5). The panel is fed from a 45kVA transformer and serves various loads and the DX condensing unit and the three mini splits. The panel was also manufactured in 2003 and appears to be in good condition. No arc flash labels were present as required per NFPA 70E.

Figure 5 – Panelboard “LD”

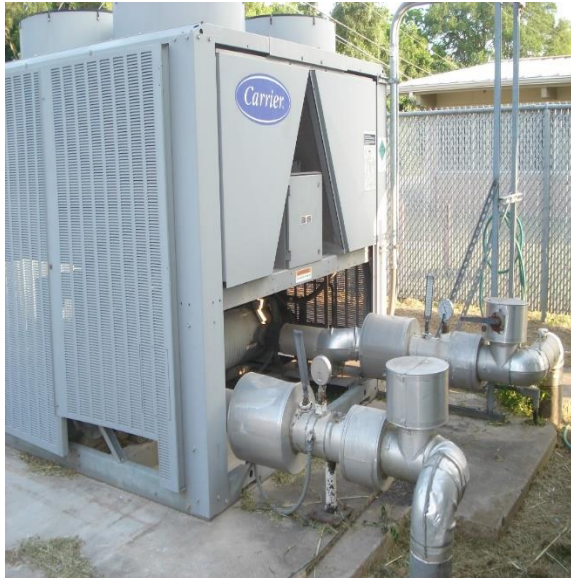
1. The Building Heating, Ventilation, and Air Conditioning (HVAC) is provided by Chilled water by way of one (1) air cooled chiller of 60 nominal Ton capacity. It is located outdoors in a connected equipment yard just west of Building D. The chiller paint finishes are showing signs of wear including internal components such as compressors. Exterior chilled water piping is clad in aluminum jacket and is observed with dents.
2. Based on the prevailing age of equipment observed, all equipment and supporting infrastructure (such as chilled water and heating water piping) appear to have been installed in 2003.

Figure 1 – Air Cooled Chiller and Exterior Piping

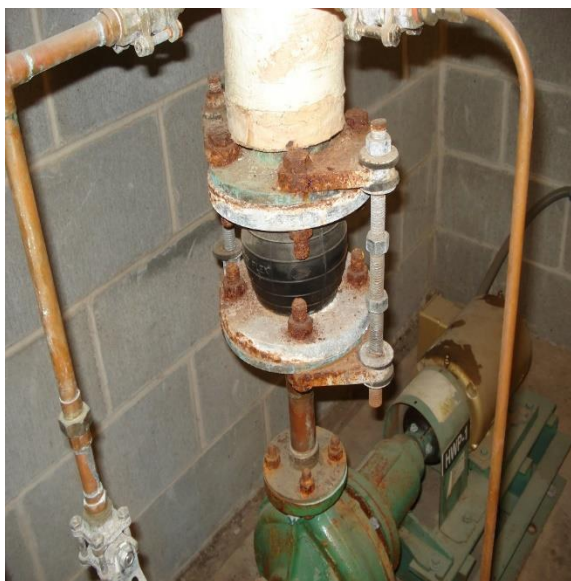
3. Chilled water is distributed by (2) end suction pumps with 3 HP motors. Pump motors are observed to be in good condition. Corrosion and signs of leaking are observed on the pump casings.
4. Heating hot water is produced by (4) natural gas fired boilers. Boilers are rated at 199,000 BTU/h each and each have a concentric type combination vent/flue. The boilers appear in good cosmetic condition.
5. Heating hot water is distributed by (2) end suction pumps with capacity as follows: 50 GPM, 42 ft. hd., 1-1/2 HP motor. Pump motors are observed to be in good condition. Corrosion and signs of leaking are observed on pump casings and associated strainers and valves.

Figure 2 – Typical Pump with Corrosion

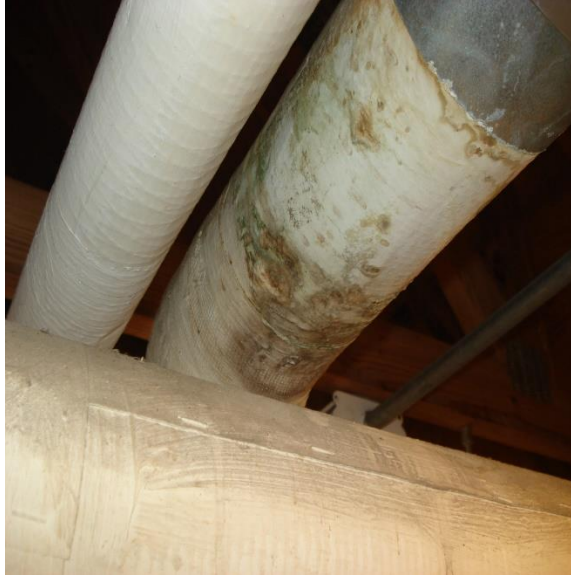
Figure 3 – Biological Growth and Water Damage on Pipe Insulation

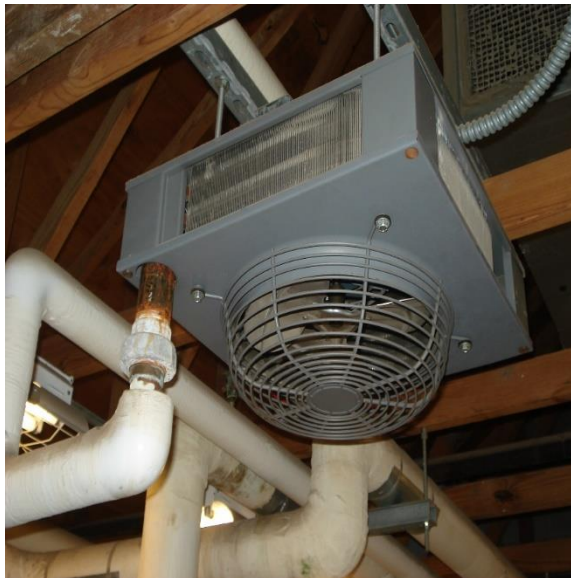
Figure 4 – Unit Heater with Corrosion at Pipe Connection

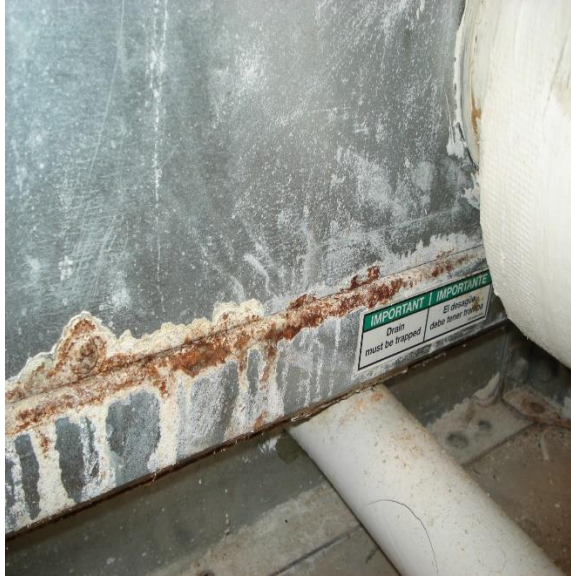
Figure 1 – Typical AHU Casing Corrosion

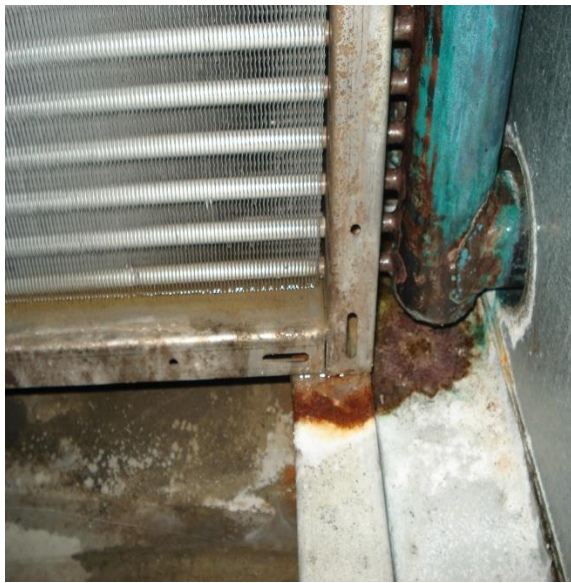
Figure 2 – Typical AHU Cooling Coil Corrosion

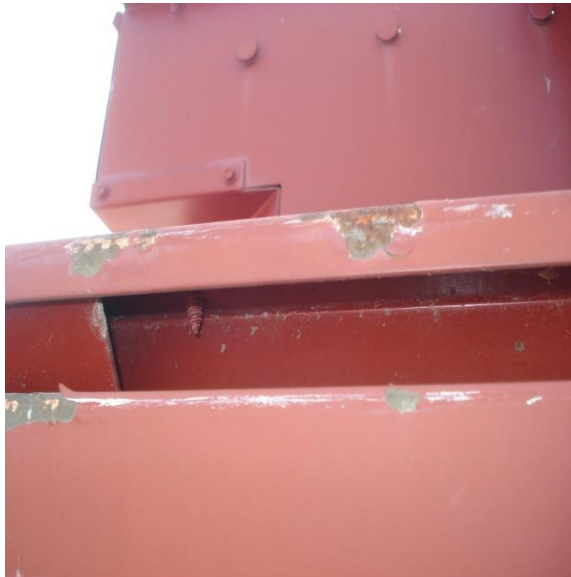
Figure 2 – ACCU-1 Corrosion on Condensing Unit Frame

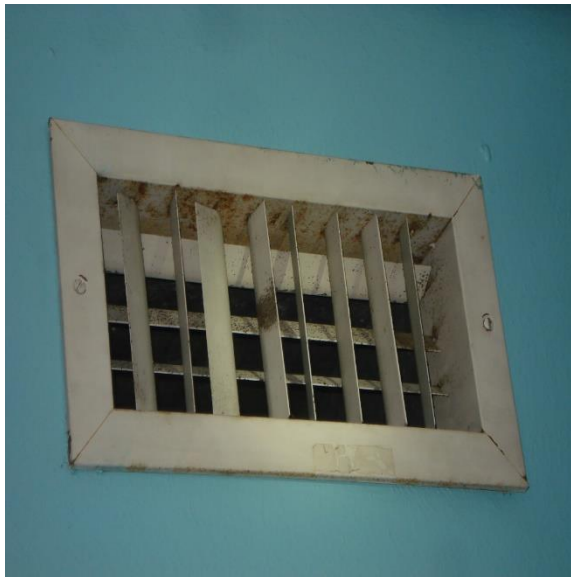
Figure 2 – Typical Air Device with Corrosion.

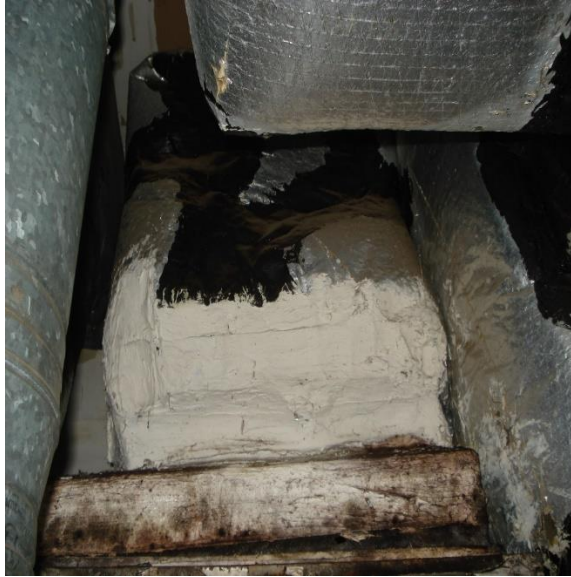
Figure 3 – AHU-1 Ductwork with biological growth.
