Heritage Preservation Grant - Historic Garage Renovation

1316 W 6th St
Austin, TX 78703
09/27/22
LAS #P0177-22

**LORD
AECK
SARGENT**

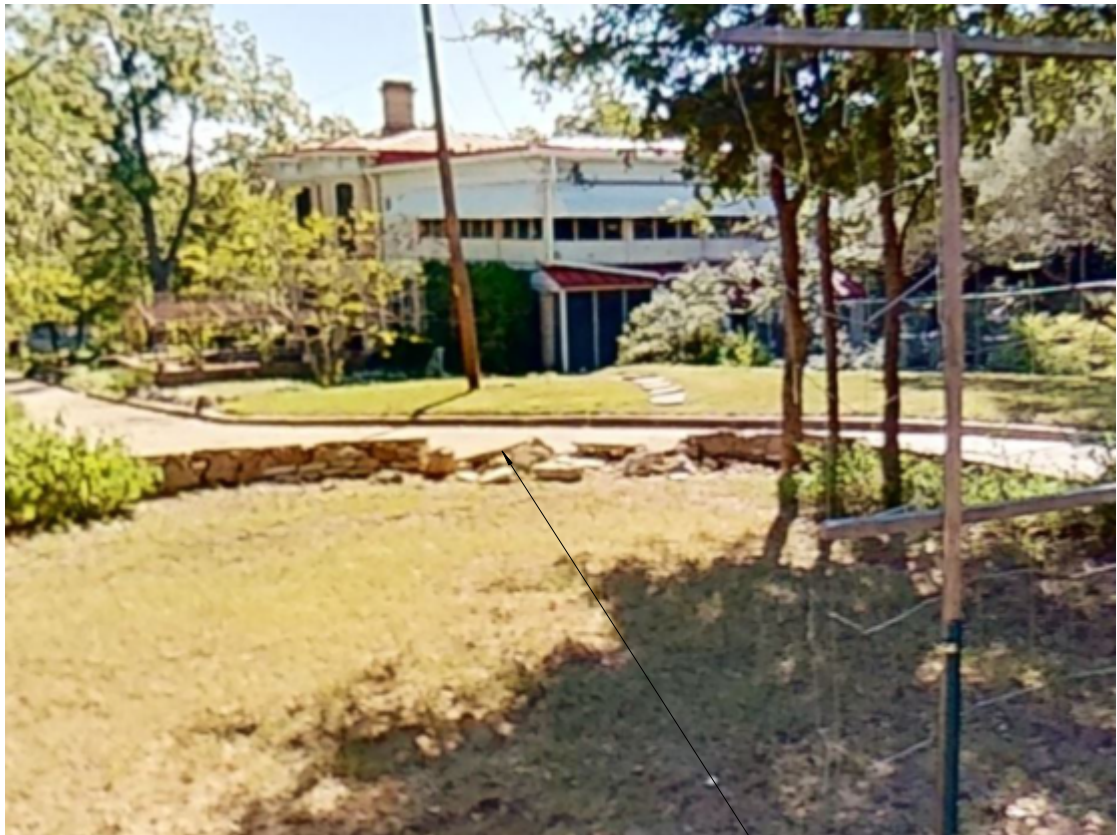
PHOTO 2: REPAIR AND REBUILD CRESCENT RETAINING WALL. DATE 2022-JUL-30.

1. REPAIR AND RECONSTRUCT CRESCENT RETAINING WALL TO ORIGINAL HEIGHT. STABILIZE, SHORE, AND REPAIR WALL FOUNDATION AS NEEDED. LINEAR FEET: 84'-8" V.I.F. REFER TO PHOTO 2.
2. RESTORE AND RECONSTRUCT RETAINING WALL LOCATED EAST OF GARAGE. MAY REQUIRE UNEARTHING AND REMOVING VEGETATION BACK TO PROPERTY LINE. CONSULT WITH CITY OF AUSTIN ARBORIST BEFORE REMOVING TREES. REFERENCE HISTORICAL PHOTOS 4 AND 5.
3. EXCAVATE TO ORIGINAL DRIVEWAY PATH GRADE. REMOVE VEGETATION AS NEEDED. REPAVE WITH CONCRETE PAD BETWEEN EXISTING DRIVEWAY AND GARAGE PER DRAWING.
4. CRESCENT WALL TO BE RECONSTRUCTED. STABILIZE, SHORE, AND REPAIR WALL FOUNDATION AS NEEDED. LINEAR FEET: 35'-0" V.I.F. REFER TO PHOTO 6A.

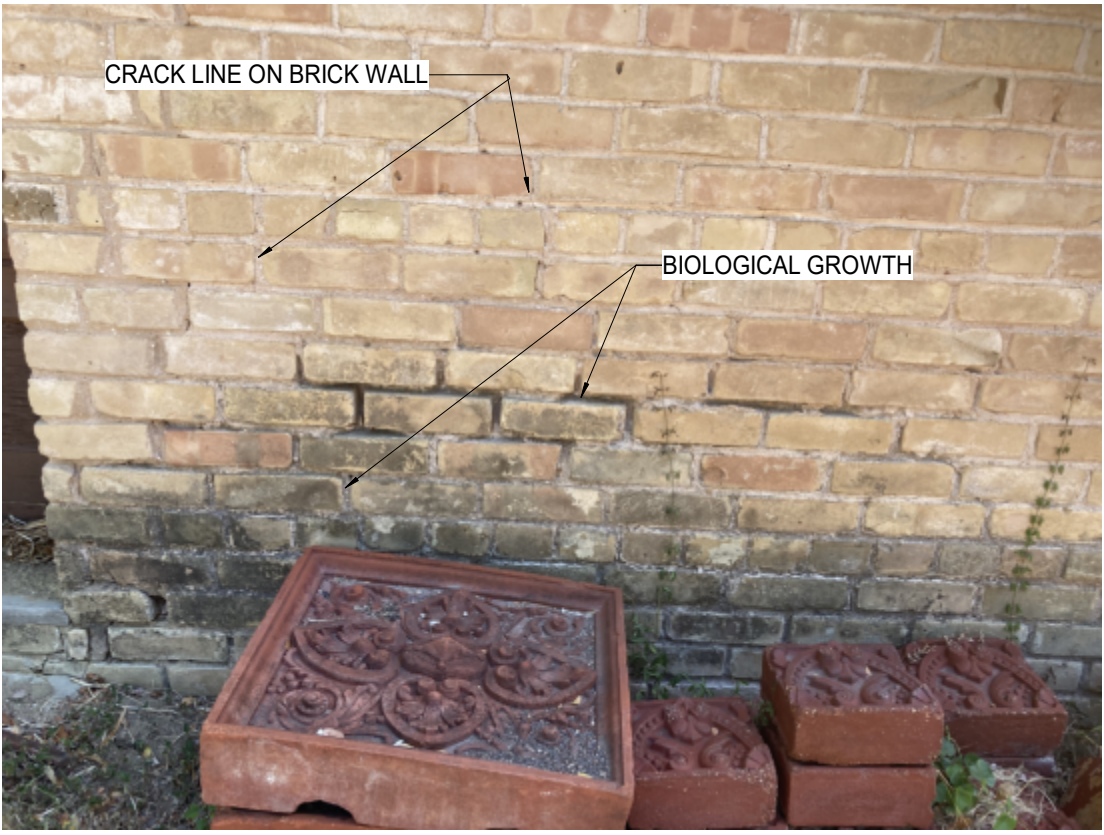
PHOTO 3: BRICK CRACKS AND BIOLOGICAL GROWTH ON SOUTH FACADE. DATE 2022-JUL-30.

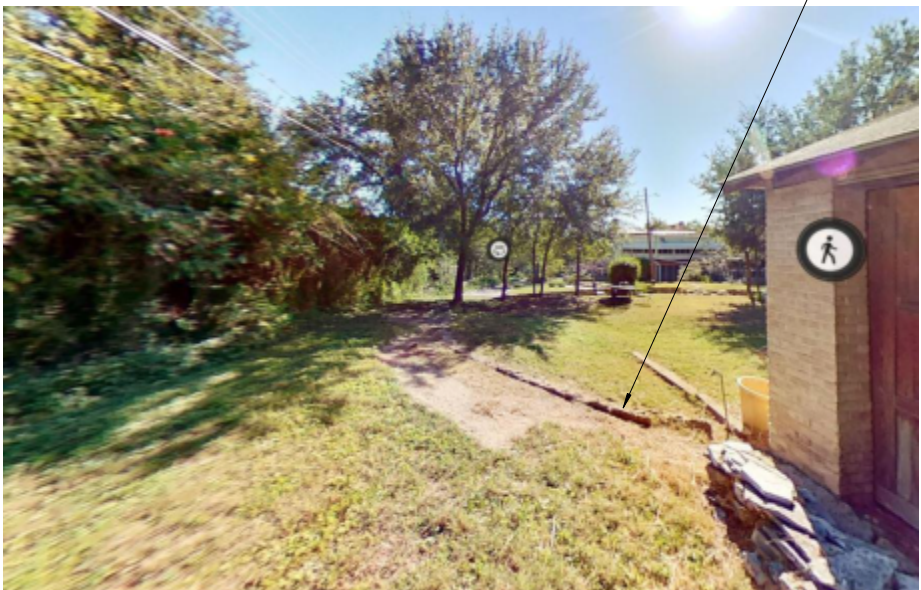
PHOTO 6A: SOUTHEAST OF GARAGE. DATE 2022-SEPT-27.

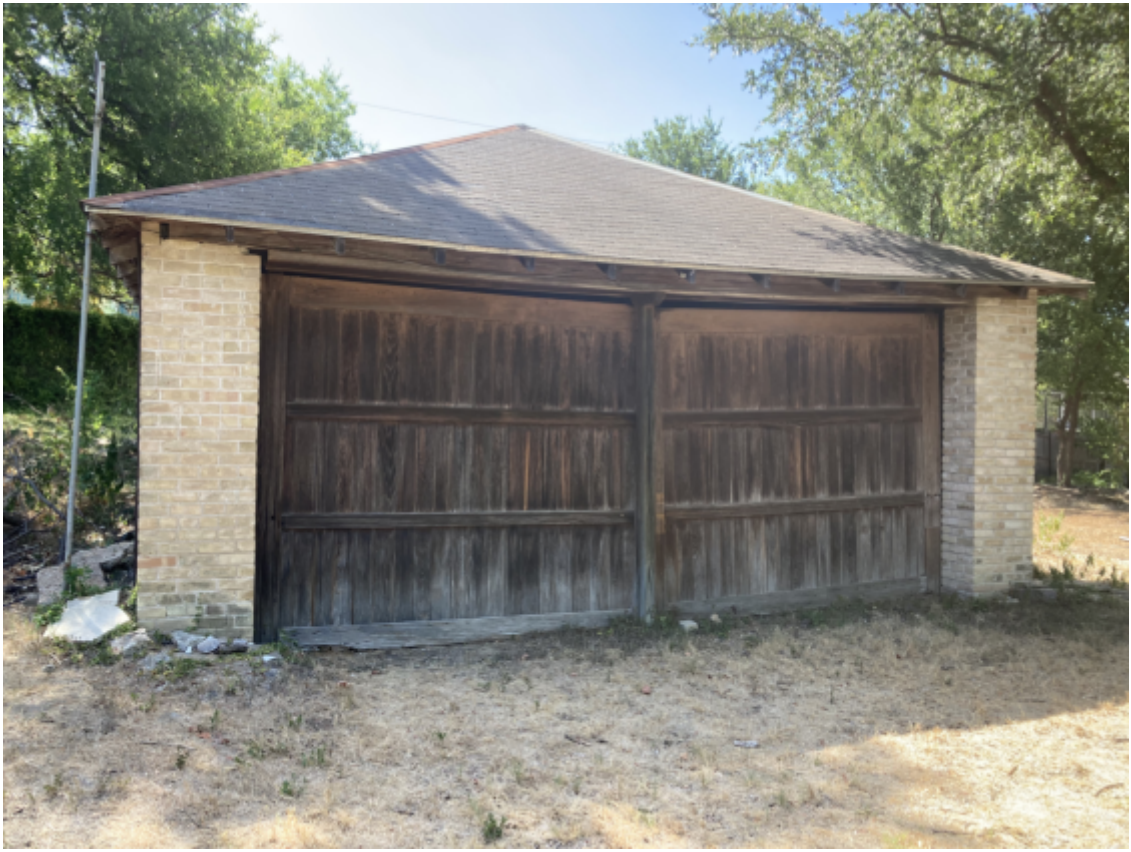
PHOTO 7: GARAGE DOOR ON WEST FACADE. DATE 2022-JUL-30.

1. REPLACE WITH NEW DOOR. TRIM AND COLOR TO MATCH HISTORIC. REFER TO PHOTOS 7-9.
2. REPLACE STRUCTURAL WOOD BEAM ABOVE BARN DOOR WITH STEEL BEAM PER ENGINEER.
3. ATTACH DOOR TRACK TO STEEL BEAM. LOCATION BARN DOOR.
4. REMOVE AND REPLACE FLOOR SLAB.
5. NOT USED.
6. REMOVE COLUMN ONCE NEW STRUCTURAL BEAM IS INSTALLED.
7. INSTALL BI-FOLD DOOR. BASIS OF DESIGN: MARVIN ULTIMATE BI-FOLD DOOR.

- REPLACE WITH NEW CEDAR SHAKE ROOF.
- REPLACE WITH NEW DOOR, TIME AND COLOR. CONDUCT PAINT ANALYSIS TO DETERMINE ORIGINAL COLOR. REFER TO PHOTOS 7 AND 8.
- REPLACE STRUCTURAL WOOD BEAM ABOVE BARN DOOR WITH STEEL BEAM. ATTACH DOOR TRACK TO STEEL BEAM. REFER TO PHOTO 12.
- INSTALL BI-FOLD DOOR. BASIS OF DESIGN: MARVIN ULTIMATE BI-FOLD DOOR. REFER TO MANUFACTURER PHOTOS 18 AND 19.

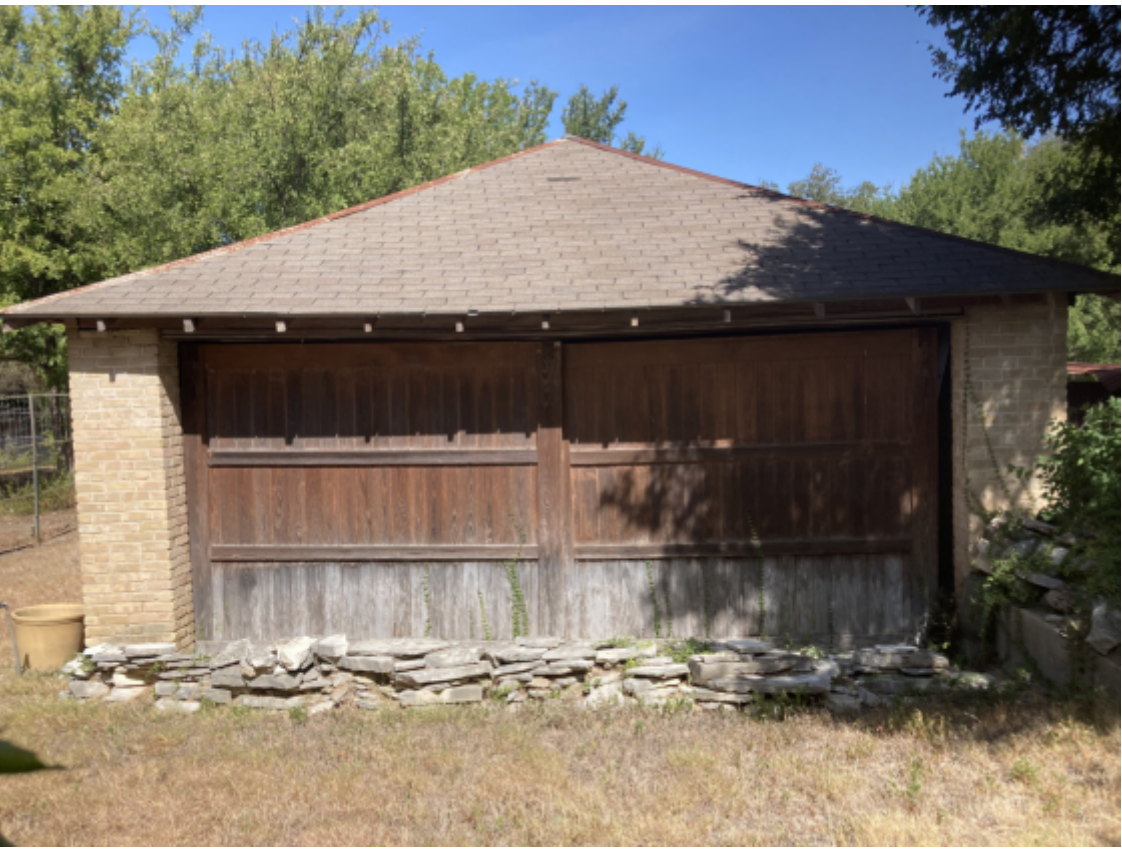
PHOTO 8: GARAGE DOOR ON EAST FACADE. DATE 2022-JUL-30.

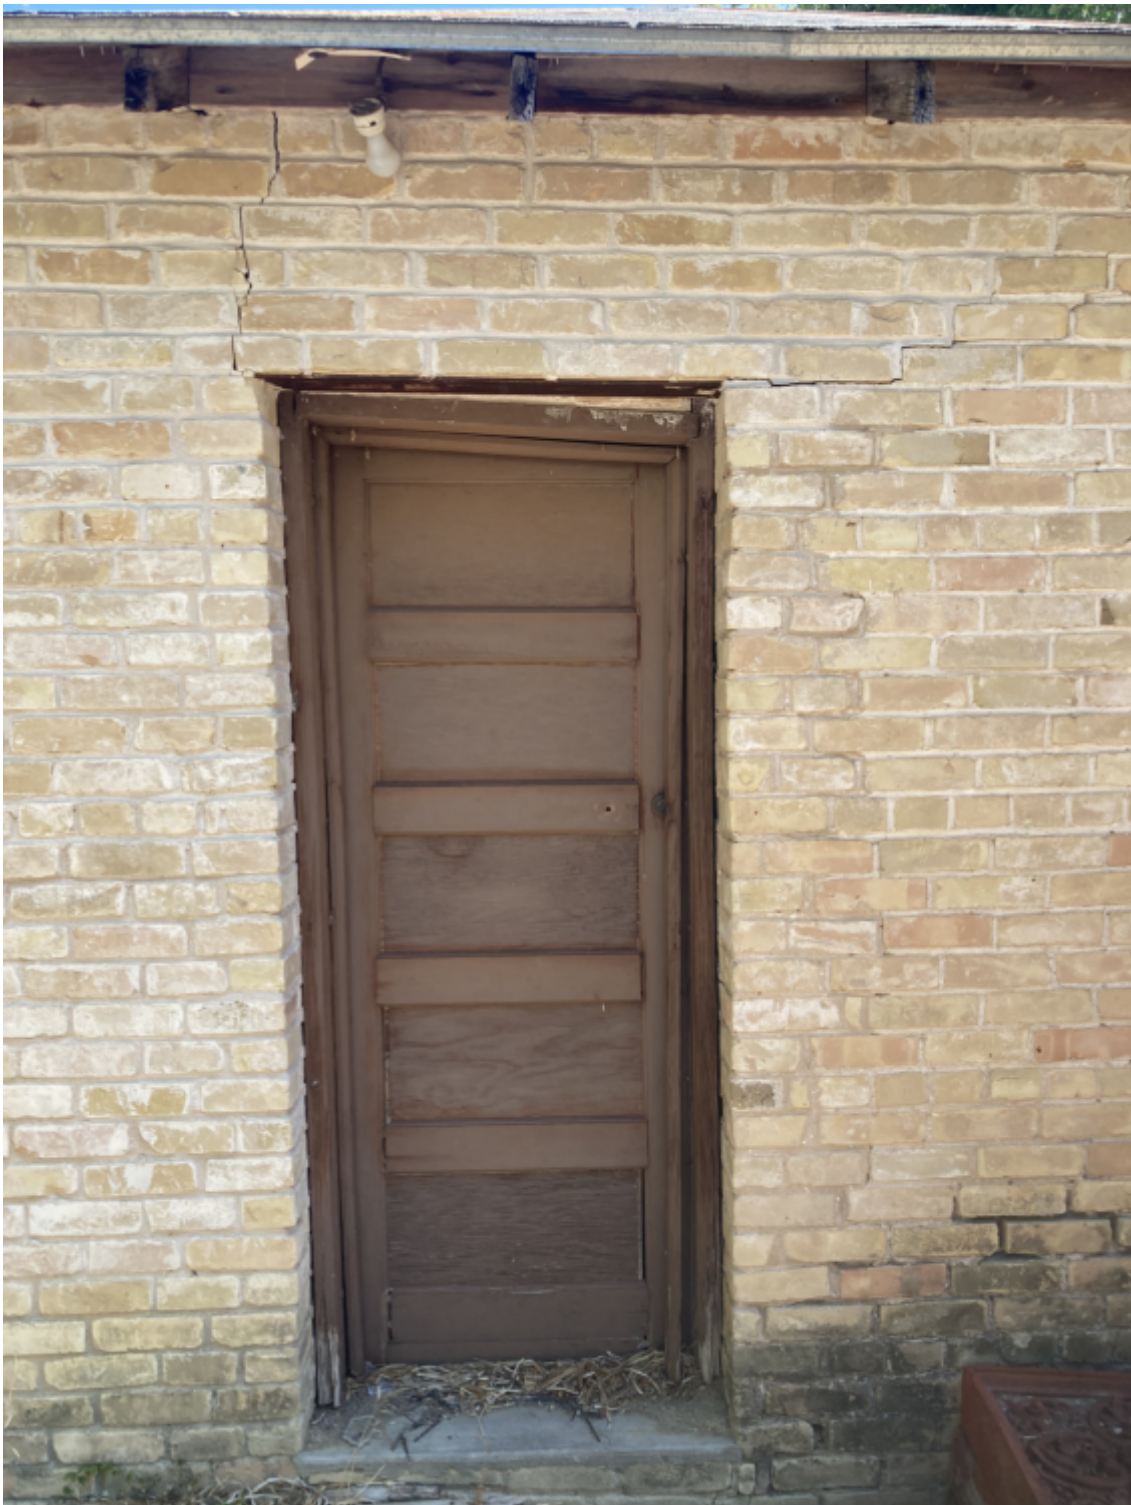
PHOTO 9: DOOR ON SOUTH FACADE. DATE 2022-JUL-30.

- SHEET SPECIFIC NOTES
- REPLACE WITH NEW CEDAR SHAKE ROOF.
 - RESTORE WITH NEW DOOR, TRIM, FRAME. NEW PAINT FOR DOOR, TRIM, FRAME. PAINT TO MATCH HISTORIC PAINT COLOR. REFER TO PHOTOS 9 AND 14.
 - NOT USED.
 - REPAIR CRACKS ON BRICK. REFER TO PHOTOS 13 AND 14.

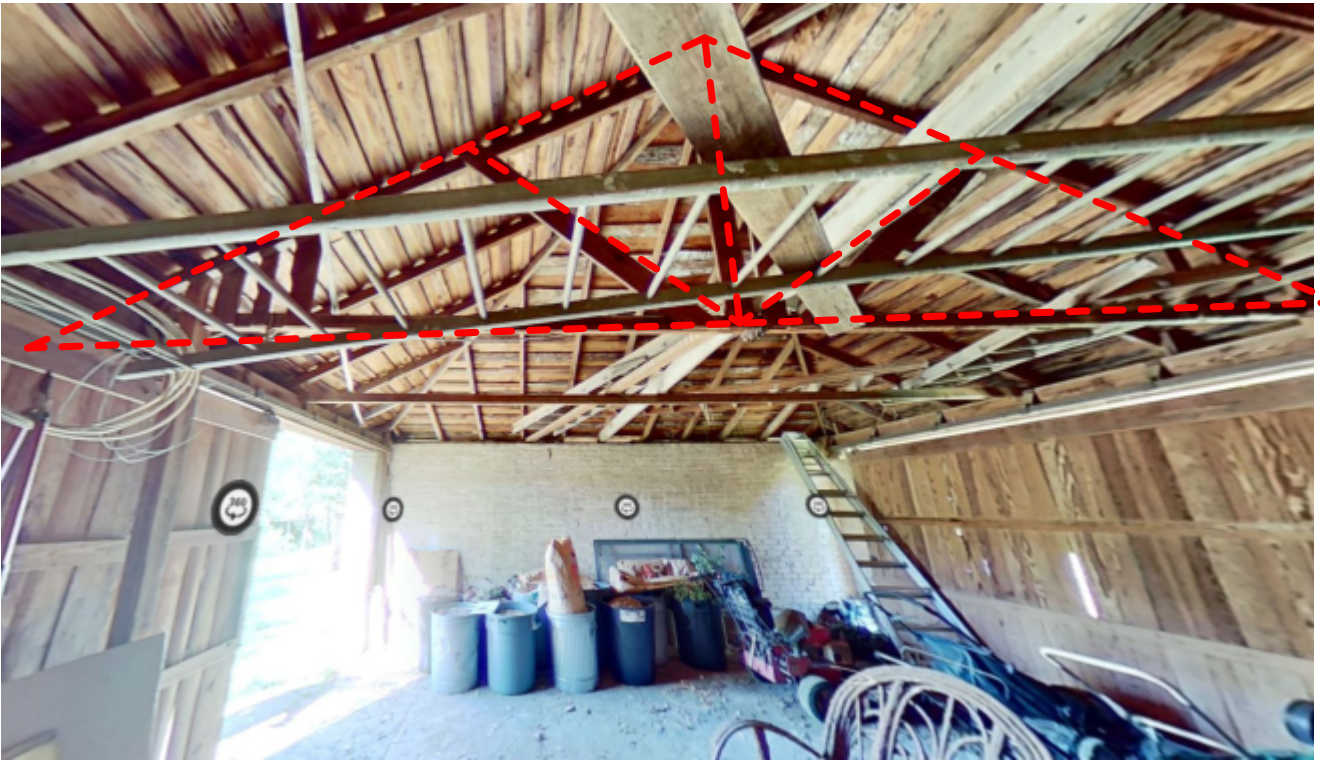
PHOTO 10: ROOF TRUSS. DATE 2022-SEP-27.

- SHEET SPECIFIC NOTES
1. PROTECT, REPAIR, AND REINFORCE EXISTING ROOF TRUSS. ADJUST TRUSS TO BEAR ON NEW STEEL BEAMS. REFER TO PHOTO 10.
 2. PROTECT, REPAIR, AND REINFORCE EXISTING ROOF RAFTERS. REFER TO PHOTO 11.
 3. REPLACE STRUCTURAL WOOD BEAM ABOVE BARN DOOR WITH STEEL BEAM PER ENGINEER. ATTACH NEW DOOR TRACK TO STEEL BEAM. REFER TO PHOTO 12.
 4. SEAL AND INSULATE GAPS ABOVE BRICK WALL AND BEAMS PER NOTES 5 AND 6.
 5. WOOD TRIM. FINISH TO MATCH EXISTING.
 6. MINERAL WOOL INSULATION.

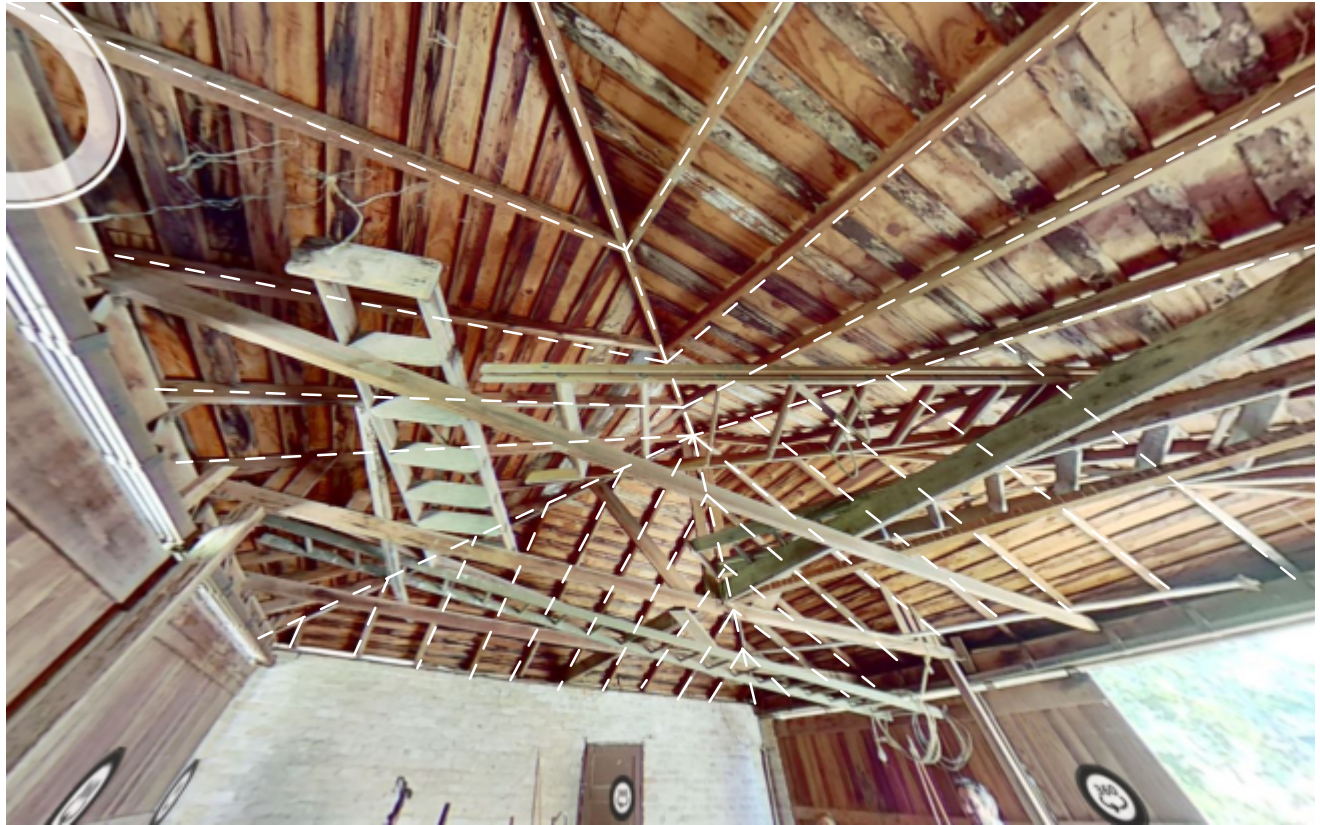
PHOTO 11: ROOF RAFTERS. DATE 2022-SEP-27.

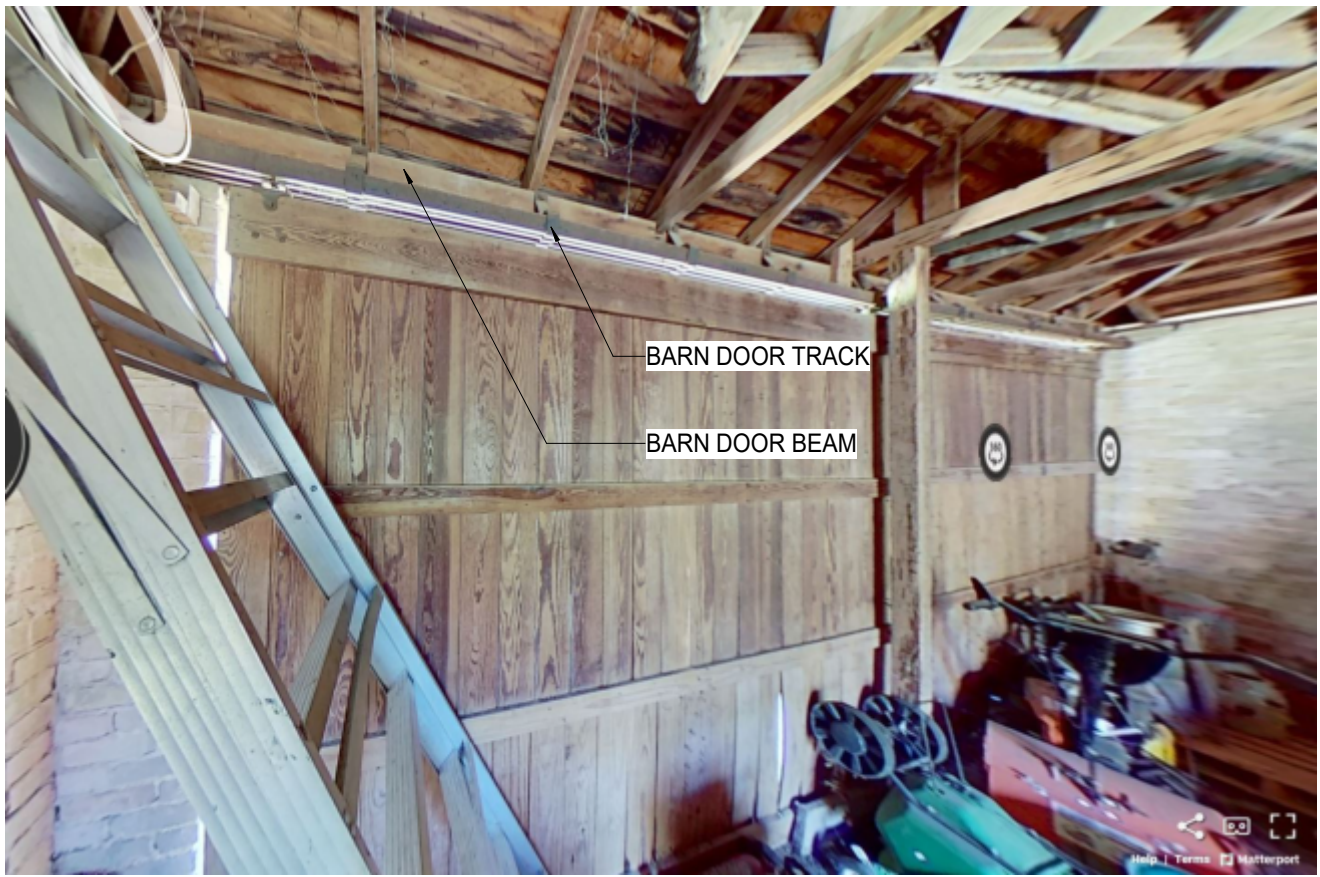
PHOTO 12: BARN DOOR, BEAM AND TRACK. DATE 2022-SEP-27.

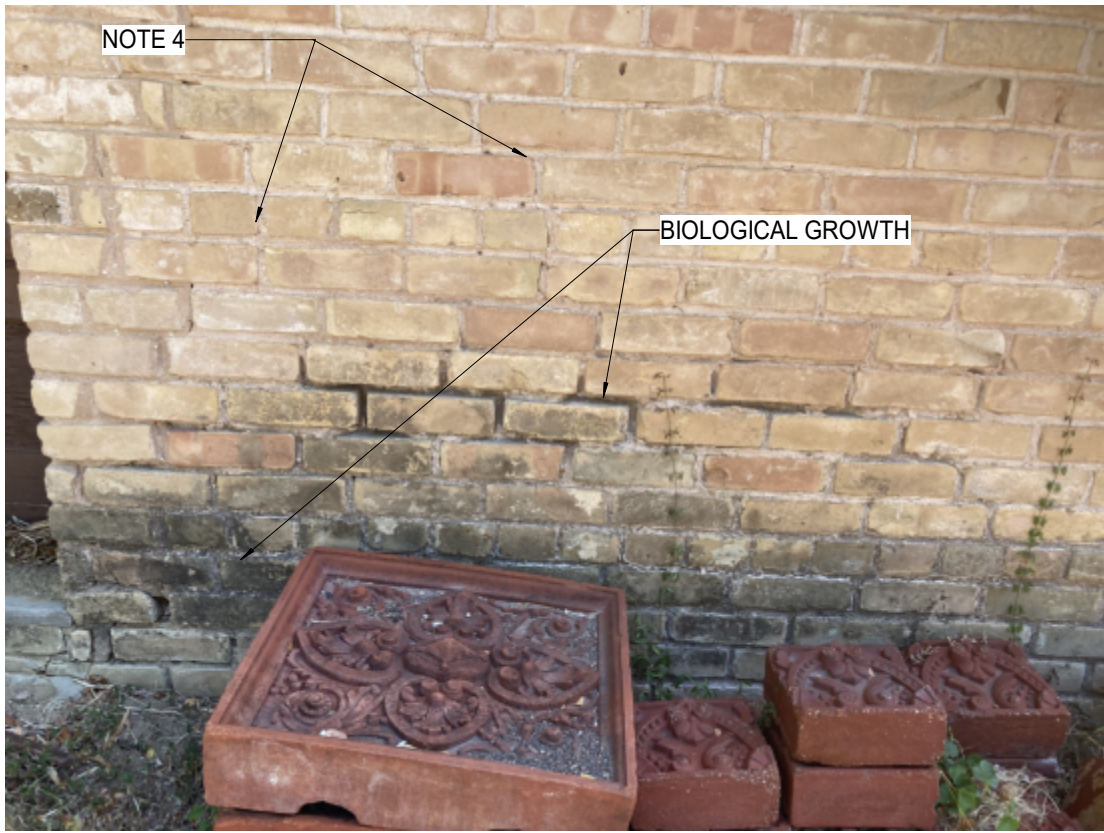
PHOTO 13: BIOLOGICAL GROWTH ON SOUTH FACADE. DATE 2022-JUL-30.

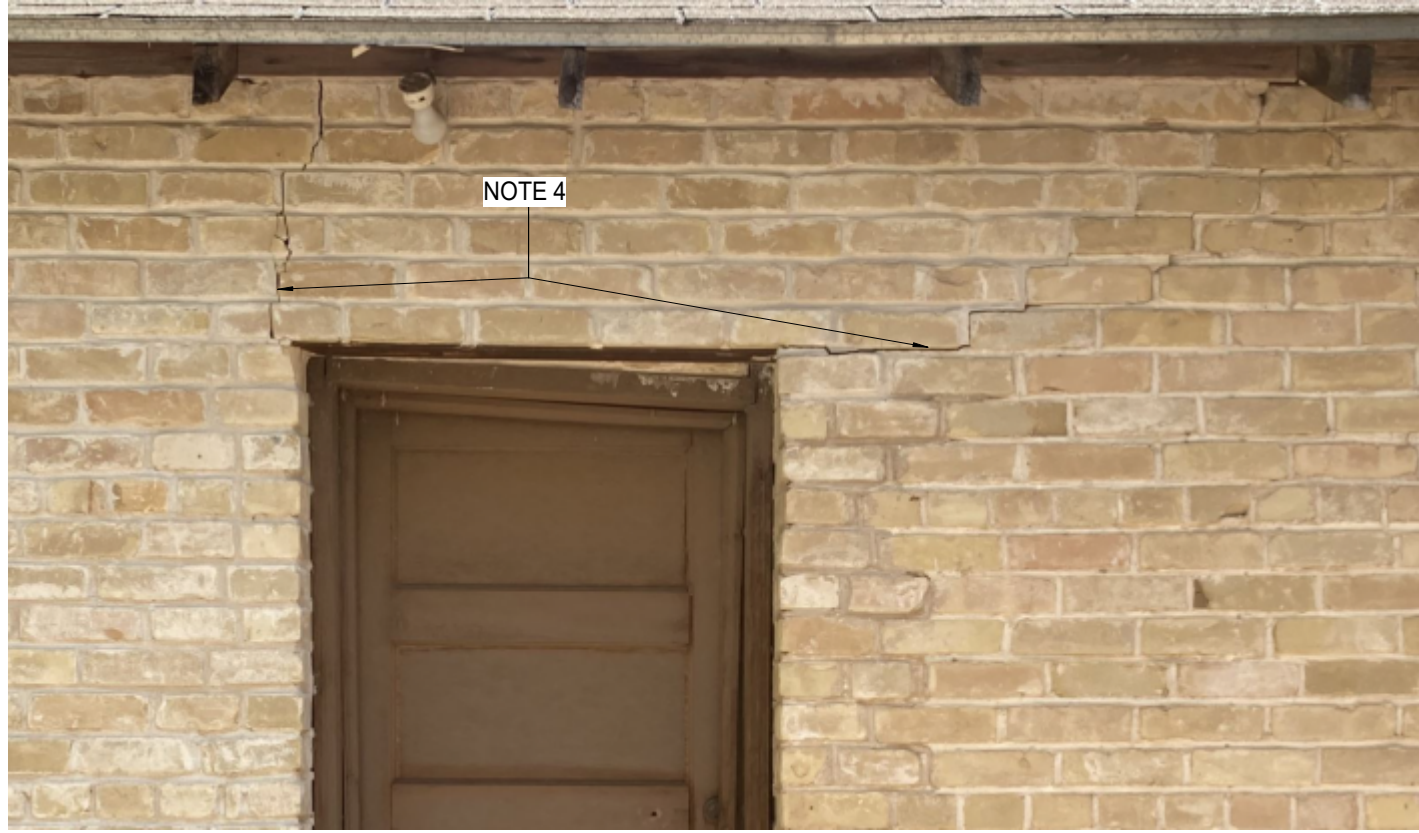
PHOTO 14: CRACKLINES ON SOUTH FACADE. DATE 2022-JUL-30.

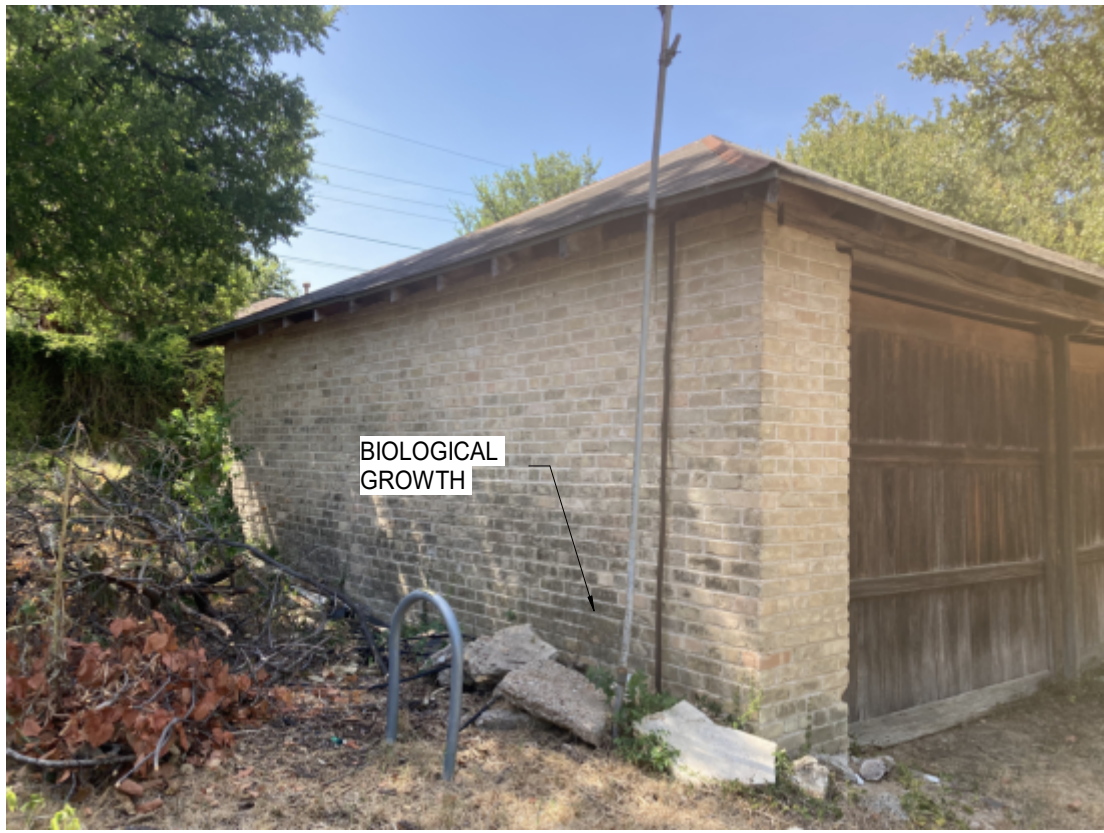
PHOTO 15: BIOLOGICAL GROWTH ON NORTH FACADE. DATE 2022-JUL-30.

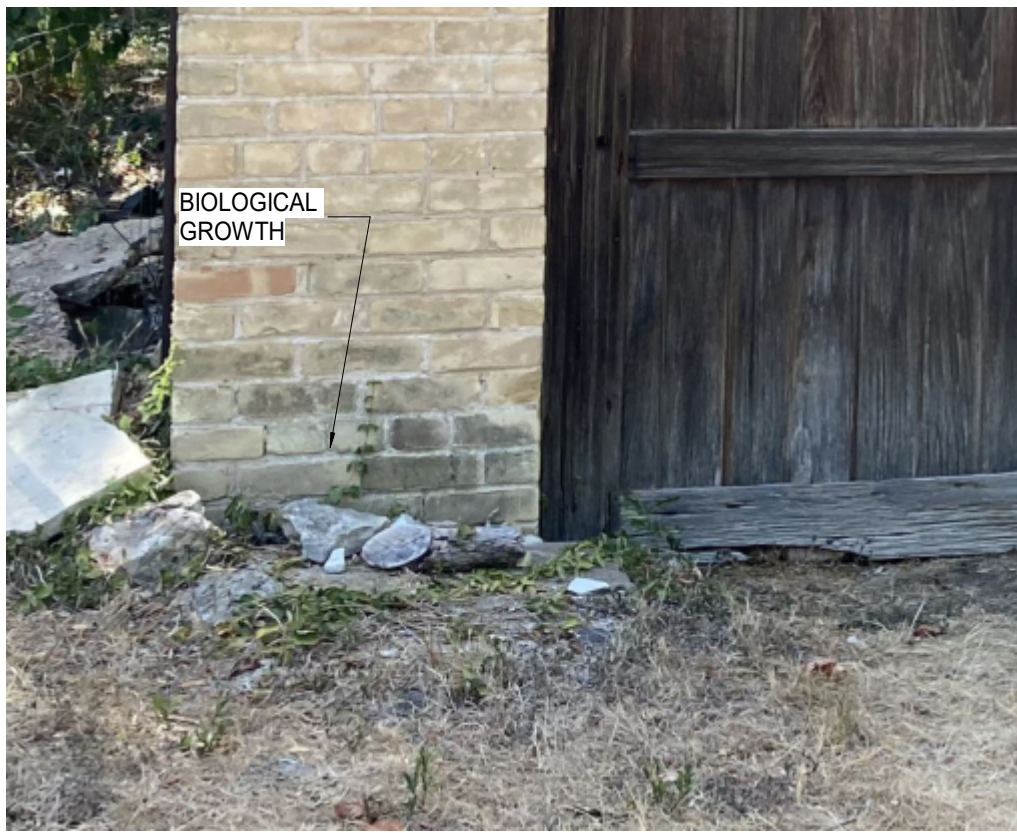
PHOTO 16: BIOLOGICAL GROWTH ON SOUTHWEST FACADE. DATE 2022-JUL-30.

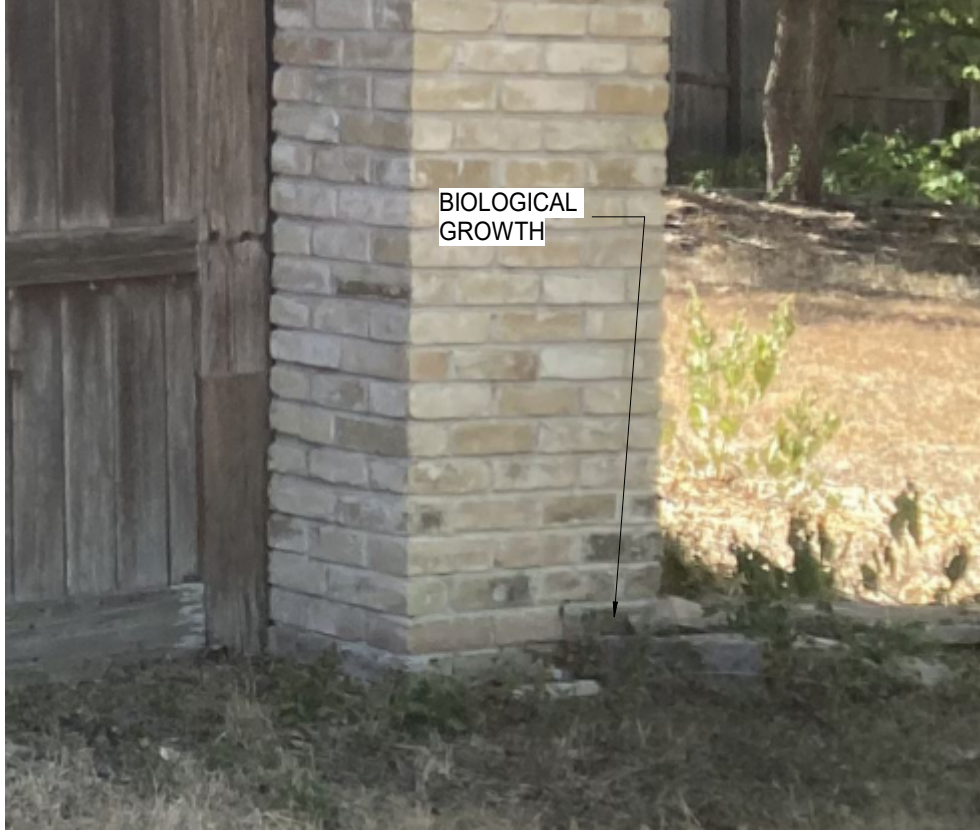
PHOTO 17: BIOLOGICAL GROWTH ON NORTHWEST FACADE. DATE 2022-JUL-30.
