Aviation Investigation Preliminary Report

Location:	Austin, TX	Incident Number:	DCA23LA149
Date & Time:	February 4, 2023, 06:30 Local	Registration:	N7827A (A1); N297FE (A2)
Aircraft:	Boeing 737-79P (A1); Boeing 767-32LF (A2)	Injuries:	128 None (A1); 3 None (A2)
Flight Conducted Under:	Part 121: Air carrier - Scheduled (A1); Part 121: Air carrier - Scheduled (A2)

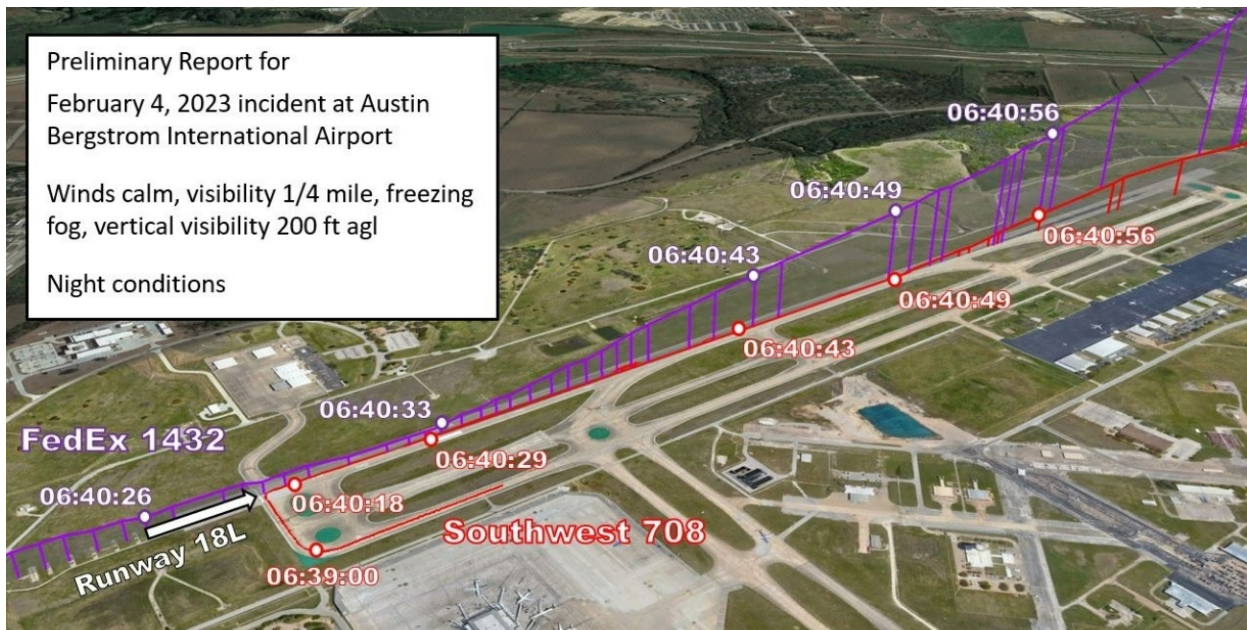
A review of preliminary Automatic Dependent Surveillance-Broadcast (ADS-B) data revealed that when FDX1432 was at the departure end of the runway climbing out of 1,900 feet, the controller instructed FDX1432 to turn left heading 080 and maintain 3,000 feet. At the same time, SWA708 was about 1,000 ft lower than FDX1432 and began a right turn away from the runway heading.

Figure 1 is a Google Earth screenshot which is overlaid with the ground tracks of FDX1432 (indicated by purple track) and SWA708 (indicated by red track). The illustration depicts runway 18L and shows the direction of travel for each airplane.

Figure 1. Ground position tracks for FDX1432 and SWA708 with respect to runway 18L.
