Neill-Cochran House Museum Slave Quarters Project  
City of Austin Certificate of Appropriateness Application 2023

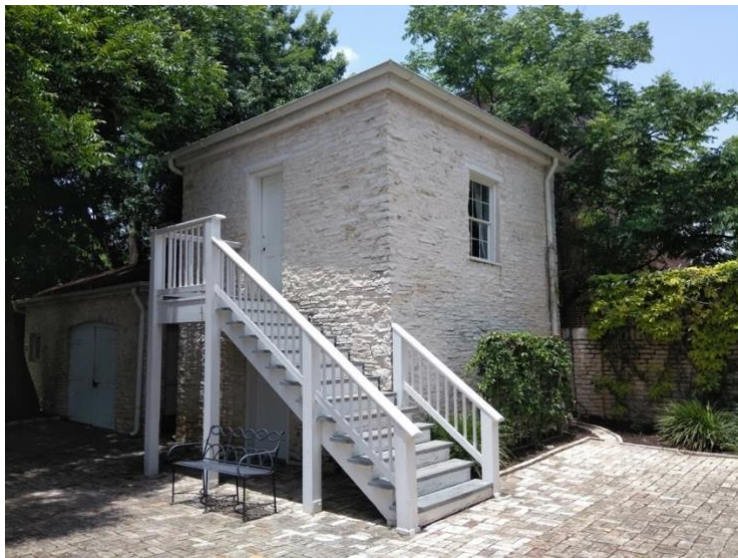
Contemporary view of the Slave Quarters from the southeast. The east façade window and 2 south façade doors are visible from this angle, along with the exterior staircase.

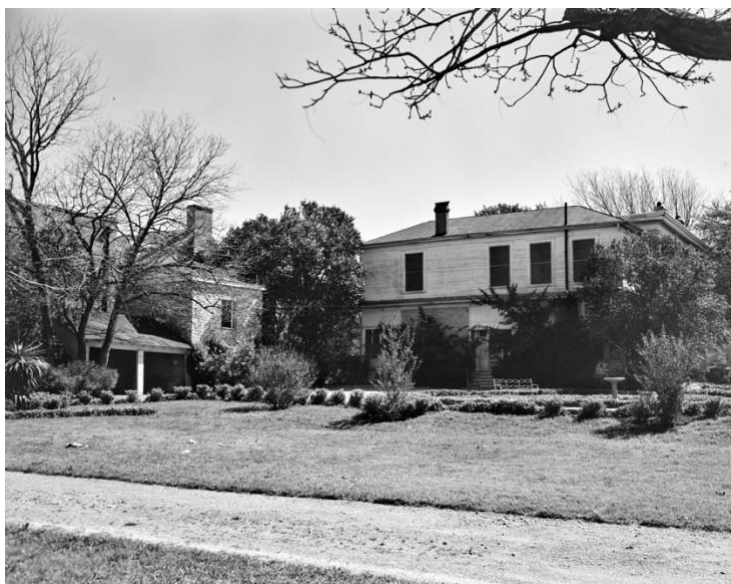
This photograph from c. 1960 soon after the NSCDA-TX acquired the property shows the back of the main house (with the 1900 rear addition) along with the Slave Quarters to the left, and the carport that the Cochrans constructed just to the west of the Slave Quarters. Note that the staircase at this time was on the east-facing façade.

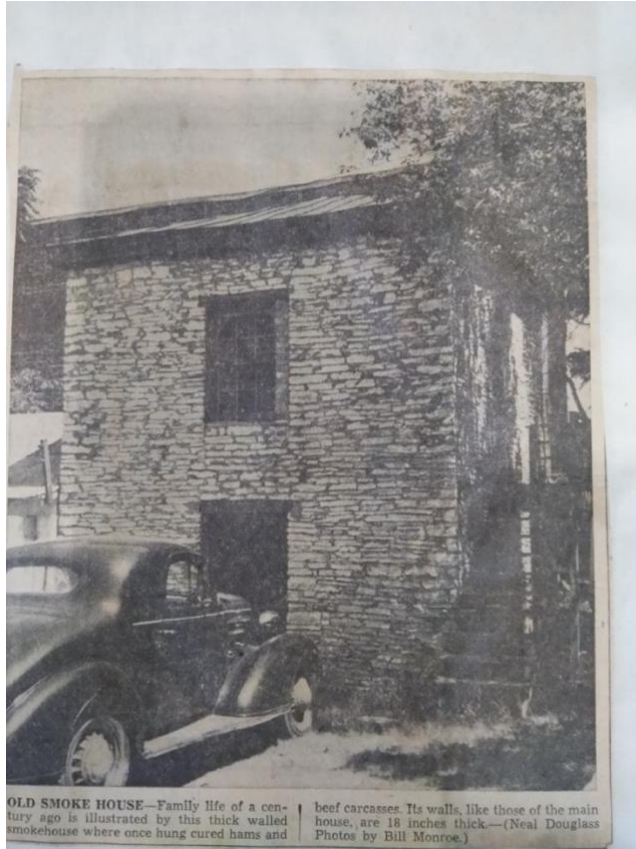
This photograph, also c. 1960 and reproduced in the *Statesman* provides a close-up view of the south-facing façade. When the door was moved, the wall was in-filled around the smaller window.

A stairway ran up the east façade to the second floor door during this time period.

Note that the roof was metal, as it is today.

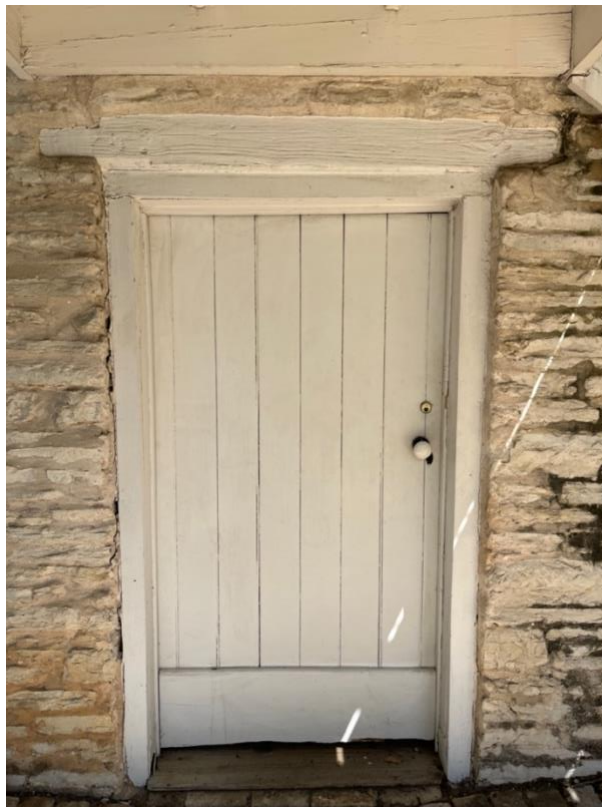
The first-floor door has been cut down and altered over time as the elements have warped it. The door will be completely replaced, including the hardware, which has failed.

We have found evidence for both long-leaf pine and cedar on the interior of the structure. We will replace the door with a new door made of one of those woods.

Wood trim and the structural lintel will be repainted to protect all wood surfaces.

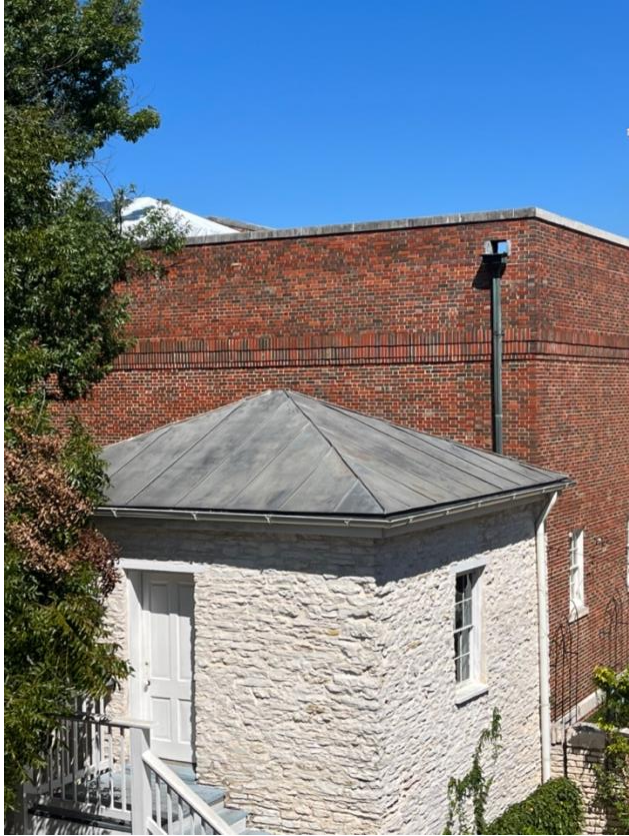
The second-floor door has been moved at least twice. It is unclear whether this is the original c. 1855 door or not. It does share similarities with the original second-floor French doors to the main house in design. We do not anticipate a need to replace this door, though it will be stripped and repainted and the hinges will be adjusted. Should any new material be required, we will use either long-leaf pine or cedar as for the first-floor door.

The copper roof has not been addressed in decades. We will assess the condition and repair as necessary. It does not appear to have any leaks and we do not anticipate repairs to be extensive.

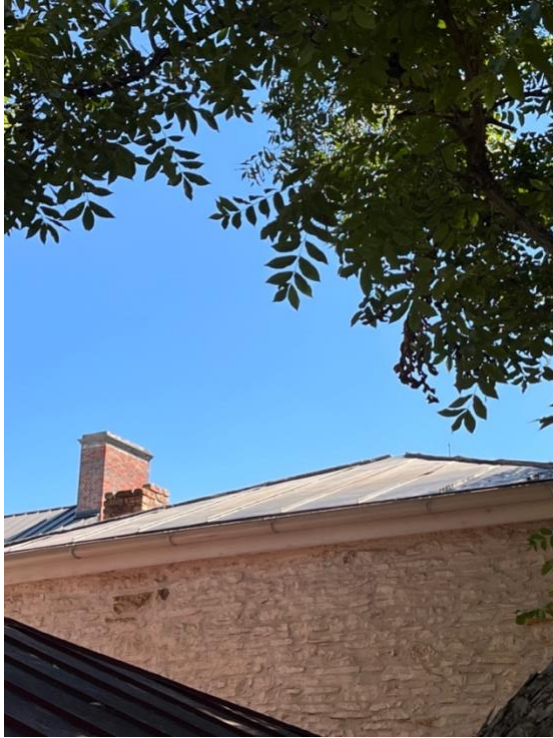
View of the roof and brick chimney from the west side. The taller chimney in the background is from the Texas Federation of Women's Clubs next door. The Slave Quarters chimney is in the foreground and has almost entirely deteriorated.

Work will be completed to restore, stabilize, and cap the chimney. We will acquire 19<sup>th</sup> century brick to match and extend the existing flue.

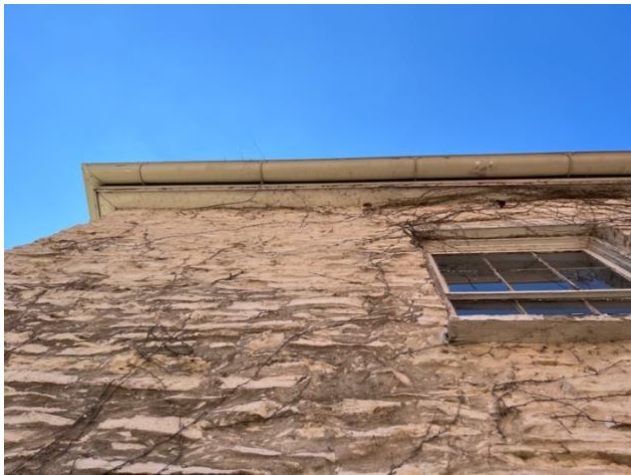
Wood fascia beneath the roof needs to be stripped and repainted to protect the original fabric.

This view gives a sense of the condition of the second-floor window. It will be stripped and re-glazed. Our expectation is that we will be able to reuse all parts. If any component must be replaced, we will replace with like materials.

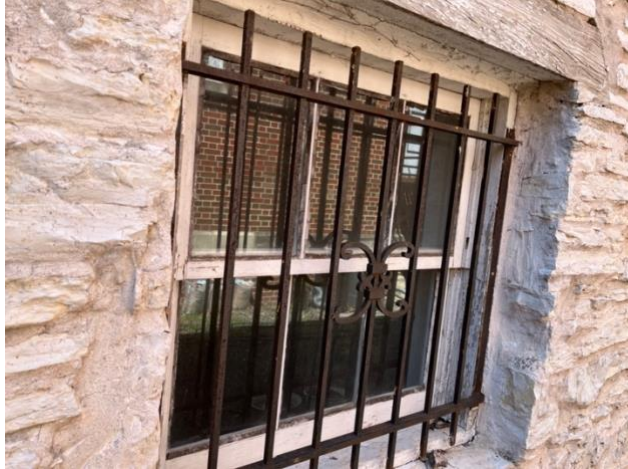
Detail of the first-floor window, including wood rot at the bottom left corner. Our expectation is that we will strip and reglaze this window. If any element requires replacement, we will replace with like materials, but we consider that eventuality to be unlikely.

The bars on the windows date to the 20<sup>th</sup> century and will be removed.

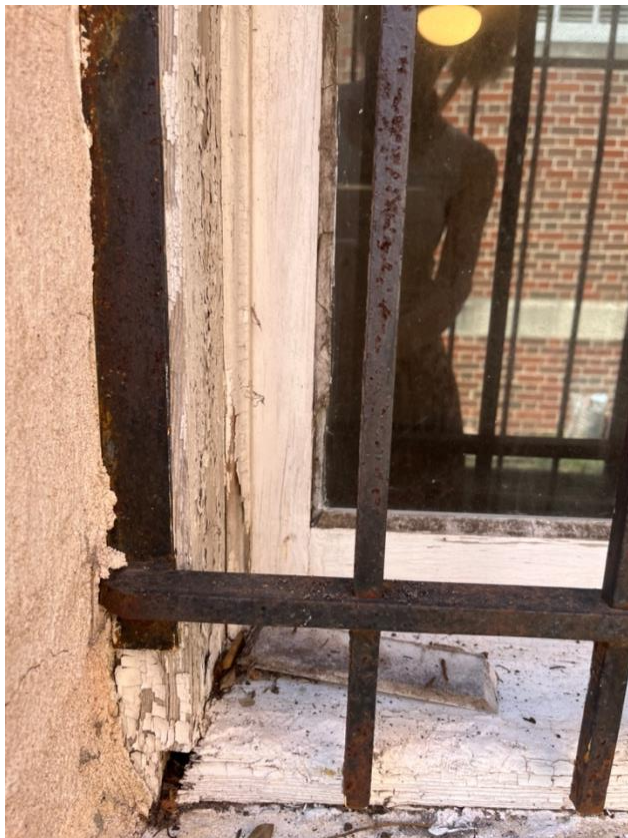
The first-floor wood window has deteriorated over time and requires repair and repainting.
