**Tree assessment: Revision 1: added information provided related to target.
Barton Springs Pool's "Flo" Pecan. Austin Tx 78704. 08/25/2023**

Scope: assess leaning Pecan tree.

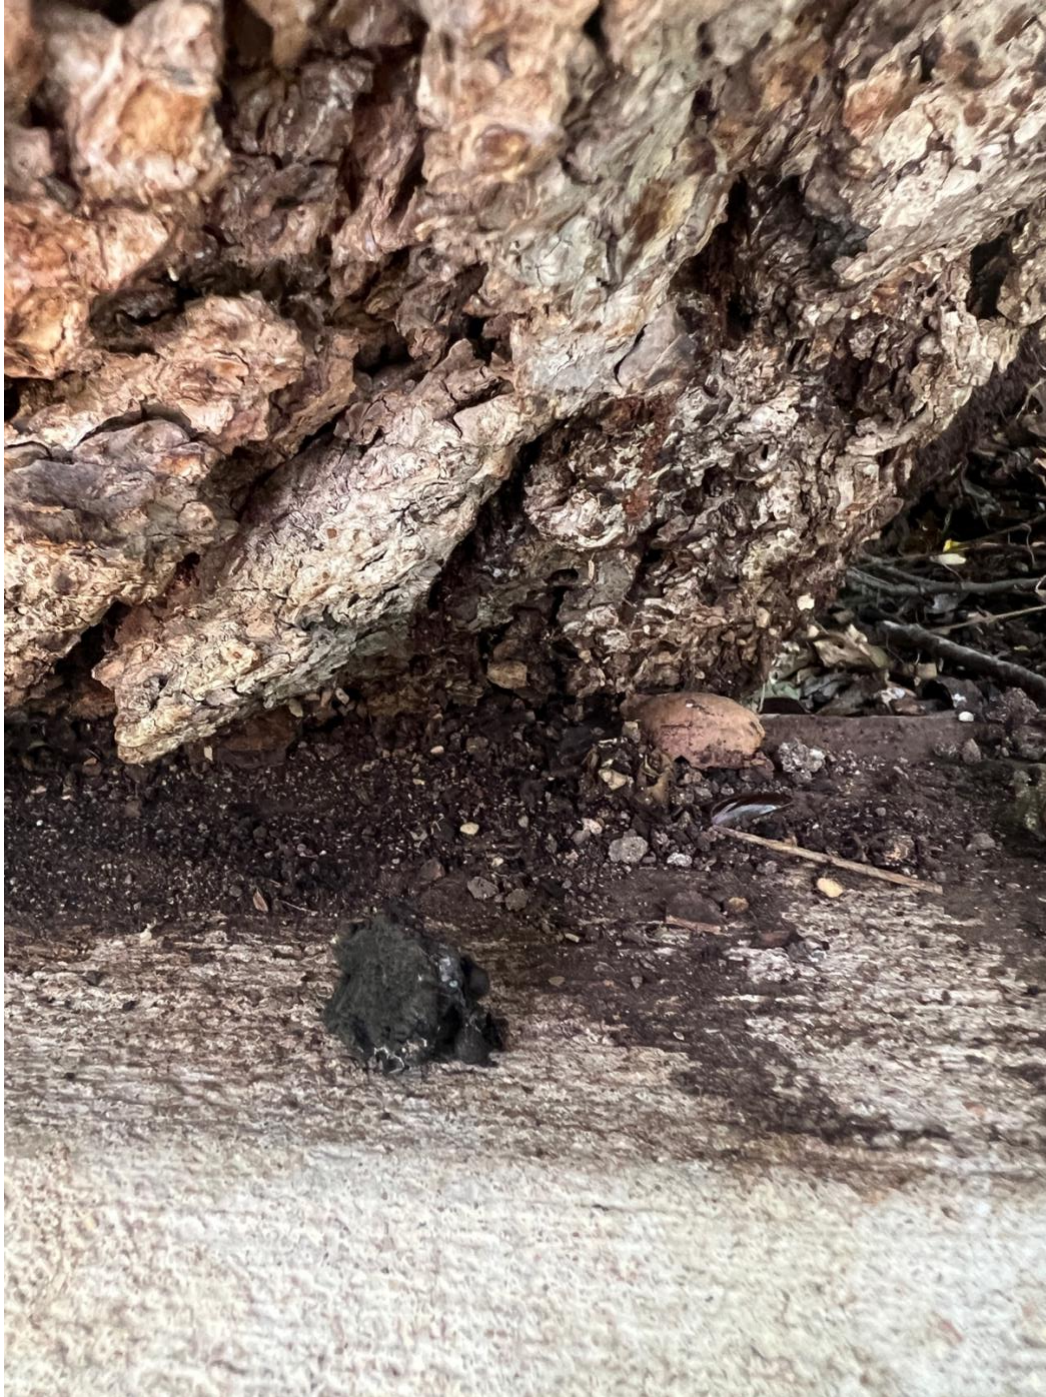
1: Kretshmaria deusta infection. The lab results provided by the client as well as our own visual inspection (see attached photos). This fungus is a well know rot mostly visible at the soil line of the root flare. It rapidly damages the root system and sapwood in the root crown and below, with the consequences being a total failure of the tree. It is most found on hackberry trees, being in fact responsible for the extreme majority of total failure of that species, giving the hackberry trees a bad name as a weak tree. It is less commonly found on Pecan trees, possibly because they are well defended against humid soil condition as they are specialized riparian trees. However, once infected, Pecan trees tend to have very poor compartmentalizing which allows a decay organism to spread quickly.

1: Kretshamaria evidence: typical "charcoal" bark collected during our inspection.

Recommendation: Remove.

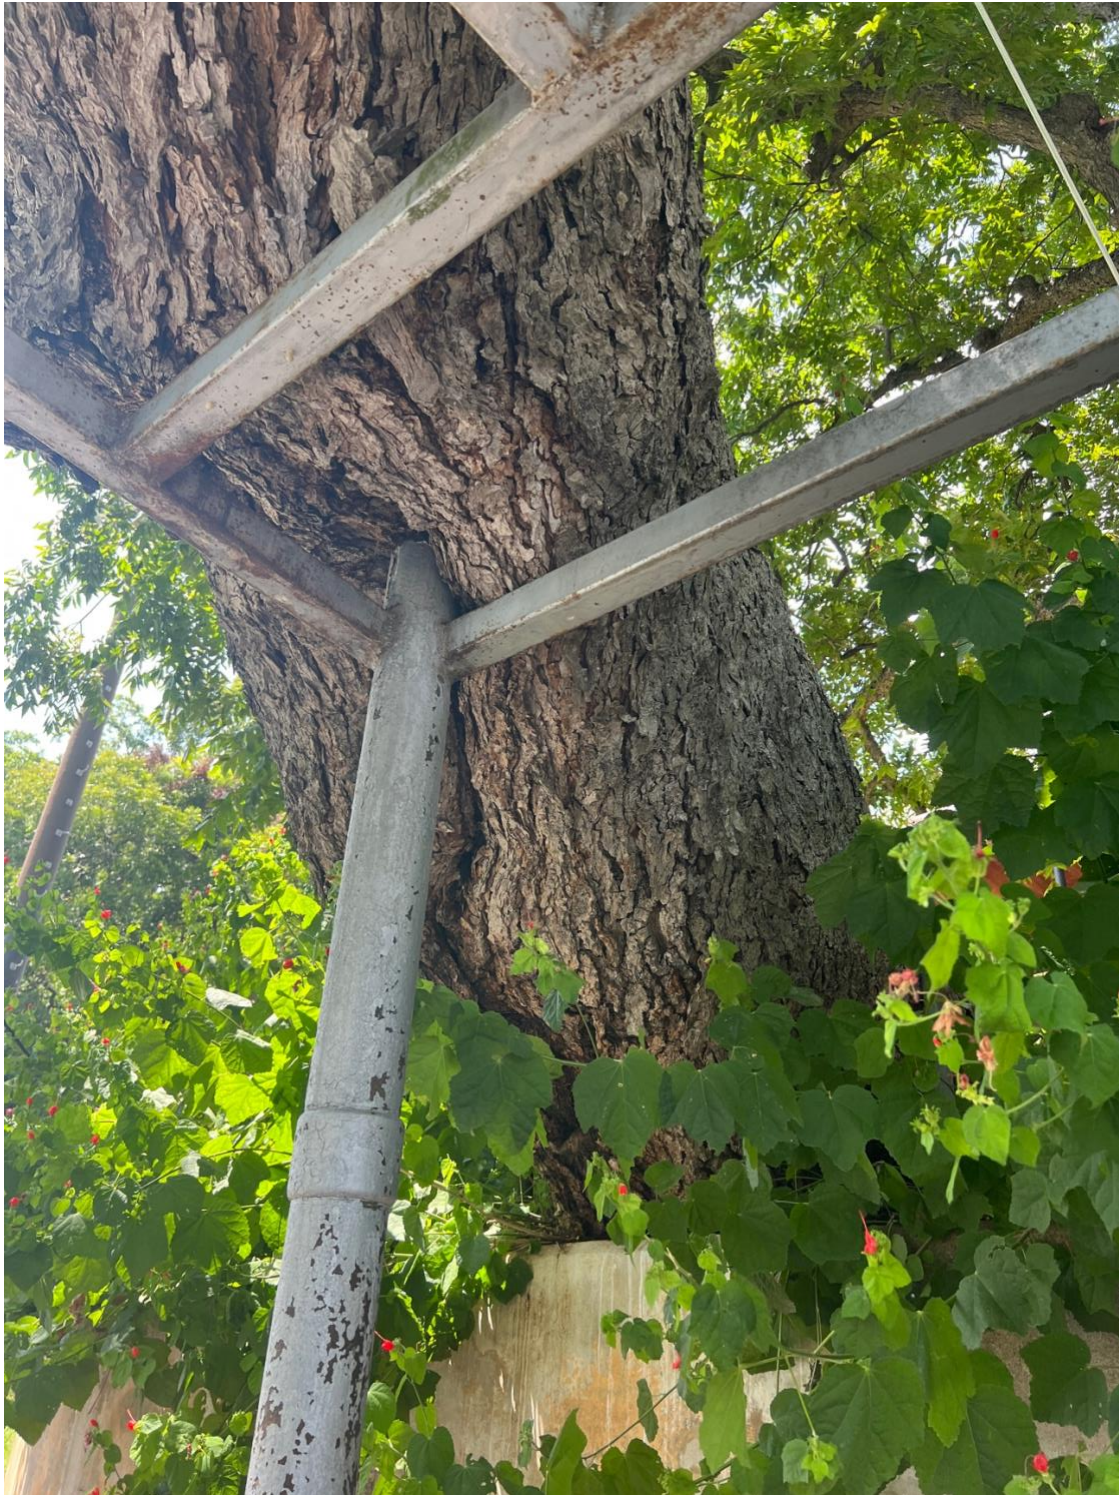
2: support system

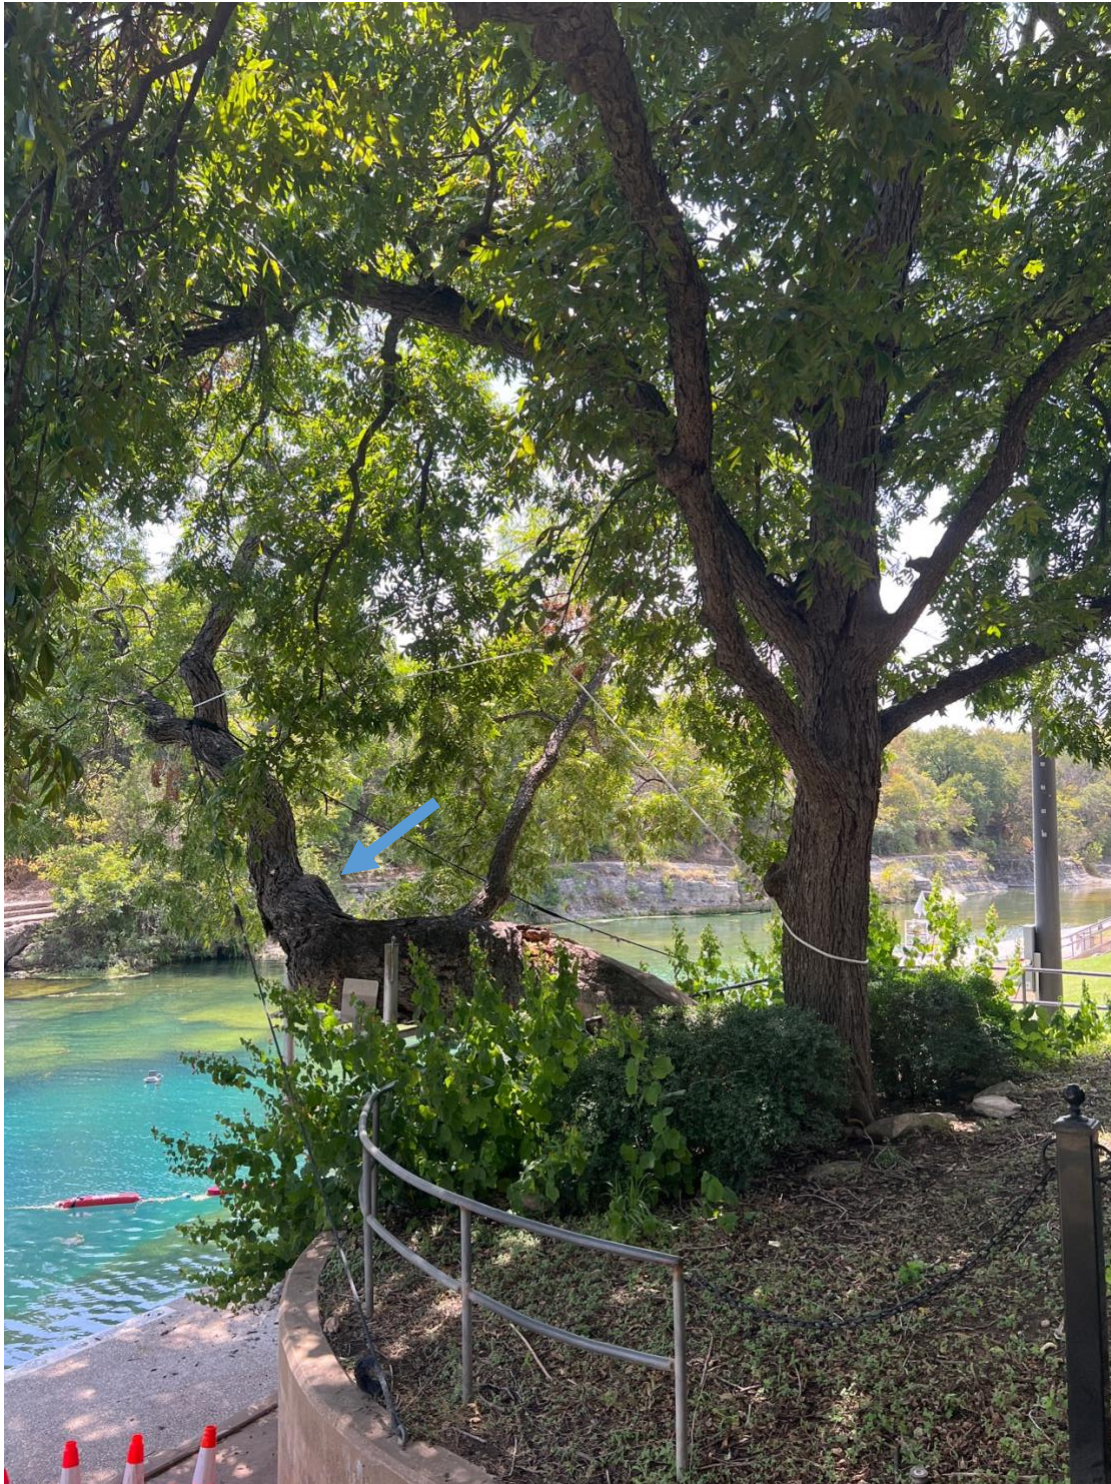
2: Main stem beyond the second support beam: Per personal communication from the urban forestry program manager, the existing historical cavity has already been investigated 2 or 3 years ago due to the concern of potential failure of the canopy over the pool area. We have not been provided the results of this investigation. We share that concern seeing as the cavity is significant and could run well beyond the support point.

3: blue arrow showing the defect past the second support point.

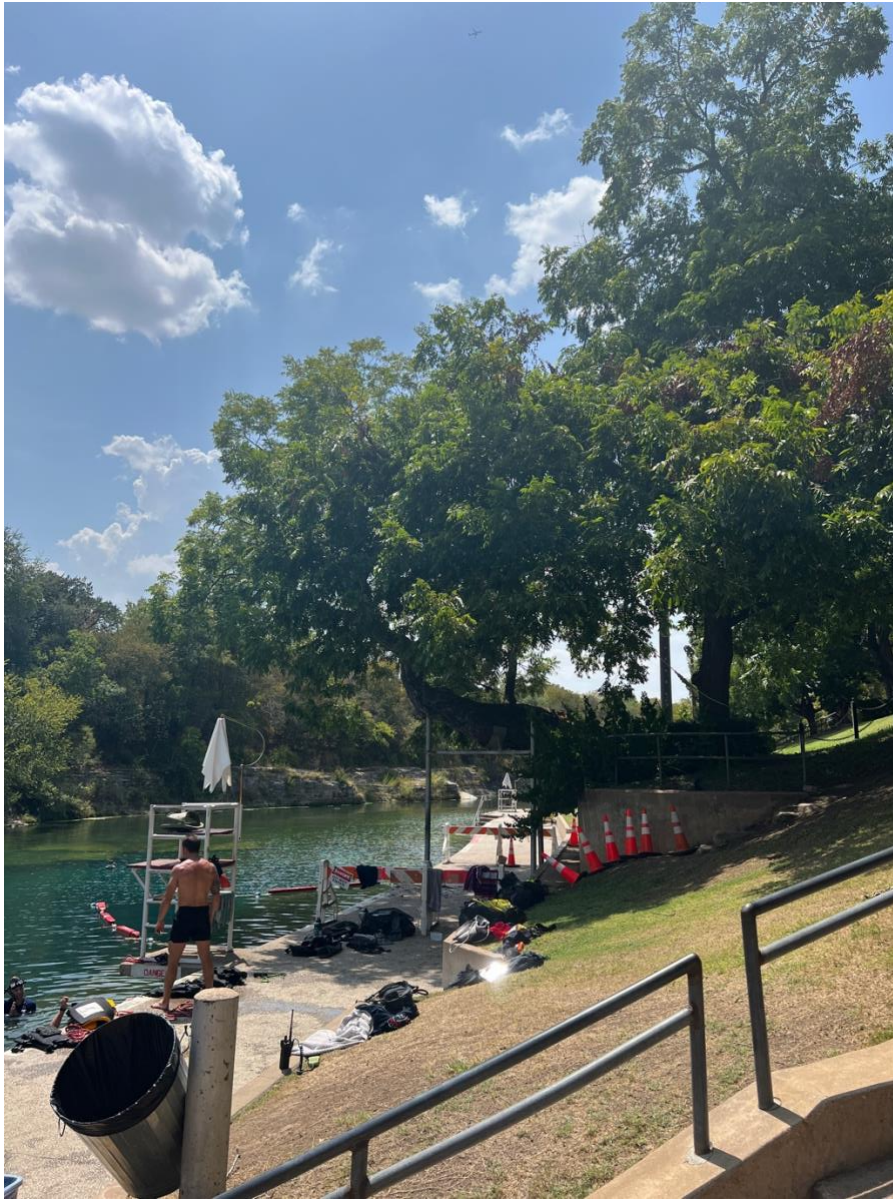
1. Walkway under the tree
2. Swimmers from Barton Springs pool
3. Infrastructure: Bypass located north of the pool itself and passing directly under the tree. City staff has communicated on Friday 15th that this infrastructure is considered critical for the pool. Damage to this infrastructure would have significant consequences for Barton Springs pool. We have no specifics as to how much load the infrastructure can handle but the pattern of failure, we are predicting can possibly impact this infrastructure. We consider that stem to be completely hollow. A failure would likely be from dead vascular tissue collapsing on itself small sections at the time, with the canopy ripping off the second support area and landing in the pool. The risk rating is already Extreme hence this added information only reinforces our rating.

4 target area and showcasing the lean

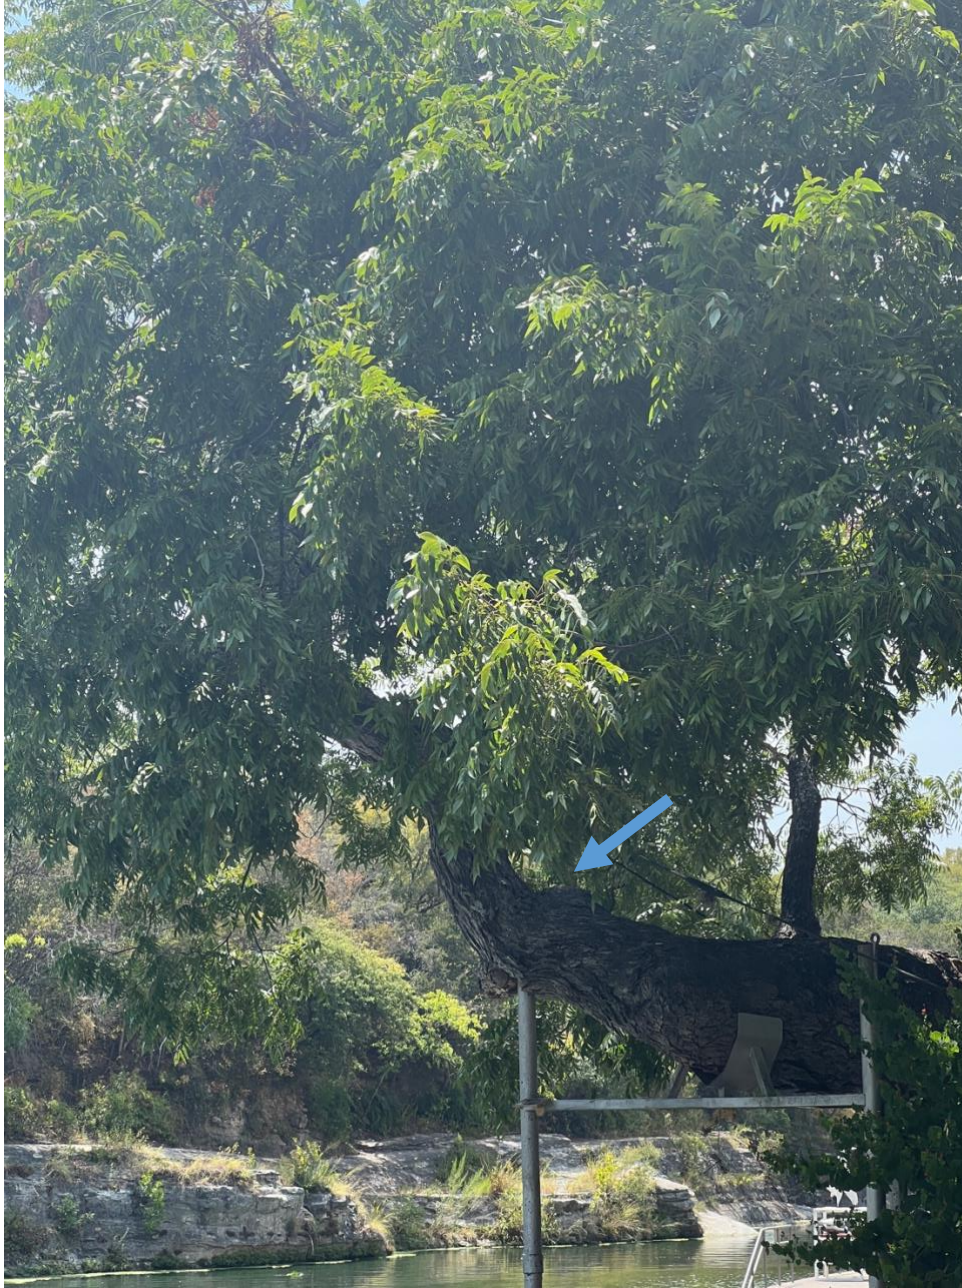
5: second support, defect location, and size of part of concern

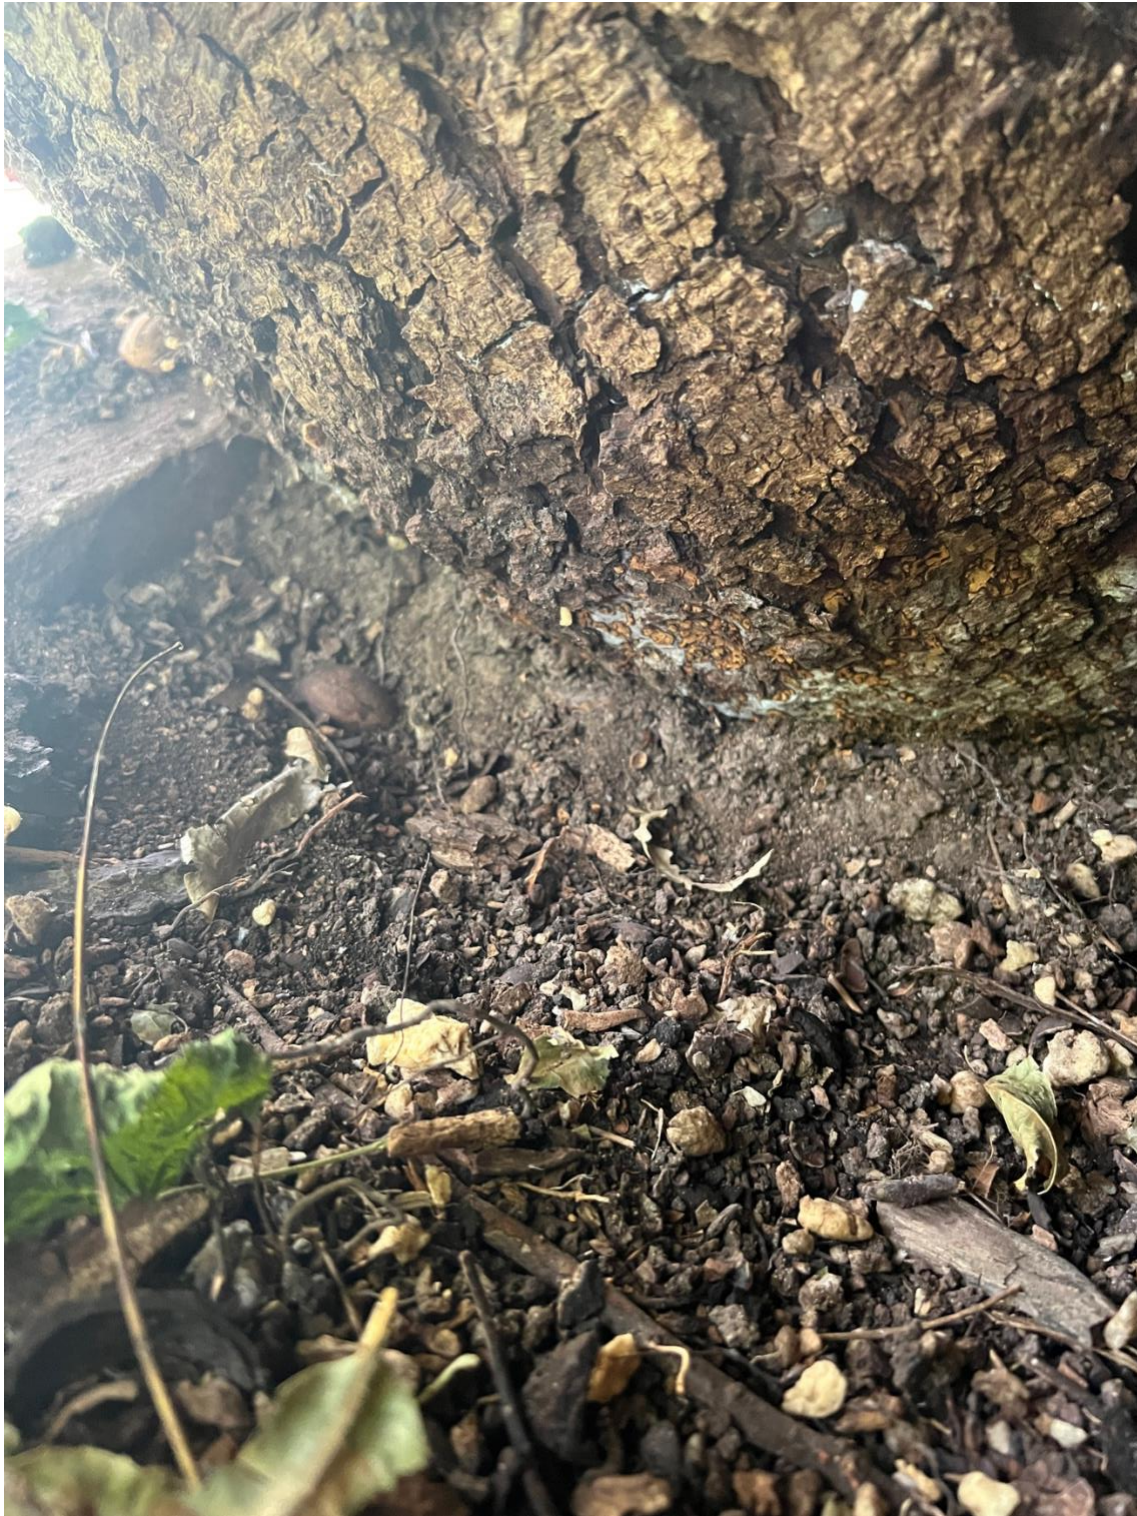
7: root flare on north side, showcasing difficulty of inspection as well as the bark texture change hinting at declining sapwood.

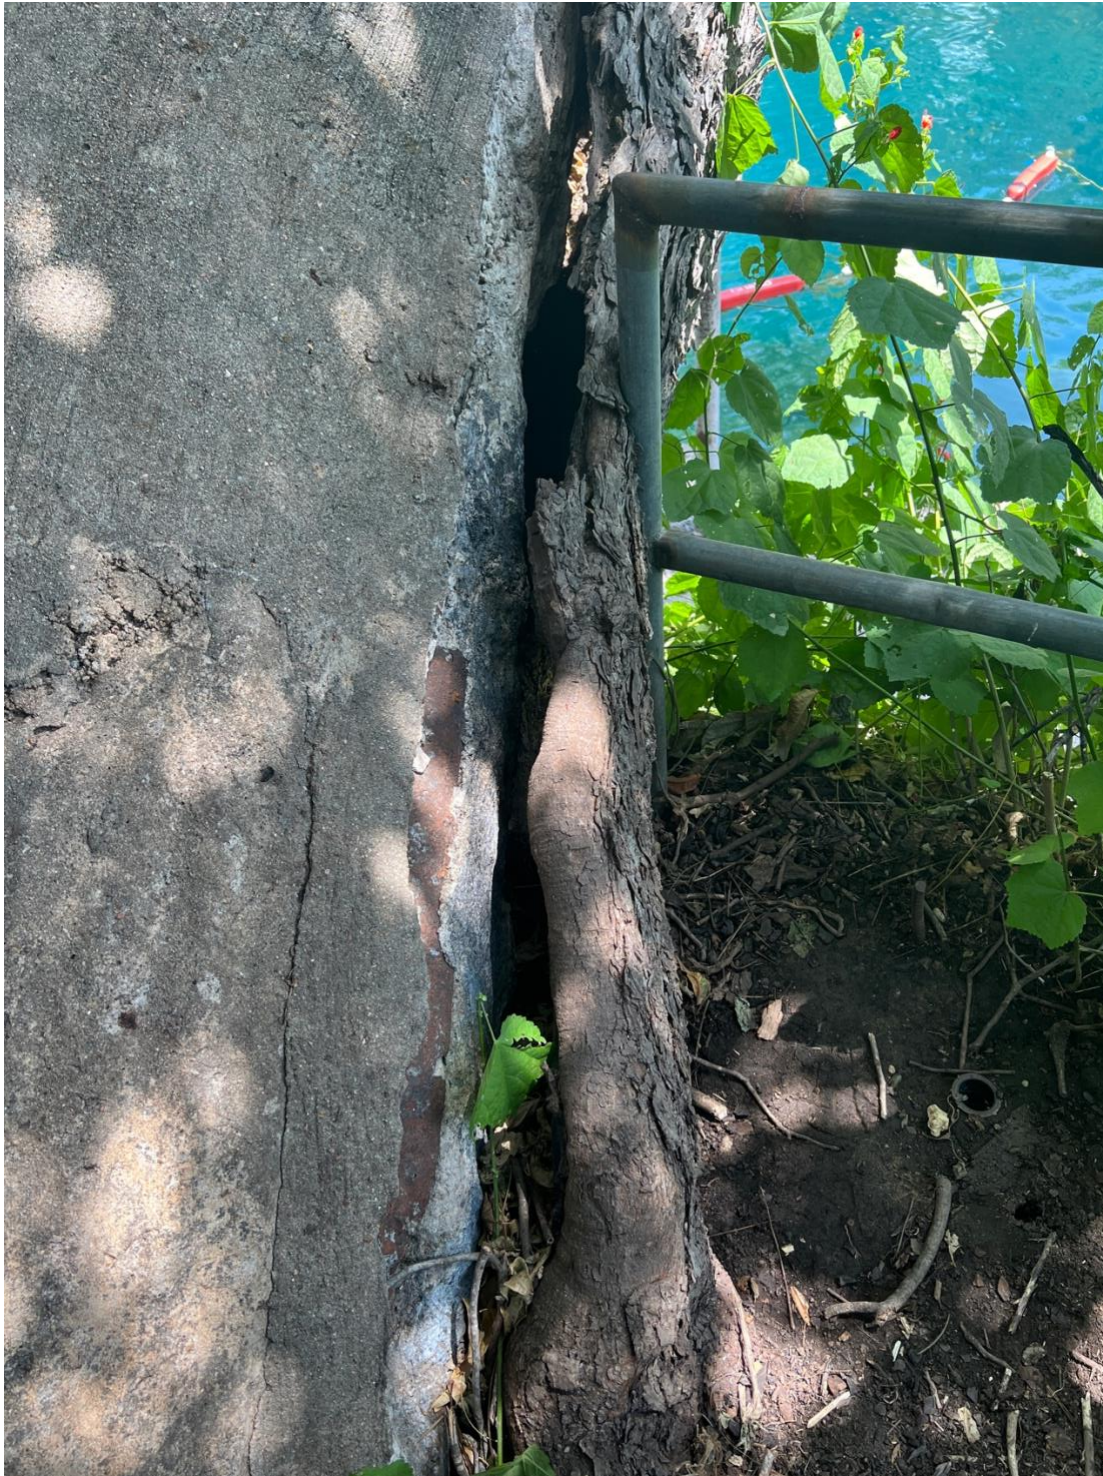
8: opposite side of main stem: no remaining heartwood.

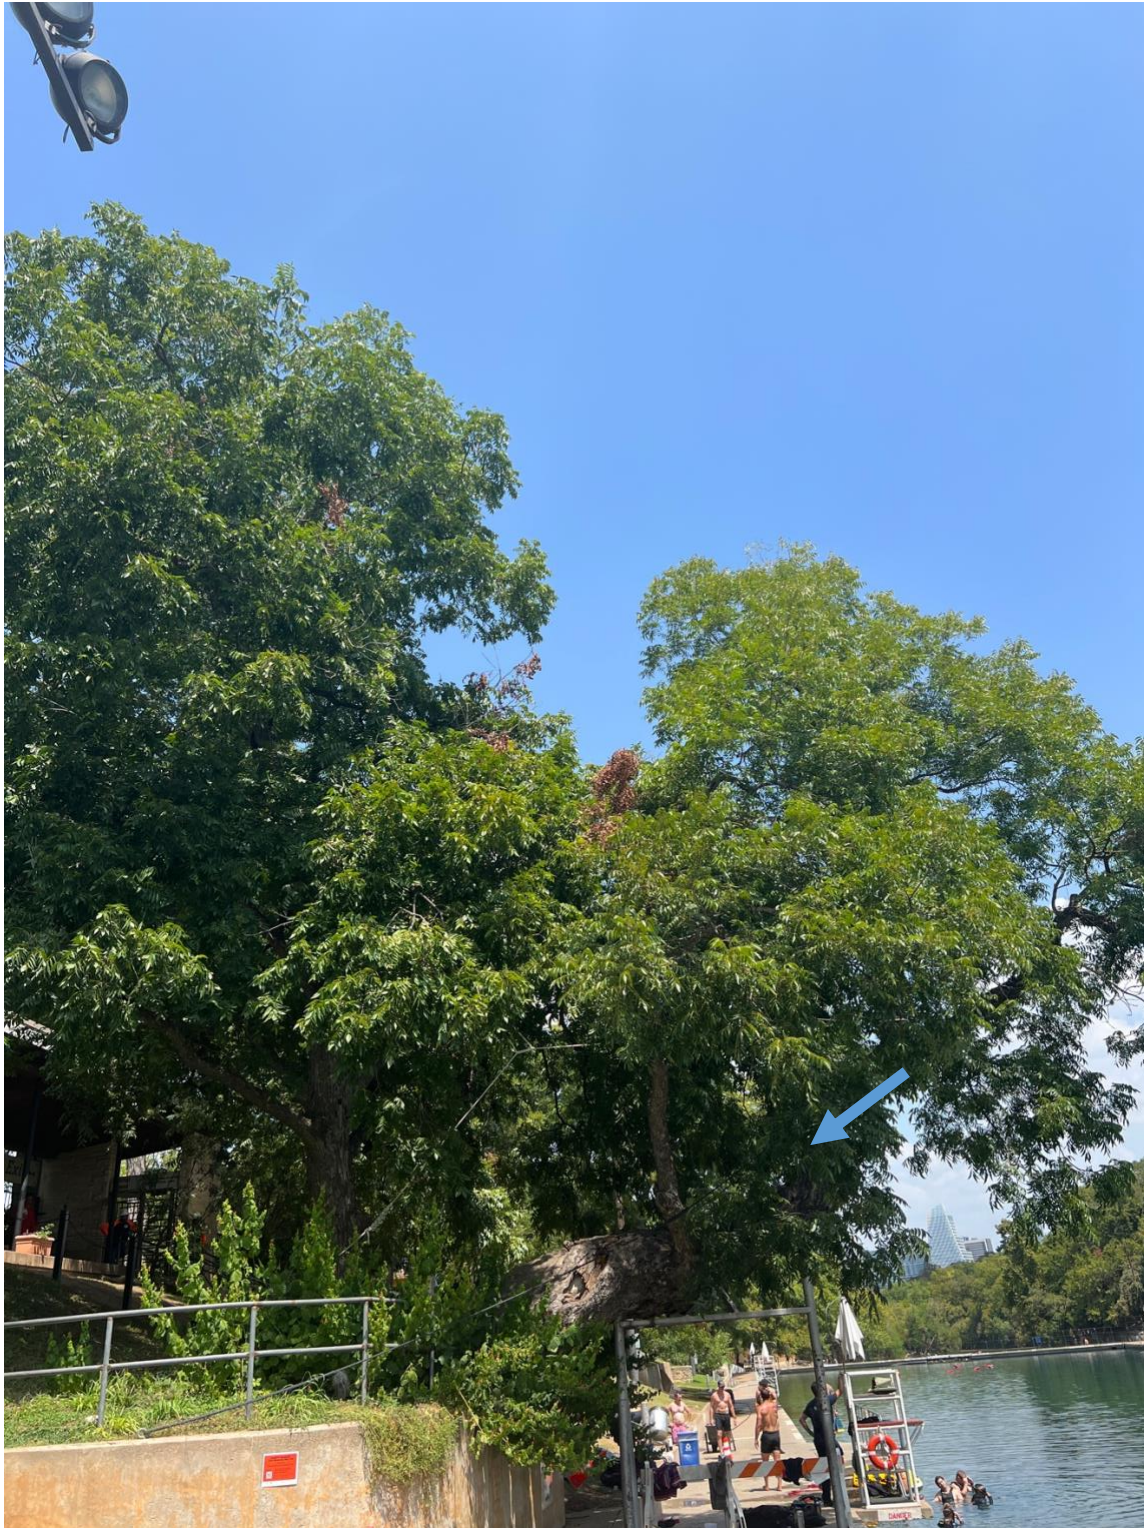
9: opposite view of target area and defect at second support point.

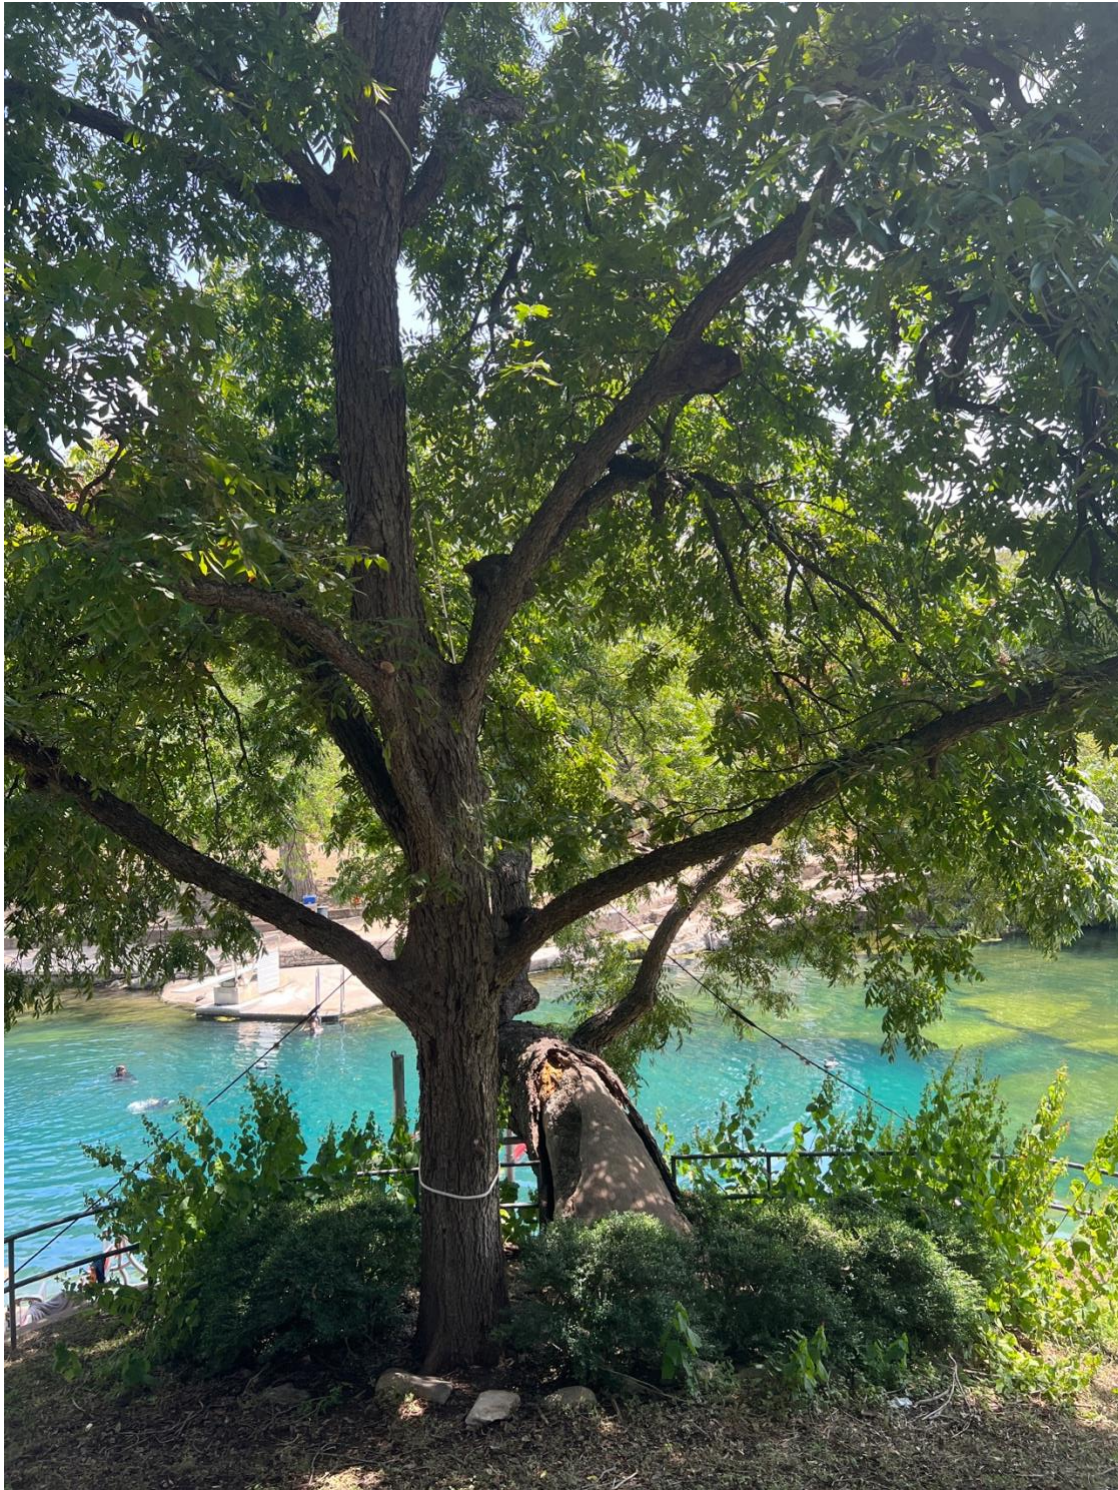
10: showcasing the replacement tree and the sapwood shell from FLO around the concrete fill.
