Austin Parks and Recreation Department

Barton Springs Pool Tree

September 25, 2023

Review of Reports and communications from the community

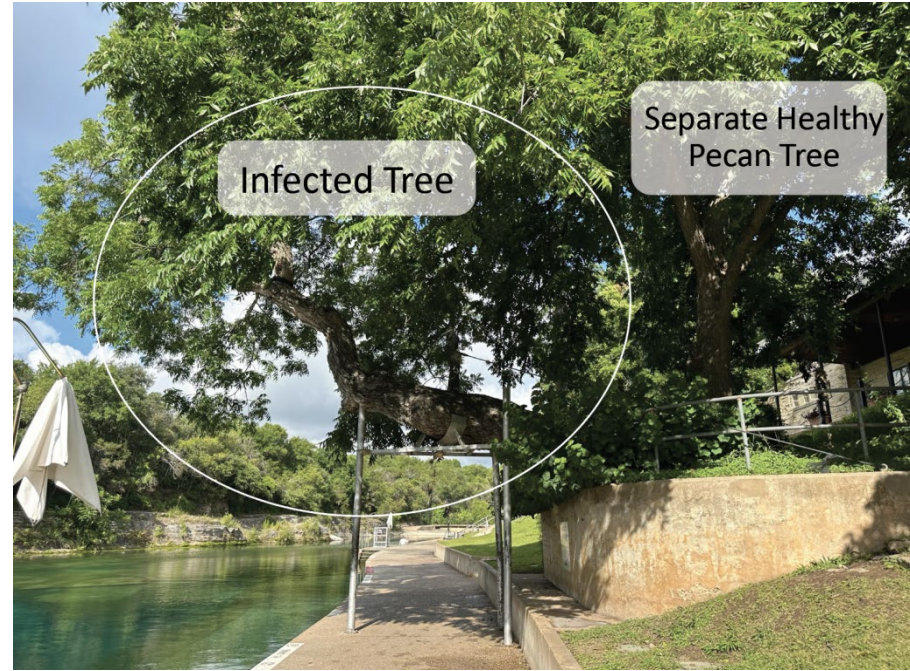
- 46" diameter Pecan tree that has leaned over pool deck since the 1920's – over 100 years old
- Iconic tree with a fatal fungal infection
- Trunk is hollow – over 90% of the trunk at the base is concrete, numerous other visible trunk cavities
- Steel structures were added to support the tree
 - First steel posts were added in the 1950's
 - An additional steel support was added in 2009
 - 2 cables were added in 2009

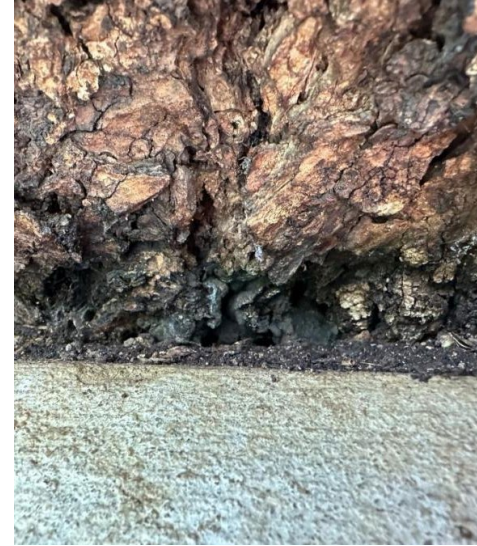
- July 6th – PARD staff noticed a fungal fruiting body at tree's base
 - Sample sent to Plant Diagnostic Lab at Texas A&M
- August 15th – Results confirmed brittle cinder fungus (*Kretzschmaria deusta*)
- August 15th - PARD contacted four independent ISA Certified Arborists for follow up inspections

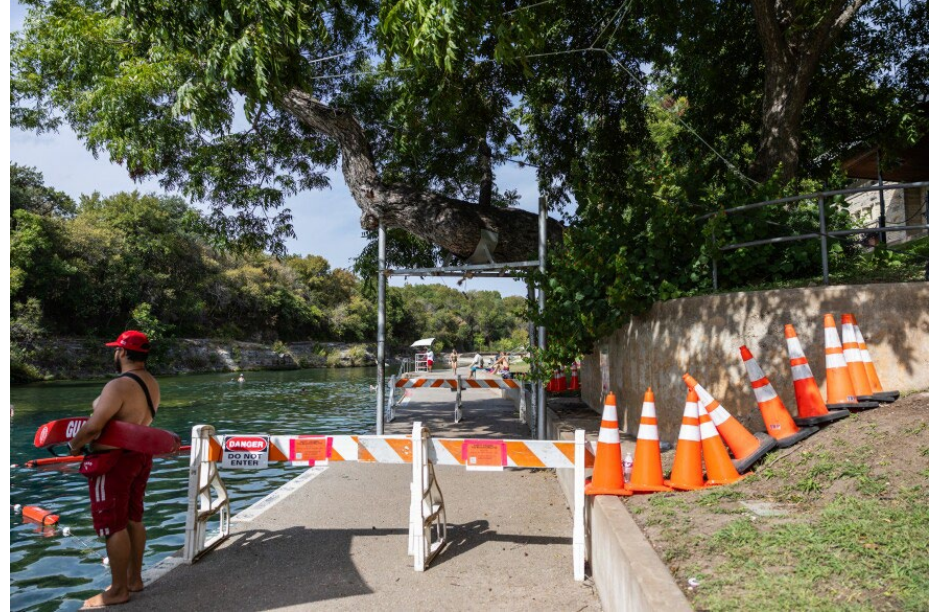
- August 18th – access restricted for public safety; additional rope added for support
- September 7th – final report received, all 4 reports identified this tree as “high” or “extreme” risk and all 4 Arborists recommended removal

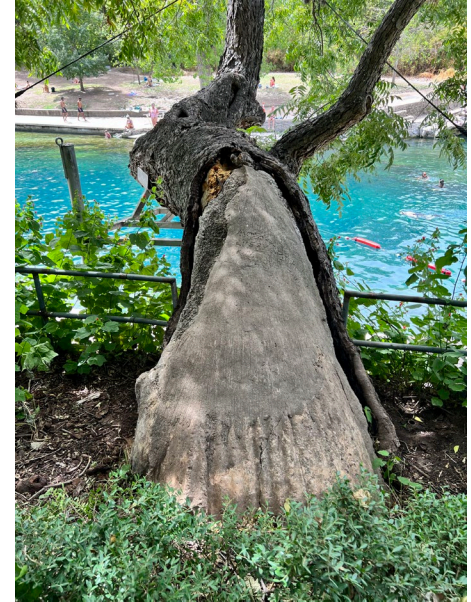
- Wood-decay fungus that causes rapid decline and structural instability
 - Actively feeds on live tissue
 - Causes trees to fall over without warning, canopy looks fine prior to failure
 - The presence of the fruiting body is the warning sign
- There is no effective treatment for brittle cinder fungus
- This infection is on the portion of the trunk that is most compromised

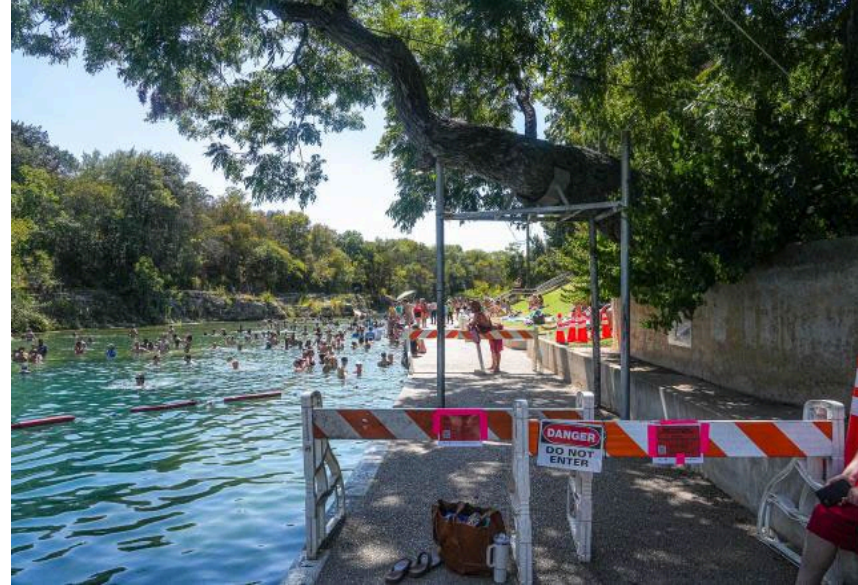
- Tree with documented risks identified from professional arborist
- Community loves this tree and PARD is working to document the importance of this tree through treestories@austintexas.gov
 - Some community support to preserve the tree as long as possible
- Barricades and cones are in place to temporarily reduce risk
 - ADA access to the pool bathrooms is currently blocked by barricades
- Buoys in the pool restrict access
 - Currently affecting lap swimmers – safety concern
