Deaccession of AIPP Artworks

AIPP Artwork Deaccession proposal October 16, 2023

August 10, 2023

Artist: Thoughtbarn, LLC
Object/Title: YMCA Community Garden Fence
Object Date: 2014
Medium: Weathering steel; galvanized steel cables encased in colored plastic sheaths; steel cable locks.
Examination date: August 8, 2023

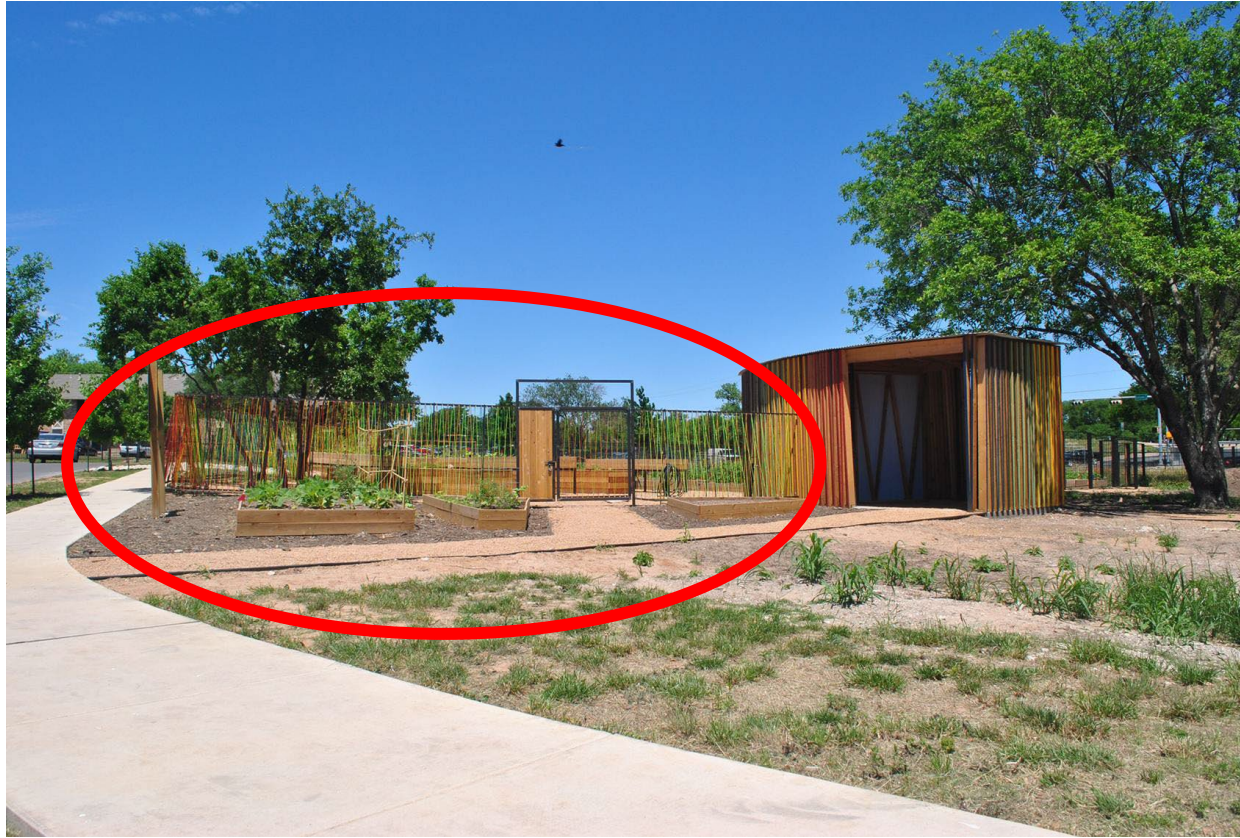
- **Rundberg YMCA Community Garden Fence:** materials have degraded making the entire structure unable to serve intended function, becoming an eyesore and a public safety hazard

Community Garden Fence (in red, shed remains on site)

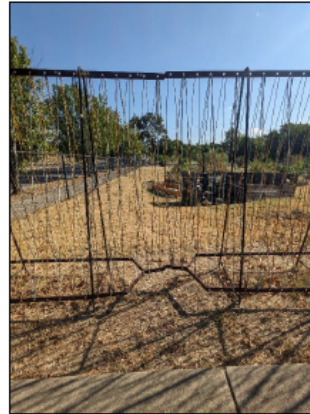
The colored sheathing over the wires has faded, giving the artwork a dull appearance rather than the bright and colorful appearance as installed. Fading is concentrated on the upper (sun exposed) surfaces.

The colored sheathing over the wires has faded, giving the artwork a dull appearance rather than the bright and colorful appearance as installed. Fading is concentrated on the upper (sunexposed) surfaces.

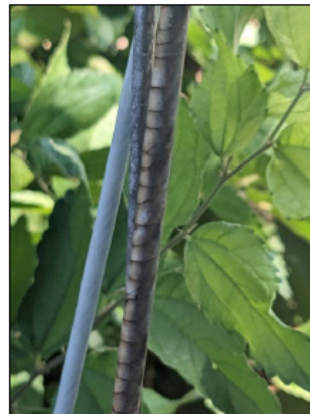
Some plastic sheaths exhibit significant deterioration and cracking. Because the cracks allow water ingress, the sheaths are corrosion-stained at cracks and elsewhere in the interior of the sheaths.

Some plastic sheaths exhibit significant deterioration and cracking. Because the cracks allow water ingress, the sheaths are corrosion-stained at cracks and elsewhere in the interior of the Sheaths.

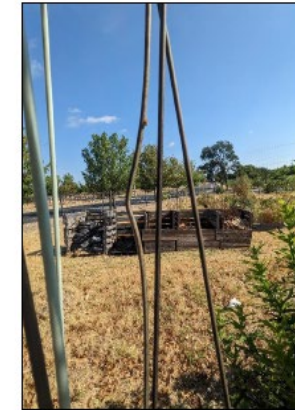
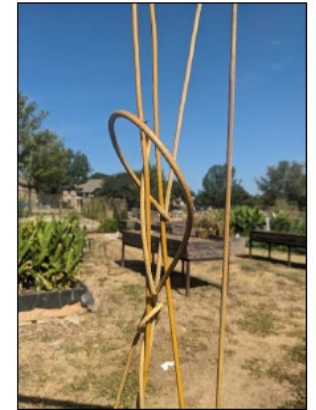
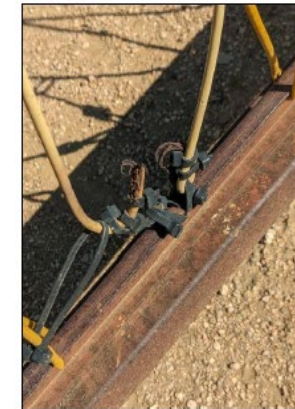
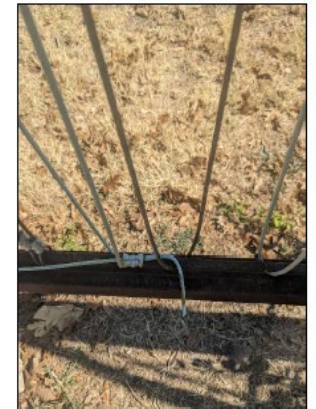
At least eight wires are noticeably bent and at least two wires are broken. In some places loose and broken wires have been better secured with cable ties; this fix disrupts the rhythm and aesthetics of the piece. Note that if only the broken cables are replaced, the color of the new cables will not match the now-faded color of the original cables.

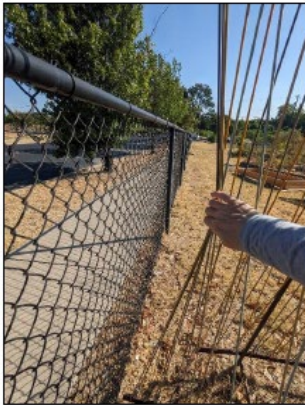
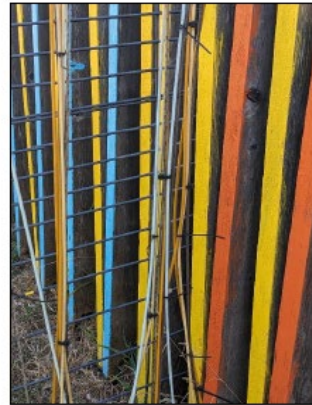
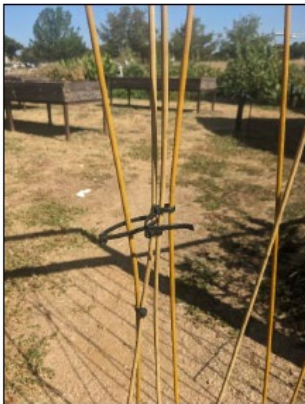
Some of the wires appear to have slackened since installation. As a result, the artwork no longer serves its intended function as a barrier to trespassing; for example, a small person could squeeze through the cables at the southwest corner without trouble. In the northeast corner, what appears to be a security grate has been installed behind the fence, interrupting the rhythmic pattern of the cables. Slack cables have been tightened with cable ties, additionally disrupting the intended visual effect.

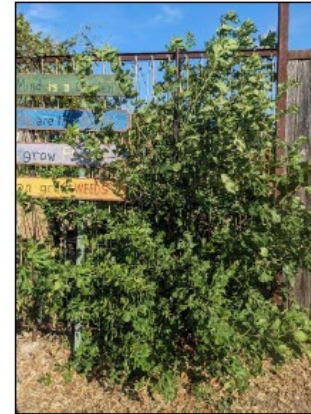
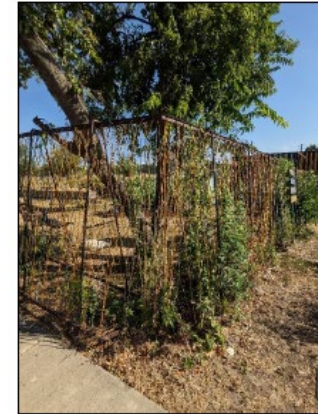
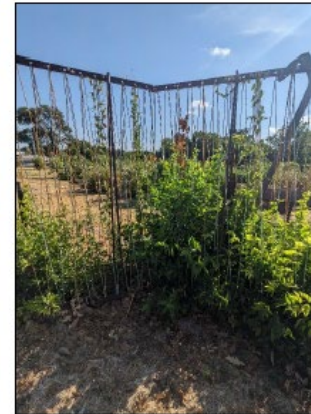
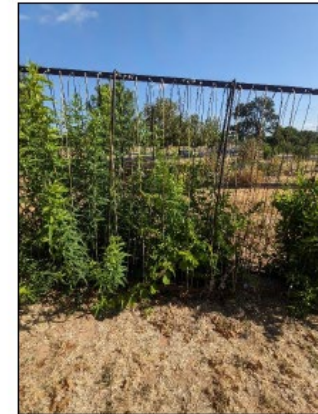
There is significant non-intentional, non-landscaped plant growth between the elements of the weathering steel frame, including a small mulberry tree and climbing vines. These plants obscure the artwork and in some cases contribute to deformation of cables.

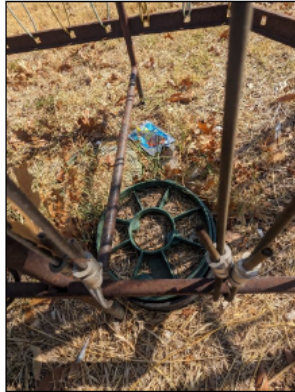
The weathering steel frame has corroded as expected, and the current corrosion layer is serving a protective function. However, the weathering steel frame may restrict access to city utilities at the 6th bay from the southwest corner.

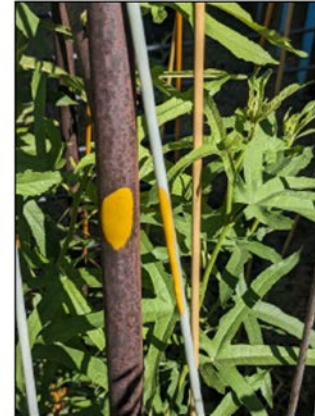
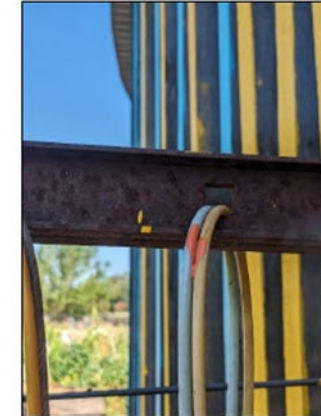
There are minor accumulations of bird droppings, paint splatters near the gazebo at the northeast corner, and trapped debris.
