NSPECT PROPERTY INSPECTION REPORT

701 Sparks Ave, Austin, TX 78705

Property Inspection Report prepared for: Rahim Javanmardi

Inspection Date: 9/6/2023

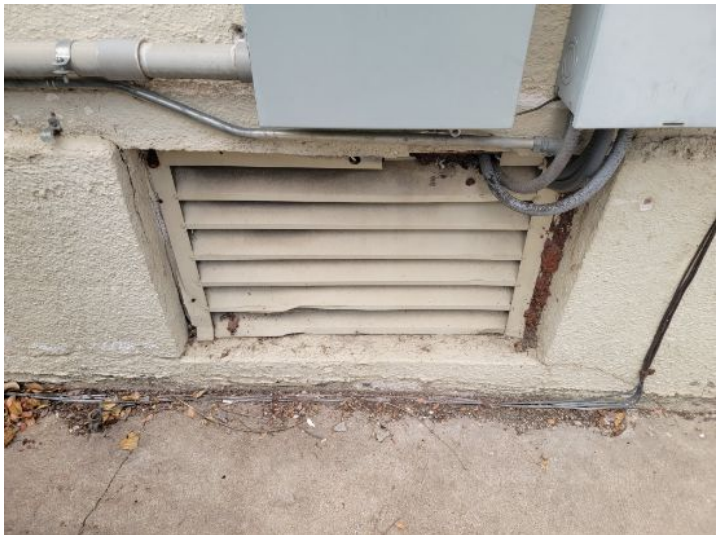
Cracking in foundation wall

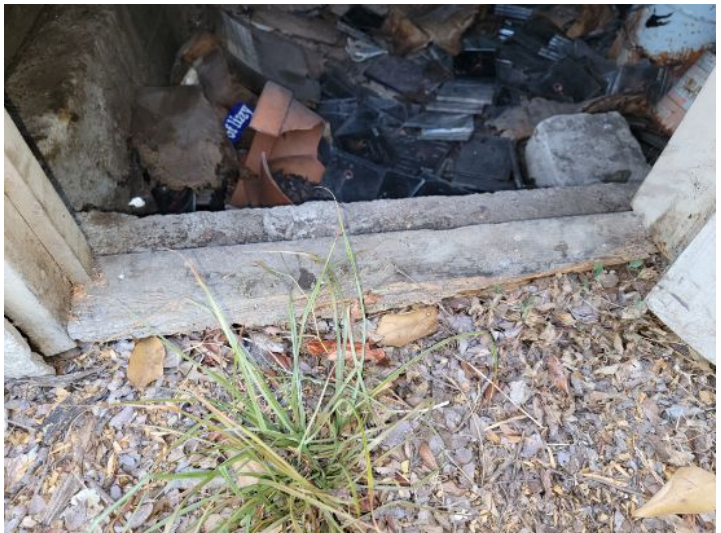
Deteriorated structural member

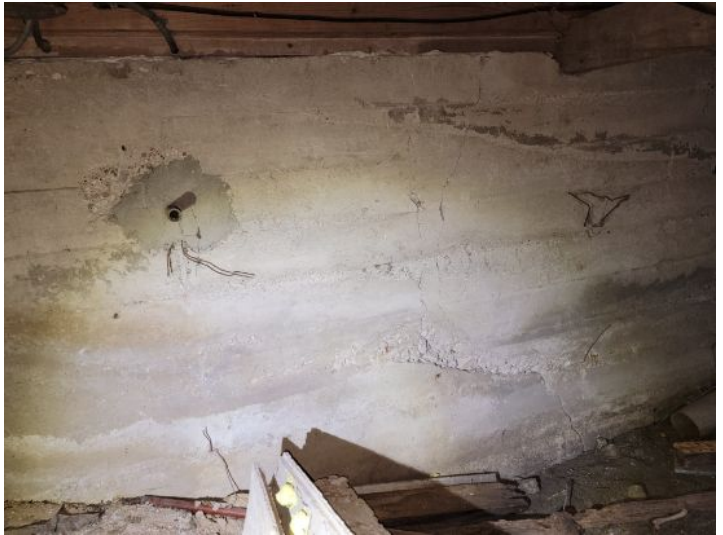
Wood debris in crawlspace

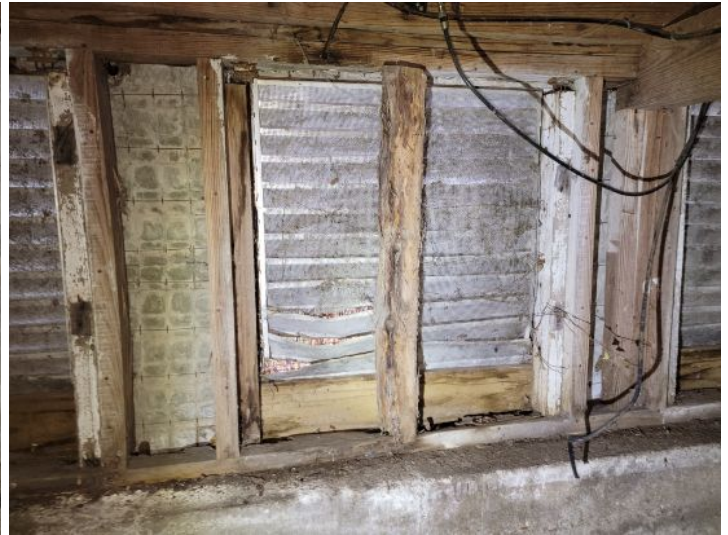
Crawlspace- wood to ground contact

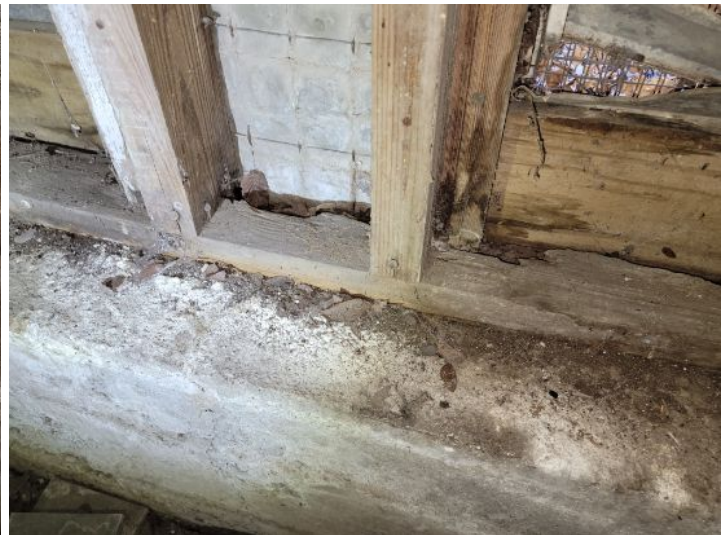
Crawlspace: Deteriorated structural support members

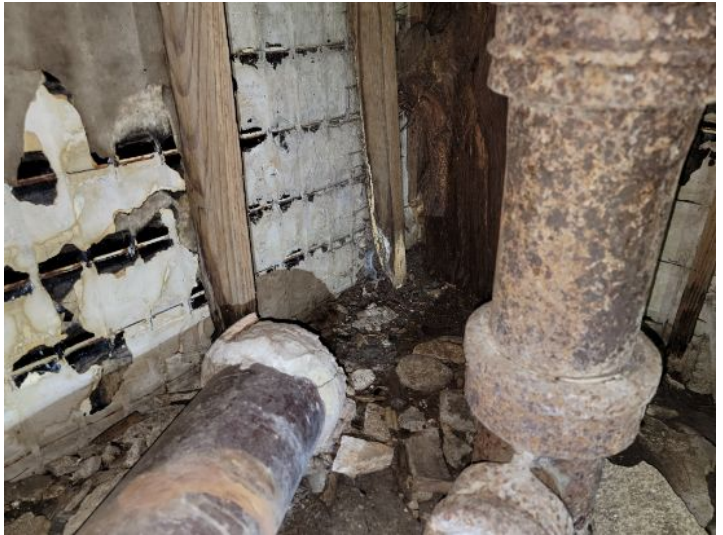
Crawlspace: Deteriorated structural support members

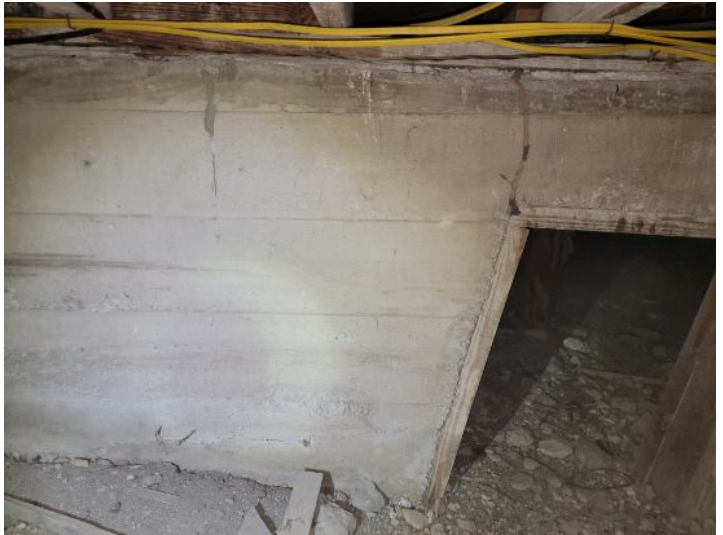
Cracking in foundation wall

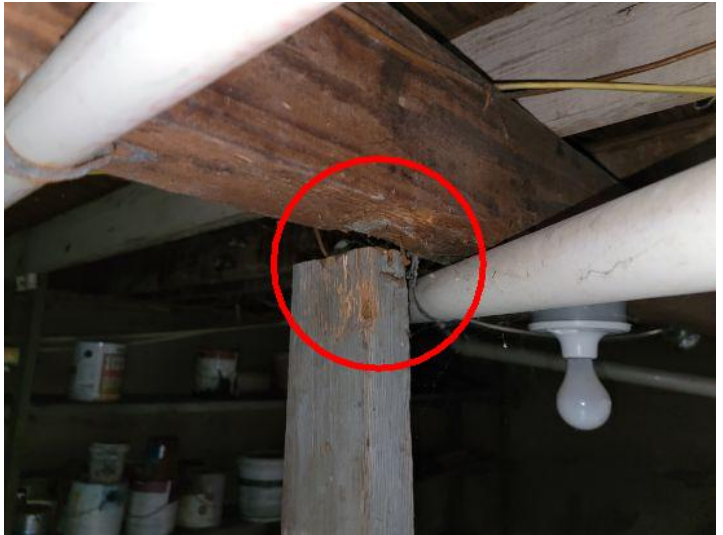
Rodent damaged basement support post

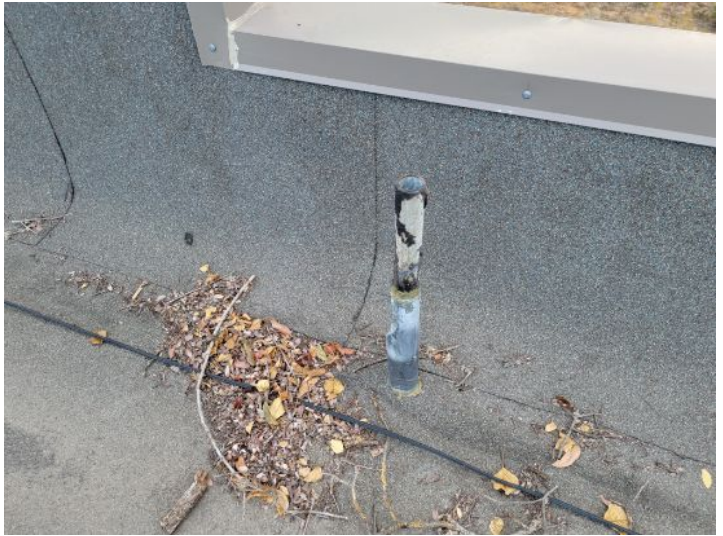
• Plumbing vent boot flashing was not found to be properly installed in all locations. Flashing was not found to be folded inside vent pipes. This can lead to moisture intrusion into the attic space and interior the home. Recommend further investigation by a qualified and professional roofing contractor and repair as deemed necessary.

Improperly installed vent boot flashing

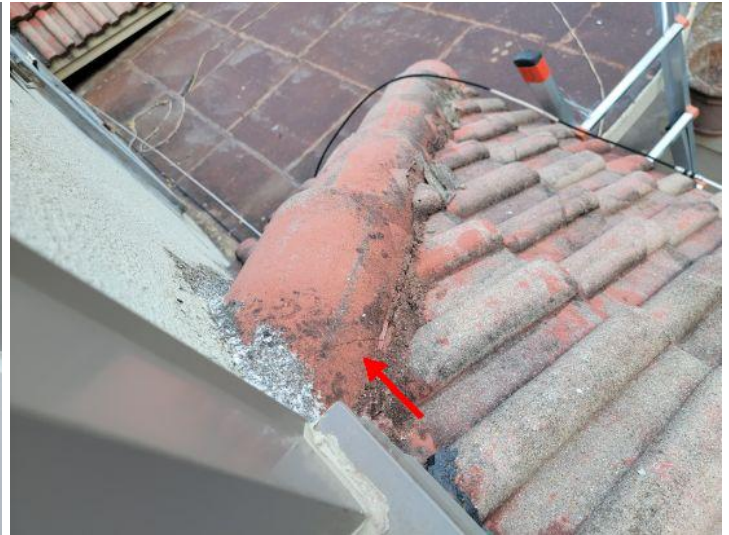
Damaged roof tiles

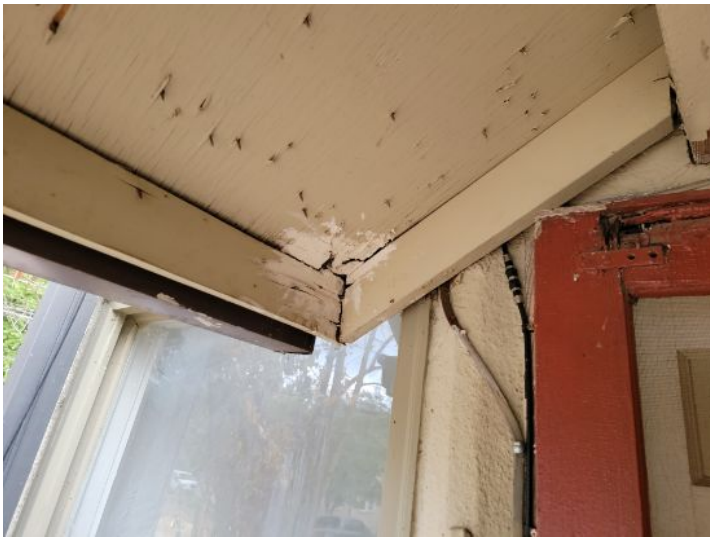
Deteriorated roof decking

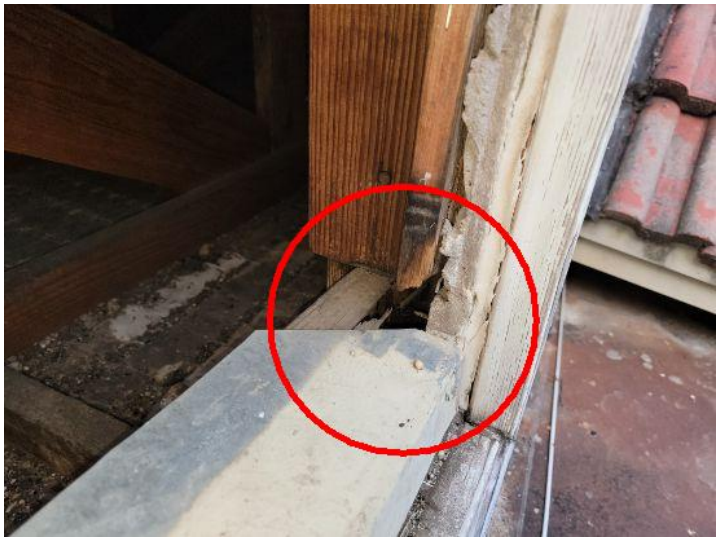
Deteriorated roof decking

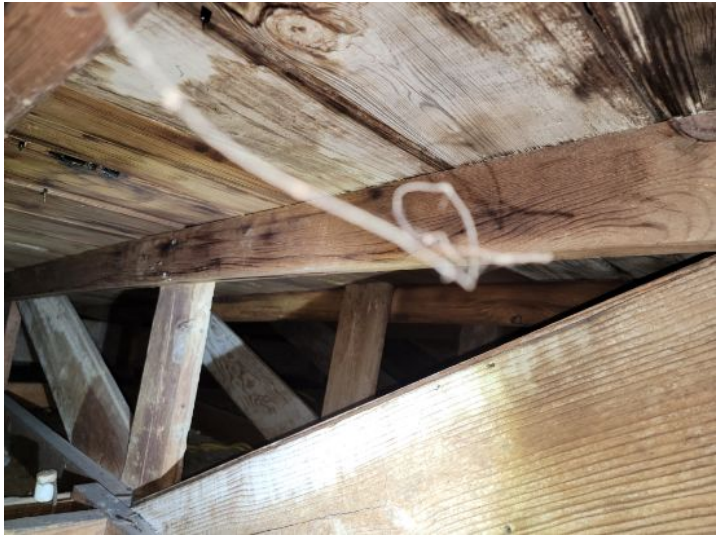
Gap in framing members. Water stains on decking and framing members.

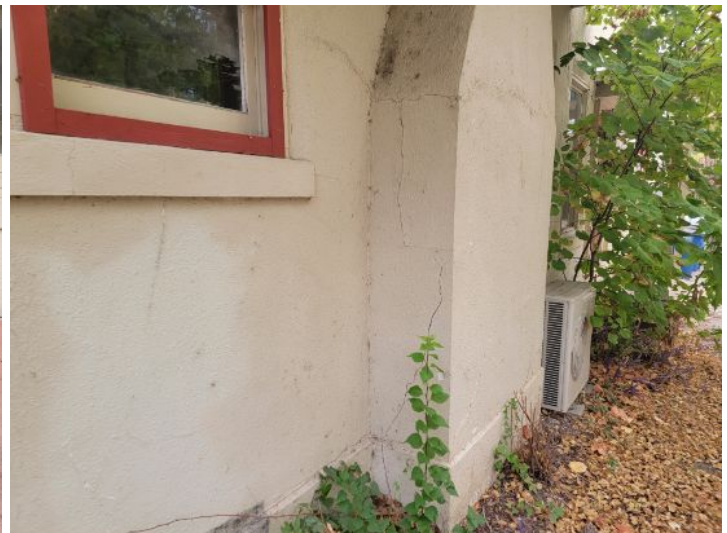
Cracking in stucco

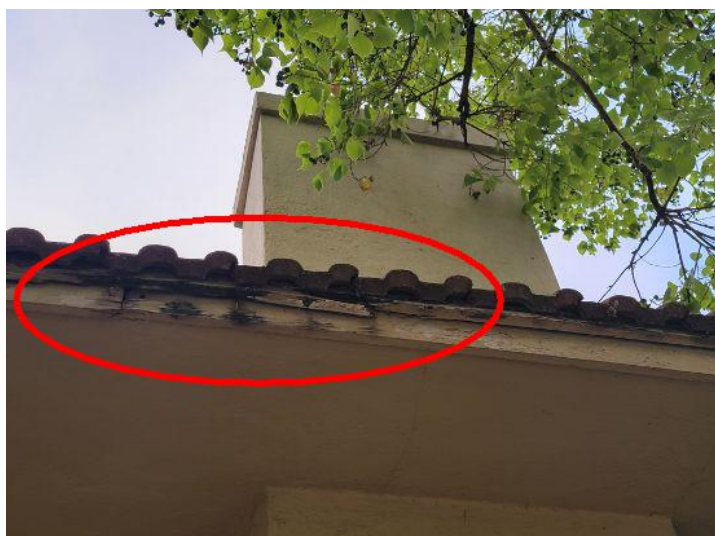
Deteriorated fascia

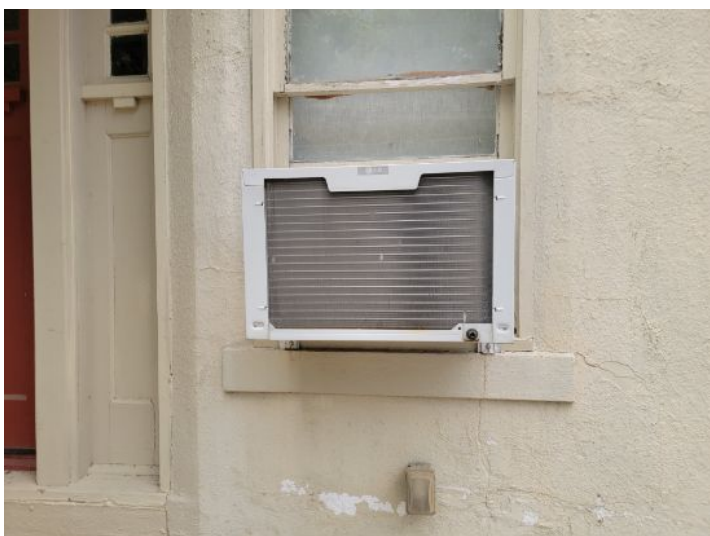
Cracking in stucco

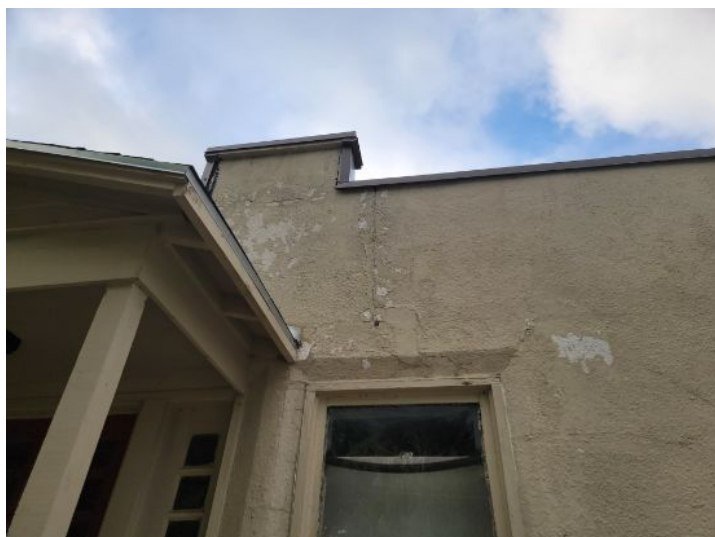
Cracking and flaking of stucco

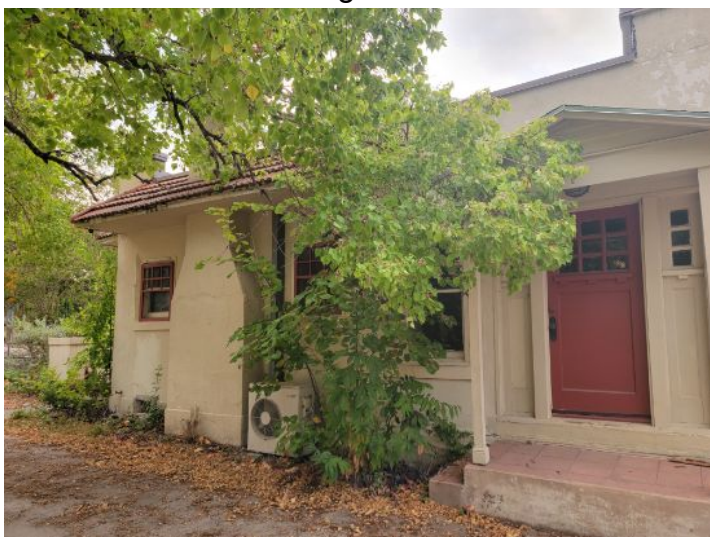
Trees contact house

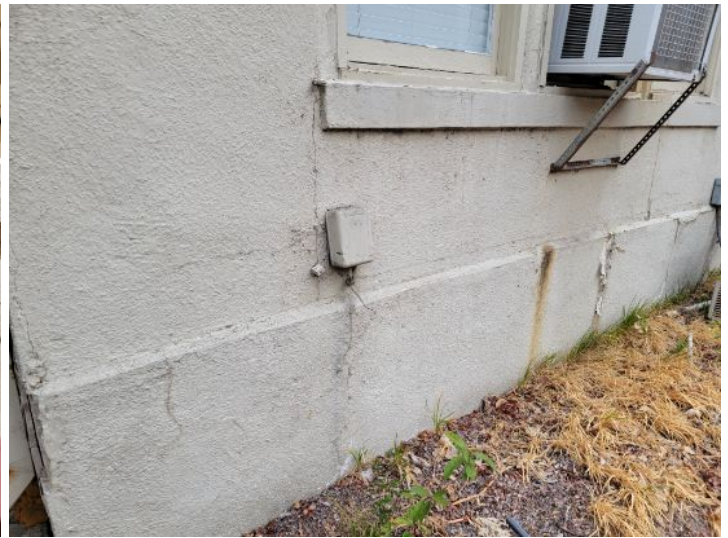
Cracking in stucco wall

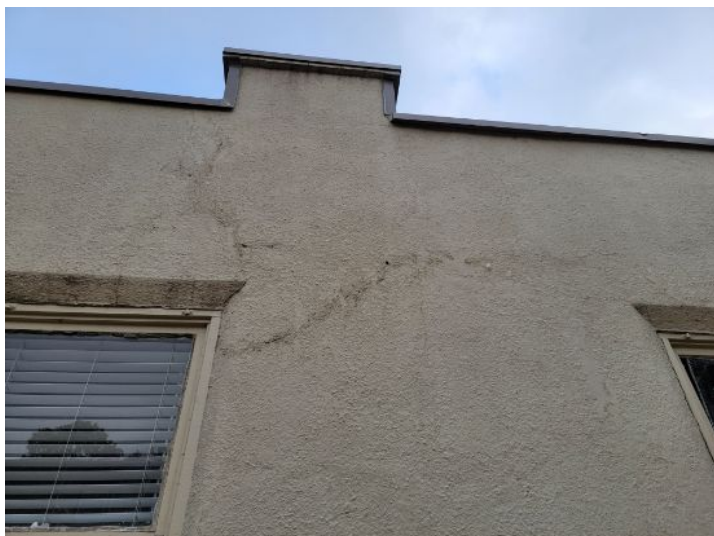
Cracking in stucco wall

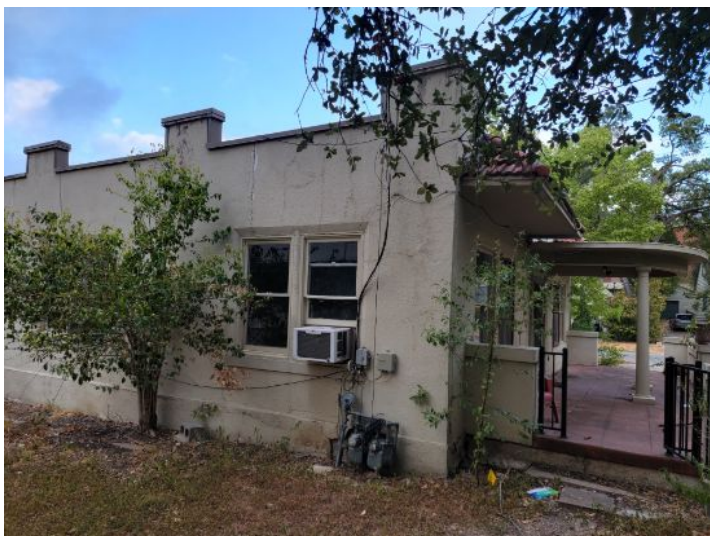
Cracking in stucco wall

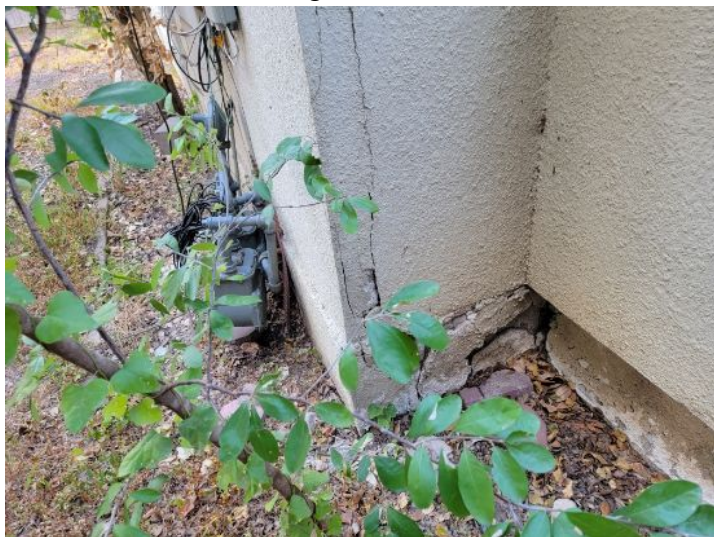
Cracking in stucco wall

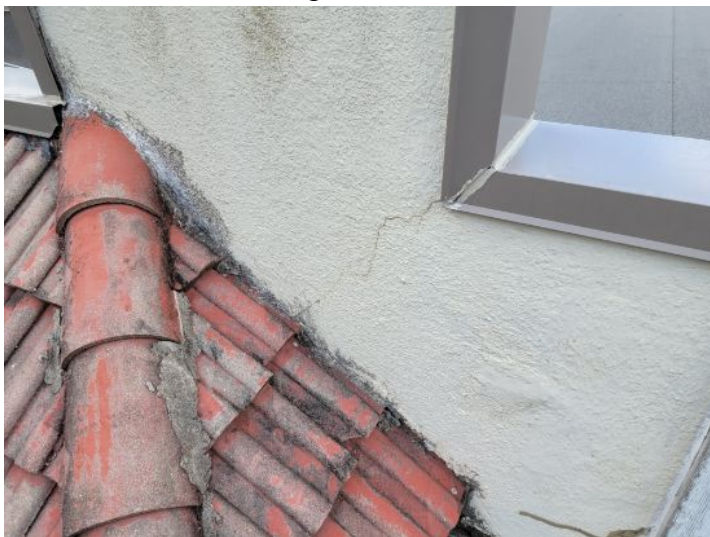
Cracking in stucco wall

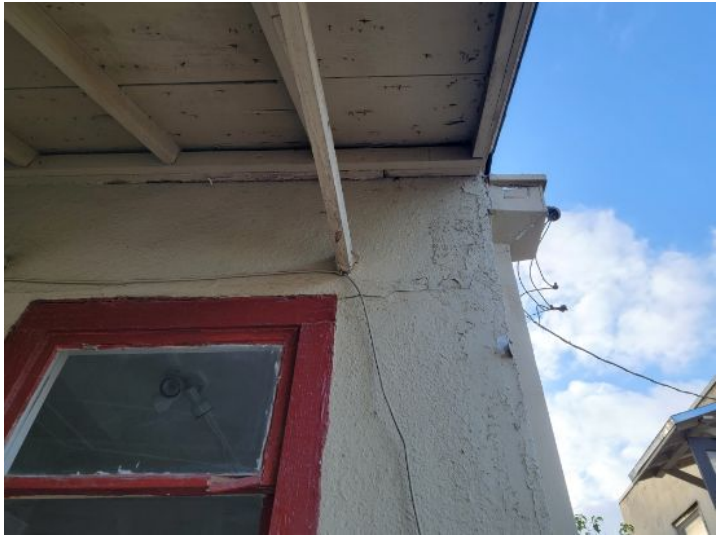
Deteriorated fascia

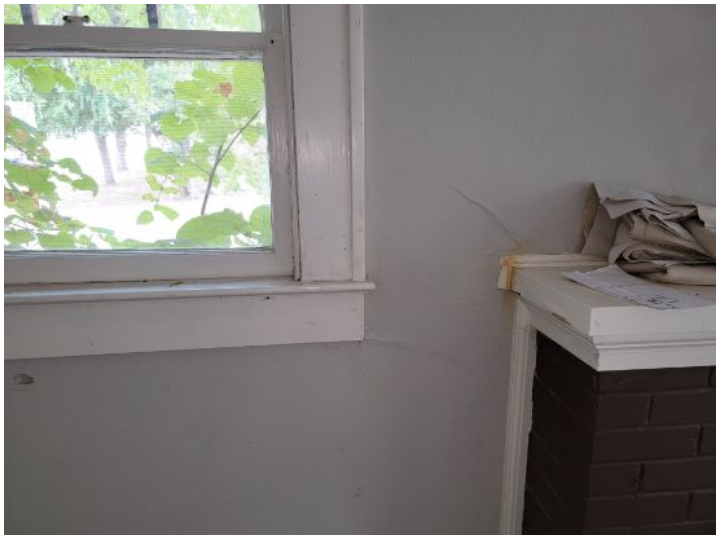
Cracking wall

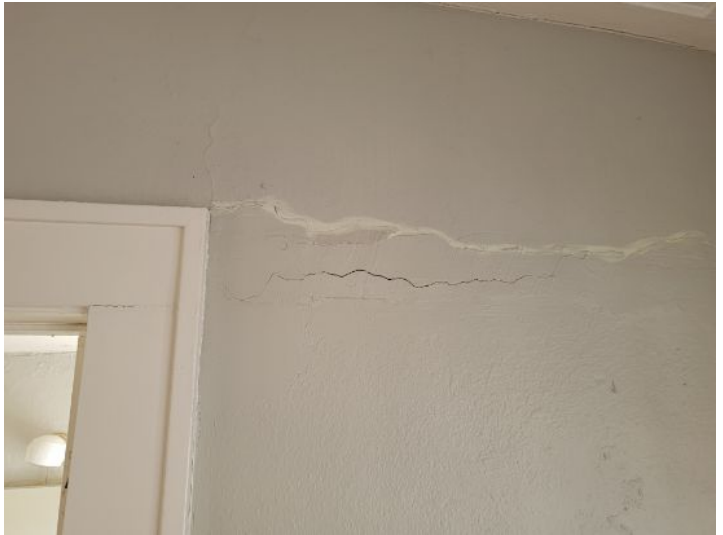
Repaired cracking in wall

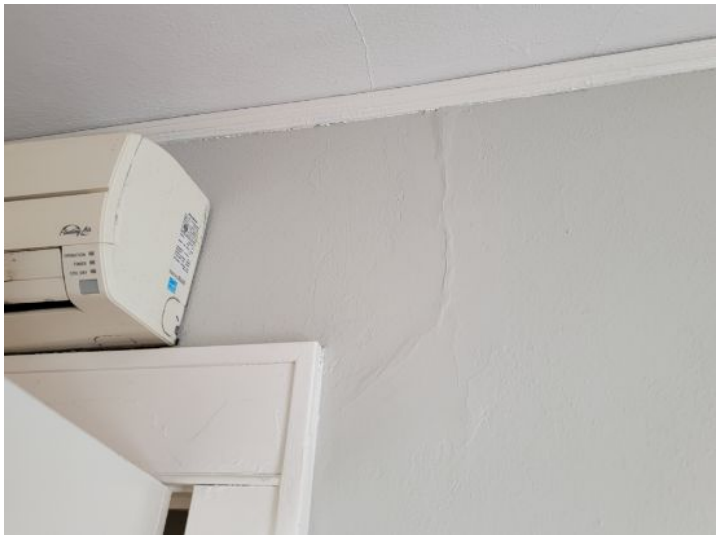
Damaged wall in 3013 Unit

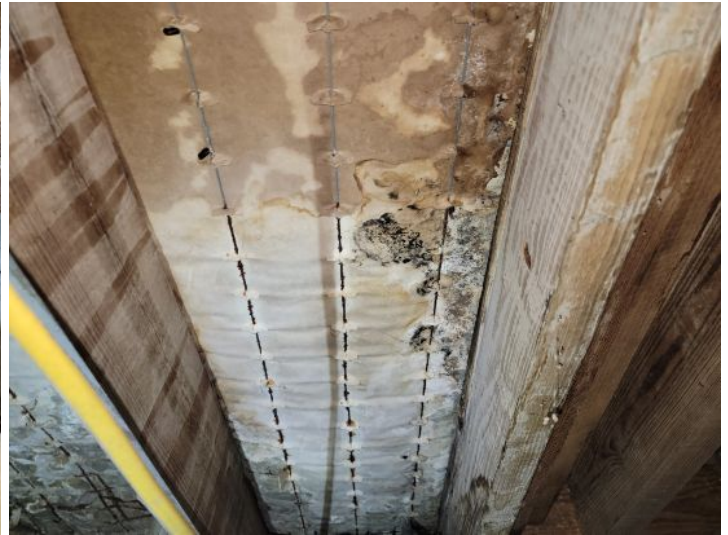
Deteriorated sub-floor and joist in crawlspace

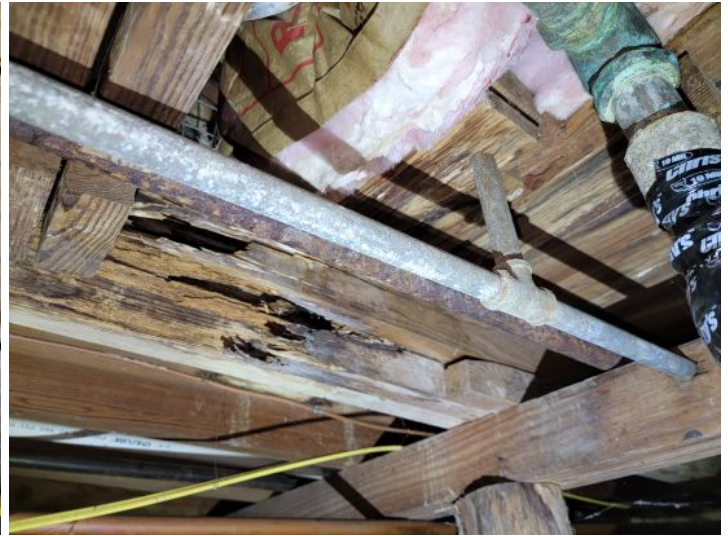
Evidence of moisture penetration and possible organic growth in crawlspace

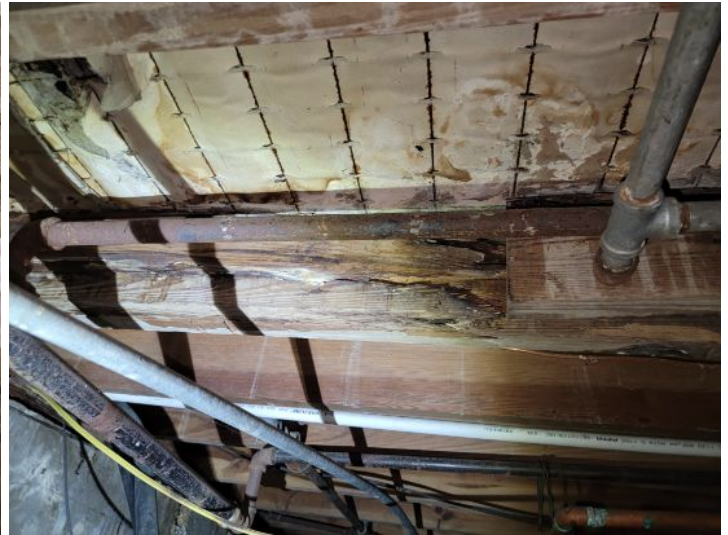
Deteriorated floor joists and sub-floor

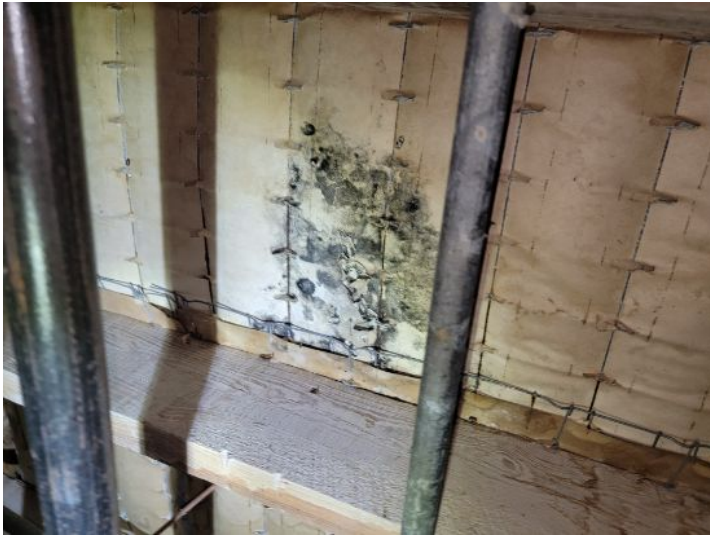
Deteriorated floor joists and sub-floor

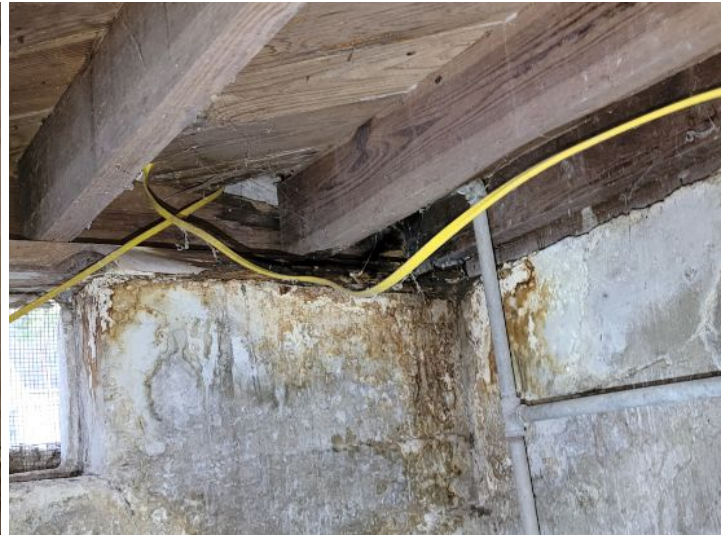
Crawlspace: Possible organic growth

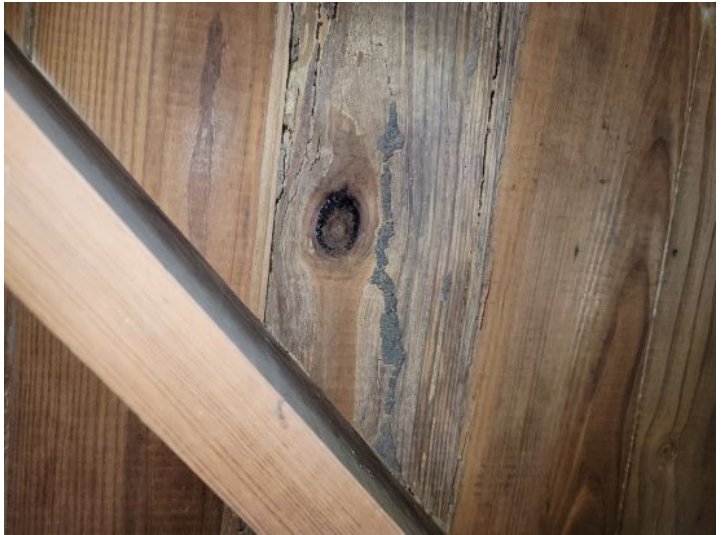
Deteriorated and fallen sub-floor

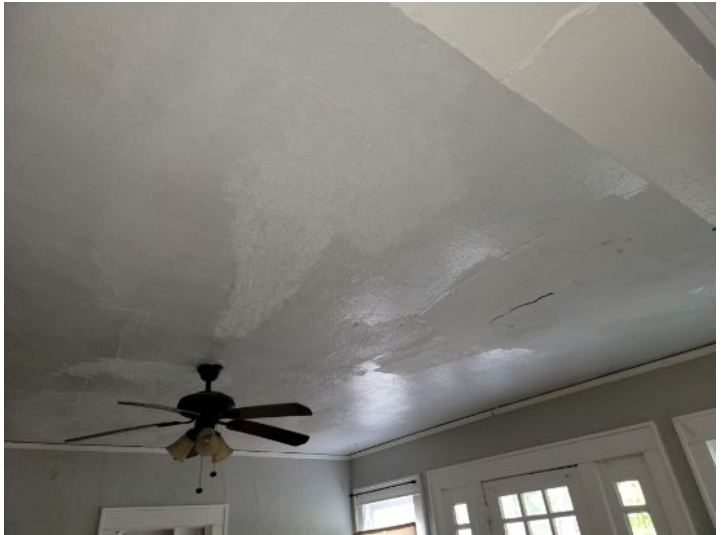
Evidence of moisture penetration

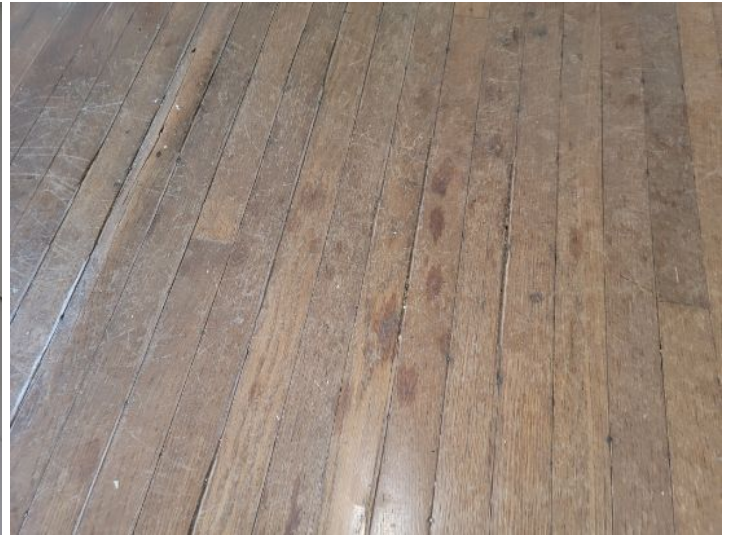
Moisture penetration

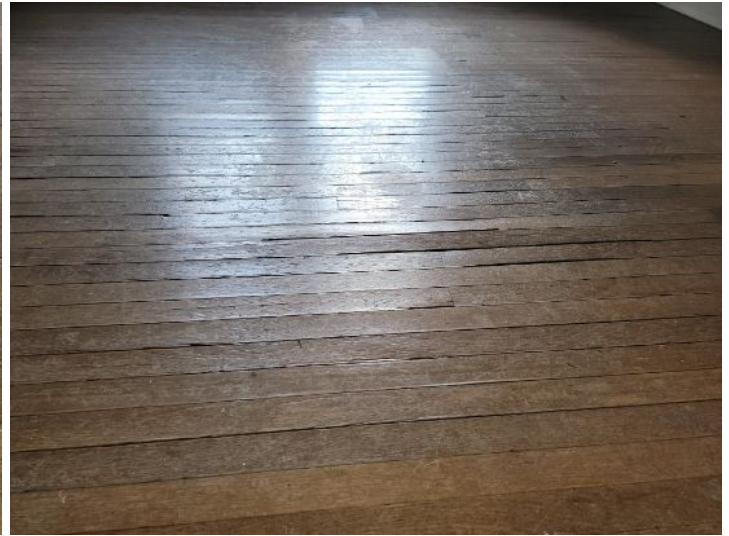
Deteriorated wood floors

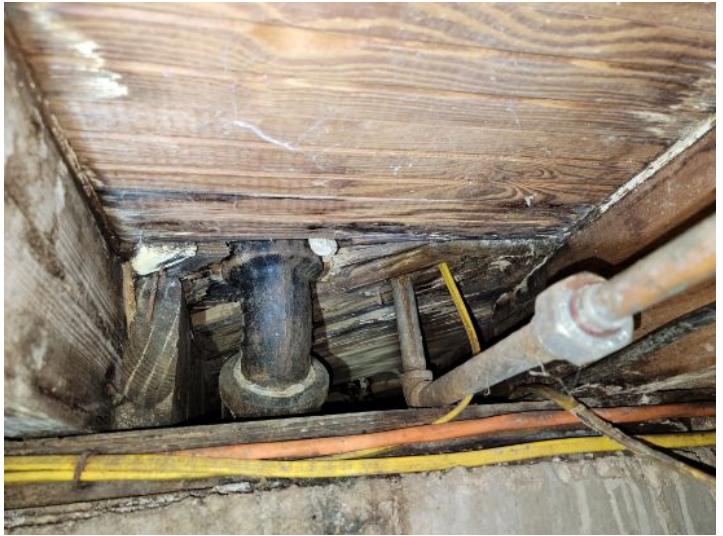
Basement: Evidence of moisture penetration and possible organic growth

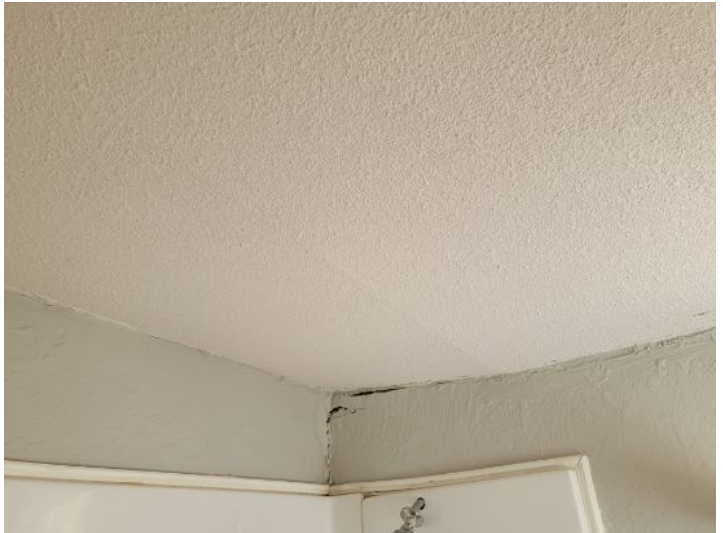
Water damaged ceiling

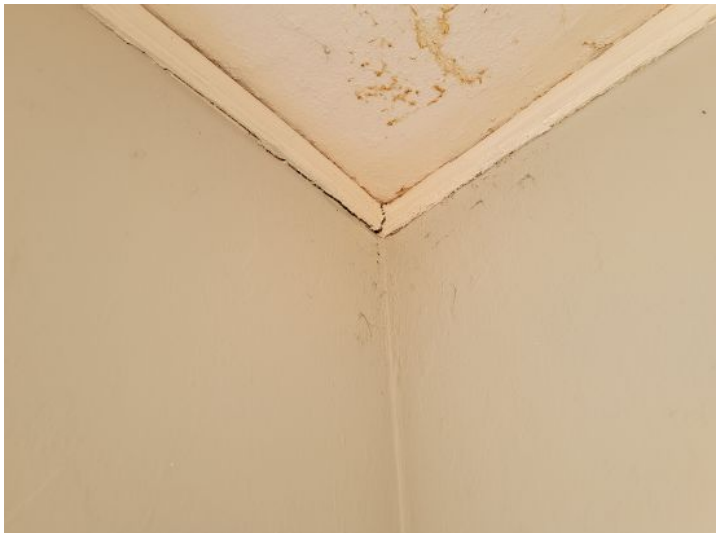
Cracking and water damaged ceiling

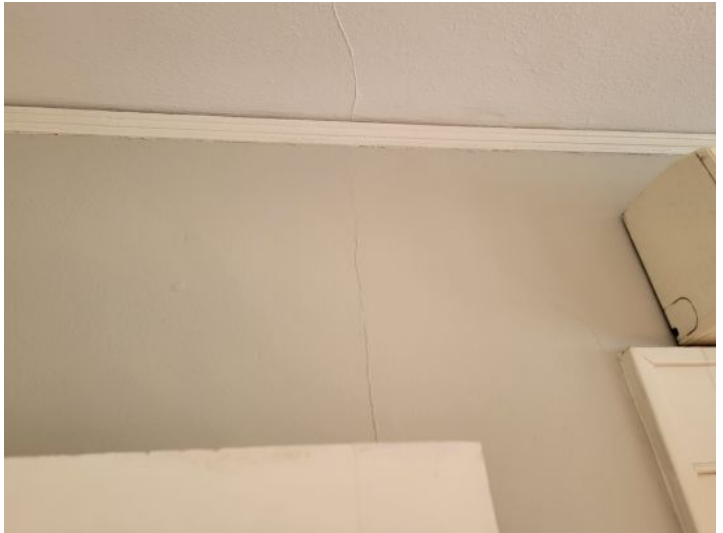
Water damaged ceiling and wall

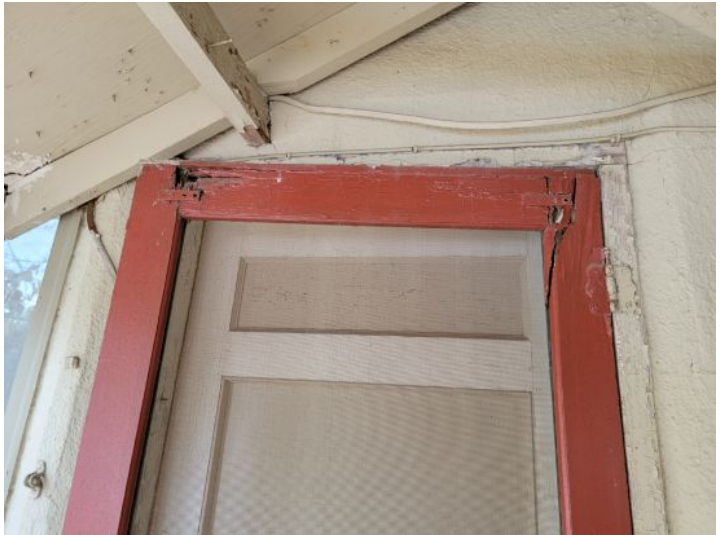
Deteriorated door

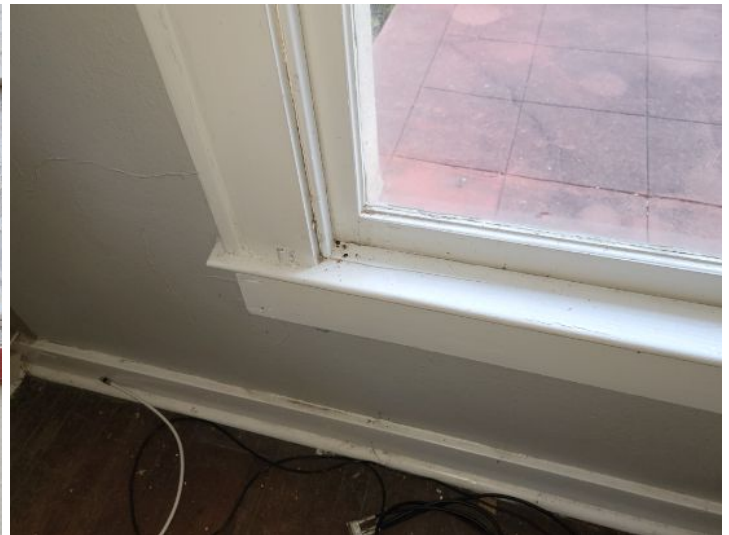
Deteriorated window frames

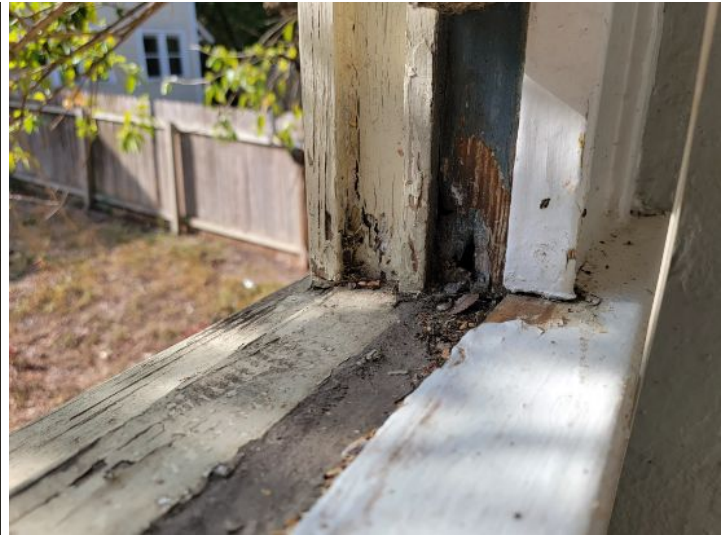
Deteriorated window frame

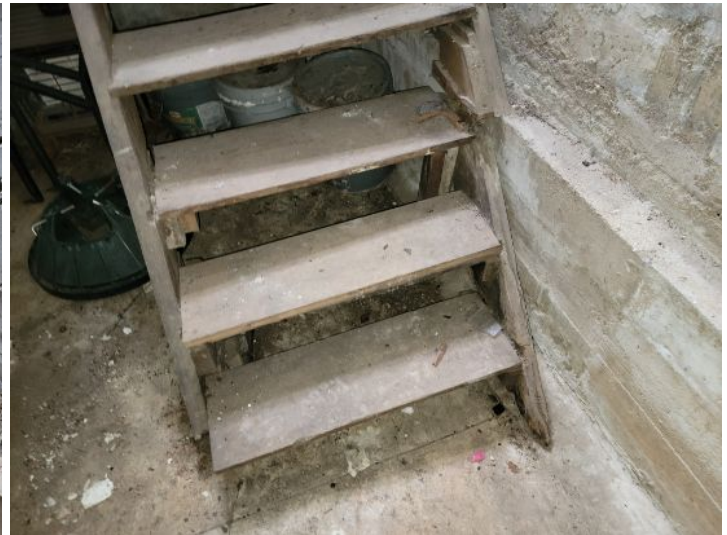
Non code compliant stairs

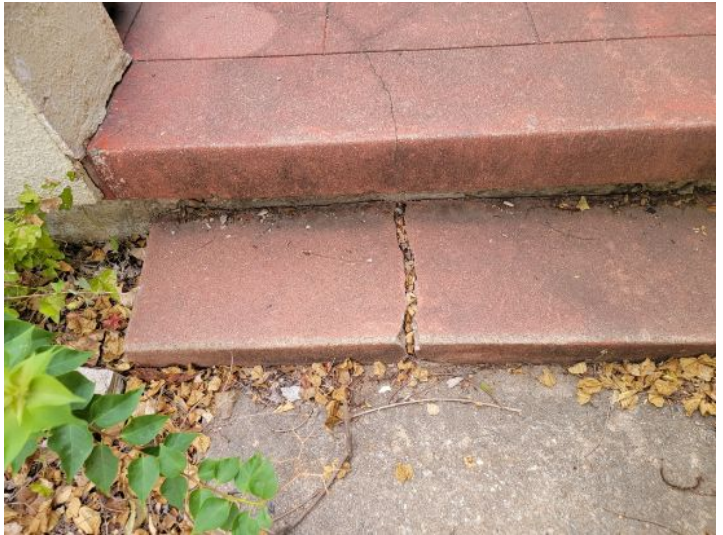
Cracking in front porch floor

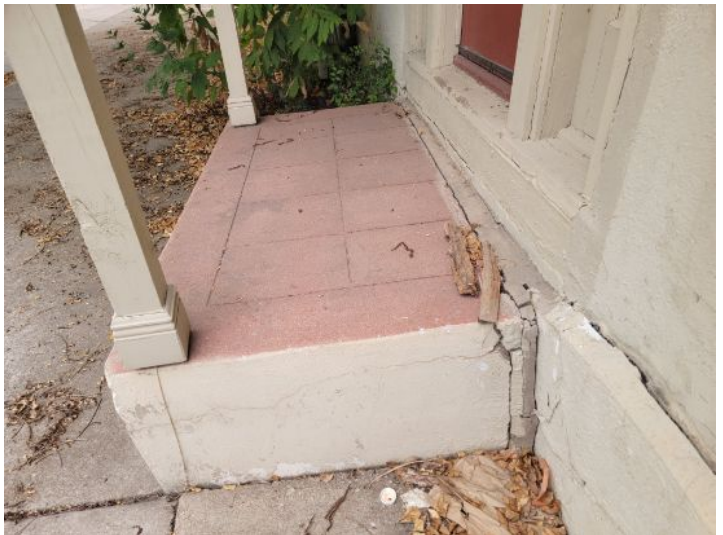
Cracking in front porch floor

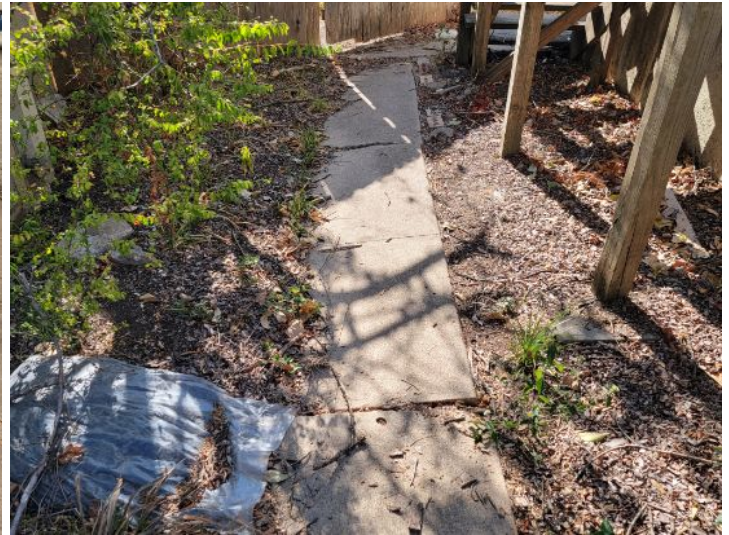
Trip hazards in driveway

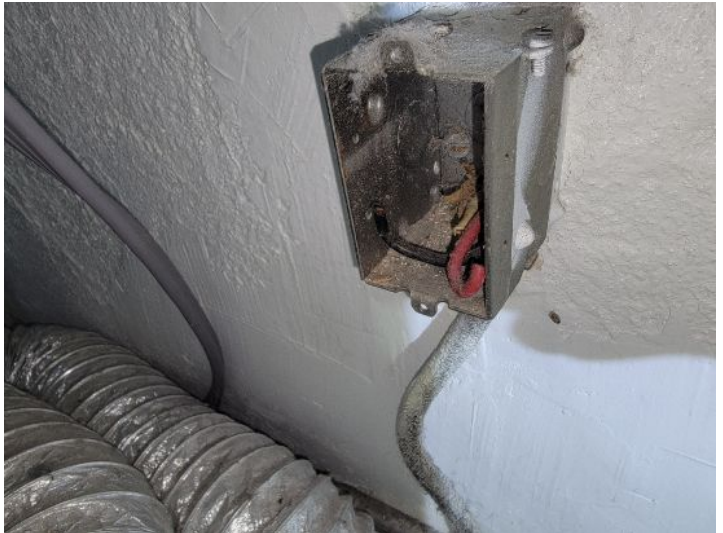
Damaged and exposed wiring

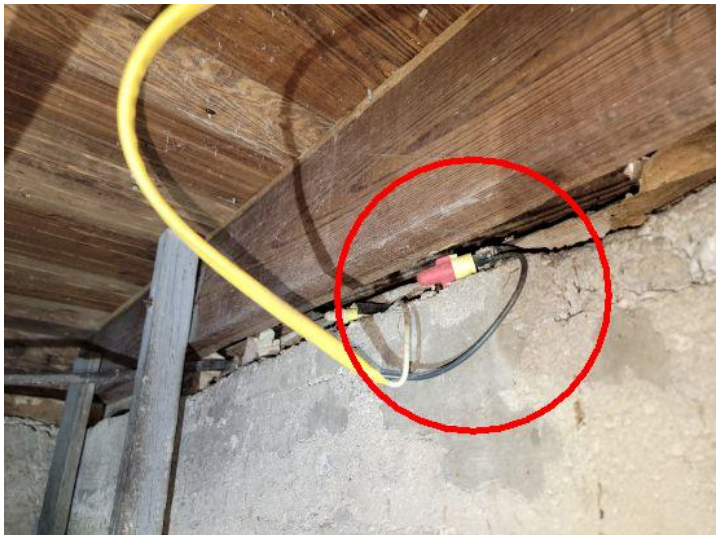
Improperly terminated wiring

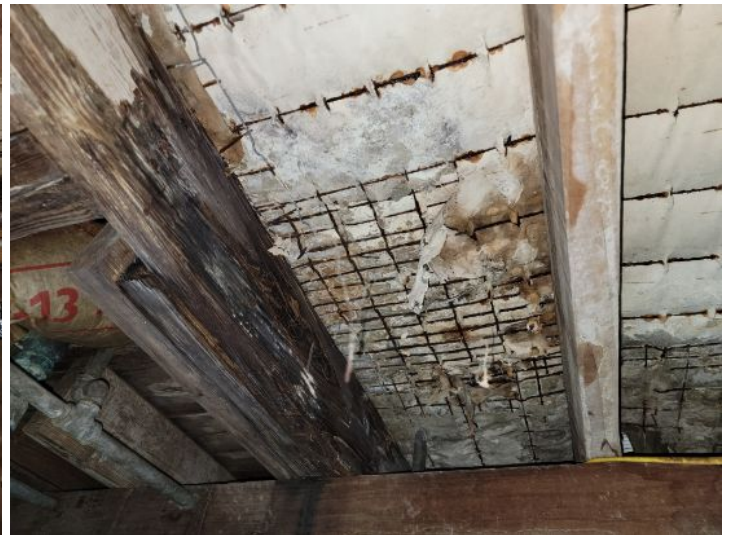
Uninsulated water piping

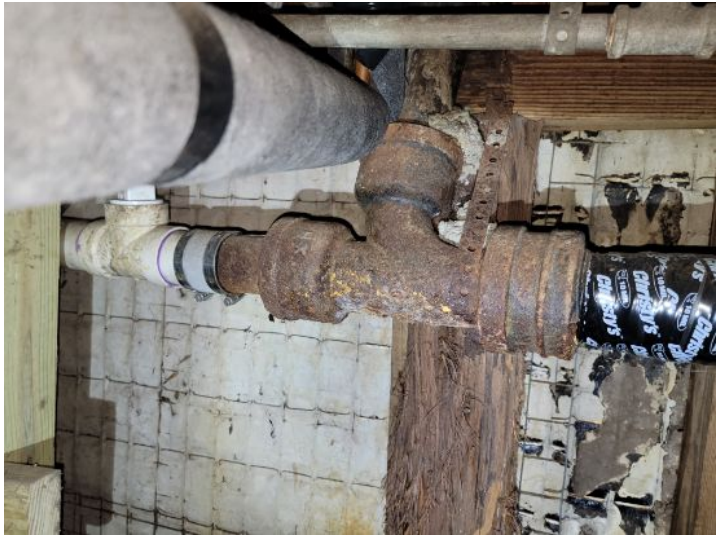
Corroded and rusted cast iron drain piping

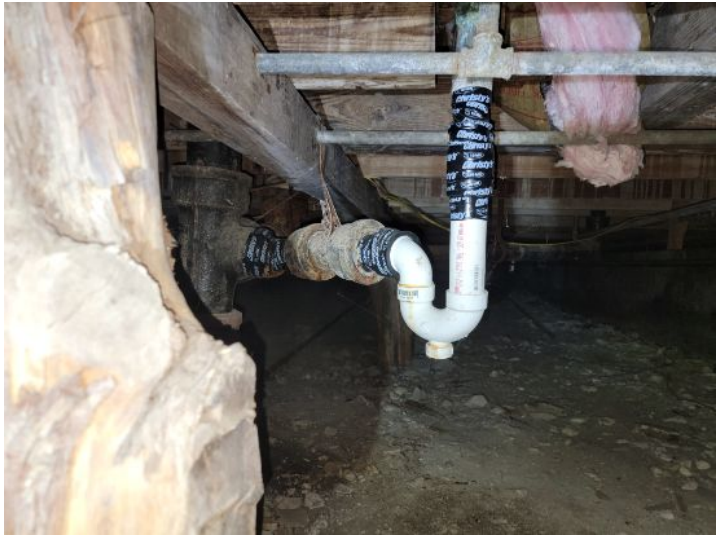
Corroded and rusted cast iron drain piping

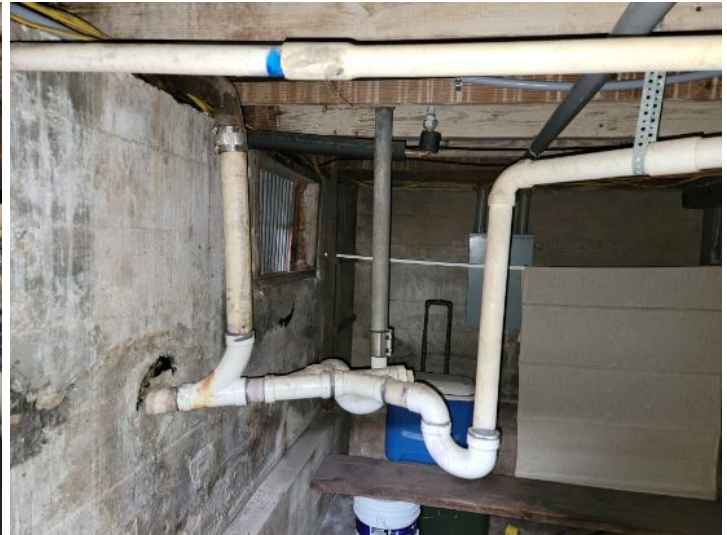
Rusted and corroded cast iron drain piping

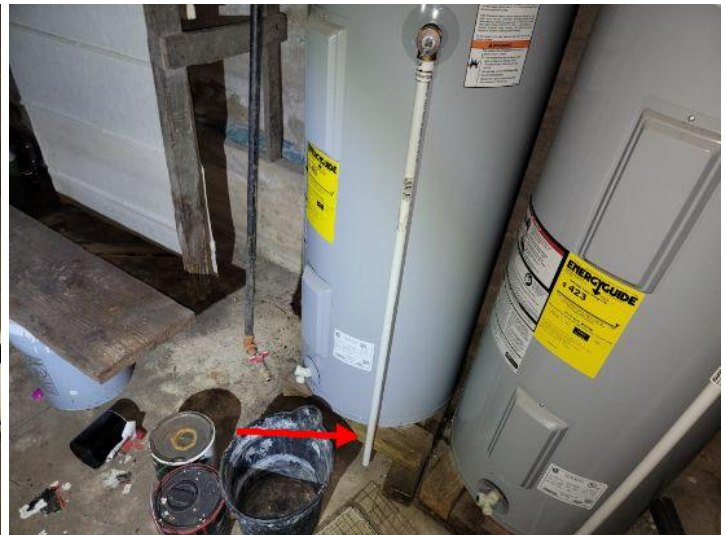
Water heaters and uncapped gas line
