701 SPARKS AVENUE

OBSERVATIONS

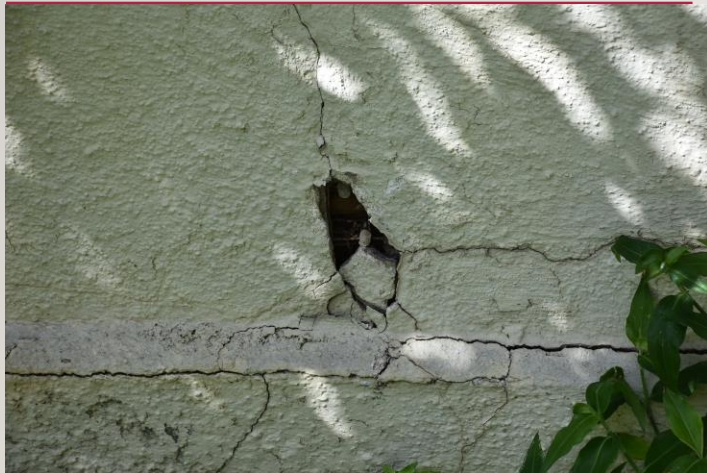
EXTERIOR

- Several Modifications to the Residence
- Exterior Stucco May be Beyond Repair
 - Underlying Deterioration
- Roofing Concerns

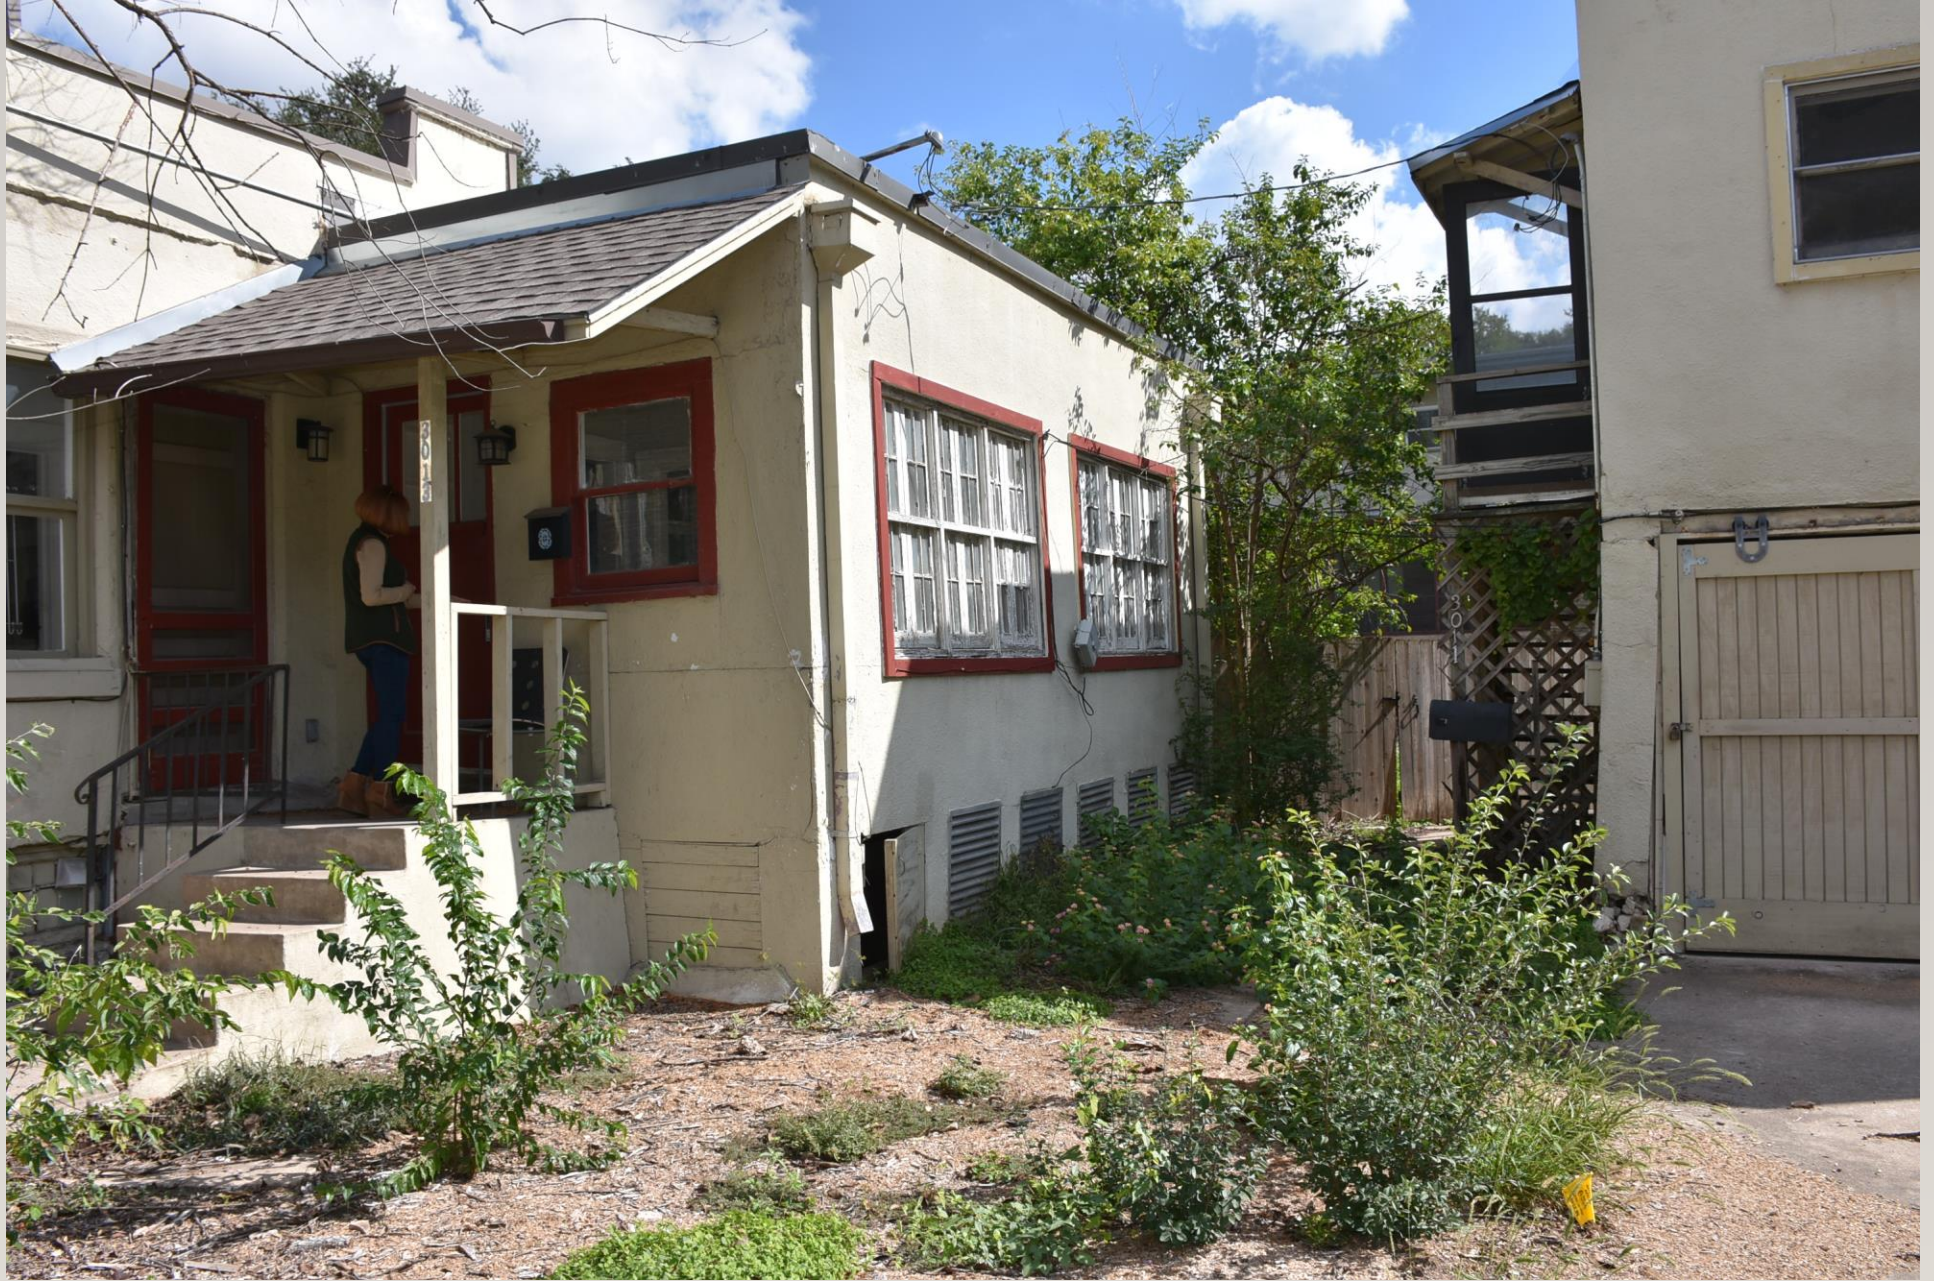
Rear Addition

- Note changes in architecture

- Shed roof added later
- Double Entrance

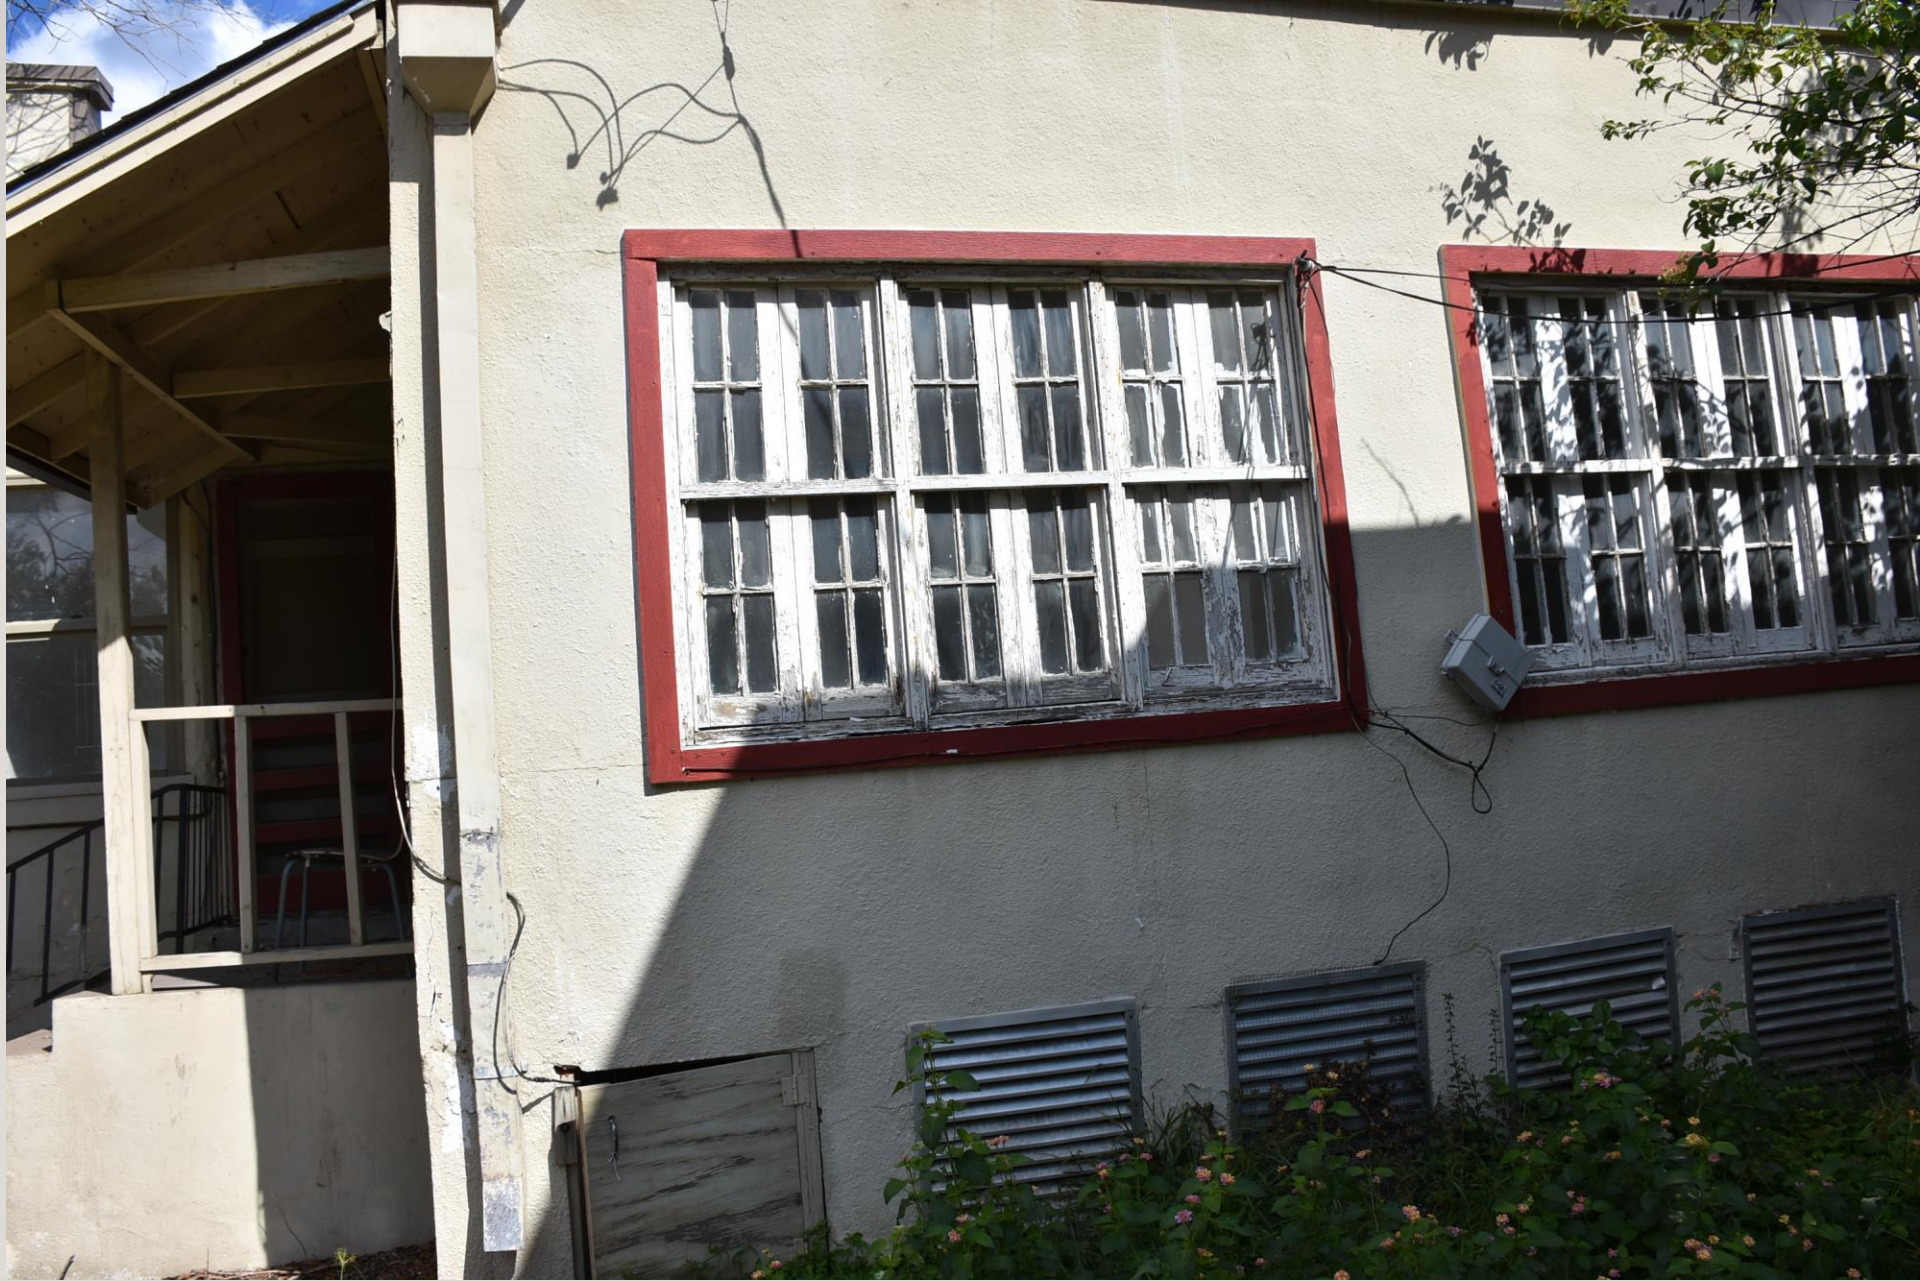
Different Windows

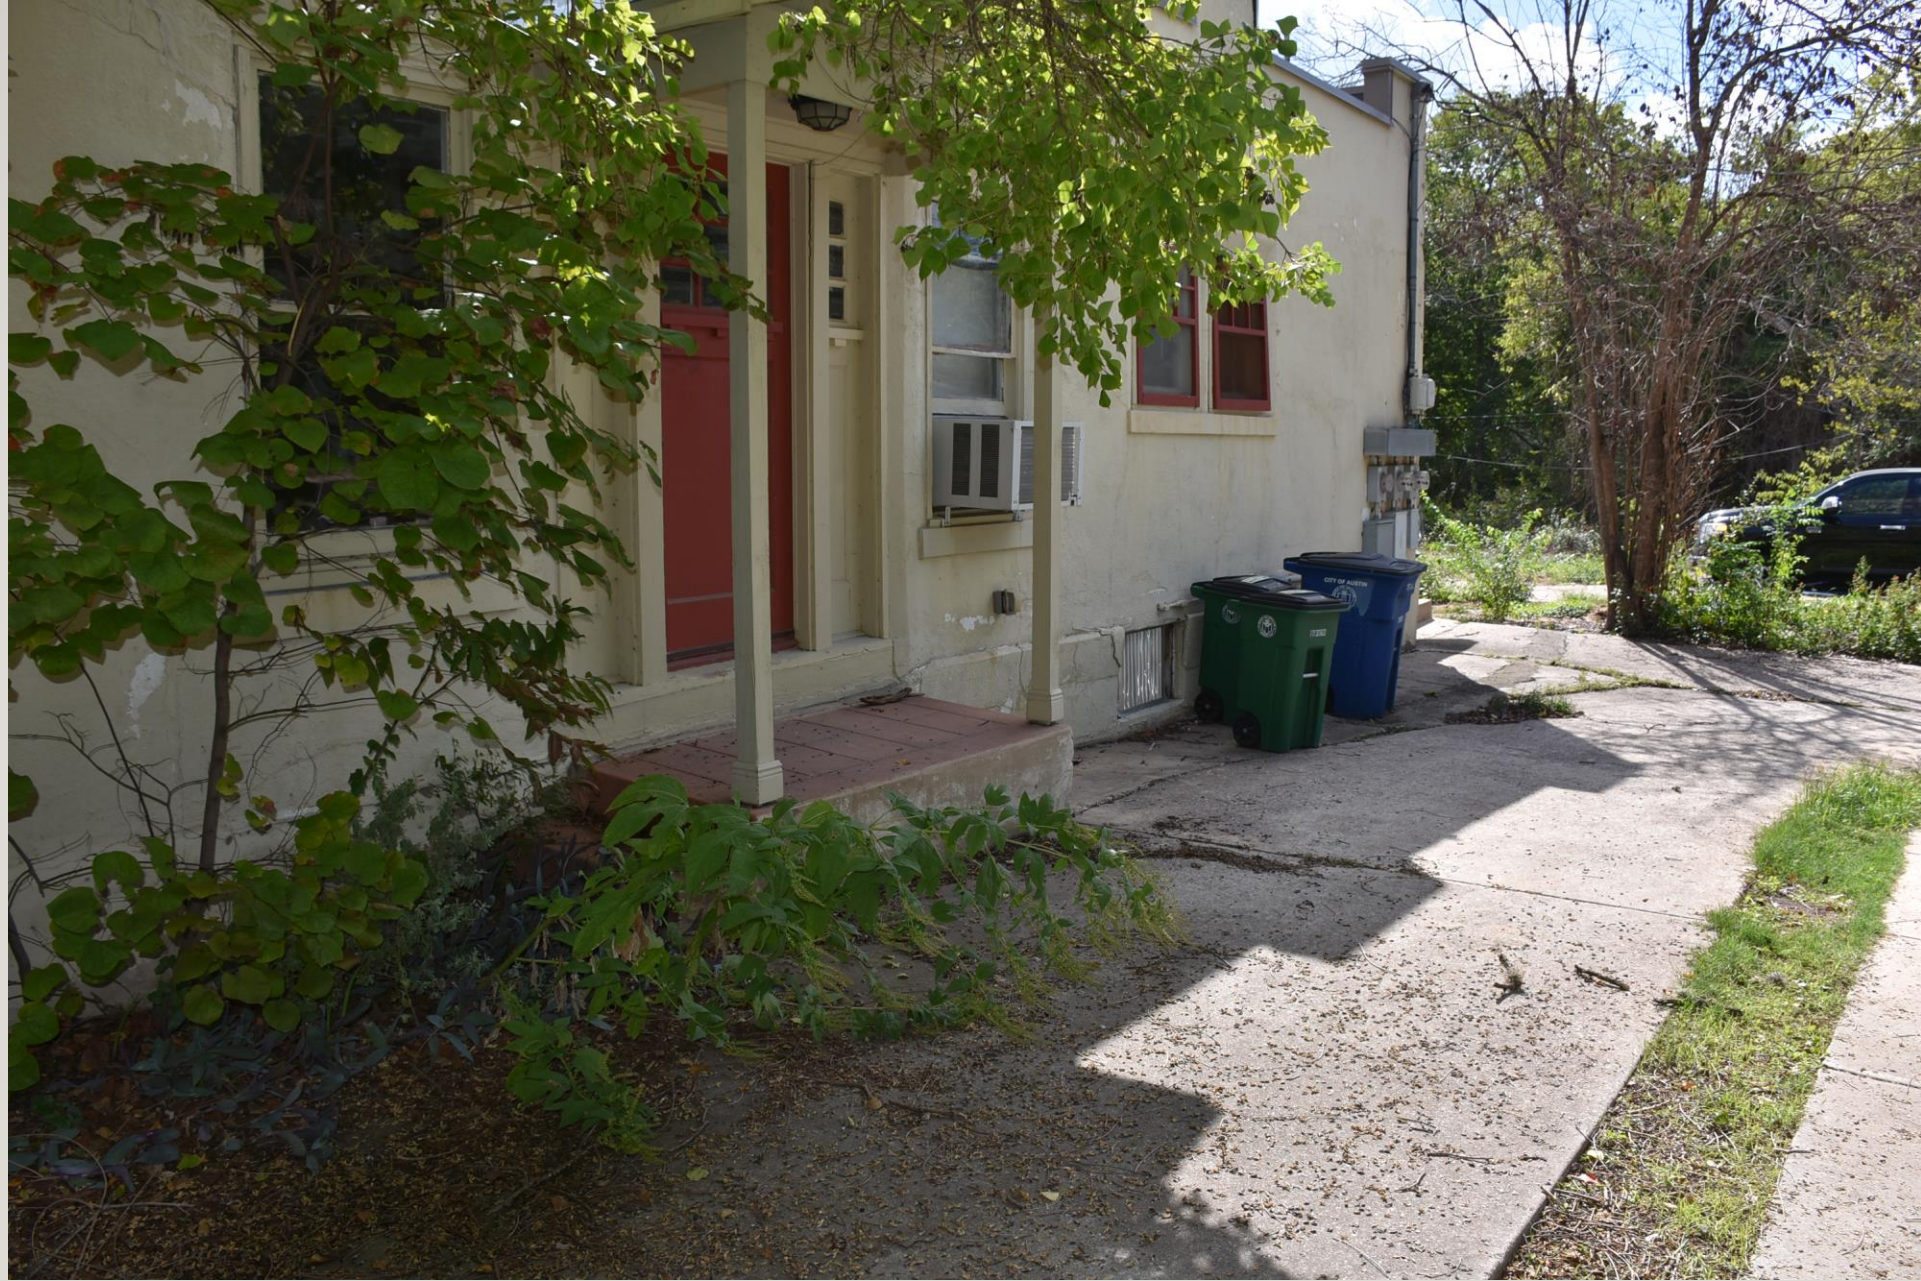
Side Entrance

- Added later
- Note decorative posts
- Modern roof
 - Different Architecture
- Stamped Concrete

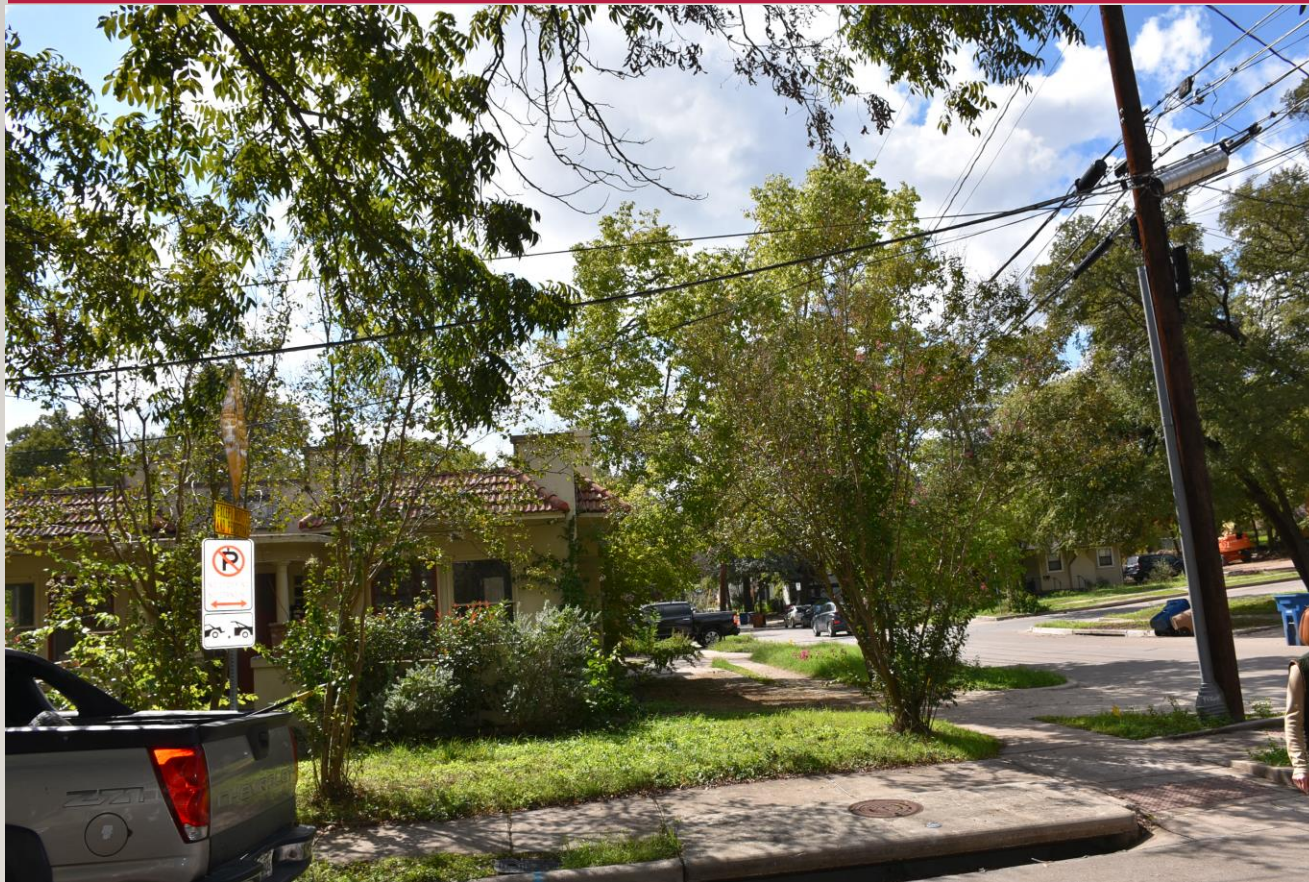
- Clay Tile Mansard
- Flat Roof
- Altered Parapet

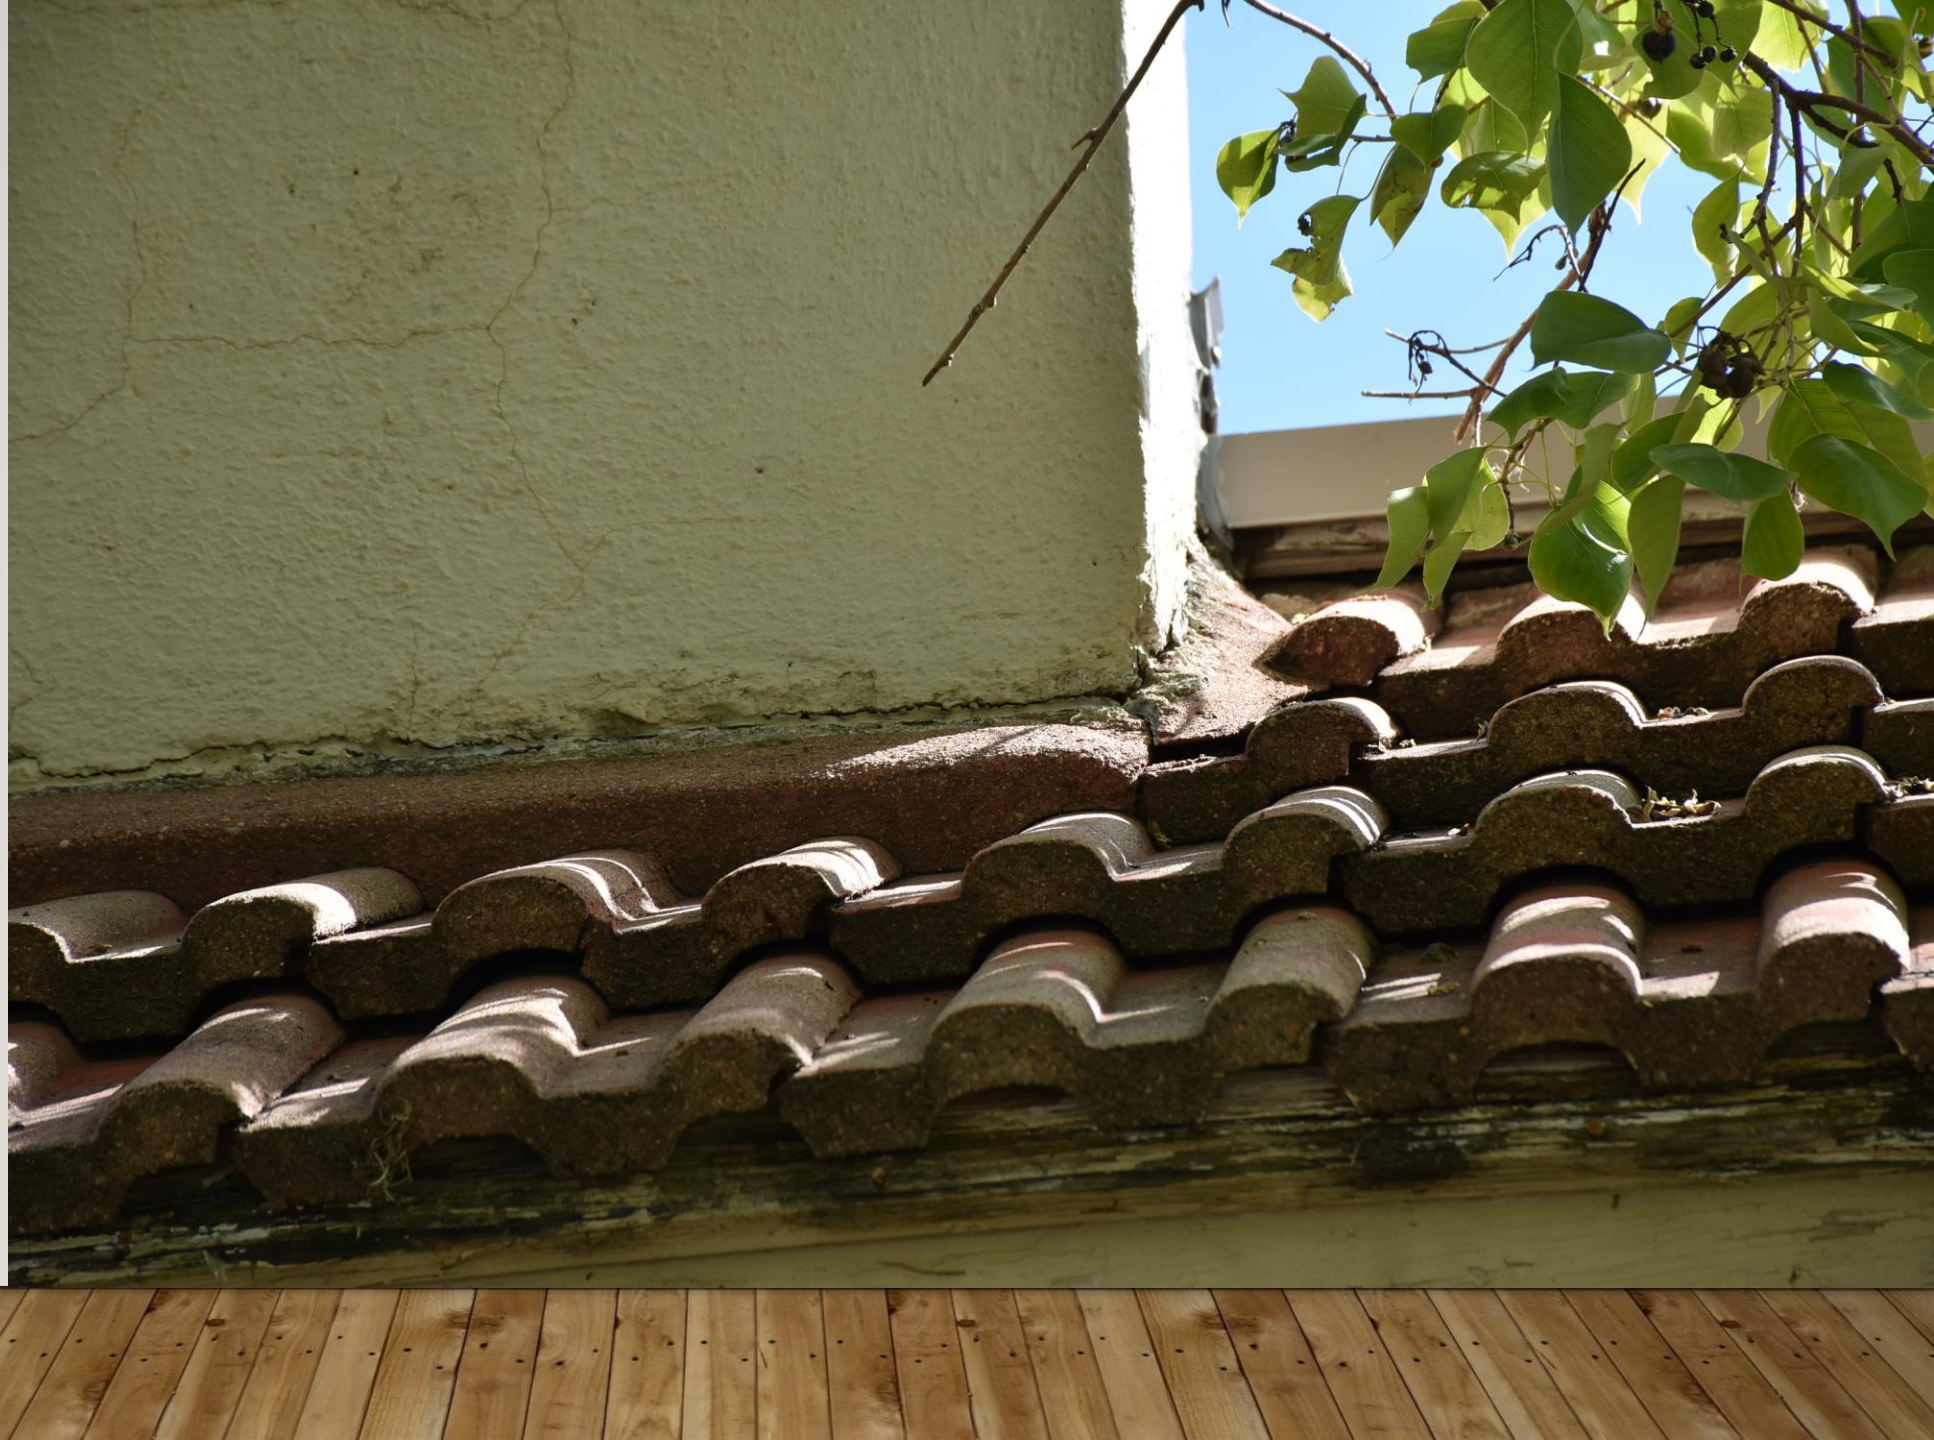
Flashing requires tile
removal

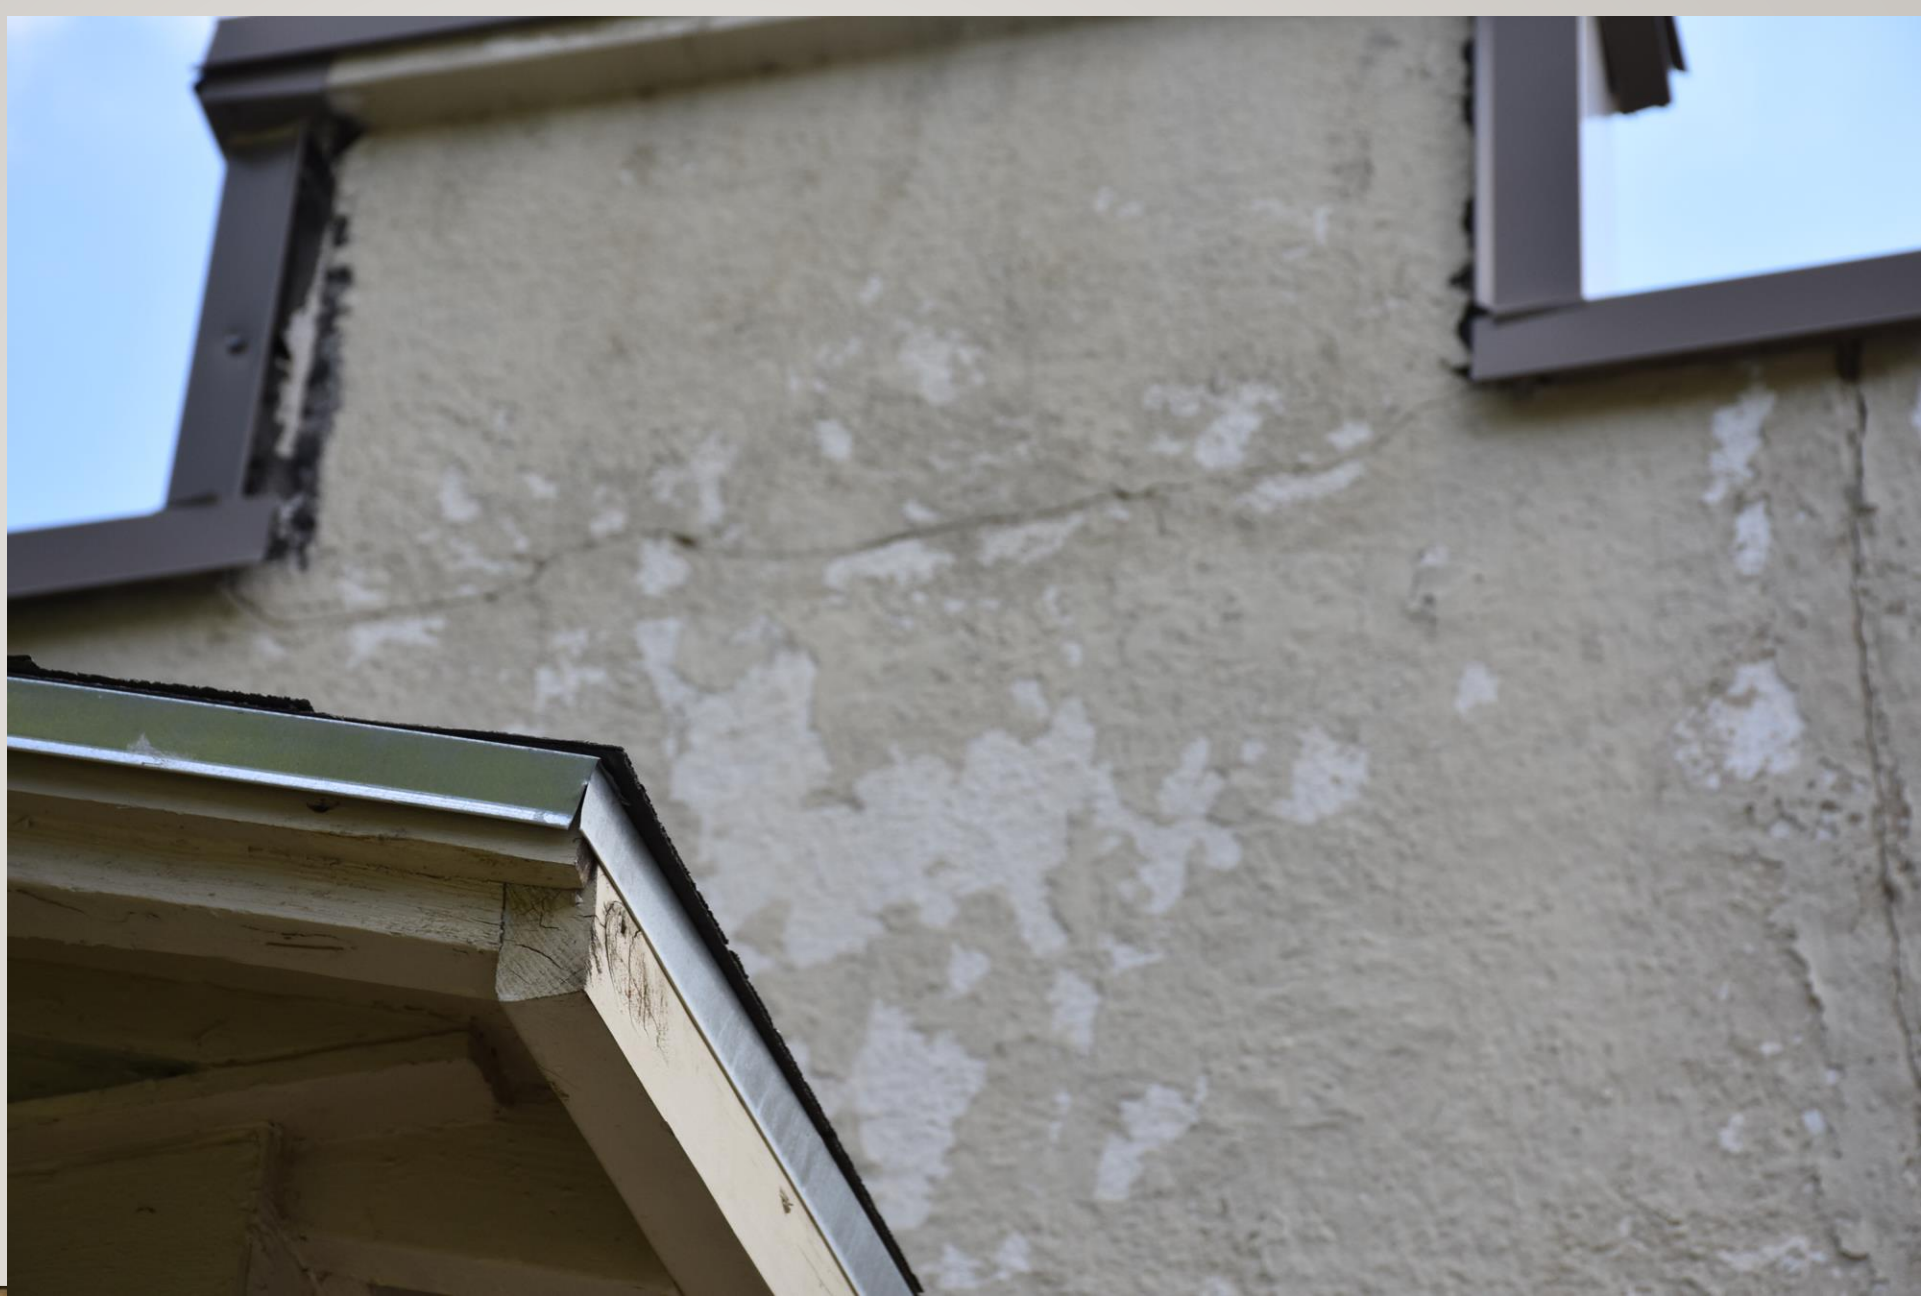
Evidence of water infiltration throughout the cladding indicating a high likelihood of wood deterioration

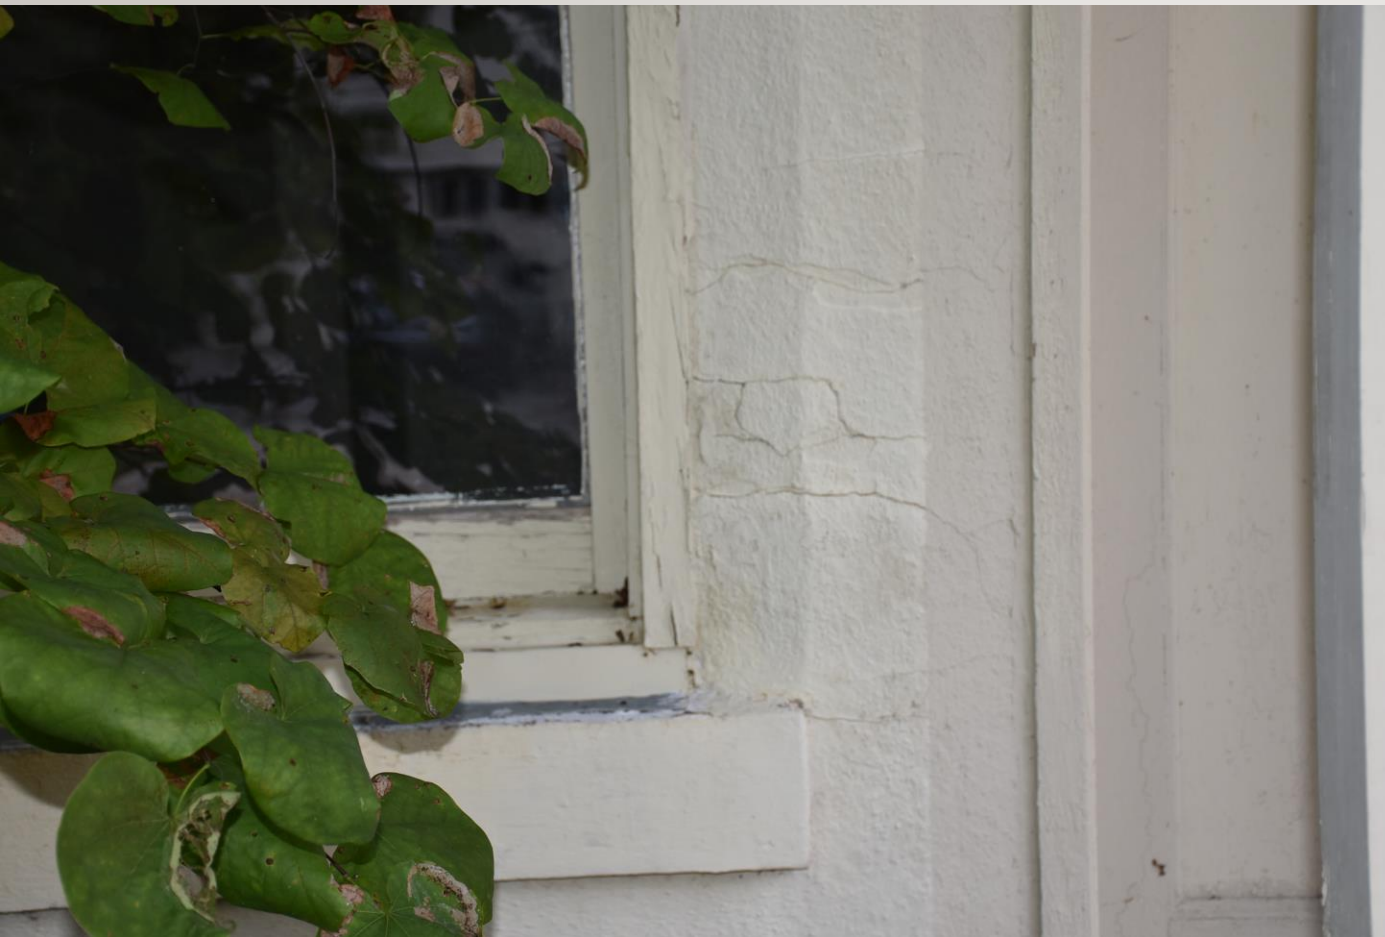
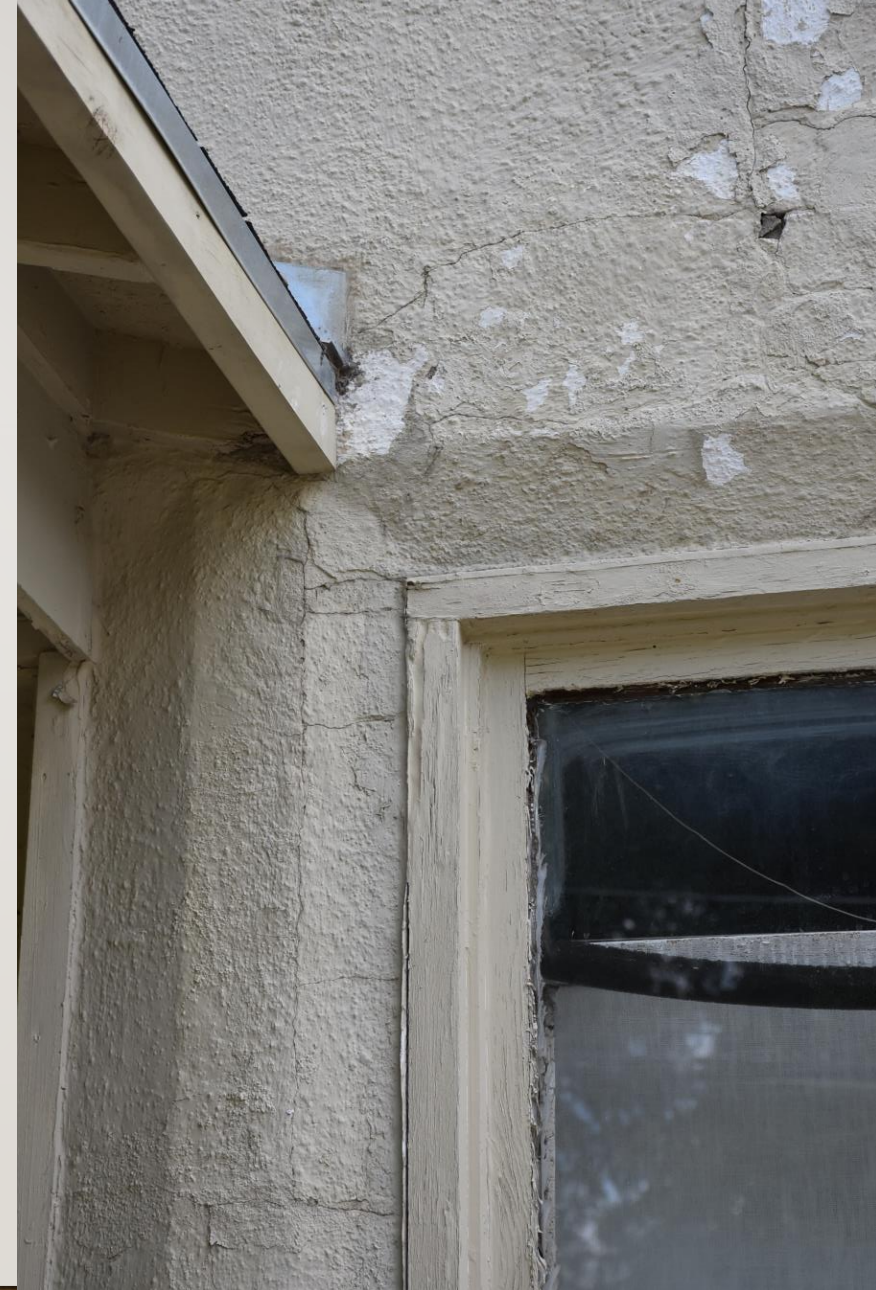
Ponding water and likely
wood framing
deterioration and decay
behind the stucco (red
circles)
