Quotes from Observation Report by ATS Engineers, Inspectors, & Surveyors, February 1st, 2024.
Photos from Cornerstone Architects, February 2nd, 2024.

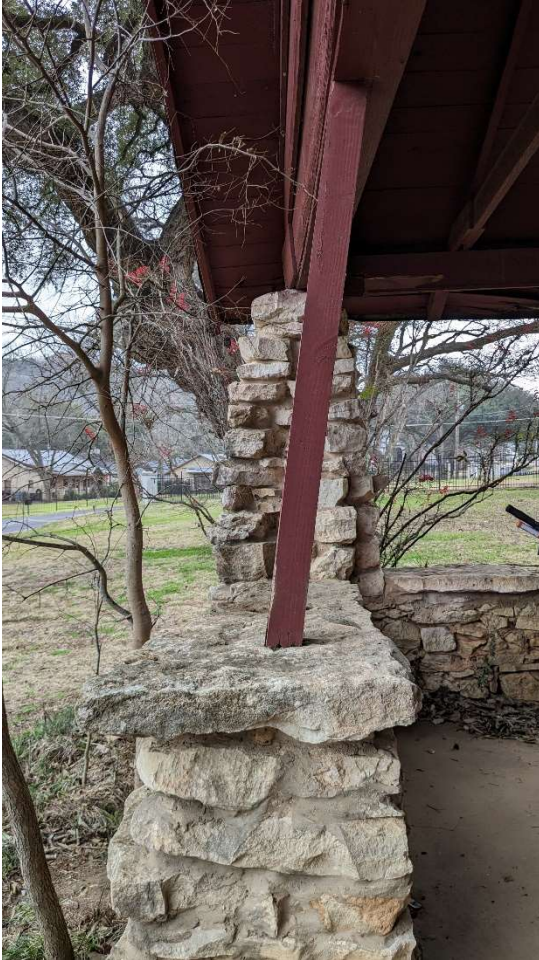
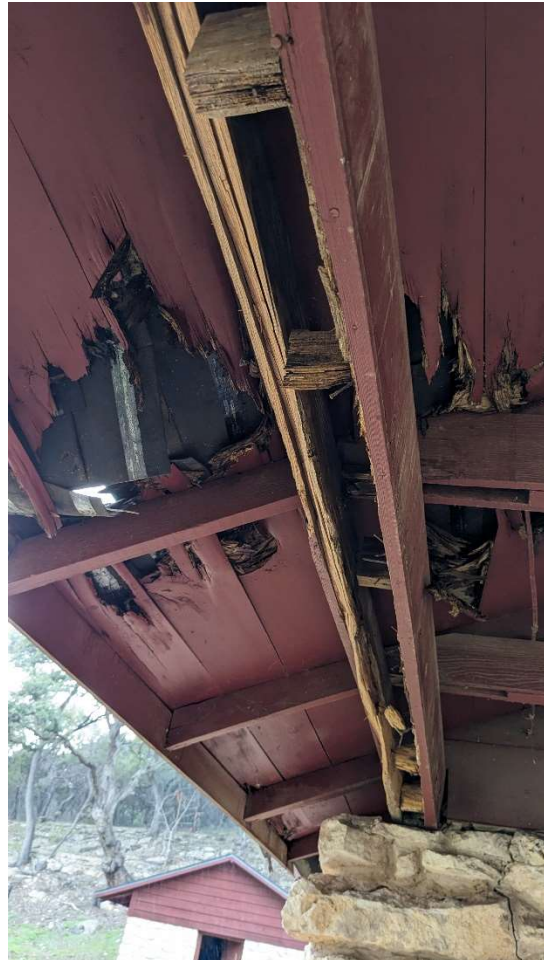
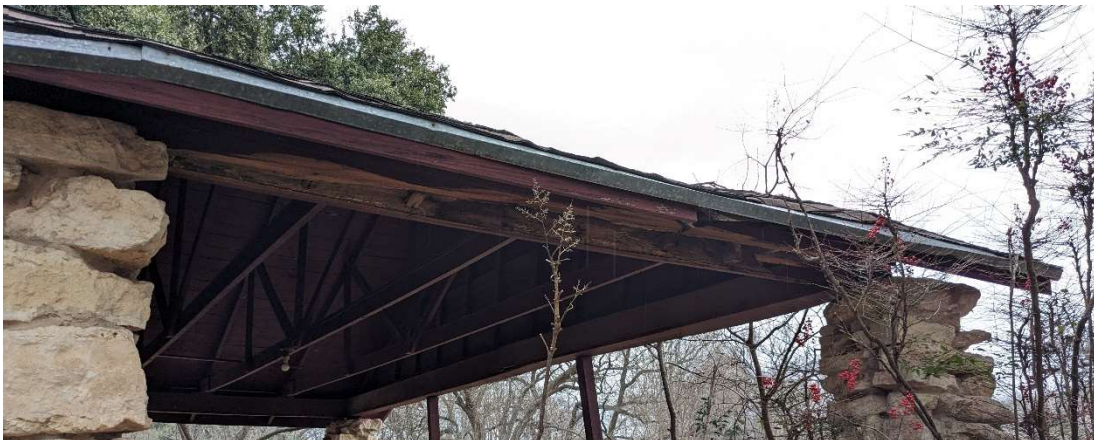
FRONT PORCH - ROOF & FRAMING

"There is a downward and inward curve of the gable framing. The wood columns at the front porch are leaning inward following the curvature of the gable. The columns appear to be undersized. It was noted that the beam supporting the left side of the porch canopy is rotting with portions missing. The roofing at the front left side of the porch is rotted and falling."

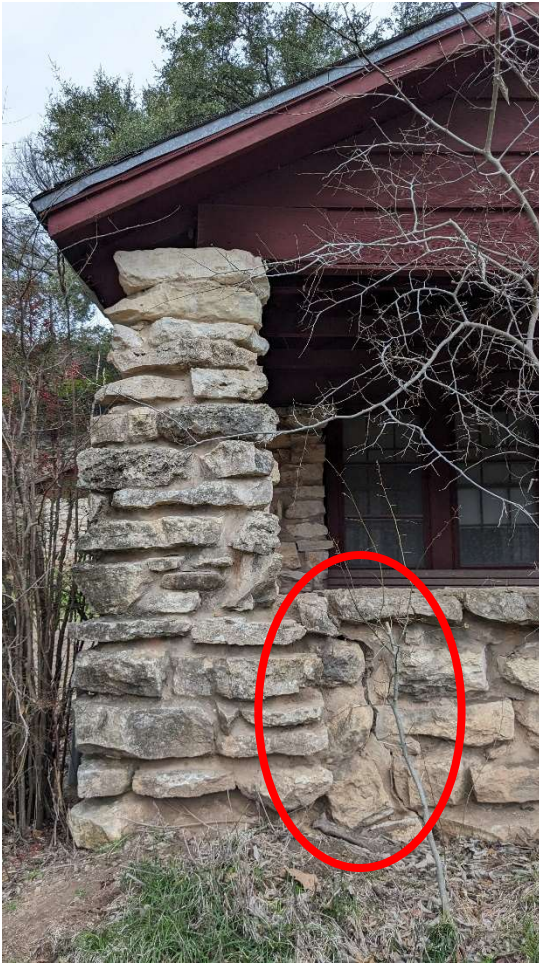
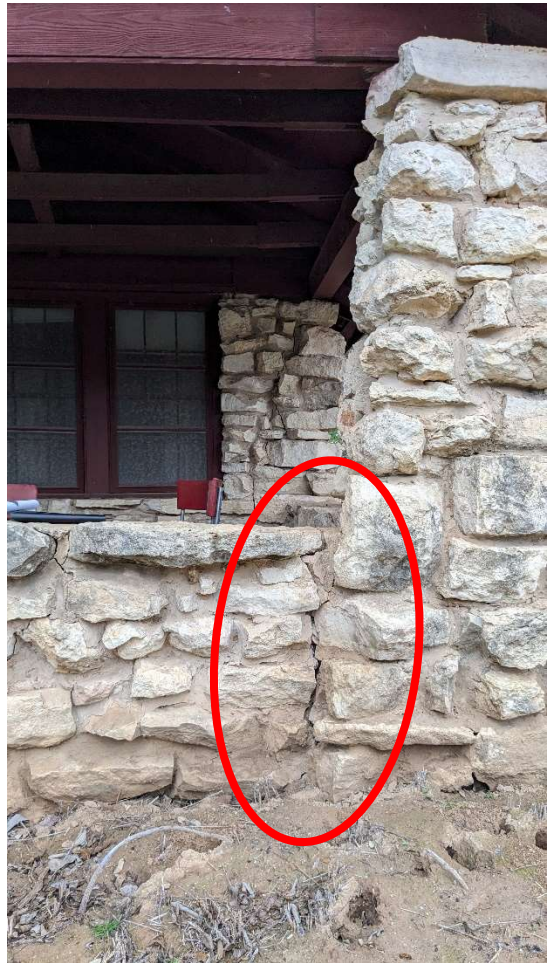
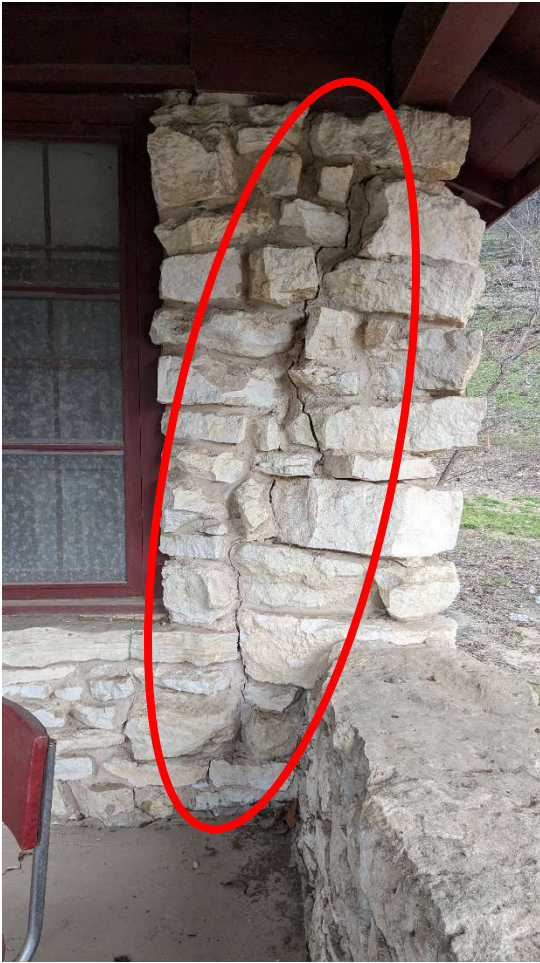
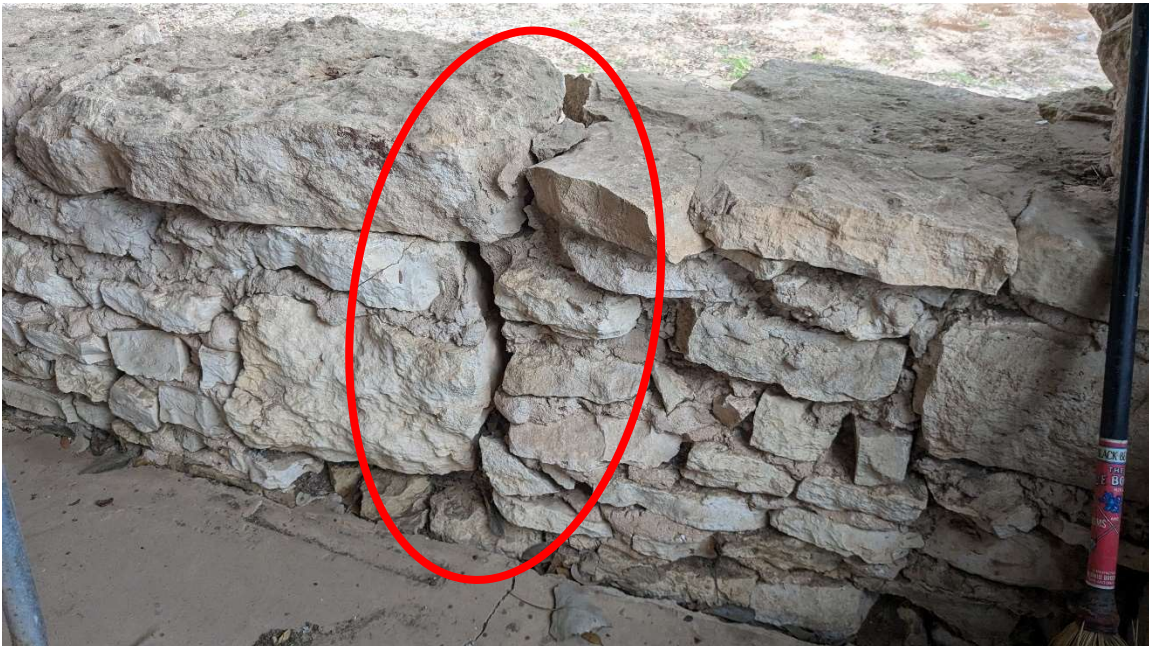
STONework

"Large cracks were noted in the wall along the perimeter of the front porch. It was noted that some cracks were more than 1" wide; for reference cracks greater than 1/8" typically require structural repair. It appears that these wider cracks are partial recurrences of larger cracks (up to 3") that were previously repaired."

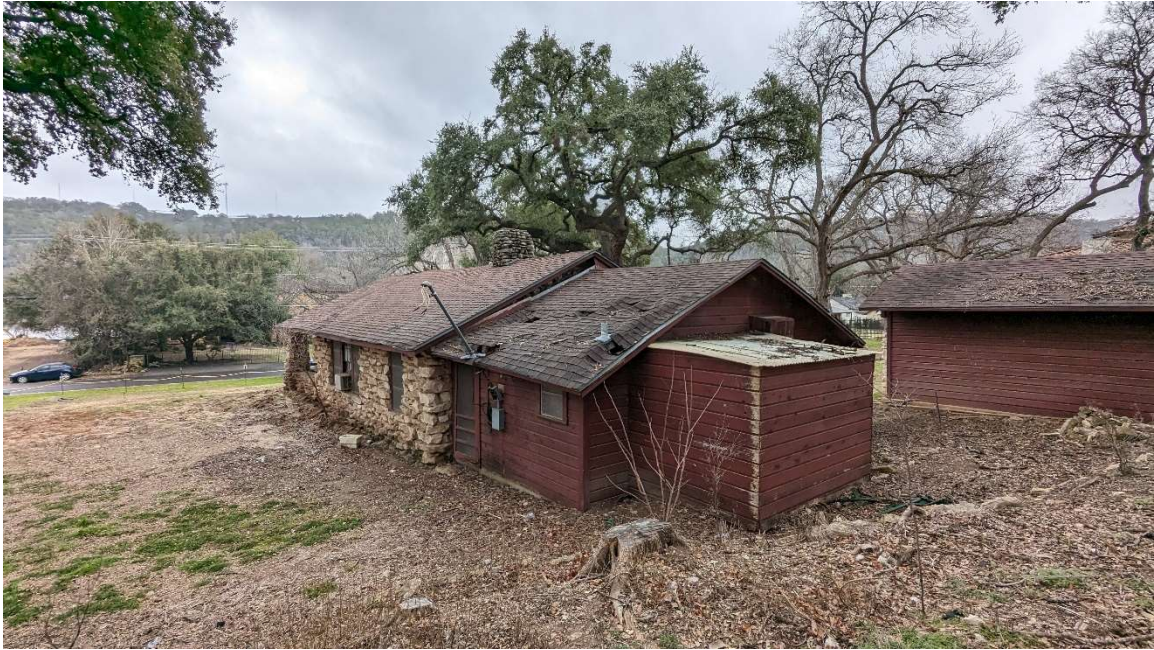
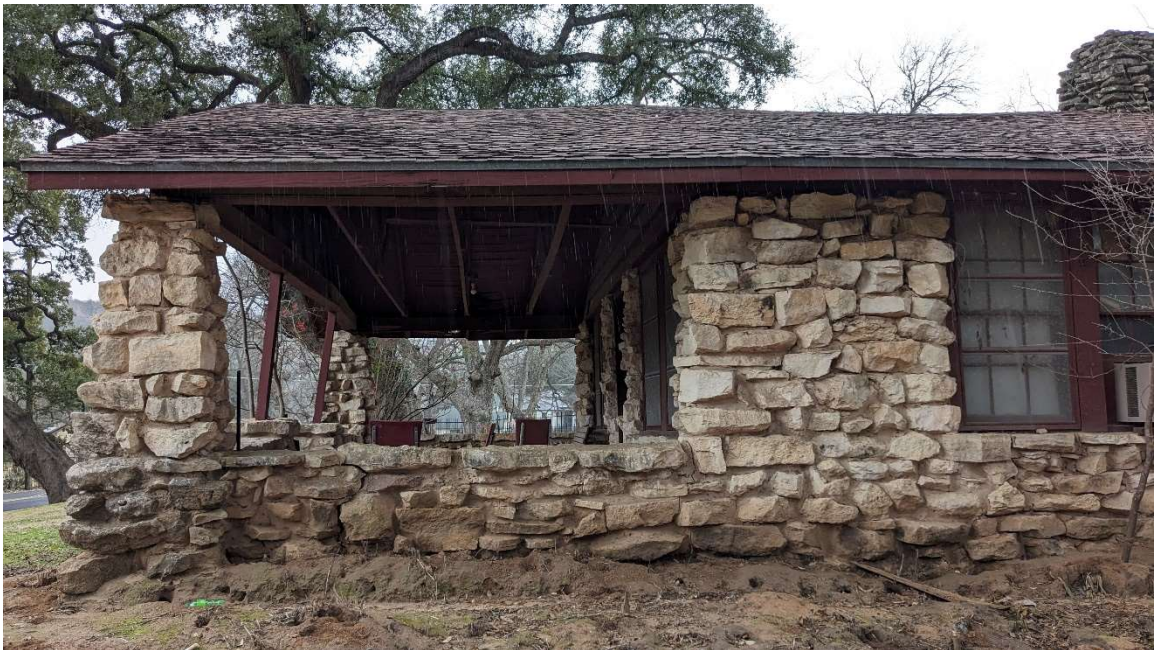
FOUNDATION

"The right side of the house appears to be a clear path for rain runoff... Part of the foundation along the right side and at the front of the entry porch has been undermined by the erosion... It was noted that the backyard drains towards the back of the house... It appears that the result of this is water migration into these areas of the house... The visible portions of the foundation framing of the house have completely deteriorated."

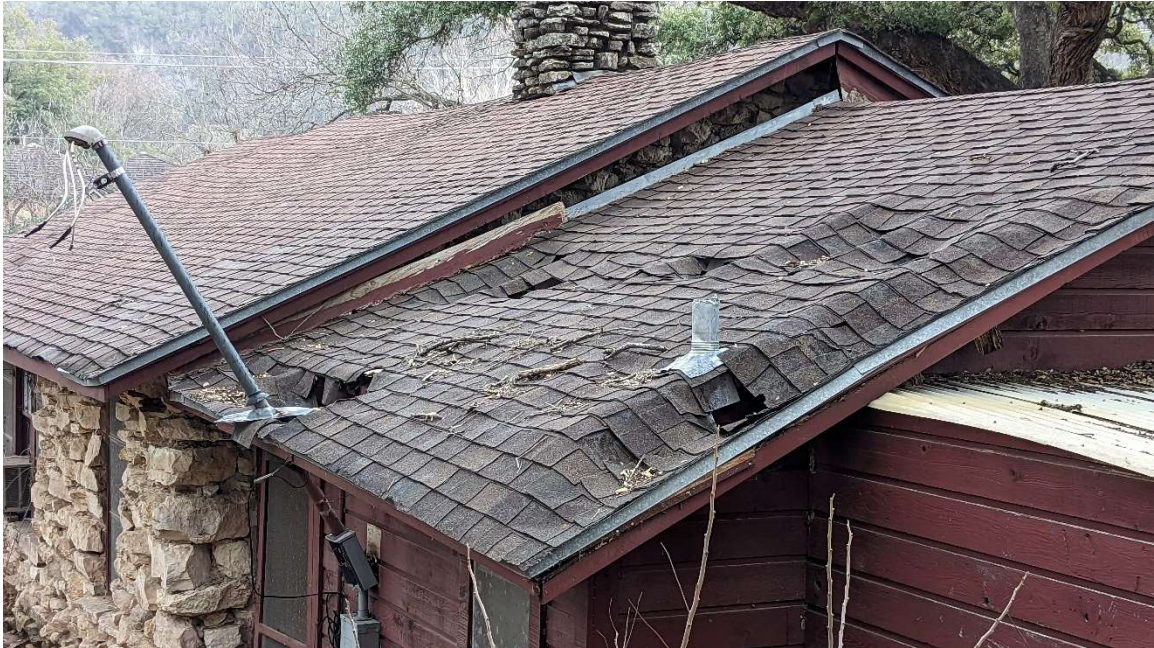
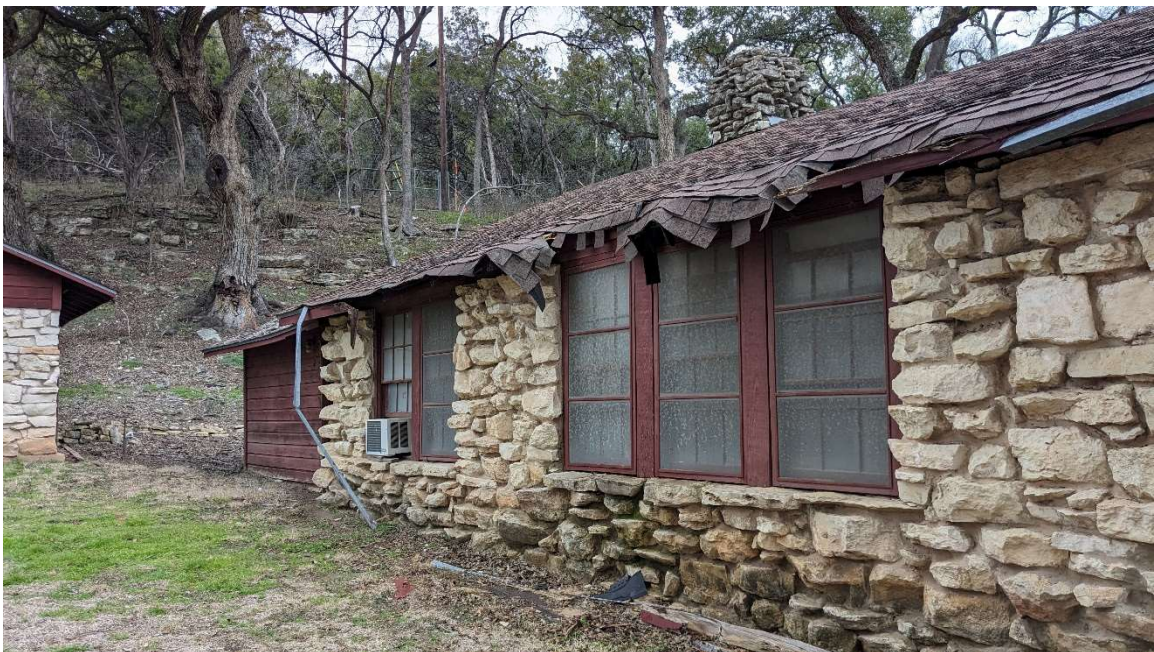
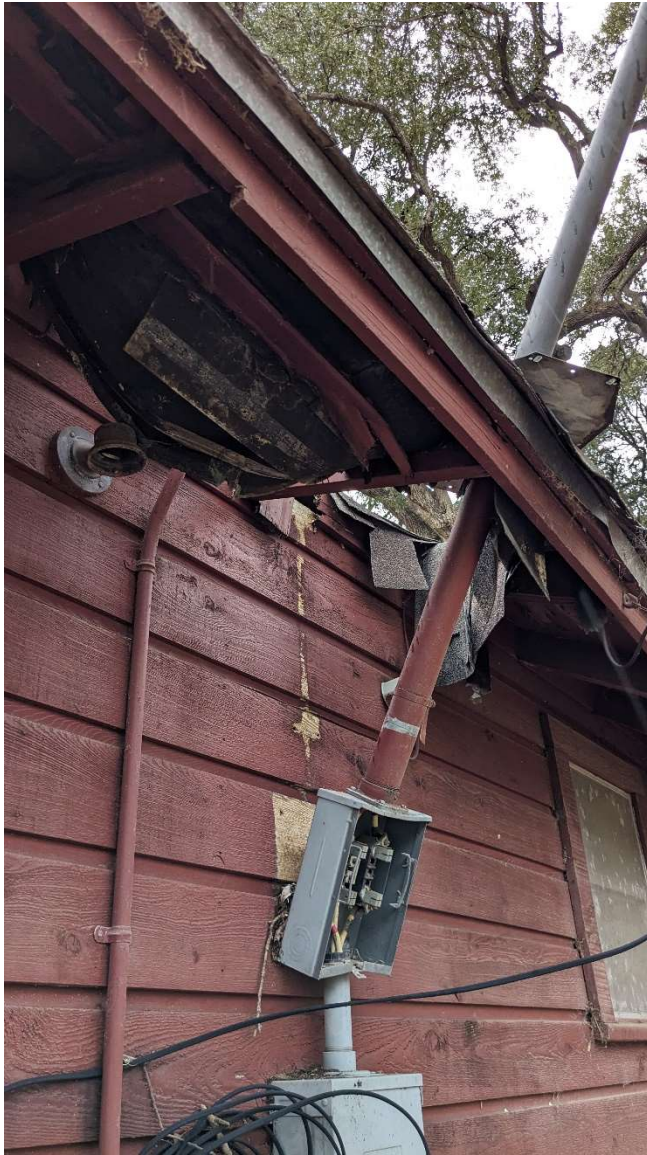
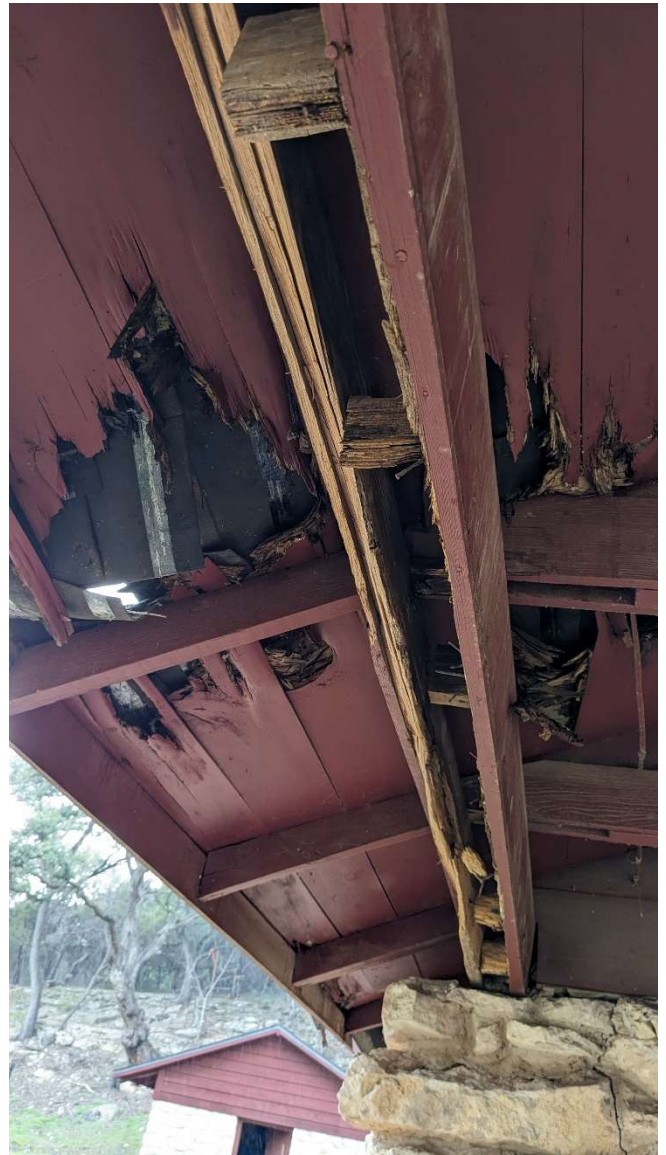
ROOF

“Several holes were noted in the roof. This resulted in wet areas in the house and the rotting of some site-built roof trusses, window headers, and other lumber in the house. It appears that several trusses have been repaired previously... The construction of the roof trusses and the subsequent repairs appear to fall significantly short of acceptable engineering practices. It appears that the roofs of both buildings have begun to collapse.”

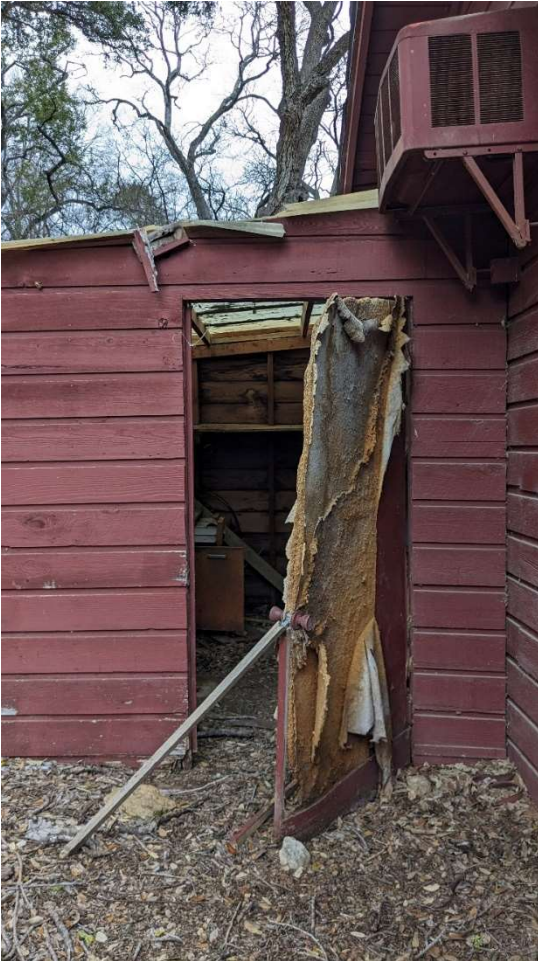
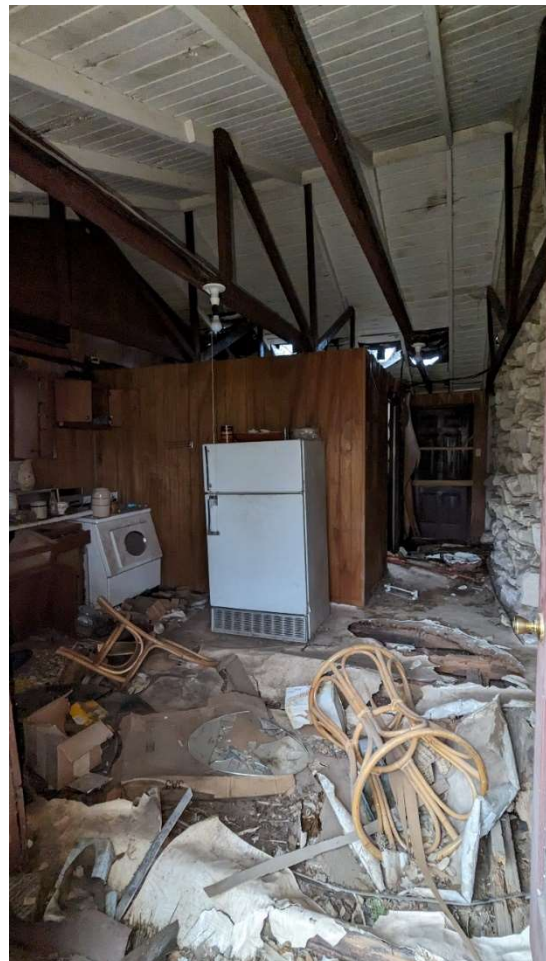
INTERIOR

"In general, the house is open to the elements... The house has an extraordinarily strong smell of mildew... It was also noted that some electrical splices were unprotected.... It was noted that the subfloor of the kitchen and the bathroom, including floor joists and beams, has almost completely rotted away. It was noted that the floor or the bathroom is filled with mildew. It was also noted that the walls were partially covered in mildew... The moisture and smell of the house poses a risk to the health and safety to persons on the property."
