803 RIVER ROAD

TREE/TOPO and AS-BUILT SURVEY

HISTORIC PRESERVATION COMMISSION
05.01.2024

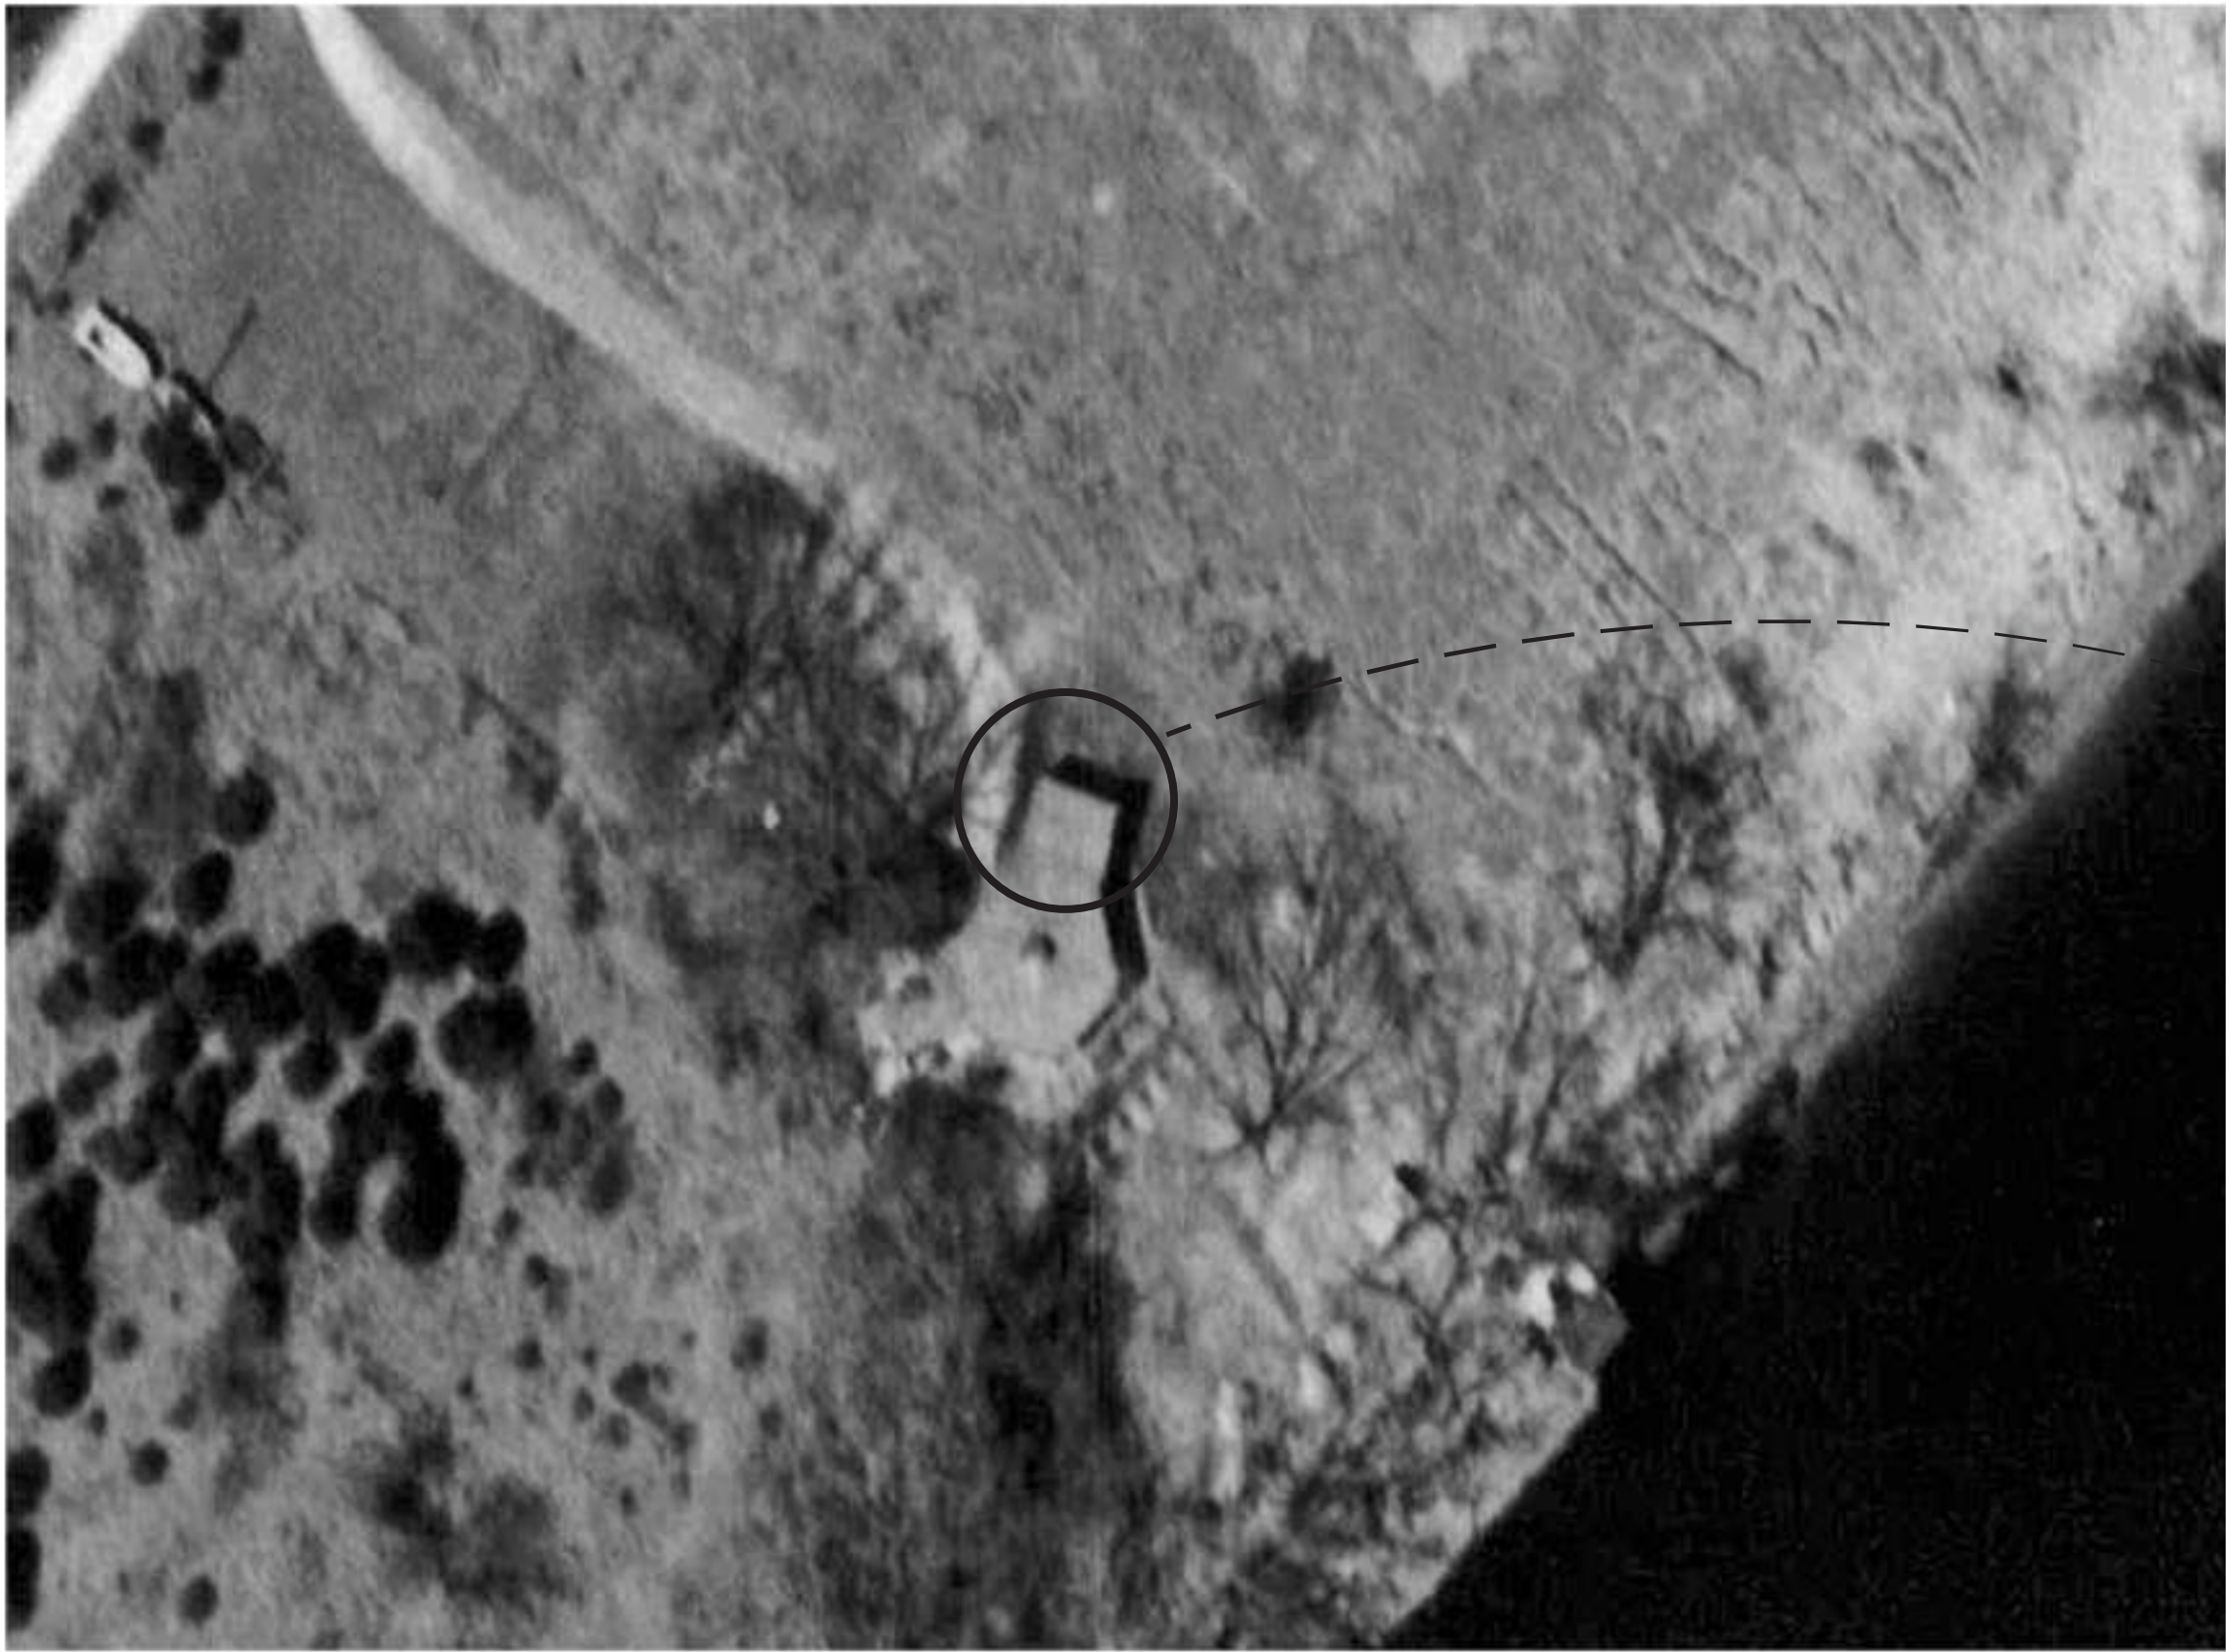
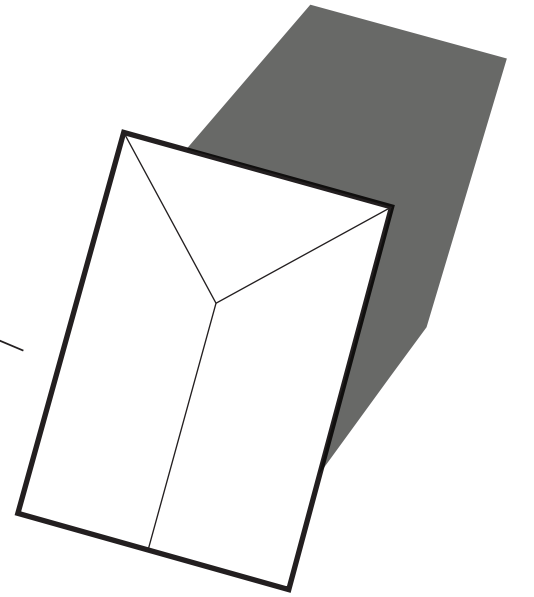
1984 HISTORIC AERIAL (PHOTO TAKEN AT APPROX. 1PM CST)

FLAT ROOF (HIP ROOF)
SHADOW PATTERN

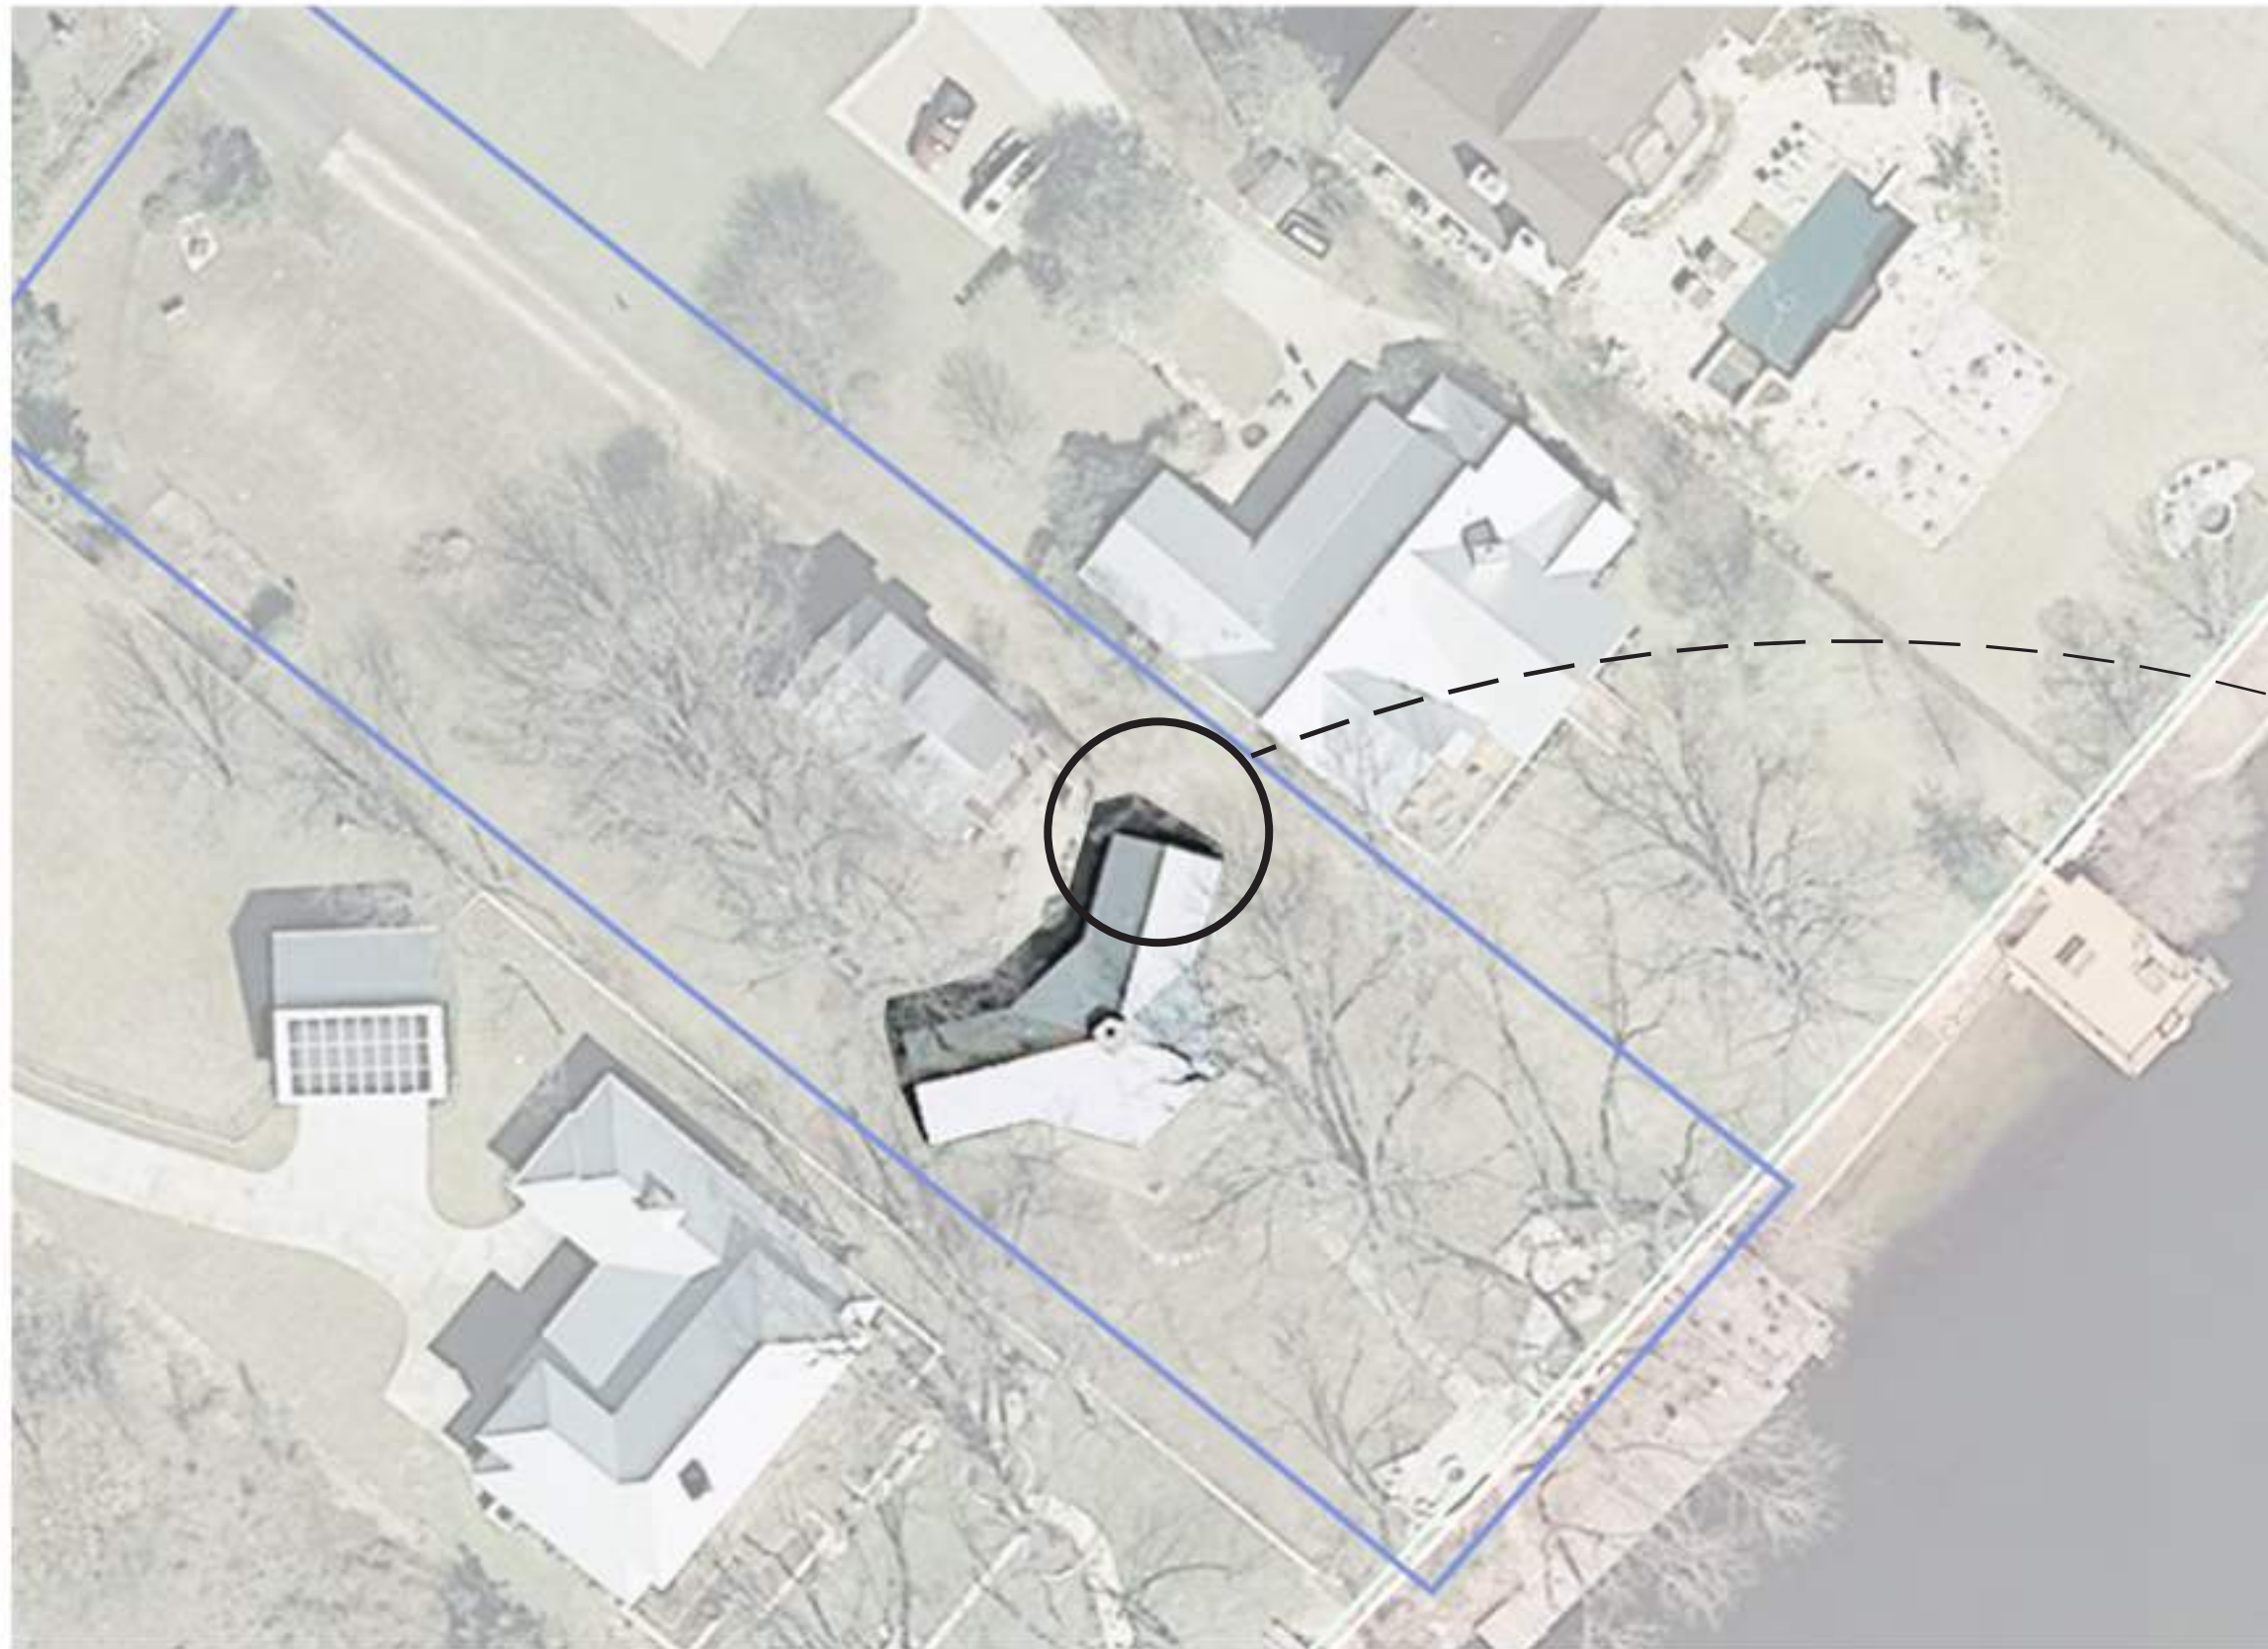
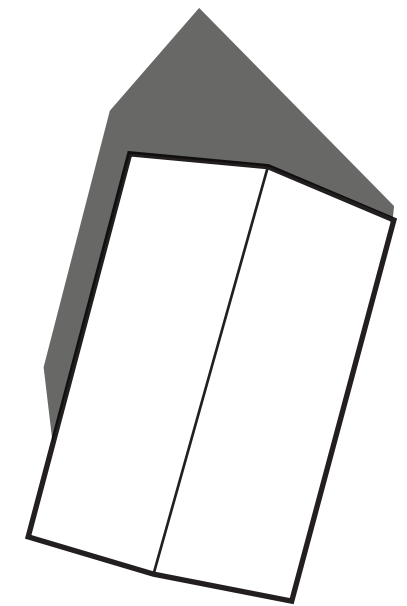
2009 HISTORIC AERIAL (PHOTO TAKEN AT APPROX. 12PM CST)

GABLE ROOF
SHADOW PATTERN

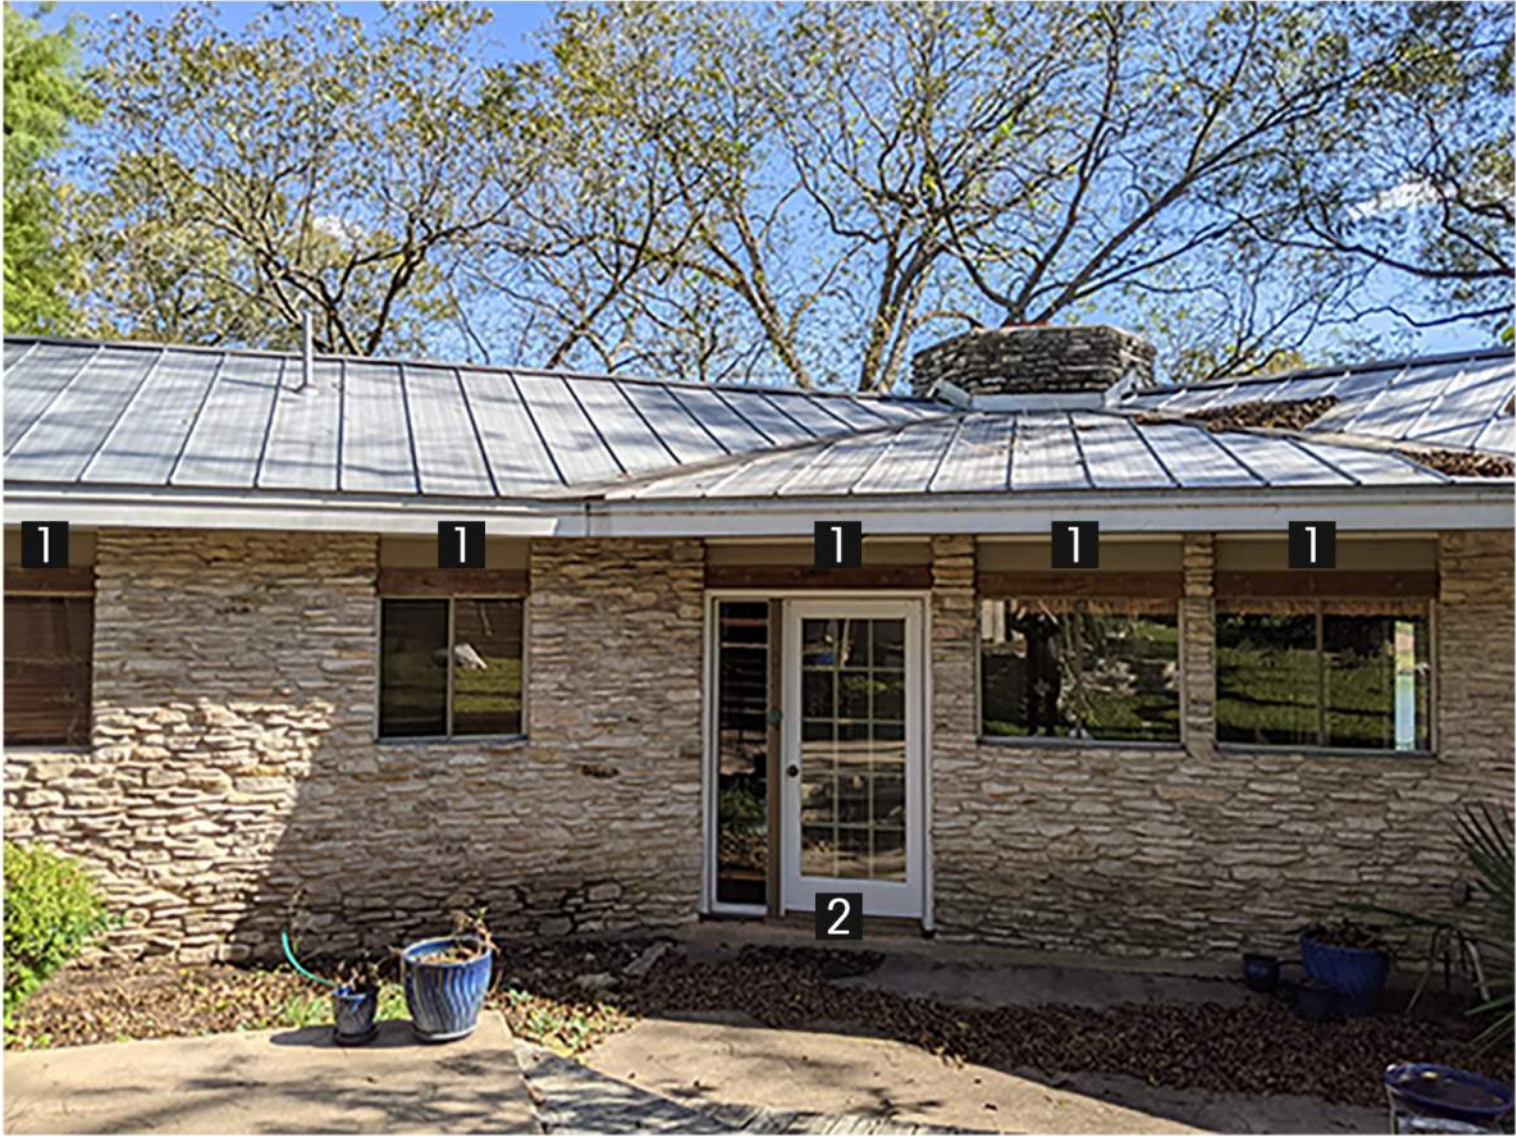
FRONT ENTRY / ELEVATION (MAIN STRUCTURE)

- 1 Non-structural applied 'wood headers'.
- 2 Non-original front door with applied window grid is not consistent with mid-century fenestration design.

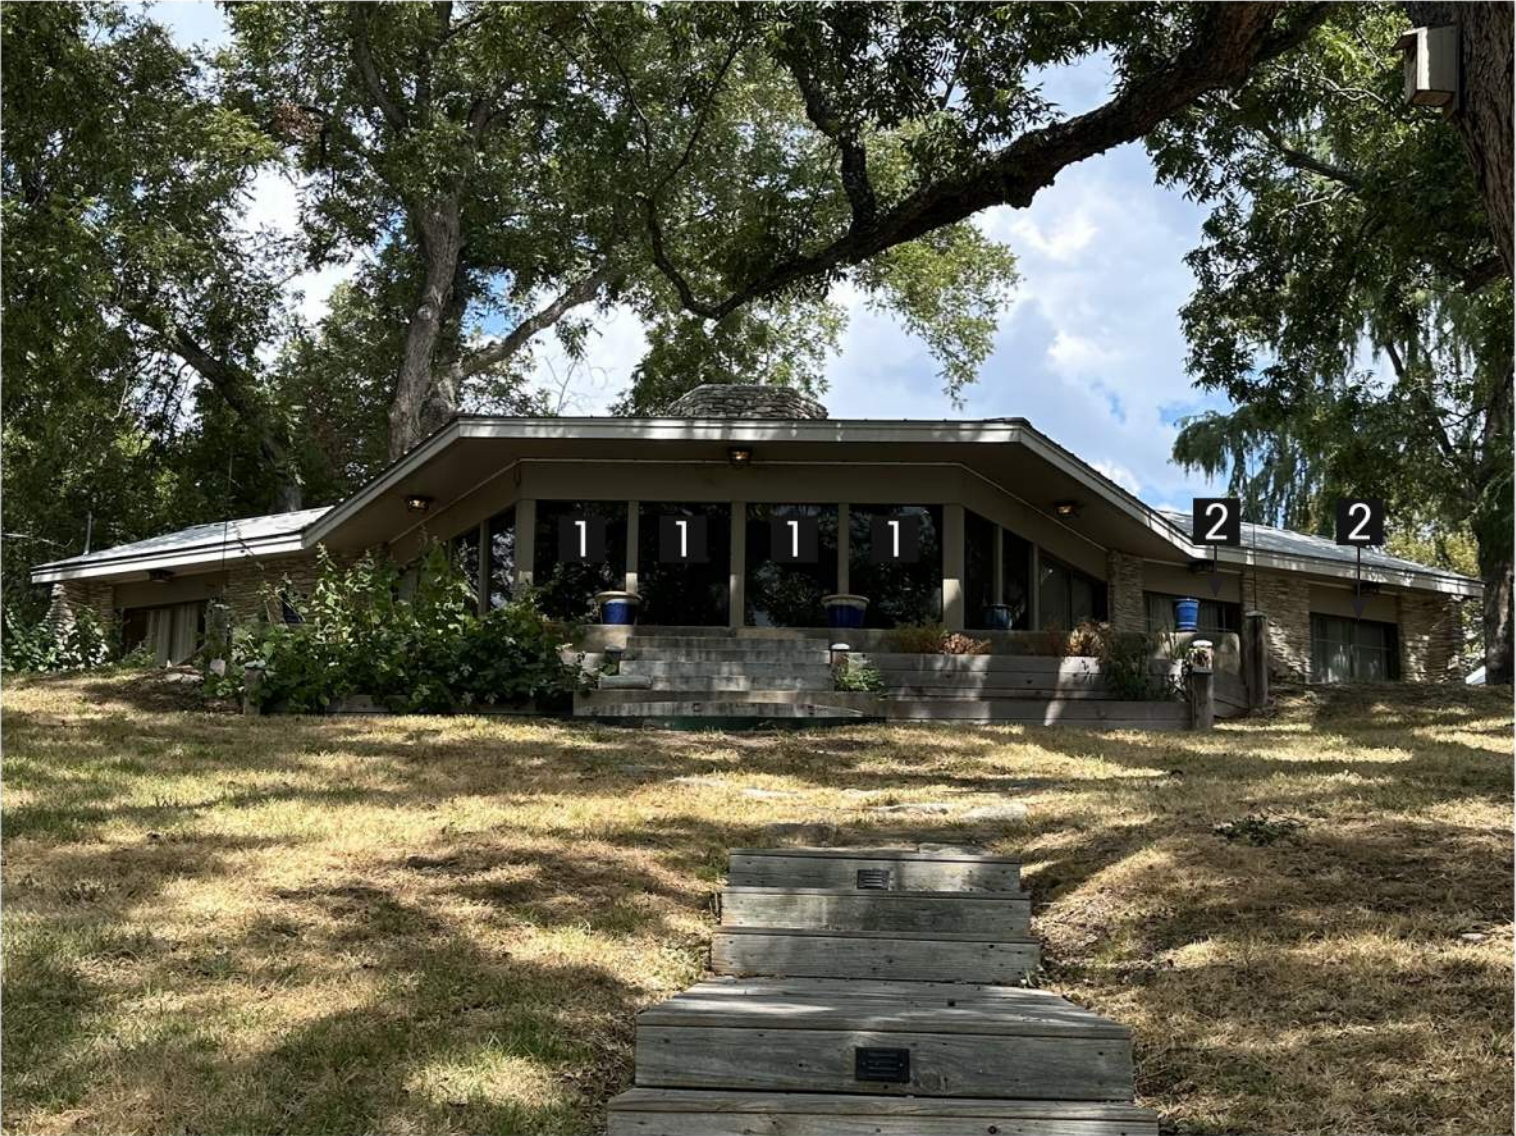
REAR ELEVATION (MAIN STRUCTURE)

- 1 Acrylic windows are not believed to be original, typ. across facade.
- 2 Applied window grids are not consistent with mid-century fenestration design.

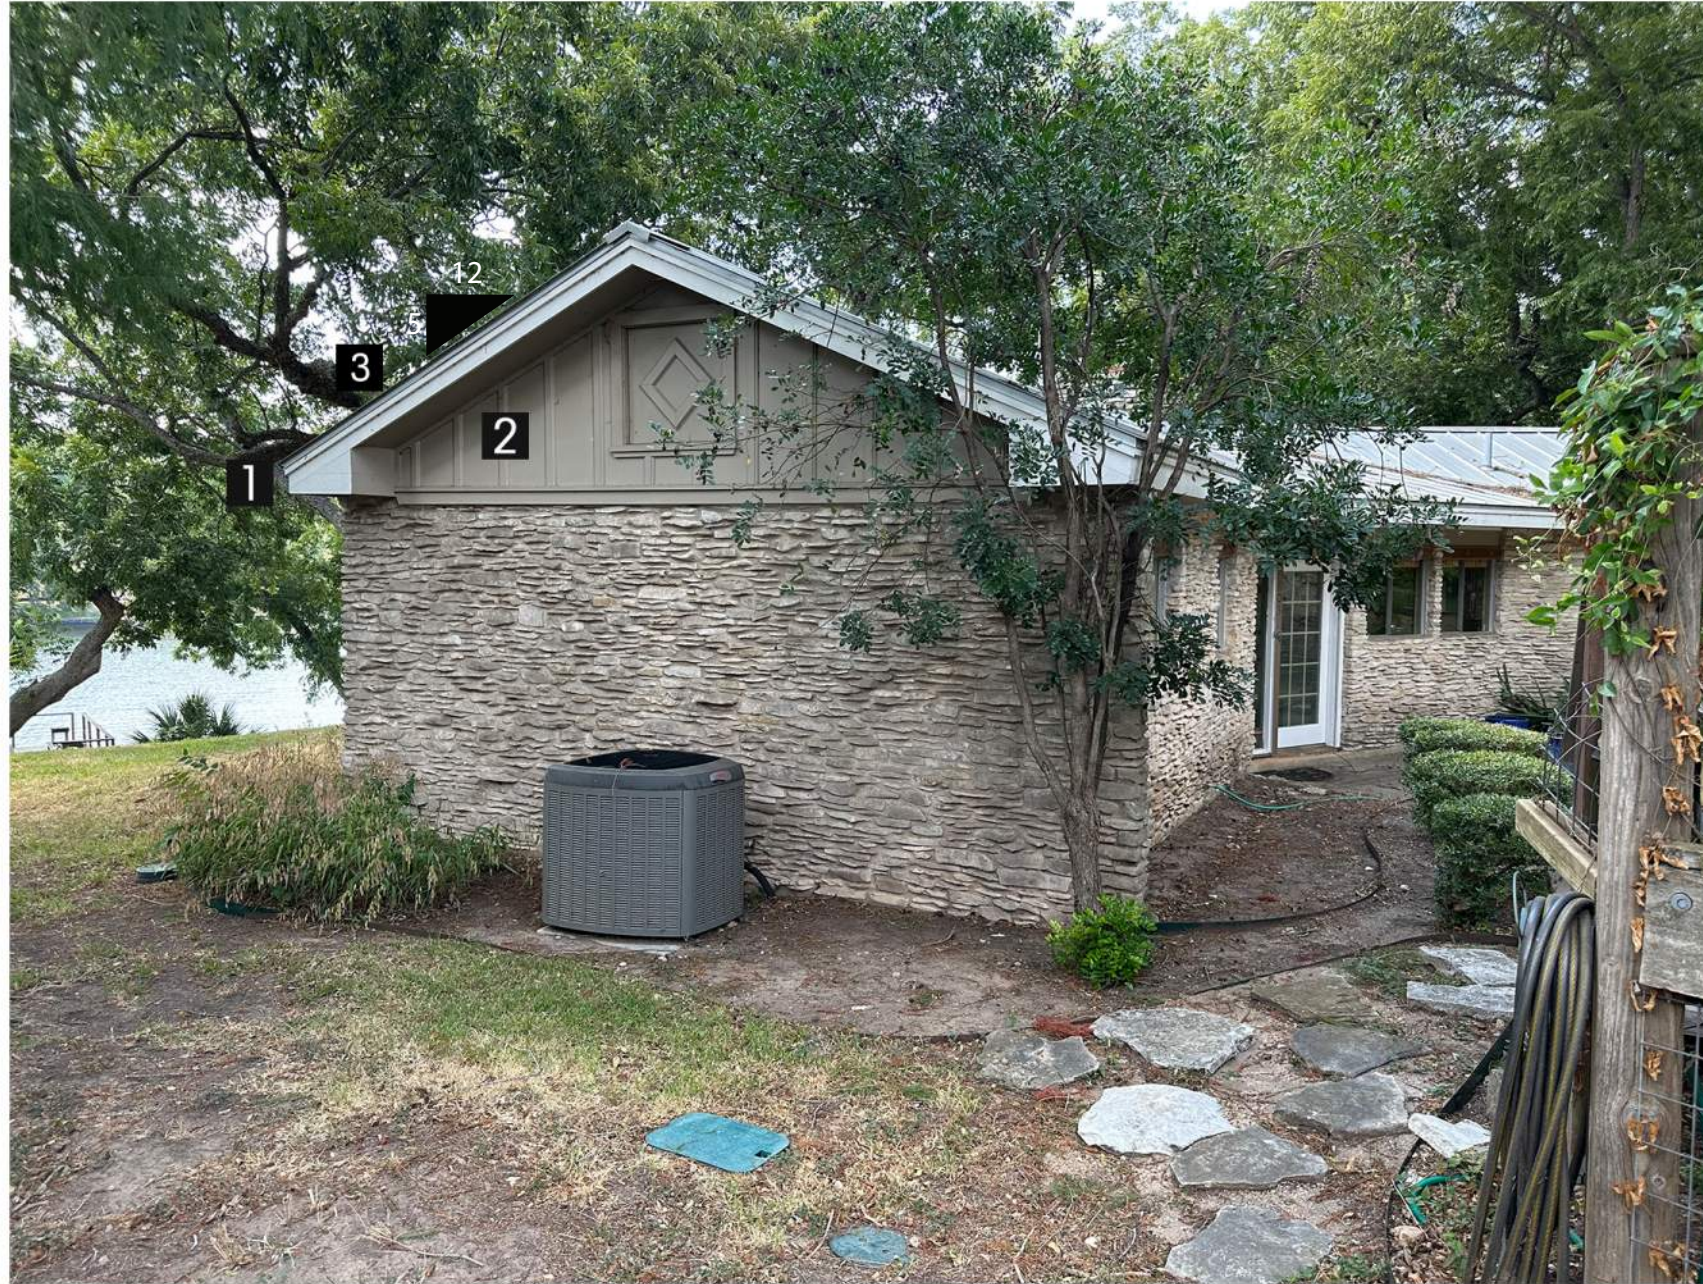
SIDE (NORTH) ELEVATION (MAIN STRUCTURE)

- 1** Box-End Fascias are not consistent with mid-century design detailing.
- 2** Rustic wood siding and applied ornamentation at gable ends is not believed to be original and was likely added at the same time as the gable roof.
- 3** 5/12 roof pitch is not consistent with mid-century design detailing.

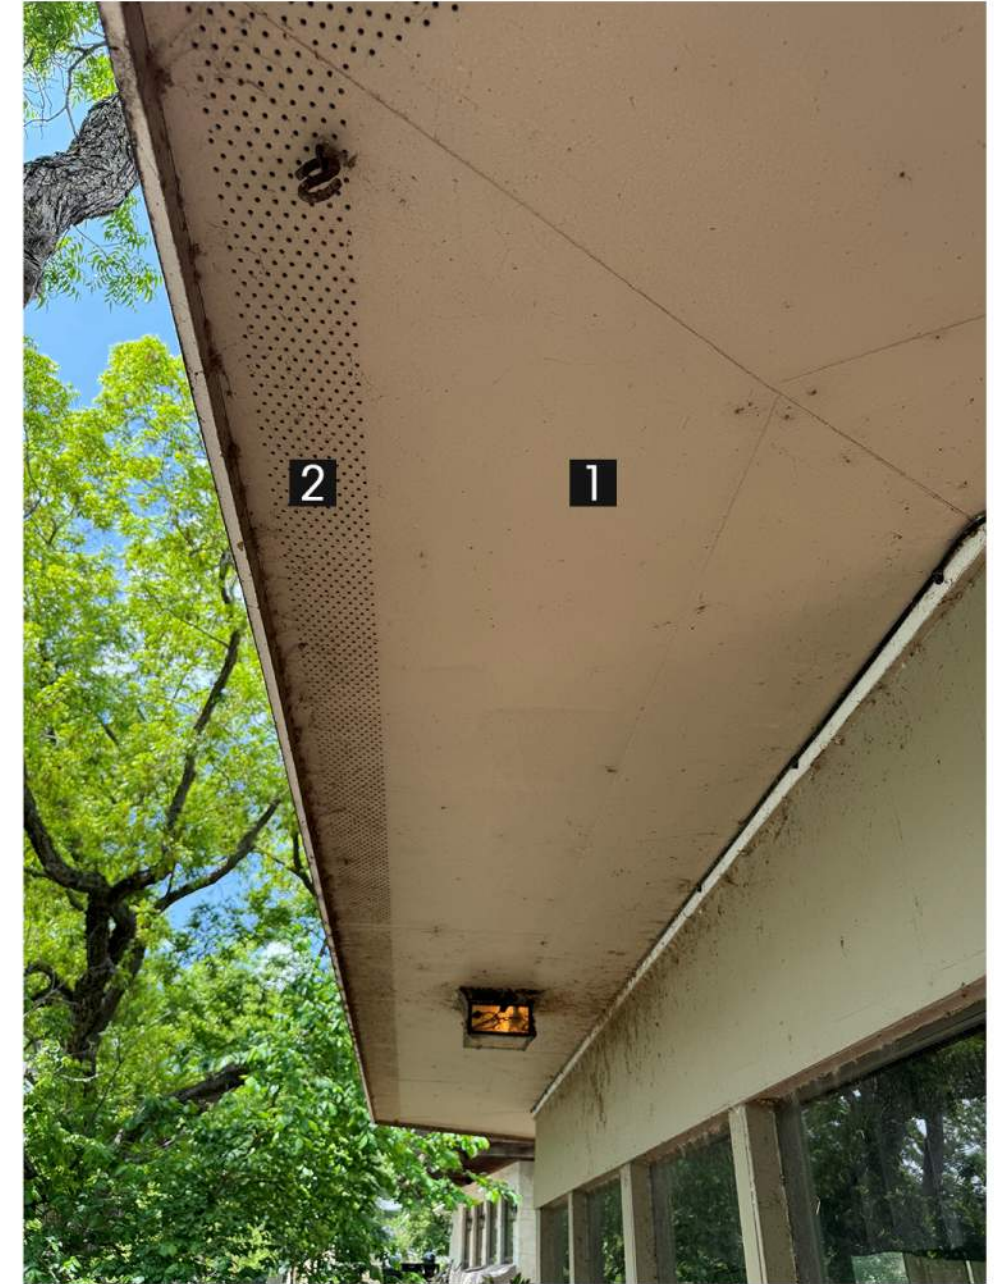
CONTINUOUS FIBER CEMENT SOFFITS

- 1** Fiber Cement Soffits are not original. This building material was not used until the mid-1980s.
- 2** Continuous perforated soffit vents are not original and were not used prior to the 1970s.
