1611 WETHERSFIELD

**1611 WETHERSFIELD, AUSTIN TEXAS 78703**  
**NEW CONSTRUCTION / ADDITION SUBMITTAL**

# AUSTIN PROPERTY INSPECTIONS, PLLC

1611 Wethersfield Rd  
Austin, TX 78703

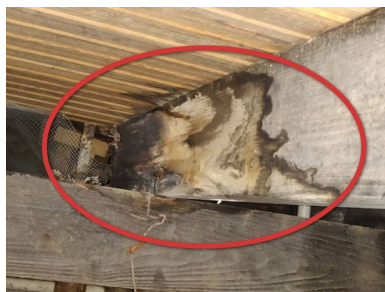
Previous water leaks.

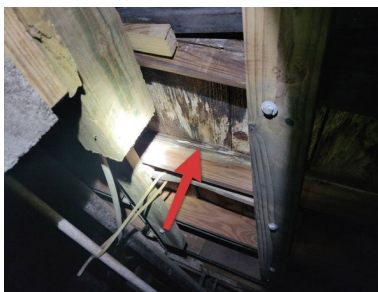
Previous water leaks.

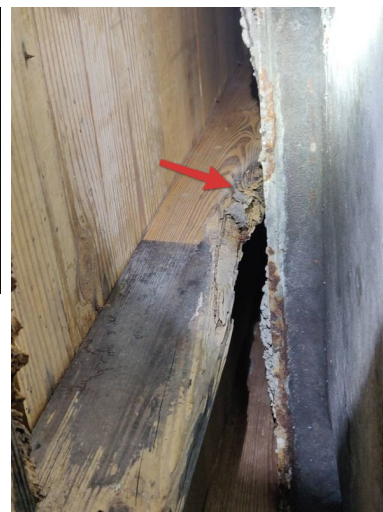
Wall stud - termite damage.

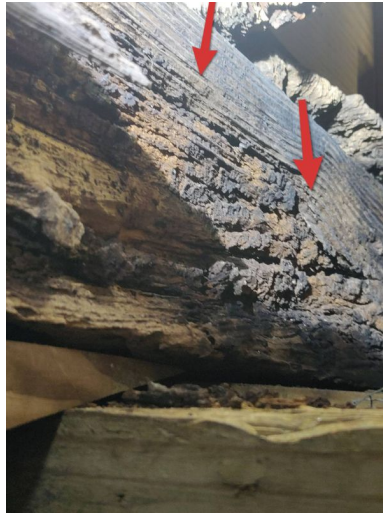
Beam - termite damage.

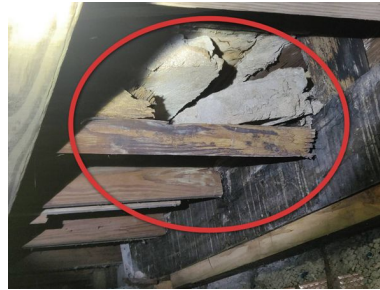
Right side - damage.

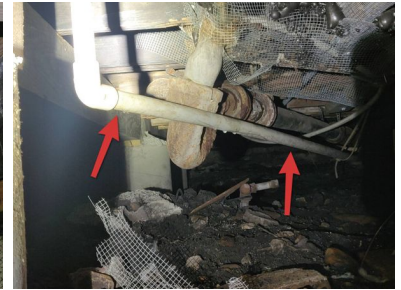
Exposed water supply line.

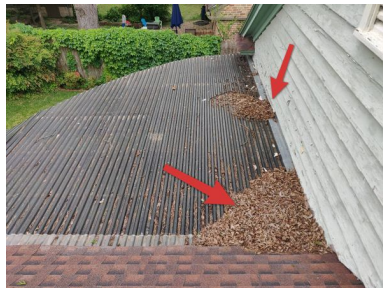
Back - debris.

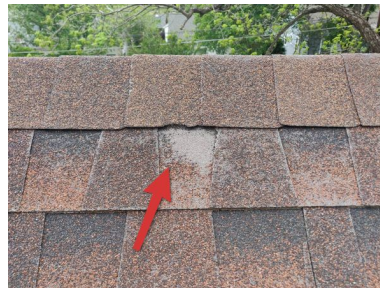
Front - damaged shingle.

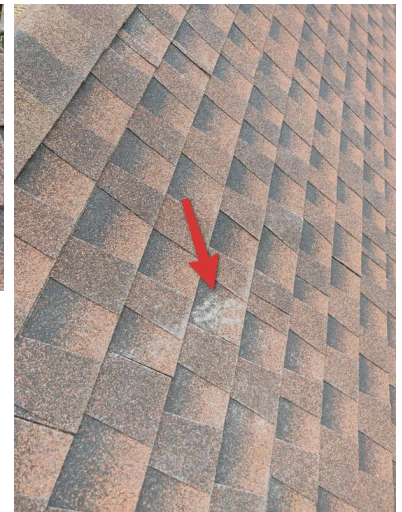
Front - granule loss.

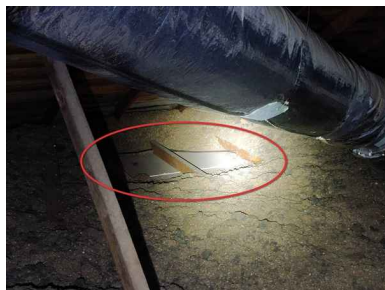
Attic 1 - missing insulation.

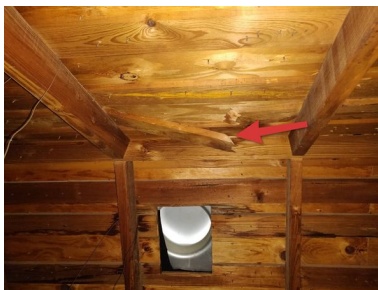
Attic 1 - roof decking - damage.

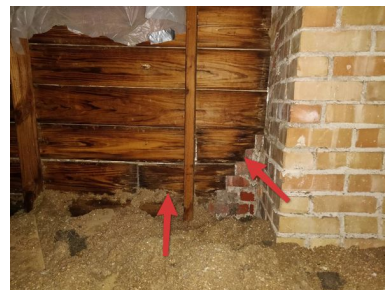
Attic 1, left side - previous water leaks.

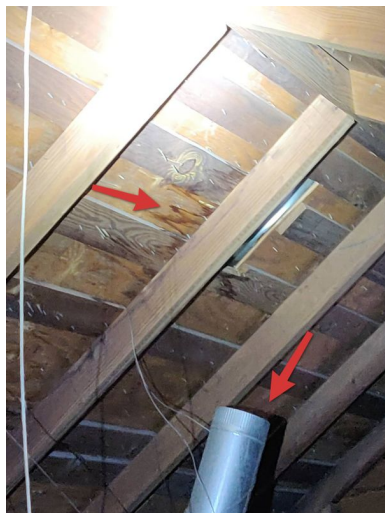
Attic 1 - previous water leaks and range hood exhaust vent.

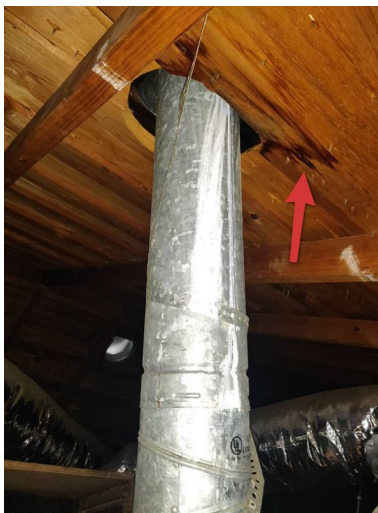
Attic 1 - previous water leaks.

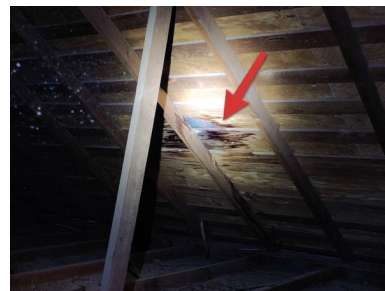
Attic 1 - previous water leaks.

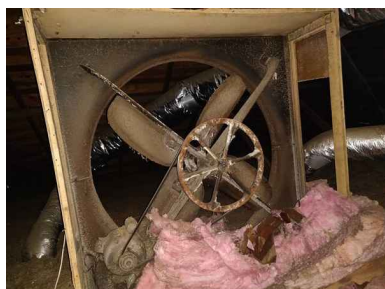
Attic 1 - old fan/ventilator.

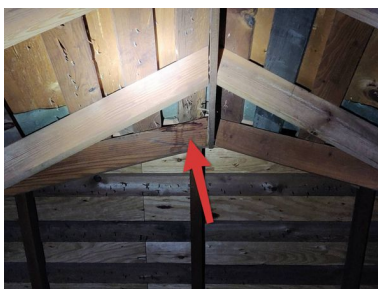
Attic 1, - previous water leaks.

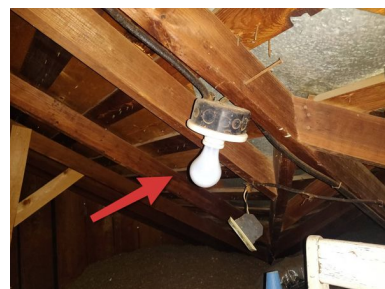
Attic 2, service light - inoperable.

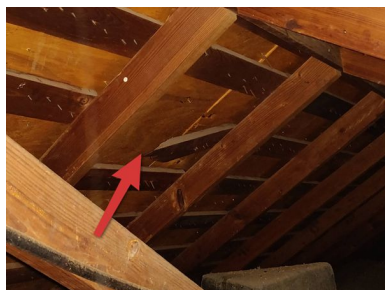
Attic 2, roof decking - damage.

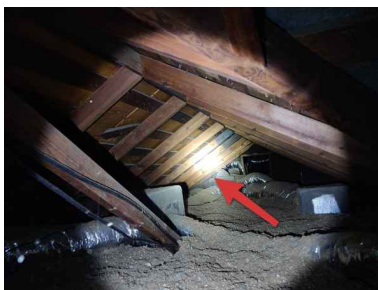
Attic 2 - missing purlin brazing.

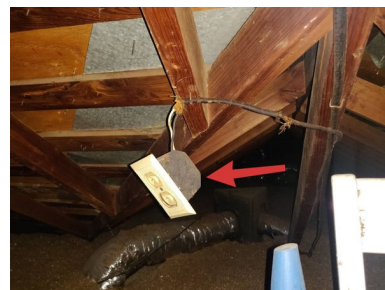
Attic 2 - unsecured outlet.

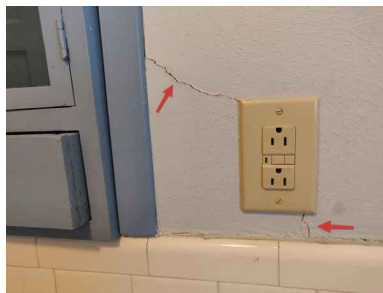
Bathroom - drywall crack.

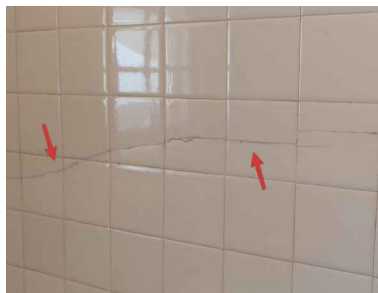
Bathroom - tile crack.

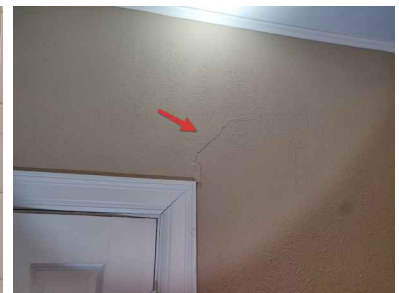
Living room - drywall crack.

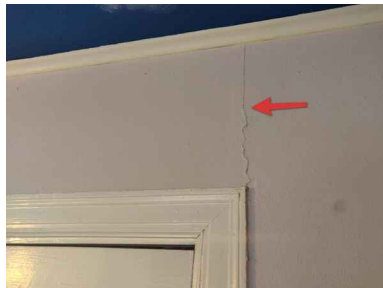
Left side hallway - drywall crack.

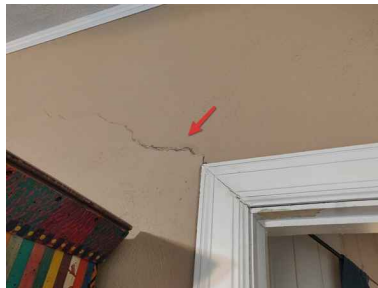
Living room - drywall crack.

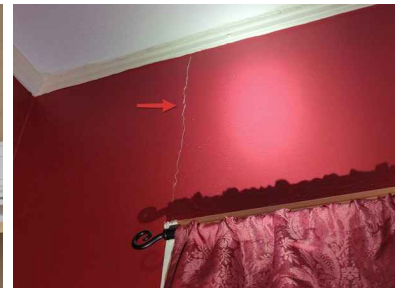
Front right bedroom - drywall crack.

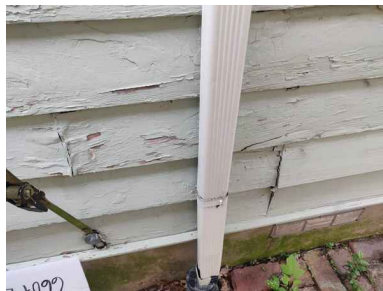
Right side - deteriorated siding.

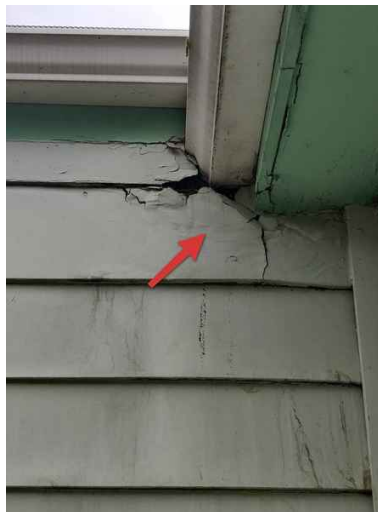
Left side - water damage.

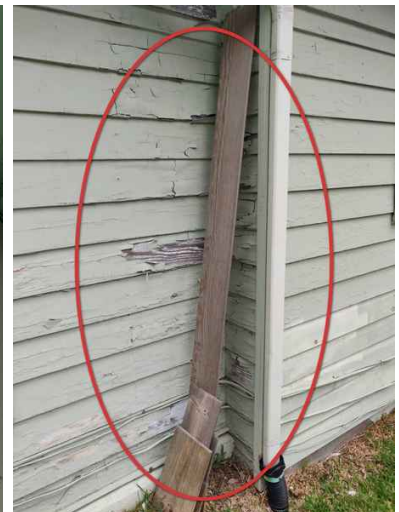
Left side - deteriorated siding.

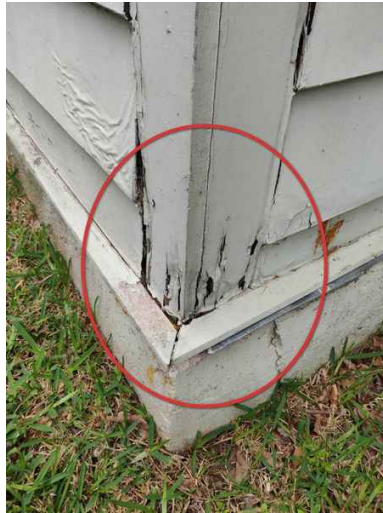
Left side - water damage.

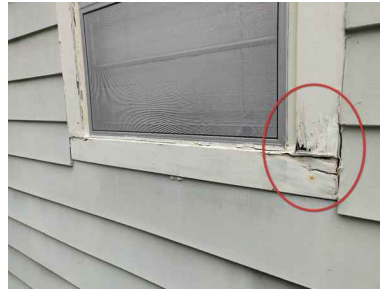
Right side - water damage.

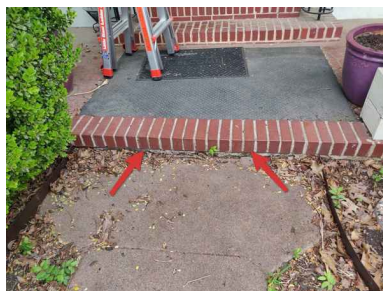
Front - loose step.

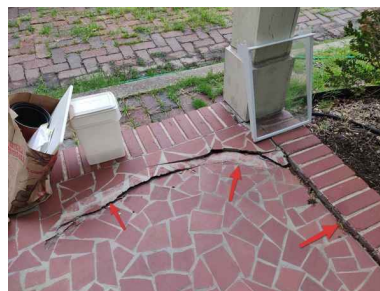
Front porch floor - crack.

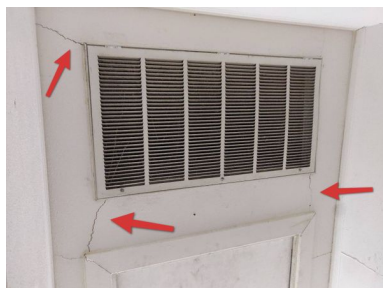
Hallway - drywall cracks.

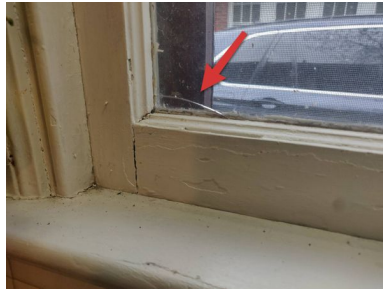
Kitchen window - broken glass pane.

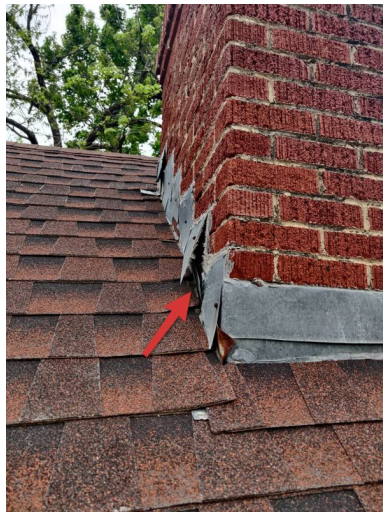
- The chimney flashing is loose at various locations.

Chimney flashing - loose.

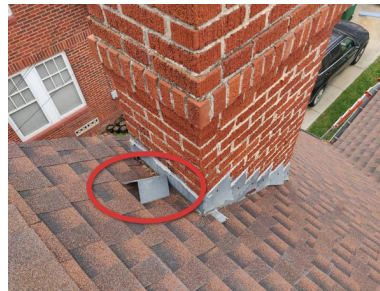
Chimney - loose flashing.

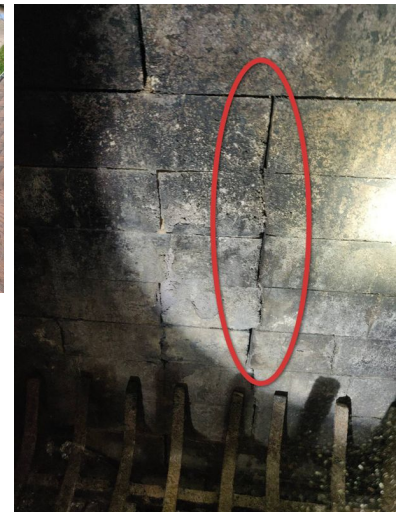
Firebox - gaps.

- Recommend sealing the gaps inside the firebox.

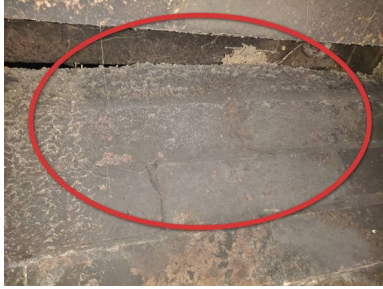
- There is creosote build-up at the chimney flue. It should be cleaned.

Fireplace flue - dirty.

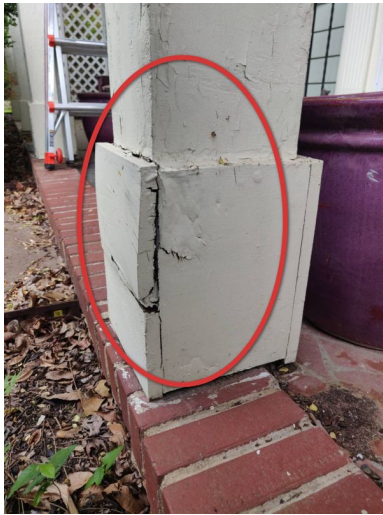
- The front porch columns have water damage at the bottom.

Front porch column - water damage.

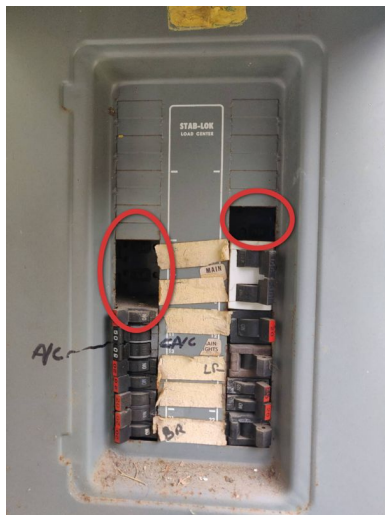
- There are missing knockouts. Shocking hazard.

Main electrical panel - missing knockouts.

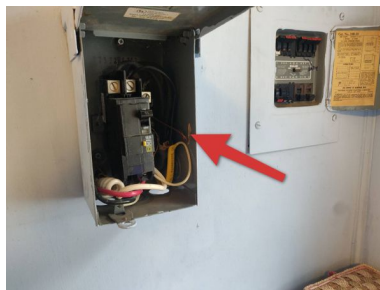
- The left panel is not properly secured. The cover is missing.

Laundry room, electrical sub-panel - missing cover.

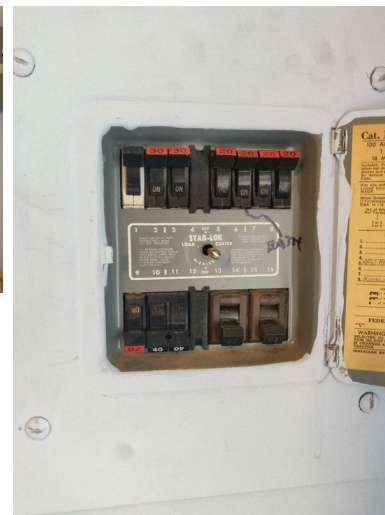
- The electrical panel and breakers are Federal Pacific Stab-Lok brand (FPE). Federal Pacific Stab-Lok panels and breakers have been known to be defective. Recommend further investigation into Federal Pacific Stab-Lok at the Consumer Product Safety Commission. Recommend further evaluation by a licensed electrician and that necessary repairs be done.

Laundry room, electrical sub-panel - FPE Stab-Lock.

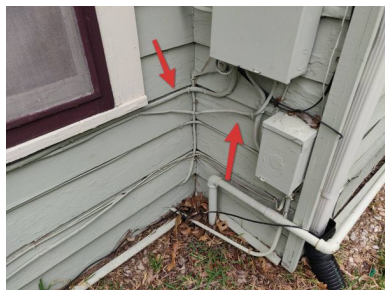
Left side - exposed wiring.

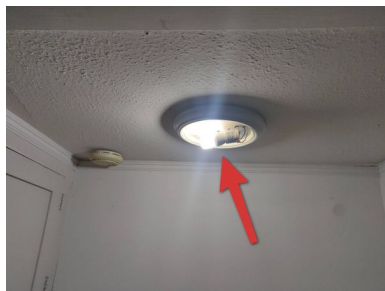
Hallway - missing guard cover.

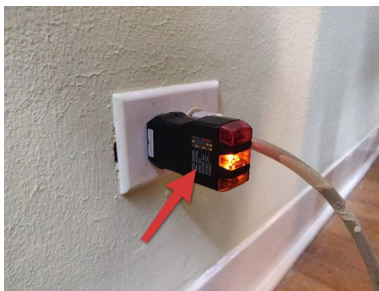
Living room - open ground.

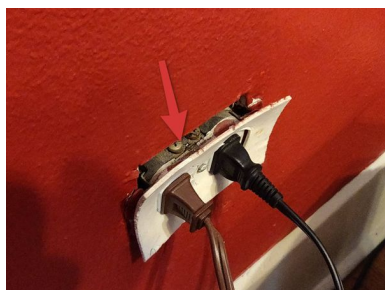
Front right room - missing cover.

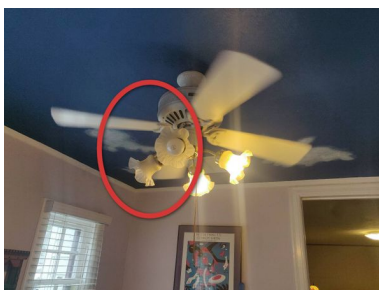
Back hallway - inoperable light bulbs.

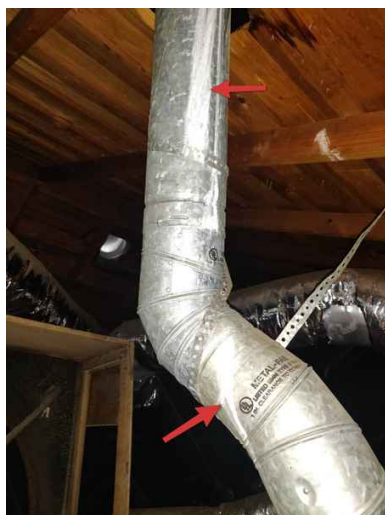
- There are signs of water leaks in the furnace exhaust vent pipe.

Attic 1, furnace exhaust vent.

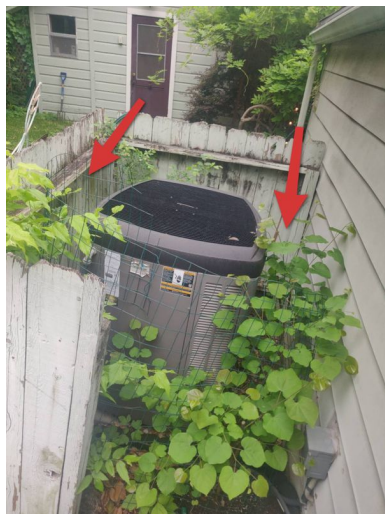
- There is vegetation and debris around the condenser unit. Recommend a minimum of 2 feet clearance around the unit to maximize its efficiency.

Back - A/C condenser unit.

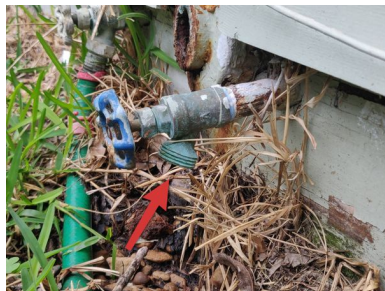
- The right side hose bib is missing a vacuum breaker device, used to prevent contaminated water from being siphoned back into the drinking water system.

Left side - missing vacuum breaker.

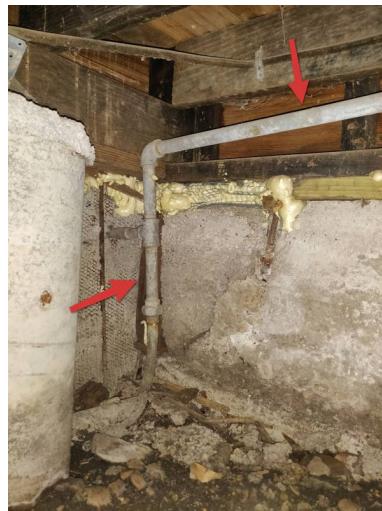
- Galvanized piping was observed as the water supply lines material. Corrosion in galvanized pipes could cause lower water pressure throughout the home.

Crawlspace - galvanized water supply line.

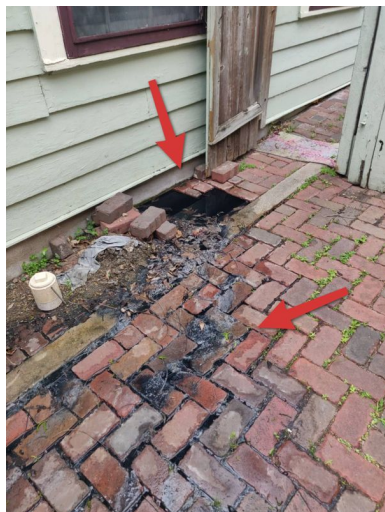
- On the right side of the house, there is a wastewater leak. There is a very strong odor present.

Right side - waste water leak.

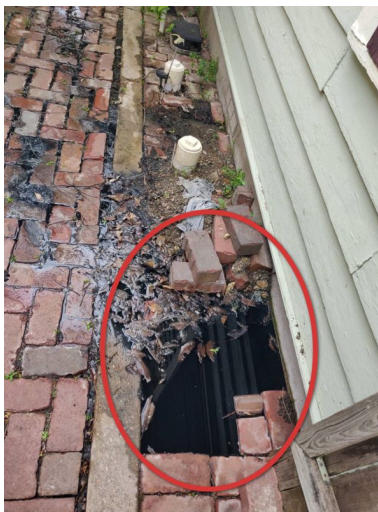
Right side, waste water leak - strong odor.

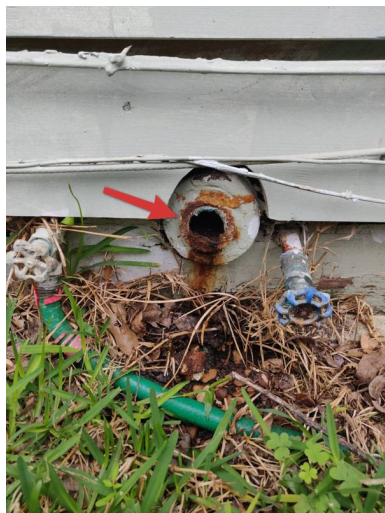
- On the left side, the clean-out is missing a cap. Water was observed coming out of the cleanout.

Left side, cast iron cleanout - missing cap.

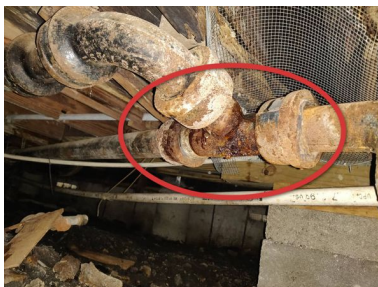
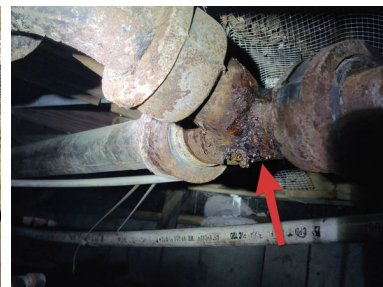
- In the crawlspace, there is a leak in the cast iron sewer/drain line.

Crawlspace, cast iron sewer/drain line - leak.

- Recommend further evaluation of the sewer system by a licensed plumber. Recommend doing a sewer line camera inspection by a licensed plumber to confirm the condition of the sewer lines.

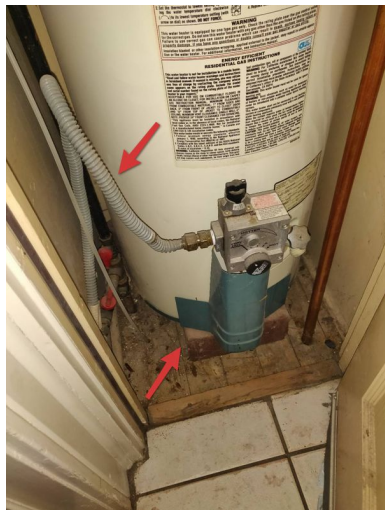
Water heater - missing sediment trap and drain pan.

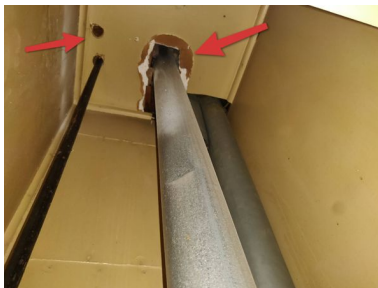
Utility closet ceiling - not properly finished for fire protection.

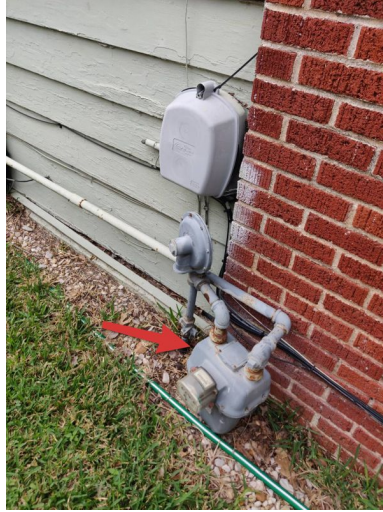
- There are no visible bonding wires present at the gas meter. Bonding the gas meter ensures that normally non-current-carrying conductive objects that are bonded are at the same electrical potential. If metal bodies that are not bonded are at significantly different voltage potentials, and if they are simultaneously contacted, there may be a shock or fire hazard.

Left side - gas meter.
