Appendix

UMLAUF HPEU PLAN

EXISTING CONDITIONS ASSESSMENT

Existing Conditions
Accessibility Assessment

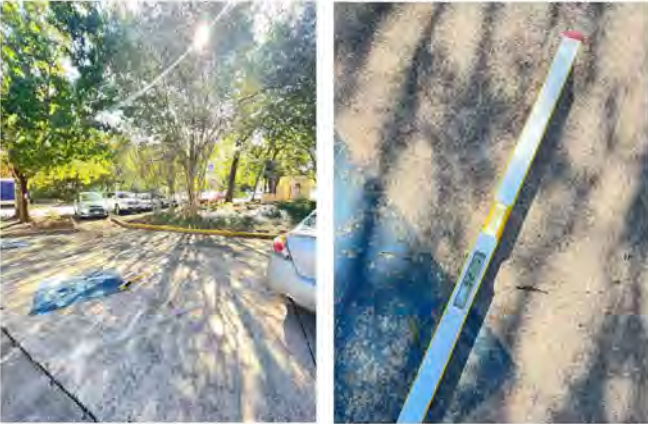
LOCATION: Parking

FINDING: Currently there are two accessible parking spaces. One shall be designated as van accessible with a wider access aisle. The parking slopes are up to 2.6%, whereas 2% is the maximum slope in all directions.

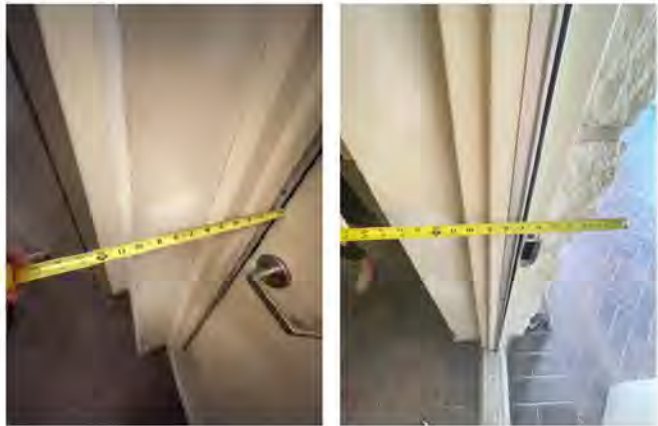
LOCATION: Door to restrooms

FINDING: The door is in a 16" thick overall wall. However, the interior wall is 10" to the door frame and exceeds the maximum thickness allowed for a recessed door. The door shall be reformed within the wall to reduce the interior thickness to 8" or less.

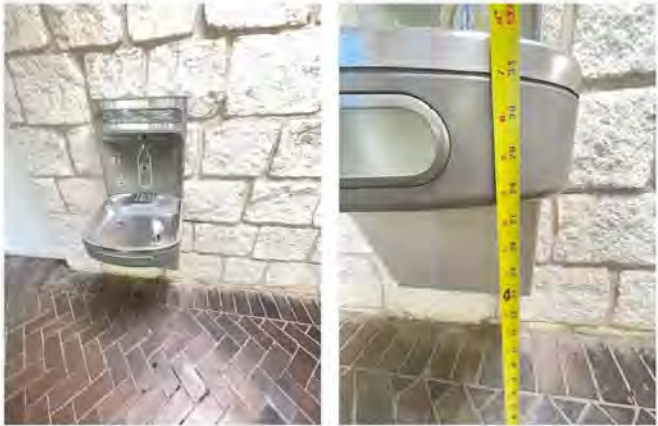
LOCATION: Near the Gallery restrooms

FINDING: There is one 'low' fountain. An additional 'high' fountain shall be provided. The low is also a protruding object as the bottom edge is 27 1/2". The low shall be lowered 1/4" and the high fountain provide an apron for edge protection.

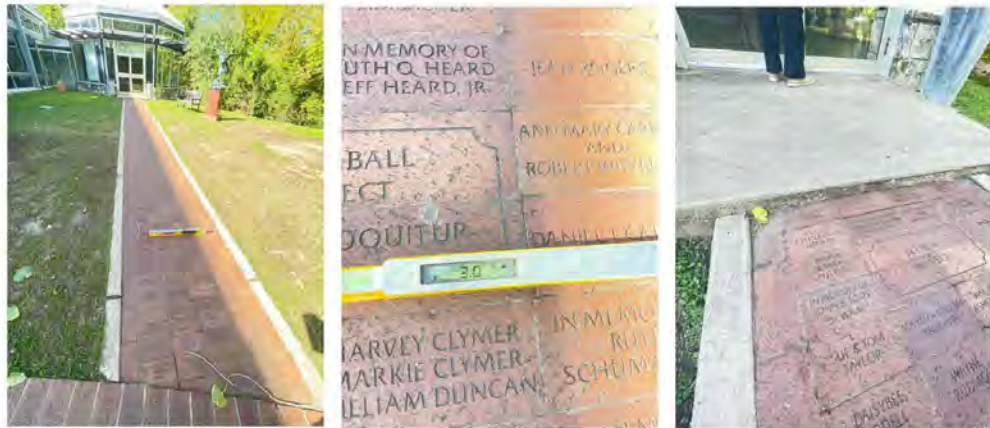
LOCATION: Pavers to Crenshaw Room

FINDING: The red brick pavers have a cross slope of up to 3%, whereas 2% is the maximum. There is also a change in level exceeding 1/4" at the entrance. The pavers shall be reconstructed and the change in level reduced to 1/4" or less.

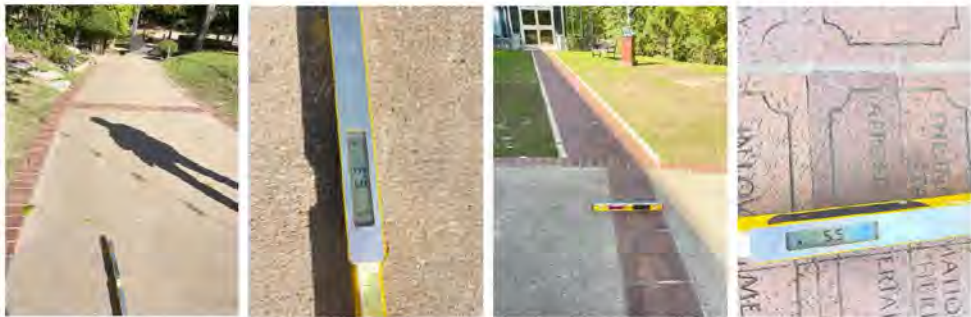
LOCATION: Concrete to the bridge

FINDING: The sloping concrete has a running slope up to 6.3% and shall meet ramp requirements with handrails on both sides and level landings. There is more than a 30" grade drop, therefore shall provide an intermediate landing. Where the change in direction occurs to go to the Crenshaw room, shall be a level landing and not exceed 2%. Currently the slope is 5.5%.

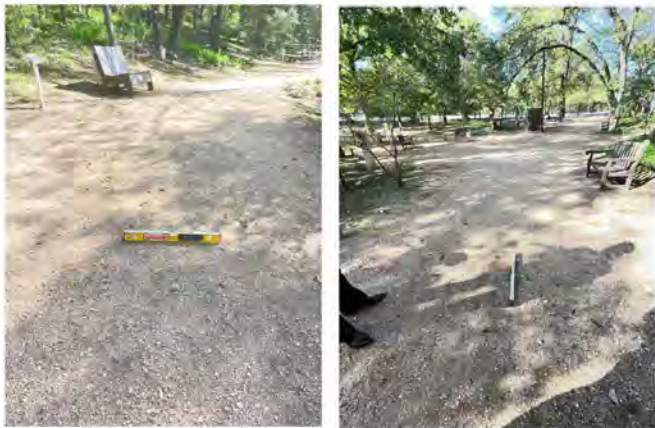
LOCATION: Throughout

FINDING: The decomposed granite routes throughout have inconsistencies in slopes and ground surfaces. Many areas the running or cross slope is excessive. The attached Site Plan has areas noting excessive slopes to regrade. When the routes are regraded, ensure the DG is compacted well with a binding agent.

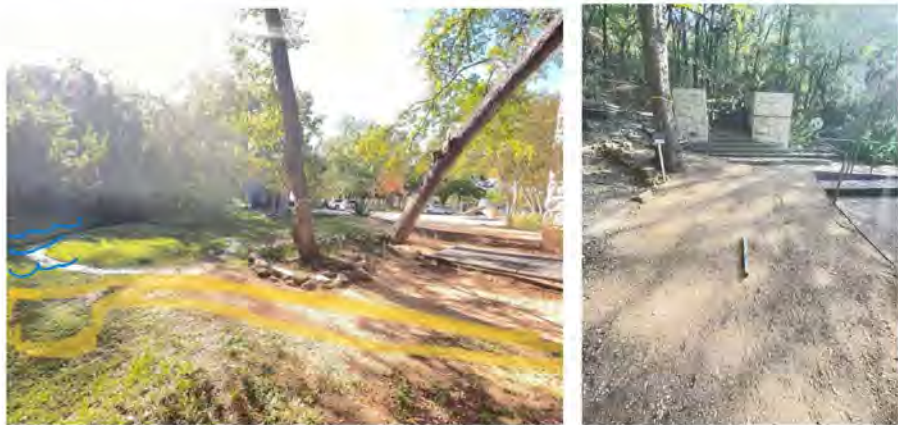
By creating an accessible route to the circular paver art installation, this provides an opportunity to create an equivalent experience from the upper non-compliant trails with the waterfalls. The adjacent waterfalls and louder creek noise could be considered a similar experience from the upper trail.

Wayfinding signage shall be provided at the stairs to indicate what is at the top and also where the equivalent accessible experience is provided.

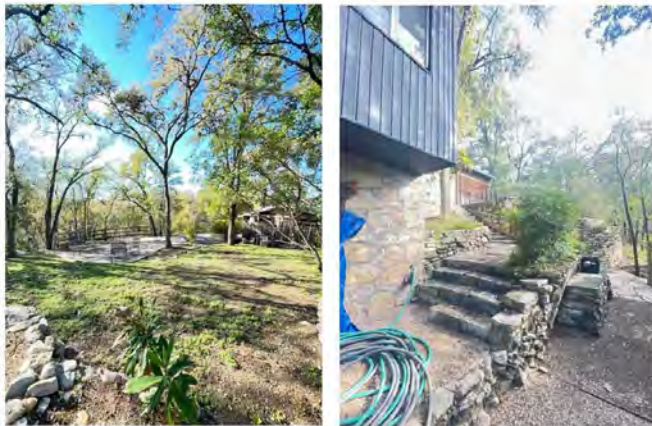
LOCATION: Terraces

FINDING: There are several different levels of outdoor spaces. If each terrace provides a unique experience, each shall be on an accessible route. Depending on what is deemed historic in nature will depict programming in regard to accessibility.

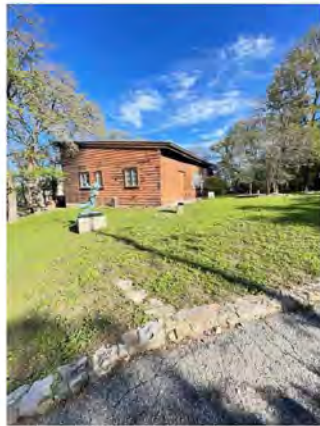
LOCATION: Studio

FINDING: The studio shall be connected via an accessible route. The double doors is the best option with minimal grade changes.

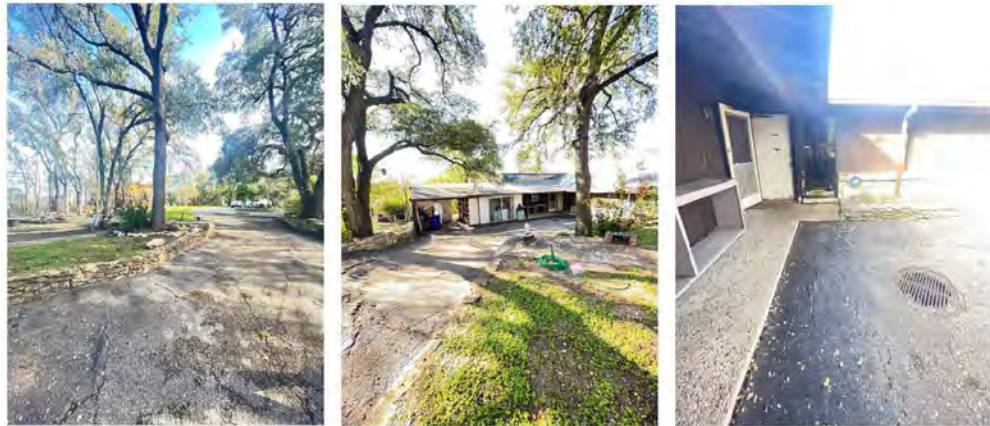
LOCATION: Parking
FINDING: Ensure if parking is provided, there be at minimum one van accessible parking space with an accessible route to the elements and front door entry.

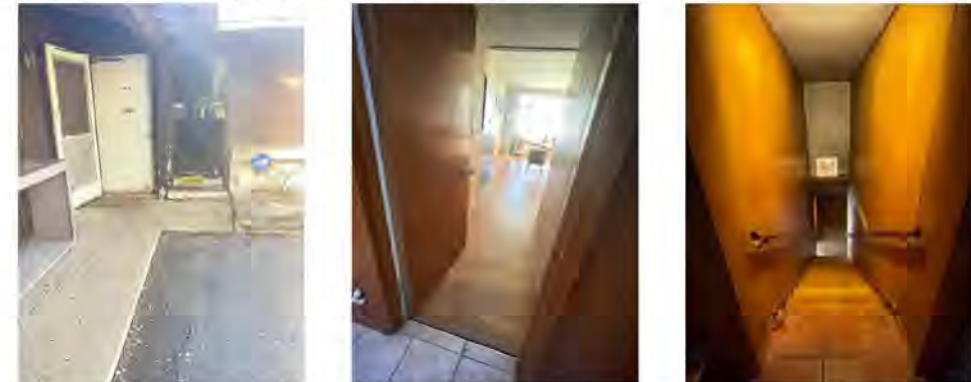
Comment #16: NON-COMPLIANT; Umlauf House Interior

LOCATION: Main Floor
FINDING: Generally, the main floor areas that will be of interest will be accessible for a tour route. The main entry door and throughout the living areas is wide enough to accommodate a 36" accessible route.
Areas of nonconformance to consider if important to be on an accessible route for a Tour or for Employee Use:
Front door hardware.
The current middle office does not provide 18" door maneuvering clearance and 32" door width.
The pink bathroom has no compliant fixtures.
The basement shall provide an accessible route. A route from the exterior is an option. If the exterior is deemed Historic to create an accessible entry point, the experience may be recreated from the upper floor with photos, etc. *See Title II information in the last comment.*
The basement bathroom door and fixtures are not compliant.
